FACILITIES NEEDS ASSESSMENT

STAMFORD PUBLIC SCHOOLS

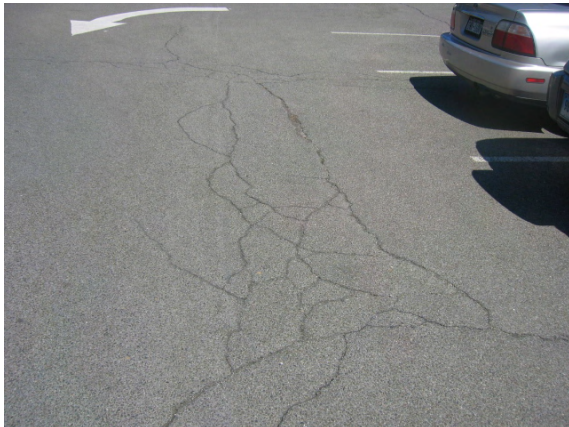
Photo #3: View of open pavement cracks.

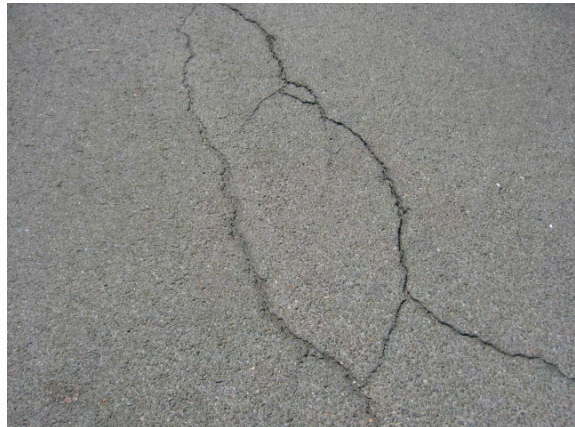
Photo #4: View of open pavement cracks.

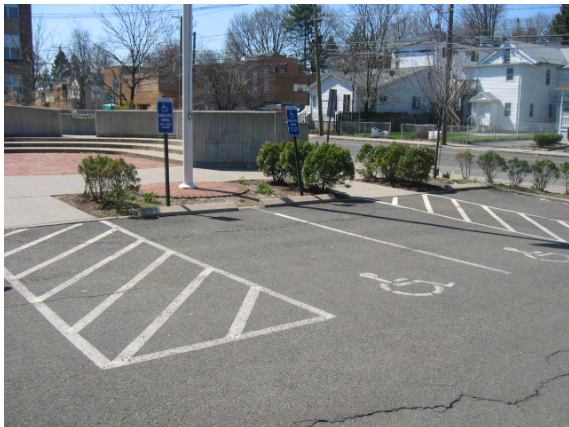
Photo #5: View of accessible parking spaces.

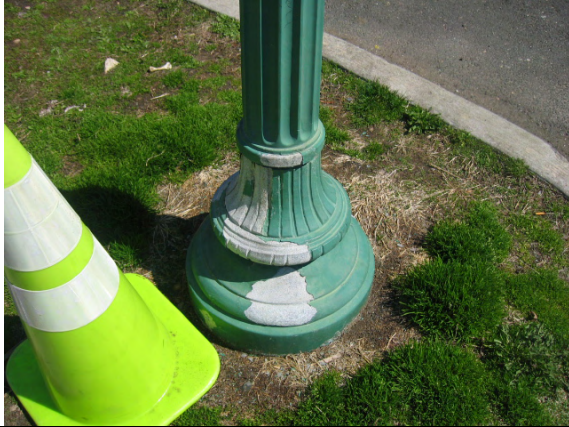
Photo #7: View of deteriorated paint coverings at the base of pole-mounted light fixtures.

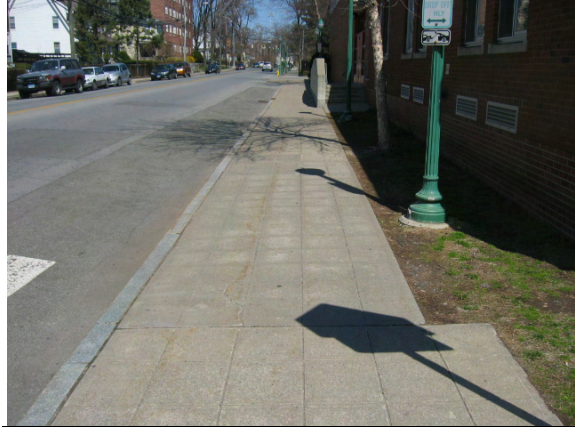
Photo #8: View of cast in place concrete sidewalks along Adams Street.

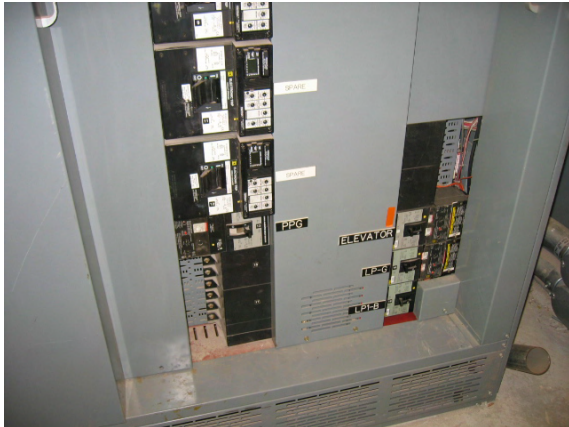
Photo #41: View of missing safety covers on main electrical panels.

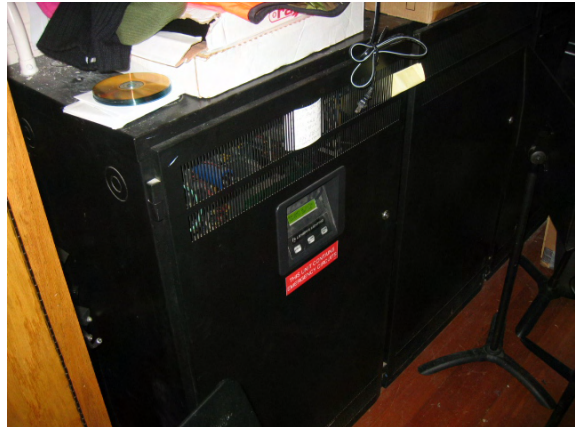
Photo #42: View of back-up battery systems.

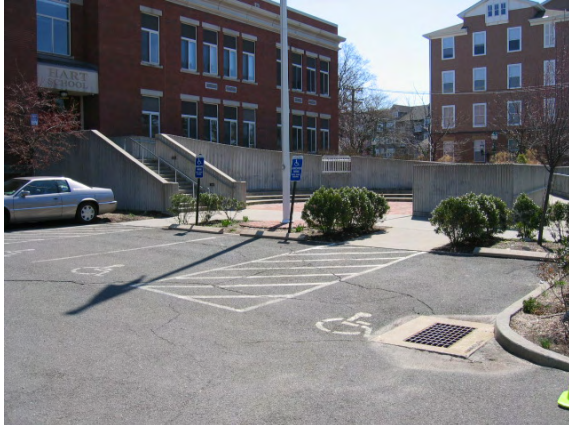
Photo #61: View of the handicapped accessible parking stalls at the front lot. Note missing posted sign to right.

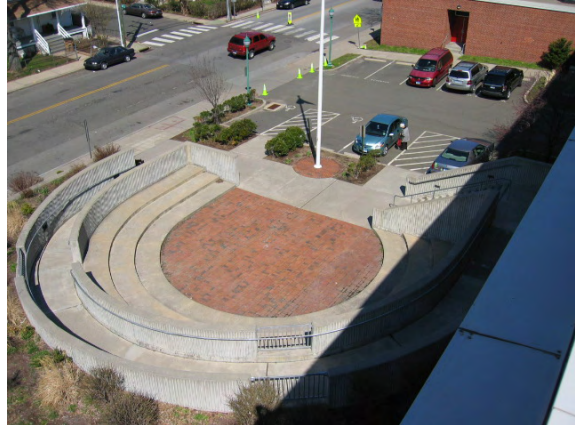
Photo #62: View of the circular concrete ADA wheelchair ramp at front entrance.

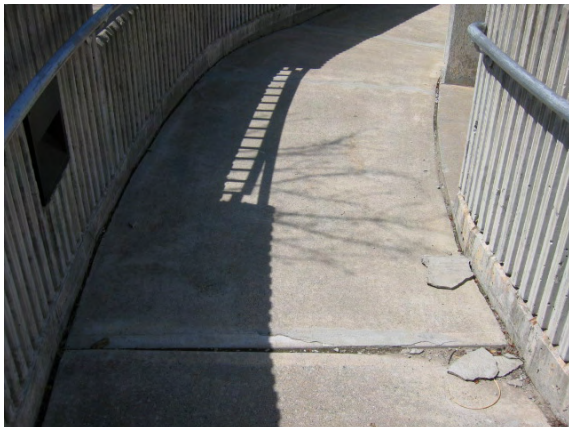
Photo #63: Several sections of deteriorated, spalled and/or settled concrete exist at the ramp.

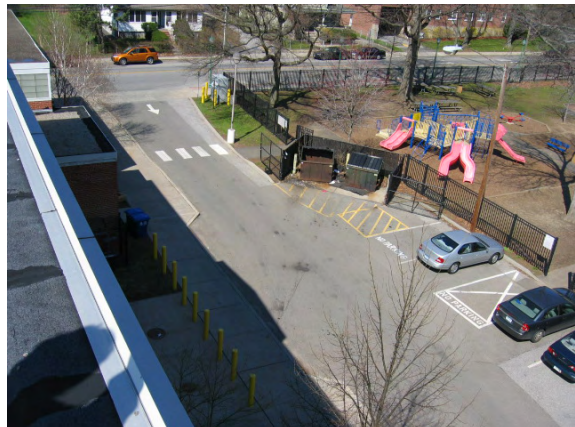
Photo #64: Overview of the north entrance driveway. No striped access aisle exists at main north entrance to playground.

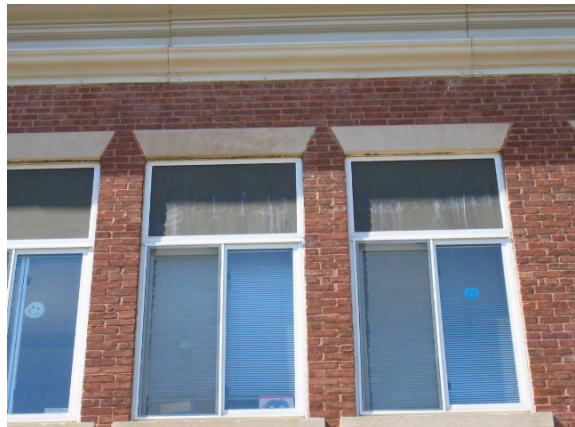
Photo #72: Detail view of the typical upper floor windows with deteriorated masonite transoms.

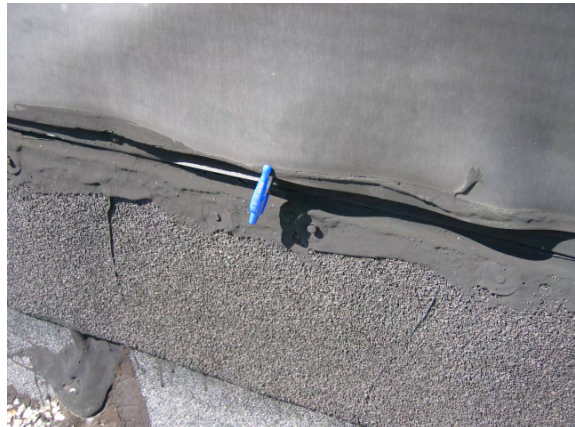
Photo #76: Isolated sections of the inboard parapet EPDM are loose and require repair.

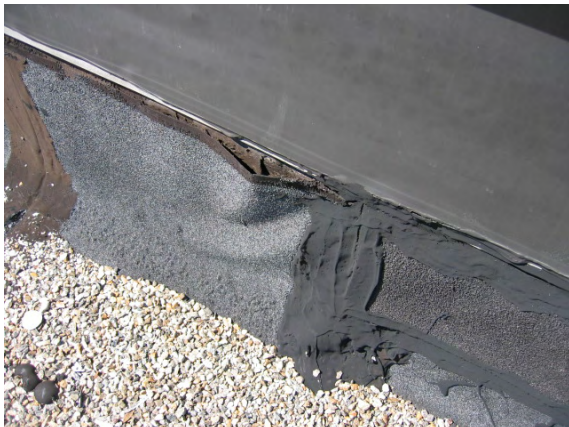
Photo #77: Detail of the isolated deteriorated mastic and base flashings along parapets.

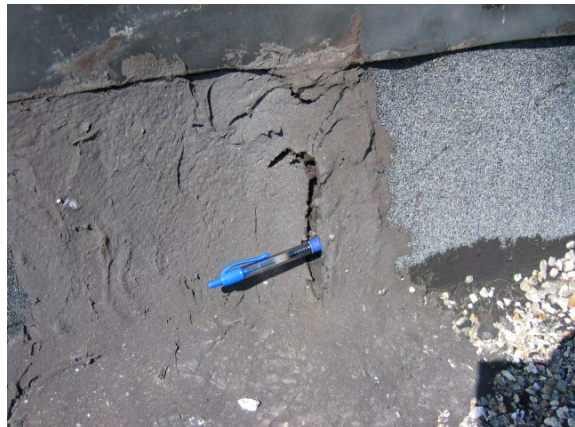
Photo #78: Detail of failed and dry/brittle mastic along parapet inboard surfaces.

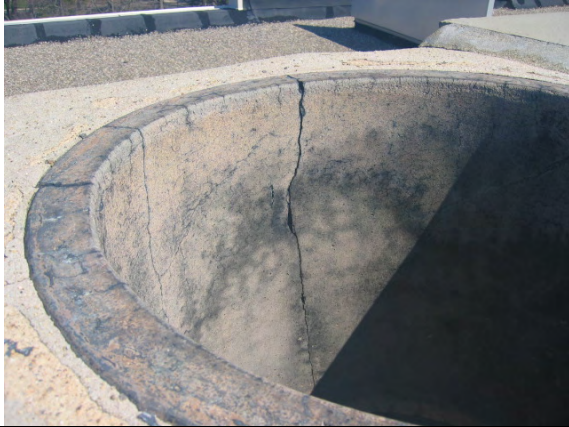
Photo #79: Detail of the cracking within the concrete and tile main boiler chimney.

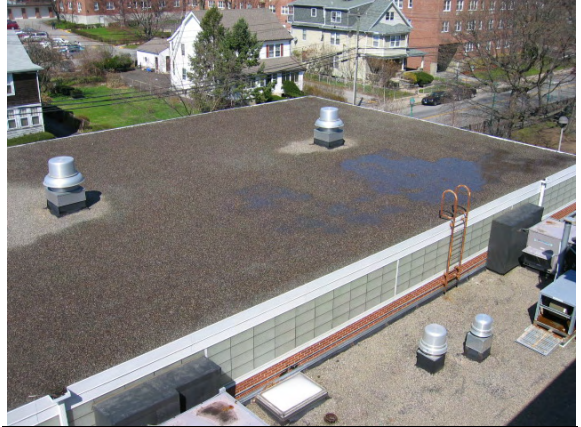
Photo #80: Overview of the flat GSBUR gymnasium roof. Note ponding. Additional drains are required.

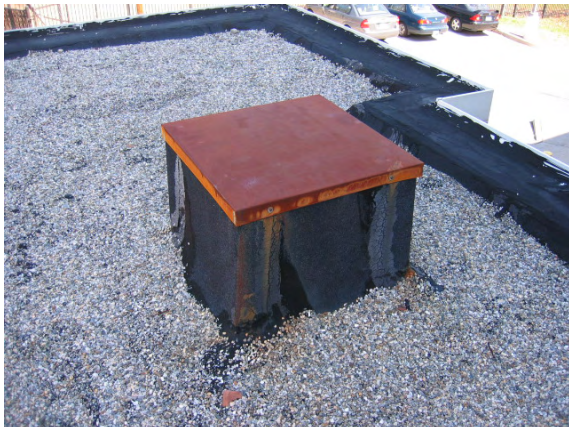
Photo #81: A few of the rooftop metals are rusted requiring routine maintenance and repainting.

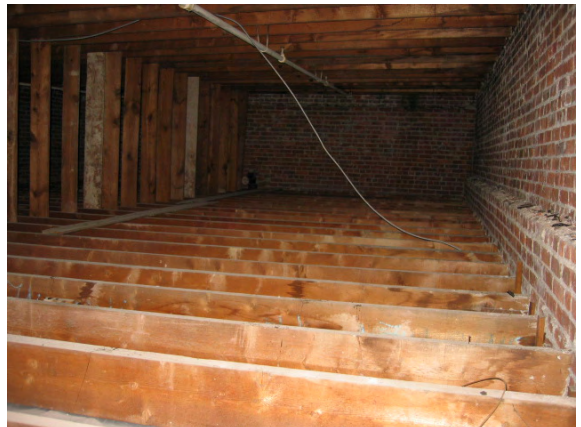
Photo #82: View of the wood framed attic space under the main flat roof system.

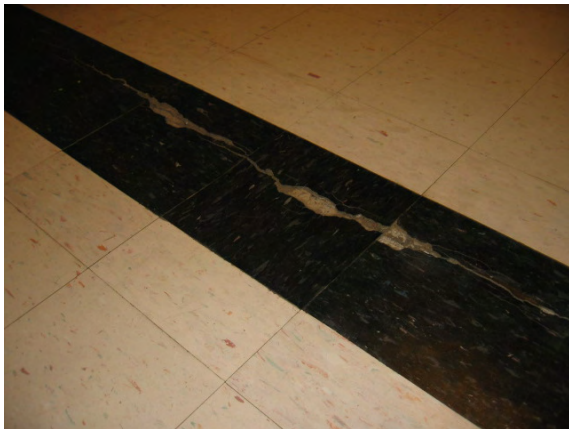
Photo #87: Isolated section of the corridor and classroom VCT flooring are cracked.

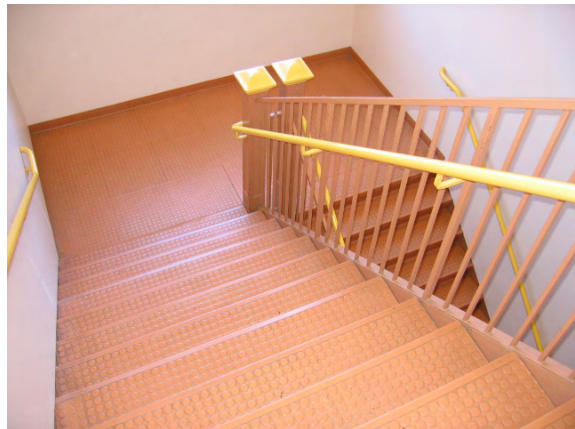
Photo #88: View of a typical common interior stairwell.

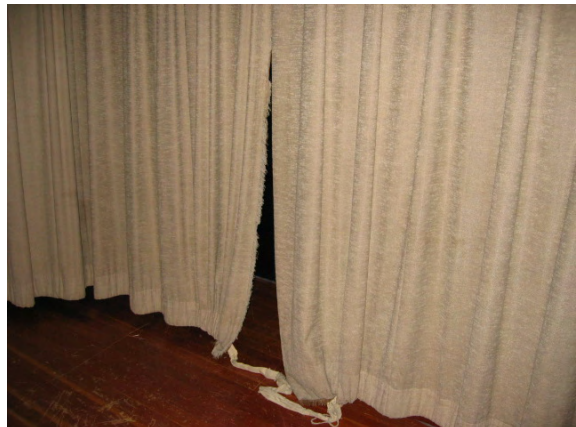
Photo #96: Fair to poor conditions were noted at the stage curtains.

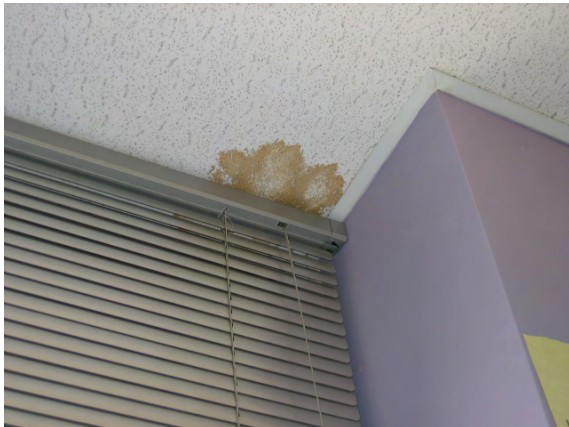
Photo #105: A few isolated stained ceiling tiles were noted along corridors and within rooms.

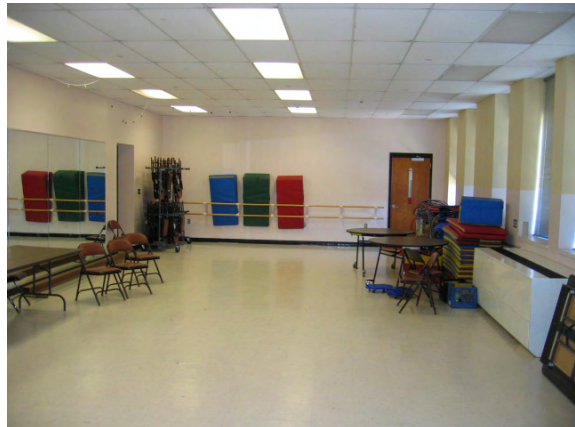
Photo #106: View of the dance studio.
