M. Gottfried, Inc.

RE: Roof report and repair quotation
Hart Elementary School
61 Adams Avenue
Stamford, CT 06902

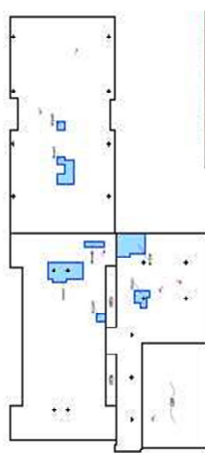
Infra-red wet area plan

The Infrared Thermographic Roof Moisture Analysis prepared by IR Analyzers showed 6 areas of wet roofing on their map. In the field, there are actually 7 areas marked out on the roof. A duplicate number 3 is marked on area B located between wet area #4 and the end of the building. All of the roof levels have wet areas except for area D.

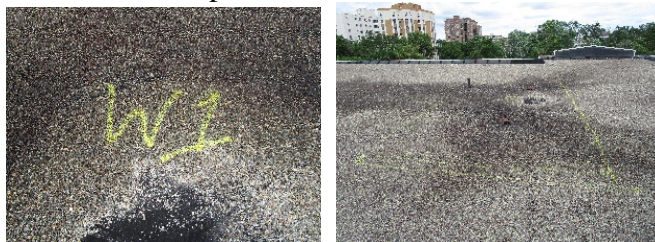
Area #1 encompasses the area around the two roof drains and a vent pipe.

No clear splits or broken blisters are evident in the marked area. We can therefore assume that the drain and vent flashings are the problems. If the wet area is removed and replaced, these items will receive new flashing. That should take care of the water leaks at this location.

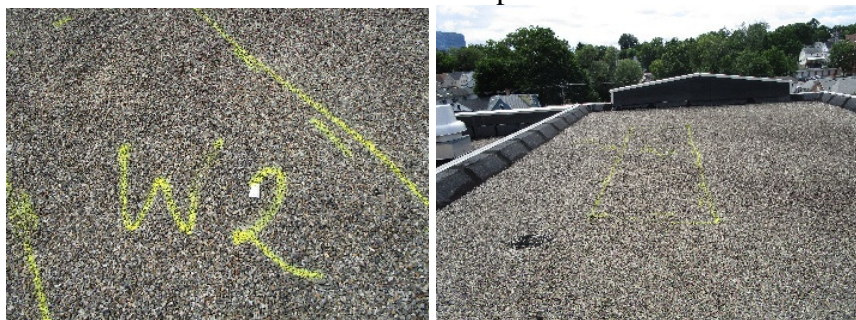
Area #2

Wet area #2 lies toward the middle of part of the roof and has no roof penetrations.

We did not see any blisters or obvious breaks in this area. Further investigation and testing would be performed here to confirm that the area is wet. The ballast would be swept and scraped, multiple test cuts taken, and the surface area thoroughly inspected. If all the additional probes reveal no moisture, sample holes will be repaired and ballast reinstalled. If moisture is found, the area will be replaced. If when removing the area, the source of the water cannot be determined, we shall inspect the nearby base flashing and roof areas. Since two roofs are present, it is possible that water can get in at the walls or nearby area, travel on top of the underlying roof and pool/leak in the marked area.

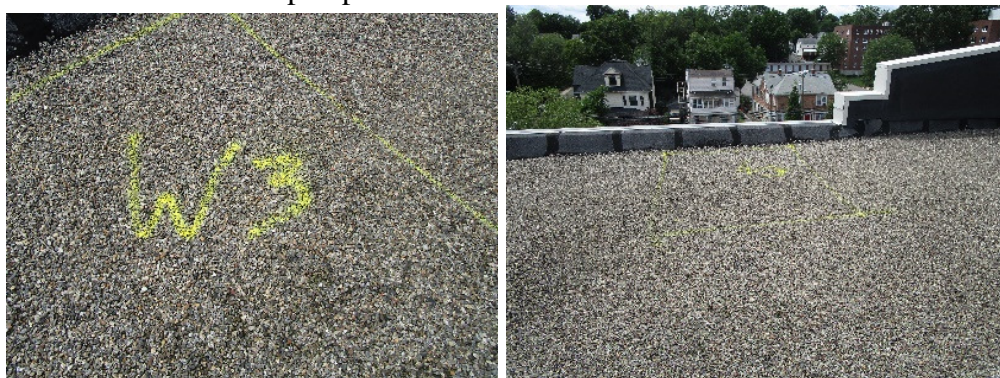
Area #3 lies next to a parapet wall.

Water infiltration at this area may be from the wall flashing or cracks in the membrane. The area should be removed and replaced. The membrane of the parapet next to this area should be replaced as well.

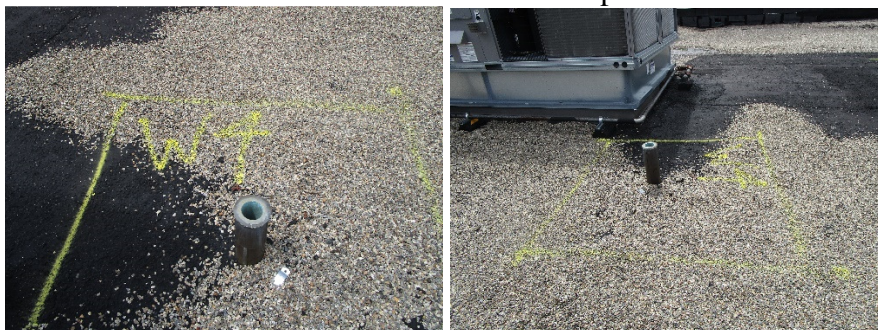
Area #4 lies at the corner of one of the roof top units and is around a vent pipe.

A test cut was performed in this area and the area was wet. The area should be cut out and replaced. Along with replacing the membrane and wet insulation, the vent would be reflashed, and we would also recommend reflashing the short and long side of the roof top unit curb that abuts the marked area.

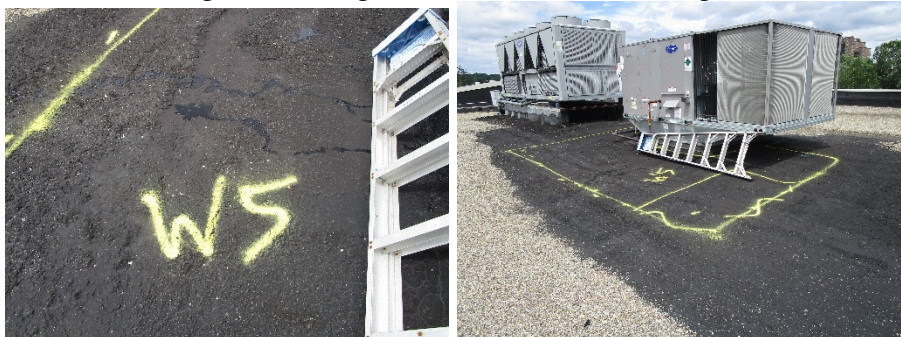
Area #5 is a large area that goes from one side of a large unit out into the field of the roof.

The roof has been coated to try to prevent leaks (as it has in a number of the marked areas on this school). It is not possible to see the condition of the membrane under the coating, so removal/replacement is recommended. In addition to replacing the marked area, the side of the roof top unit curb should also be reflashed. As a precaution the unit itself should be looked at by a mechanical contractor to make sure the leak does not originate from the unit and travel under the roof. The unit curb extension covers must also be looked at.

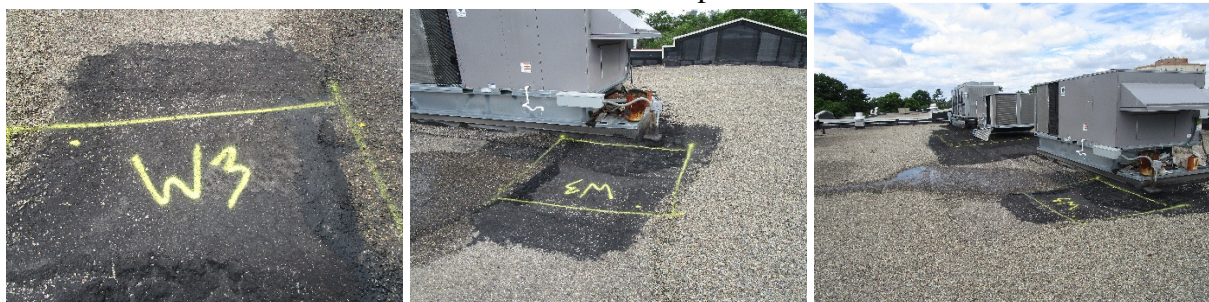
Area #3A (duplicate number 3 marked on the roof but omitted from the plan) lies a bit further down the roof from area #5. It also lies at the corner of a roof top unit.

In addition to removing and replacing the wet area we would also recommend reflashing the two sides of the roof top unit that abuts the area. This unit should be checked as well for leakage.

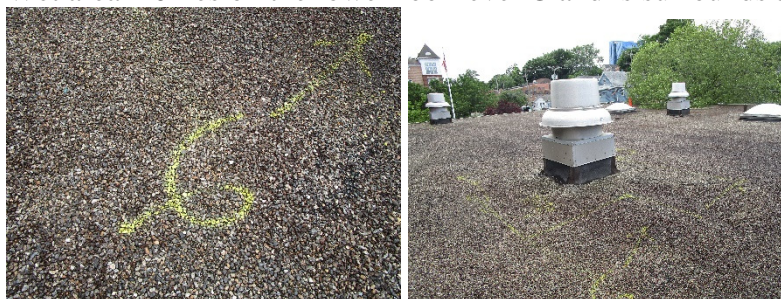
Area #6

Wet area # 6 lies on the lower roof level C and is surrounds a fan curb.

Any wet membrane/insulation around the curb should be removed and replaced and the curb reflashed.

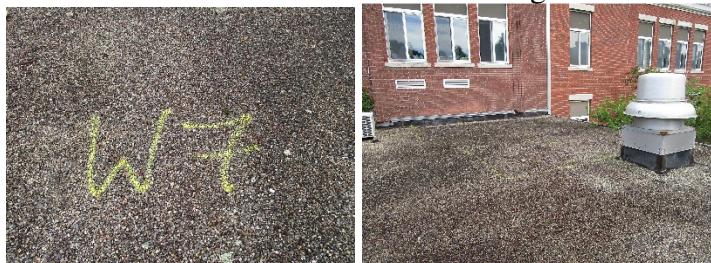
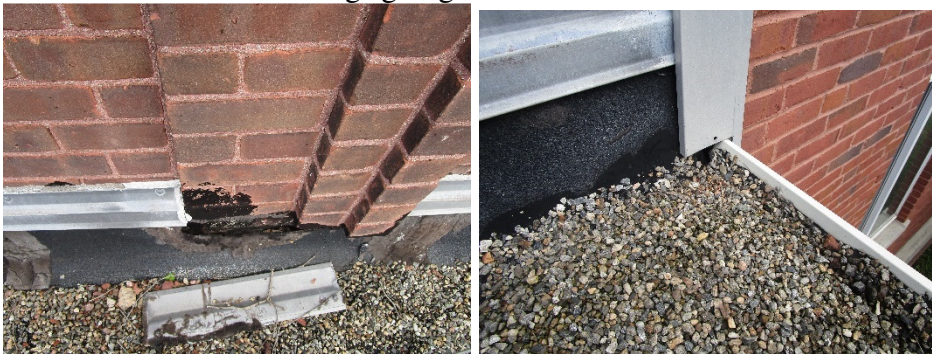
Area#7

Wet area #7 lies in the corner of roof C against the wall of the higher part of the building.

There are a number of things going on in this area.

Some of the wall counter flashing has come off, caulking at the counterflashing has shrunk and the base flashing is suspect. In addition to replacing this wet area the counter flashing needs to be repaired, replaced where missing, and recaulked.

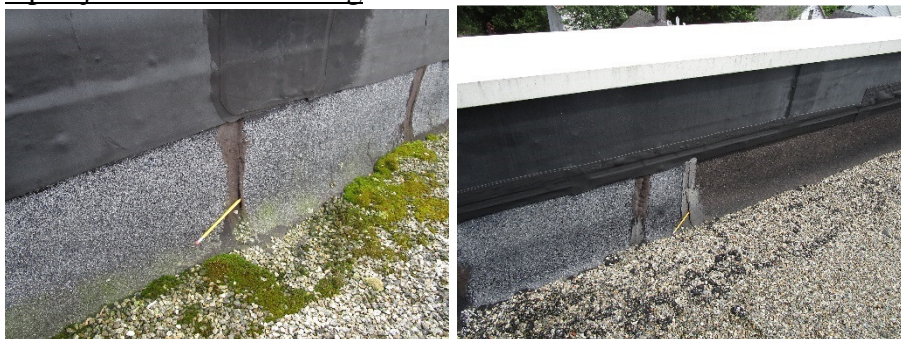
Open joints in base flashing

Open laps in the base flashing can let water into the roofing system. To repair an open flashing lap, we would scrape the gravel back at the roof and overlay the lap with two plies of mastic and reinforcing fabric.

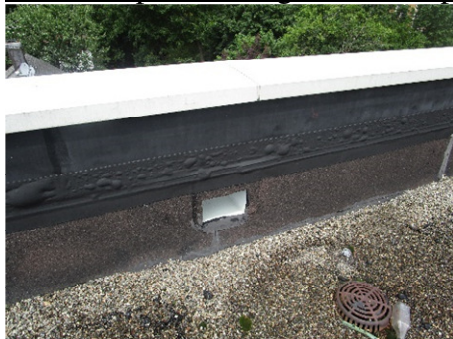
Possible open flashing around scupper openings

We recommend installing a reinforced bituminous resin membrane flashing, (Alsan flashing or equal), From the wall base flashing, turning into the scupper opening. This will seal the edge of the base flashing where it is cut around the scupper opening.

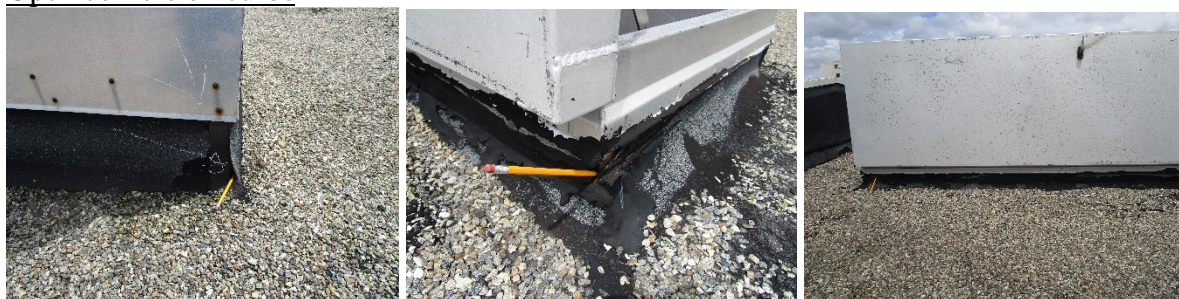
Open corners on curbs

Open corners at curbs will also let water into the roofing system. The corners and flashing of the roof hatch have shrunk and slipped enough to expose the wood blocking. All curbs must be checked, and any open corners repaired as described for base flashing laps. The entire roof hatch should be reflashed. recommended maintenance work found cover items more likely to problems Roof maintenance is designed to

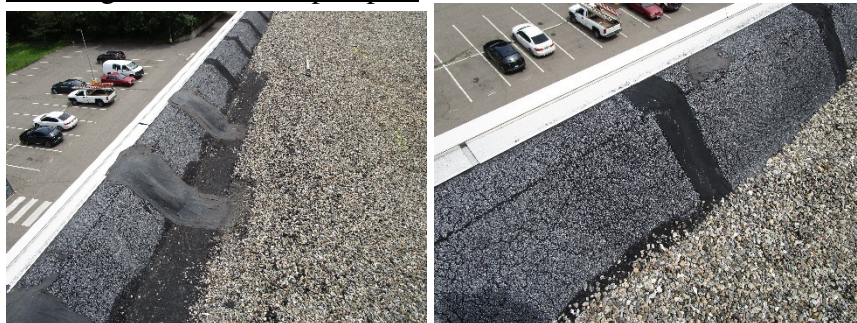
Flashing on low canted parapets

Them membrane on the low canted parapets is showing its age. Cracks and splits are visible in all areas with this detail. To replace or overlay all of this flashing would be costly. At this point in time we would recommend only repairing the open laps or any holes found in the membrane. There are also blisters (bubbles) found in the membrane of this detail and some of the vertical base flashing. These should be cut and properly sealed and repaired. The area around the blisters should be checked for holes or openings that could have let moisture in.

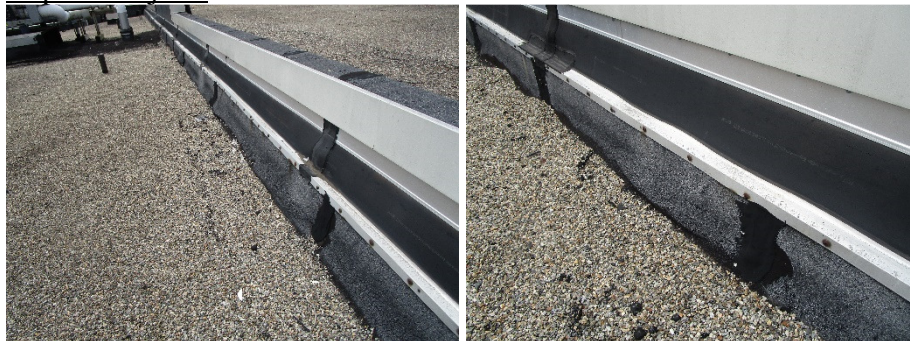
Expansion joint

Roof B is lower than roof A. At the wall between them an expansion joint is installed between the end curb of roof b and the wall of roof A. the EPDM flashing at the joints of the expansion joint needs to be checked for cracks and breaks. If any are found, the area must be properly prepared and new EPDM flashing installed. In addition, all fasteners securing the flanges of the expansion joint should be checked, replaced if missing or loose and caulked if needed.

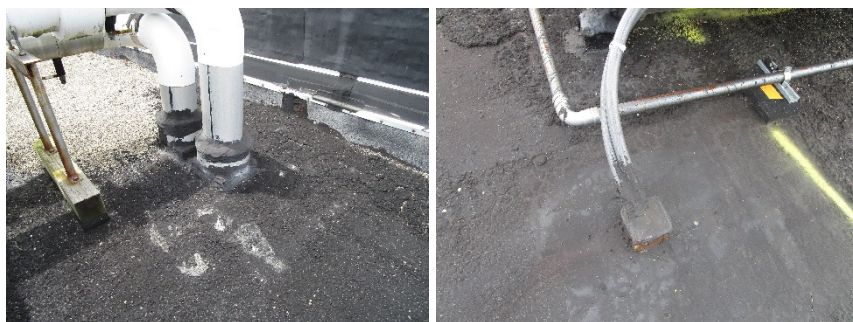
Pipes and penetrations

All penetration flashings should be checked and reflashed as necessary. We can assume that since coatings have been spread around the penetrations, leaks have occurred around them in the past. If a penetration flashing falls within the “wet areas” being replace, they will receive new flashing as part of

that work. If they do not fall within a “wet area” they will be checked, topped off, and or restriped as part of the comprehensive maintenance work. Items such as the two insulated pipes shown will be checked to see whether the sealer in the pocket goes all the way to the pipes, or if it stops at the plastic and insulation. Since the plastic cover and insulation are typically not waterproof, if the sealer stops there the sealer, plastic and insulation will be removed, new sealer installed to the pipe, and the plastic covering and insulation reinstalled down to the filler.

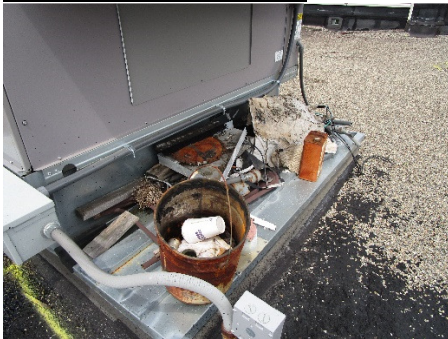
Curb retrofit extensions

It appears that the roof top units have been previously replaced and installed on the old curbs. The new units are smaller than the old ones and metal covers were put on the ends of the old curbs to make up the sizing difference. These extensions have become collection points for debris. The debris needs to be removed. In addition, the covers need to be checked to see if there are any holes in them or if any of the seams or joints are open and could let water in. These cover extensions appear to be at the ends of the roof top unit curbs near the “wet areas”. Checking and repairing this item straddles both the wet area work and maintenance work.

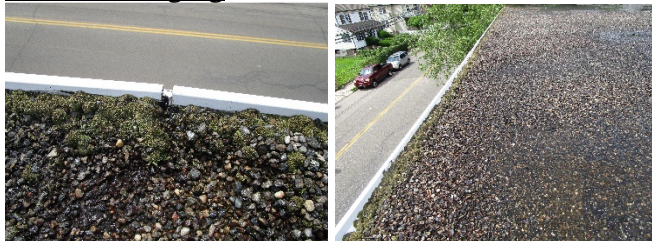
Perimeter edging

Moss is growing along the edge detail of this roof. No action is to be taken to remove this as part of the maintenance, but the condition should be noted and possible investigated in the future. The dampness and ponding on this roof may be promoting this growth.

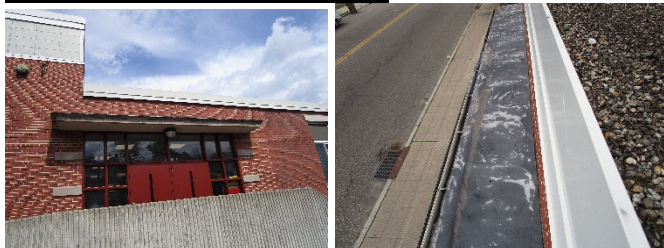
Low canopy roof over doors

The low canopy over the doors looks like it is in poor shape. We are not sure of the “importance” of this roof with regards to the overall issues mentioned above and have not included any maintenance work on it. Installing a new membrane can be quoted upon request.

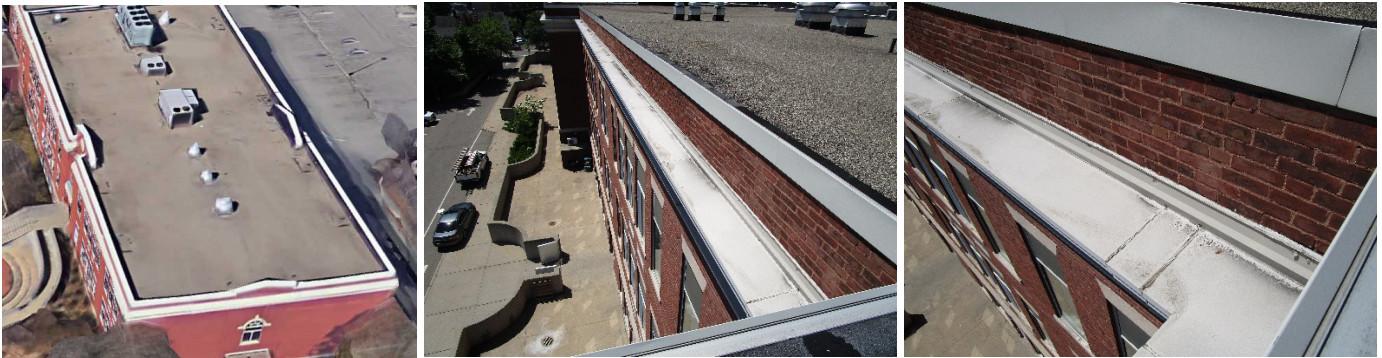
Roof shelf around upper main roof

When we performed our inspection of the roofs at Hart School, we were told of leaks that had been occurring above the windows of the top floor. The leaks do not always occur. We were also told that someone tried to repair the leaks by caulking the counterflashing above the shelf. This slowed down the leaks. We feel that these leaks are from the shelf, counterflashing above the shelf or the caulking of the counterflashing. If the leaks came from the roof, it would occur in almost all rains. In addition, if they came from the roof or parapet flashing, they would have shown up on the infrared test. One way to confirm this theory is to put a hose over the wall and water test the shelf and counterflashing. If the leak shows up, then the source comes from the components of the shelf. A possible repair could be to recaulk the shelf and counterflashing using an aerial lift. Testing and repairs are not included in this report, but we could furnish pricing upon request or the Construction manager can perform the work with their own forces or with a building caulker
