**Stark Elementary School**

City of Stamford

**DRAFT** Figure 1.1 - Areas of Concerns

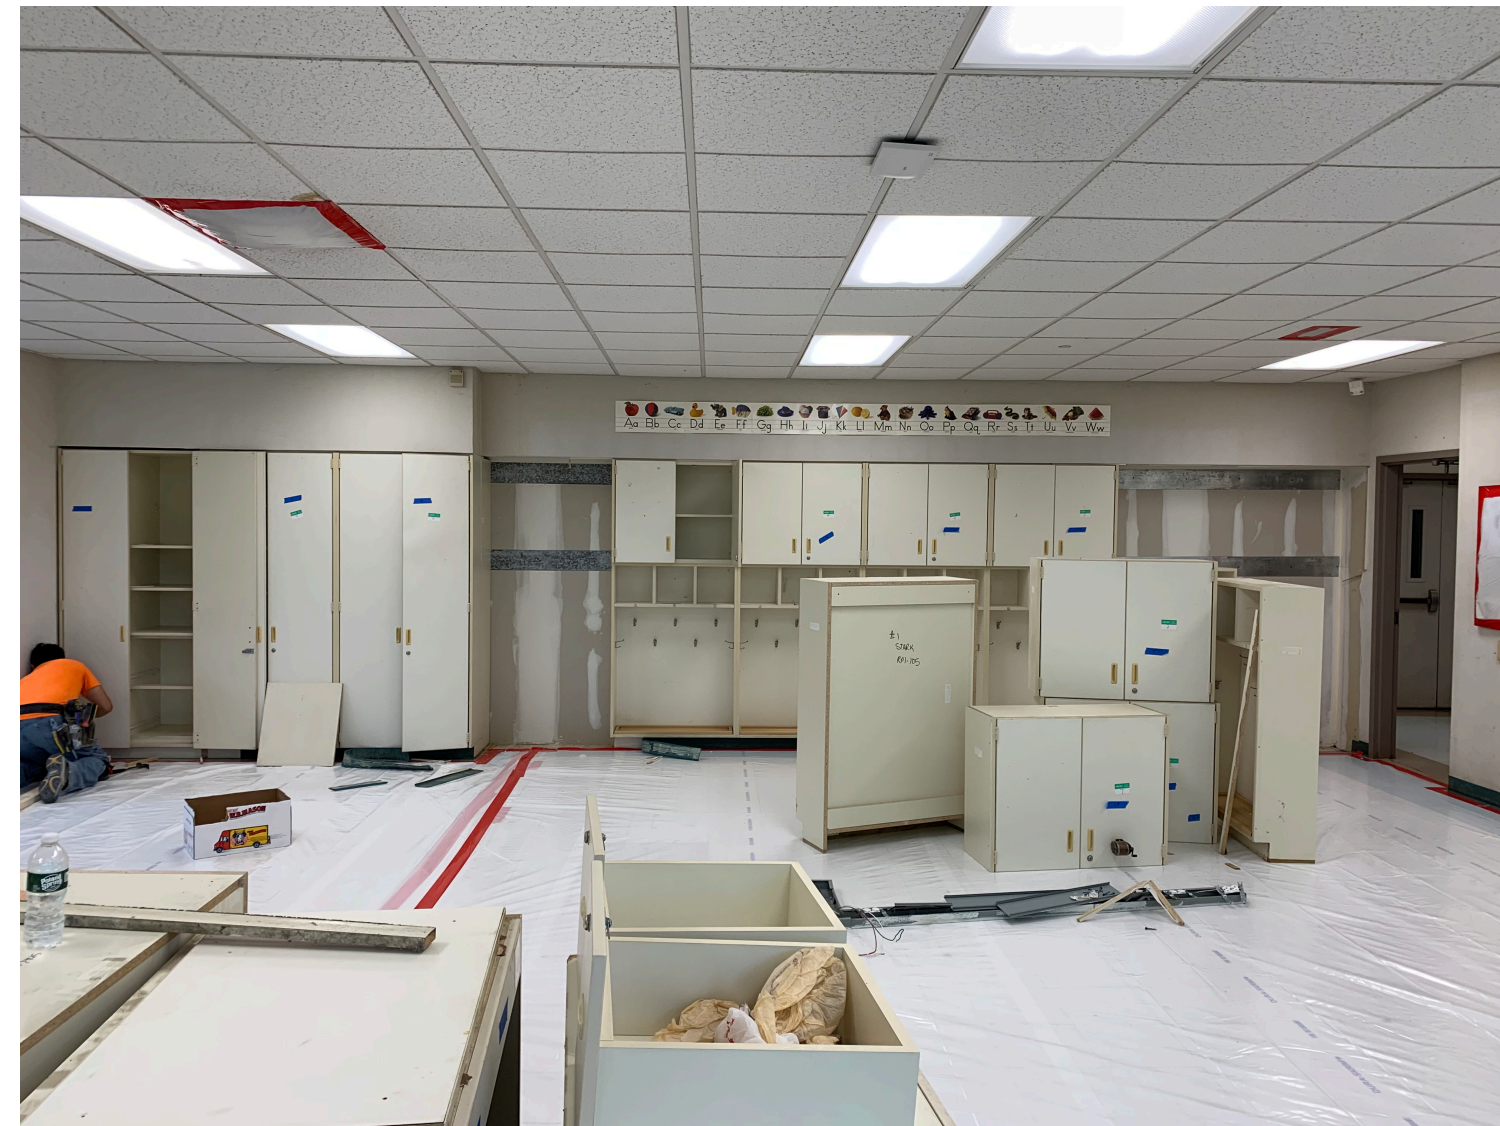
Room 105 removal of millwork

In process of demo: removing existing millwork, wall covers and drywall

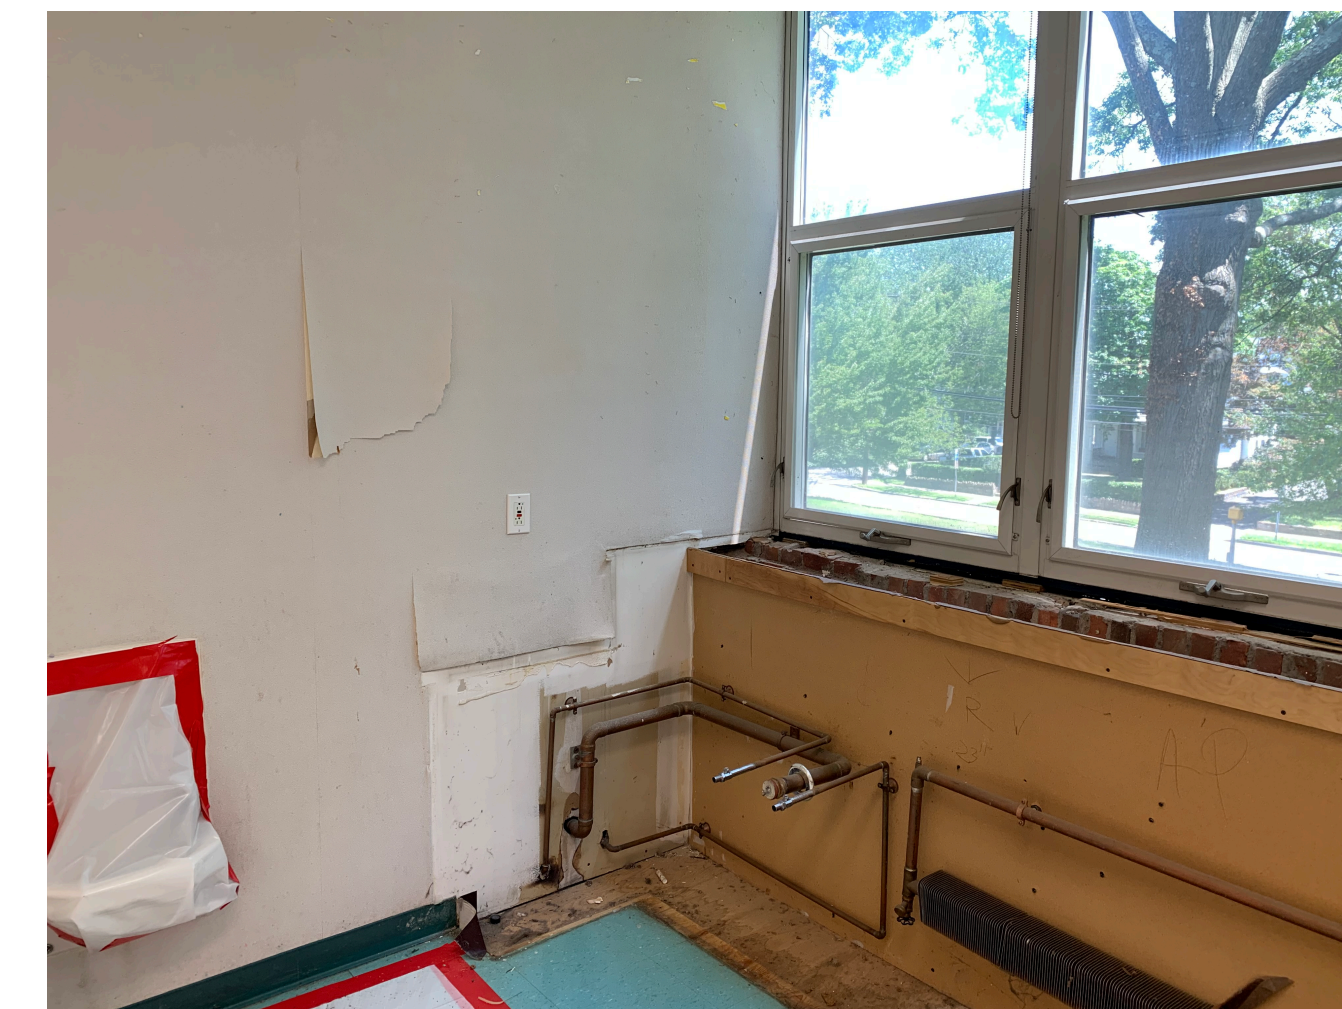
Room 105 removal of wall covering

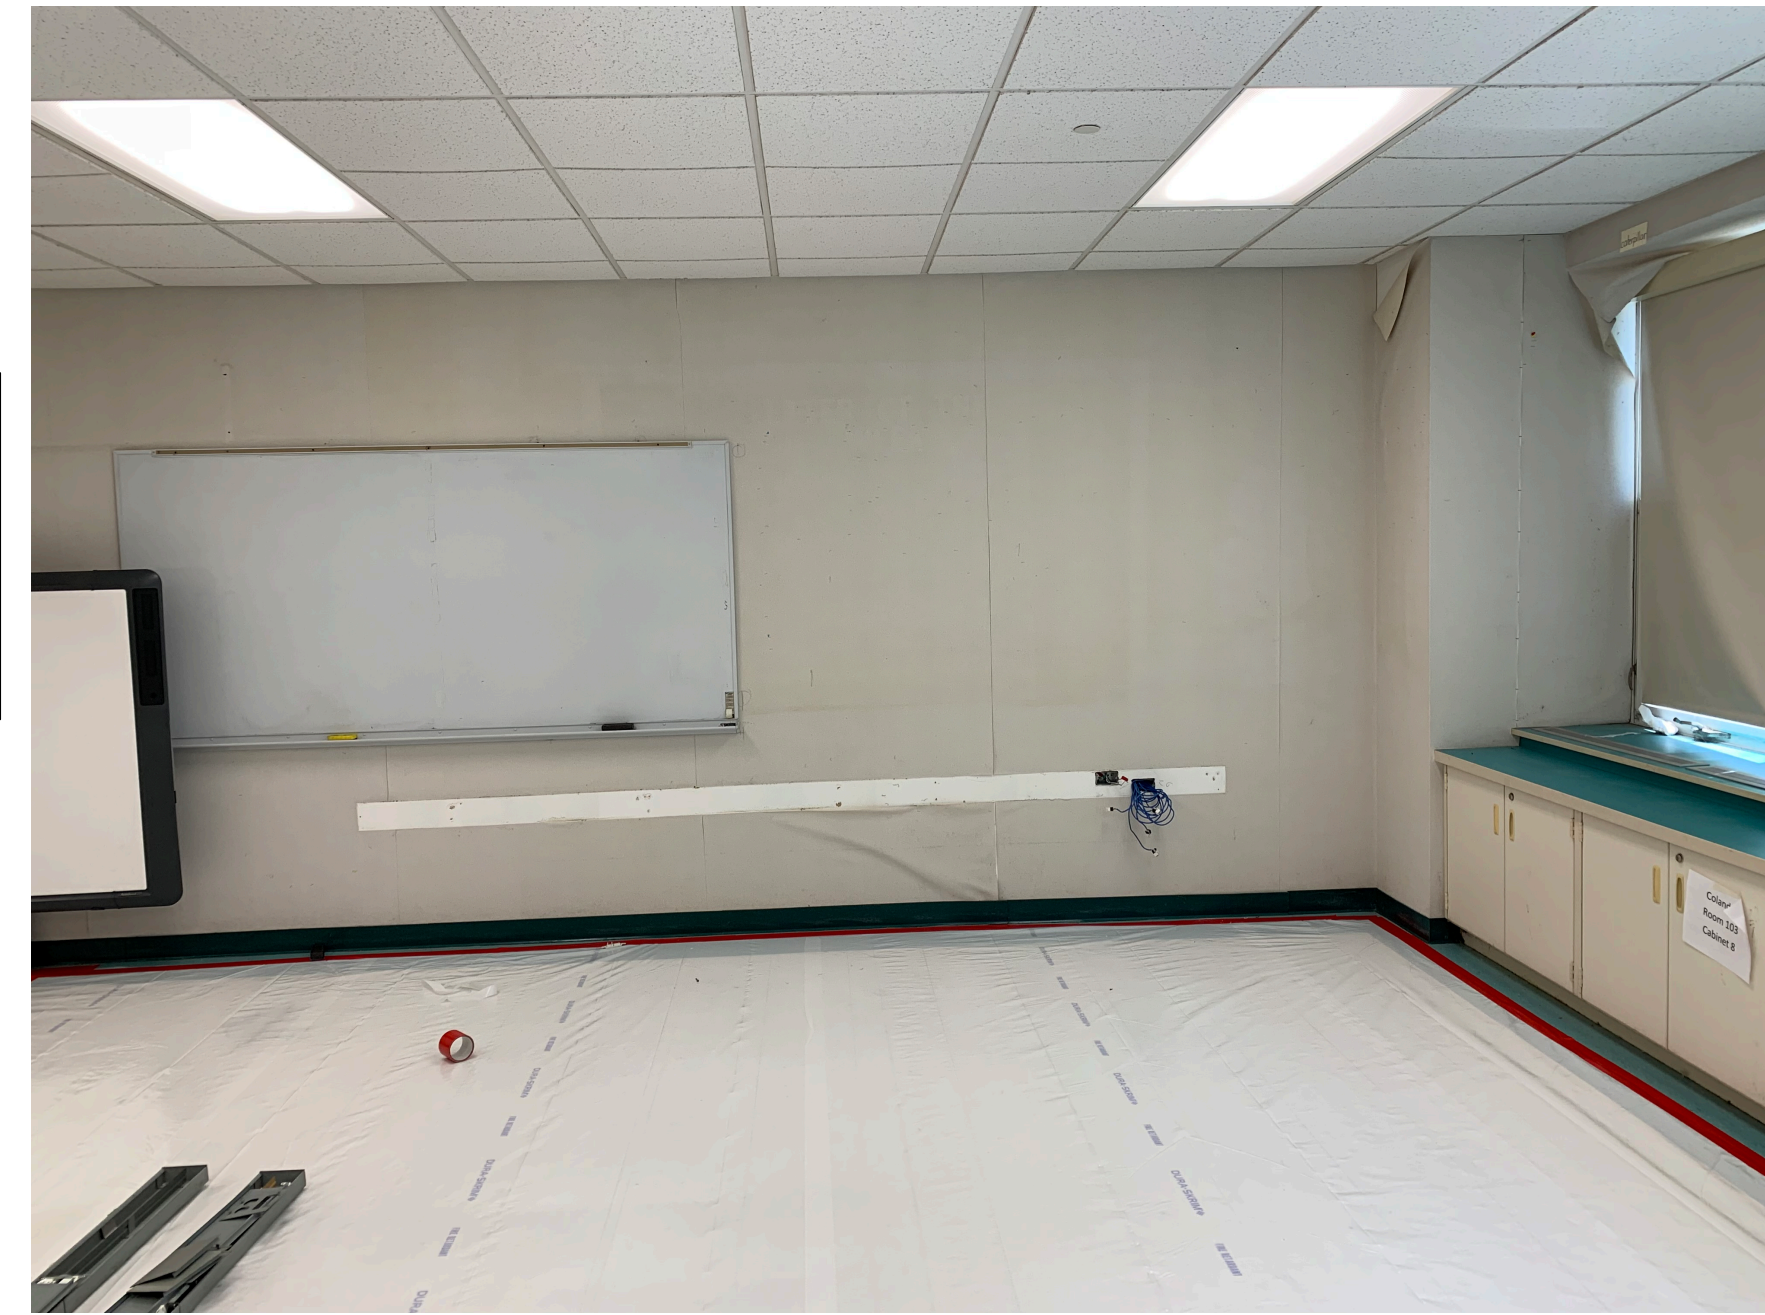
Room 103 Before beginning demo

In process of demo: removing existing millwork, wall covers and drywall

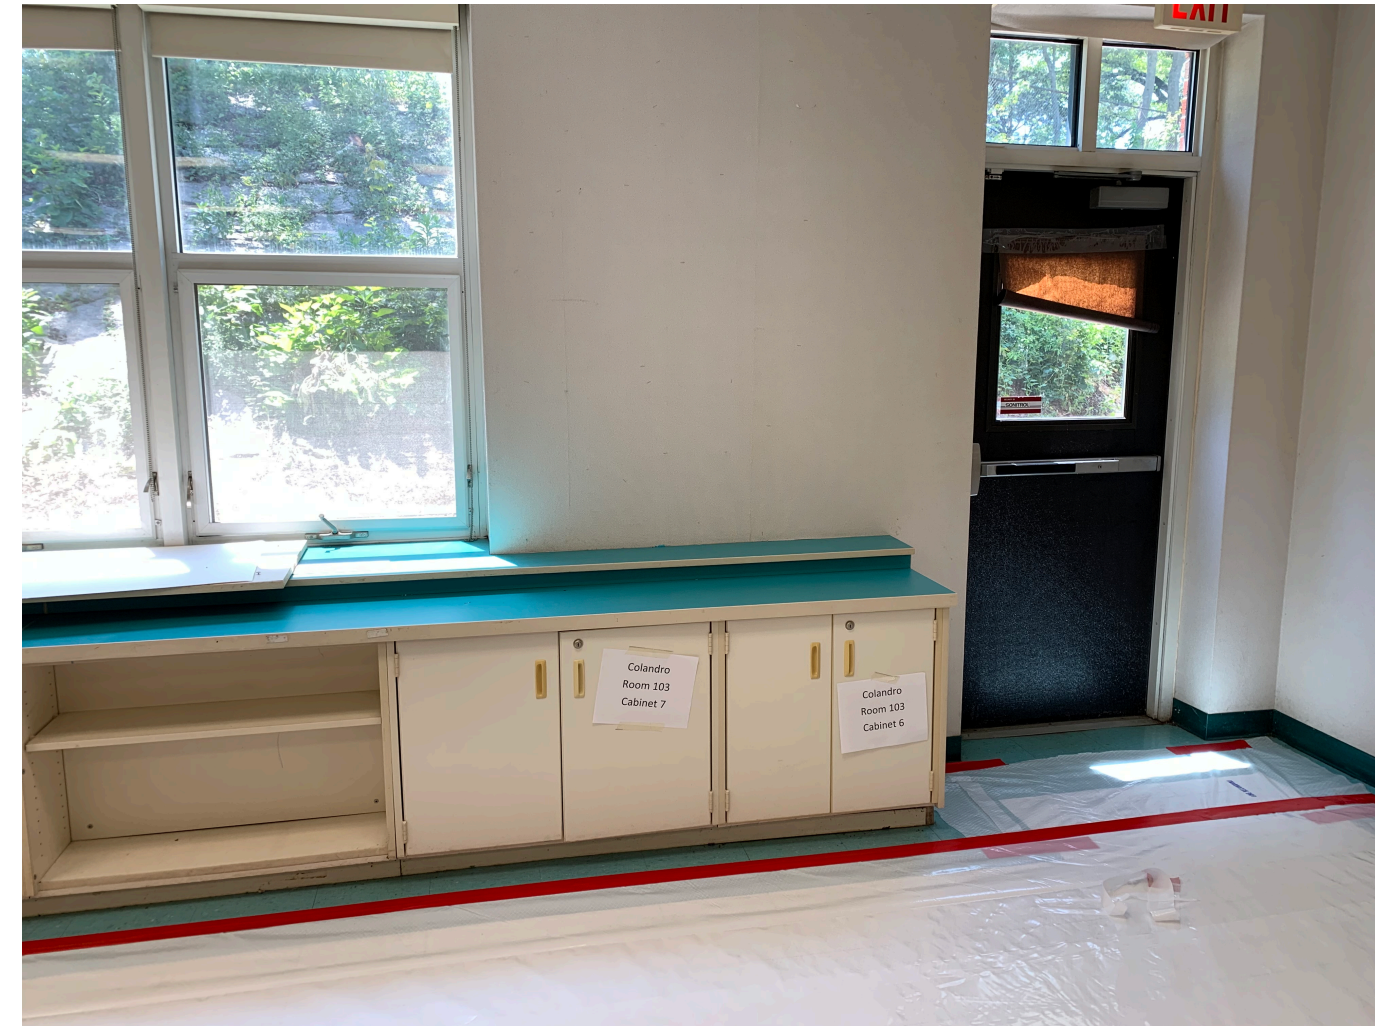
Room 103 Before beginning demo

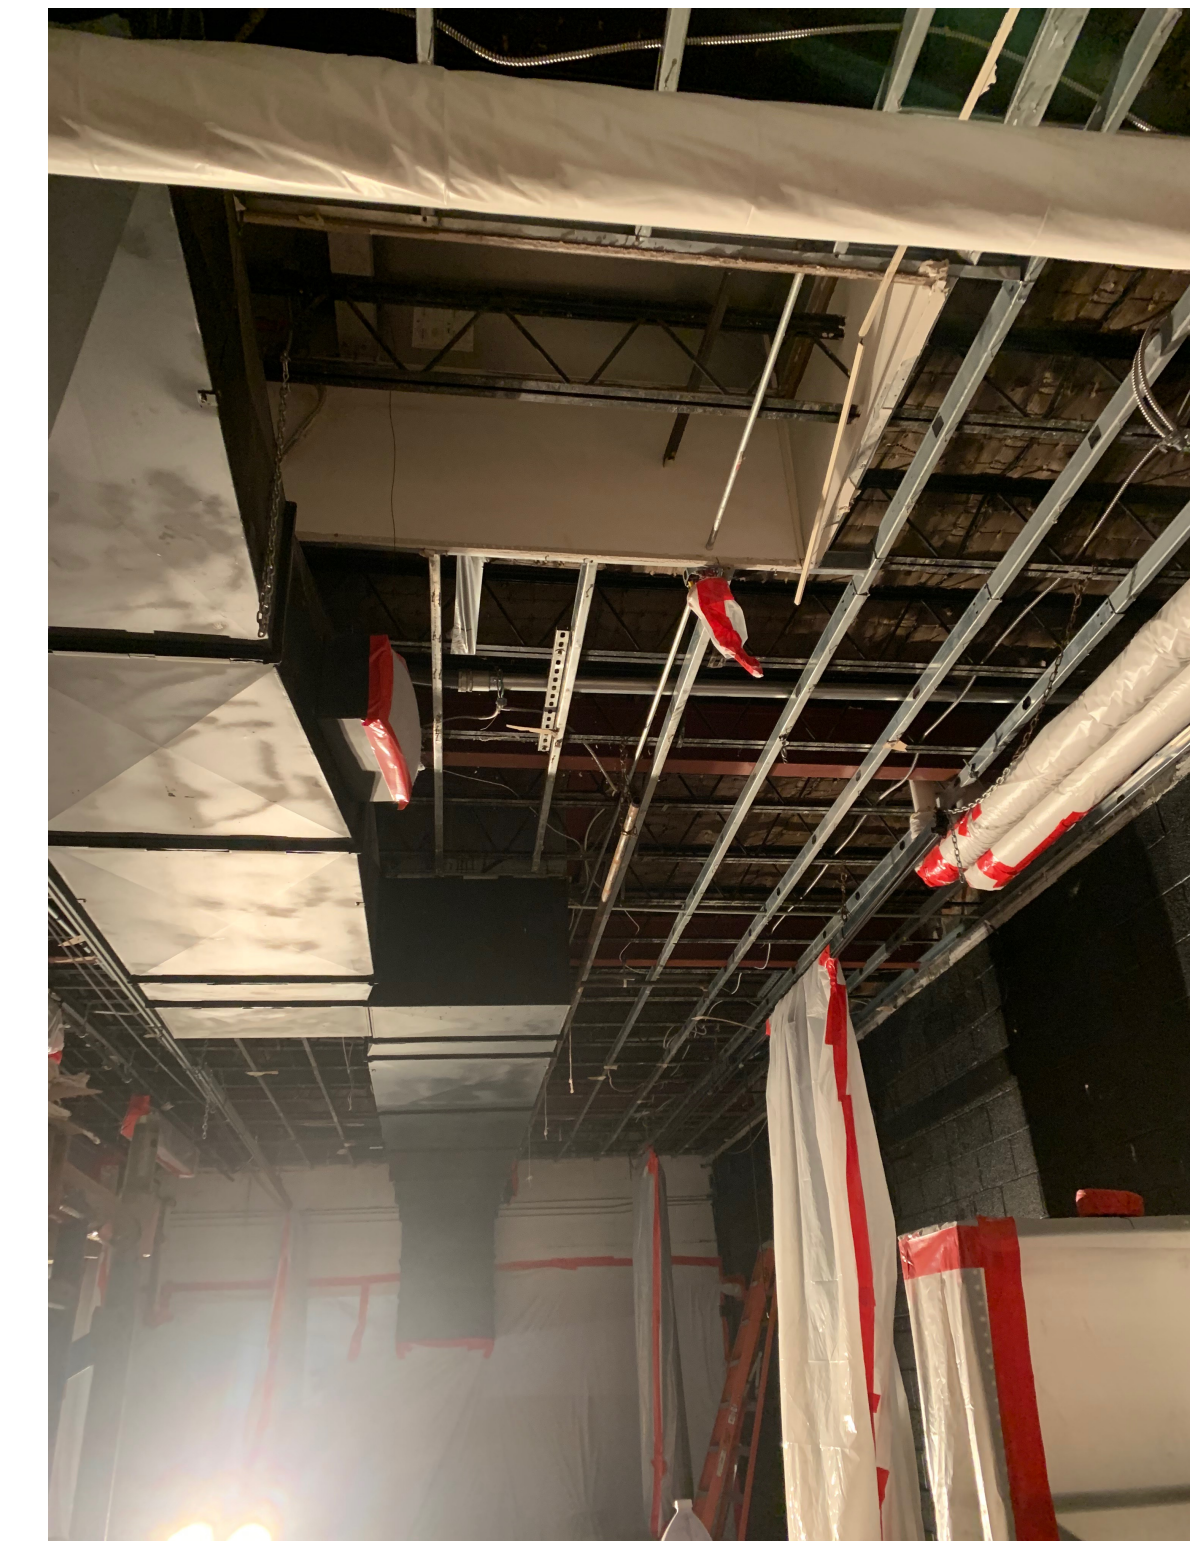
Auditorium Ceiling after Demo

Area complete: Drywall on ceiling demoed and replaced
