Julia A. Stark Elementary School

Exterior Façade Investigation

Final Report
September 19, 2019

Prepared by:
SILVER / PETRUCELLI+ASSOCIATES
Architects / Engineers / Interior Designers
3190 Whitney Avenue, Hamden, CT06518-2340
Tel: 203 230 9007 Fax: 203 230 8247
silverpetrucci.com

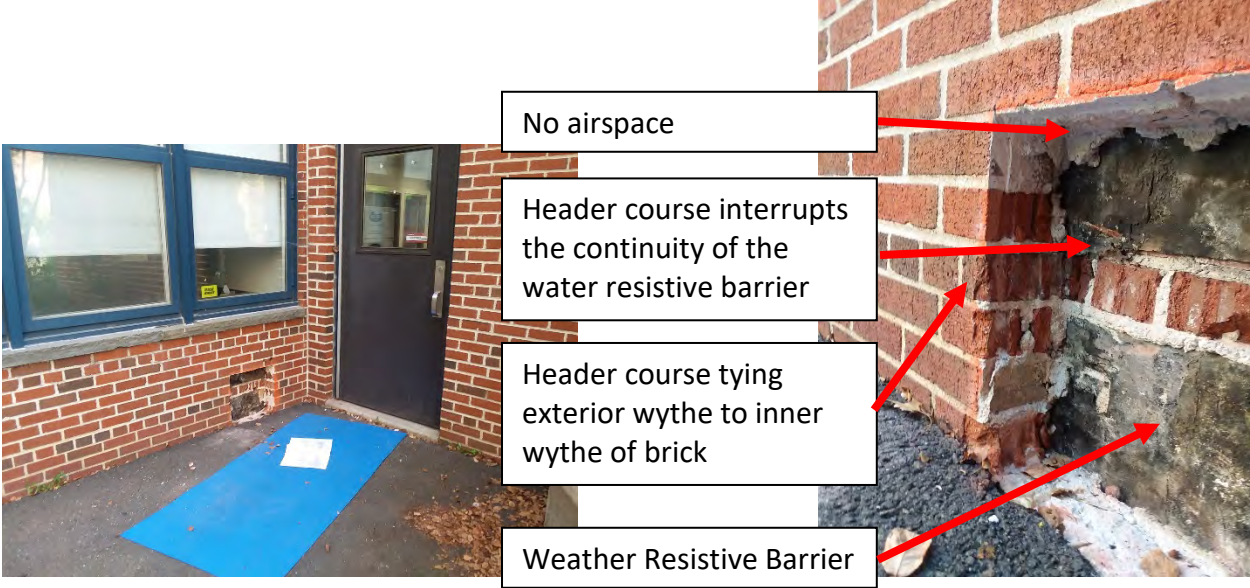
P1-1

The exterior wall construction appears to be at least 2 wythes of solid brick masonry with no air space between the layers of the brick. There is a weather resistive barrier between the exterior wythe and second wythe of brick. The WRB is interrupted by a header course at this location, three bricks above grade. There is a header course at every sixth brick course. This brick coursing is typically called Common Bond and helps tie the two wythes of brick together. The WRB is rigid but appears to be intact. There are no through wall flashing and no weeps at this part of the building.

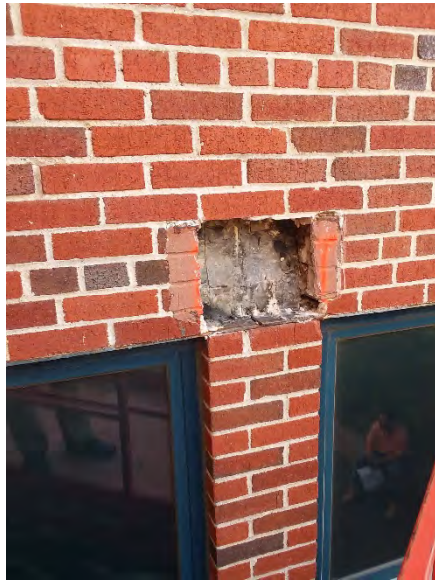
P2-1

Steel lintels above windows looks to be in good condition with minimal rust. They have been painted in the past to match the window color and need to be repainted. There are no weeps above the window lintels. The WRB runs behind the exterior wythe of brick (similar to Probe 1) and continues over the back leg of the lintel. The WRB is rigid but seams in the material are well sealed. Lintels are not sealed from one to another at brick piers between windows. Remnants of steel channels are buried in the exterior brick wythe. Concrete is packed in around the steel channel, tooled and colored to look like brick. The steel channels may have been for a canopy used to shade the south facing windows. The channels are bolted to a steel beam behind the brick.

Steel Chanel for Canopy

WRB continuous over back leg of lintel

Gap between lintels

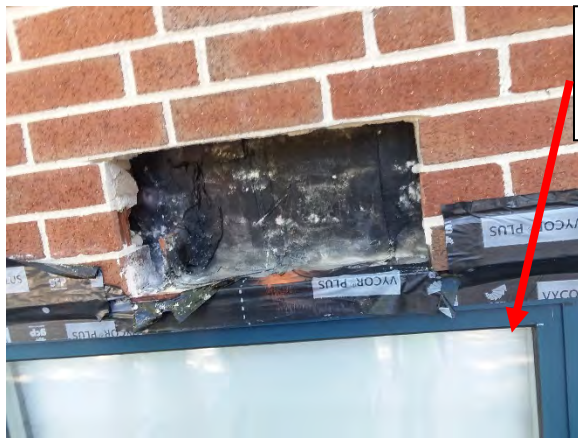
P4-1

Wall construction is similar to Probe 3. Steel lintels above windows looks to be in good condition with minimal rust. They have been painted in the past to match the window color and need to be repainted. There are minimal tube type weeps at the window lintels and are spaced 40"-48". The WRB runs behind the exterior wythe of brick (similar to Probe 3) and continues over the upward leg of the lintel. A second sheet of WRB material extends to the front edge of the horizontal leg. It is assumed that the WRB stops where the header course happens at course 5 above the window head and starts again above it. The WRB is rigid but is in good condition with no obvious tears or gaps. There is minimal mortar droppings at the lintel. There is a piece of steel that penetrates the WRB and is welded to the lintel. Mastic seals the penetration around the steel.

Temporary sealing around window openings

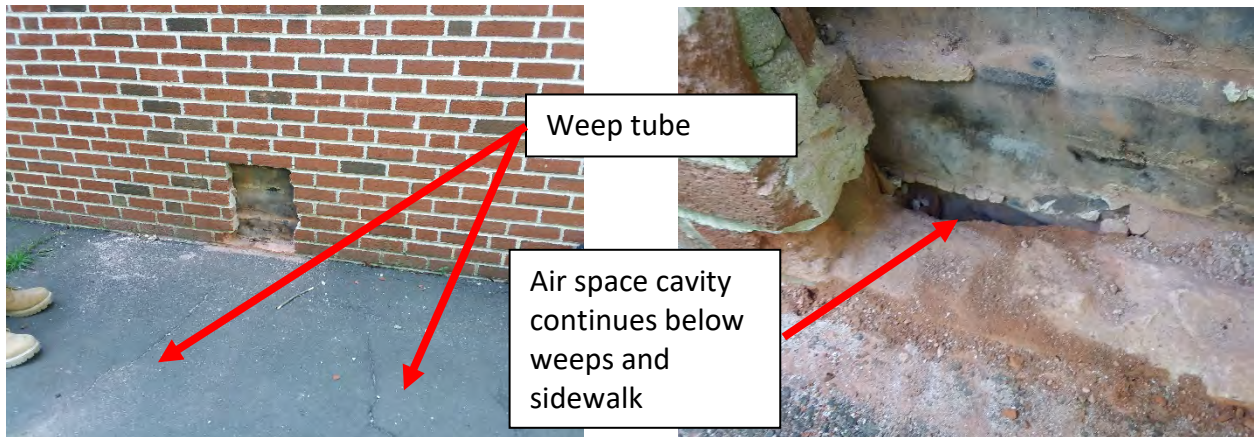
P 5-1

Wall construction at this area is a 4" brick veneer with an approximately three-quarter inch air space. There are no masonry anchors observable from this probe location. There is a rubberized WRB within the cavity. The WRB is in good condition and is not adhered to the concrete block back up. Sheets of WRB are lapped approximately 8 inches and are lapped properly to prevent water draining within the cavity from getting behind the membrane. Sheets of the WRB are not spliced together. There are weeps one course above the sidewalk surface and spaced 24" o.c. As the sidewalk slopes the weep holes remain about 1 course above the sidewalk surface. There is no through wall flashing or turn out of the WRB at the weep holes to direct water within the cavity out of the weep holes. The air space continues below the sidewalk elevation and the bottom of the cavity could not be determined. The flange of the steel column behind the WRB was able to be located. The CMU block is set into the web of the steel column. The waterproofing membrane runs continuously across the CMU backup and covers the steel column. There is no drainage mat or other material to prevent mortar droppings from entering the airspace.

Probe 5: Section 4 on Sheet A303 – This area was part of the 1994 addition. Weep tubes are located only one course above finished grade. Damp proofing of the foundation wall was not able to be observed on the foundation wall. Fabric flashing does not turn out into the brick grout joint at the masonry weeps. There is no pea gravel within the cavity space. No rigid insulation was able to be observed at this location.

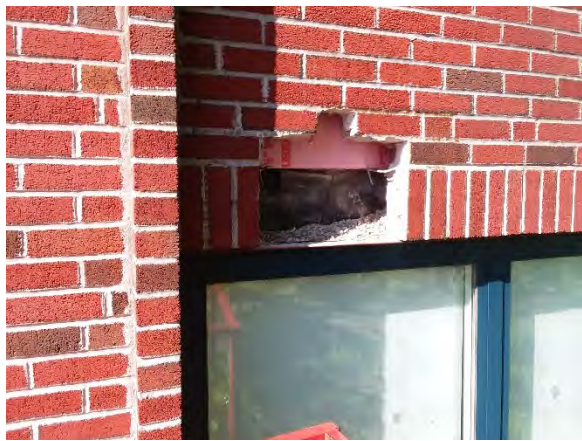
P 6-1

There is an approximately two-and-a-half-inch air space which consists of 1 1/2 inches of rigid insulation, adjustable masonry anchors embedded in the CMU backup mortar joints, pea gravel mortar drop type netting, and a rubberized WRB membrane. Weep tubes are spaced 16 inches o.c. above the window. The steel angle lenti is in generally good condition. Lenti does not extend into masonry at either side of window opening. Rubberized flashing is turned into the mortar joint at 8 in above the window head. Two pieces of steel angle are visible and welded to the window lintel, transferring the load of the brick veneer the floor framings steel beam, running parallel to the exterior wall at the floor line. Rubberized waterproofing is cut around the steel angles, compromising the Integrity of the waterproofing membrane. There is no waterproofing membrane behind the rigid insulation. There is no observable WRB on the CMU. There is a gap between the two steel angles which is open. It appears that the concrete blocks interior face is continuous across the gap between the steel angles.

Pea gravel behind weep holes

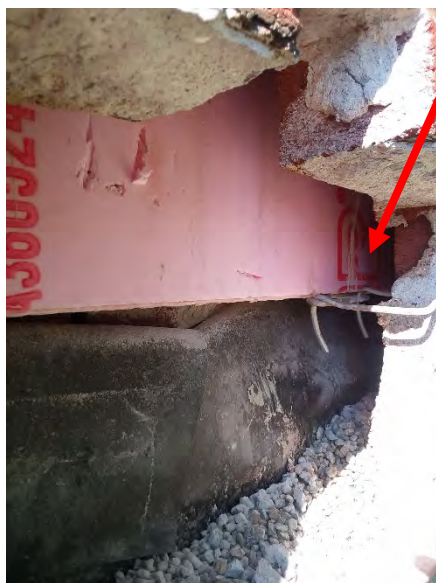
P 6-3

Adjustable masonry anchors

WRB tucked into mortar joint

WRB cut at steel angles

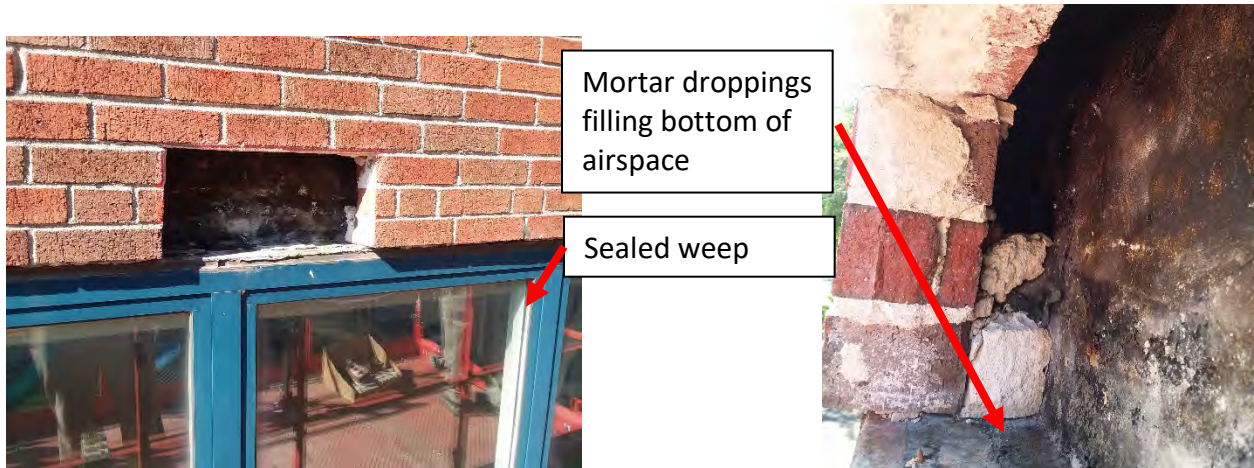
P7-1

Probe is over the cafeteria window. Some of the weeps at the window lintel have been sealed. The steel lintel is slightly rusted and pitted. The airspace is approximately 1 1/2 inches. The bottom of the airspace is full of mortar for approximately one brick course high. The WRB is in relatively good condition. The bottom edge turns out over the horizontal leg of the steel lintel. One corrugated brick tie was found within the airspace. WRB on top of the window lintel is no longer adhered to the steel. Fasteners used to anchor the window frame are slightly penetrating the top of the steel lintel. Windows appear to have been moved back into the masonry opening approximately 1 inch based on white staining observed on the brick piers between windows. With the windows in its original location it would have been approximately 1 inch beyond the front edge of the window lintel. Some portions of the existing WRB are still well adhered to the steel lintel.

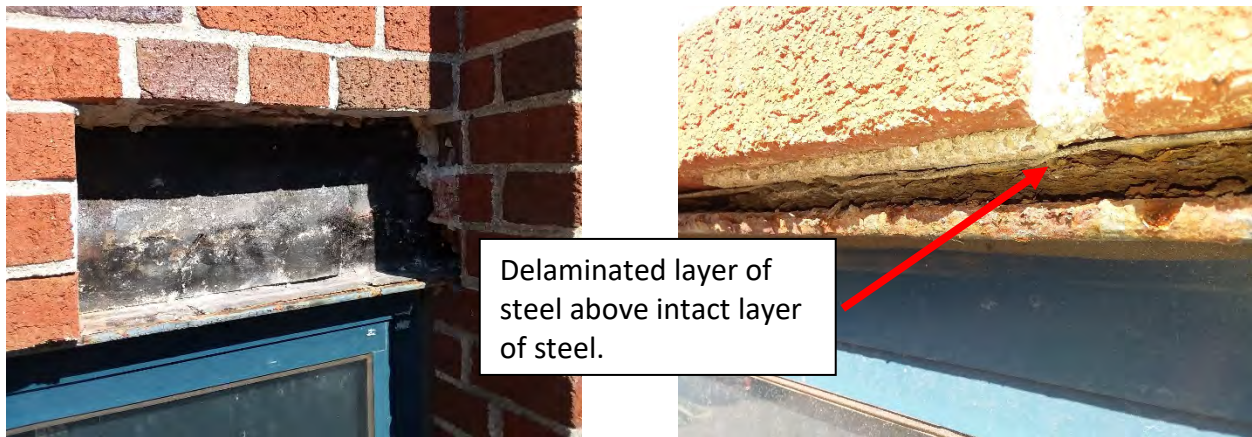
P8-1

The exterior wall construction appears to be at least 2 wythes of solid brick masonry with no air space between the layers of the brick. There is a weather resistive barrier between the exterior wythe and second wythe of brick. The WRB is interrupted by a header course just above the probe opening and the WRB is tucked into the mortar joint of the inner brick wythe. The WRB at the far-right corner, near the pier, appears continuous up in between the first and second wythes of brick. The WRB turns out, over the top of the steel lintel and is well adhered to it. There appear to be no weep holes above any of the windows at this location. Steel lintel is let into the pier at either side of the window. Area of lintel over the second from right window has started to show signs of significant rust. It appears that an original lintel may have been left in place and a new lintel placed underneath it. The original lintel is heavily rusted and is delaminating. Delamination increases the thickness of the steel and pushes against adjacent materials. This phenomenon may be why the new lintel is sagging and can also cause brick to crack.

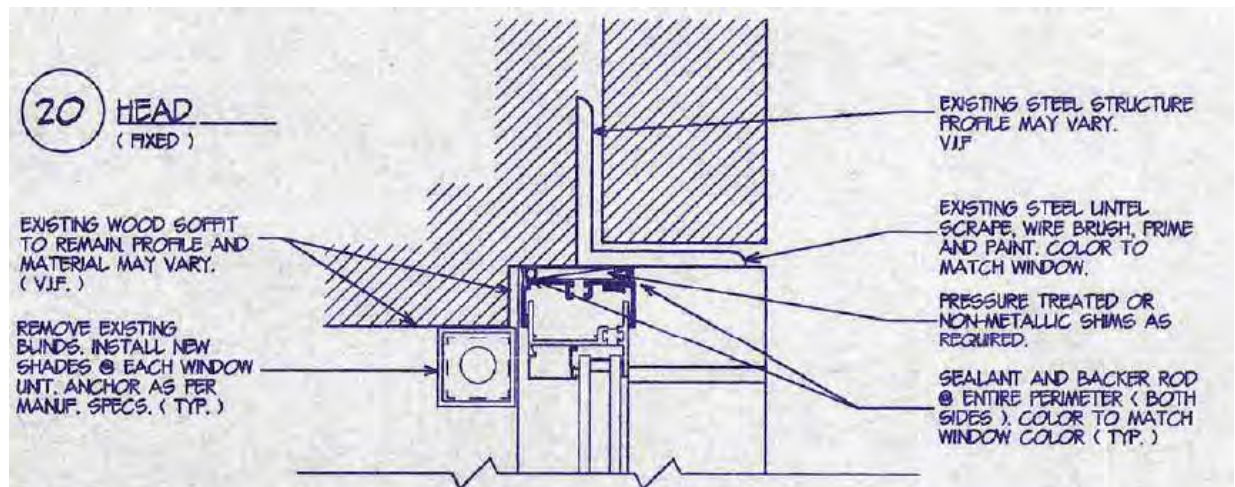
Detail 20 on Sheet A-702

Probe 2: Detail 20 on Sheet A702 - This area was part of the 1951 addition. Renovations of this area during the 1994 addition included replacement of the existing window, wire brushing and painting of the exposed surfaces of the steel window lintel.

Probe 8: Detail 20 on Sheet A702 - This area was part of the 1951 addition. Renovations of this area during the 1994 addition included replacement of the existing window, wire brushing and painting of the exposed surfaces of the steel window lintel.

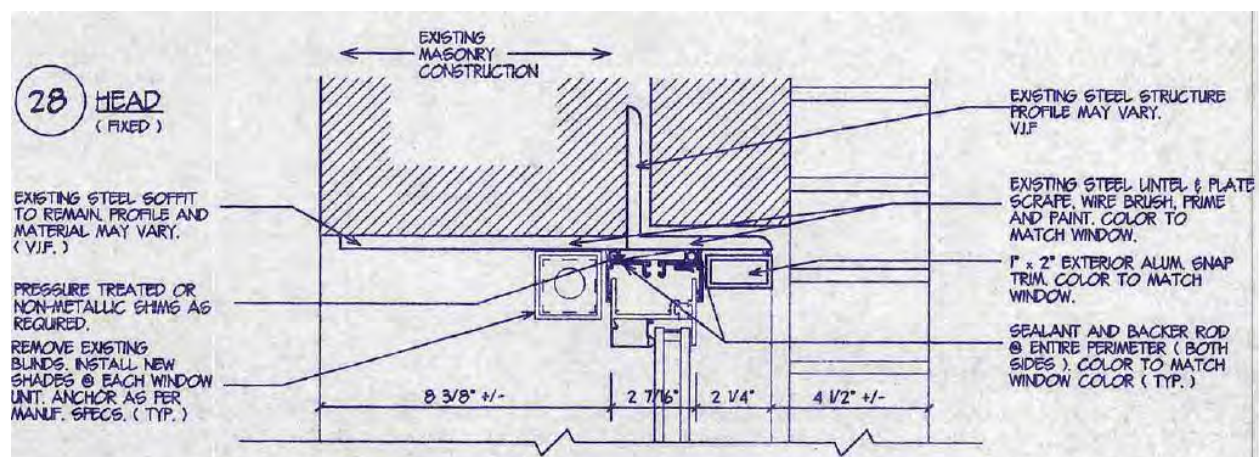
Detail 28 on Sheet A-702

Probe 4: Detail 28 on Sheet A702 - This area was part of the 1969 addition. Renovations of this area during the 1994 addition included replacement of the existing window, wire brushing and painting of the exposed surfaces of the steel window lintel.

Probe 7: Detail 28 on Sheet A702 - This area was part of the 1969 addition. Renovations of this area during the 1994 addition included replacement of the existing window, wire brushing and painting of the exposed surfaces of the steel window lintel.

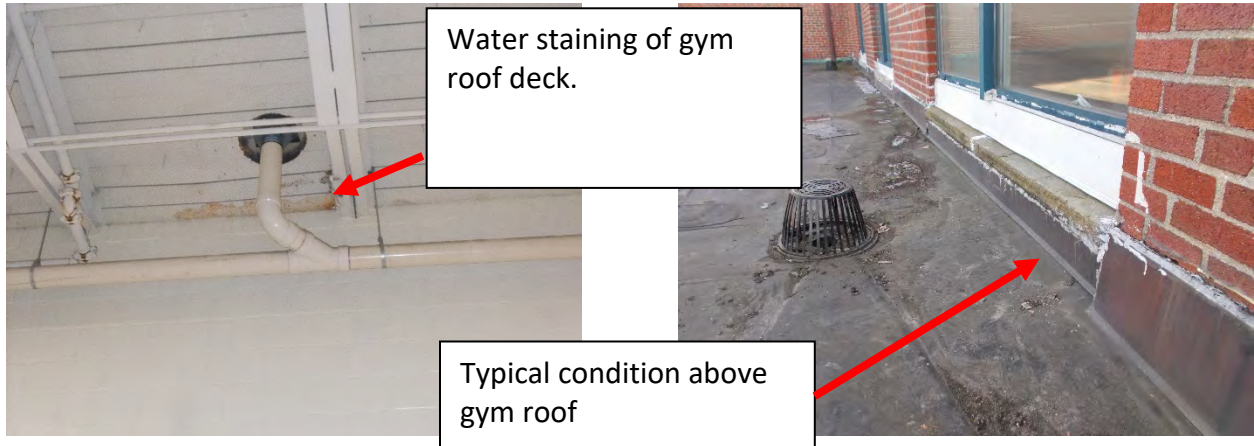
1-1

1. Water stains were found at the intersection of the gym roof to the corridor wall. The staining is also adjacent to a roof drain. At this location the corridor wall extends above the gym roof and has clearstory windows into the corridor.
2. Extensive water staining of the gypsum wall board around the entire window opening at room 170 (1969).
3. Water staining of the interior face of concrete block of room 170, just below the second floors beam. Block is exposed above the ACT (1969).
4. At Janitors Closet next to room 252, exposed concrete block wall at exterior wall had vertical cracks, floor to ceiling, at three locations along the wall (1969).

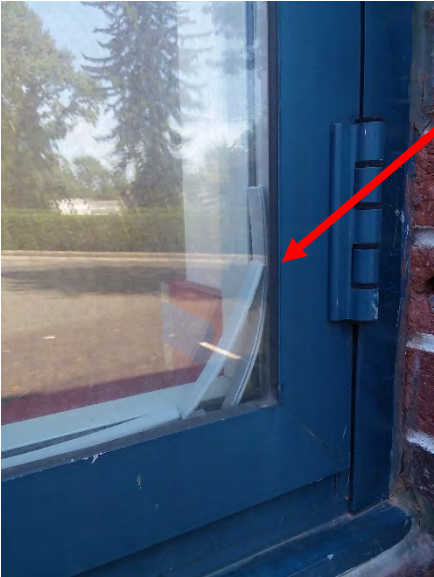
1-1

1. Seals between IG window panes are failing.
2. Sealant around windows openings is cracked and failing.
3. Control/Expansion joints are cracked and failing.

Failing Seals

2. Building should be surveyed for all areas needing repointing.
3. All existing sealants should be raked out and provided with new sealant.
4. Steel lintels need to be replaced and/or scraped and painted.

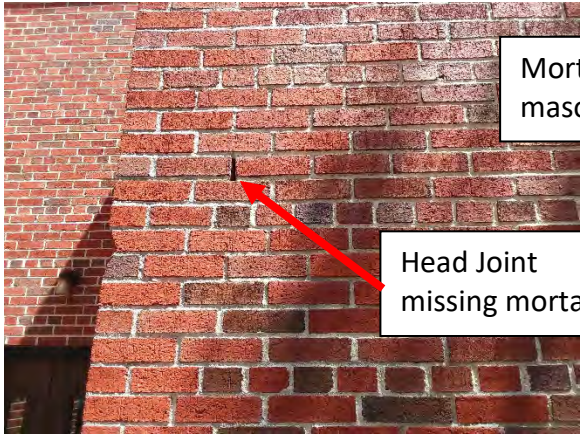
4-1

4. Several head joints around room 104 are missing mortar.
5. Mortar is missing at the head joints and under the stone windowsills at rooms 104 and 105.
6. Mortar is missing from the top corners of window openings at room 104 and 105.
7. At rooms 104 and 105 the precast parapet cap has shifted, and mortar is missing from its head joints and below the cap. Efflorescence on face of brick. Brick at parapet elevation is shifting.
8. Mortar joint at rooms 104 and 105 between 1927 and 1951 addition is open.

Mortar missing at masonry opening

Head Joint missing mortar

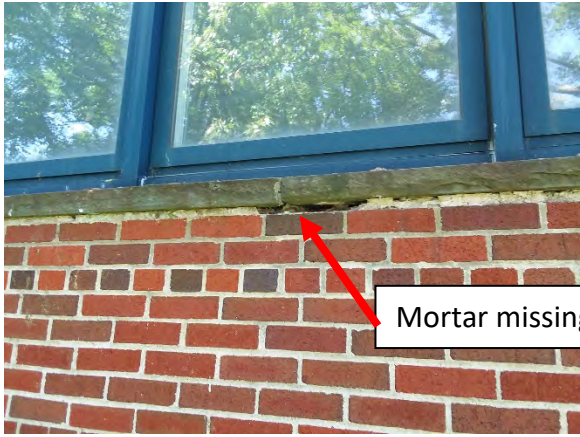
5-2

Precast cap out of alignment

Mortar missing

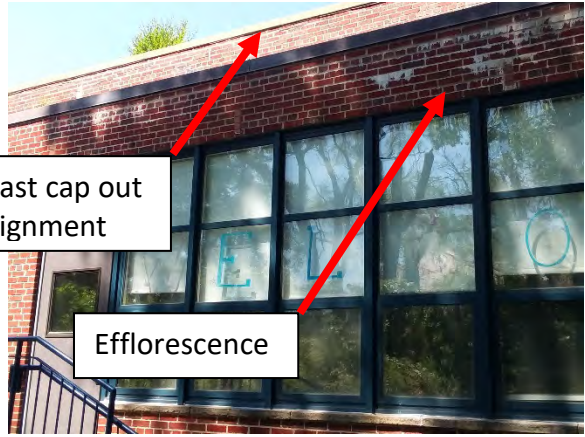
7-1

Efflorescence

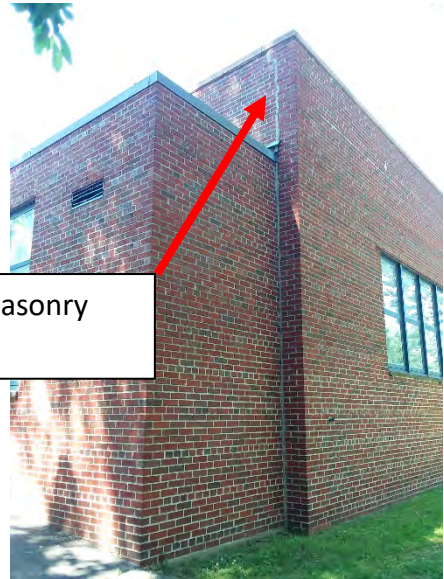
9-1

9. A vertical crack has propagated from the intersection of the 1927 and 1951 buildings up to the parapet cap at room 105.
10. At room 105 a vertical crack has propagated from the head of the windows on the west elevation to the parapet cap. And a diagonal crack from the right top corner nearly to the parapet cap.

Cracked masonry

14. Gaps between the exterior brick of this building and the 1951 addition, Rooms 104 and 105, need to be addressed.
15. Stairs and handrails outside of Rooms 104 and 105 must be repaired.

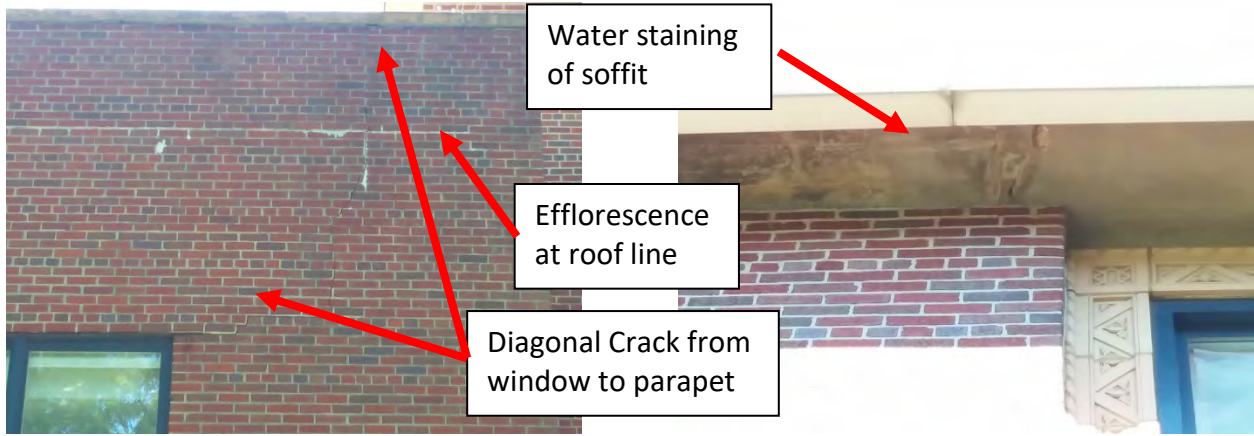
11. Efflorescence is forming at approximately the roof level across the west elevation of room 105.
12. Vegetation is growing from the roof over Rooms 104 & 105.

13. There is water staining of the main roof's soffit around the entire building.
14. Mortar of the joint between the mosaic tile and brick is deteriorated.

Water staining of soffit

Efflorescence at roof line

Diagonal Crack from window to parapet

13. The flat roof area and roof edge flashing need to be replaced. Slate roofing should be removed, WRB be placed on the sheathing and slate shingles be reinstalled. Roof edge flashing should be repaired, and gutters be reinstalled to capture water that is getting to the soffit.

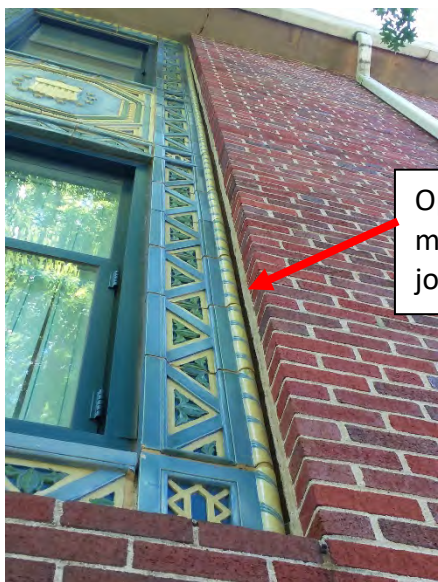
15-1

15. At the main office, the joint of the mosaic tile and brick at the right side of the masonry opening is open from sill to head (2 stories)
16. Masonry opening at basement access door on the east elevation has large gap around door opening and sealant is open.

Open masonry joint

17. Vegetation growing out of the roof must be removed and ballasted roof be repaired.
18. Mortar joints between decorative terracotta tile and brick must be fixed.

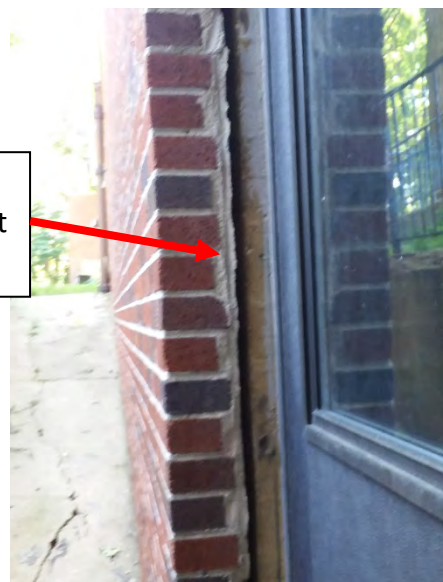
16-1

Open sealant joint

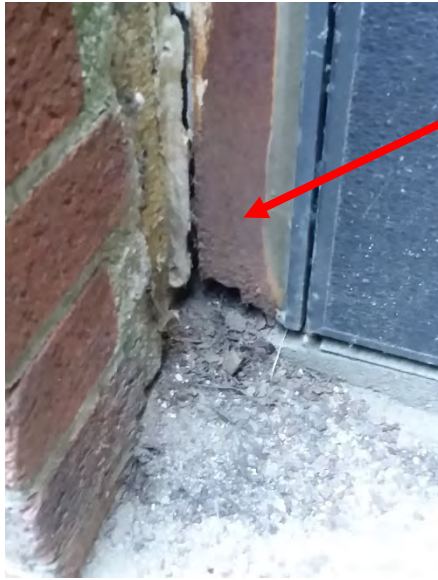
17-1

17. Door frame at basement access door on the east elevation is rusted through at the base and is open to the interior.
18. Retaining wall to basement access is bowed and leaning.

Rusted metal door frame

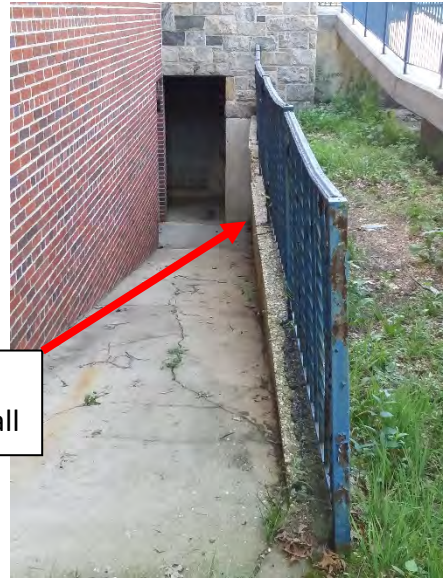
18-1

Bowed retaining wall

19. Retaining wall and ramp leading to lower level must be replaced.
20. Sink hole forming outside Stair 2 in the courtyard must be filled and pavement repaired.

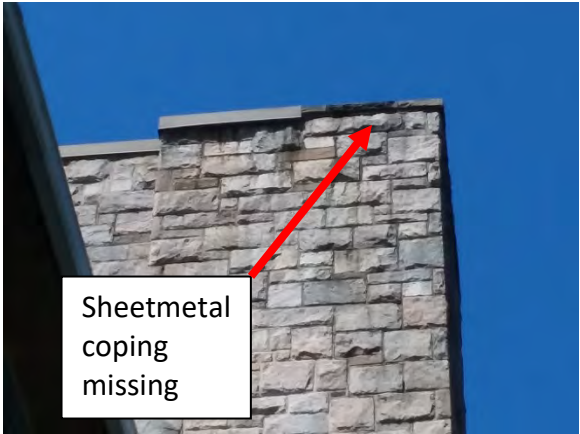
22-1

22. Sheetmetal coping at chimney is missing.
23. Concrete of front entrance stairs is spalling and needs repair. Stair treads are uneven and need to be reset. Stair risers are inconsistent.

Sheetmetal coping missing

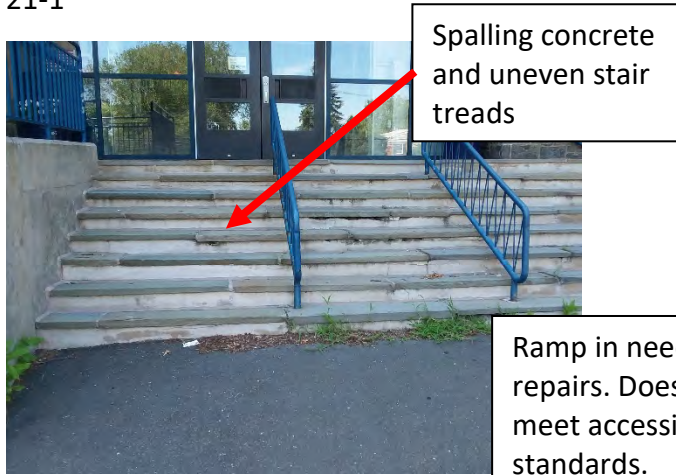
23-1

Spalling concrete and uneven stair treads

22. Front entrance stairs and handrails must be repaired.
23. Stone veneer walls need to be repaired.
24. Masonry weeps must be cleared of obstructions preventing water from weeping out of the cavity.
25. Steel protruding from the brick at the top corners of the south facing windows should be cut further back into the building to allow new face brick to be patched into these locations.

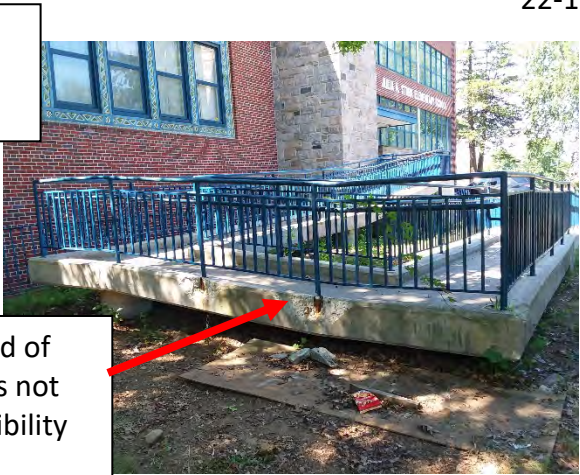
24-1

24. HC ramp to front main entrance has spalled large areas of concrete at railing posts.
25. Vegetation is growing out of cracks at the top of the wall outside of nurse's room.

Ramp in need of repairs. Does not meet accessibility standards.

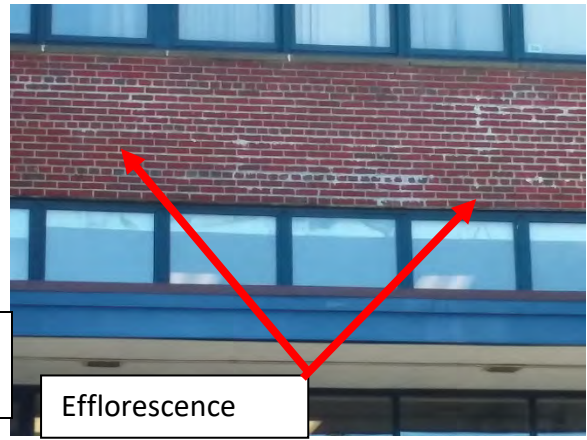
26-1

26. Efflorescence on north and east elevations between first and second floor windows and at the north end of east elevation below first floor windows.

10. Asphalt walking surfaces should be replaced with a more durable material.
11. All areas showing efflorescence should be investigated for water infiltration near these areas.

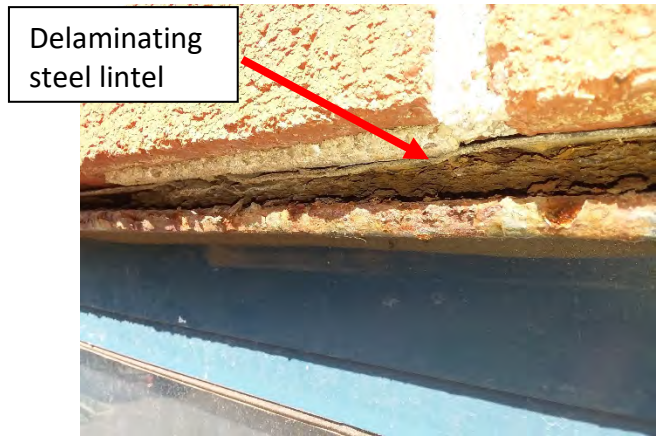
27-1

27. Steel lintels at the head of the first-floor and basement windows on the east elevation have a substantial amount of rust and appear to have the original steel lintel still above a newer one. The original steel lintel is delaminating and may be contributing the large sage observed across the three window openings.

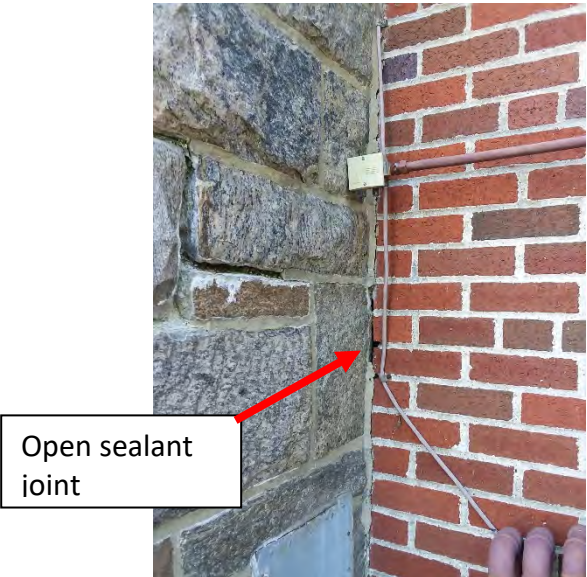
28-1

28. Gaps in sealant between granite and brick finishes on east elevation.
29. Corner of granite wall on east elevation requires repair.
30. Mortar missing at joint of masonry window sill.

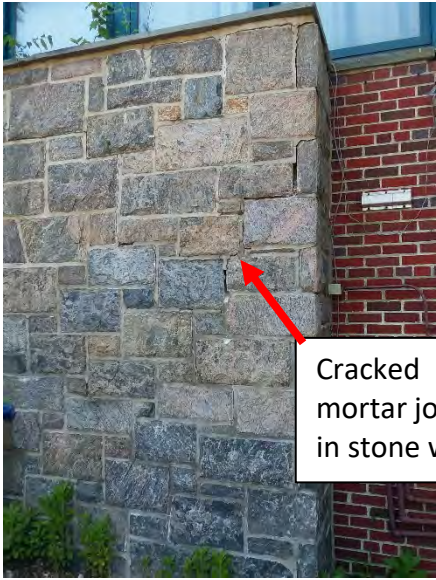
29-1

Cracked mortar joints in stone wall

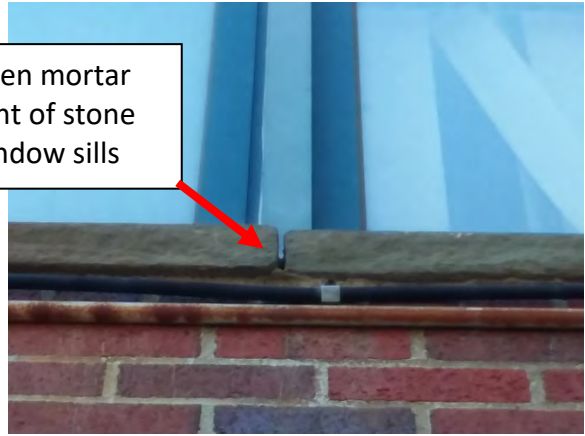
30-1

Open mortar joint of stone window sills

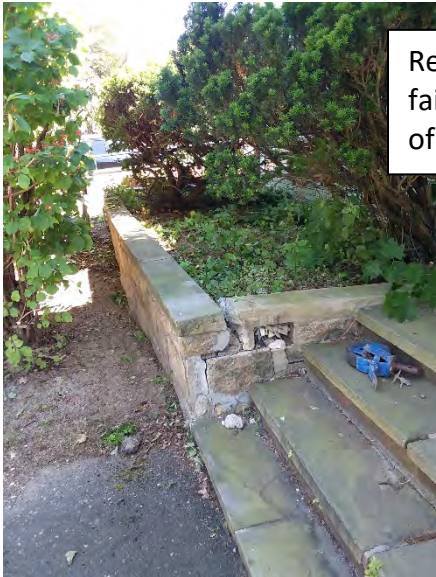
31-1

31. Planter wall outside of Auditorium is pushed out and is need of repair.
32. Asphalt paving at landing of stairs outside of Auditorium is not level with stair treads and must be repaired.

Retaining wall failing outside of auditorium

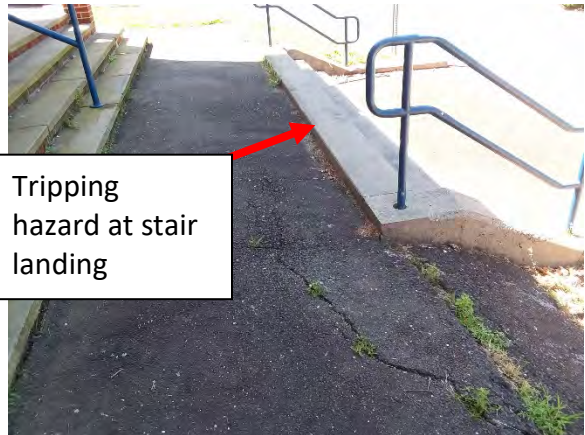
32-1

Tripping hazard at stair landing

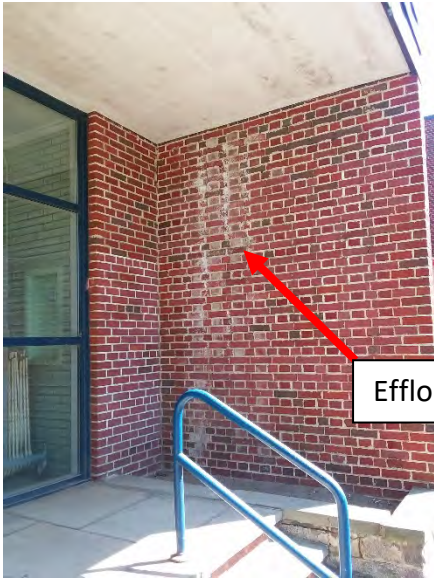
33-1

33. Efflorescence on wing wall outside of Auditorium.
34. Lintel paint is peeling and must be cleaned and repainted.
35. Canopy outside of stair near room 249 is deteriorated and must be repaired.

Efflorescence

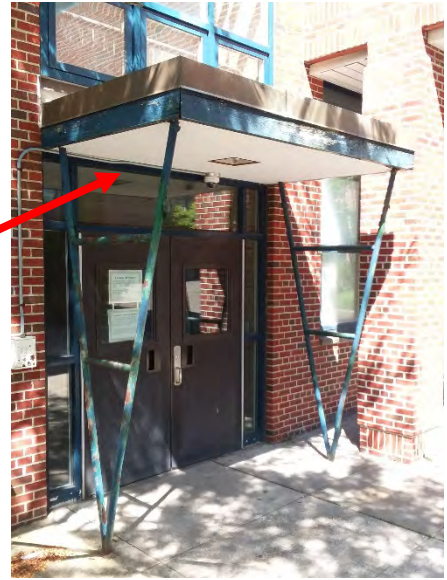
35-1

Canopy in need of repair

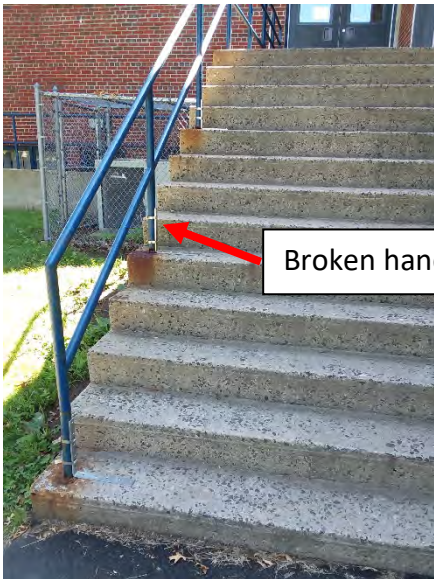
36-1

36. Handrail posts at stairs outside of Cafeteria are rusted and broken.
37. Railing at stair outside of Cafeteria should be a guardrail and does not meet the requirements for a guardrail.
38. Brick above stairs outside of Cafeteria is uneven.
39. Unprotected opening in brick at junction box at east wall of Cafeteria.
40. Break metal cap at top of pilaster at north elevation of Cafeteria are pitched back towards the building.
41. Control joint between 1969 & 1951 buildings near room 252 is open rigid and delaminating from the brick.
42. Control Joint between room 256 of the 1994 building and room 254 of the 1969 building is dried out and cracked.

Broken handrail bases

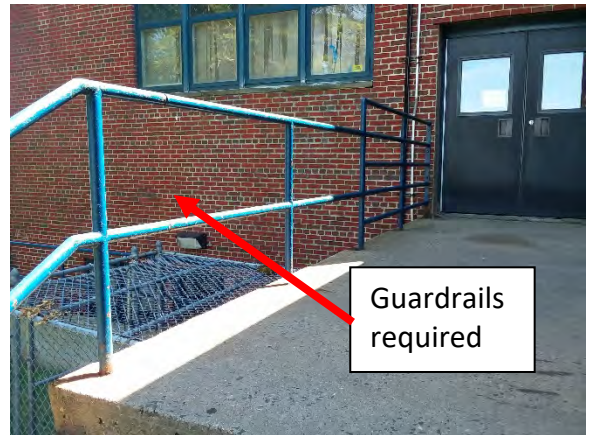
37-1

Guardrails required

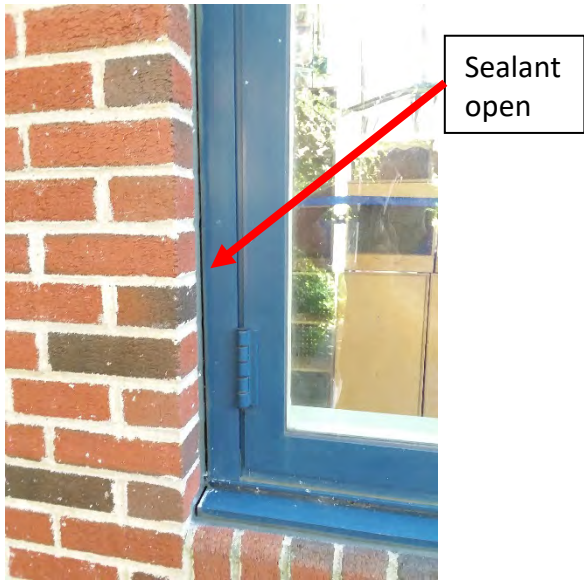
43-1

43. Sealant around windows in this building addition is split and open.
44. Brick at roof elevation over room 205 is projecting out beyond the course below.

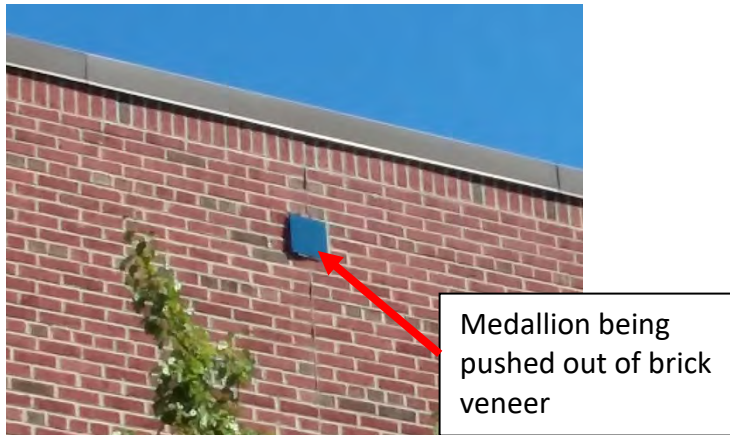
45-1

45. Blue medallion between rooms 203 & 204 is popping off building.
46. Masonry at top of column across the hall from room 205 is cracked.
47. Control joint sealant is cracked and dried out. Typical around building.

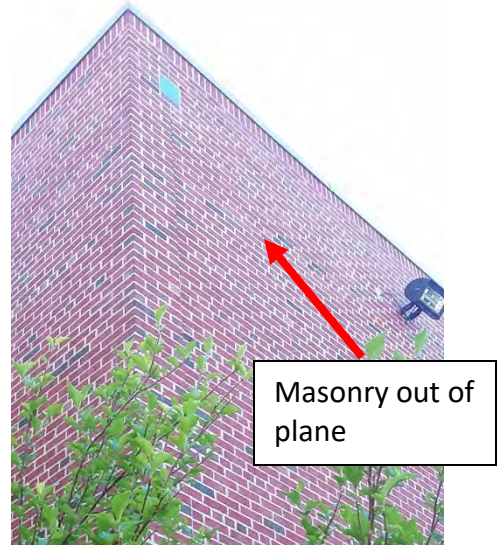
51-1

50. Sealant at the right side of the window of room 212 appears to be missing.
51. At second floor janitors closet, near room 212, masonry between control joint and inside corner is out of plane with the rest of the wall.

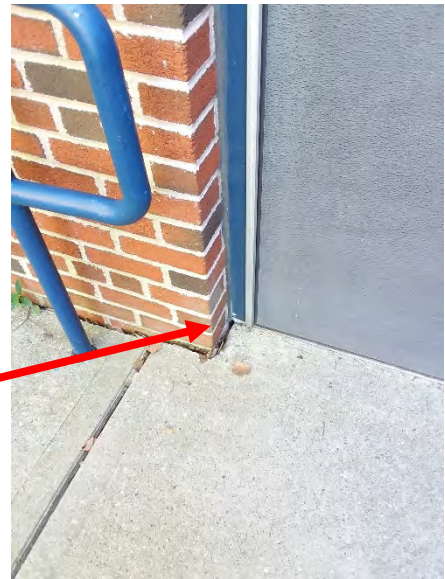
52-2

52. Landing slab at double door into first floor hallway, near room 117, has unsealed openings at the bottom corners of the door opening.
53. Fibers are coming out of the bottom weep holes outside of rooms 201 through 205.
