M. Gottfried, Inc.

RE: Roof report and repair quotation
Julia Stark Elementary School
398 Glenbrook Road
Stamford, CT 06906

As per your request we went to the above school to perform an inspection of the roofs, and, using the Infrared Thermographic Roof Moisture Analysis Report as a guide, look for possible sources of water leaks in the noted "wet areas". We also were to perform test cuts to verify the wetness and determine the roof components in those areas. We were also asked to provide pricing on replacing the wet areas, and to provide a recommendation and pricing for roof maintenance.

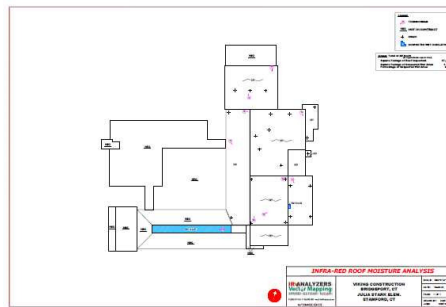
Infra-Red Drawing showing wet areas

We were provided with two active warranties on the roofs at Stark School. One warranty (from GAF) covers a smaller gravel surfaced BUR. This warranty expires in August of 2023. The infra-red scan showed one small wet area on this roof against the wall of the adjacent higher section. The other warranty (from RPI) covers a much larger area of the roof and spans 3 roof areas. An overall look at the roofs of the school and the moisture scan shows the roofs to be in relatively good shape, with only one roof area (at the top of the slate roof) that is entirely wet and needs replacement.

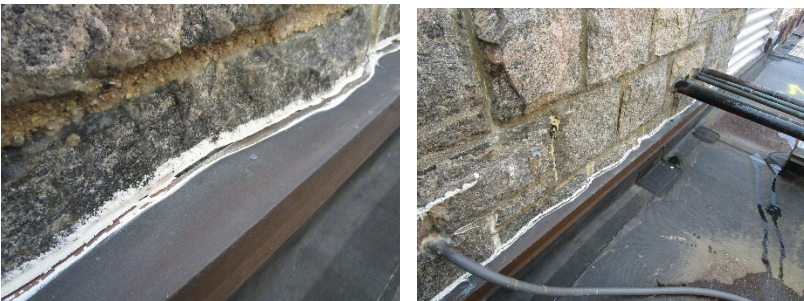
Roof Area A

Roof area A is an adhered EPDM roof. It is in good condition. All laps and membrane flashings appear tight and sealed. The issue we found on this roof level deals with the caulking at the reglet flashing in the stone wall.

The metal reglet flashing is wide, probably to account for the variable thickness of the stone. The caulking used to seal the joint has separated and deteriorated. The old caulking should be cleaned and new caulking installed.

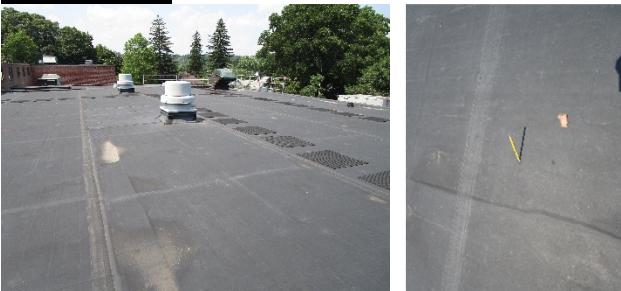
Roof Area B

Roof area B is part of the RPI warranted roof areas. The roof is in good shape. We did find a couple of holes in the roof that should be repaired as soon as possible.

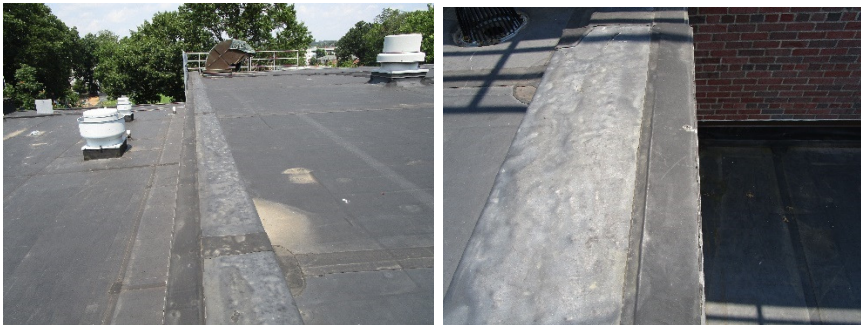
One item that we noticed on this roof area, as well as with all of the RPI roofs, is that the perimeter metal edging flange is 4" and the membrane cover-strip is only 5". This does not leave much of an overlap on the field sheet on top of the parapets. No action needs to be taken for this detail, and the roof is under warranty, but this detail should be monitored and if signs of peeling or cutting at the back edge of the metal are seen RPI should be contacted immediately.

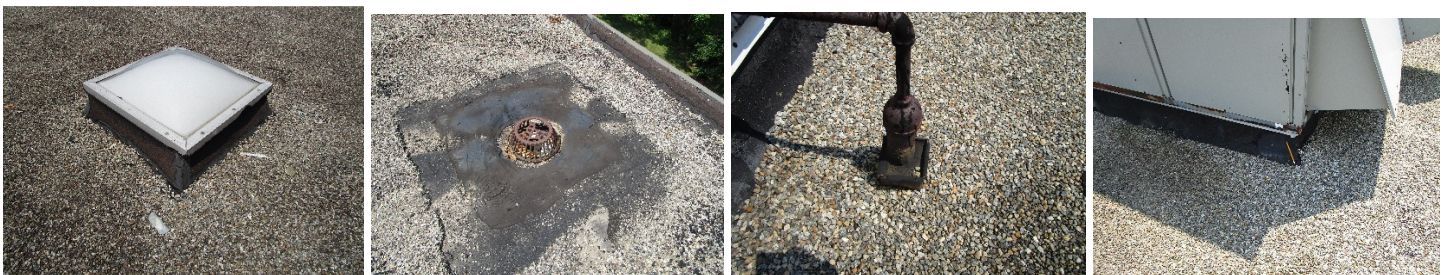
Roof Area C

Roof area C is a gravel surfaced BUR and we believe it is covered by the GAF warranty. The roof is 16 years old and in need of roof maintenance.

Flashing on the roof curbs need to be checked and patched. Some open corners were found on the curbs. The filler in penetration pockets has settled and needs to be topped off. It looks like there have been previous problems at the above roof drain. It has been patched and coated. The flashing needs to be inspected and the lead needs to be checked to see if it has worn out. If problems are seen with the flashing, the existing materials should be removed, new lead installed and the drain reflashed.

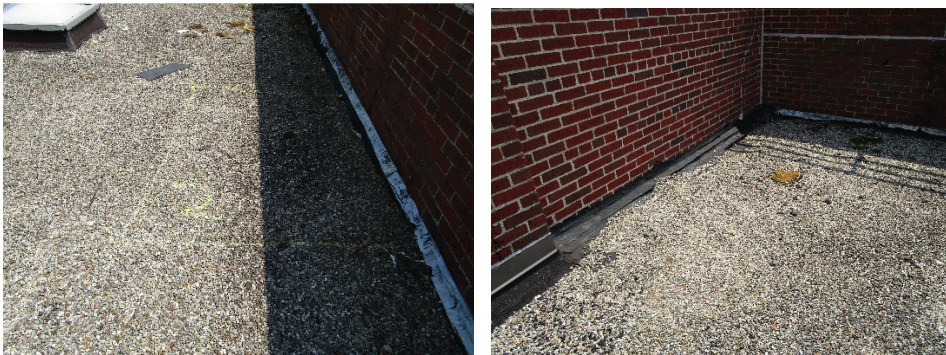
Wet area

A small wet area was marked out against the wall of the higher section. The base flashing is very low at this wall, and the area marked is at a high point of the roof, making the flashing even shorter. The wet area should be removed and replaced, new base flashing installed, and a termination bar installed at the top of the base flashing. Further down the wall from here we found that the base flashing at the wall has been coated. All the base flashing should be checked and repaired as needed.

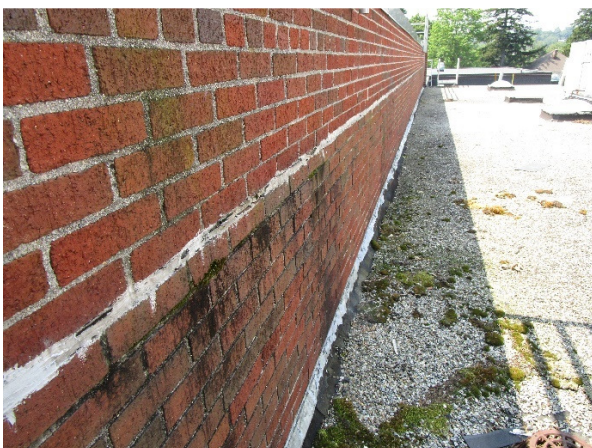
Problems with the wall

The rising wall above this roof area does not look to be in good shape. There is moss and organic growth on it, there are cracks in the wall and a large joint or crack has opened, been caulked and the caulk has failed. Wall conditions must be addressed to keep water out of the building. Problems in the wall may also be contributing to the water getting into the roofing system.

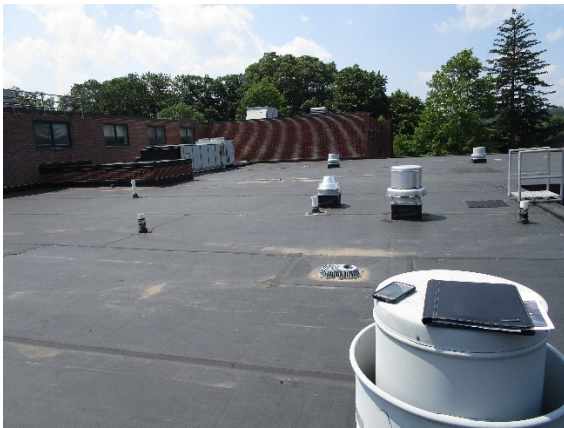
Roof Area D

Roof area D is a fully adhered EPDM roof. It is in relatively good shape, but basic roof maintenance is needed. This would include checking/patching corners on curbs, checking vent flashings, drains, etc., We did find a few items that need more attention.

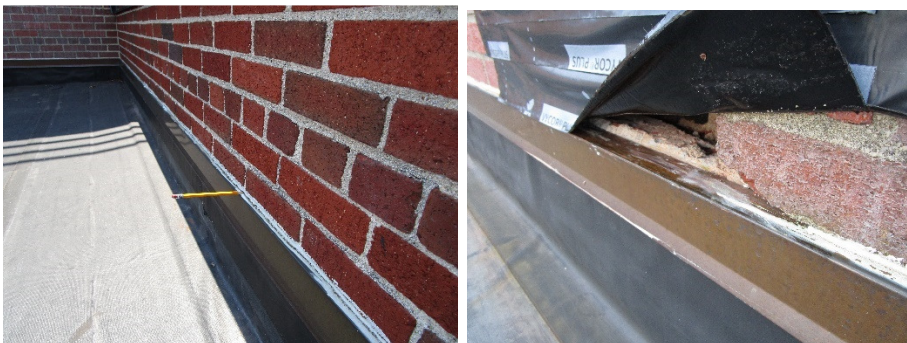
Reglet flashing

The reglet flashing that goes around the roof at the rising walls needs to be recaulked. The caulking is cracked and open. At one area of the wall it looks like a penetration was removed and the wall has not yet been filled in. We were able to see that the metal reglet flashing only goes in the wall joint a little, and it is flat, rather than turned up at the back. The lack of depth, failed caulk and flat metal means that water can get in the joint, go behind the metal and behind the roof membrane base flashing. This joint should at least be recaulked. In future reroofing project, cutting the joint deeper and using proper reglet flashing should be considered.

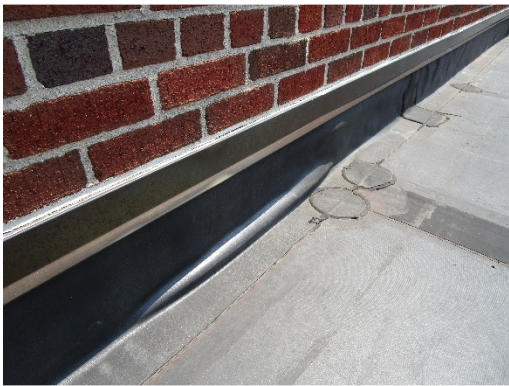
Water pocket behind wall flashing

At one area along the wall flashing a water pocket has formed. This may be due to the above mentioned issues at the reglet joint. The blister should be cut and patched.

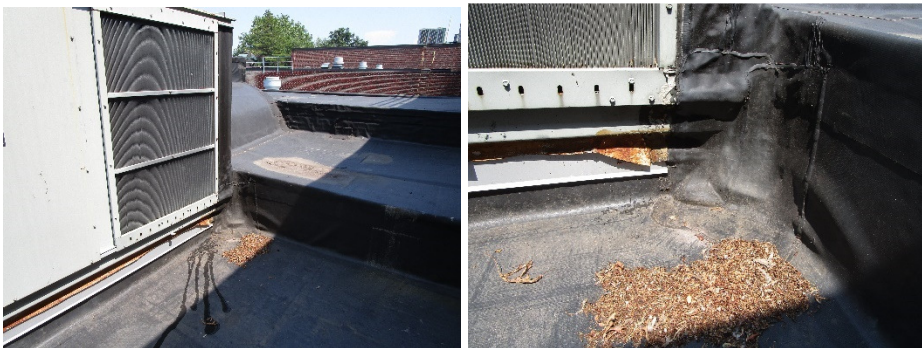
Flashing detail at unit and duct

When this roof was done, one of the ducts must have been very low to the roof. The duct was “built into the roof”. The end of the unit and curb were also “built in”. When we inspected the flashing on the unit curb we were able to push water out of the rubber. This detail needs a closer inspection and to patch the infiltration point if possible.

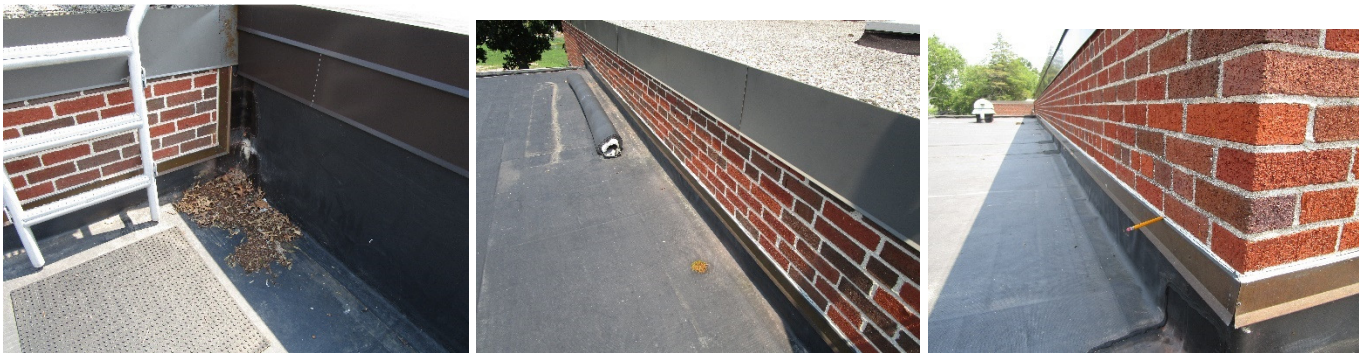
Roofs E & F are adhered roofs similar to D. They are in good condition and need only basic maintenance except for the reglet flashing. The caulk in the reglet joint at these levels is in a similar condition to that of roof D. The joint should be recaulked.

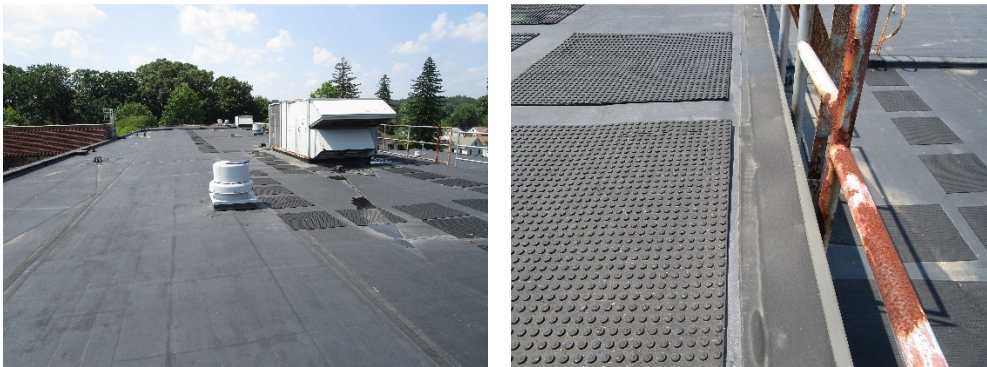
Roof H

Roof Area H is part of the RPI warrantied system. It is detailed in the same fashion at the perimeter as Area B. It is in good condition; however, maintenance and repairs are needed at a number of conditions.

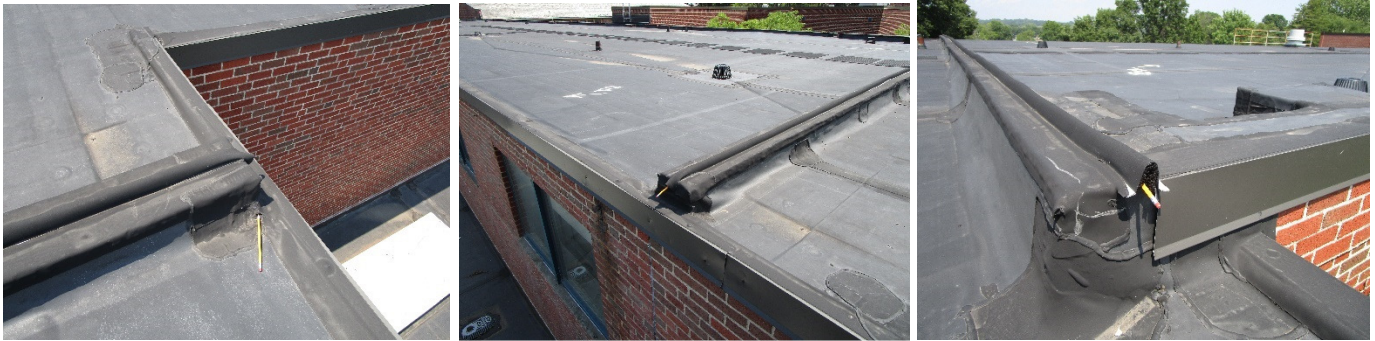
Expansion joint

The ends of the expansion joint do not appear to have been finished and are open. These need to be properly flashed and sealed.

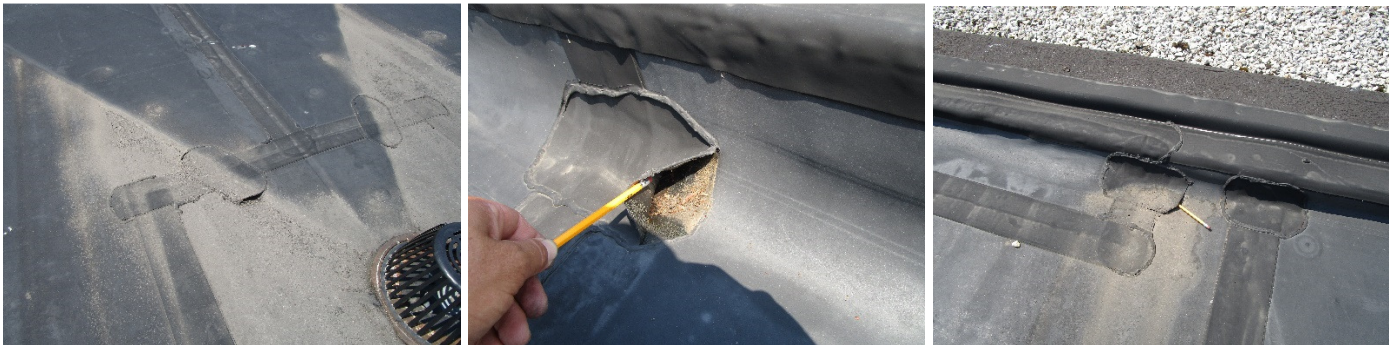
Loose and peeling patches

There are many patches on this roof that are peeling or lifting. These all should be cleaned and repatched. In addition at the expansion joint curb with the Built-Up-Roof, EPDM was used for the tie-in. This is not a standard detail and may peel up over time. We recommend applying a Bituminous resin flashing material (compatible with both EPDM and asphaltic membranes) and reinforcing fabric over the tie-in side of the curb.

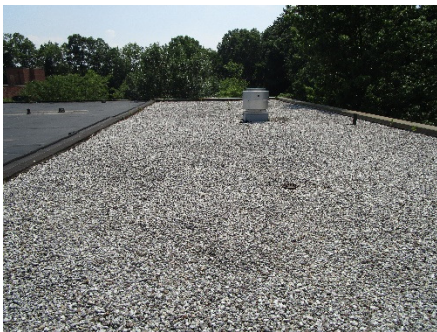
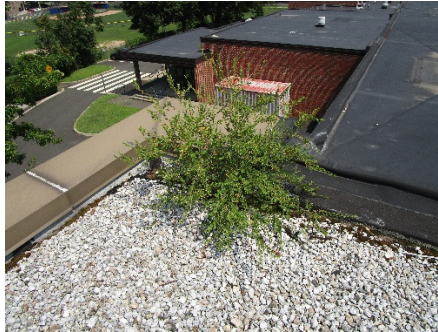
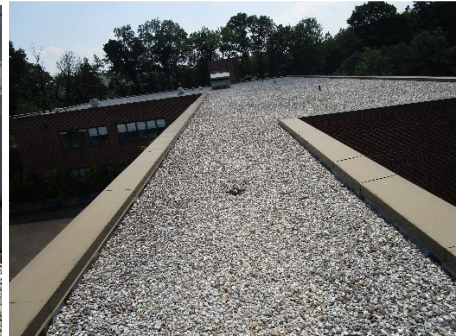
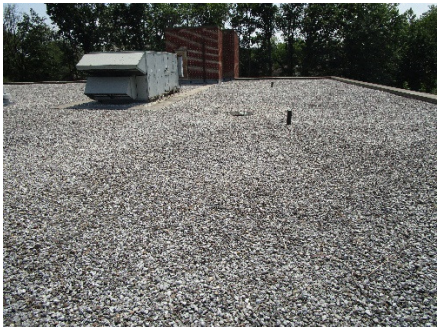
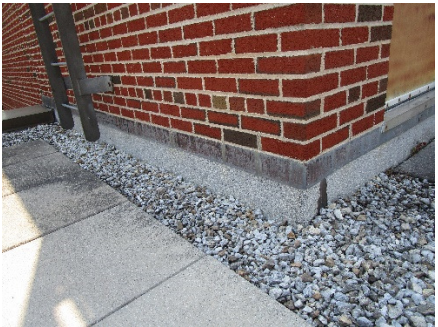
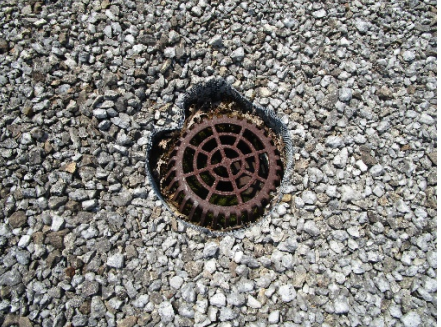
Roofs I, J and K are all inverted or "IRMA" built-up roofing systems. The membrane is on the deck, then insulation, filter fabric and ballast are on top of it. This type of system tends to have very long life spans because of the protected and temperature regulated nature of the assembly. Going by time span pictures of the school, it looks like these roofs cover an addition that was installed in the early 2000's. Only the visible portion of the flashings were inspected on these roofs and all look to be in good condition. General maintenance to remove organic growth, clear drains, etc., should be performed. There are also two conditions that need more attention.

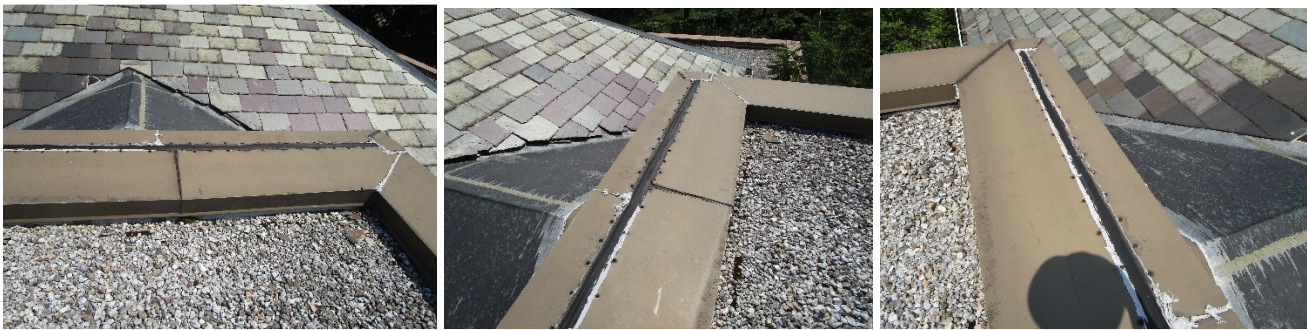
Tie-in with slate roof on roof J

The tie-in to the older existing building with the slate roof is performed using metal flashing over what looks like a flexible membrane. The screws are rusting in the metal and judging by the caulking applied to some of the areas, the joint has leaked in the past. This detail should be closely inspected, recaulked and the joints possibly overlaid with PS EPDM flashing if necessary.

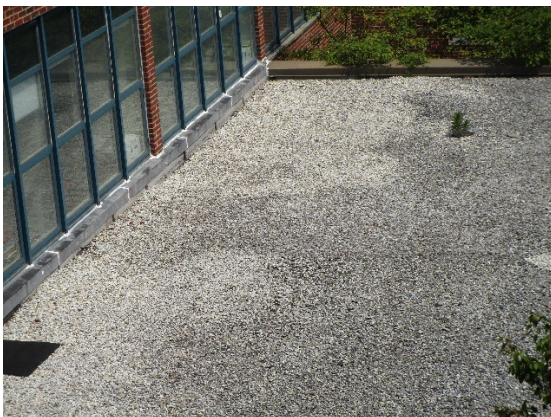
Caulking at window ledge on roof k

It appears that the ledge at the windows above roof K has previously leaked and been caulked. This area needs to be closely inspected and properly recaulked.

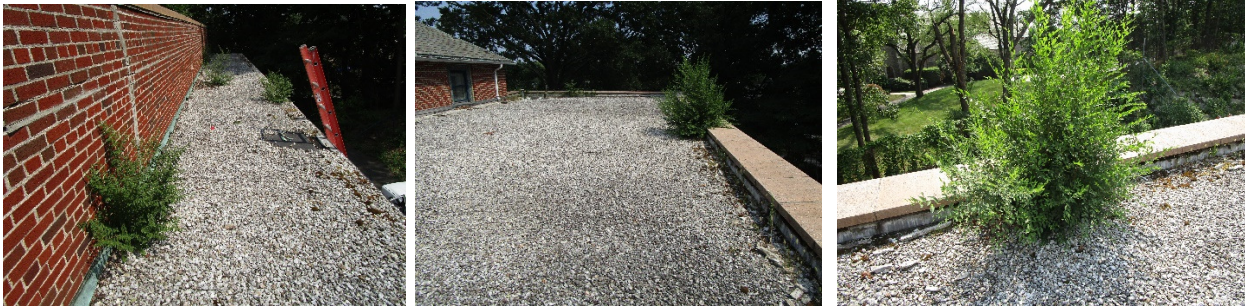
Roofs L & M are old “IRMA” roofs. As such, only visible flashing was looked at. Organic growth needs to be removed from these roofs. In addition, drains need to be cleared and ballast redistributed in some areas.

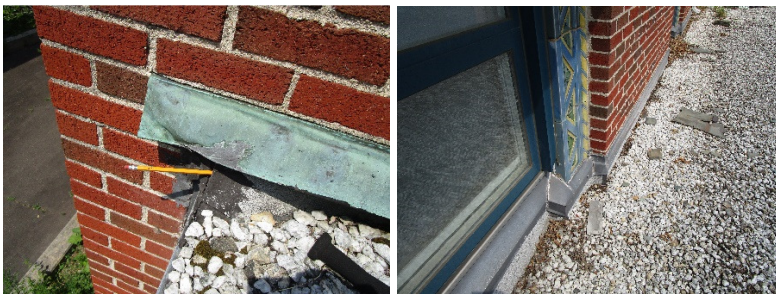
Caulking and flashing repairs

All corners should be inspected and resealed and caulking should be checked at all window flashing.

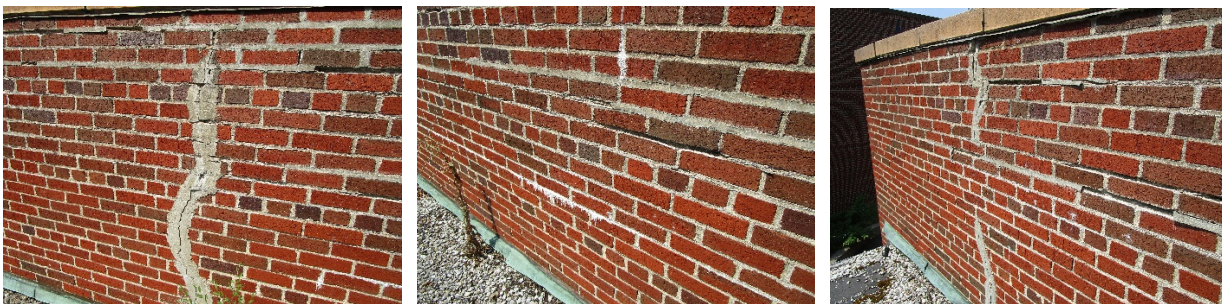
Possible major wall problem between roofs L & M

The masonry wall between roofs L & M is in extremely poor shape. There are vertical cracks in the wall missing mortar between bricks, missing mortar under the coping stones and some possible bowing. This wall should be looked at by the school’s architect or engineer and the appropriate repairs made. The wall condition is also affecting the coping stones at the top of the wall.

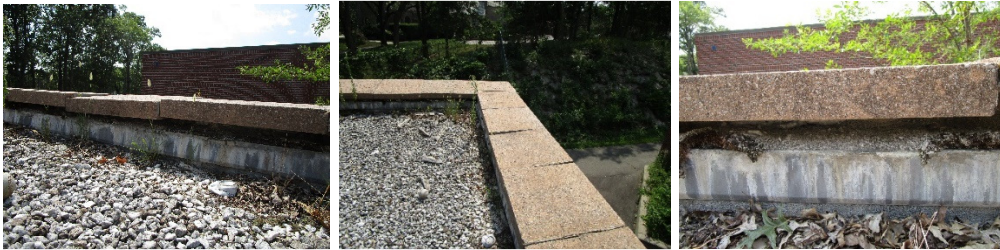
The coping stones are no longer lying flat and even. This may be due to the problems with the brick wall, eroded mortar or both. This needs to be looked at along with the wall.

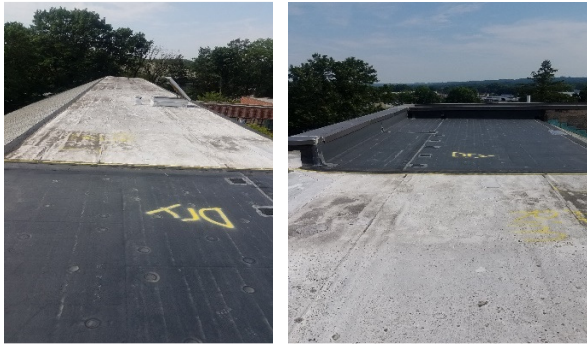
Roof Areas N and O

Roof areas N and O lie above the slate roof. They are separated by a small step in the roof. Roof N was shown as all wet on the infra-red report; area O was dry. Because the entire area of N was shown as wet, we recommend that this roof be removed and replaced. We can provide pricing for this replacement upon request. Roof N needs only basic maintenance.

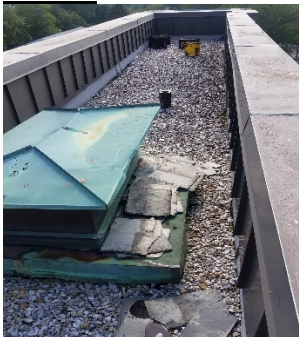
Roof P is above the slate roof as well. It is a narrow IRMA style built-up-roof. It looks to have become a collection area for broken/changed slate and some other debris. It needs to be cleaned and have general maintenance.
