# Infrared Thermographic Roof Moisture Analysis

**PERFORMED FOR:** Viking Construction  
1387 Seaview Ave.  
Bridgeport, CT 06607

**LOCATION:** Julia Stark Elementary  
Stamford, CT

**CONDUCTED ON:** May 8 & 9, 2019

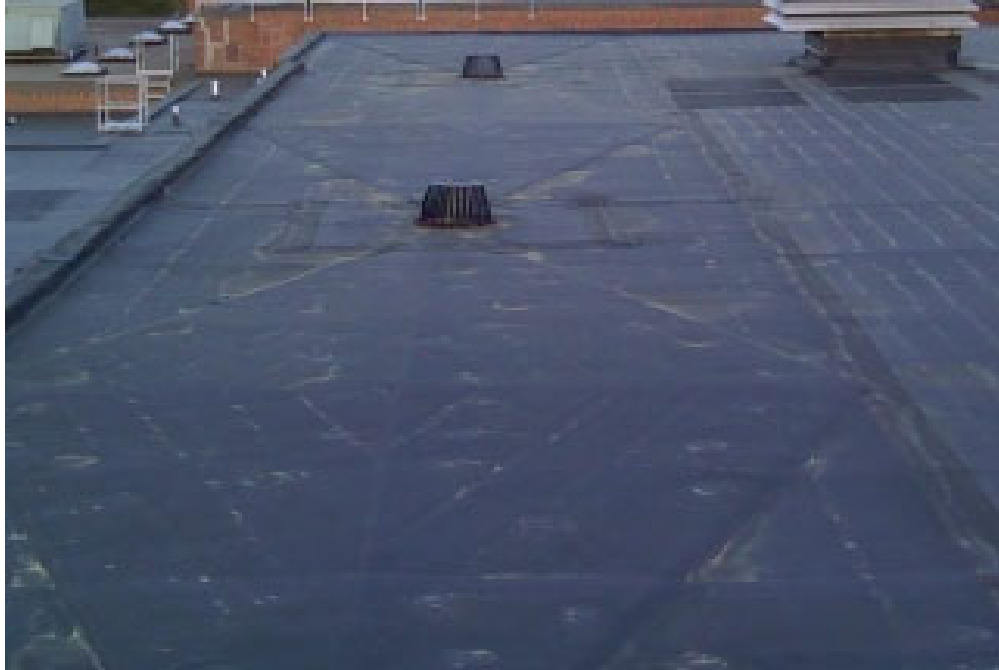
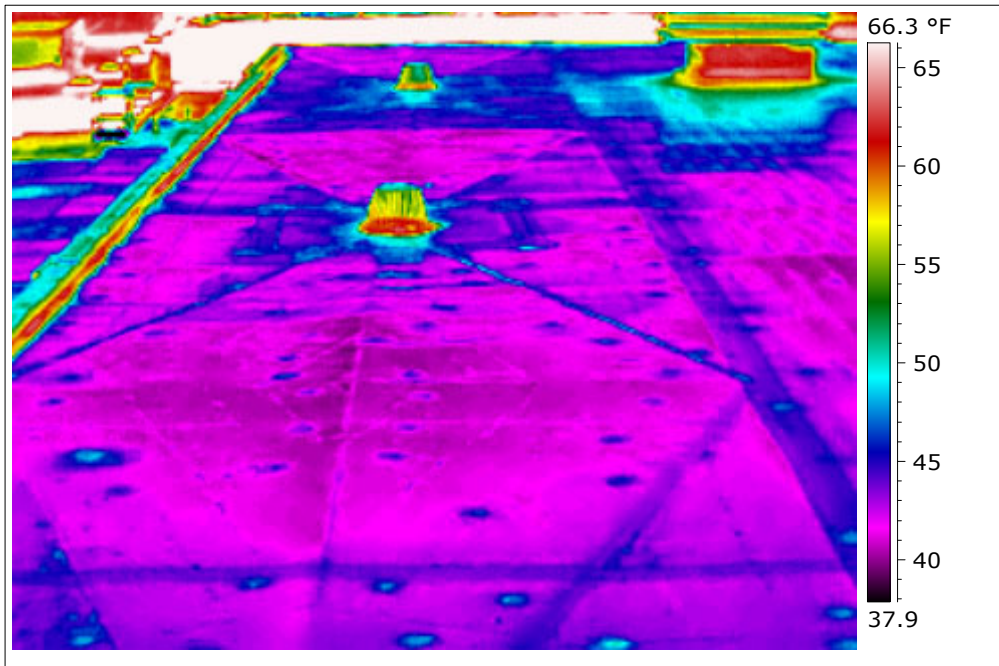
Thermogram # 1

Dry area of roofing

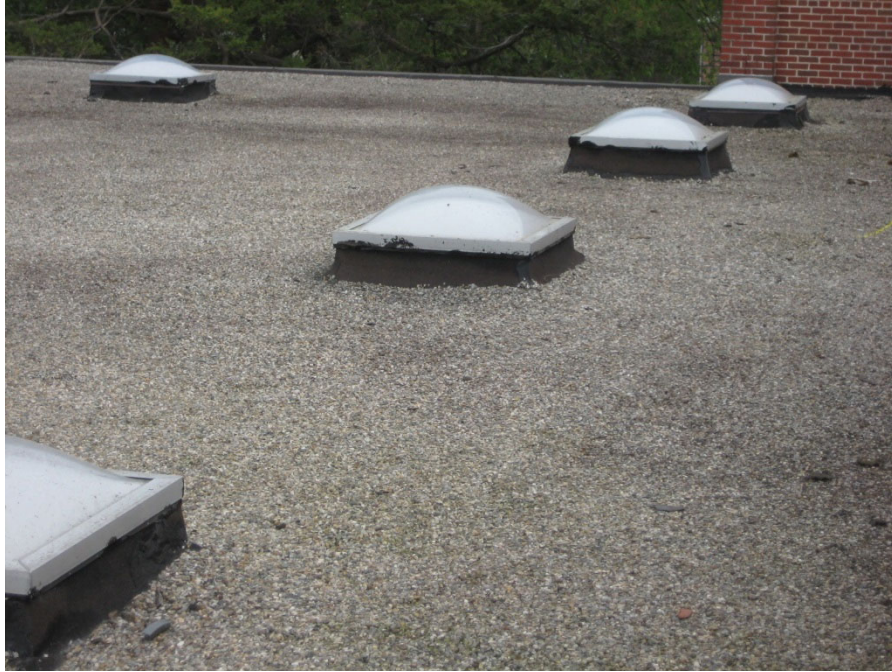
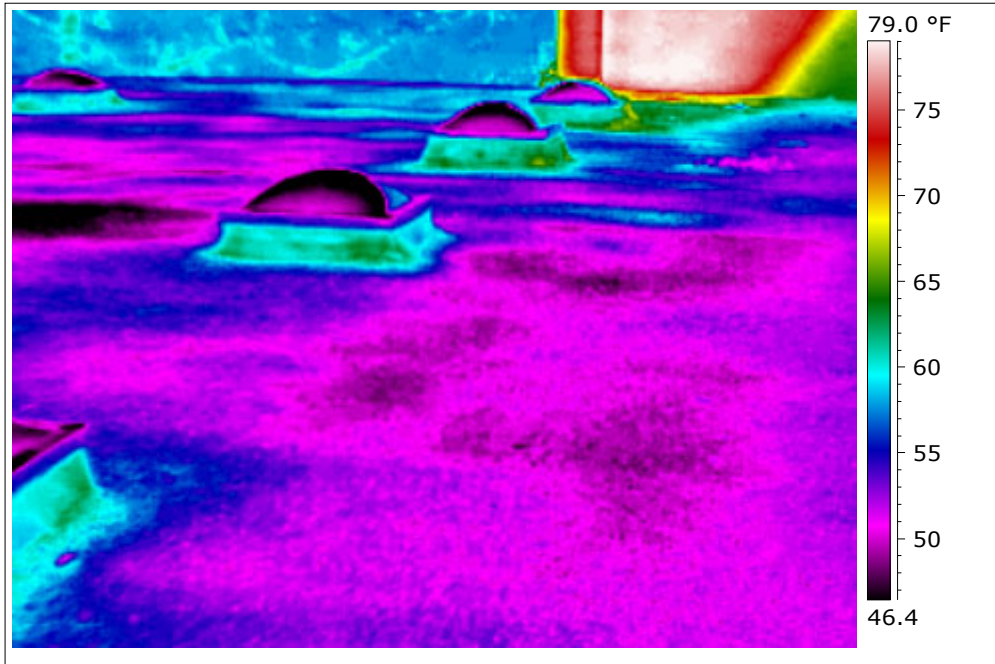
Thermogram # 2

Dry area of roofing

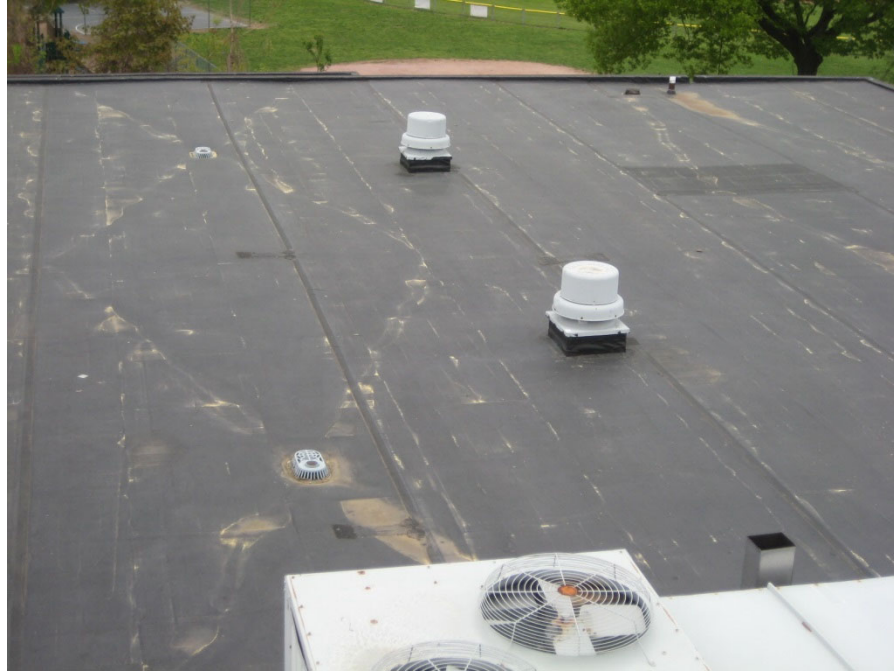
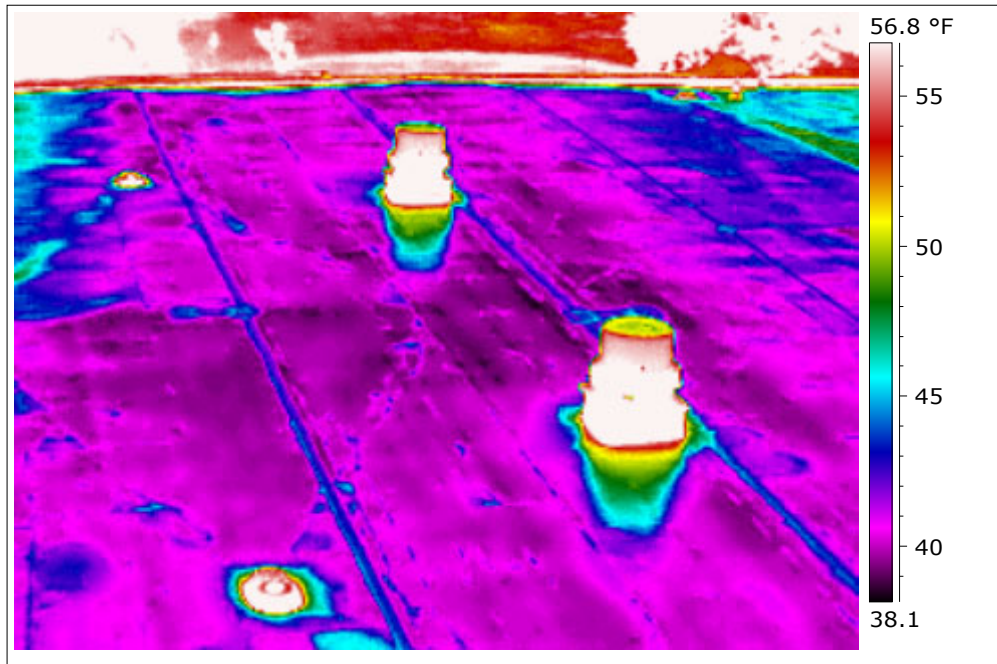
Thermogram # 3

Dry area of roofing

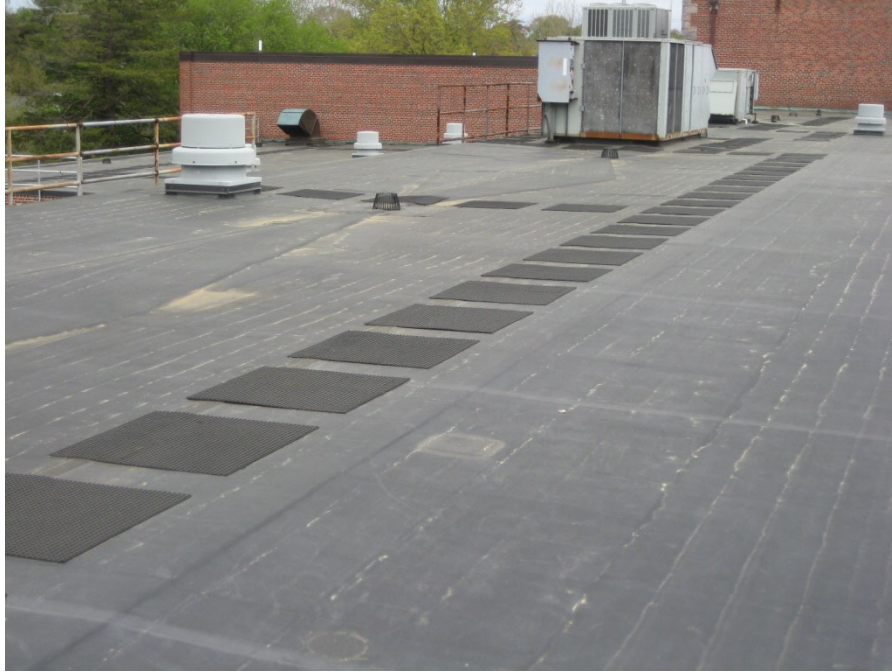
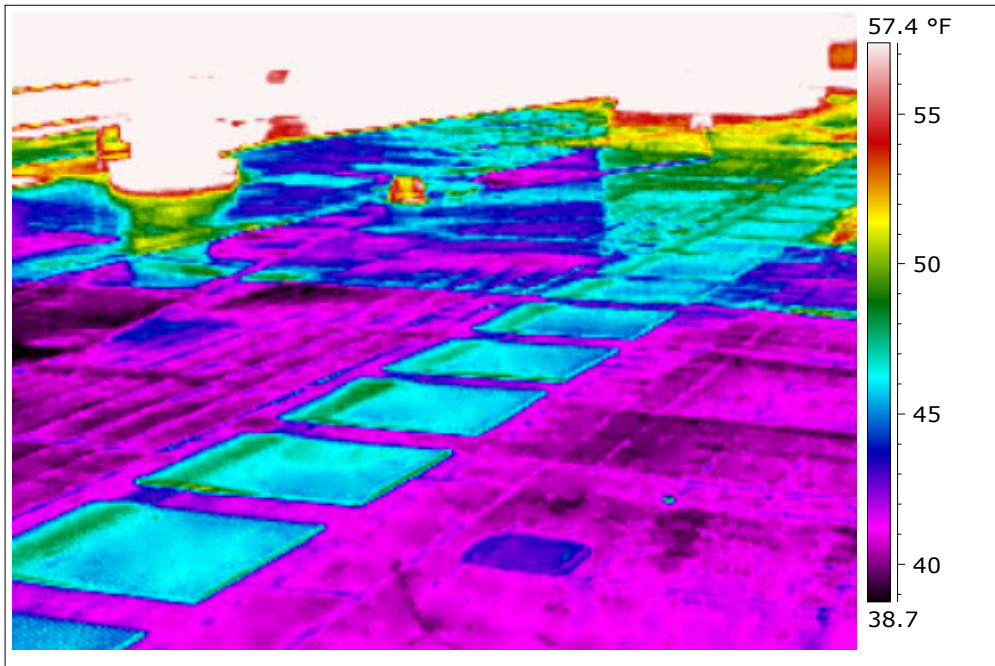
Thermogram # 4

Dry area of roofing

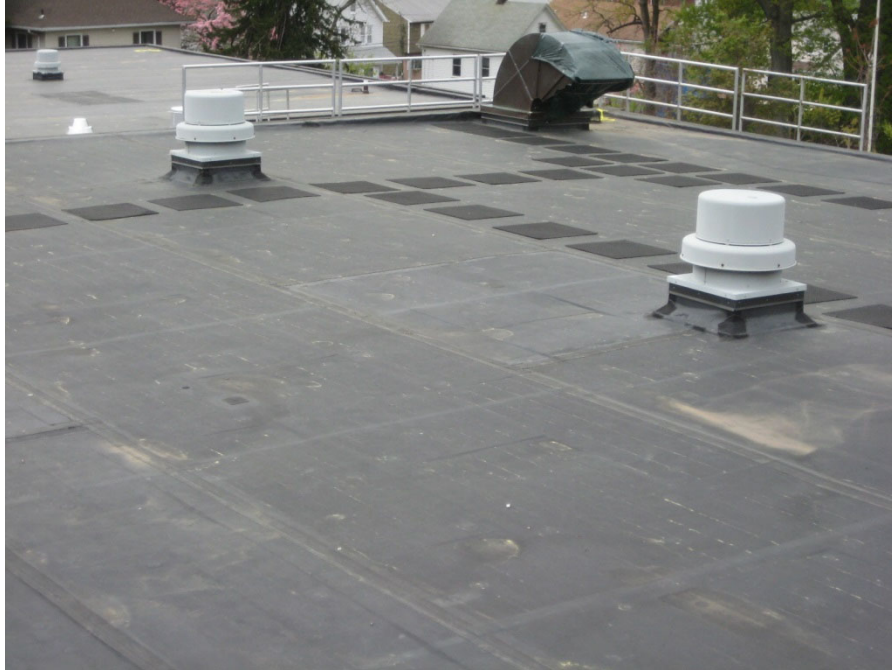
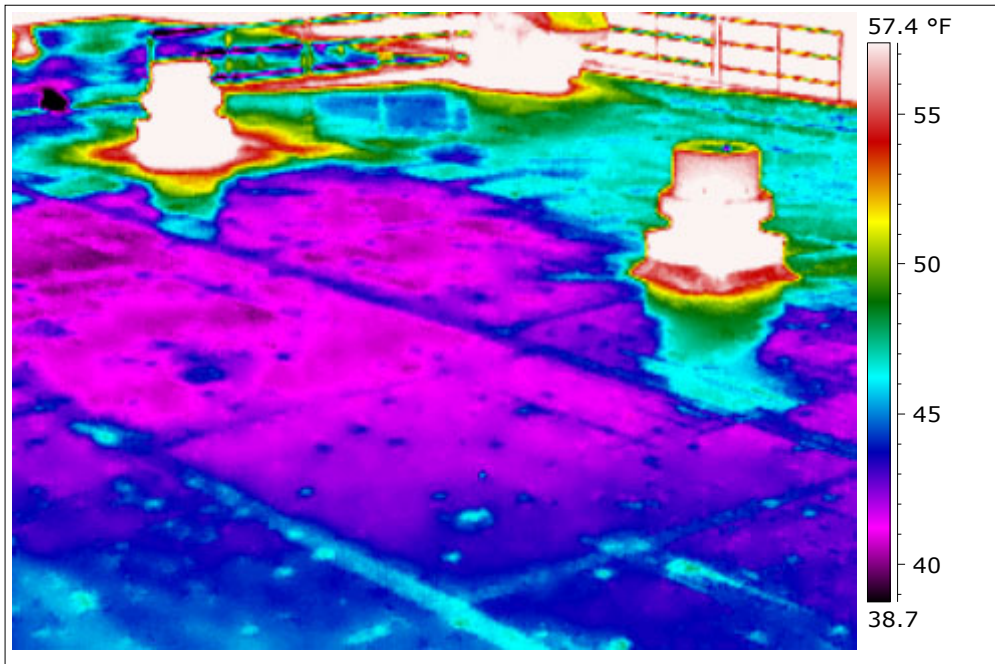
Thermogram # 5

Dry area of roofing

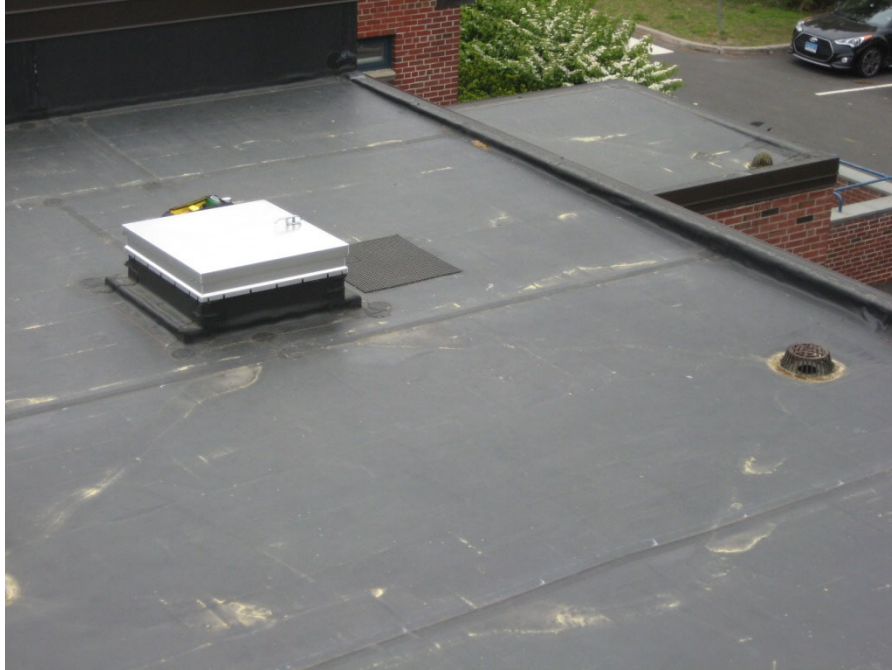
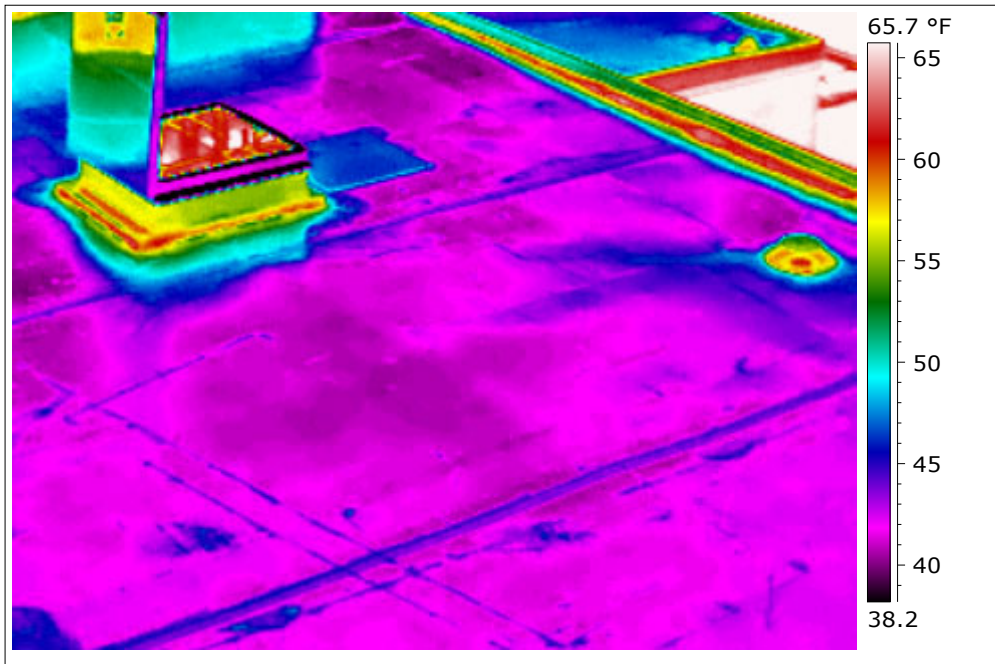
Thermogram # 6

Dry area of roofing

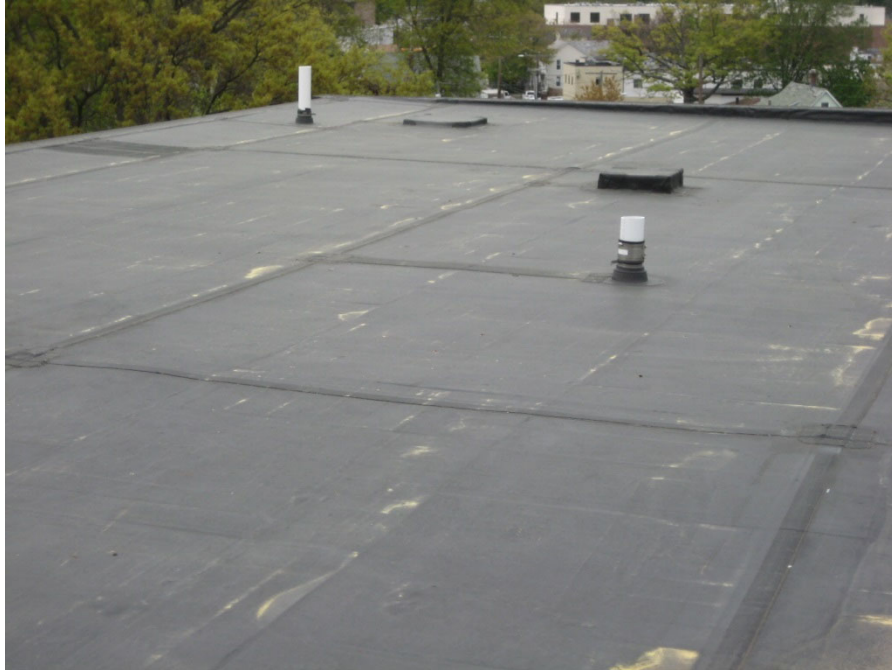
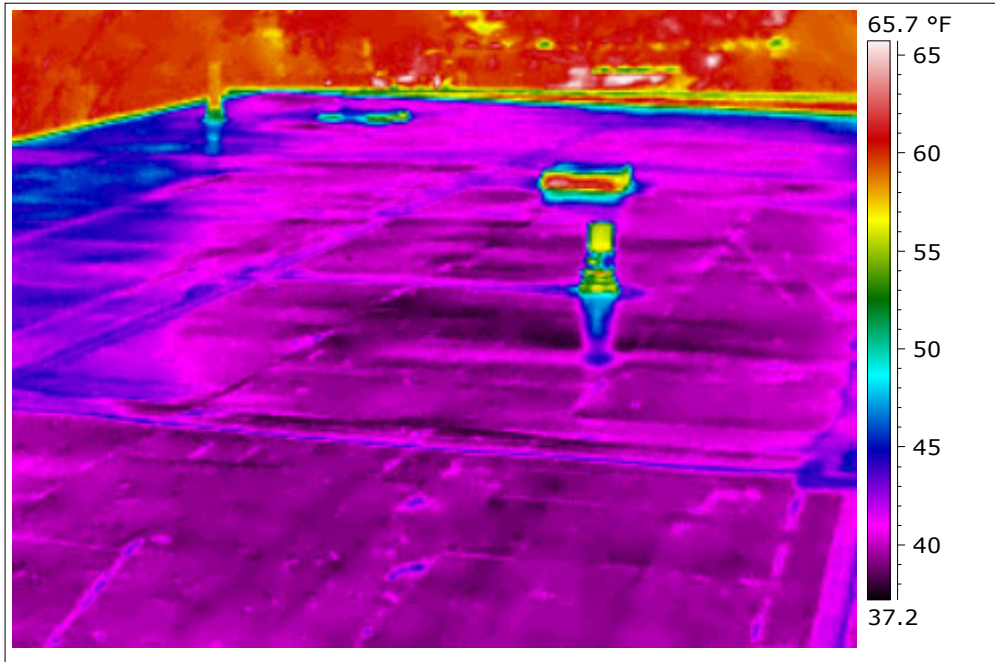
Thermogram # 7

Dry area of roofing

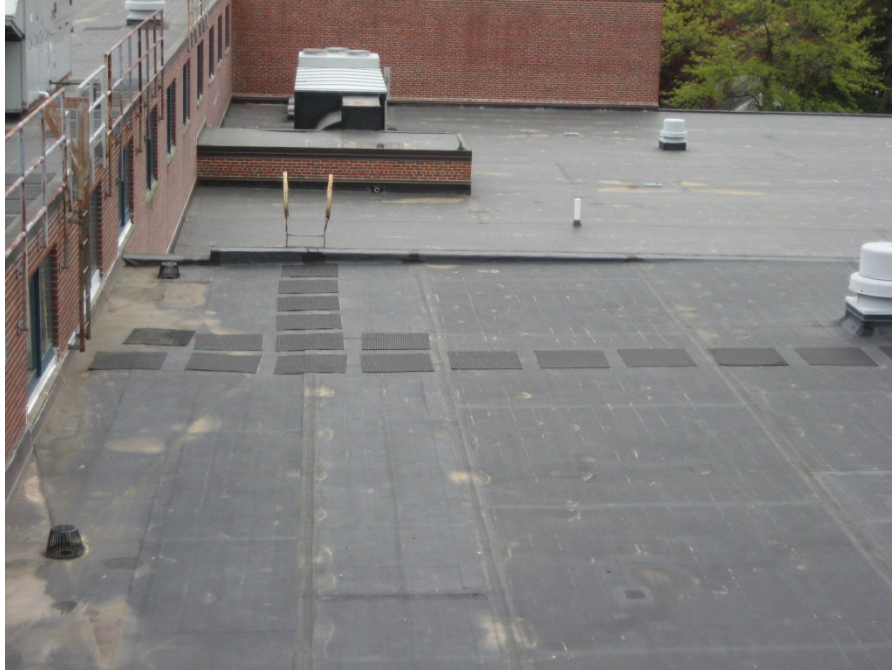
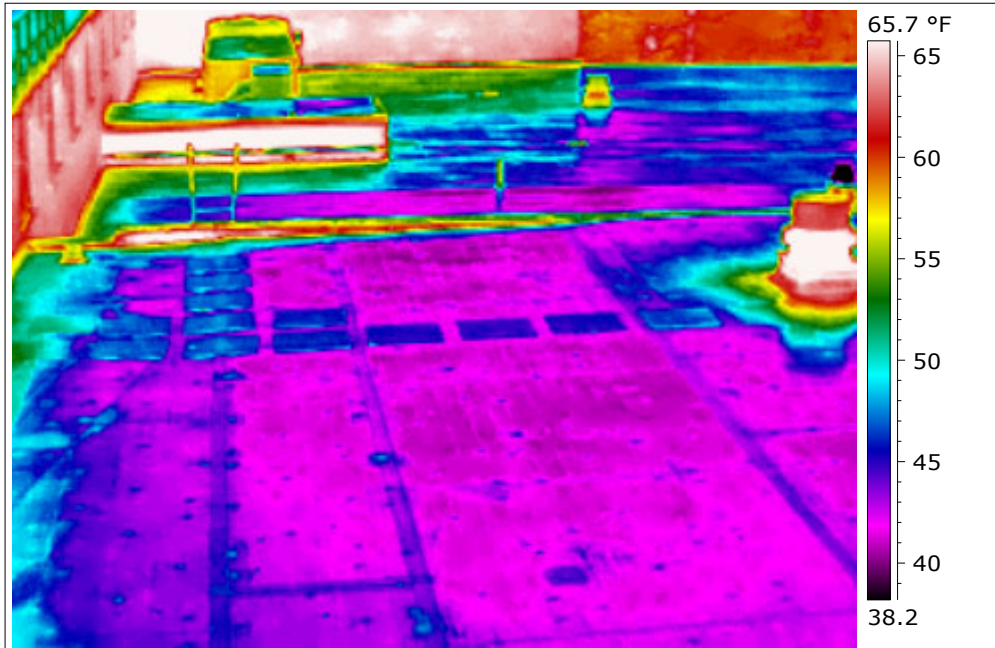
Thermogram # 8

Dry area of roofing

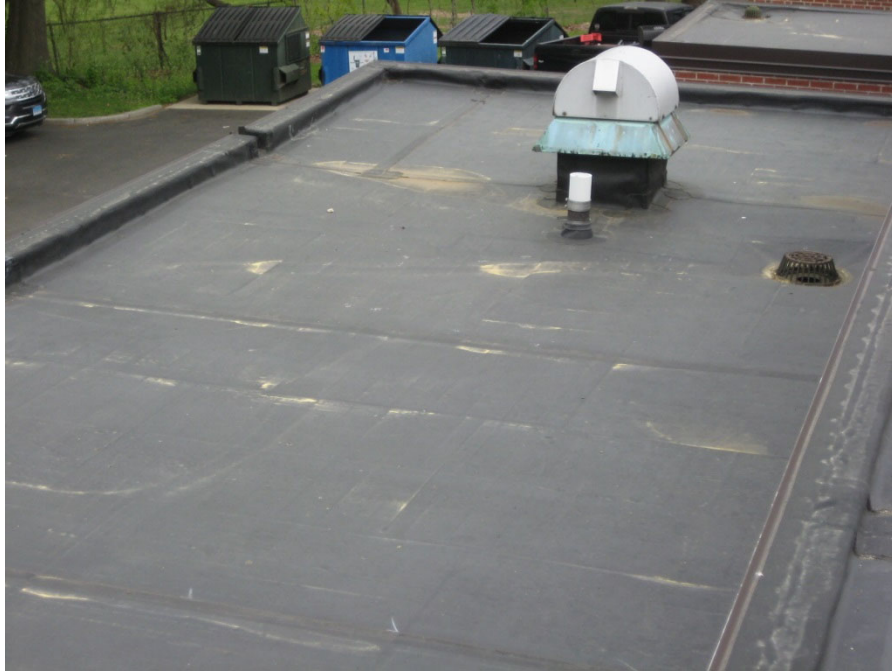
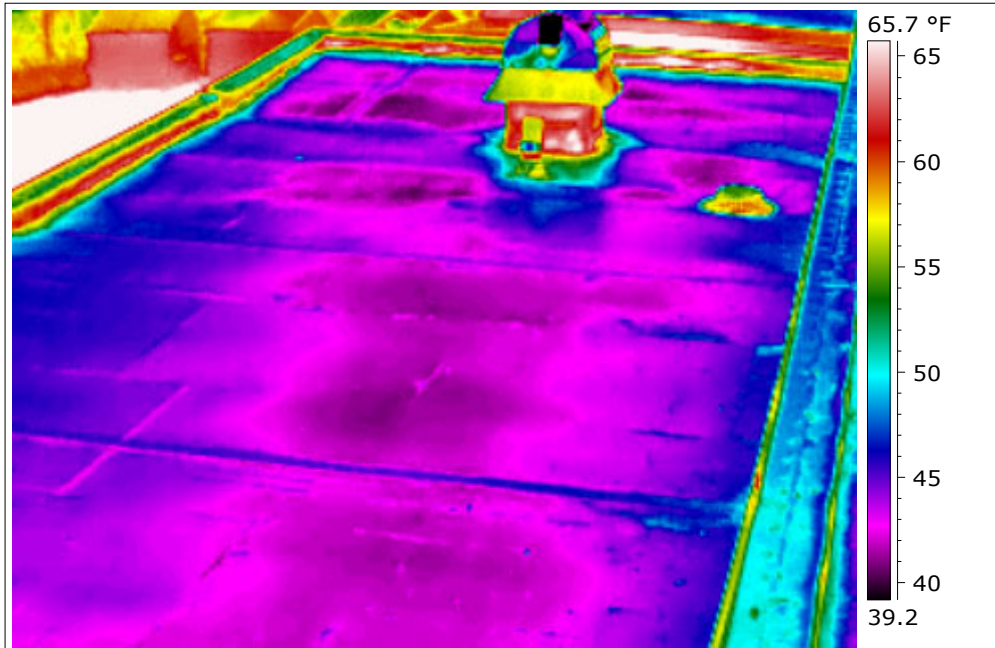
Thermogram # 9

Dry area of roofing

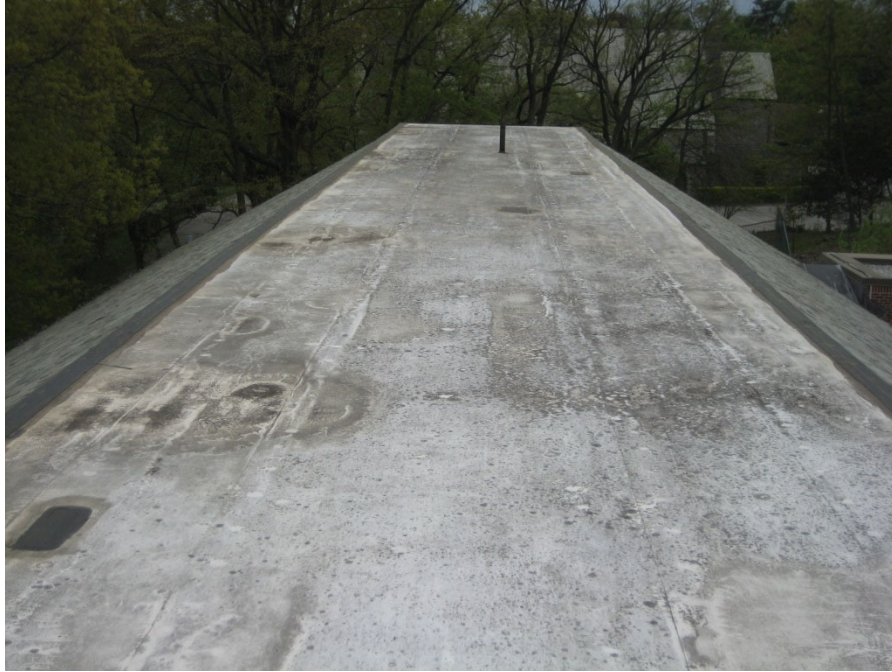
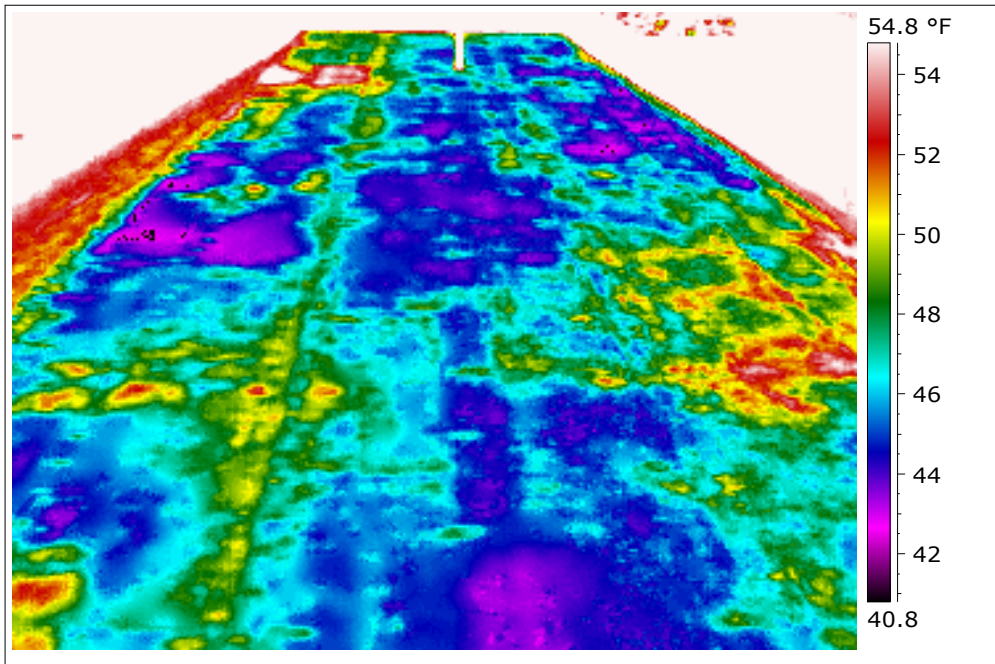
Thermogram # 10

Wet Area #1
