WORK PERFORMED AT STARK ELEMENTARY SCHOOL

- *Tighe&Bond* – identified areas of concern on both floors of the school.
- *AAIS* – cleaned the mold in the areas of concern.
- *Bismark Construction company* – rebuilt the walls in the areas of concern.
- *Simpson Gumpertz & Heger* – engineers water tested select areas of the building at exterior doors and windows.

Work was done during the Christmas break 2018.

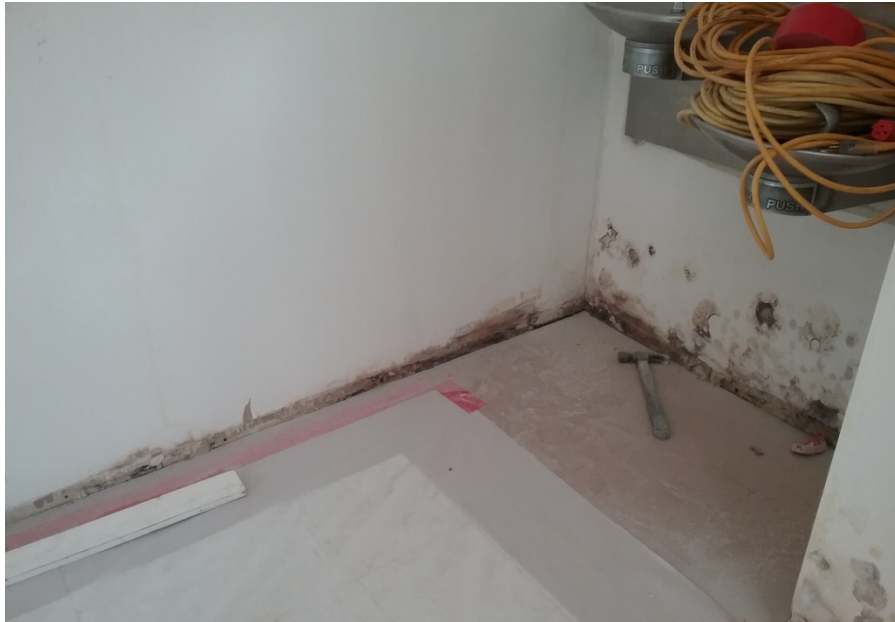
Wall covering was removed on the first floor to identify the location of the mold.

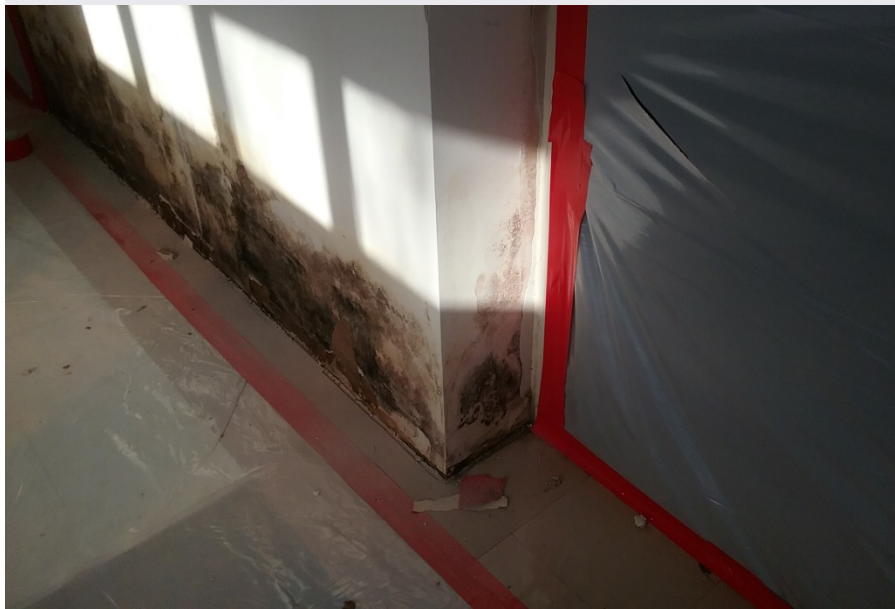
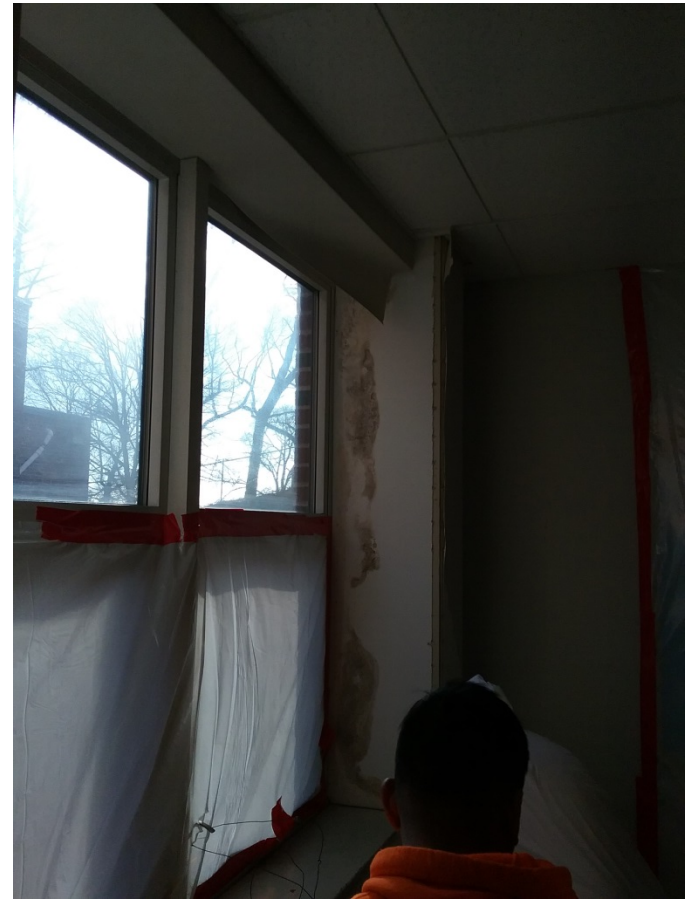
Wall covering was removed on the 2nd floor hallway to identify leaks and mold growth.

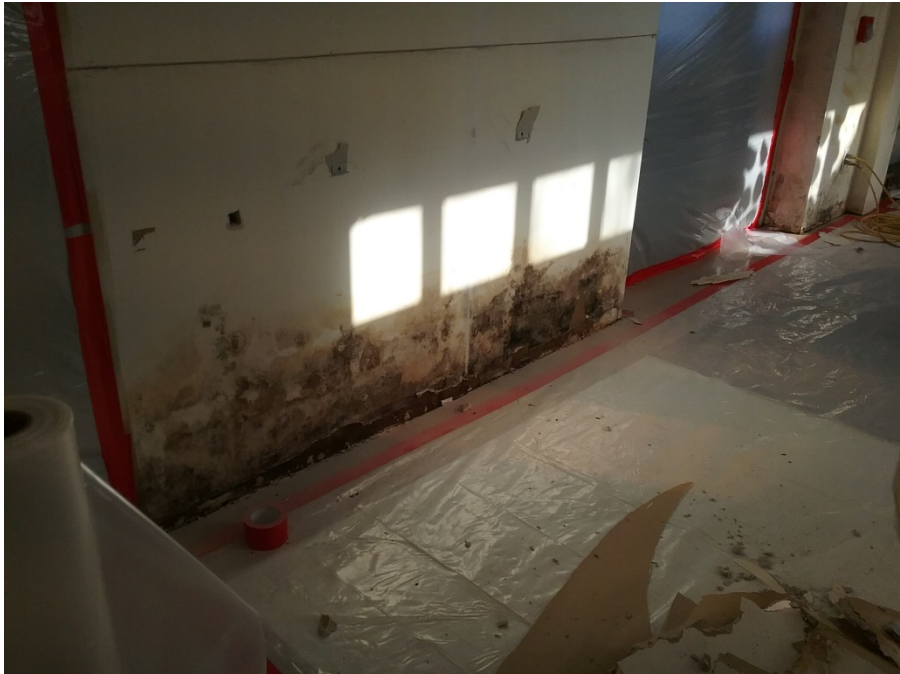
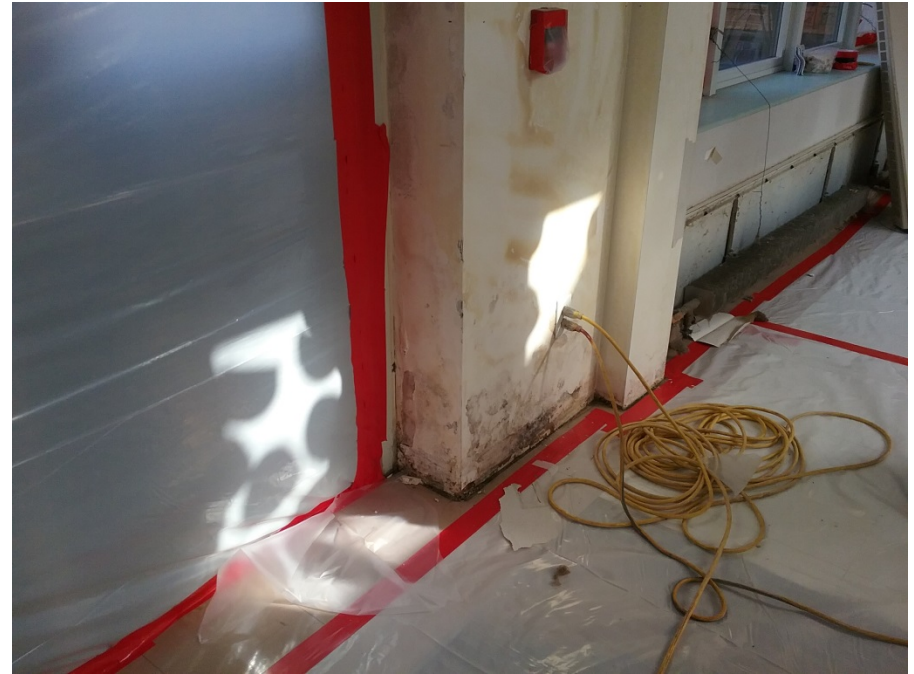
Wall covering was removed at the ground floor hallway to identify mold.

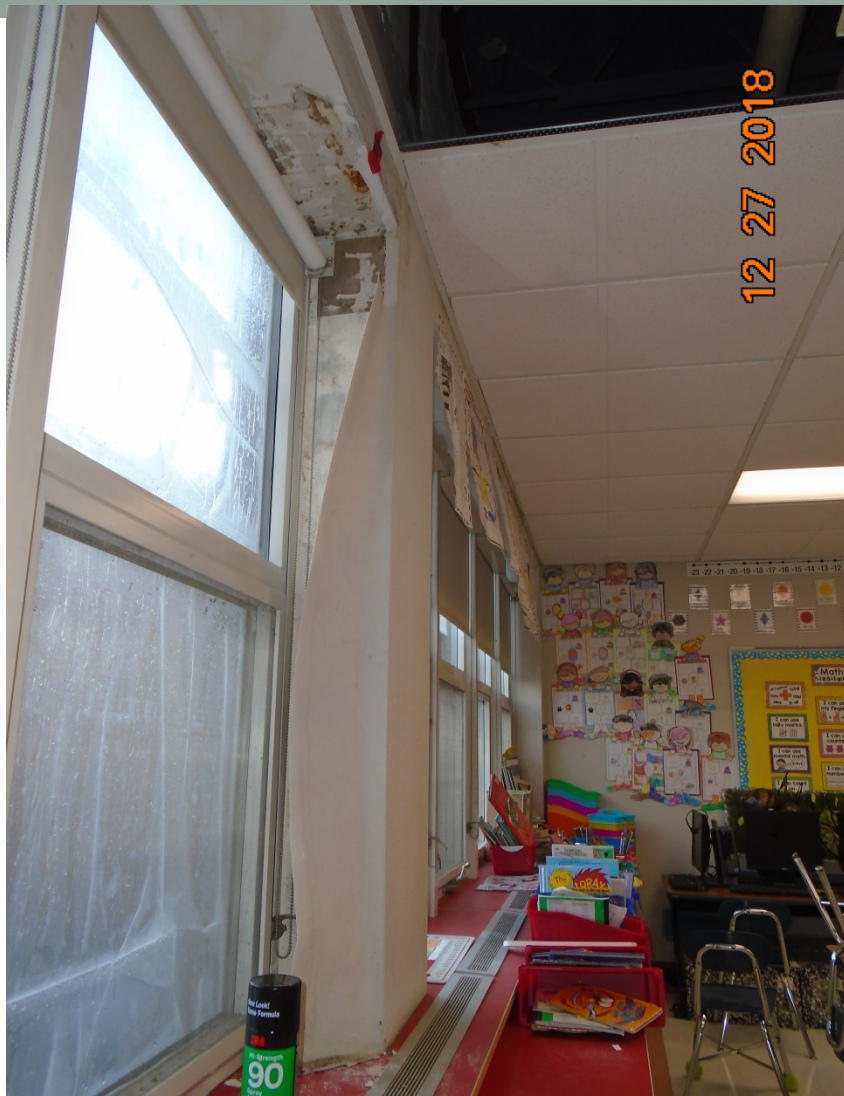
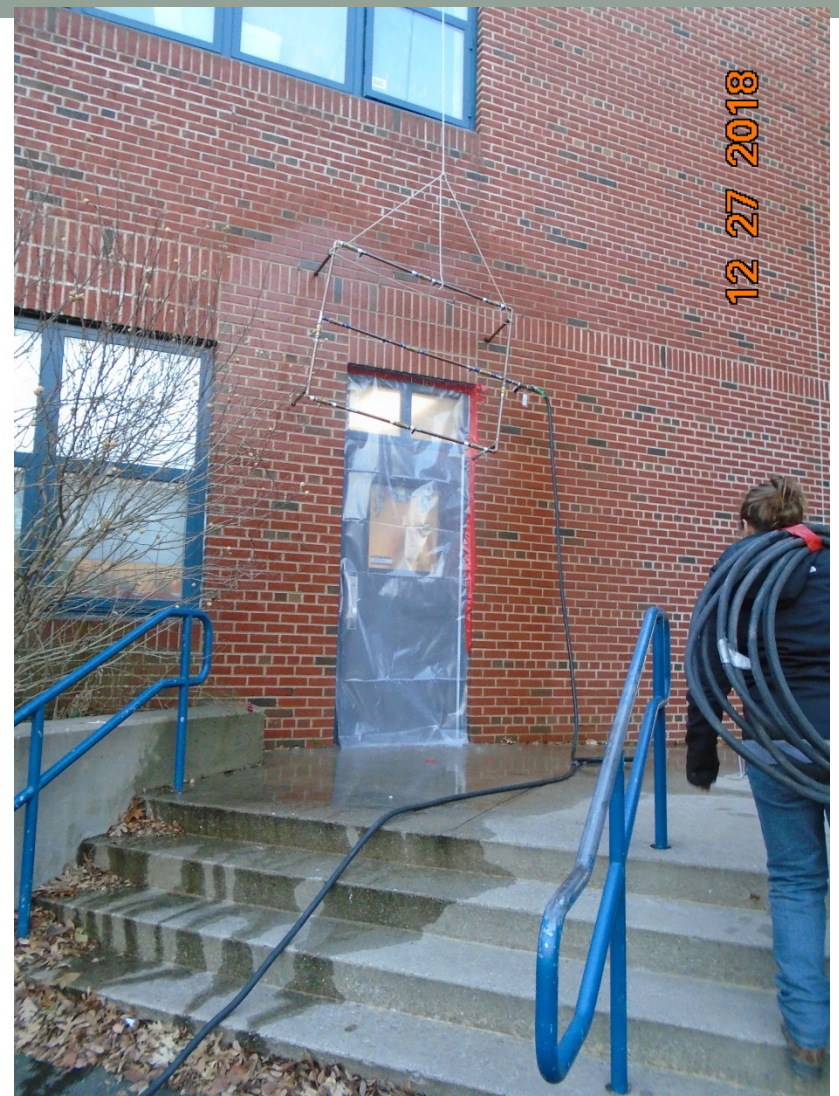
Engineers tested select windows and doors for water intrusion.
December 27, 2018

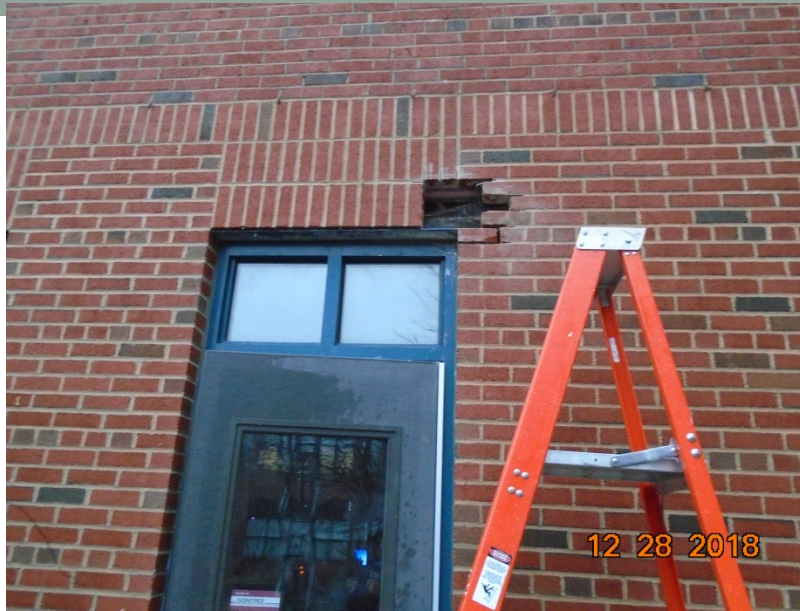
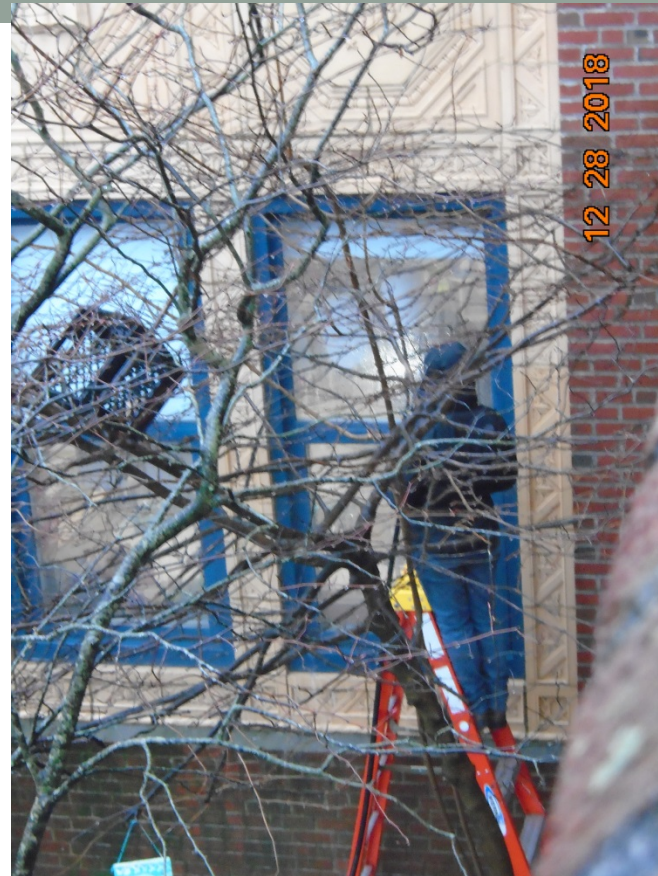
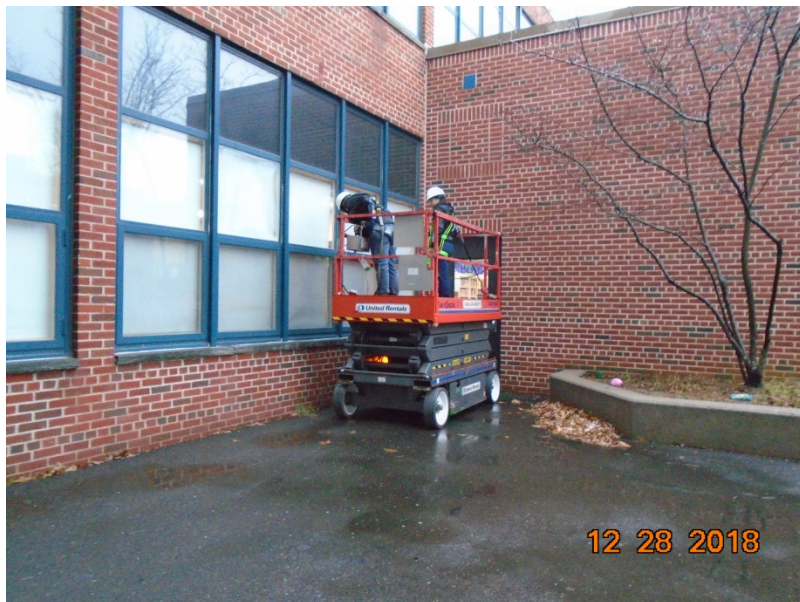
Engineers continued testing the integrity of windows and doors. In addition to testing, the engineers removed brick at window and door to inspect window and door flashing and the composition of construction.
