Infrared Thermographic Roof Moisture Analysis

PERFORMED FOR: Viking Construction
1387 Seaview Ave.
Bridgeport, CT 06607

LOCATION: KT Murphy Elementary
Stamford, CT

CONDUCTED ON: May 16 & June 4, 2019

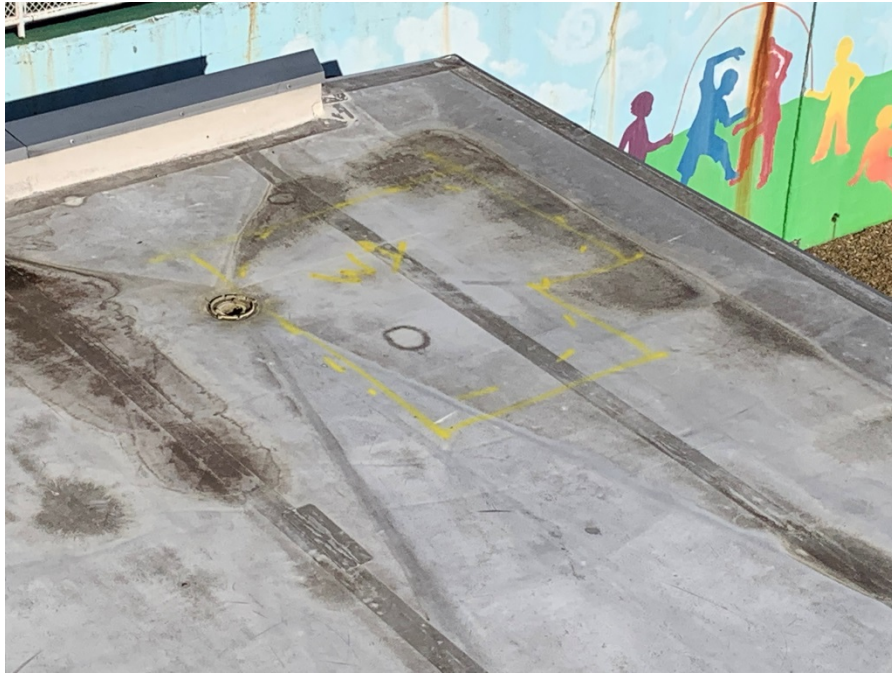
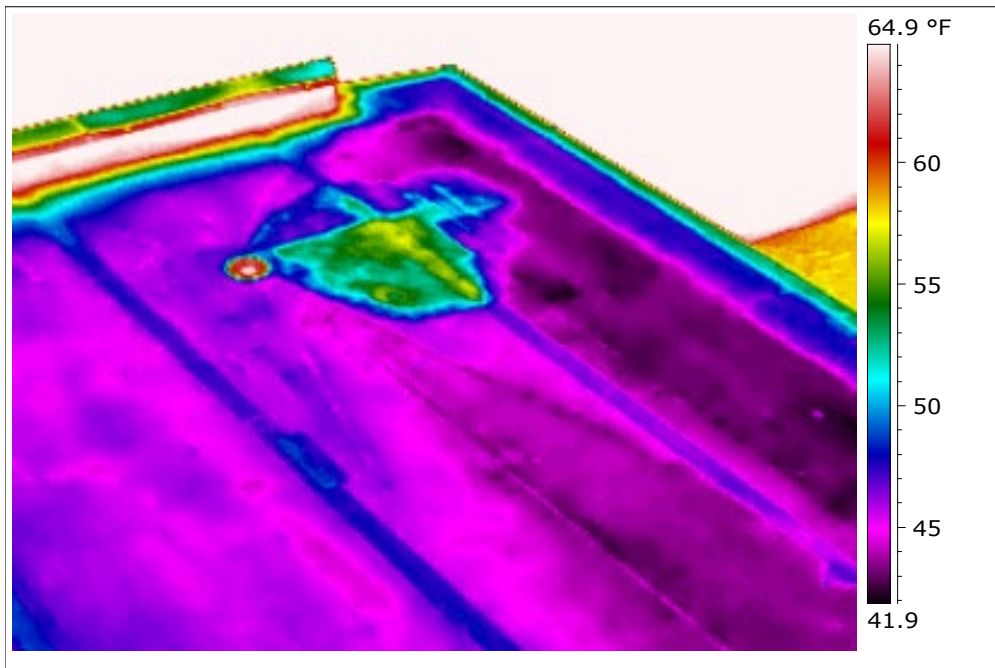
Thermogram # 1

Wet Area #1

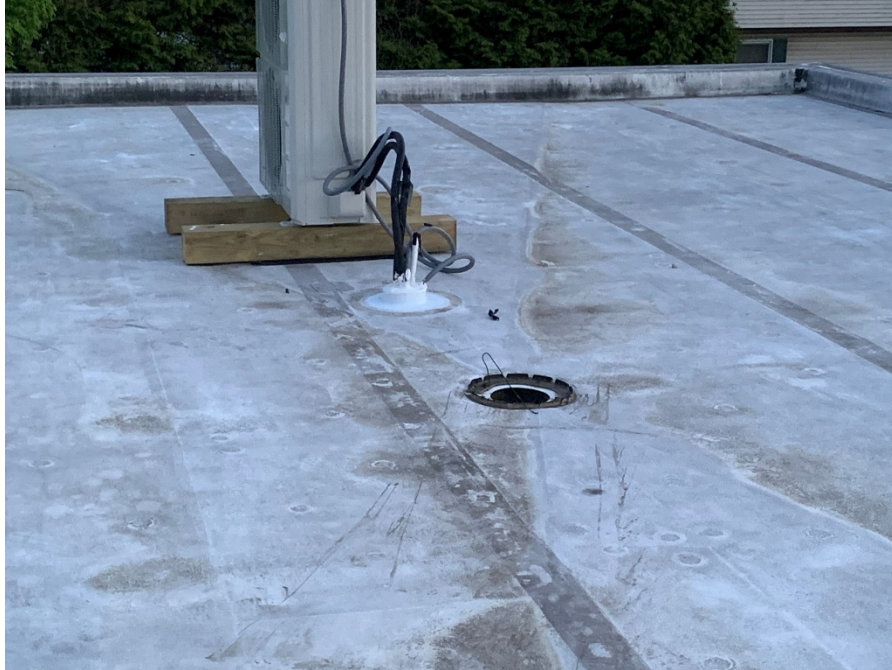
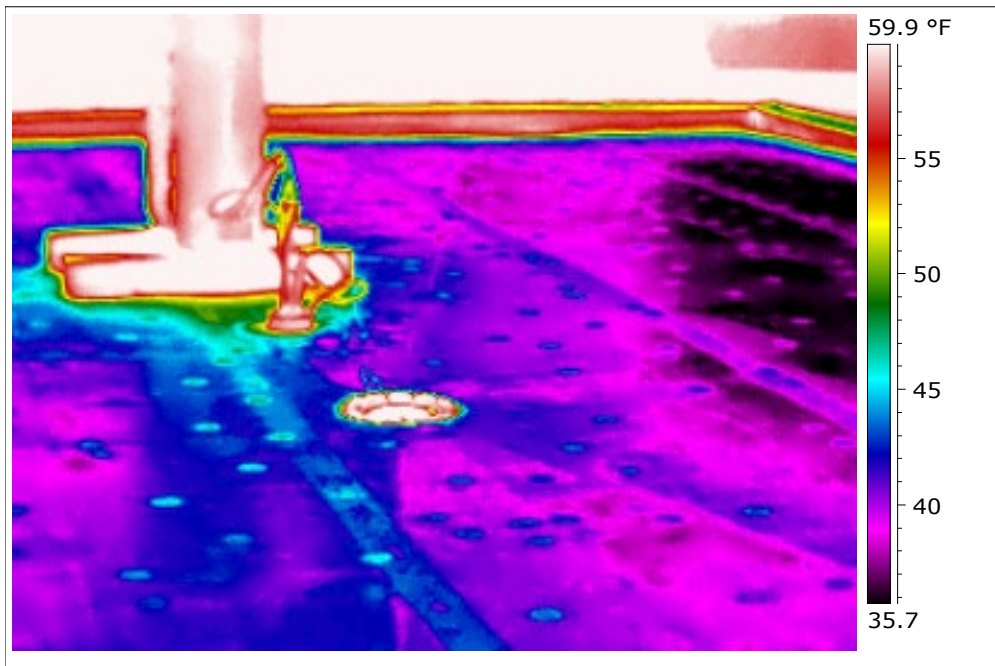
Thermogram # 2

Dry area of roofing

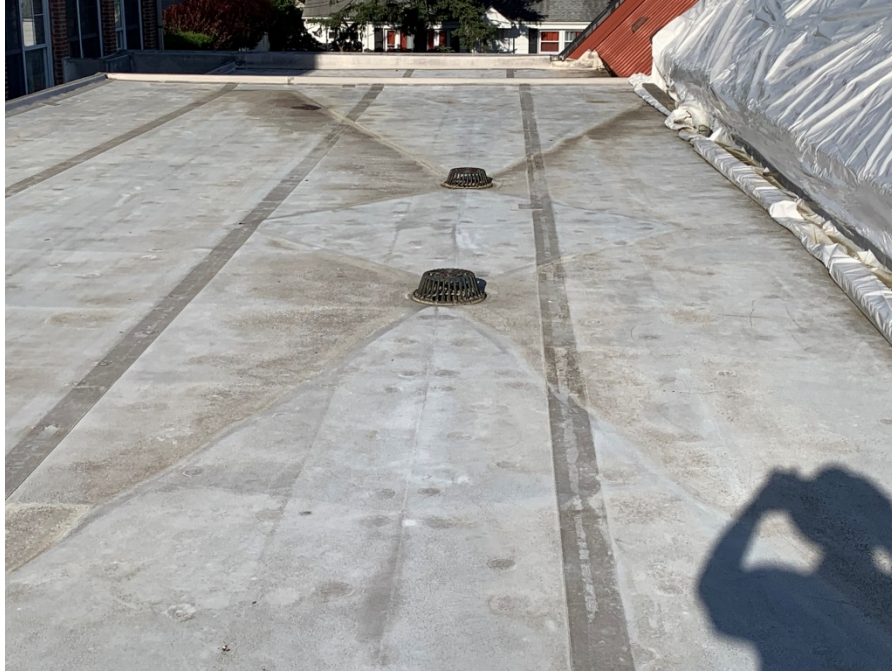
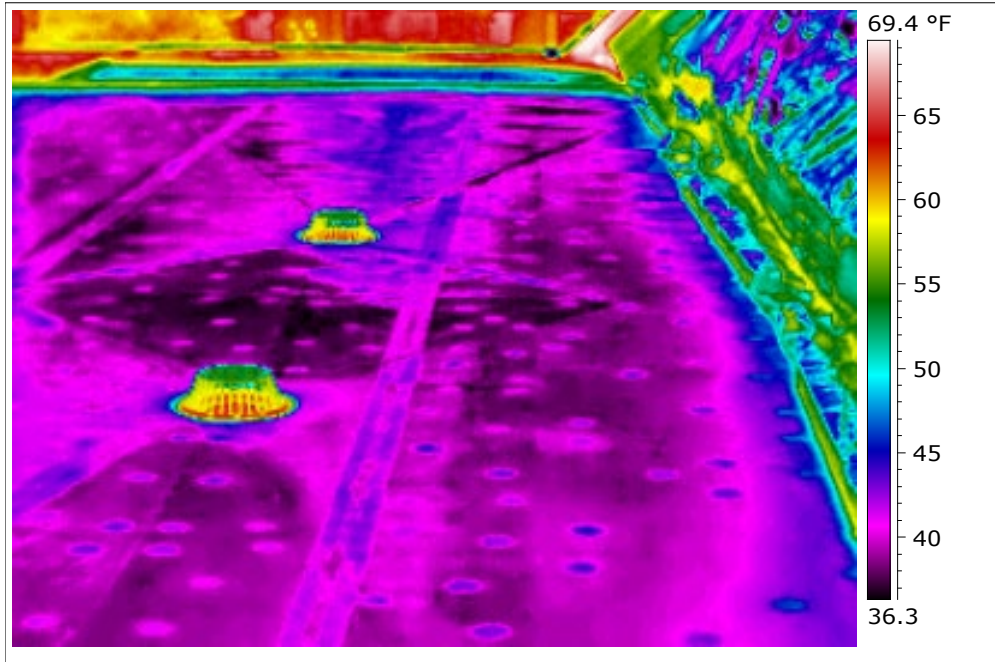
Thermogram # 3

Dry area of roofing

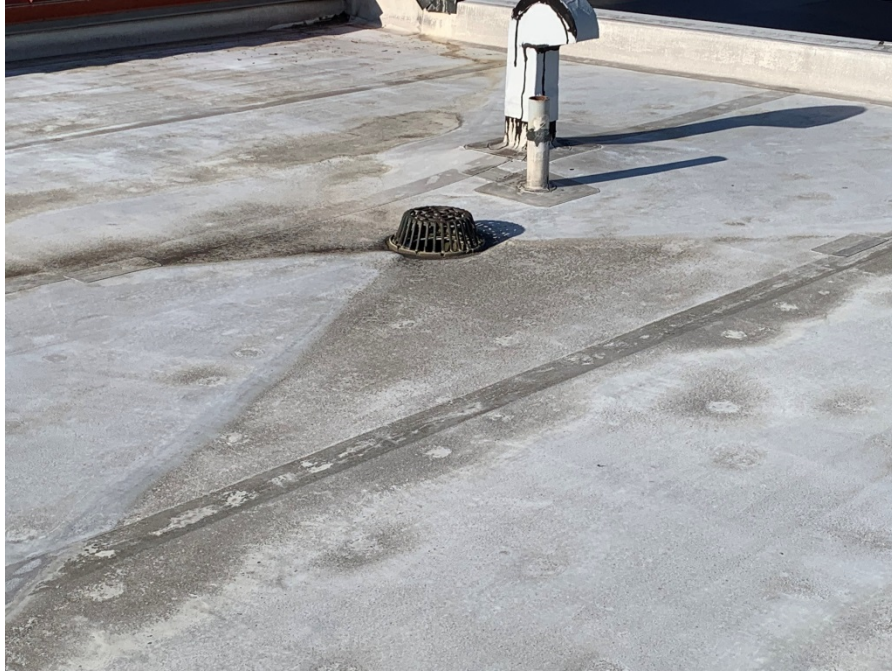
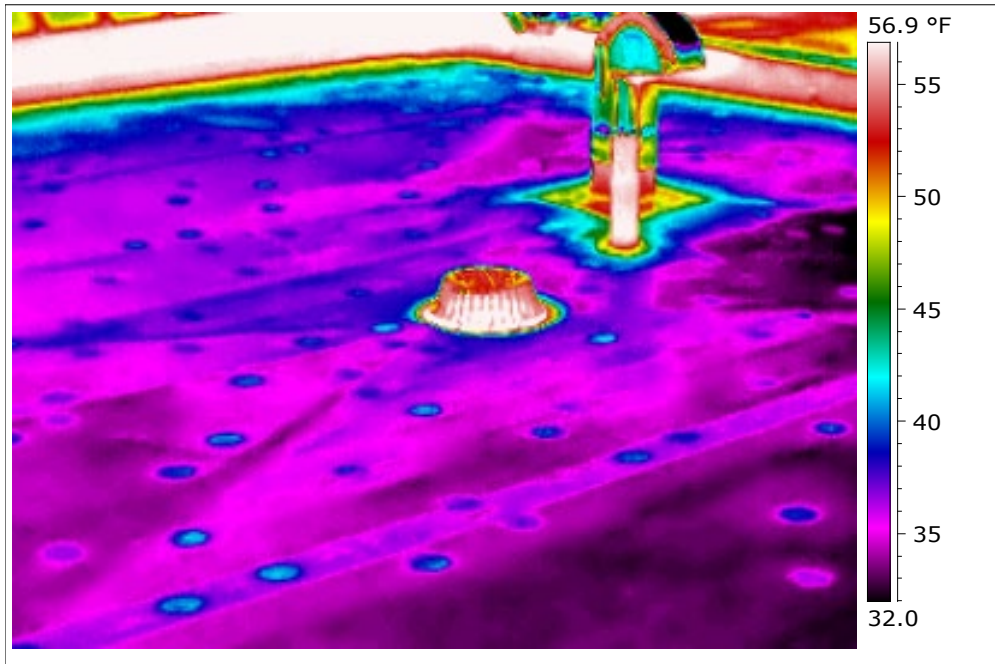
Thermogram # 4

Dry area of roofing

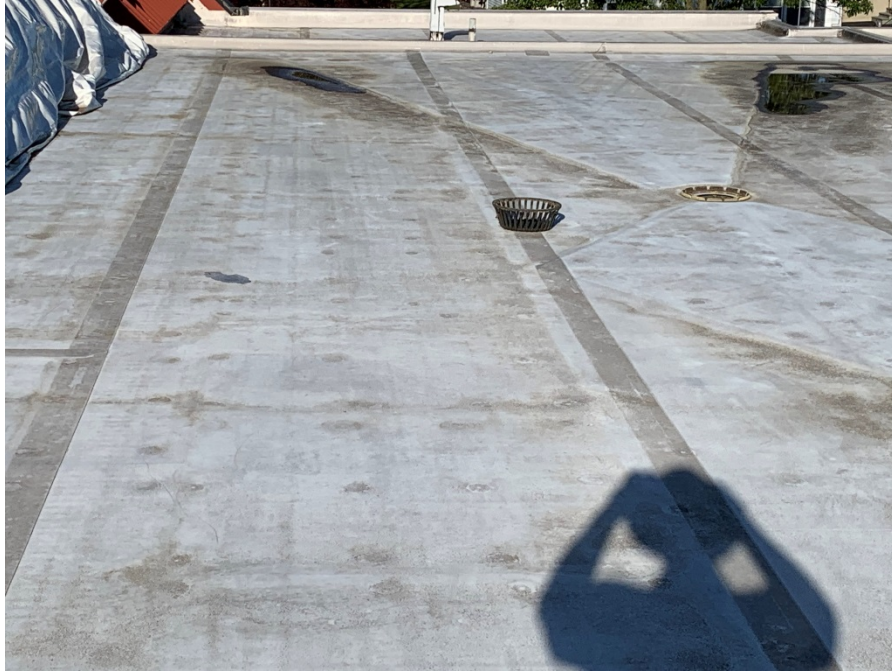
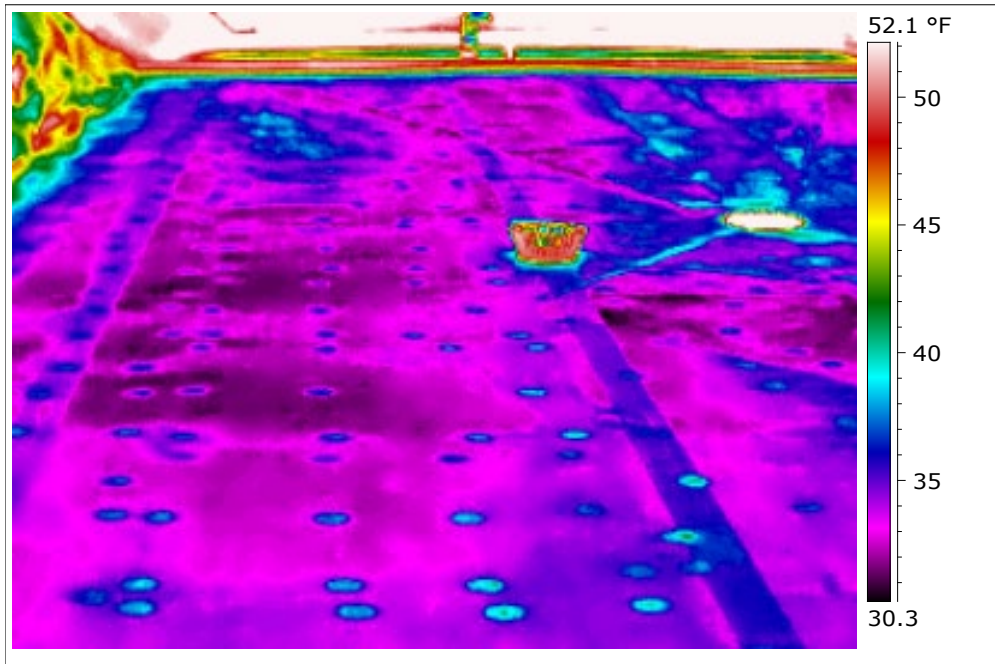
Thermogram # 5

Dry area of roofing

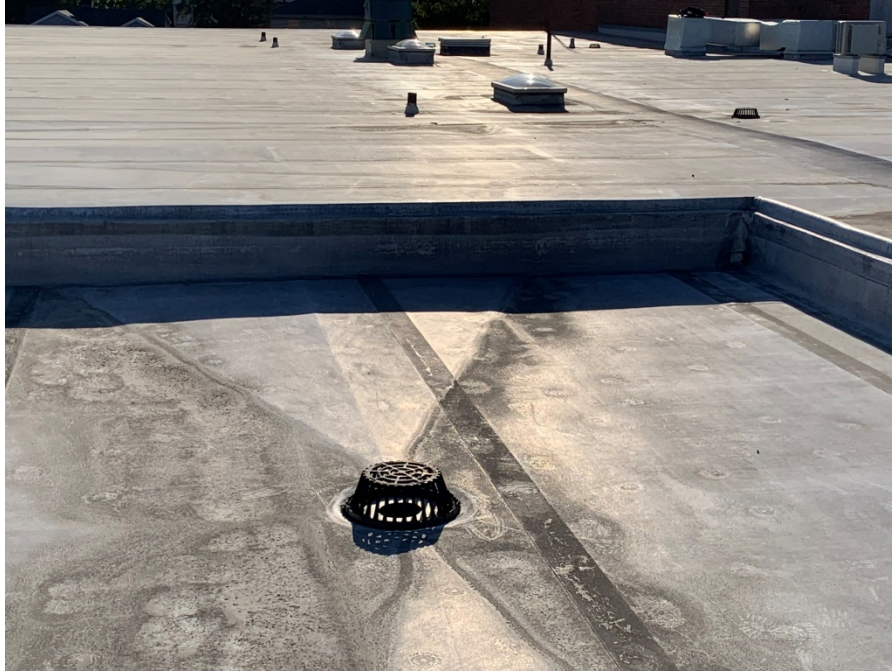
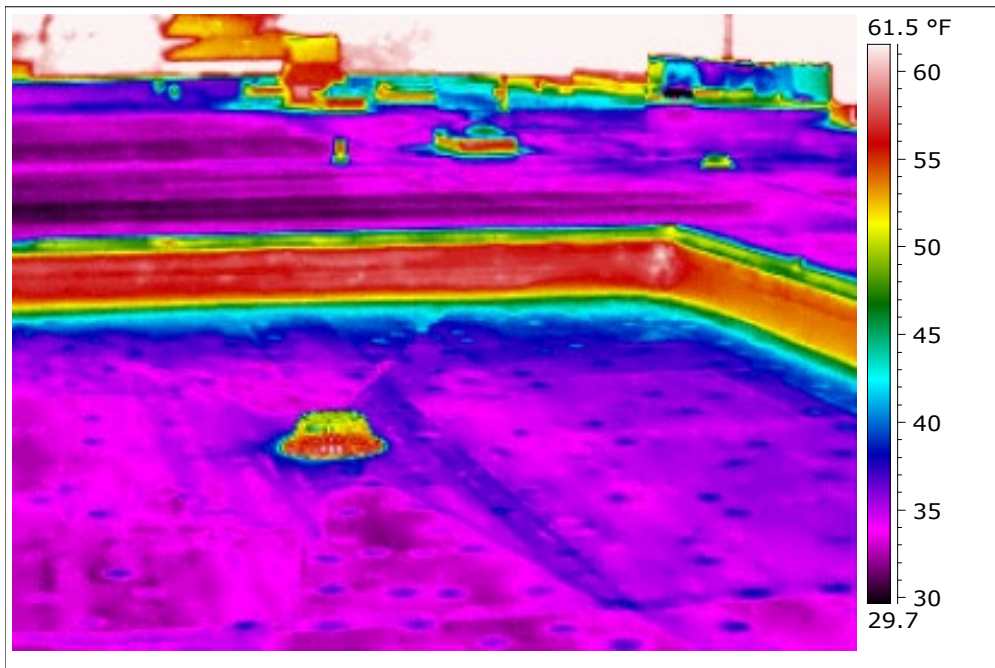
Thermogram # 6

Dry area of roofing

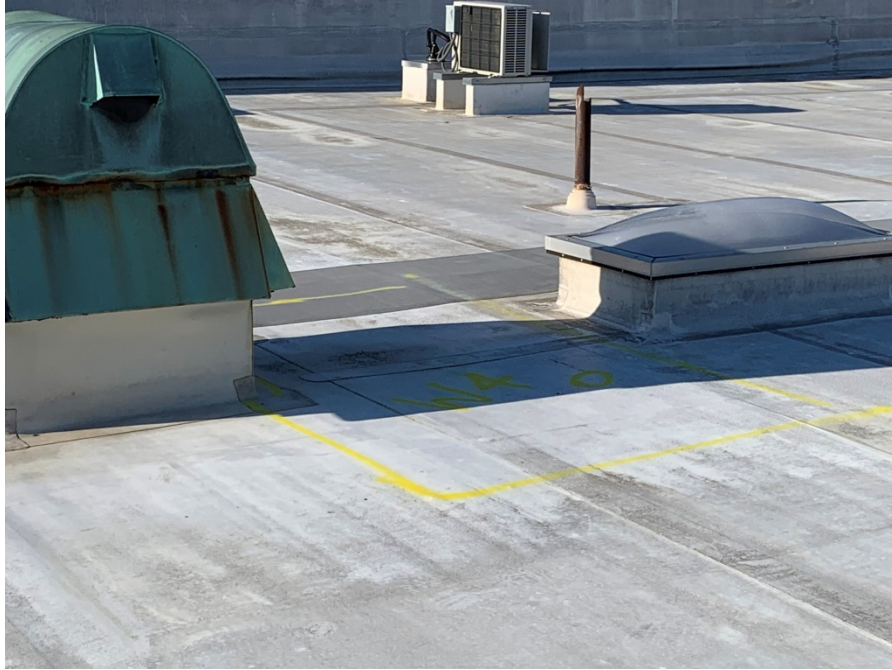
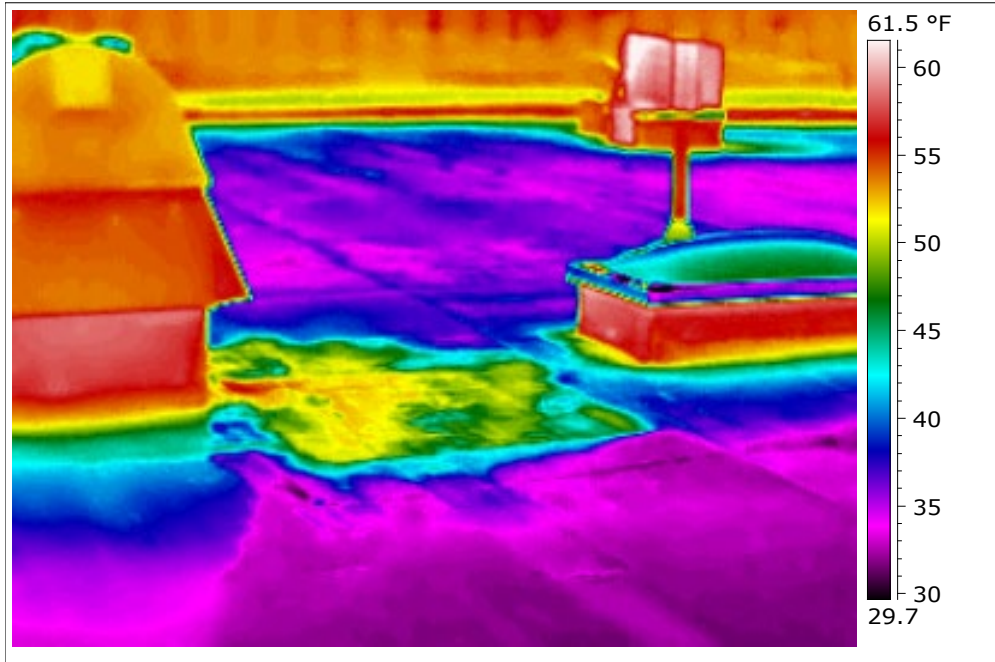
Thermogram # 7

Wet Area #4

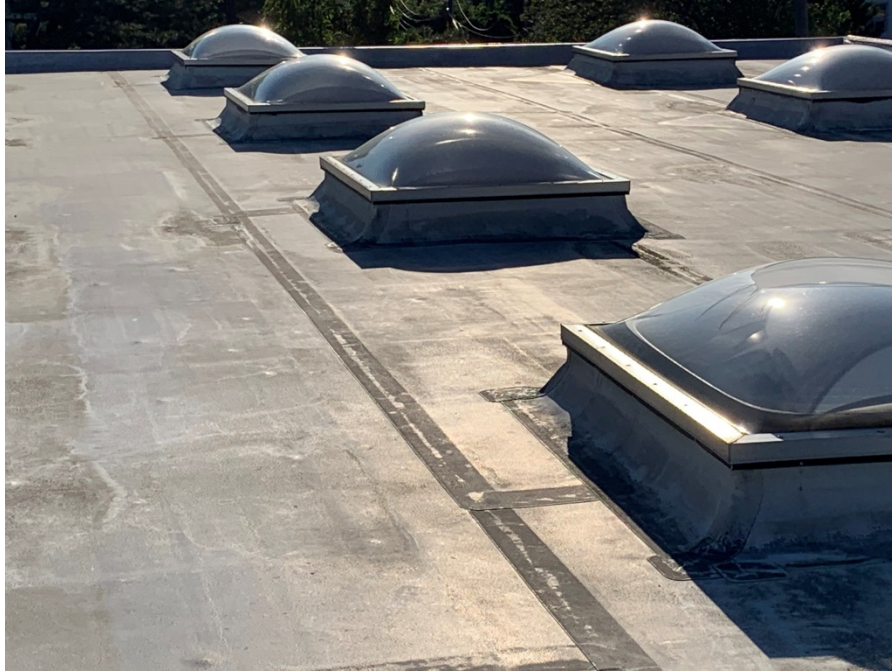
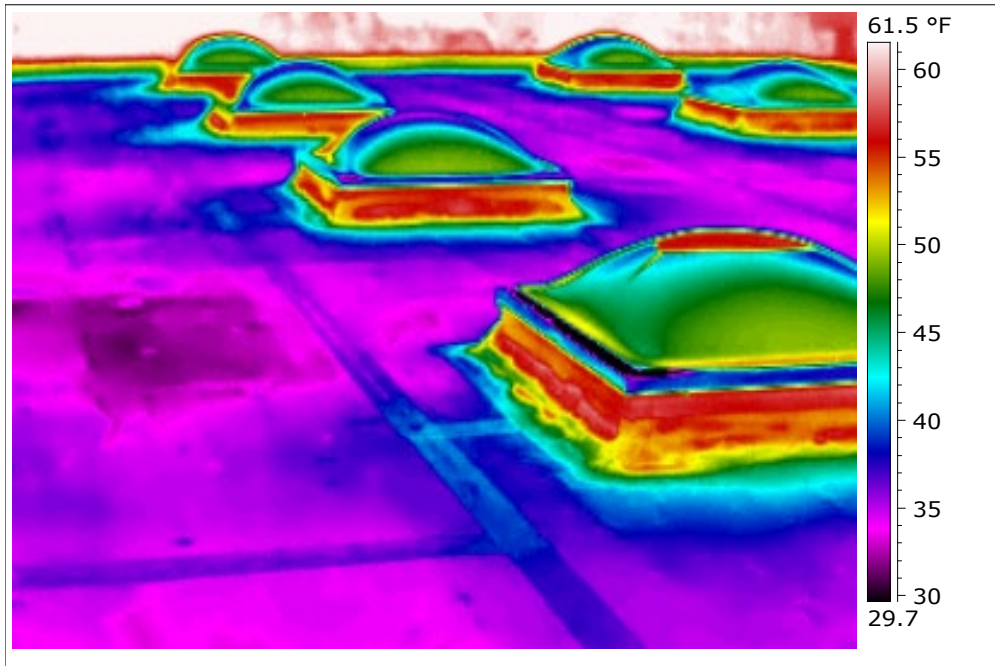
Thermogram # 8

Dry area of roofing
