FACILITIES NEEDS ASSESSMENT

STAMFORD PUBLIC SCHOOLS

Facilities Needs Assessment

K.T. MURPHY ELEMENTARY SCHOOL

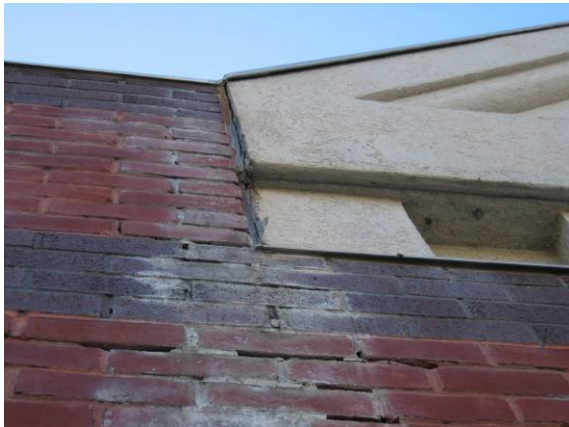
Photo #3: Detail of the efflorescence and worn brick mortar joints at main entrance

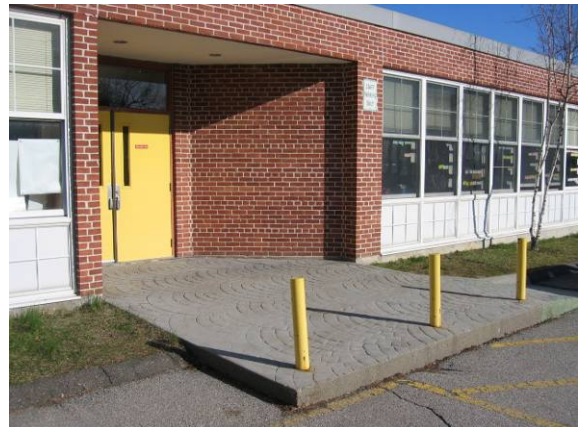
Photo #6: View of the common entrance to the kindergarten wing - no ADA ramp exists

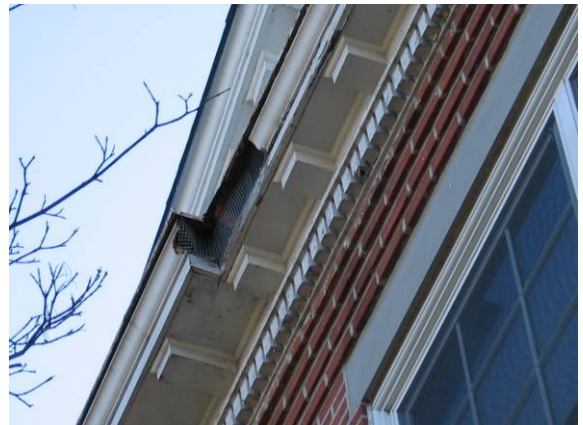
Photo #10: Detail of deteriorated wood soffits and eaves at the 3-story portion

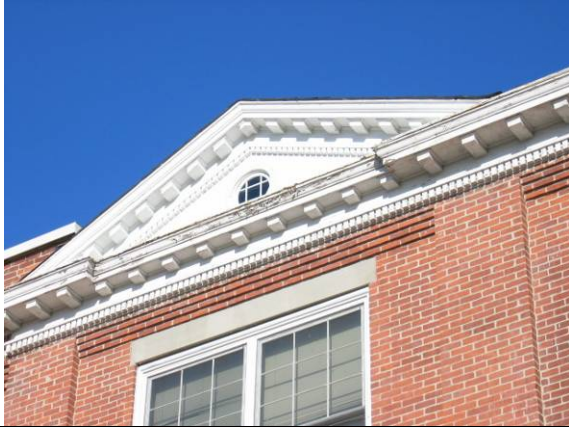
Photo #13: Detail of the rear façade roof dormer with deteriorated wood trim

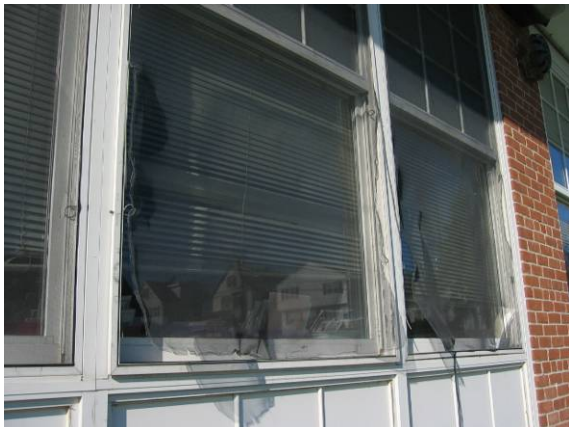
Photo #17: Detail of the widespread damaged window screens

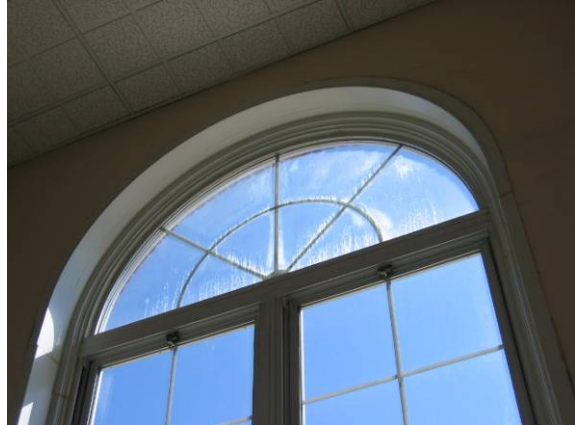
Photo #20: Several of the stairwell and classroom windows were failed with fogging

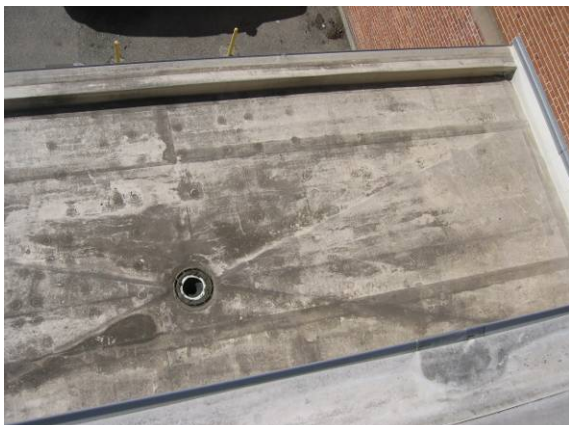
Photo #23: Several of the flat roof drain strainers were observed to be missing

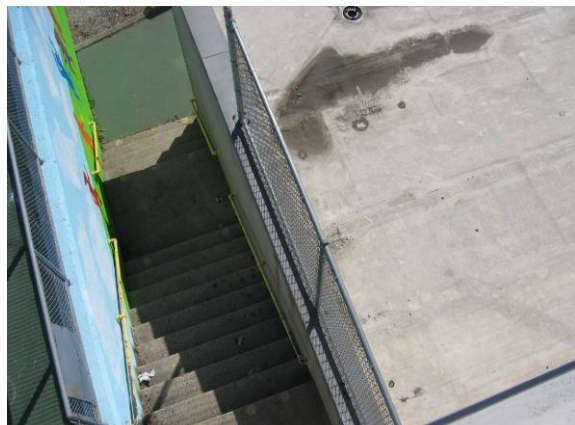
Photo #24: Management reported that vandals have accessed the lower kindergarten roof via this stair wall

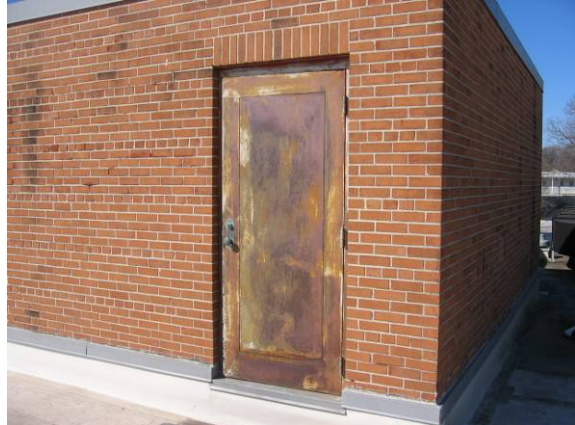
Photo #26: Several of the outdoor common and roof access doors are rusted

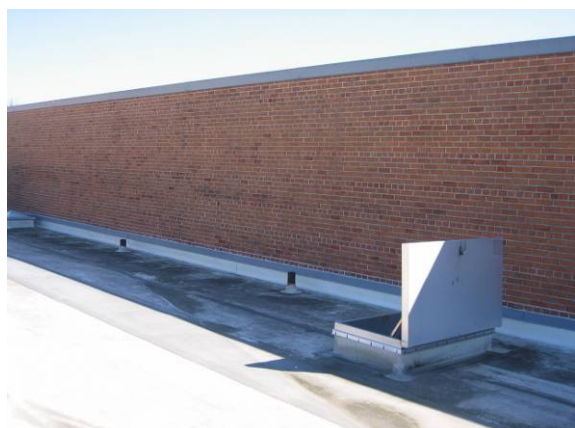
Photo #30: Access to the upper gymnasium flat roof would be improved with a fixed roof ladder secured to the brick wall

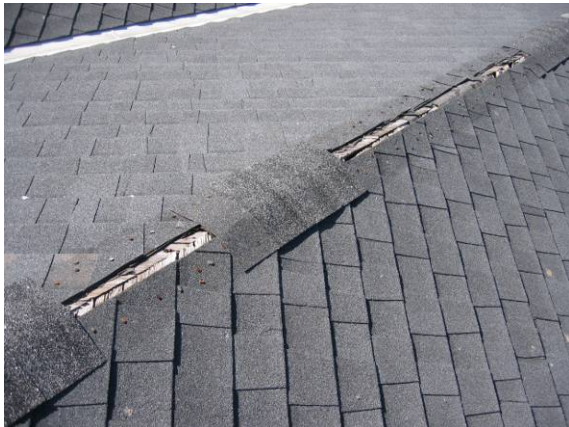
Photo #33: Detail of the damaged or missing roof shingles along the hip ridges

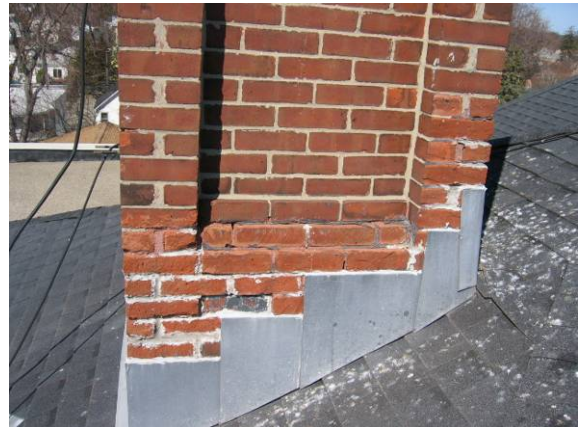
Photo #34: The brick chimney exhibited a few isolated open mortar joints

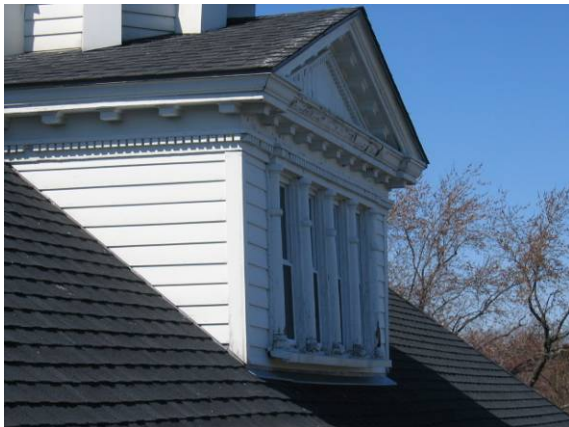
Photo #35: Close-up views of the front and rear wood dormers revealed peeling paint and deteriorated wood trim

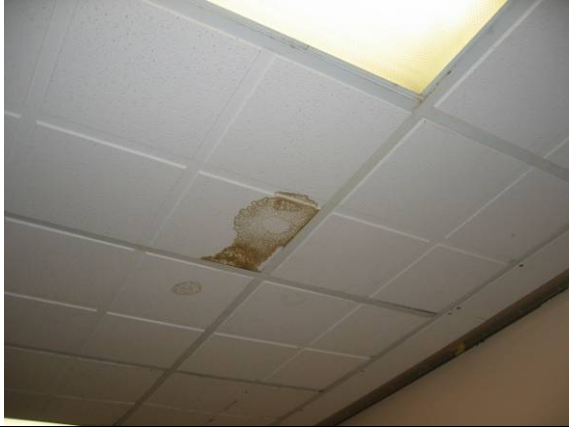
Photo #43: Isolated sections of the suspended acoustic ceilings were stained

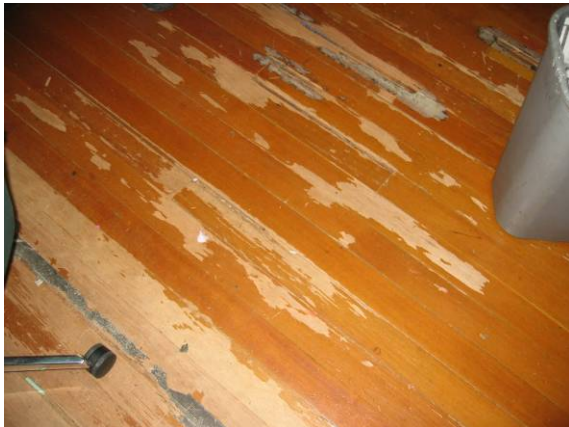
Photo #45: Detailed view of the deteriorated auditorium stage wood planks

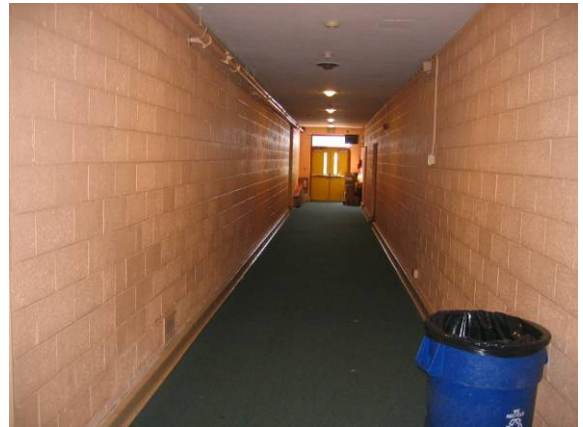
Photo #46: View of the egress corridor near the auditorium. A clogged or leaking roof drain exists within the CMU wall.

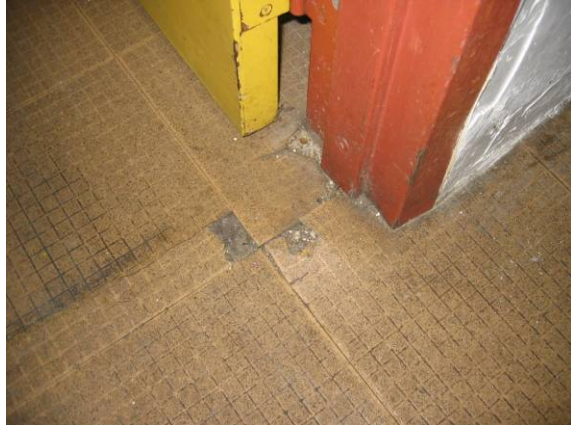
Photo #49: Detail view of the deteriorated and lifting kitchen floor tiles

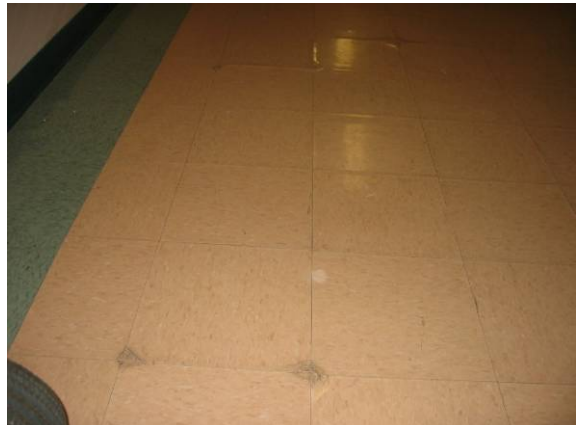
Photo #52: Detail view of several isolated sections of damaged VCT floor tiles

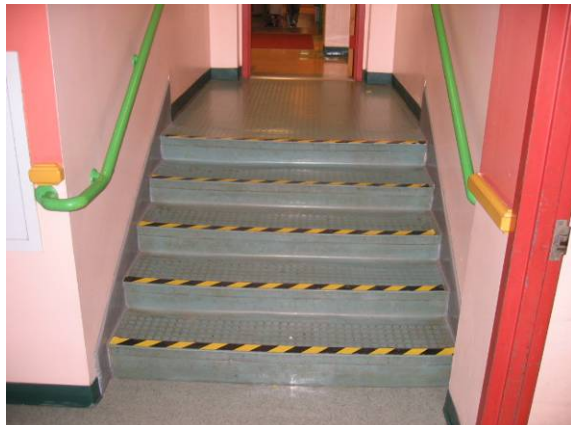
Photo #53: Several short stair runs exist connecting the two main building sections - no wheelchair lifts exist

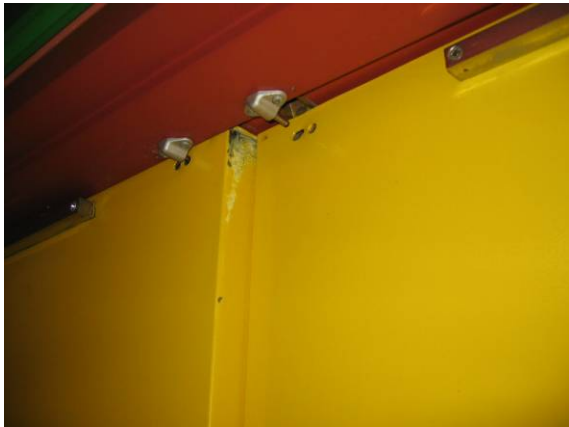
Photo #57: Detail view of the improperly closing fire doors

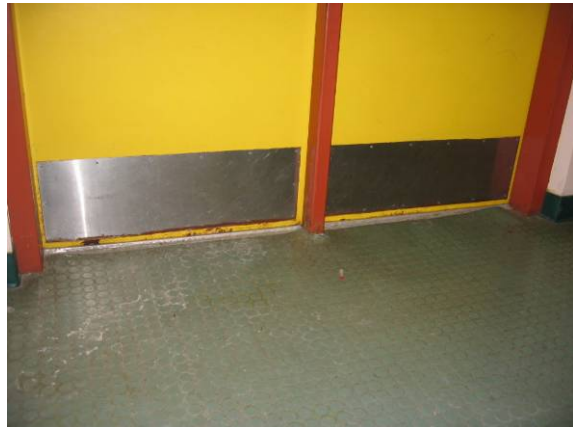
Photo #58: Detail view of the rusted and delaminating exterior doors

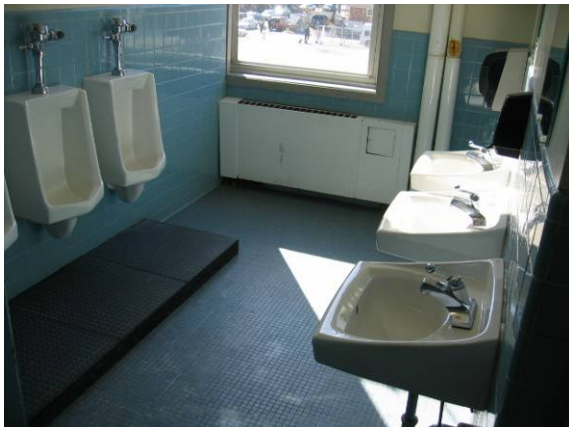
Photo #59: None of the common child toilet rooms are handicapped accessible

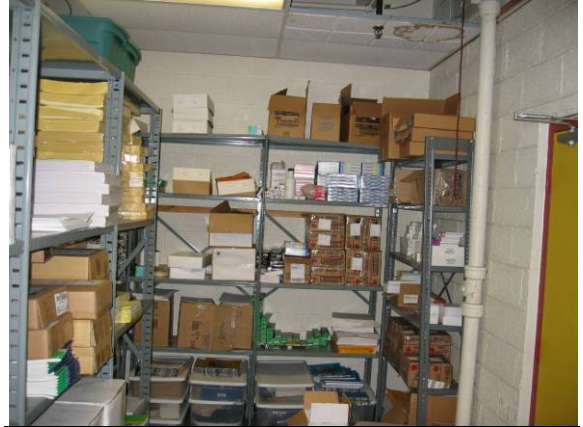
Photo #68: View of the school supply closet - stained/missing ceilings tiles were noted

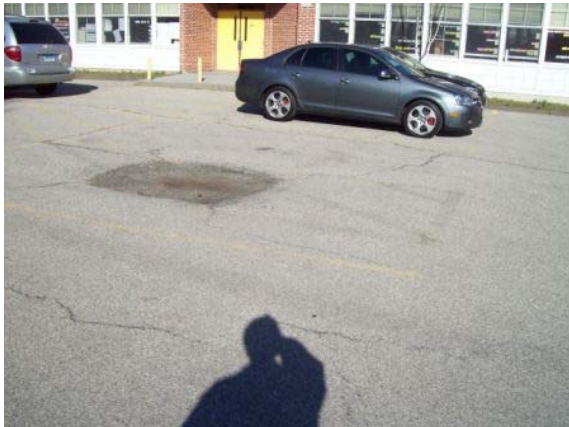
Photo #123: Damaged area in staff parking lot

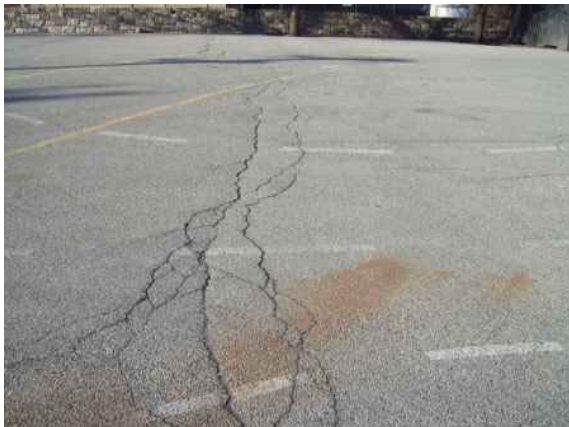
Photo #125: Damage in northwest paved area

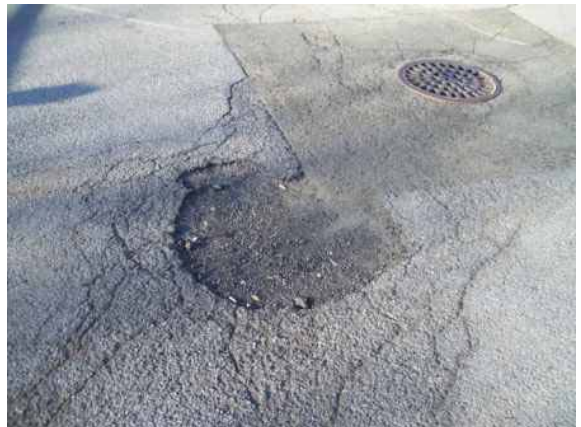
Photo #126: Damage in northwest paved area

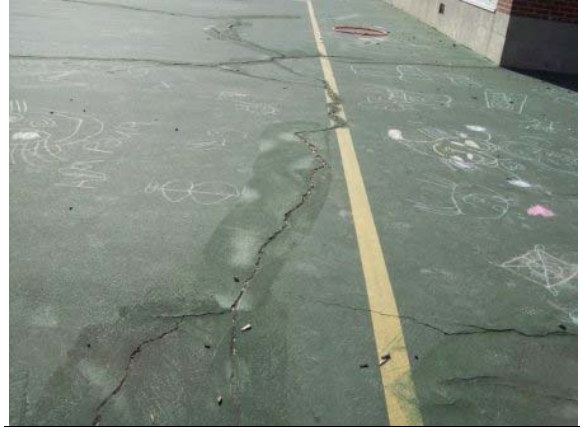
Photo #128: Cracking in paved area

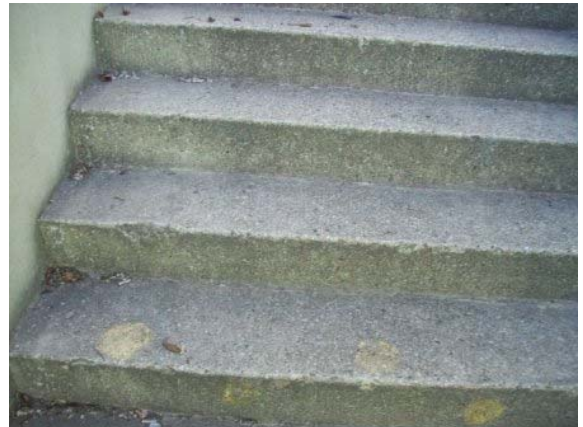
Photo #130: Damage at concrete steps

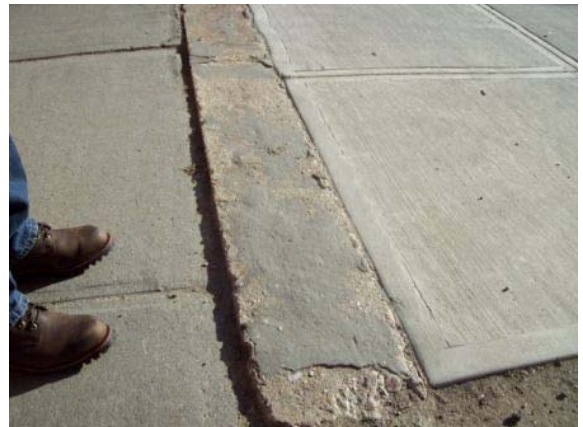
Photo #132: Tripping hazard near front entrance

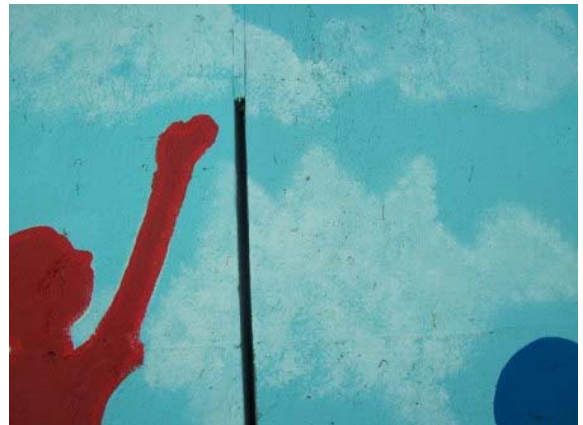
Photo #138: Expansion joint missing sealant (south retaining wall)

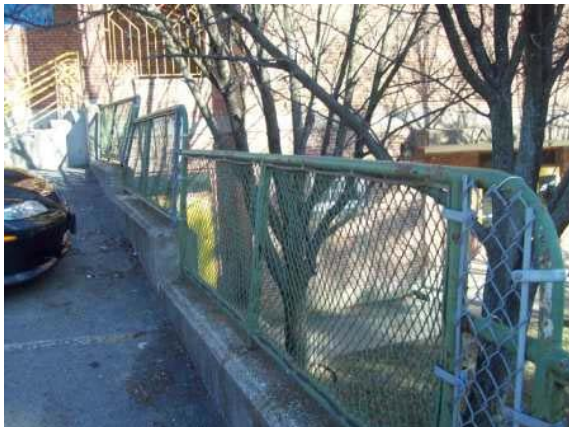
Photo #143: Damaged fence at west retaining wall

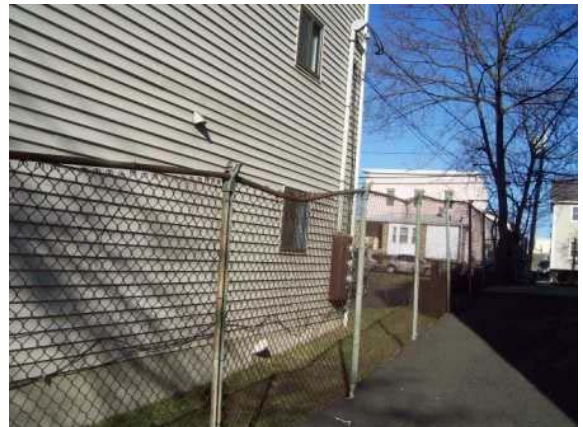
Photo #144: Damaged fence at north property line
