On February 17, 2019, Martha Quinto from our office visited two elementary schools in Stamford with possible mold issues related to plumbing and fire protection systems.

KT Murphy

#### Hart

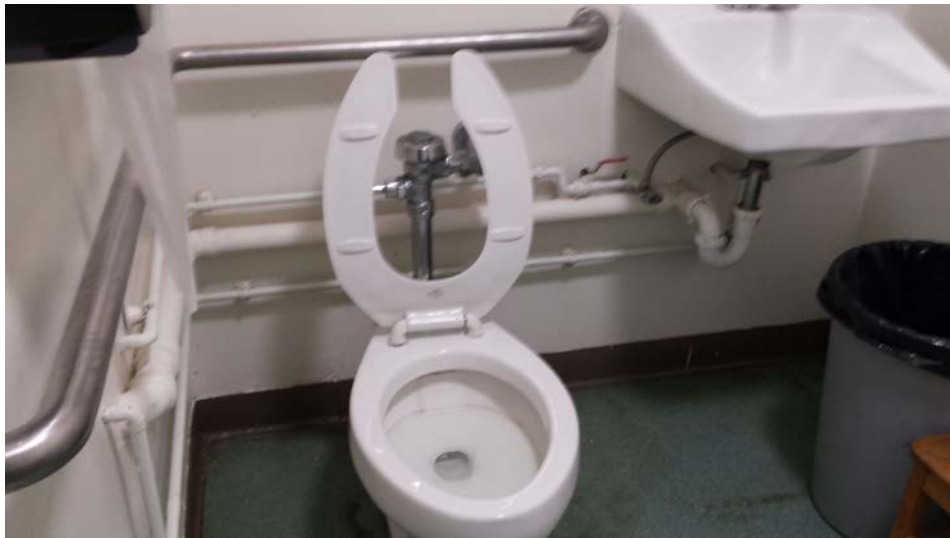
1. General Observations: The plumbing and sprinkler systems observed were in well-maintained and free of leaks. Piping requiring insulation to prevent condensation and or heat loss was generally adequately and thoroughly insulated. There were a few isolated cases of uninsulated domestic water piping routing exposed in small toilet rooms to reach single fixtures (Nurse's T.R., 2<sup>nd</sup> floor Room 24A T.R.)

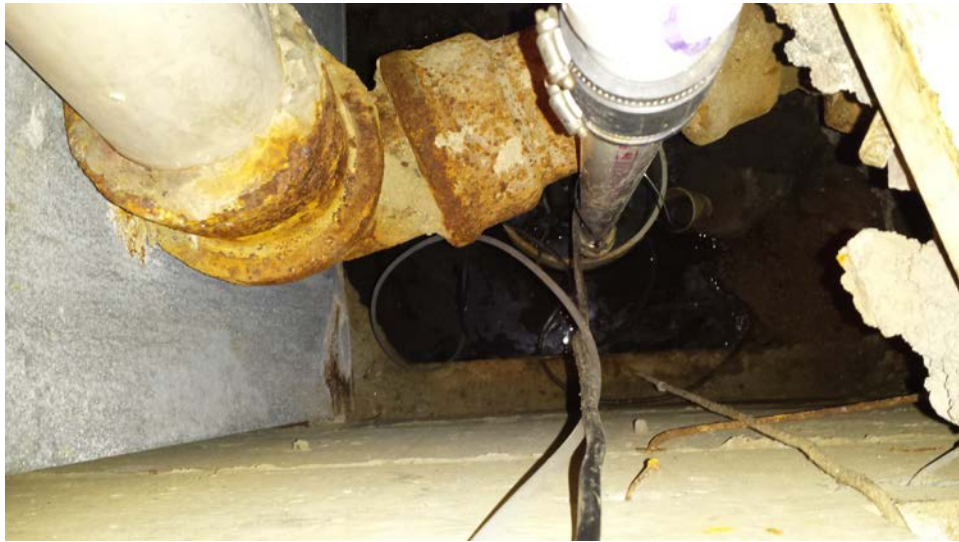
Water (presumably ground water) collects within the open cavity, and was visible about 3-4 feet below the Corridor finished floor. A submersible sump pump has been installed in the cavity, within a large diameter plastic pipe surround.

As the sump is open to building atmosphere, with standing water even when the water level does not activate the pump, a moist condition exists that cannot be prevented. Since the front seating in the auditorium is about 3 feet below finished Corridor floor, the groundwater is particularly detrimental to that space.

- 1) The optimum solution is to eliminate the collection of groundwater under the building slab. This would probably entail a widespread installation of perforated drainage piping, collecting to a larger sump pump/basin.
- 2) Unless groundwater level is greatly reduced, it appears that the sump is necessary to prevent water damage in the auditorium's lower areas. A sump basin with vapor tight cover and piped inlet should be installed, and the remaining surface area of the cavity (at corridor floor level) sealed up with concrete.

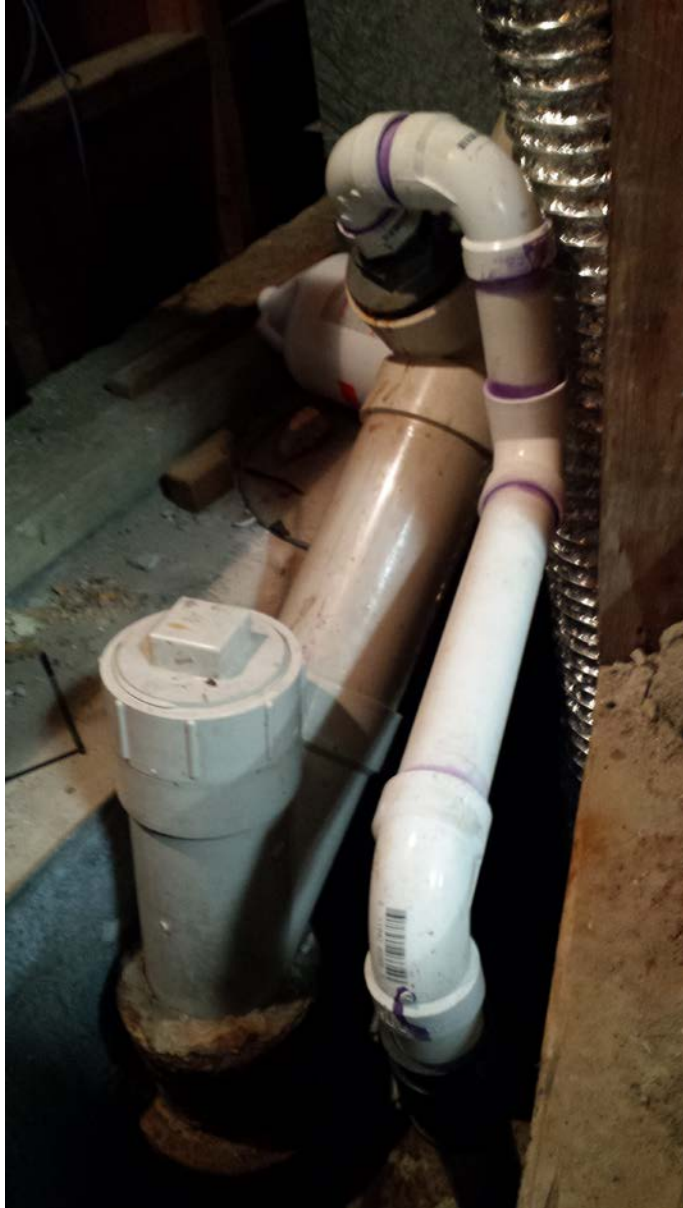
Pump discharge was piped into a storm main dropping to below grade in the same wall cavity.

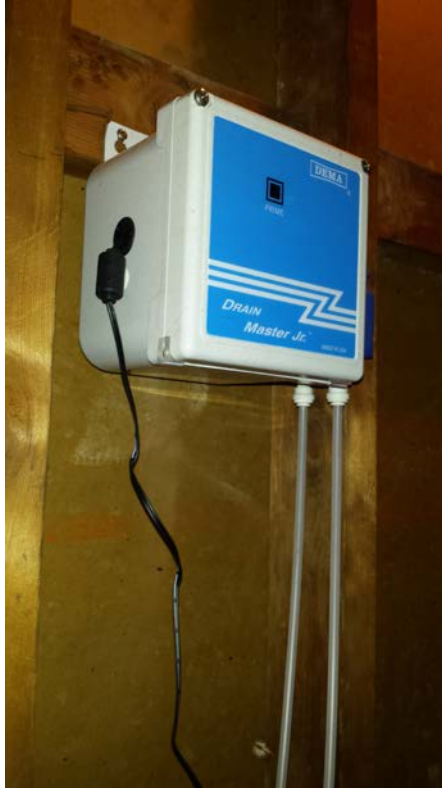
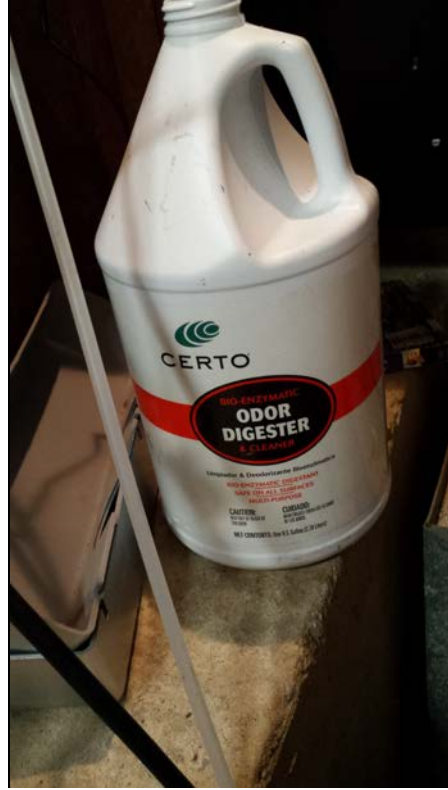
A Drain Master Jr. chemical dosing controller and an empty gallon container of bio-enzymatic odor digester were also found in the cavity.

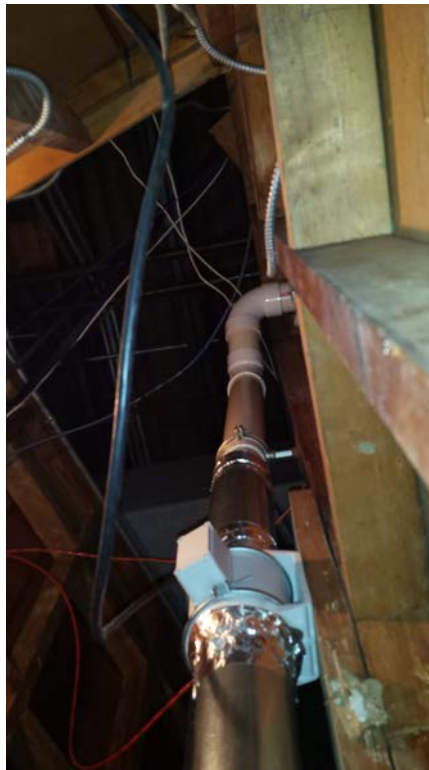
An in-line fan (Soler-Palau TD-100) has been installed to transfer air into or out of the cavity:

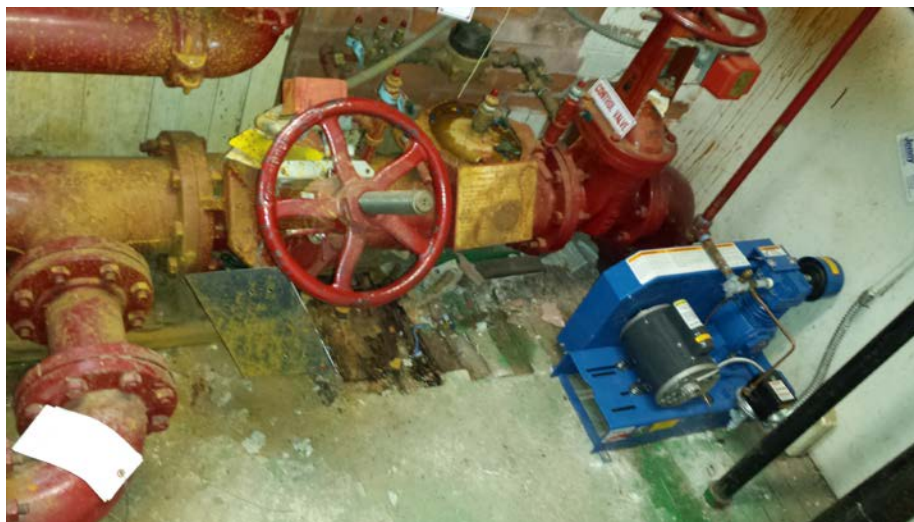
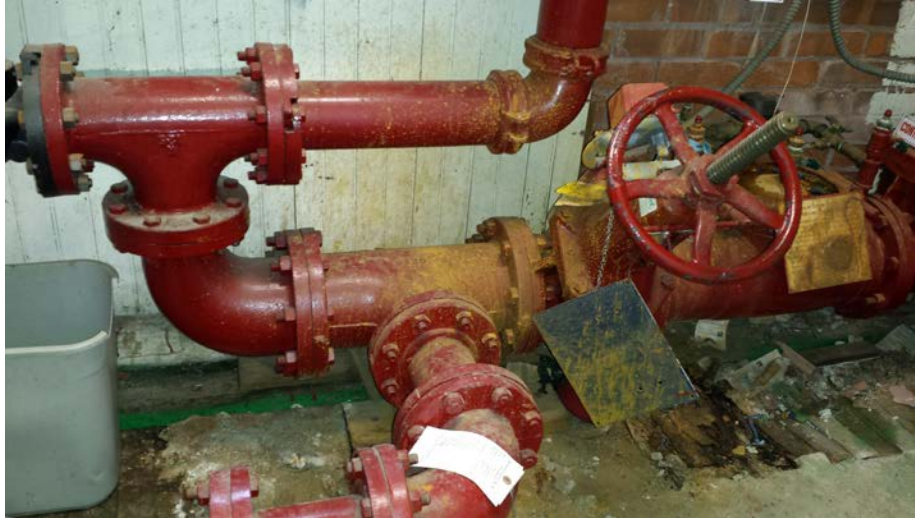
3. Fire Service Entrance Room: This room has been exposed to excessively moist conditions as evidenced by corroded condition of some piping and valves, and rusty water stains on walls. Rotted wood flooring covers what appears to be a floor cavity, possibly an open drain. The water damage and staining appears recent (staining over intact red pipe paint), and worse in the vicinity of the backflow preventer, which is a double check type, without relief discharge. Perhaps backflow preventer malfunction causes the water damage and staining.

Recommendations: Verify history and source of the moisture and staining. Assure that all major test/drain piping is directed outside and drains adequately away from the building. Assure all minor/auxiliary drain piping that cannot drain by gravity to outside is directed to a viable drainage system.

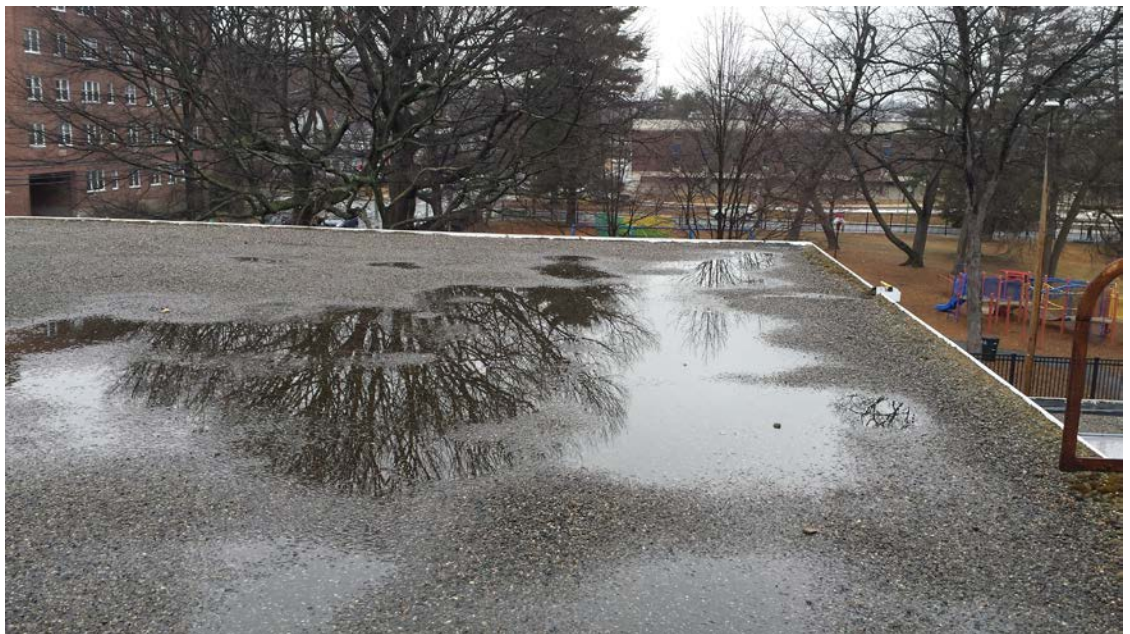
1. General observations: The plumbing piping systems and fixtures observed throughout were in generally leak-free condition, and piping requiring insulation to prevent condensation and or heat loss was adequately and thoroughly insulated. Roofs appear to be well-drained, though there was some standing water at the north east corner of the Gym roof.

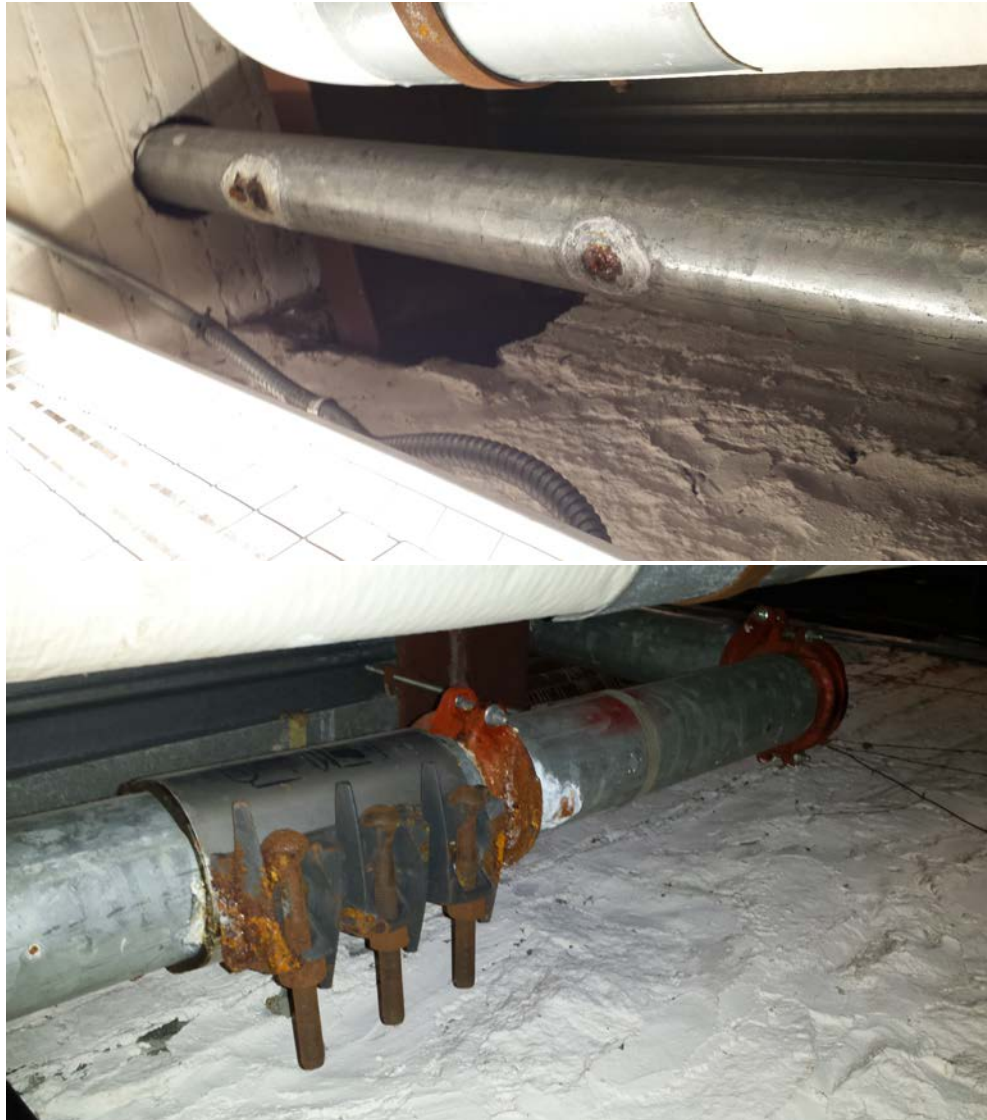
2. Some pitting/corrosion was observed on galvanized dry sprinkler system piping where it passes into the boiler room from the Water Room and Custodial Office to the south. This may be due to condensation; this section of piping appears to have been repaired already:

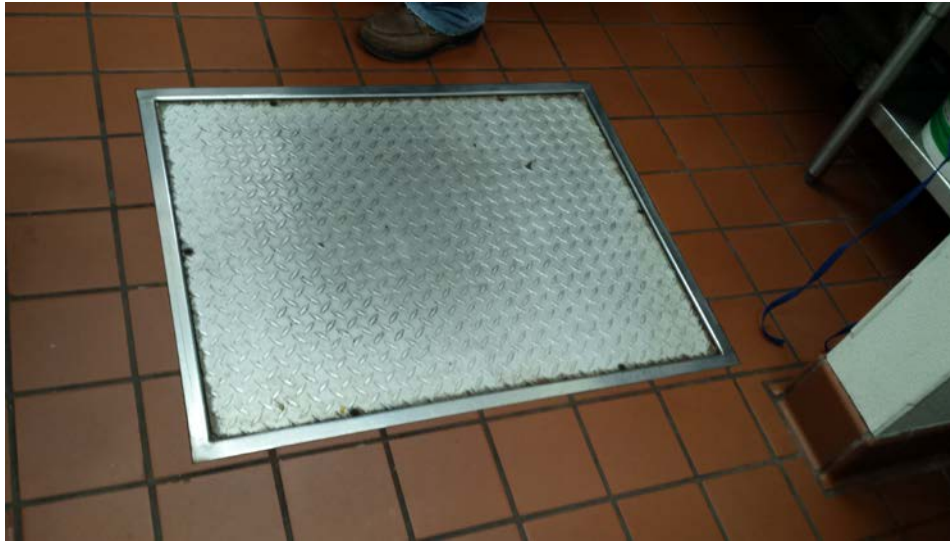
3. Engineers were advised by maintenance personnel (as were architects visiting separately), that the “septic” smell in the Music Room is most likely being generated by the grease trap located in the adjacent kitchen. While the kitchen is in close proximity to the Music Room, no septic smell was observed in the Music Room or in the Kitchen during our visit. Although many gas regulator vents open to atmosphere near this area, the complaint was confirmed to be about ‘septic’ rather than ‘natural gas odorant’ smells. Further field investigation regarding the nature and

location of the grease trap waste and vent piping is required, as Plumbing drawings were not found in the Hart drawing set made available for review.

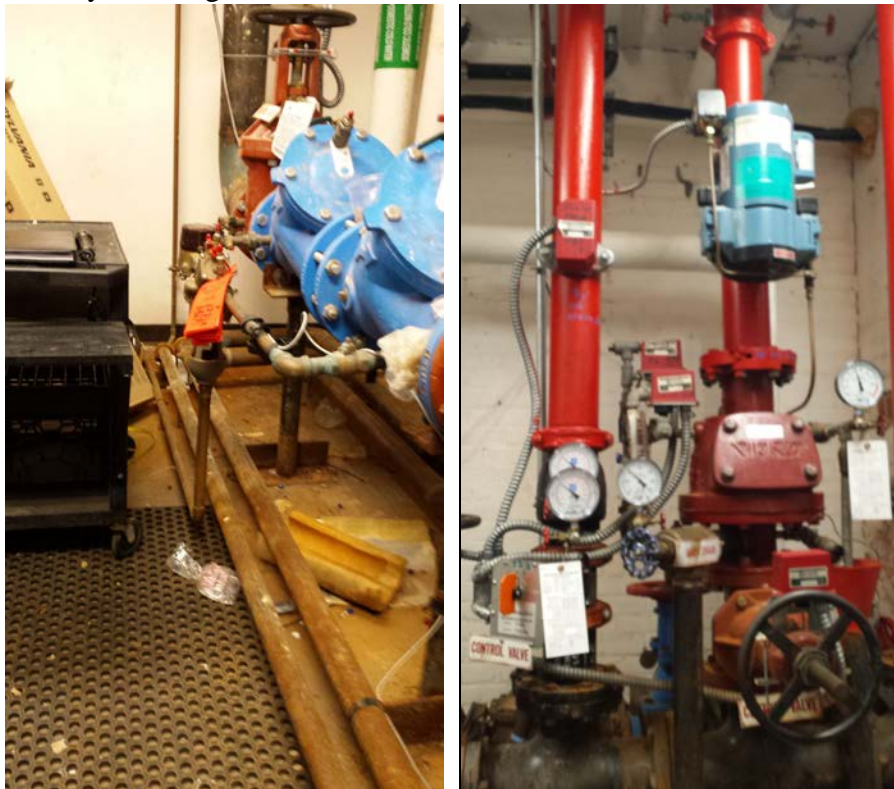
4. Fire and Domestic Water Service Entrance Room: Major pressurized sprinkler test piping is not discharged to the exterior of the building. Instead, main sprinkler tests, along with the domestic water service's backflow preventer relief discharge, are open-ended in the vicinity of a single floor drain.

This arrangement is not sufficient to keep up with the discharge rate of any of these devices. For instance, NFPA 13 states that sprinkler main drain test connections “shall be so installed that the valve can be opened wide for a sufficient time to assure a proper test without causing water damage.” In the case of Hart School, to adequately test the backflow preventer in a forward manner at sprinkler system design flow rate, the drain needs to discharge approximately 300 GPM. Furthermore, the 4” reduced pressure backflow preventer’s relief, at 100 psi static pressure, is capable of a worst case 700 GPM discharge rate. Under these circumstances, the floor drain would be quickly overwhelmed and flooding inevitable.

- 1) Sprinkler system main drain test connections should be piped directly to outside, with auxiliary drains provided to gravity-drain trapped, non-pressurized portions after the main drain test valve is closed.
- 2) The domestic water service’s reduced pressure backflow preventer should be fitted with a water relief discharge sensor interlocked with an automatic service shutoff valve located upstream of the backflow preventer. If the backflow preventer experiences mechanical failure or clogging and the relief fails “open”, the automatic valve will shut off the water service to prevent further relief discharge.
