Infrared Thermographic Roof Moisture Analysis

PERFORMED FOR: Viking Construction
1387 Seaview Ave.
Bridgeport, CT 06607

LOCATION: Newfield Elementary
Stamford, CT

CONDUCTED ON: May 8 & 9, 2019

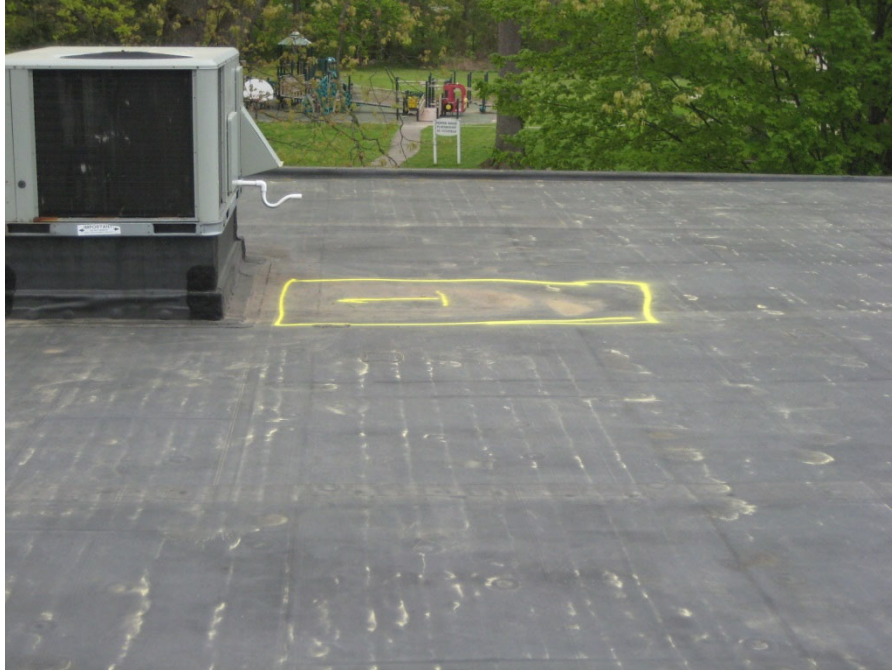
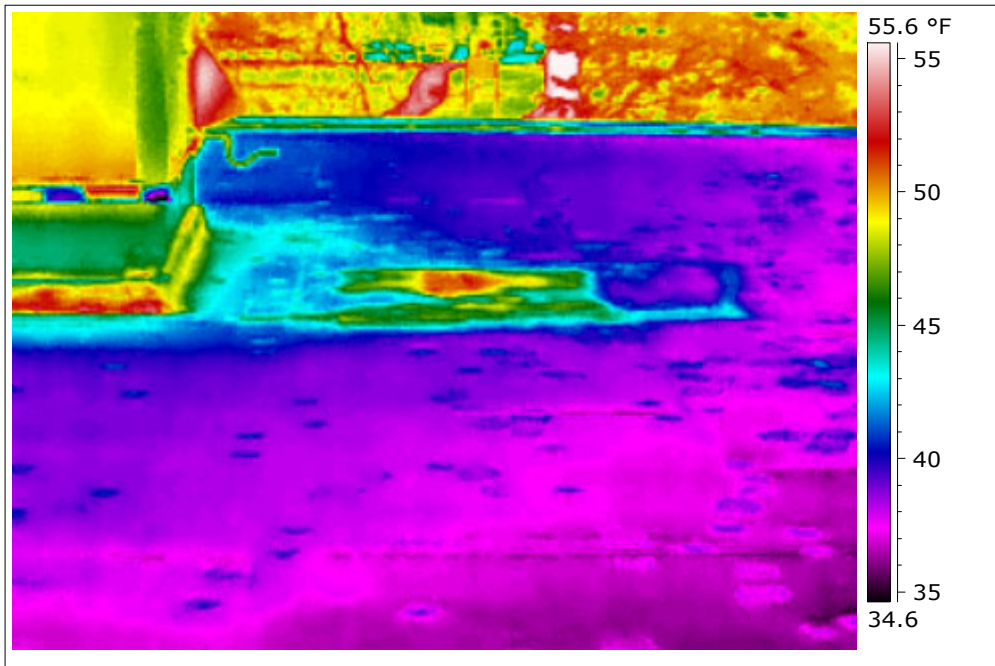
Thermogram # 1

Wet Area #1

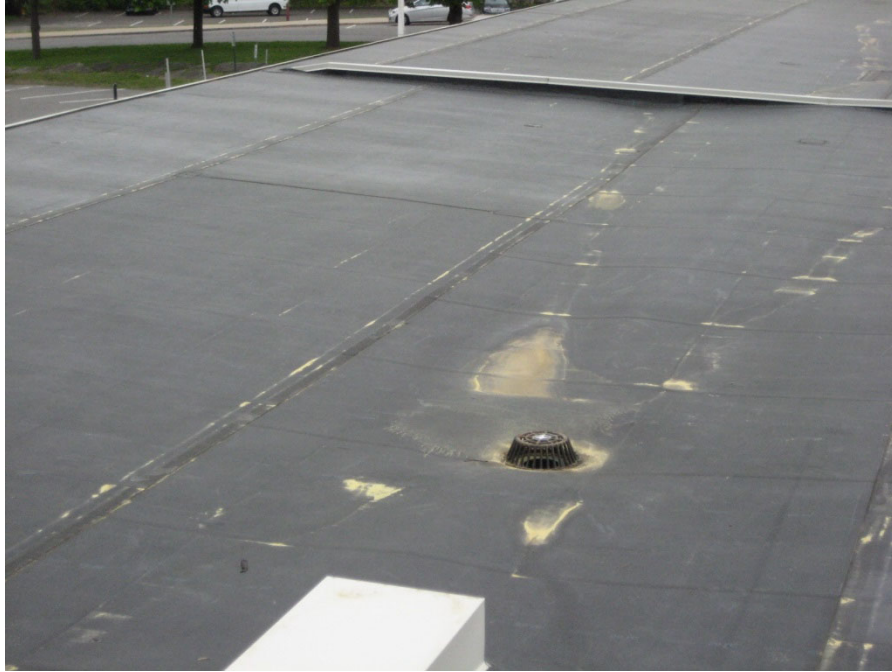
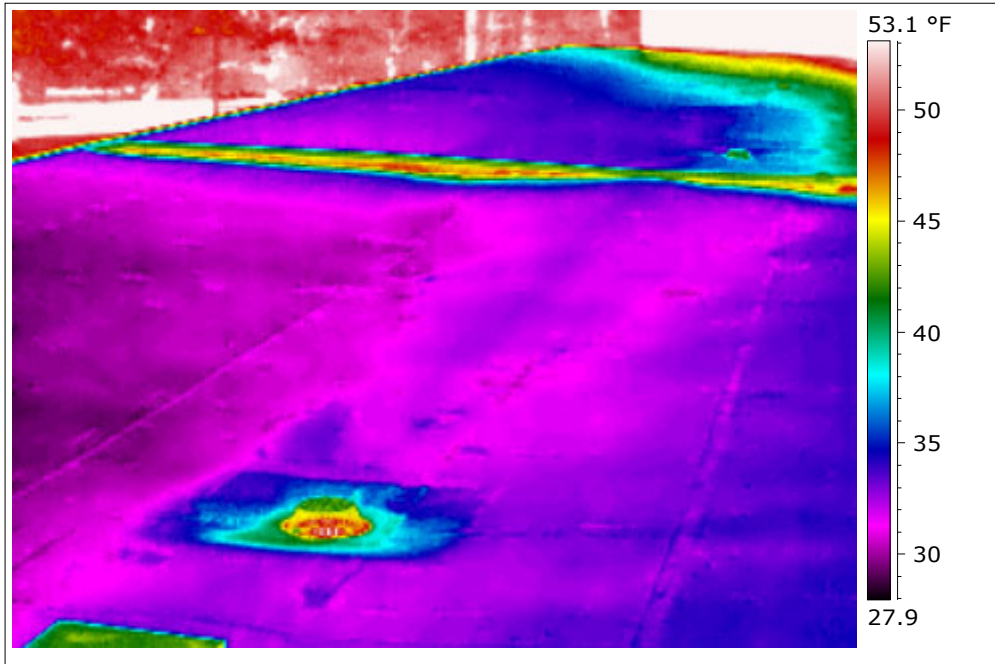
Thermogram # 2

Dry area of roofing

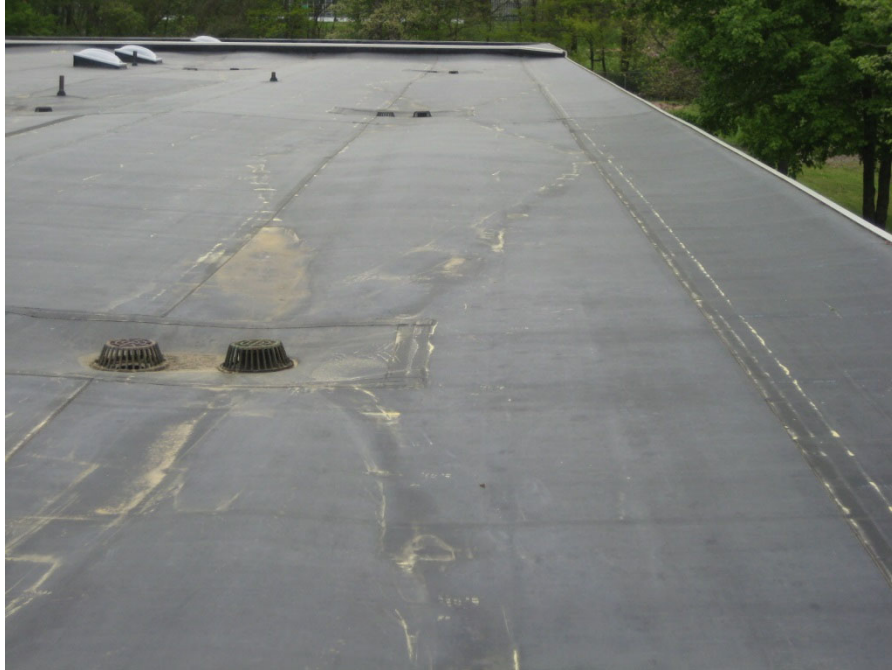
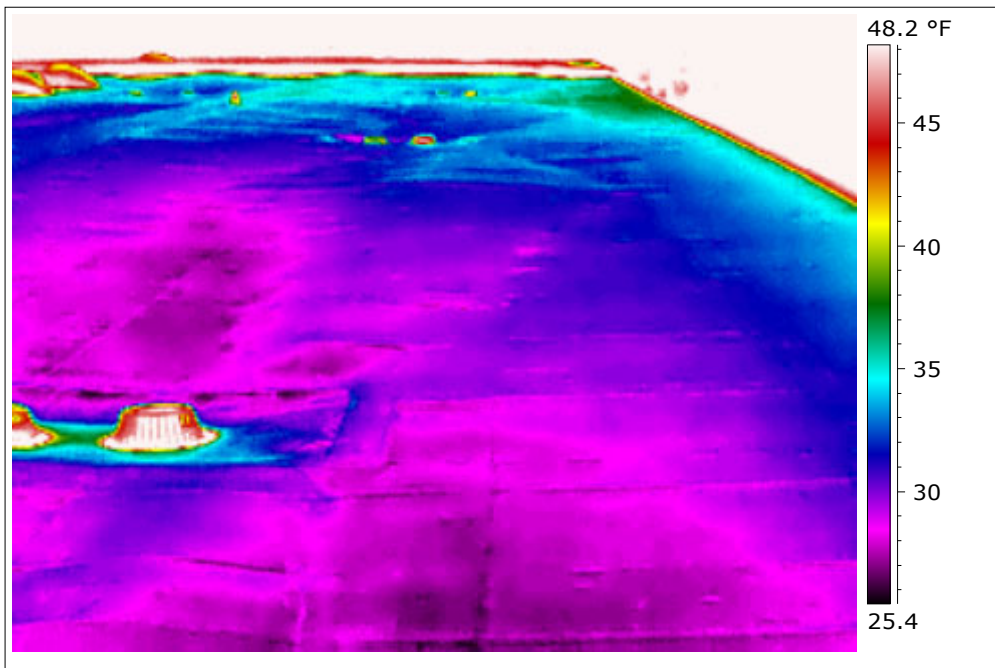
Thermogram # 3

Dry area of roofing

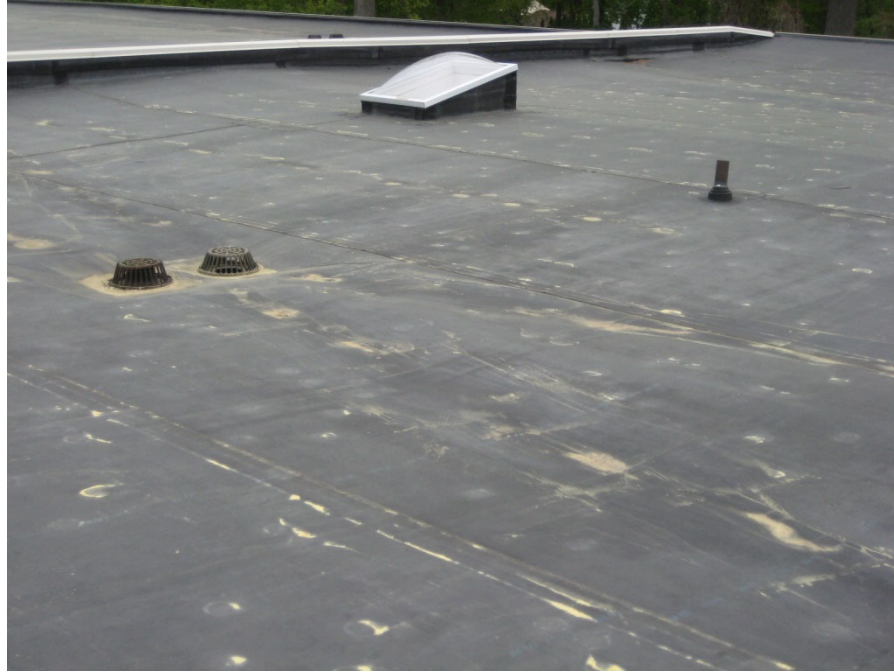
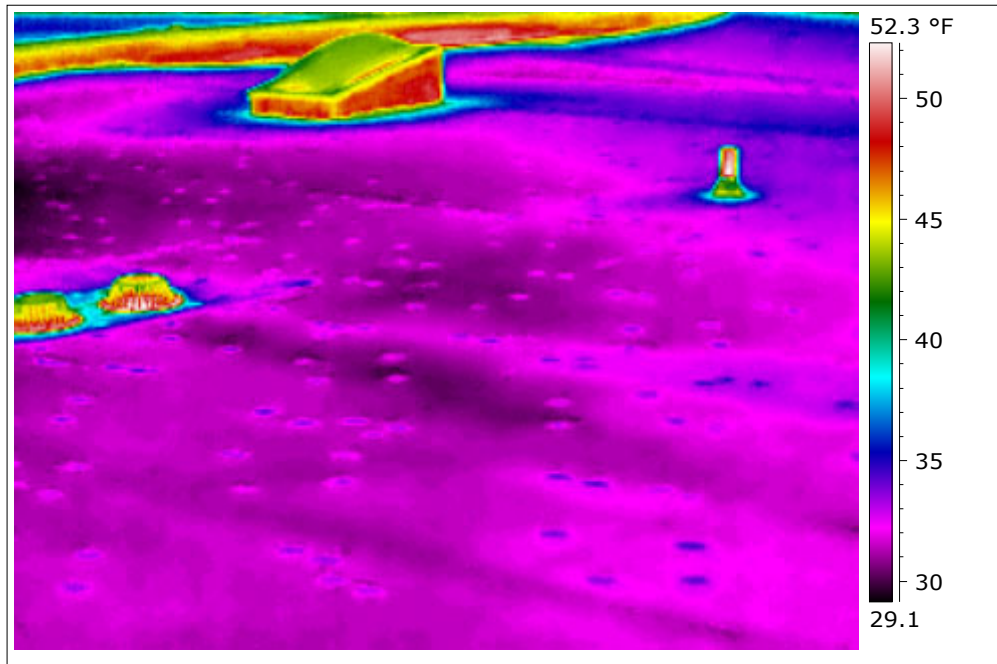
Thermogram # 4

Dry area of roofing

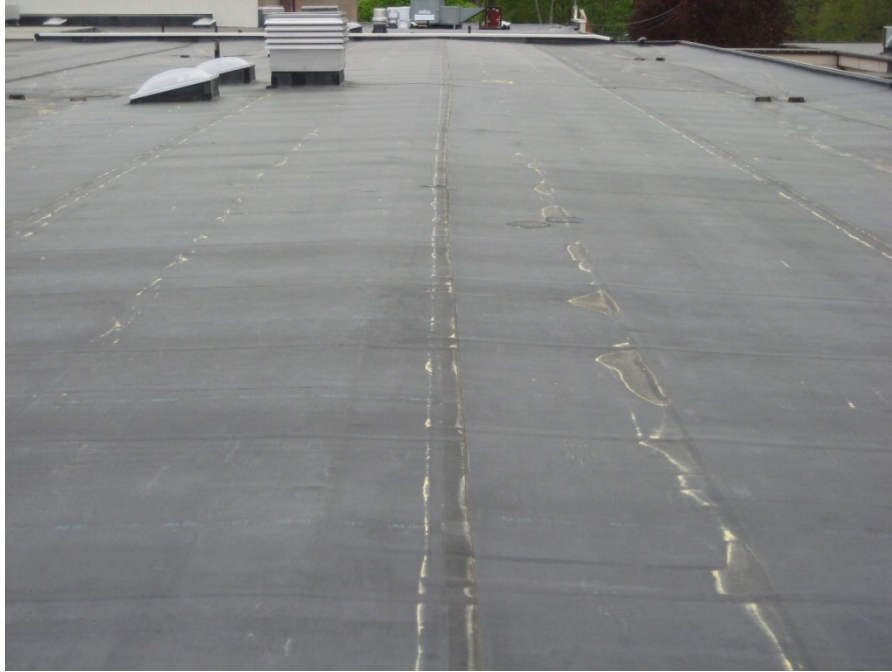
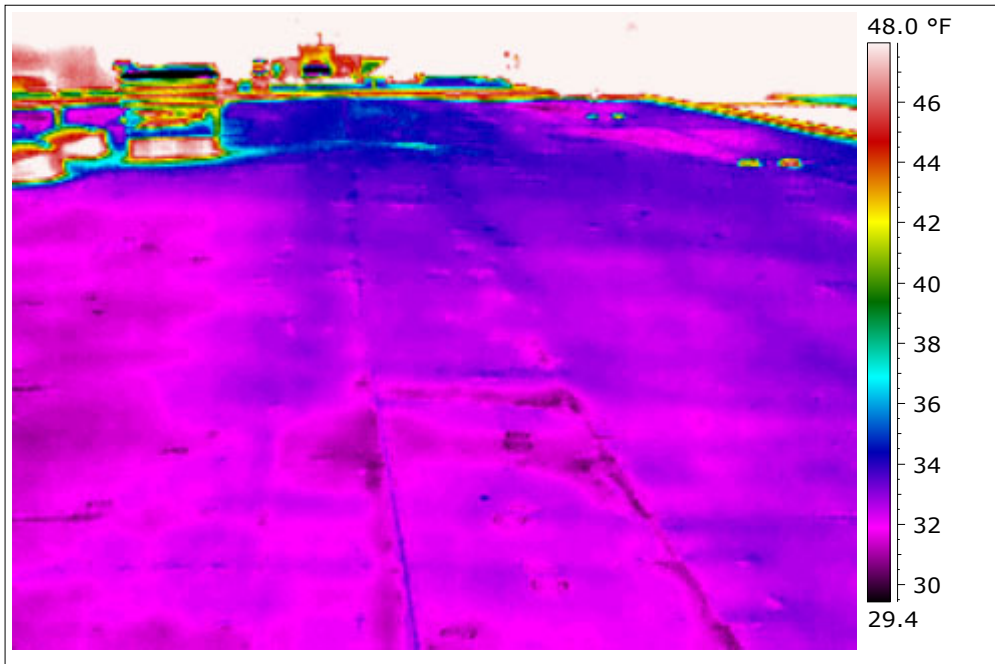
Thermogram # 5

Dry area of roofing

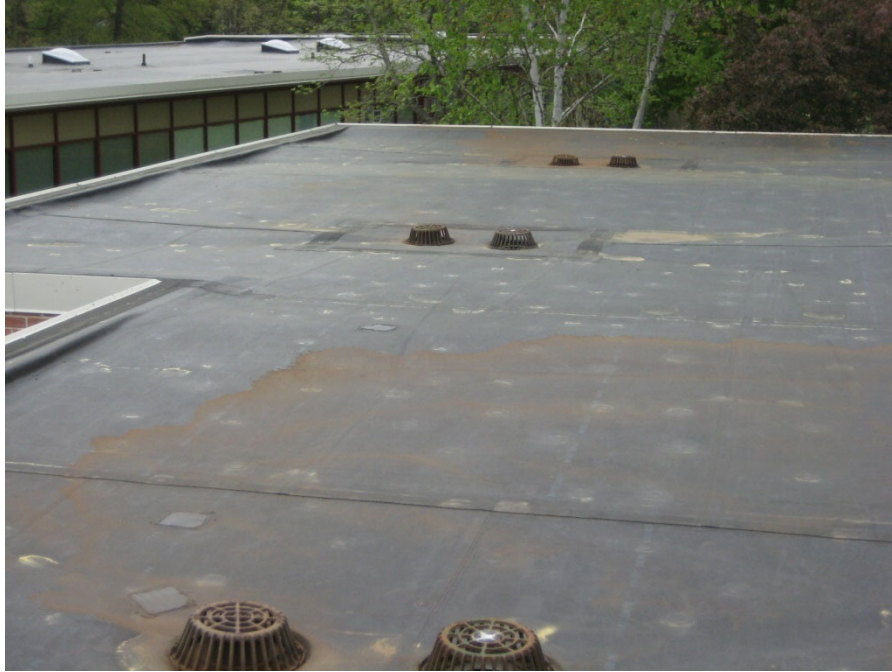
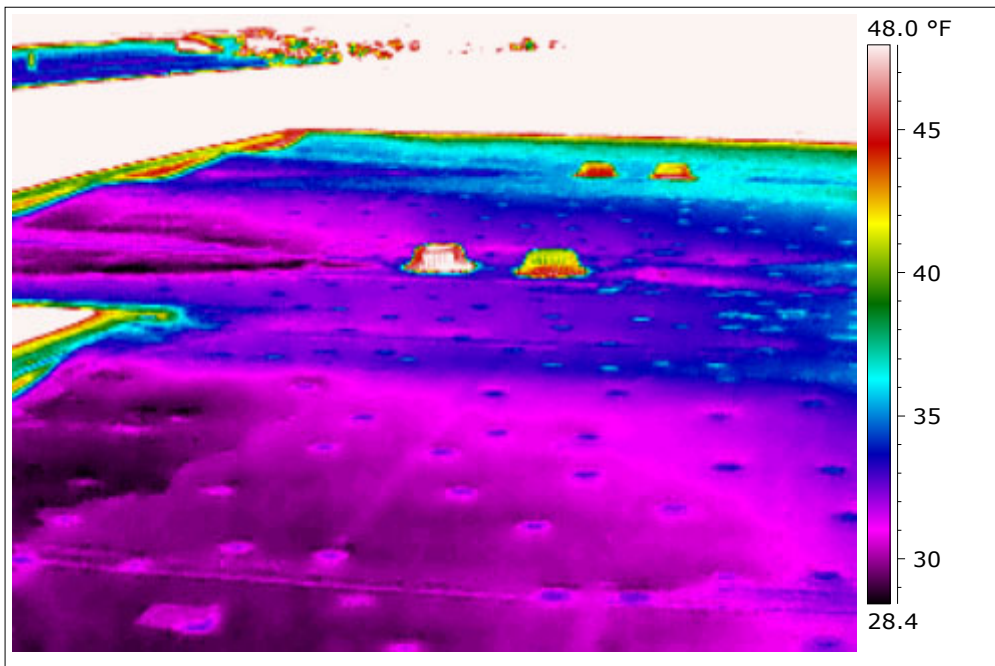
Thermogram # 6

Dry area of roofing

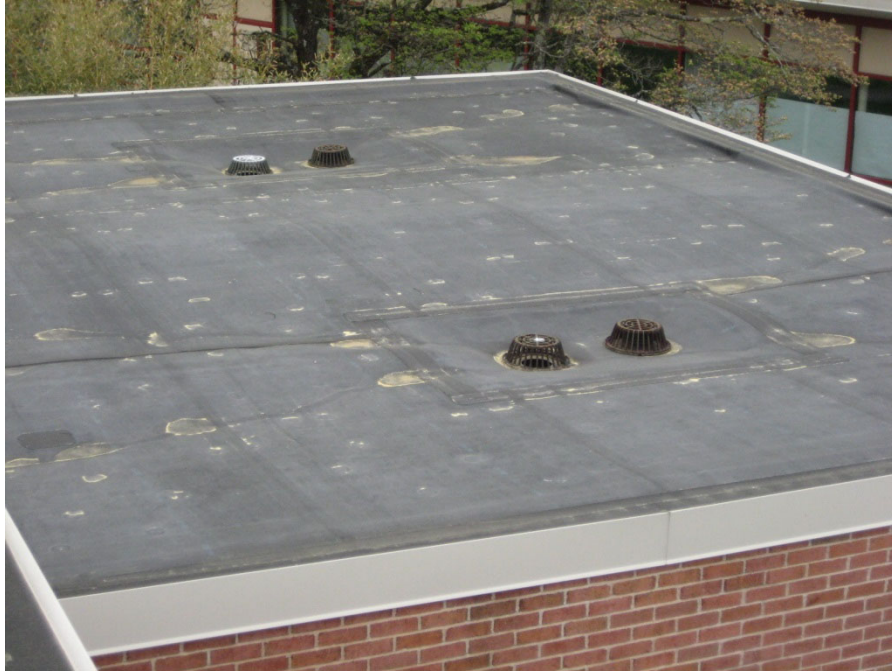
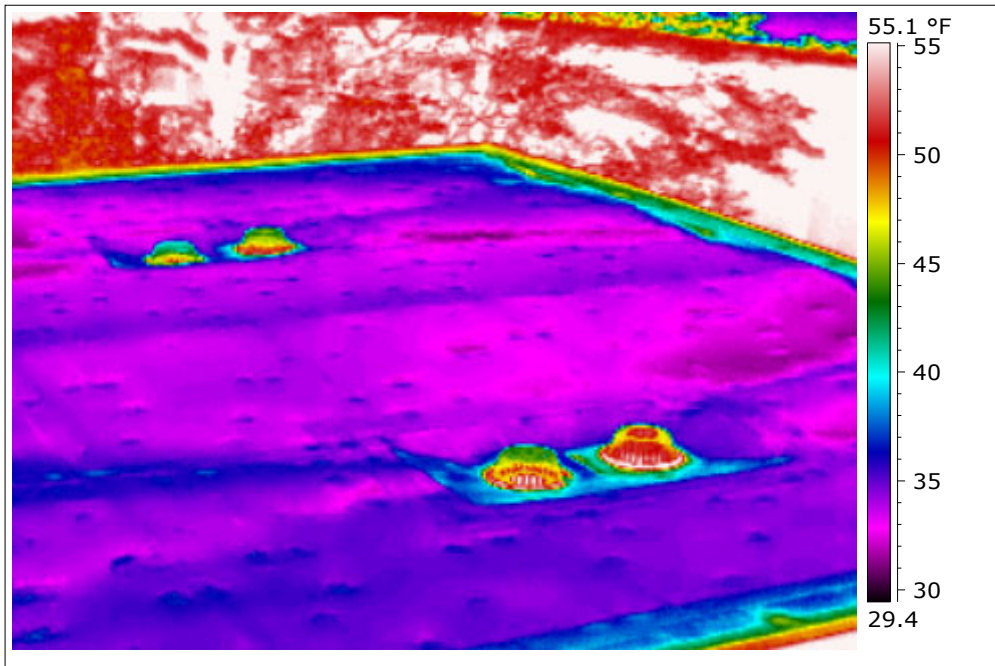
Thermogram # 7

Dry area of roofing

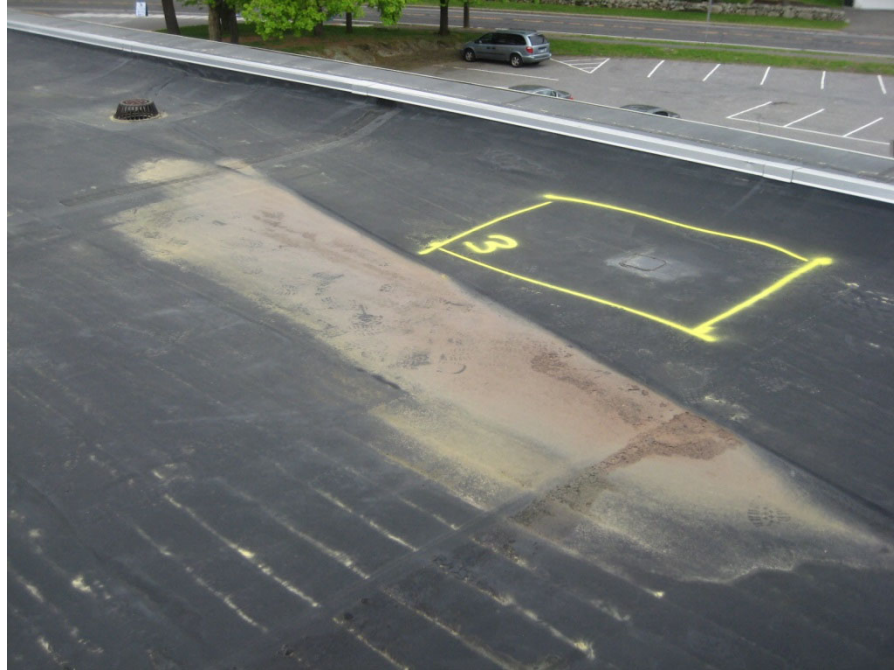
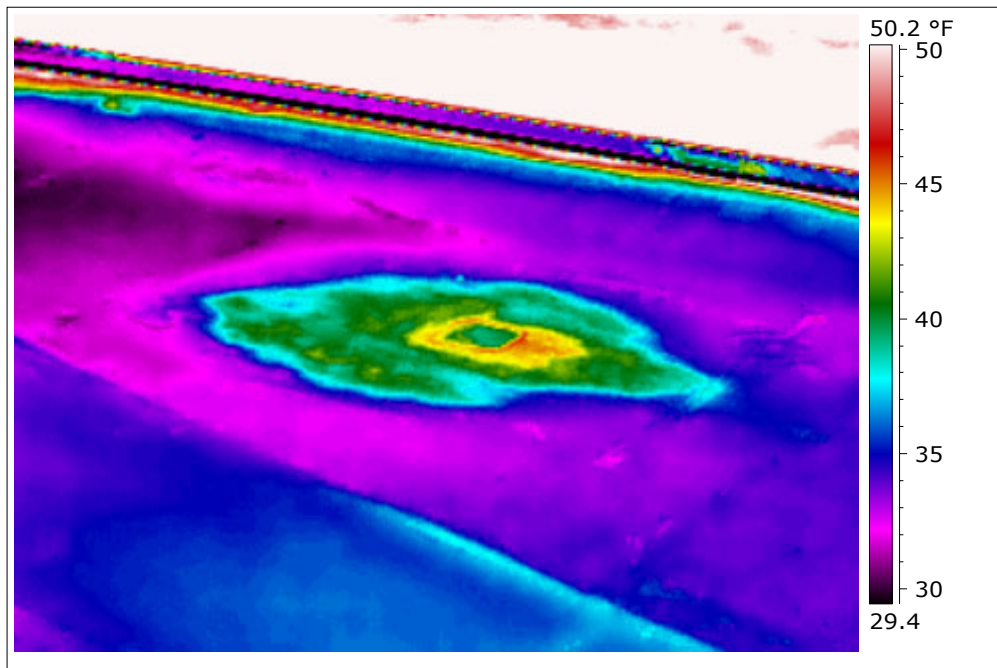
Thermogram # 8

Wet Area #3

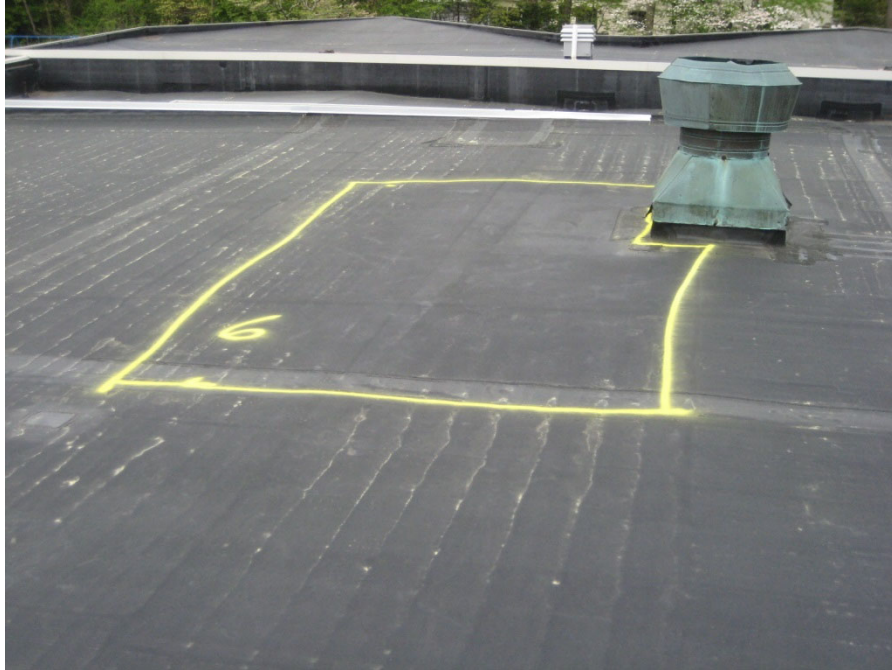
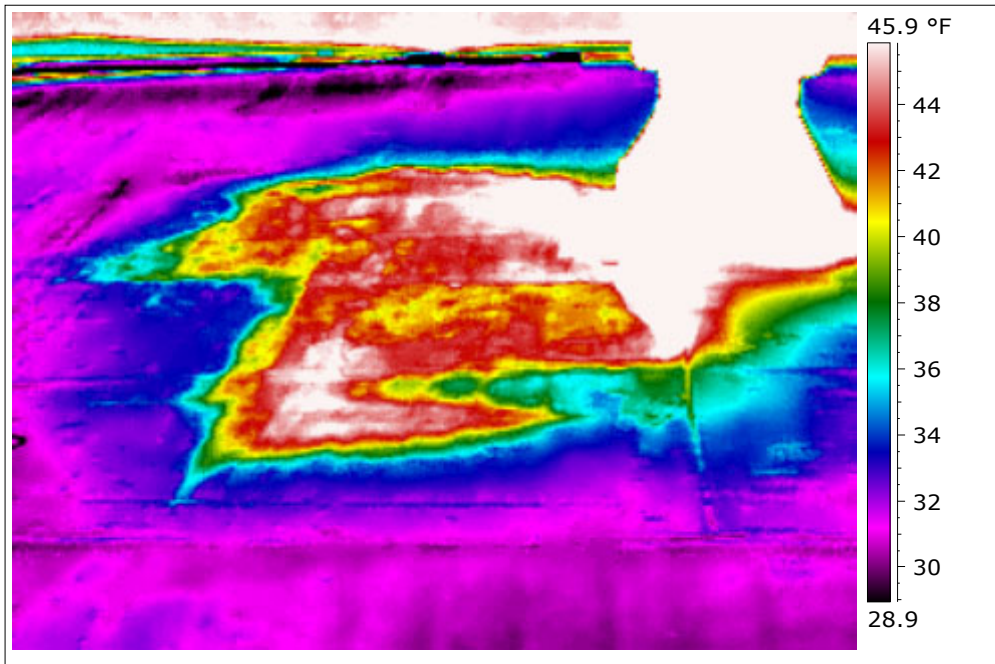
Thermogram # 9

Wet Area #6

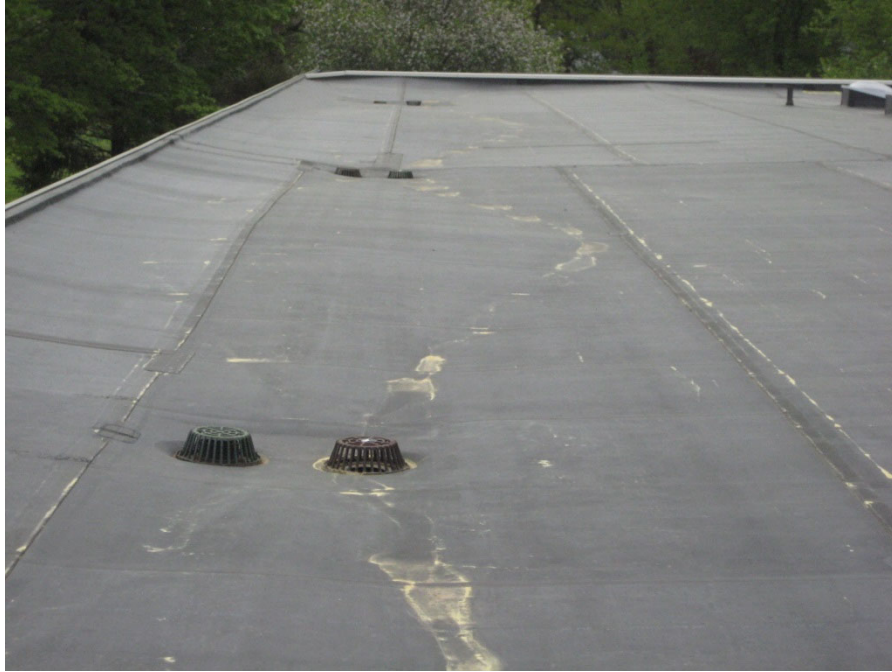
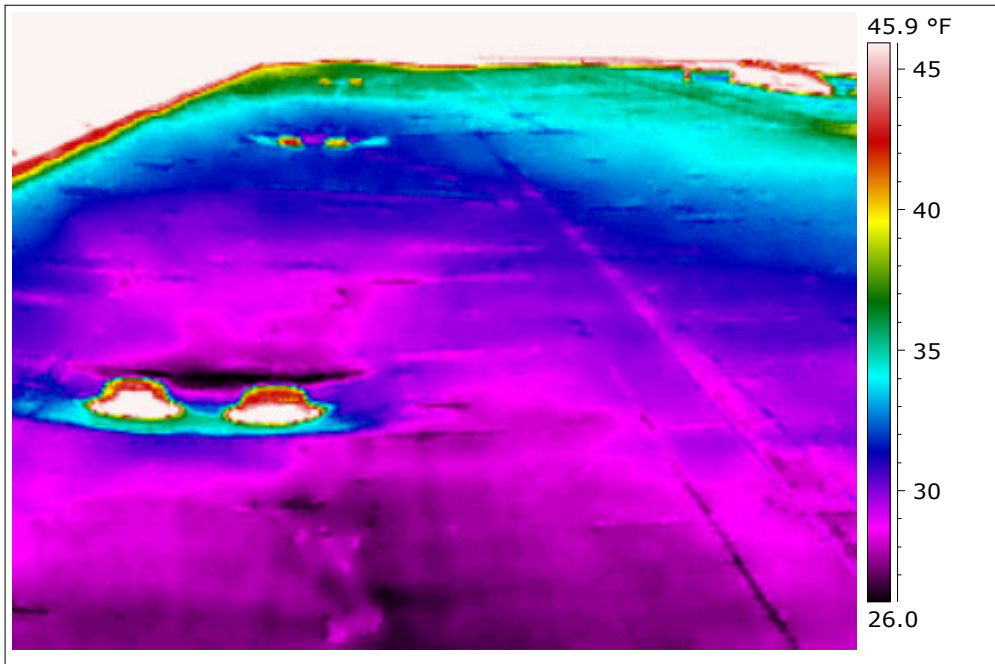
Thermogram # 10

Dry area of roofing
