M. Gottfried, Inc.

RE: Roof report and repair quotation
Newfield Elementary School
345 Pepper Ridge Road
Stamford, CT 06905

Wet areas found in the moisture scan

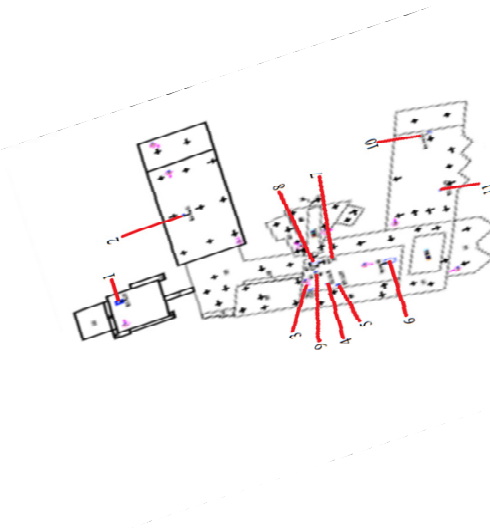
Areas of moisture shown on Roof Scan

The roofs on Newfield school are in very good shape. The infrared scan revealed 11 small wet areas on the roof. These appear to have mainly been caused by holes in the roof membrane. These holes have been patched. Most of the school is covered by John Mansville Adhered EPDM roofing systems installed in 2013 (outlined in green). These roofs have active 20-year roof warranties that will expire in September of 2033. JM roofs cover most of the main school. Only 3 small wet areas were found on the JM roofs. The second highest roof level has an Adhered Firestone EPDM roof (outlined in red). It was installed in 2000 and its warranty will expire November of 2020. This roof level contains most of the marked wet areas. The third area with a warranty covers part of the portable classrooms (outlined in yellow). The warranty on this section will expire July of 2025. This area has one wet area. During our inspection, we not only saw the marked areas but also found a number of maintenance items, and items in need of repair that should be addressed in order to correct issues that may cause leaks in the future as well as keep the roofing systems and associated flashing details performing up to their maximum potential well past the warranty periods.

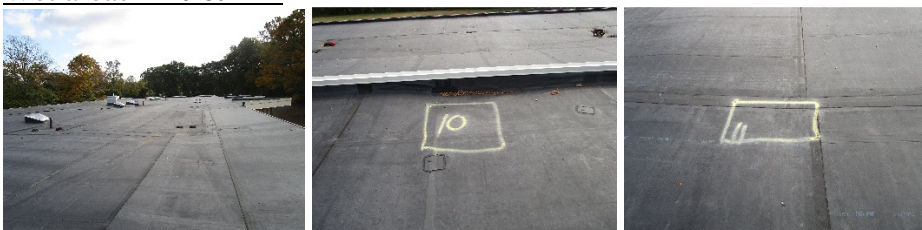
Wet areas # 10 & #11

Right side classroom wing containing areas #10 & # 11

Wet areas # 10 and #11 are found near patches and a lap. When the wet areas are replaced the surrounding laps, patches and flashing details will be checked and any fishmouth, additional holes, loose patches, etc., will be repaired.

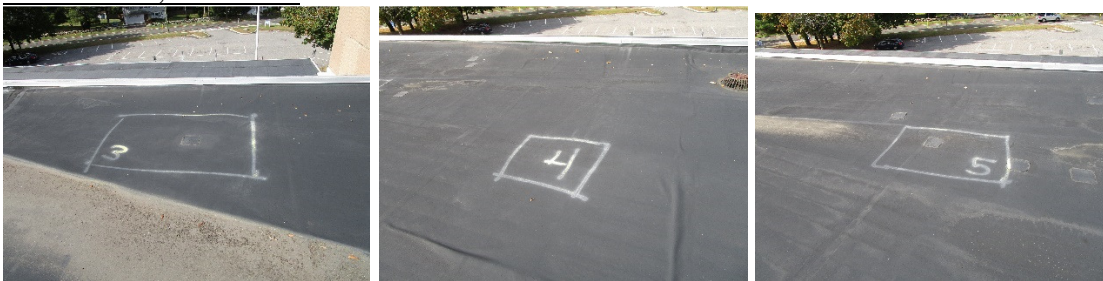
Wet area #3, #4 and #5

Wet areas 3 and 5 are found around patches. These were most likely caused by holes. Areas 4 has no patches and is not by any laps. There is a drain nearby. This area needs further investigation.

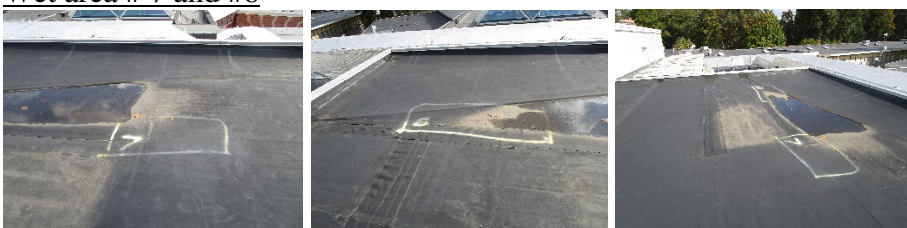
Wet area # 7 and #8

Areas 7 and 8 lie on both ends of an area that holds water.

Wet areas 7 and 8 are found on both ends of and area of ponded water. There are a number of laps that run into and near this area. The laps are rippling and may have issues that are causing the water infiltration.

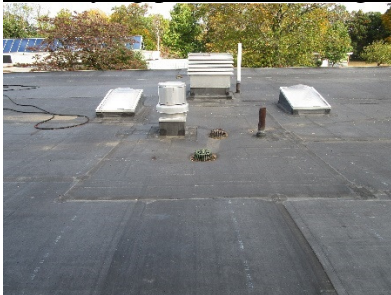
Overlaying perimeter of large patch

The area shown above containing the drains, vent and curb appears to be a large patch or was done with a separate sheet of membrane. This membrane goes over many other laps. Even though there are T-patches at these intersections, we recommend overlaying the perimeter of the sheet with new flashing membrane to ensure the laps and intersections remain tight.

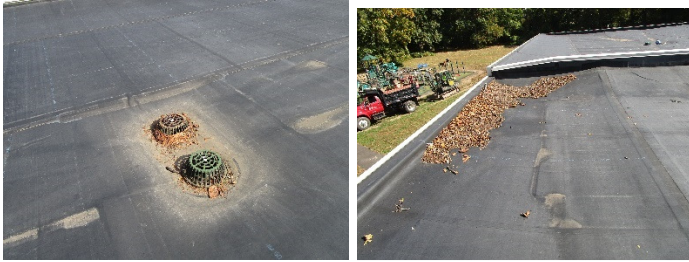
Cleaning debris from drains

Cleaning debris from drains and various natural collection points on the roof should be part of regular maintenance.

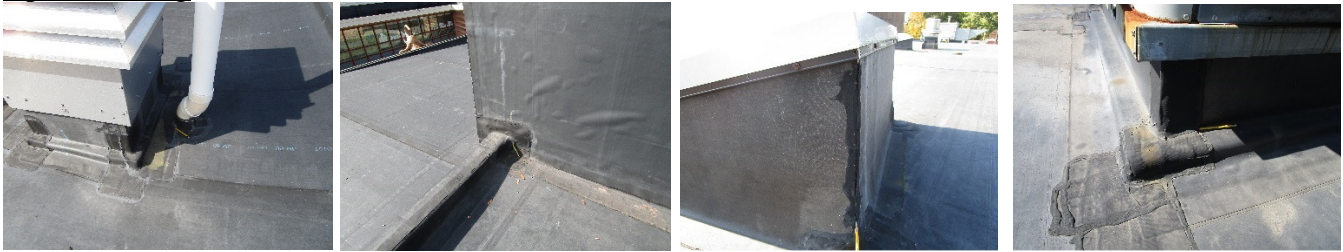
Open Flashing

Open flashings were found at pipe penetrations, curb corners, skylight curbs, etc. All curbs and penetrations must be checked, and any open flashings repaired before water can enter the system and cause leaks.

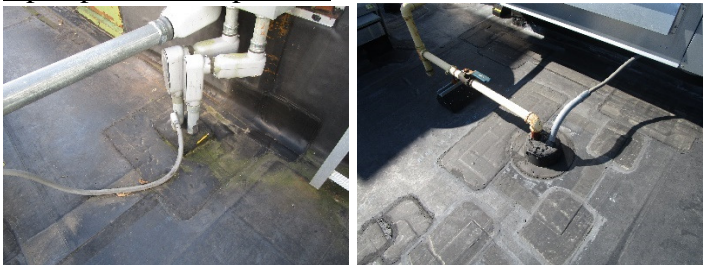
Open penetration pockets

All penetration pockets must be checked and any areas with voids or lifting flashing repaired. In one case, the insulation around the pocket is crushed. It appears that serviceman step over the conduit at the same spot and this repeated action has damaged the insulation. Rather than just repair the penetration pocket the surrounding area should be cut out, fresh insulation with a high-density cover board installed, the roof repaired, and a new penetration pocket installed. The HD coverboard will strengthen the area and prevent the crushing problem from happening again.

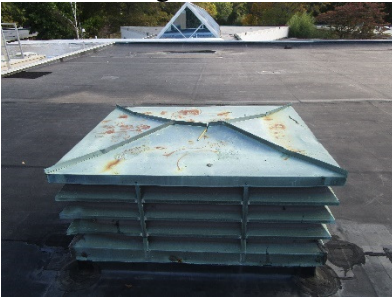
Deteriorating vent cover

The cover on this vent has some splits, dents and is rusting. A new cover should be fabricated and installed before this on deteriorates further and leaks occur.

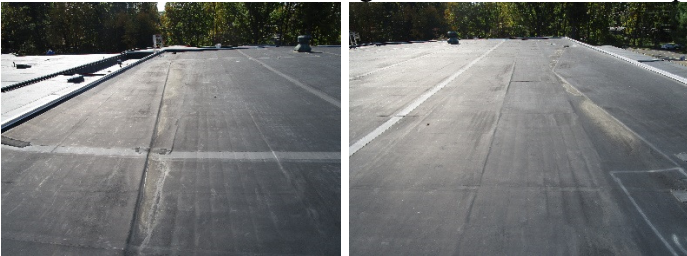
Area of insulation debonding from the deck on the upper Firestone roof

It appears that the insulation along the two long sides of the upper Firestone roof are coming away from the deck. We would recommend installing two rows of fastener and plates on each side to secure the insulation and roof at these perimeter edges. EPDM Coverstrip would be installed over the rows of screws and plates. It is important to secure this area before further lifting or wind damage can occur.

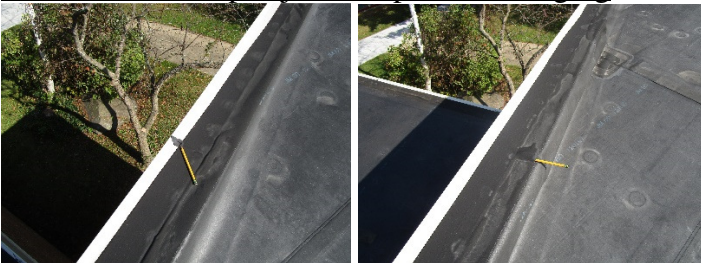
Fishmouths and open joints at perimeter edging

In some areas around the roof perimeter we found some fishmouths or open joints in the perimeter metal edge flashing. All the roofs perimeter should be walked and any open joints or fishmouths repaired.

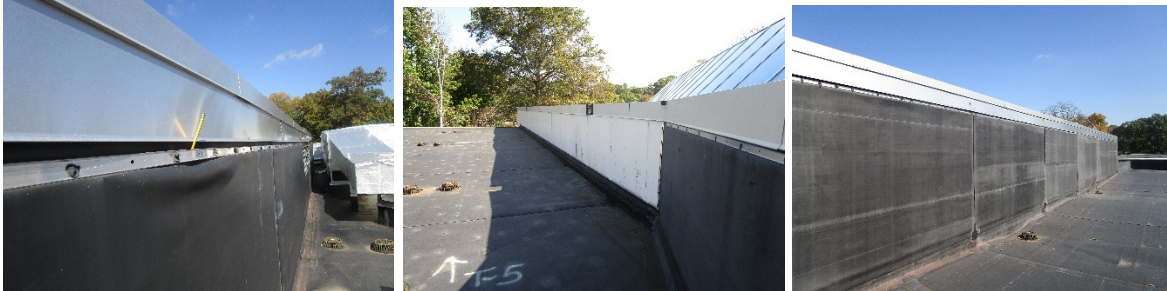
Installing additional counterflashing at walls with EPDM flashing between roof levels

There are a number of areas where EPDM flashing was installed over walls between roof levels. This occurs between the main roof and the Firestone roof, the main roof and the “triangle” sections over the media center and in sections between the levels on the media center. In some instances, the termination bar at the top of the membrane is not keeping constant compression and the membrane is sagging or loose. Over time the top edge of the membrane could become susceptible to water infiltration. We suggest installing an additional piece of counterflashing that is slid under the upper roofs metal fascia. The additional metal flashing would cover the top of the membrane and termination bar in order to eliminate this future potential problem.

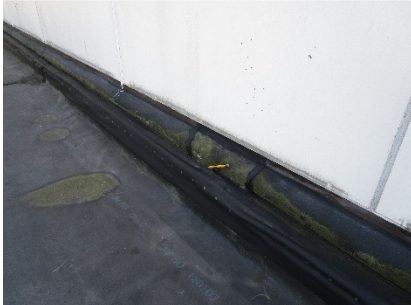
Opening of expansion joint flashing at media center roofs

The membrane stripping where the bellows of the expansion joint meets the roof curb is opening. The entire length of the base of the expansion joint needs to be resealed.

Another interesting condition here is that part of the wall between the expansion joint and the higher roof is covered in EPDM membrane (see picture in the above section), but not the entire wall. We can provide a quotation to cover the balance of this wall with membrane if it is thought that the panels may eventually leak, and it is desirable to complete the membrane work on this section of wall.

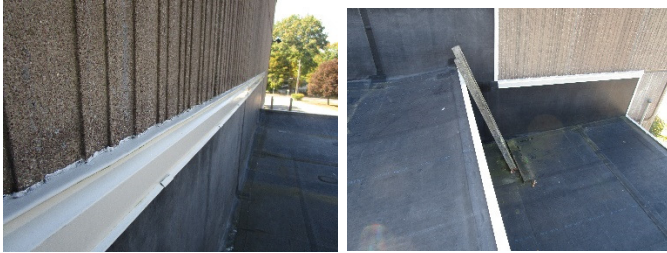
Caulking at counterflashing

A reglet counterflashing is installed at the wall above the small front canopy and continues on the section of wall on going on above the main roof. The caulking is wearing out and a new caulk bead should be installed. In addition, it appears that people get on the main roof by putting a ladder to the canopy and then use an old piece of wooden ladder to get from there to the main roof. The ladder left between levels is not a safe means of access and it should be removed and or replaced with a secured ladder.

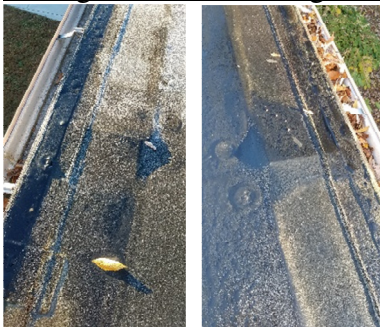
Lifting of wood blocking at some edging of the GAF warranted modular classroom roof

Some of the wood blocking under the edging is lifting. This should be refastened, and the fasteners overlaid with new membrane.

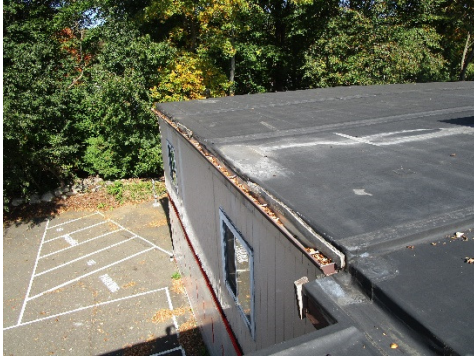
Perimeter edge detail of the modular classrooms

The edge detail at the modular classrooms is questionable. The membrane is brought down over the edge and then a wooden fascia board is fastened over the turned down membrane. A gutter is installed directly below the wood. The wood is rotting and coming off in many places. This removes the securement for the membrane and allows water to run behind the gutter down the face of the classroom. The gutters are also clogged with leaves.
