# Initial Assessment—Photographic Log

**Client:** City of Stamford Mold Task Force

**Job Number:** S-2087-033

**Site:** Newfield Elementary School

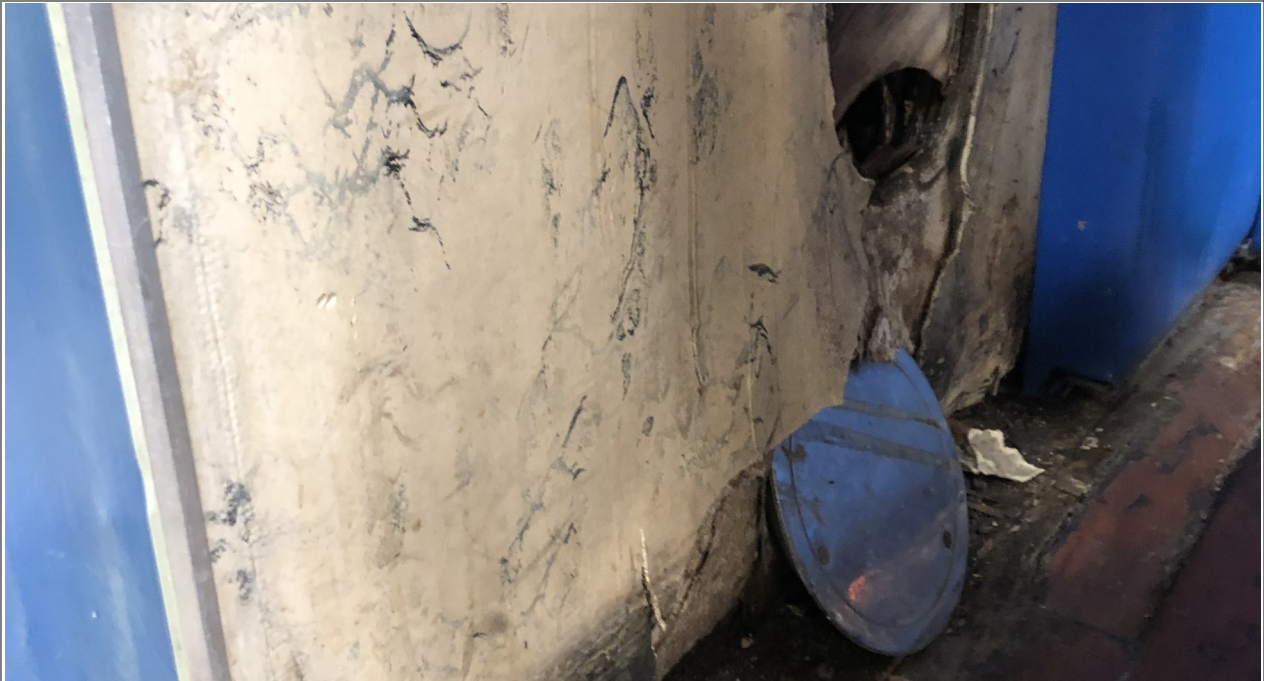
<b>Photograph No.:</b> 19	<b>Date:</b> 11/5/18	<b>Direction Taken:</b> —
<b>Description:</b> Mold Growth at Wall—Gymnasium

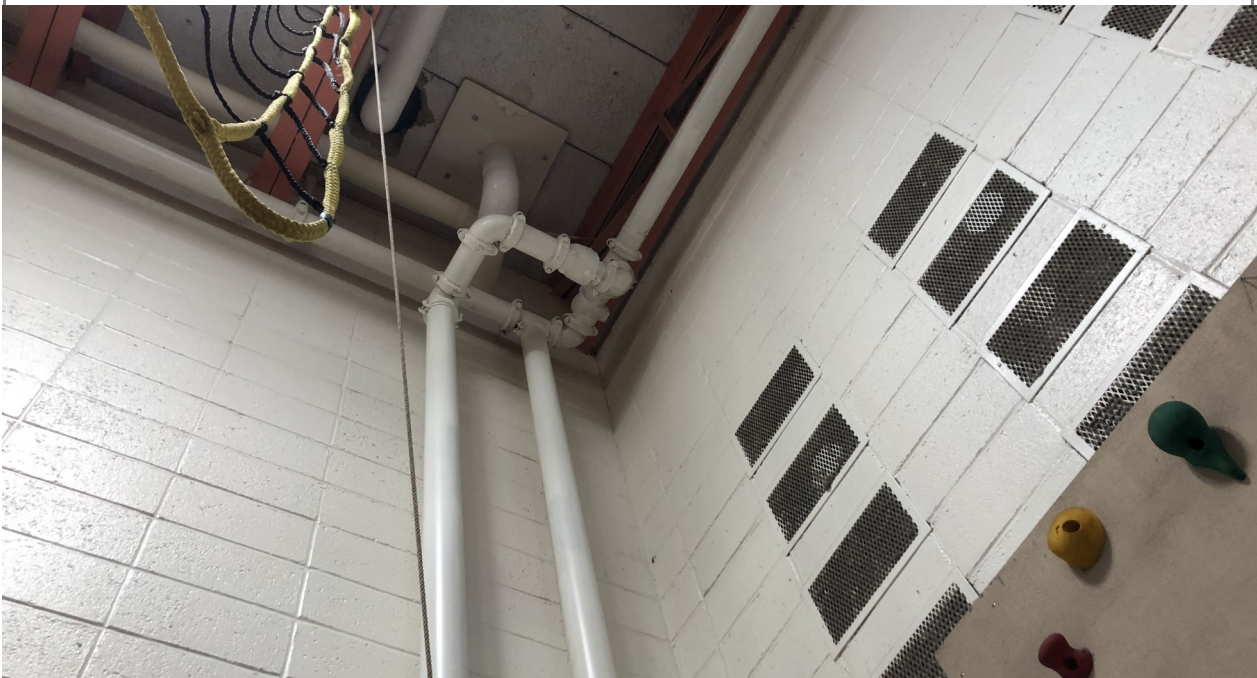
<b>Photograph No.:</b> 20	<b>Date:</b> 11/5/18	<b>Direction Taken:</b> —
<b>Description:</b> Water Staining on Drywall at Roof Drain - Gymnasium
