FACILITIES NEEDS ASSESSMENT

STAMFORD PUBLIC SCHOOLS

FACILITIES NEEDS ASSESSMENT OF NORTHEAST ELEMENTARY SCHOOL

EMG Project #: 88166.09R-010.017
Date of Report: August 27, 2009
On-site Date: February 17 and 18, 2009

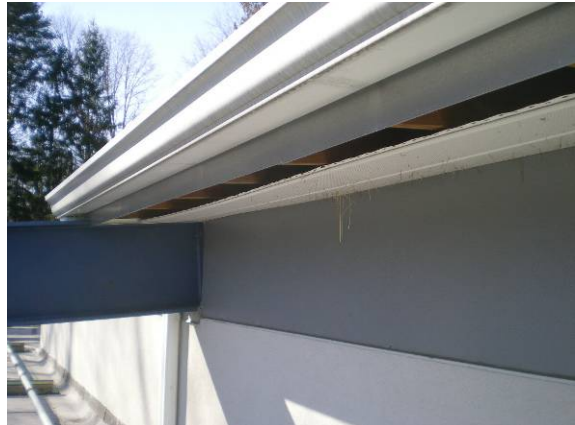
Photo #16: Missing soffit panel at Media Center

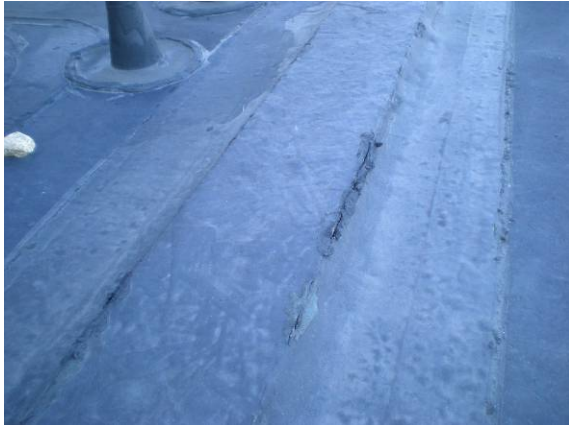
Photo #19: Cracking at single ply membrane over modular section

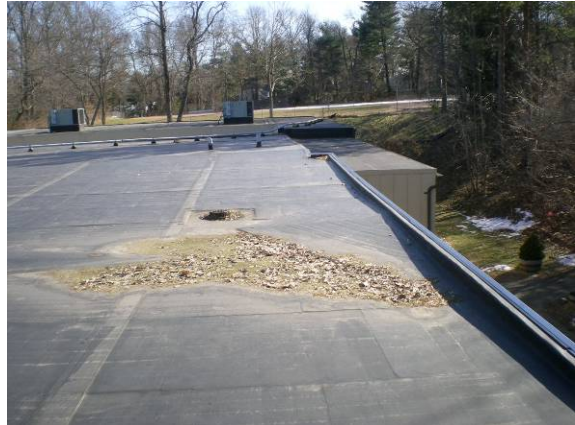
Photo #20: Evidence of ponding on original school building

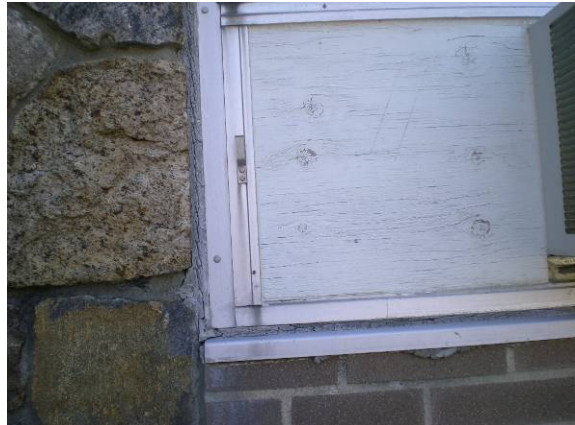
Photo #22: Sealant condition

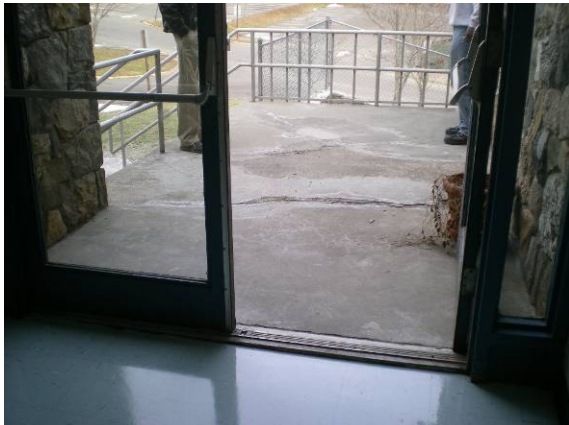
Photo #23: Side entrance with low guardrail and cracked landing

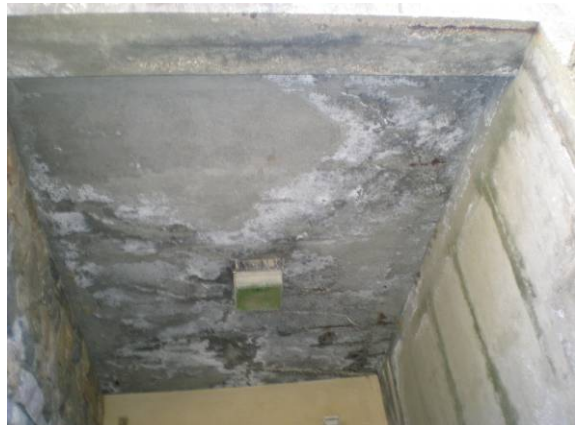
Photo #24: Underside of cracked landing on side entrance

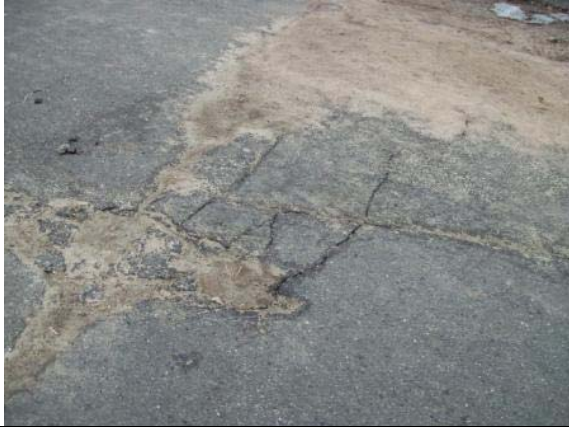
Photo #31:	Asphalt damage in service drive
------------	---------------------------------

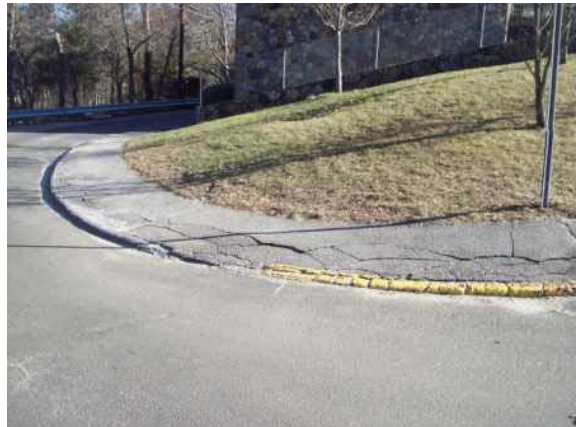
Photo #34:	Asphalt damage at asphalt walking path
------------	--

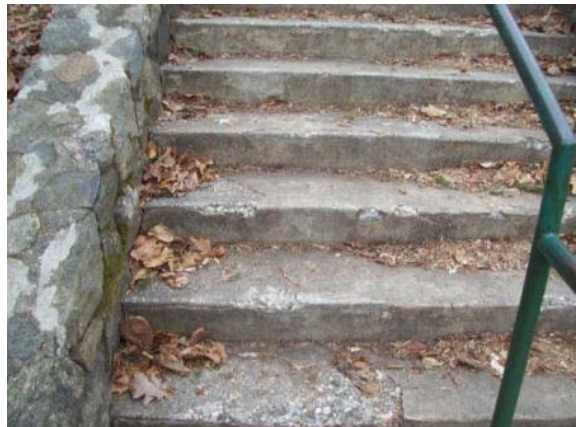
Photo #36:	Damage to concrete steps
------------	--------------------------

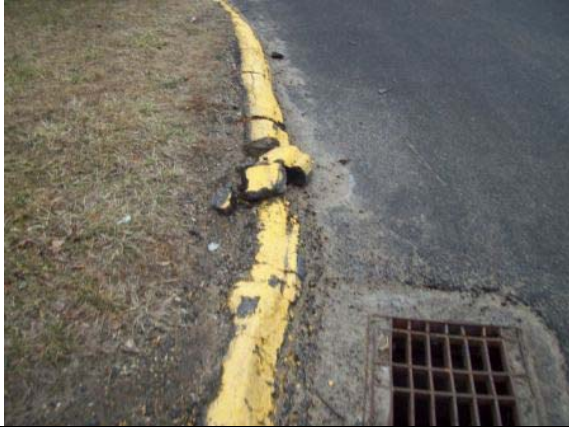
Photo #37: Damage to asphalt curbing

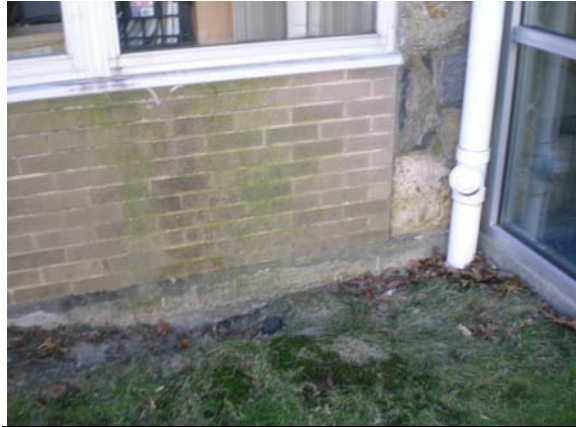
- Evidence of significant erosion was observed along the south side of the building, near the ball fields and paved athletic areas. The maintenance staff also reported significant drainage problems such as ponding and overflow onto the pedestrian steps at the south elevation of the building. Additional drainage problems were reported at the west side of the building. The steep slope adjacent to the playground appears to be causing ponding along the west wall and subsequent flooding in the classrooms. It is recommended that a drainage study be performed in order to determine the proper corrective action for the drainage issues and recommend any necessary repairs in the area. The cost of the drainage study is included in the Replacement Reserves Report. The costs of the corrective action and recommended repairs are to be determined by the study and are not included in this report.

Photo #38: Erosion at front elevation of building

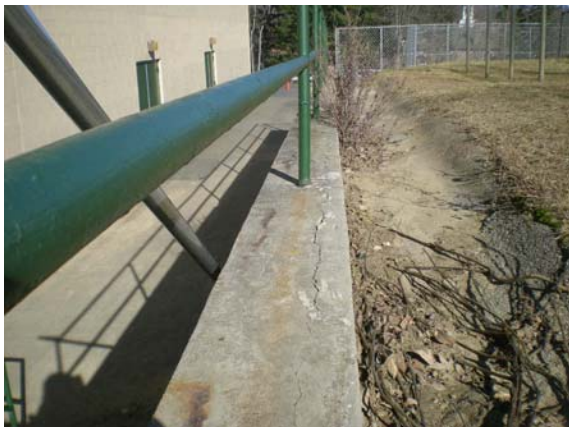
Photo #41: Cracking along top of retaining wall

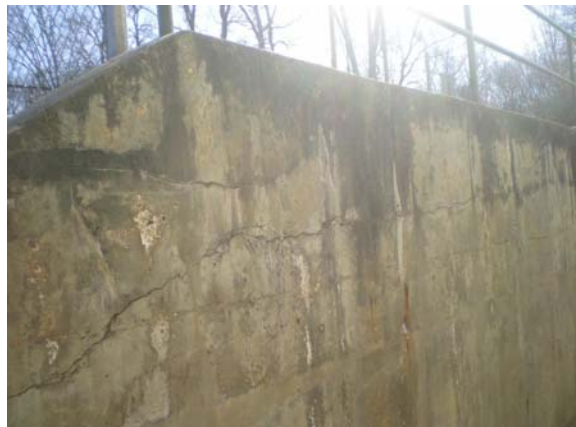
Photo #42: Cracking along face of retaining wall

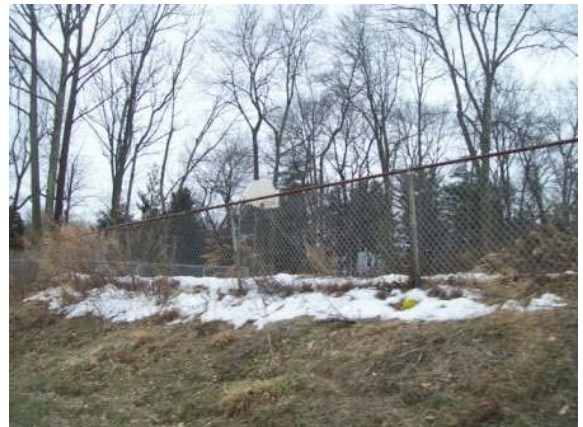
Photo #48:	Damaged site fencing
------------	----------------------

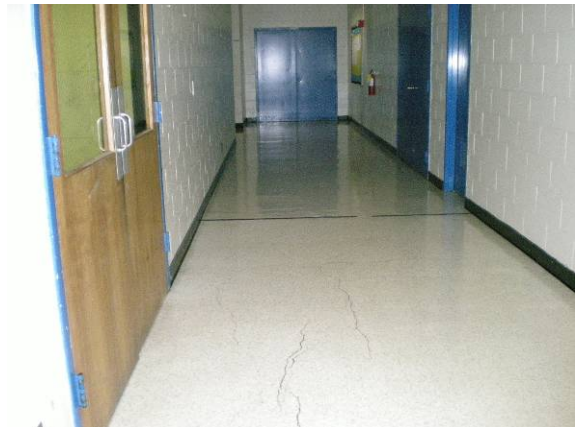
Photo #52: Cracks in corridor flooring finish

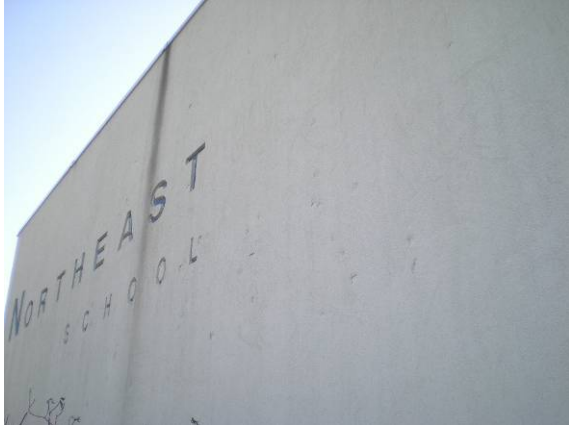
Photo #55: Damage to EIFS at Media Center

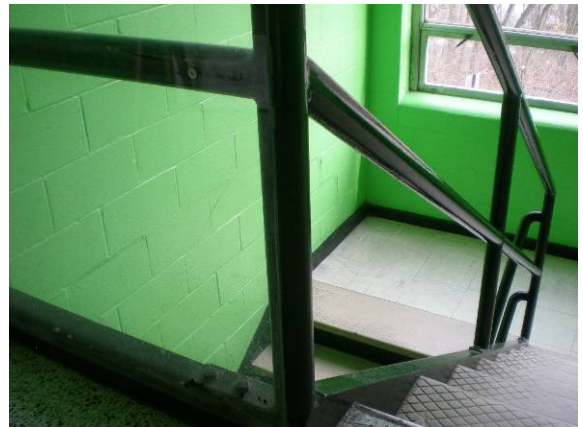
Photo #60: Stairwell with acrylic at top landing but no protection along stair portion of railing

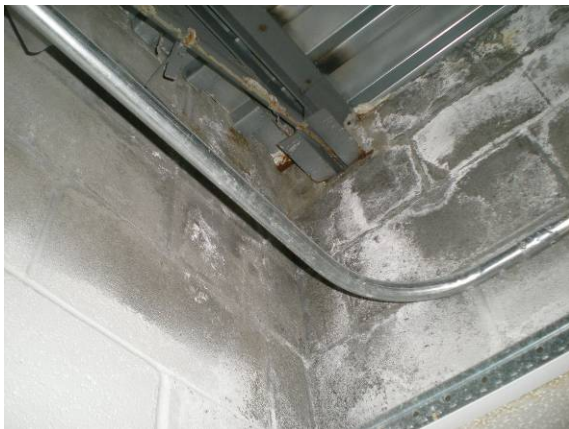
Photo #65: Evidence of roof leak at Media Center storage room

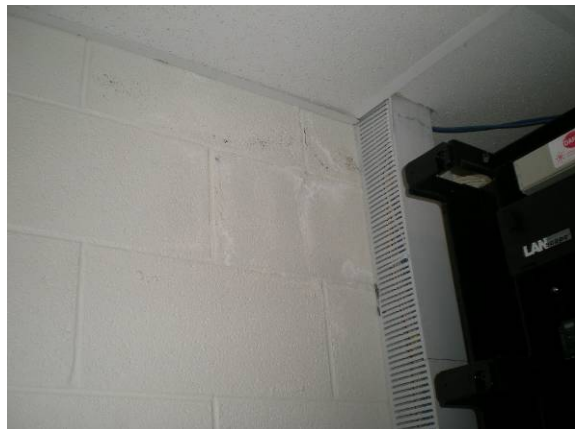
- Based on the numerous locations of isolated suspect mold, a mold assessment should be conducted by a health and safety professional with experience performing microbial investigations. In addition, the source of this moisture should be addressed in order to prevent future mold problems. The estimated costs of corrective action shall be determined as part of the mold assessment recommended. See Section 3.3 for further information. The estimated costs are included in the Replacement Reserves Report.

Photo #66: Suspect mold in Media Center server room

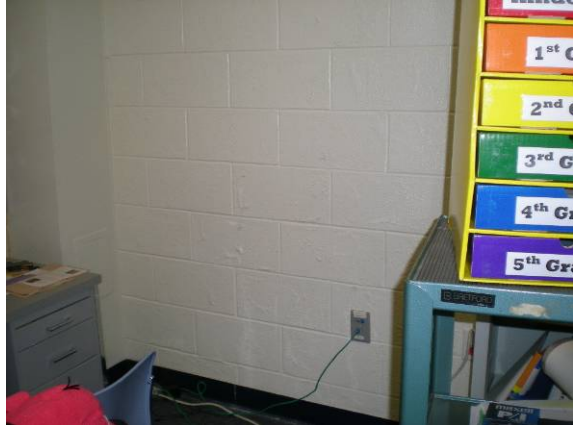
Photo #67: Water infiltration at Media Center office

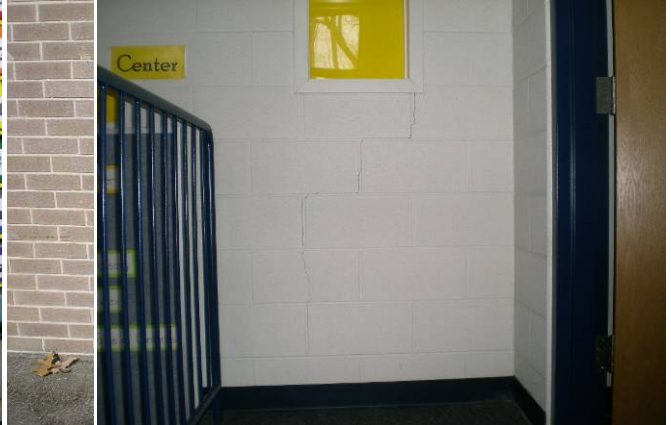
- Isolated areas of the concrete masonry unit bearing walls are in poor condition. Stair step cracking and cracks through the concrete masonry units were observed in the Media Center, the upper level mechanical room and on the exterior brick veneer at the southeast corner near the transformer. An engineering professional must be retained to analyze the existing condition, provide recommendations and, if necessary, estimate the scope and cost of any required repairs. The estimated cost to retain an engineering professional is included in the Replacement Reserves Report. The cost for any possible subsequent repairs is not included in the cost tables. See Section 6.1 and 6.2 for additional information.

Photo #68: Settlement cracking in Media Center

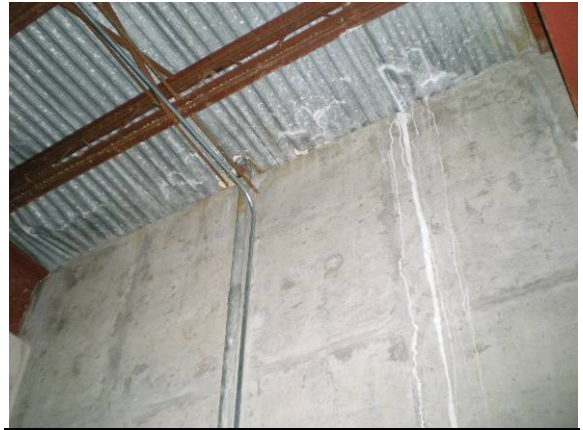
Photo #74: Water infiltration at subterranean wall in storage area at front of building

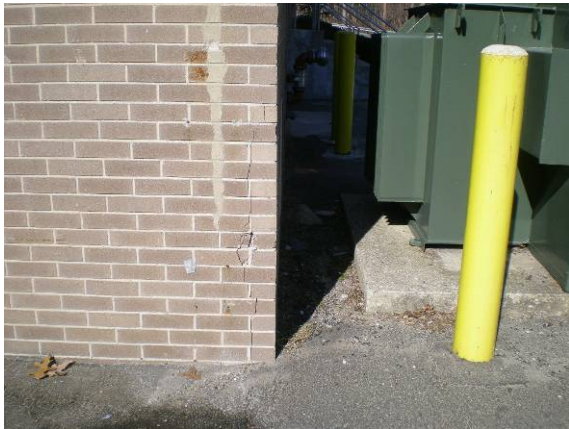
Photo #75: Cracking at southeast corner near transformer

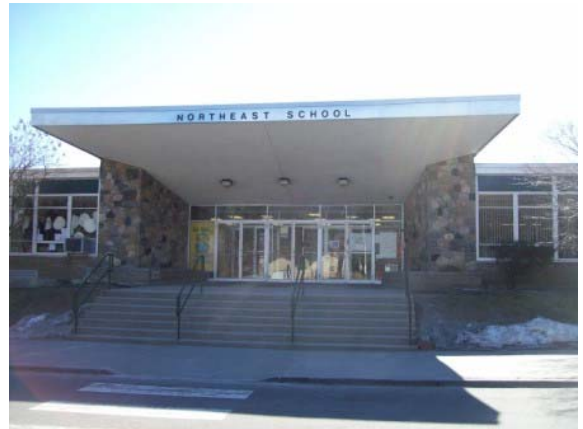
- The mobility impaired accessibility into and throughout the school, to the Annex Building and to the playgrounds is poor or non-existent. The only accessible entrance is at the Media Center. The lower floor of the school is not accessible without the addition of an elevator. Restrooms are not accessible. An accessibility specialist must be retained to analyze the existing condition, provide recommendations and, if necessary, estimate the scope and cost of any required repairs. The estimated cost to retain a specialist is included in the Replacement Reserves Report. Separate itemized costs for accessibility improvements are included in the Replacement Reserves Report.

Photo #78: Main entrance to school. Not accessible.

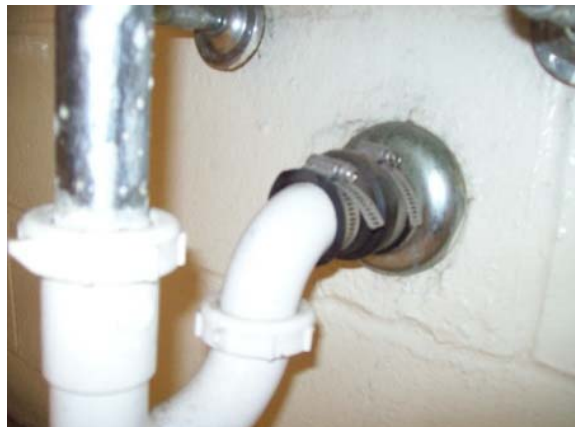
Photo #96: Prior repairs to drain lines

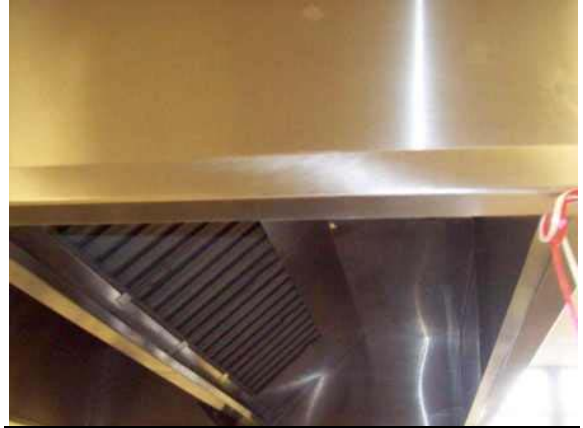
Photo #116: Kitchen exhaust hood without fire protection

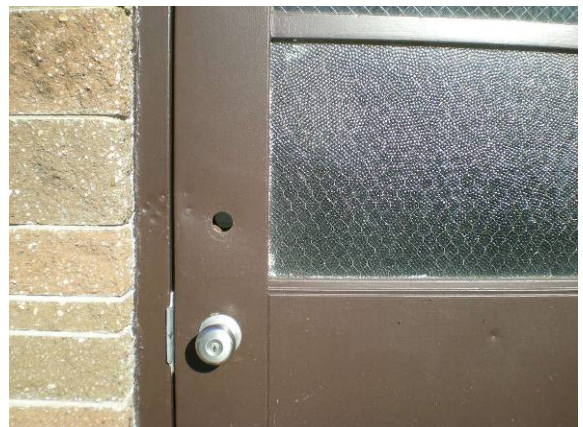
Photo #132: Missing locking device at Annex building
