Initial Assessment—Photographic Log

Client: City of Stamford Mold Task Force

Job Number: S-2087-033

Site: Northeast Elementary School

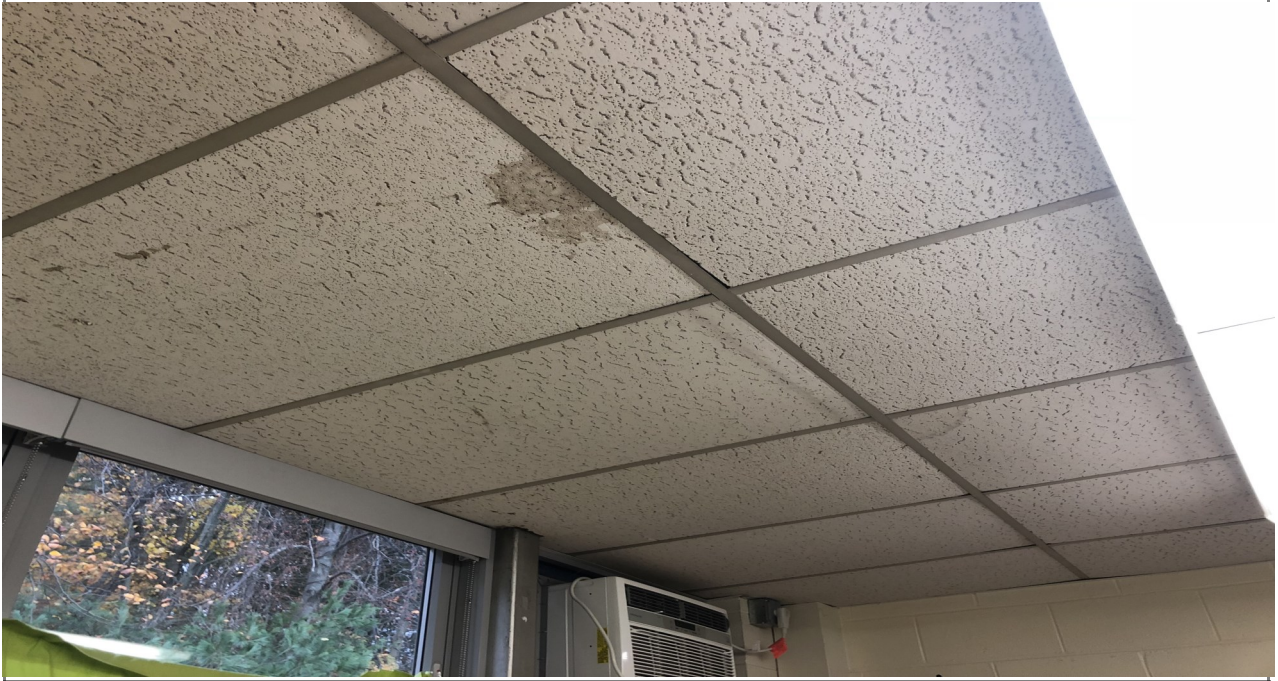
| Photograph No.: 11 | Date: 11/7/18 | Direction Taken: — |

| Description: Water Stained Ceiling Tile—Classroom 110 | | |

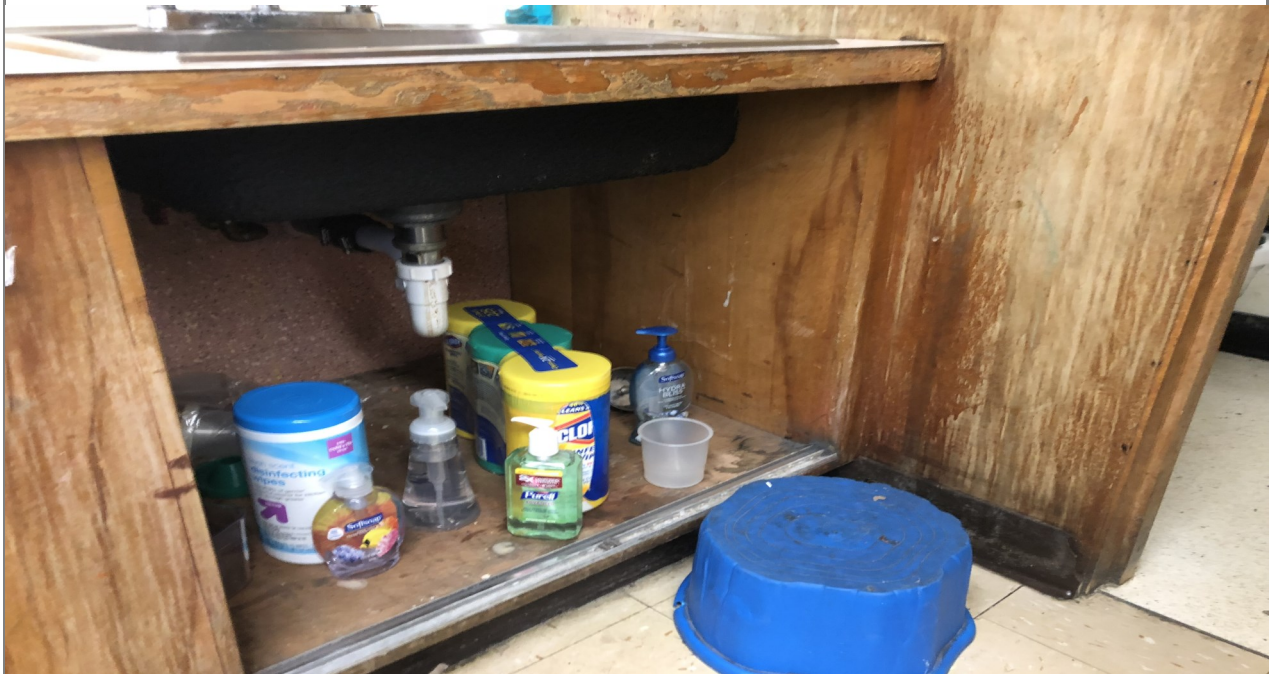
| Photograph No.: 12 | Date: 11/7/18 | Direction Taken: — |

| Description: Water Stained Sink Cabinet—Classroom 110 | | |
