# **Infrared Thermographic Roof Moisture Analysis**

**PERFORMED FOR:** Viking Construction  
1387 Seaview Ave.  
Bridgeport, CT 06607

**LOCATION:** Northeast School  
Stamford, CT

**CONDUCTED ON:** April 24 & 25, 2019

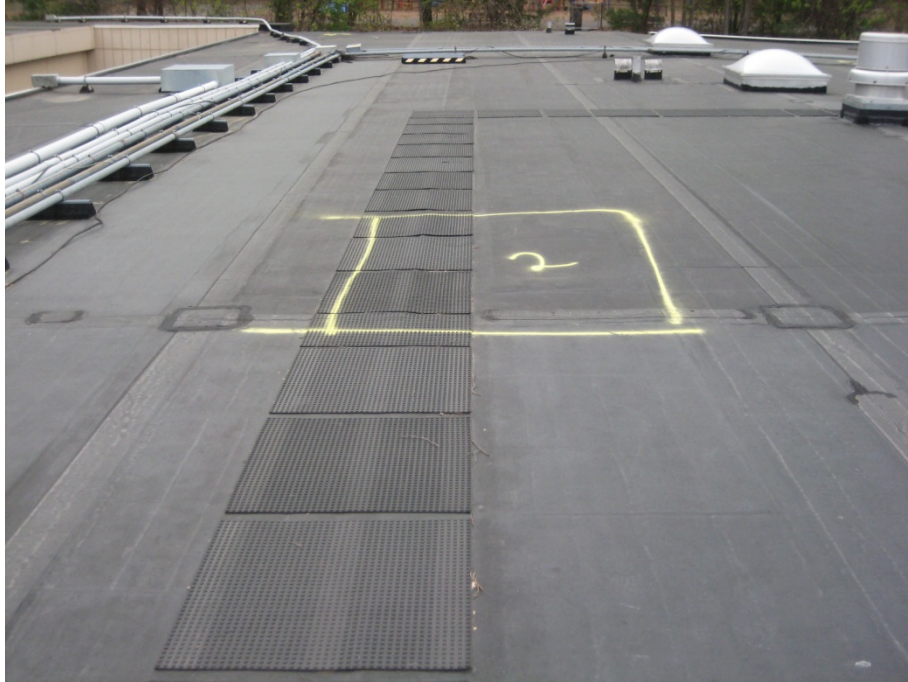
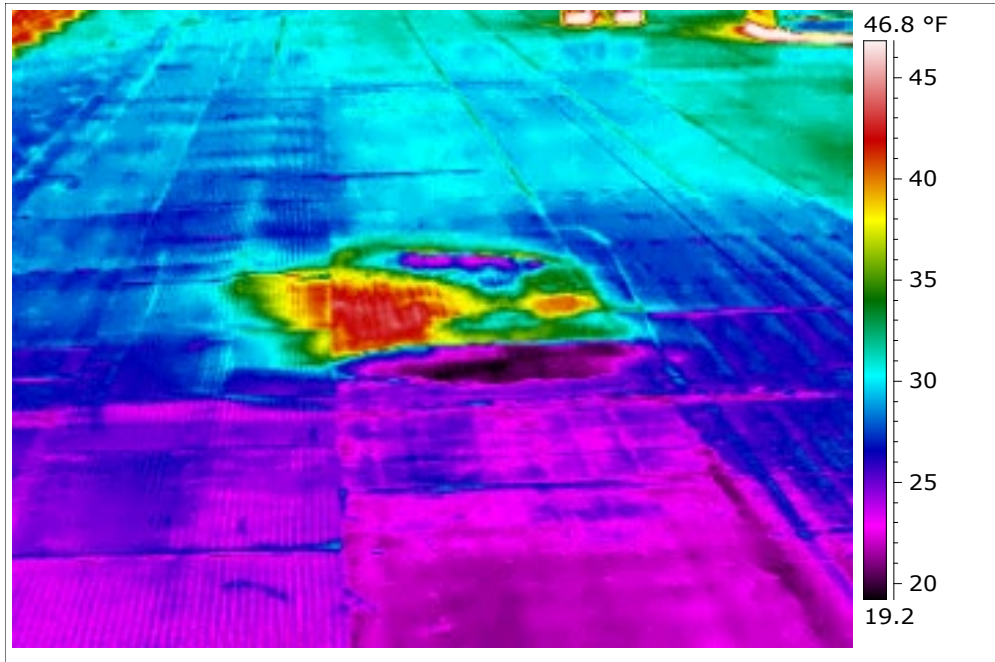
Thermogram # 1

Wet Area #2

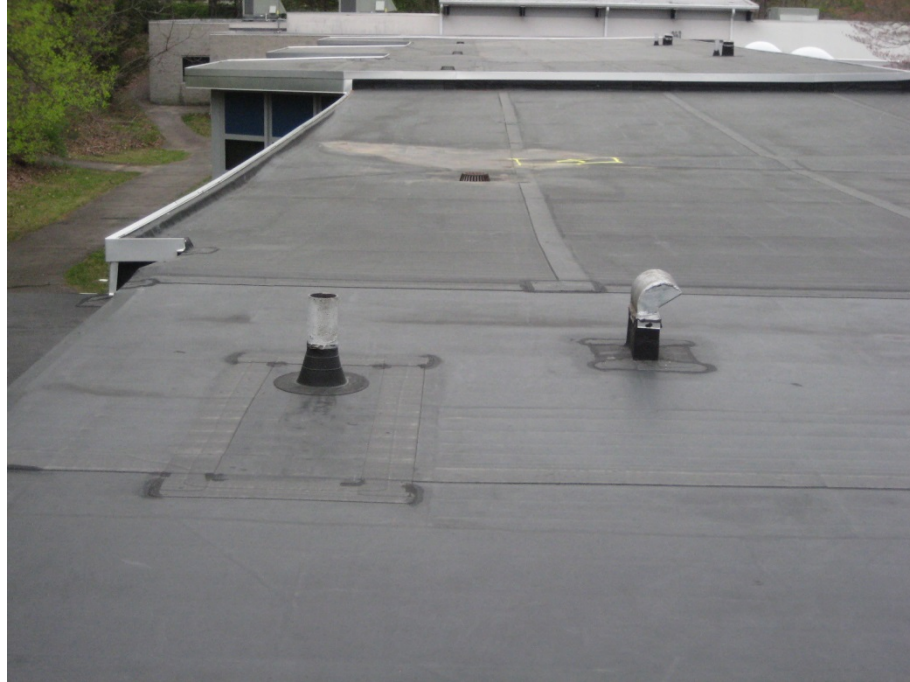
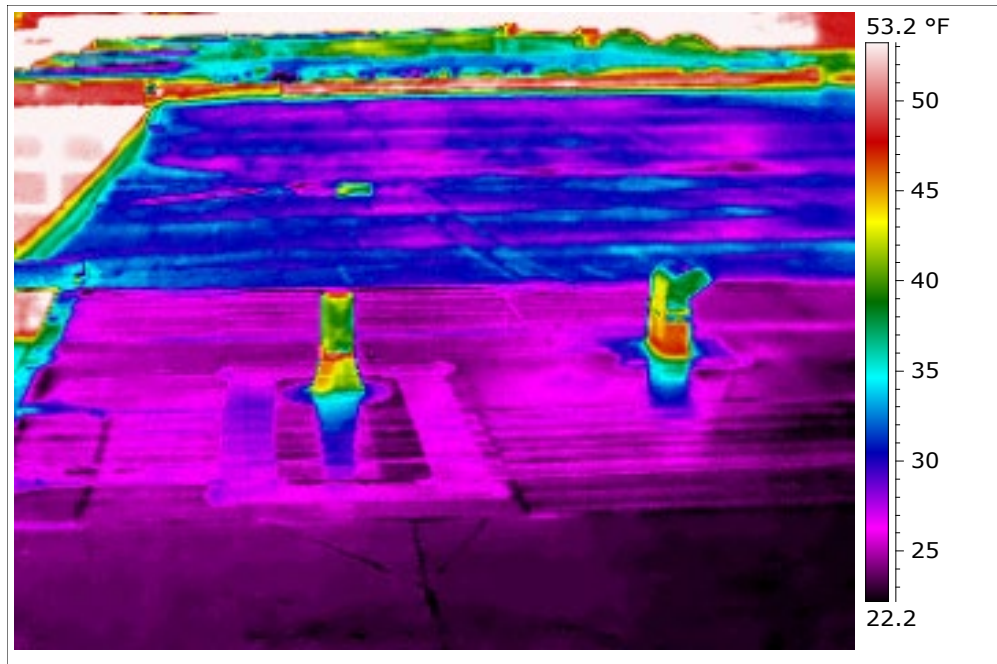
Thermogram # 2

Dry area of roofing

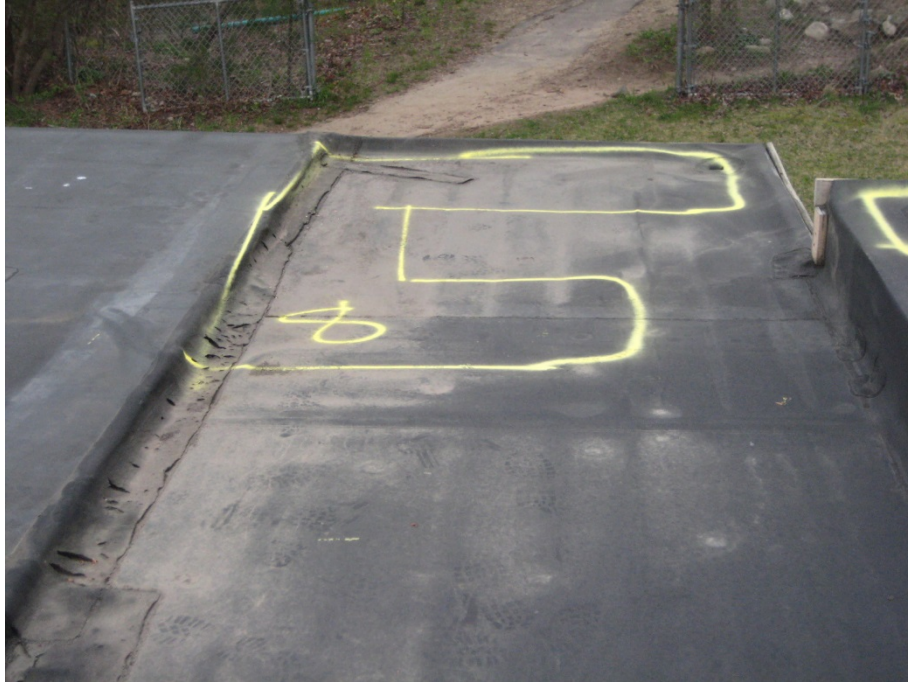
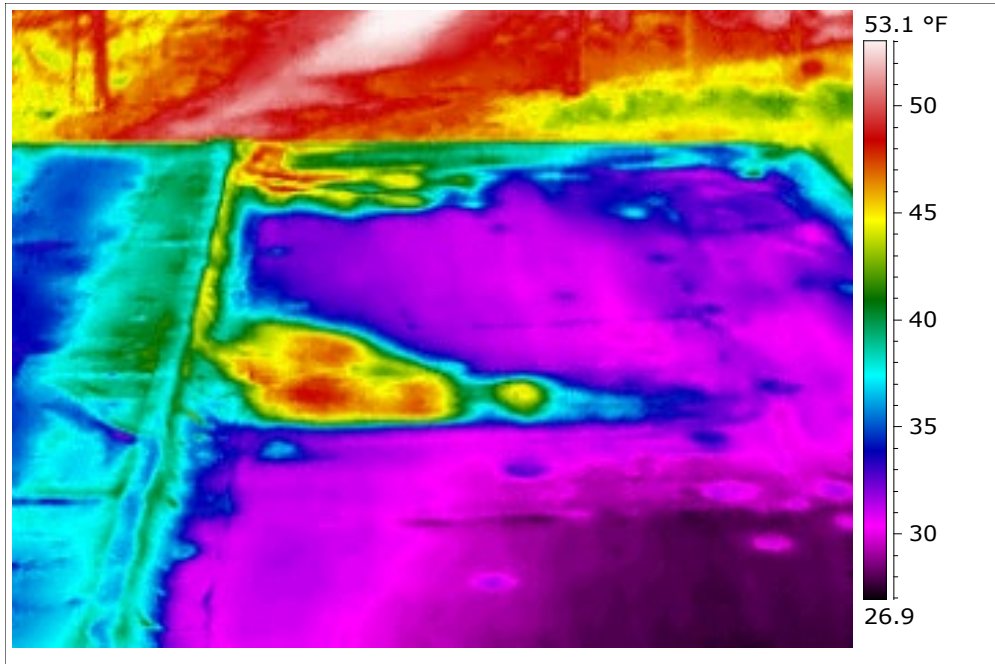
Thermogram # 3

Wet Area #8

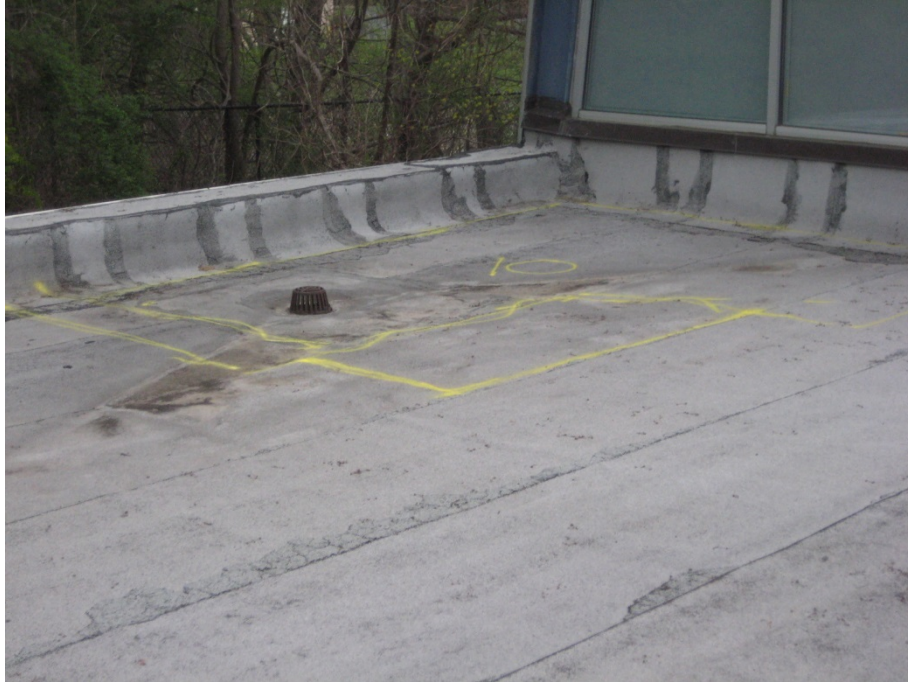
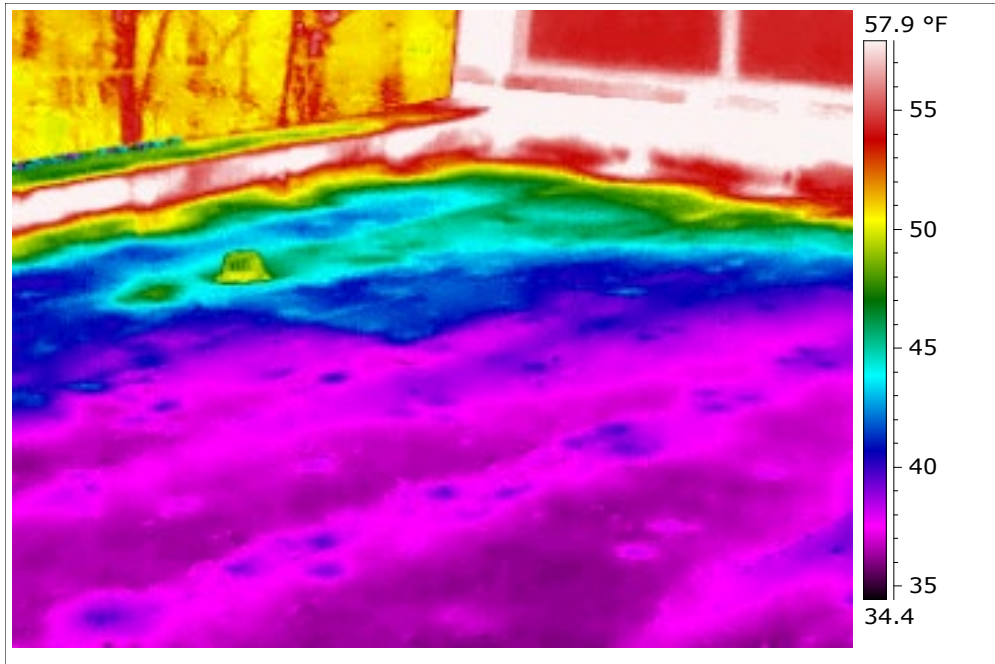
Thermogram # 4

Wet Area #10

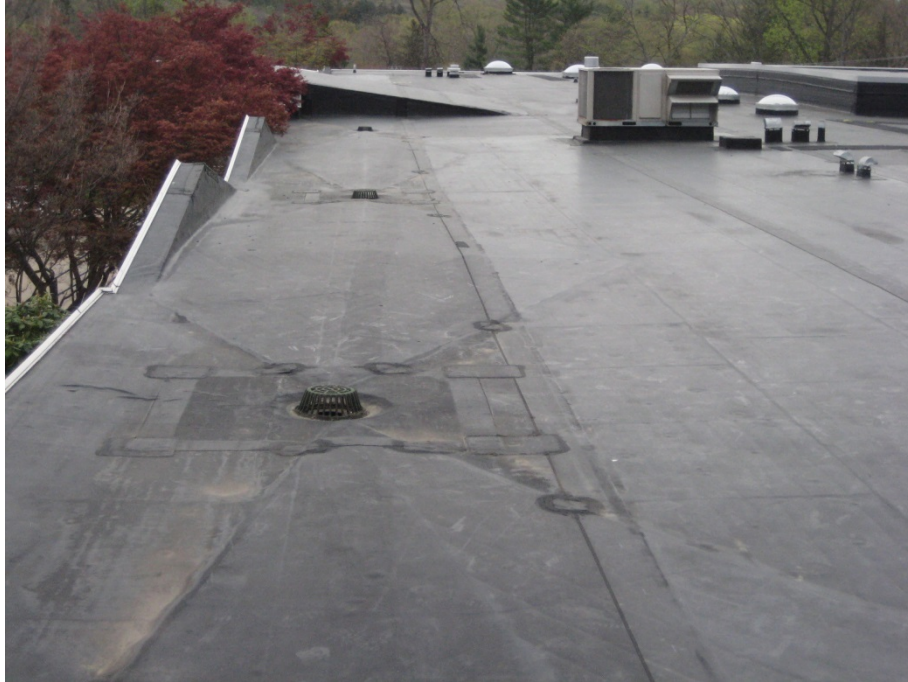
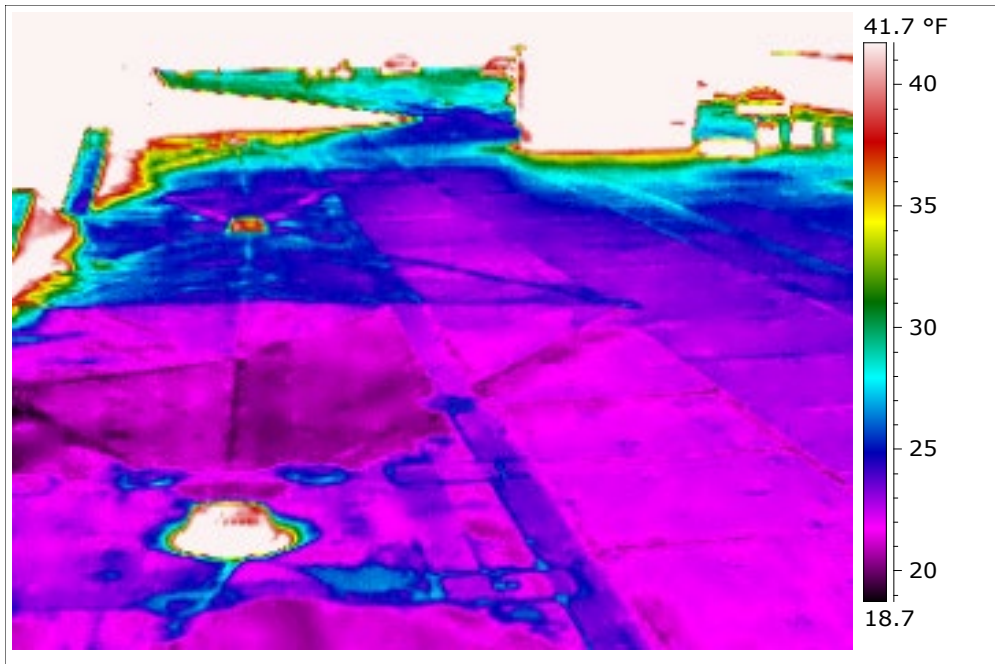
Thermogram # 5

Dry area of roofing

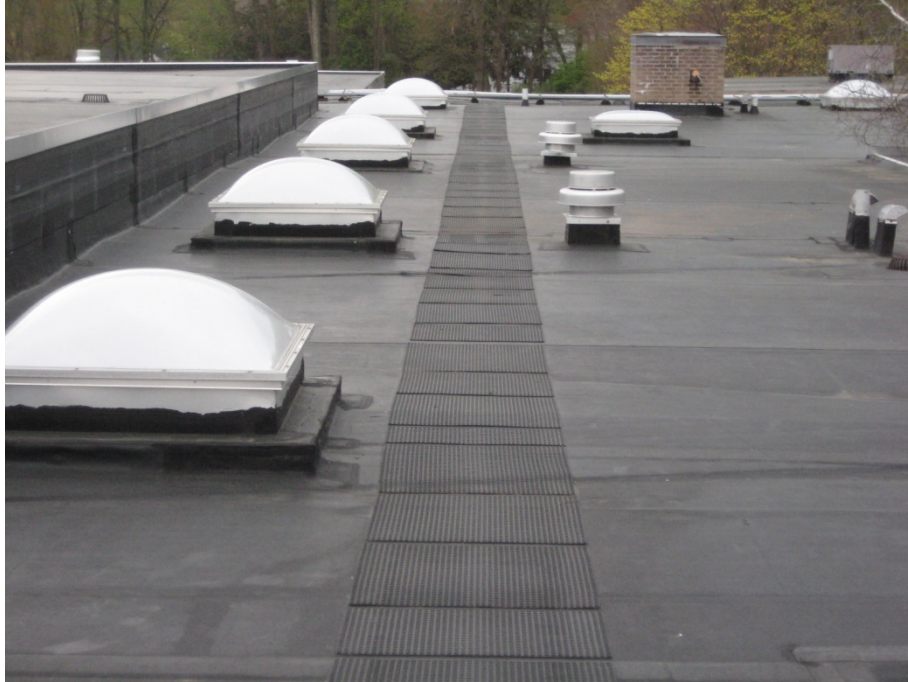
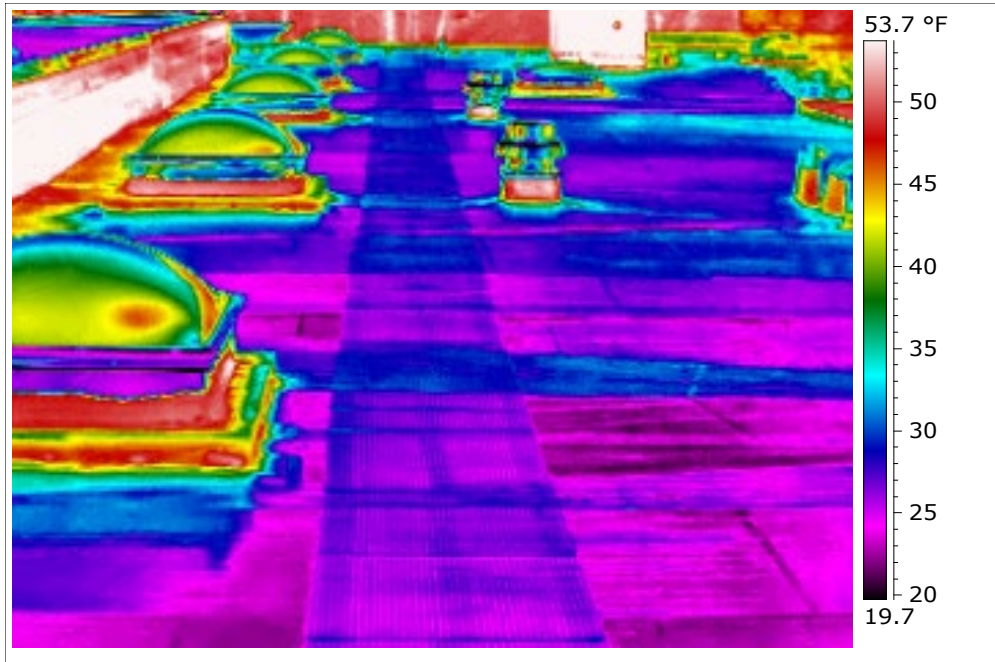
Thermogram # 6

Dry area of roofing

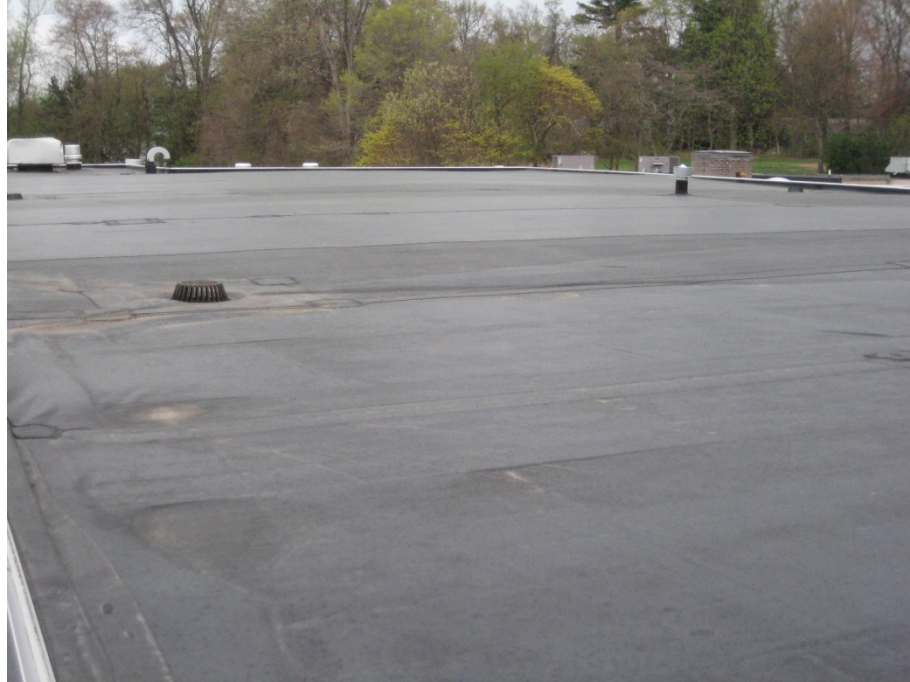
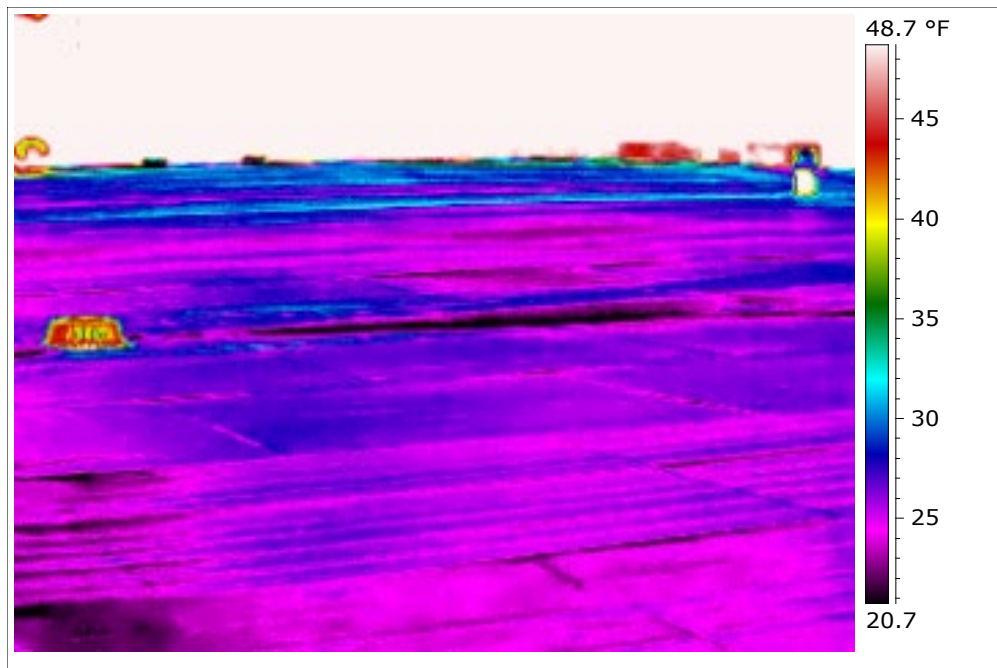
Thermogram # 7

Dry area of roofing

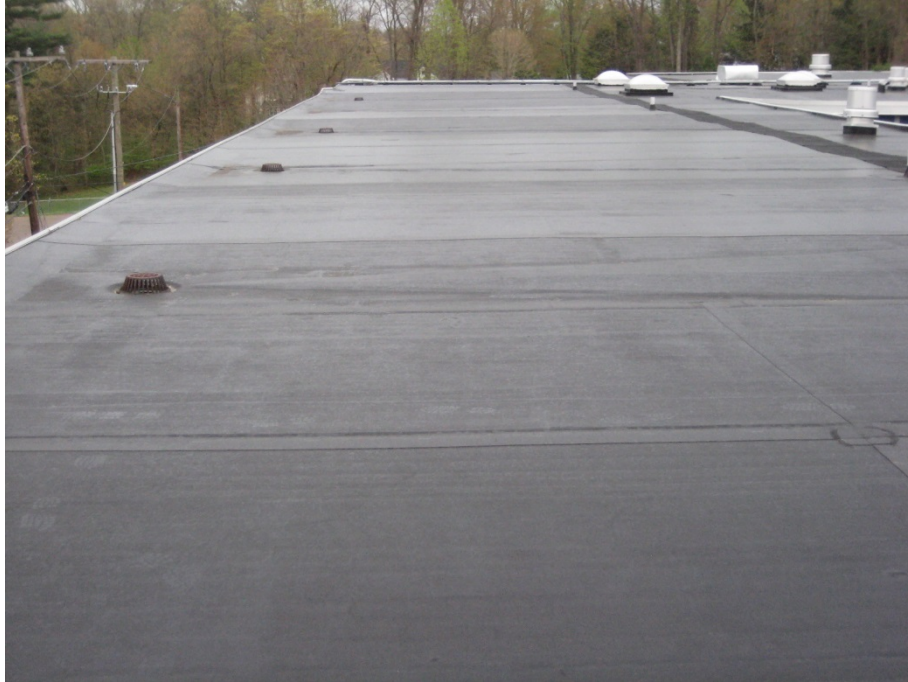
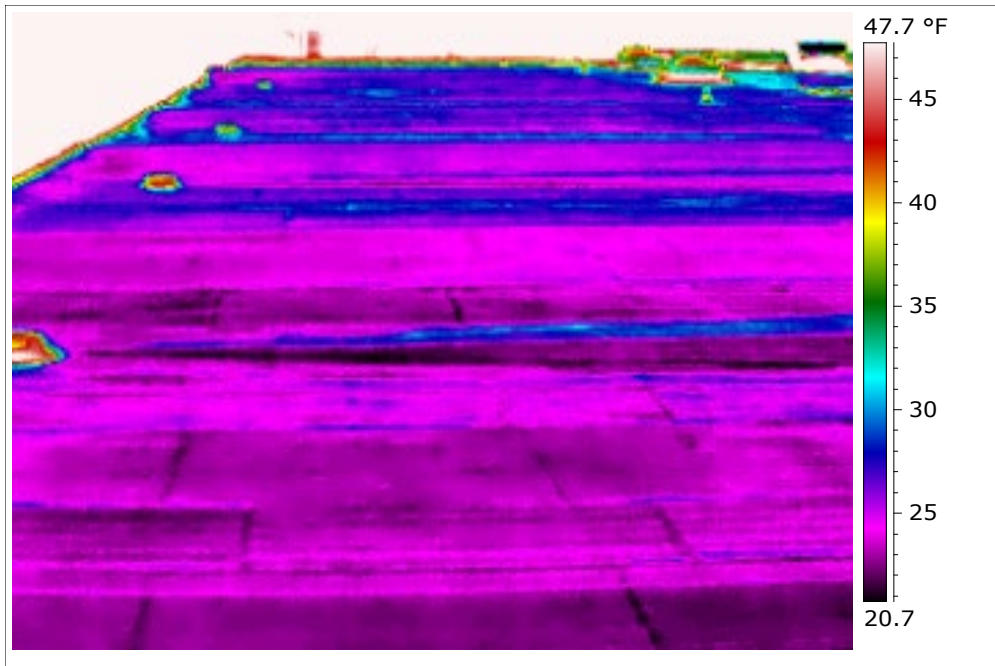
Thermogram # 8

Dry area of roofing

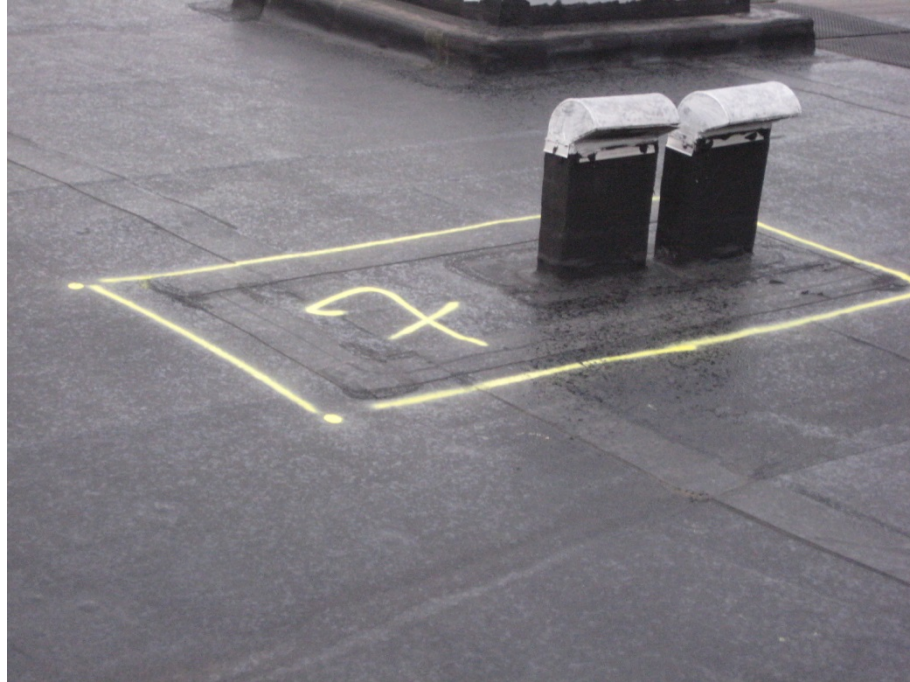
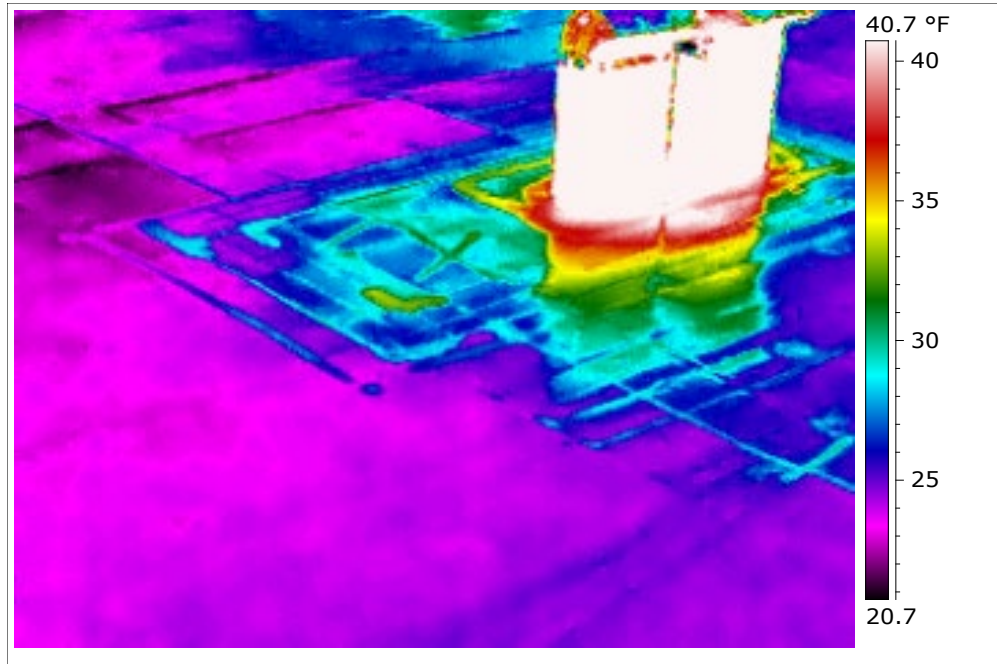
Thermogram # 9

Wet Area #7

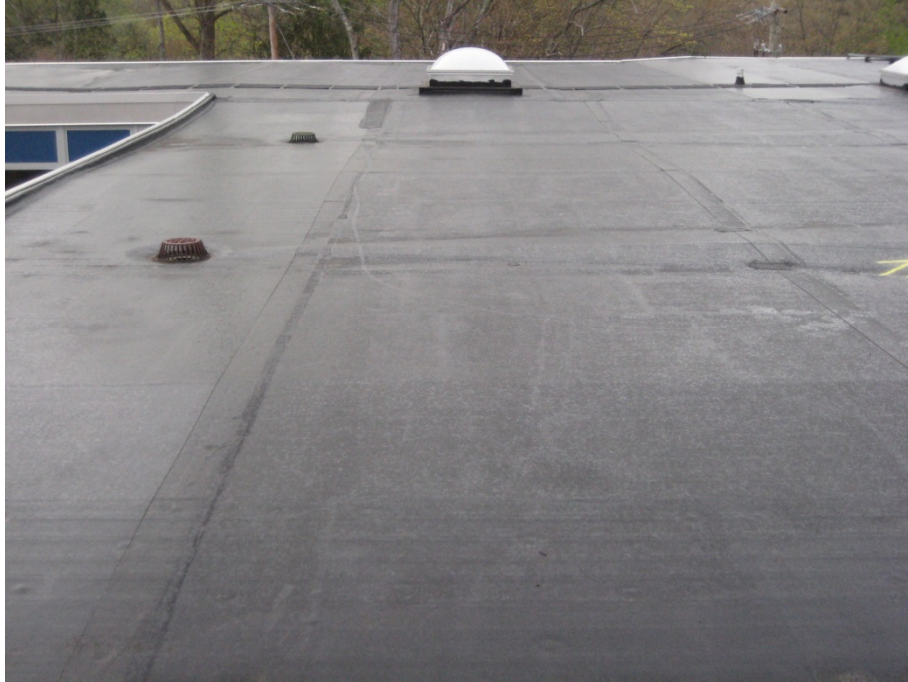
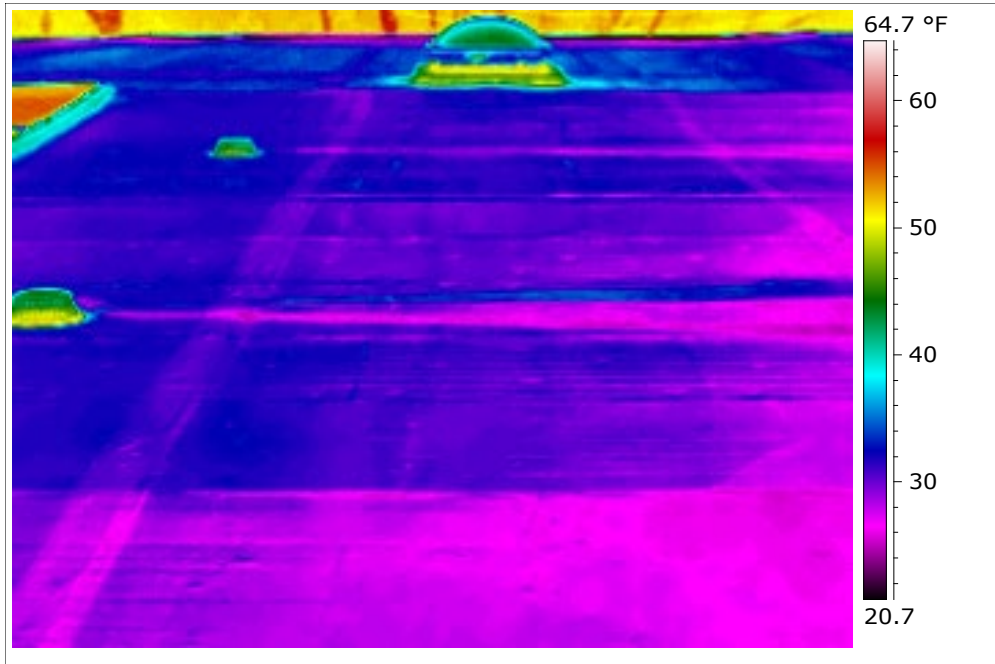
Thermogram # 10

Dry area of roofing
