M. Gottfried, Inc.

RE: Roof report and repair quotation
Northeast School
82 Schofieldtown Road
Stamford, CT 06903

As per your request we went to the above school to perform a visual inspection of the roofs, look for possible sources of water leaks, see what leaks could be repaired under warranty, provide pricing for repairs not covered by warranties and make recommendations and provide pricing for preventative maintenance.

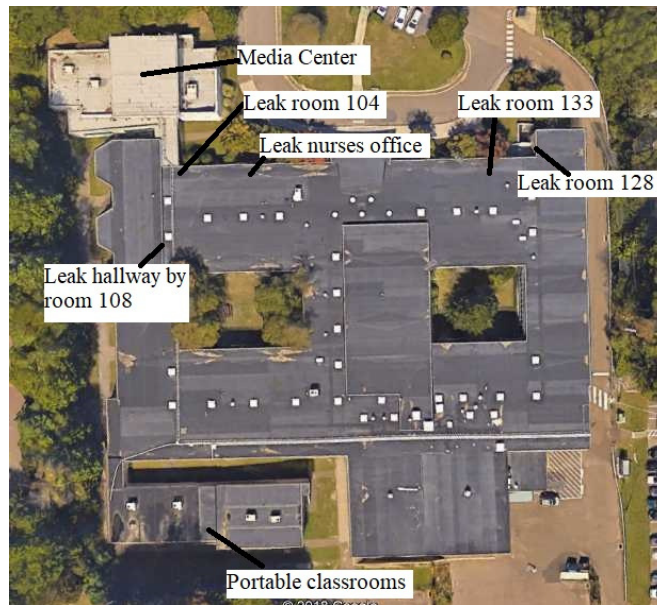
Active leak location and overall layout of Northeast School

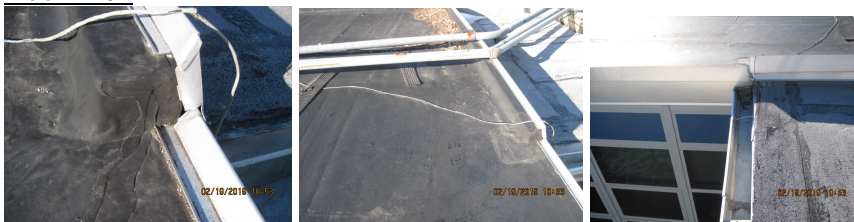
Room 104

The leak at room 104 falls at the perimeter edge of the building. We can see a gap between the high and low pieces of edging where water may be able to get into the building. The gutter and leader at the connector roof, below this corner should also be looked at. Repairing this area may or may not be covered depending on what we see when we take of the edging. Cleaning and checking the gutter and leader will be included in the Owner's quotation.

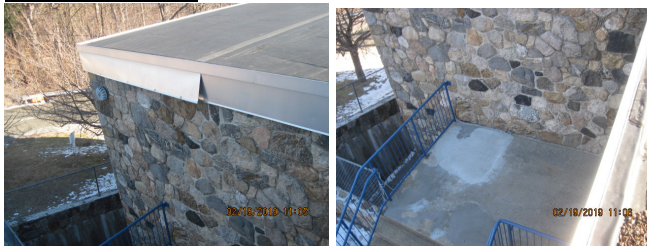
Classroom 128

The leak at room 128 shows up low on the wall. We did not see any issues with the roof membrane. It is possible rain may be blowing in under the loose fascia, but we suspect that water is coming in at the slab at the top of the stairs and soaking through the wall. Repairing the metal will be in the Owners quote. If the wall is leaking, its repair is by others.

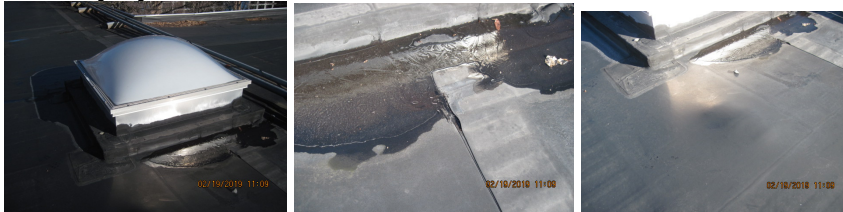
Hallway by classroom 108

The leak in the hallway appears to come from the flashing around the skylight. We can see some of the membrane is wrinkled and lifting. All the flashing around the skylight will be checked and repaired. This item will fall under the Carlisle repairs.

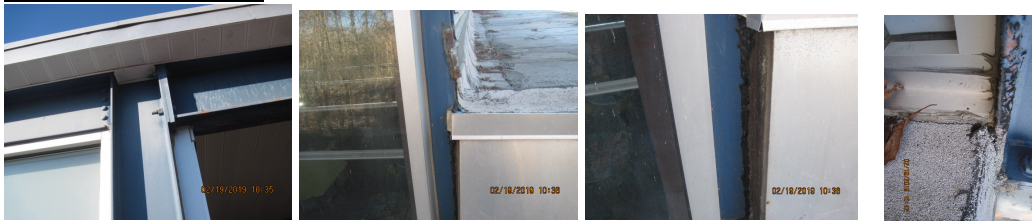
Media Center Leaks

The media center is getting leaks on the walls alongside the vertical steel beams.

We can see gaps and shrunken caulking along these beams. We would like to water test these areas to confirm that the water infiltration is coming from these gaps. If this is the case, the gaps and open areas should be recaulked. The testing is included in the Owners repairs, the caulking and subsequent repairs can be priced after the results of the test are known. The Owner may also wish to have a caulking contractor come and provide a quotation to recaulk all these areas to help tighten the building regardless of the test's outcome.

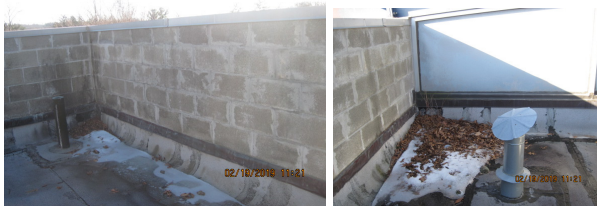
The media center also is experiencing water coming in below the high block walls. We think water is soaking through the block and traveling down the wall. The walls should be sealed with an elastomeric coating or water-proof paint. We can provide a quote to perform this work, the Owner can have it done with its own staff, or the Construction manager can have this work performed by others.

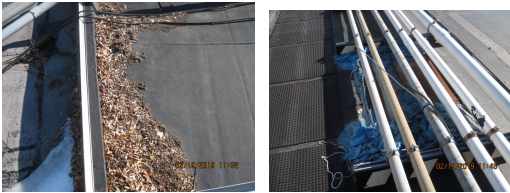
Debris

There are areas with leaves and even metal wrapped in plastic tucked under pipes on the roof. Leaves can lead to organic growth and trap moisture. Metal debris can blow around and cause holes. The roof needs to be cleaned of leaves and debris.

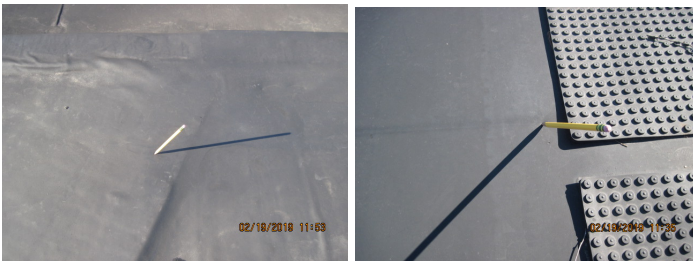
Holes in the roof might not cause leaks right away, but they let water into the roofing system and will eventually cause leaks. Holes must be repaired immediately before the roof is damaged and more extensive repairs are necessary, (see the next item).

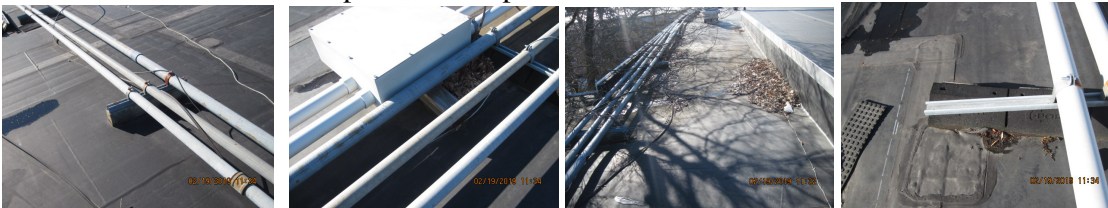
Items on the roof without a protective slip sheet

The manufacturer requires that item on the roof rest on loose slip sheet of EPDM membrane. This will keep sharp edges, splinters or metal from coming in direct contact with the roof membrane, where they may cut or damage the roof if the item shifts. Slip sheets need to be installed under all the sleepers. In the last picture, the metal support has shifted and pushed up the patch. This patch will have to be repaired.

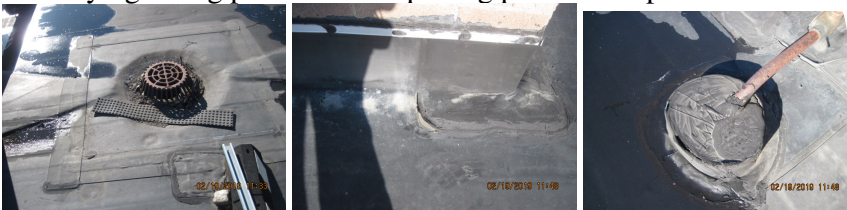
Overlaying lifting patches and repairing penetration pockets

We found a few areas where some stripping in and patches on the roof are starting to peel or lift. These need to be cleaned and overlaid with new EPDM flashing. In addition, the penetration pockets need to be primed and "topped off" with additional pourable sealer.

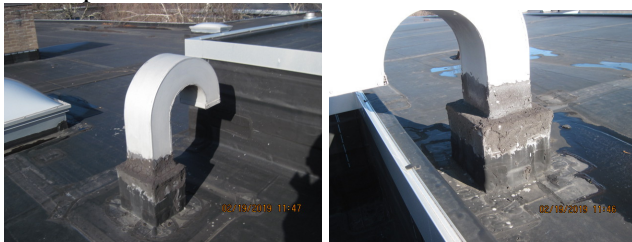
Incompatible materials

Roofing cement has been applied around these goosenecks. We would assume that this was done to address a previous leak. The problem is that roofing cement is not compatible with EPDM membrane. These items need to be cleaned and the bases reflashed. The area around the gooseneck should be coated with a PMMA membrane.

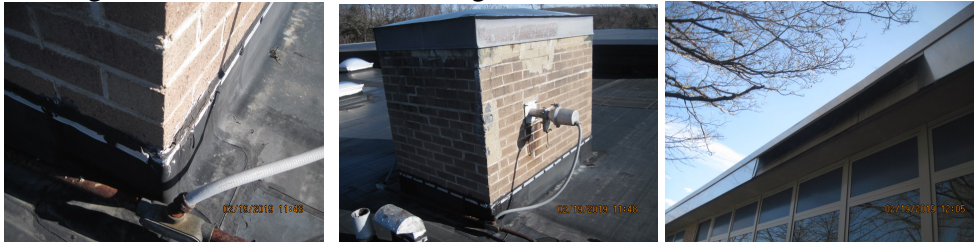
Missing termination and metal flashing

Proper watertight termination flashing depends on continuous bar and maintained caulking. A piece of the termination bar is missing at the corner on the chimney. That should be installed and the top of the bar recaulked. While going around the school, we also noticed that a piece of the fascia is missing. It should be replaced.

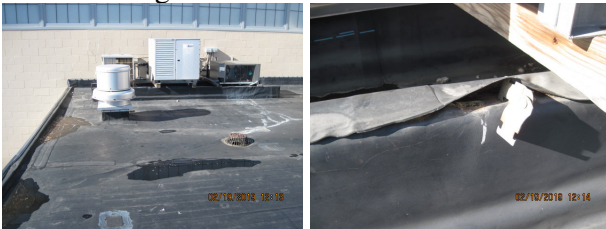
Curb flashing

The sleeper flashing for these units on the lower roof has failed. There is no separation sheet or metal cap on the sleepers, and it appears that the membrane has failed and opened and is letting water in. The sleepers should be properly flashed.

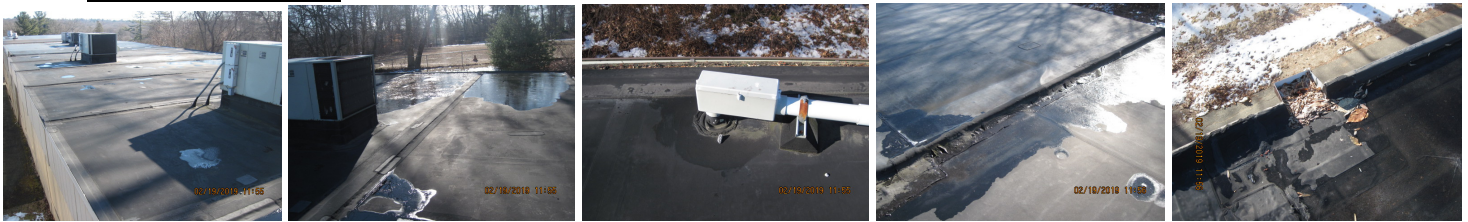
Portable Classrooms

The roofs on the portable classrooms are in poor shape. Laps are starting to peel, curb flashings need to be checked, penetration flashings need to be repaired and scuppers need to be cleaned and checked. To try to prolong the life of this roof, we can clean, prime and overlay all the laps with new EPDM membrane, repair all failing corners, penetration flashings, scuppers, etc., We cannot stop water from ponding on the roof and running over the sides.

Our price to perform the maintenance and repair work to the portable classroom roof is \$ 10,390.00

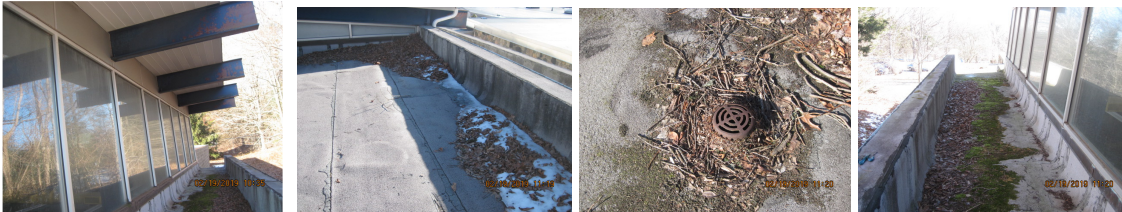
Debris

There are many levels, nooks and crannies on the library roof where leaves and debris have collected. These trap moisture on the roof and clog the drains. The roofs should be cleaned.

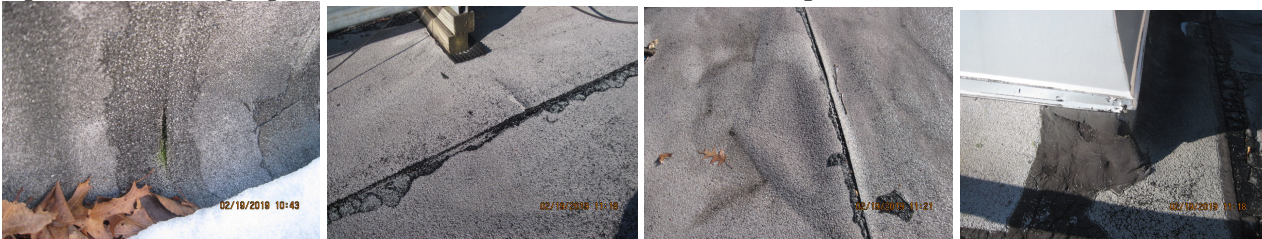
Open base flashing, open fishmouths in the roof membrane and open corners on curbs

We found numerous locations where the laps on the base flashing are starting to pull open. We also saw fishmouths, or lifted areas in the laps in the field membrane and open corners on curbs. These items can let water into the roofing system and should be repaired.

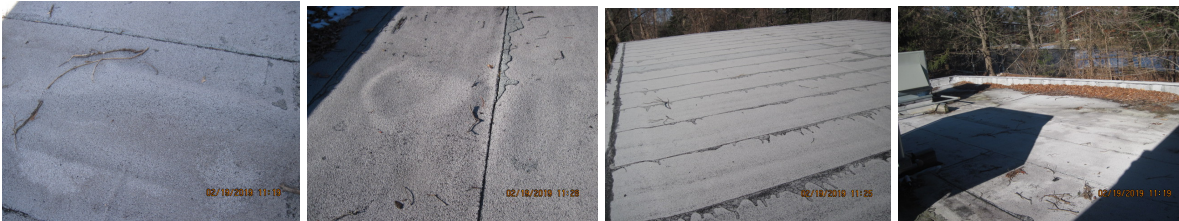
Bubbles and blisters in the roof membrane

There are numerous bubbles or blisters in the roof. If stepped on, they may break and allow water to enter the roof. Blisters become more pronounced in warmer weather. That being said, we saw large blisters on a cold day. Some of the smaller blisters could be left as is, but large ones in traffic areas or by laps should be cut, reset and overlaid with new membrane.

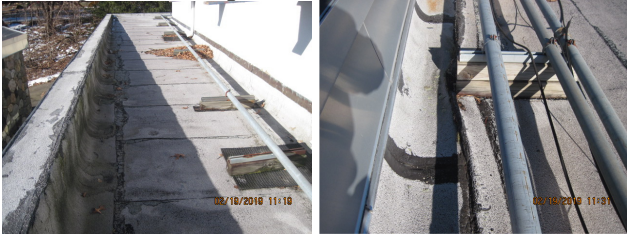
Damage from sleepers

Just as on the EPDM roof, it is important to protect the roof membrane from sleepers and other items laid on the roof. On this roof, some sleepers have separation pads, and some don't. We found one area without pad where the blocking has shifted and pushed the base flashing far enough to eliminate the lap on the field sheet. Slip sheets should be installed and the base flashing repaired where it is damaged.

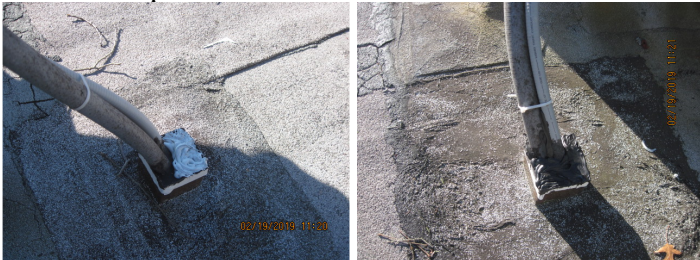
Penetration pockets need to be maintained and periodically "topped off" with new pourable sealer or mastic. If this isn't done, as the filler shrinks with age, it pulls away from the pocket and penetration leaving a pathway for water. The pockets on this roof not only need filling but restriping around the base.

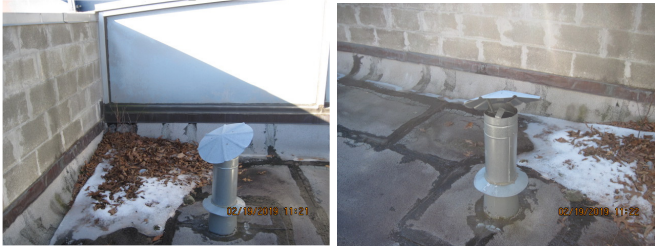
Broken vent caps

Some of the vent caps have been broken. These should be refastened and resecured.
