# **Infrared Thermographic Building Envelope Analysis**

**LOCATION:** Northeast School  
Stamford, CT

**CONDUCTED ON:** April 24, 2019

**PERFORMED BY:** Jeff Demeter, Certified Thermographer

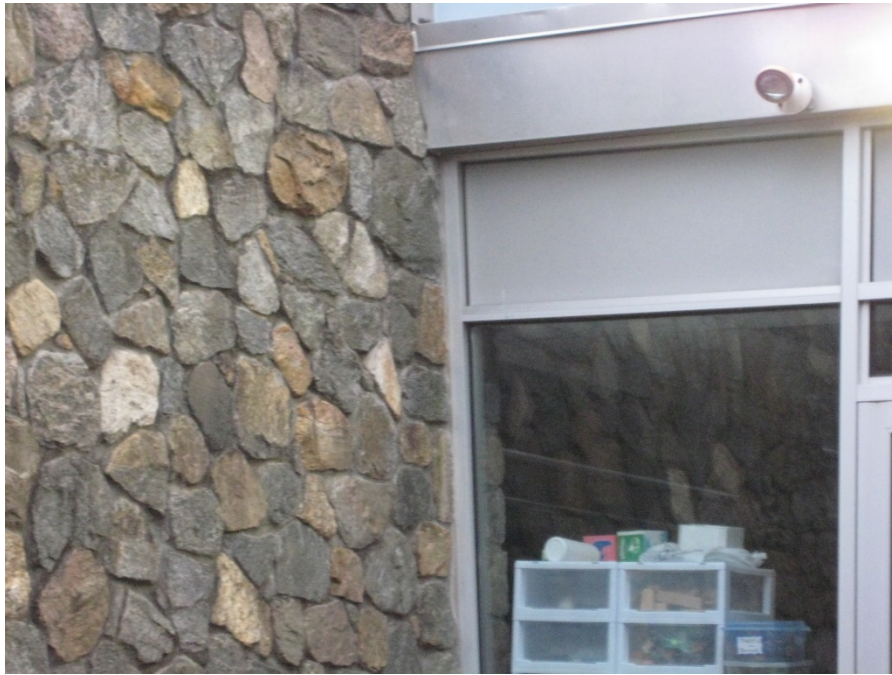
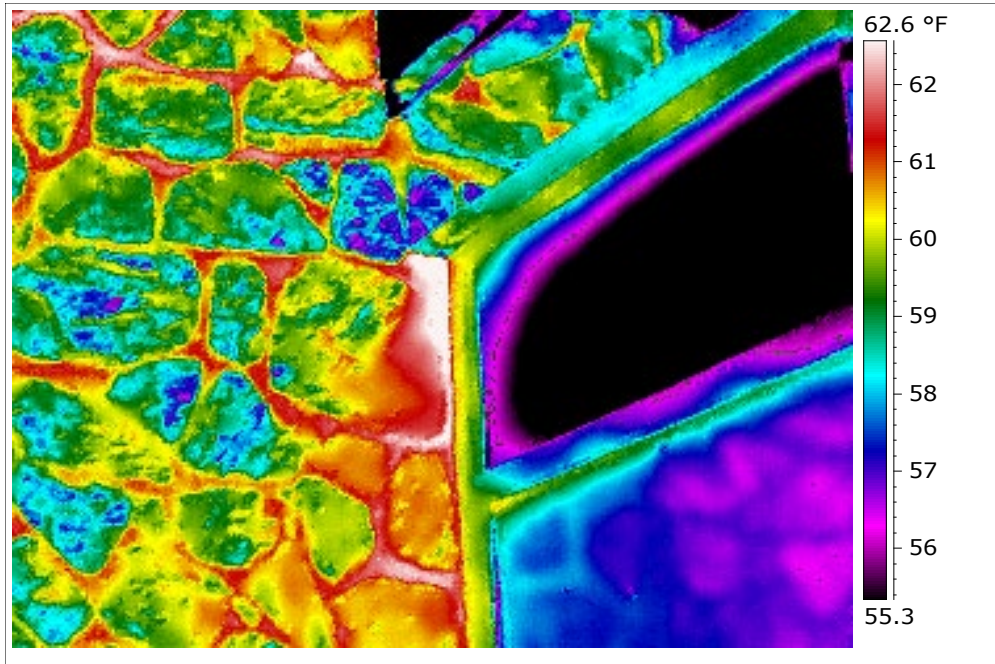
Thermogram # 1

Location of Target: Media Center – Northeast Entrance

Target Shown: Stone wall to metal & glass entrance transition

Problem Category: Air Leakage – exfiltration & Conduction Loss

**WALL** - Overall, the majority of the sidewall area exhibited very good performance with only minor areas of conduction loss. In many of the thermograms, the overall infrared patterns were quite consistent with only occasional and small thermal anomalies. However, there were periods of sunshine during the day preceding the testing and this can have an effect on the imagery. Therefore, in this Thermogram, the temperature increases noted could be at least partially caused by residual solar gain. When construction techniques are relatively uniform throughout a structure, and in situations where solar loading may be a factor, the west, south and east exposures may exhibit increases in temperature related to solar gain, while north elevations will typically be less affected.

**WALL** - When viewed from the outside, warm air exfiltration at leaky building joints and penetrations will appear as warmer temperatures in Thermogram #1. If possible, these sources of warm air exfiltration should be sealed to reduce heating costs and improve occupant comfort. Air movement through narrow gaps can often be corrected with the careful application of high-quality, long-lasting caulking compounds. To seal large gaps it may be necessary to retrofit the leaky joints and penetrations with expanding foam insulation. Ideally, sites of air leakage should be physically investigated from both inside and out, and all gaps should be sealed.

**WALL** - Overall, the majority of the sidewall area exhibited very good performance with only minor areas of conduction loss. In Thermograms #1, 3, 5 & 6, the overall infrared patterns were quite consistent with only occasional and small thermal anomalies. However, there were periods of sunshine during the day preceding the testing and this can have an effect on the imagery. Therefore, in this Thermogram, the temperature increases noted could be at least partially caused by residual solar gain. When construction techniques are relatively uniform throughout a structure, and in situations where solar loading may be a factor, the west, south and east exposures may exhibit increases in temperature related to solar gain, while north elevations will typically be less affected.

Recommendation: **WALL** - When viewed from the outside, warm air exfiltration at leaky building joints and penetrations will appear as warmer temperatures in the thermogram. If possible, these sources of warm air exfiltration should be sealed to reduce heating costs and improve occupant comfort. Air movement through narrow gaps can often be corrected with the careful application of high-quality, long-lasting caulking compounds. To seal large gaps it may be necessary to retrofit the leaky joints and penetrations with expanding foam insulation. Ideally, sites of air leakage should be physically investigated from both inside and out, and all gaps should be sealed.

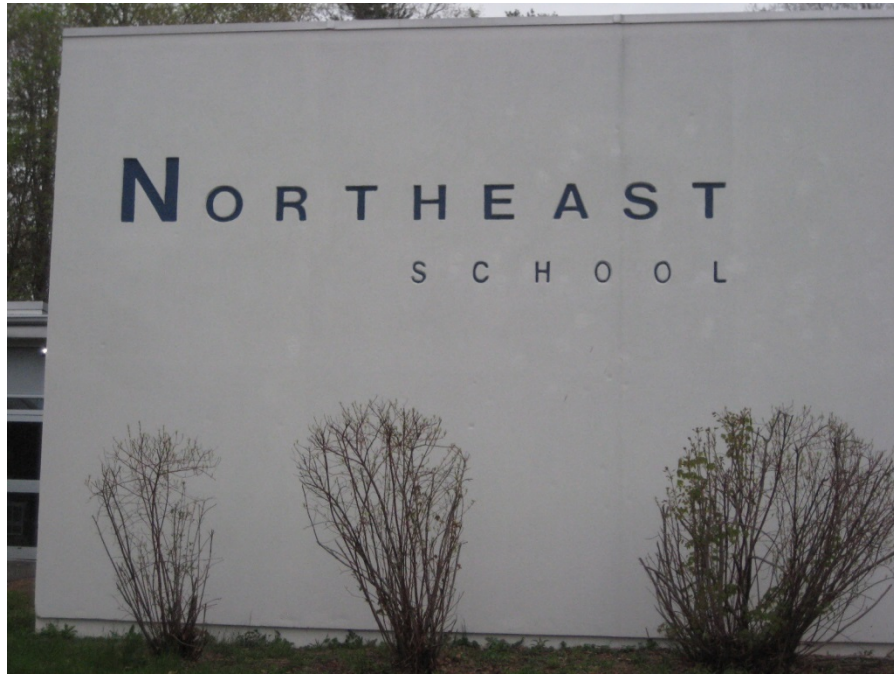
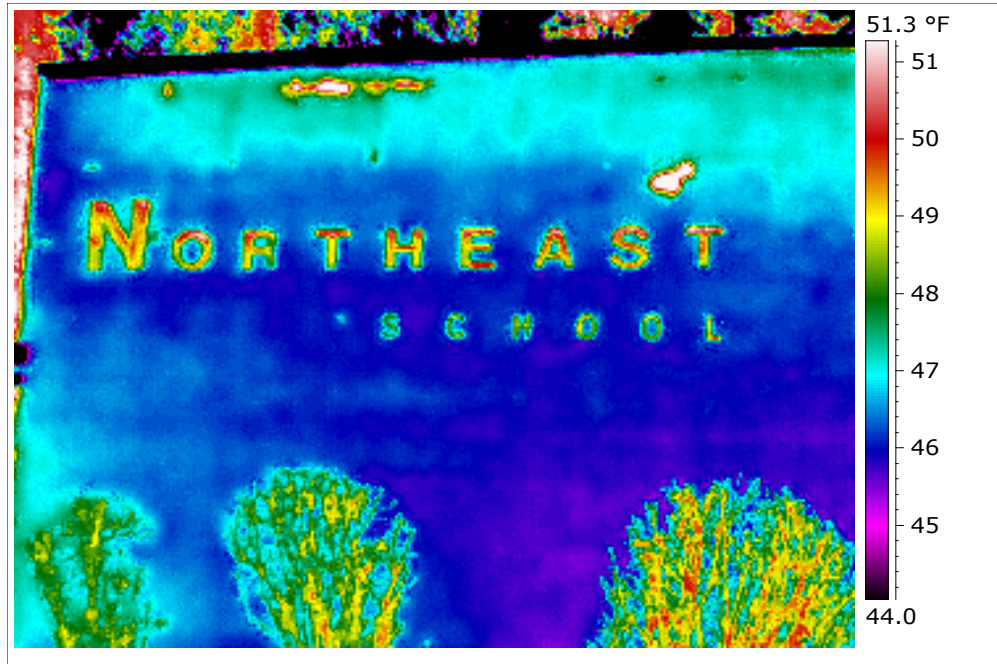
Thermogram # 2

Location of Target: Media Center – East Wall

Target Shown: South portion

Problem Category: Air Leakage – exfiltration & Conduction Loss

**WALL** – Thermogram #2 illustrates areas of the EIFS that have elevated temperatures, typical of moisture damage in the insulation. However, there are other factors beside moisture damage that can create warm thermal anomalies in these systems. For instance, gaps between insulation boards can allow heat to escape from the building even though the insulation is dry. Also,

variations in the application of the insulation and finish can create subtle, but recognizable, temperature differences. Typically, areas with the warmest temperatures are the most likely locations of moisture damage. Areas showing smaller temperature increases (represented by blue, cyan and green) while not as likely to contain significant moisture damage, still should be physically investigated if a thorough analysis is to be performed.

Recommendation: **WALL** - This thermogram illustrates areas of the EIFS that have elevated temperatures, typical of moisture damage in the insulation. However, there are other factors beside moisture damage that can create warm thermal anomalies in these systems. For instance, gaps between insulation boards can allow heat to escape from the building even though the insulation is dry. Also, variations in the application of the insulation and finish can create subtle, but recognizable, temperature differences. Typically, areas with the warmest temperatures are the most likely locations of moisture damage. Areas showing smaller temperature increases (represented by blue, cyan and green) while not as likely to contain significant moisture damage, still should be physically investigated if a thorough analysis is to be performed.

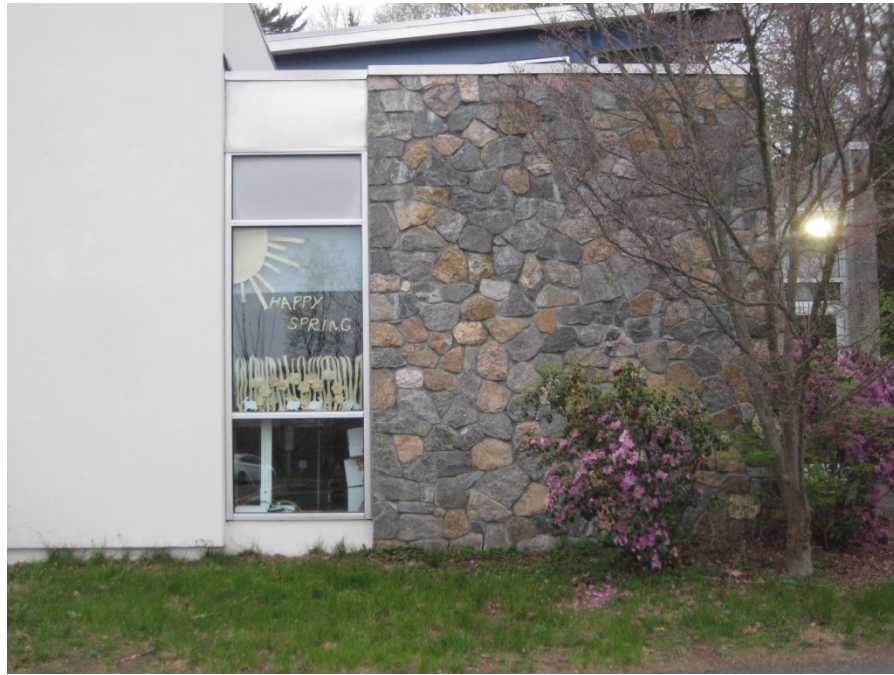
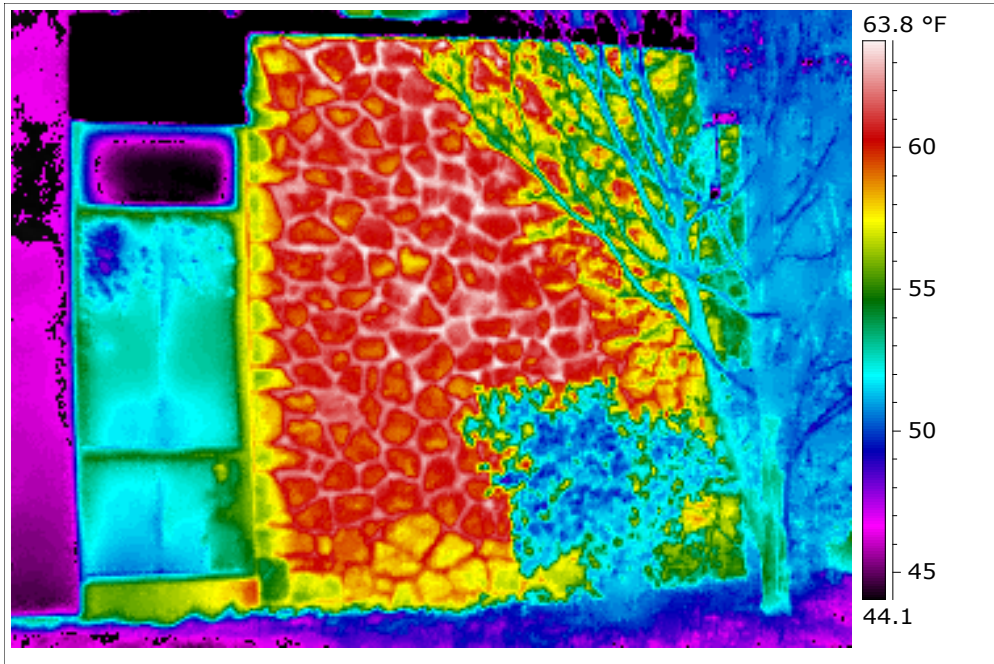
Thermogram # 3

Location of Target: Media Center – East Wall

Target Shown: North portion

Problem Category: Conduction Loss

Recommendation: **WALL** - Overall, the majority of the sidewall area exhibited very good performance with only minor areas of conduction loss. In many of the thermograms, the overall infrared patterns were quite consistent with only occasional and small thermal anomalies. However, there were periods of sunshine during the day preceding the testing and this can have an effect on the imagery. Therefore, in this Thermogram, the temperature increases noted could be at least partially caused by residual solar gain. When construction techniques are relatively uniform throughout a structure, and in situations where solar loading may be a factor, the west, south and east exposures may exhibit increases in temperature related to solar gain, while north elevations will typically be less affected.

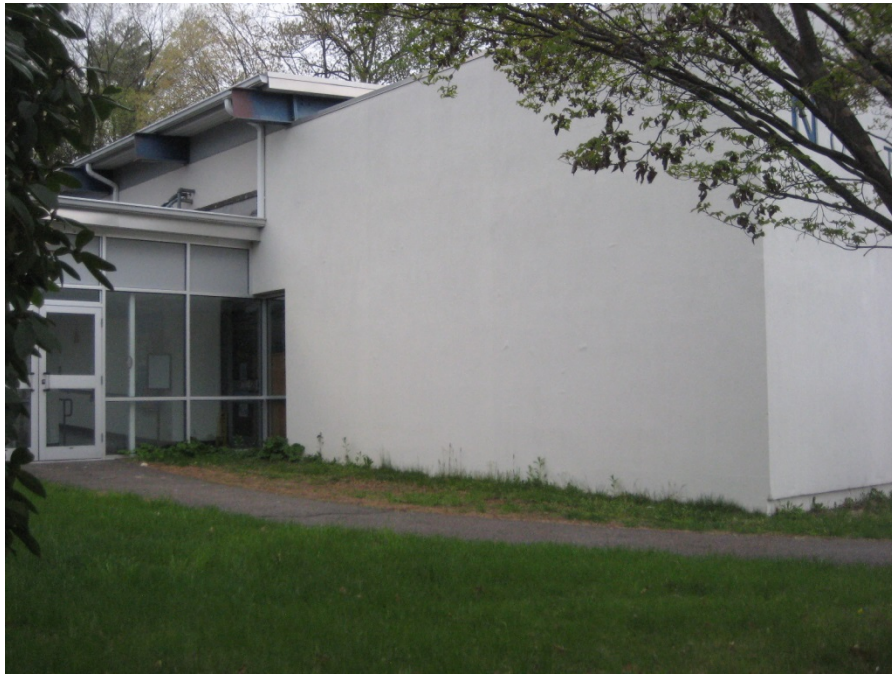
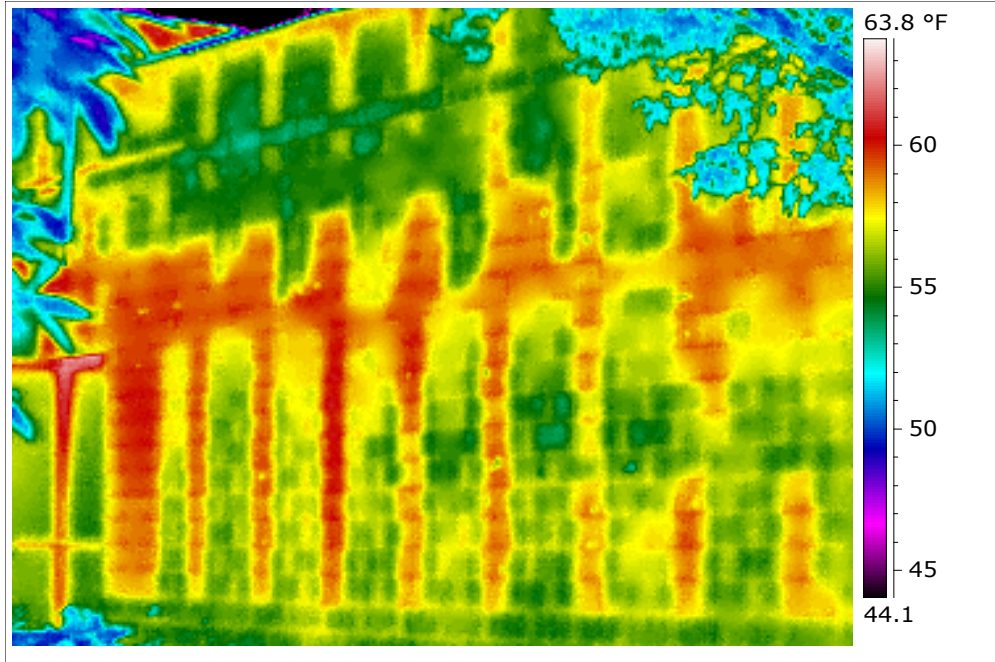
Thermogram # 4

Location of Target: Media Center – Southeast Wall

Target Shown: Most of the wall from glass walkway

Problem Category: Conduction Loss

**WALL** - In Thermograms #4, there is significant conduction losses through the masonry wall in this area. If possible, the construction of this wall should be physically investigated to determine if the wall is insulated, and if the insulation has been properly installed. Although there are significant heat losses here, retrofitting masonry walls often involves substantial expense. There may not be a practical, cost-effective way to reduce these conduction losses. It may be prudent to perform a comprehensive cost-benefit analysis to determine the return on investment (ROI) and advisability of any retrofits designed to reduce these conduction losses.

Recommendation: **WALL** - There are significant conduction losses through the masonry wall in this area. If possible, the construction of this wall should be physically investigated to determine if the wall is insulated, and if the insulation has been properly installed. Although there are significant heat losses here, retrofitting masonry walls often involves substantial expense. There may not be a practical, cost-effective way to reduce these conduction losses. It may be prudent to perform a comprehensive cost-benefit analysis to determine the return on investment (ROI) and advisability of any retrofits designed to reduce these conduction losses.

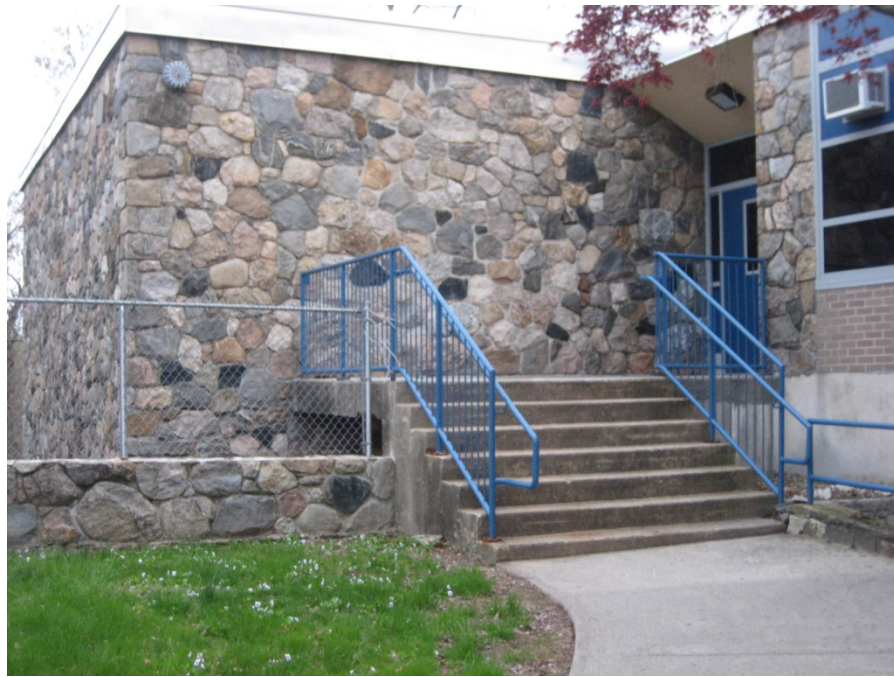
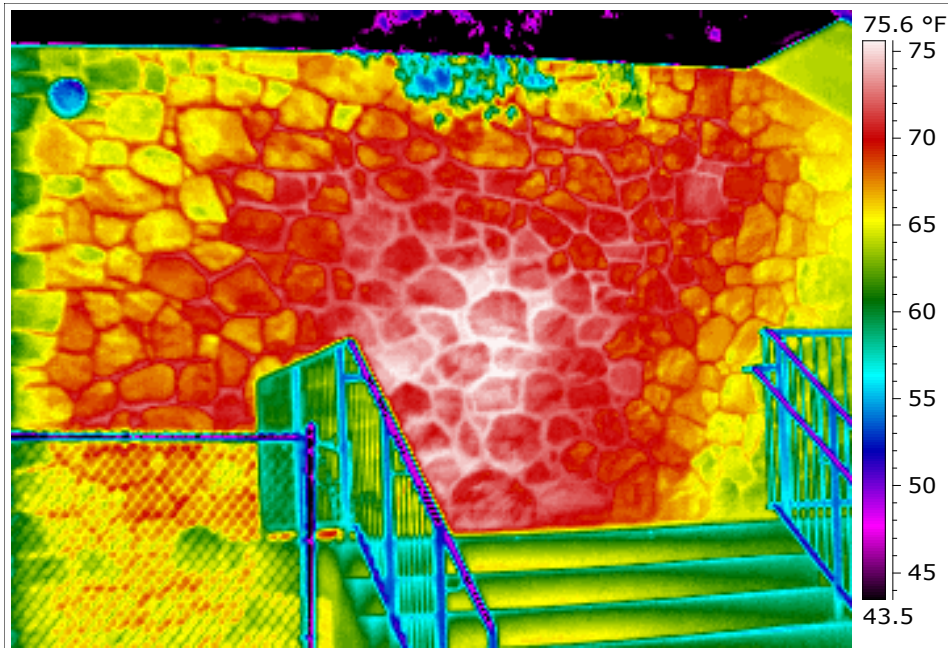
Thermogram # 5

Location of Target: Front of School - Northeast Entrance (Upper)

Target Shown: Wall area by stair landing

Problem Category: Conduction Loss

Recommendation: **WALL** - Overall, the majority of the sidewall area exhibited very good performance with only minor areas of conduction loss. In many of the thermograms, the overall infrared patterns were quite consistent with only occasional and small thermal anomalies. However, there were periods of sunshine during the day preceding the testing and this can have an effect on the imagery. Therefore, in this Thermogram, the temperature increases noted could be at least partially caused by residual solar gain. When construction techniques are relatively uniform throughout a structure, and in situations where solar loading may be a factor, the west, south and east exposures may exhibit increases in temperature related to solar gain, while north elevations will typically be less affected.

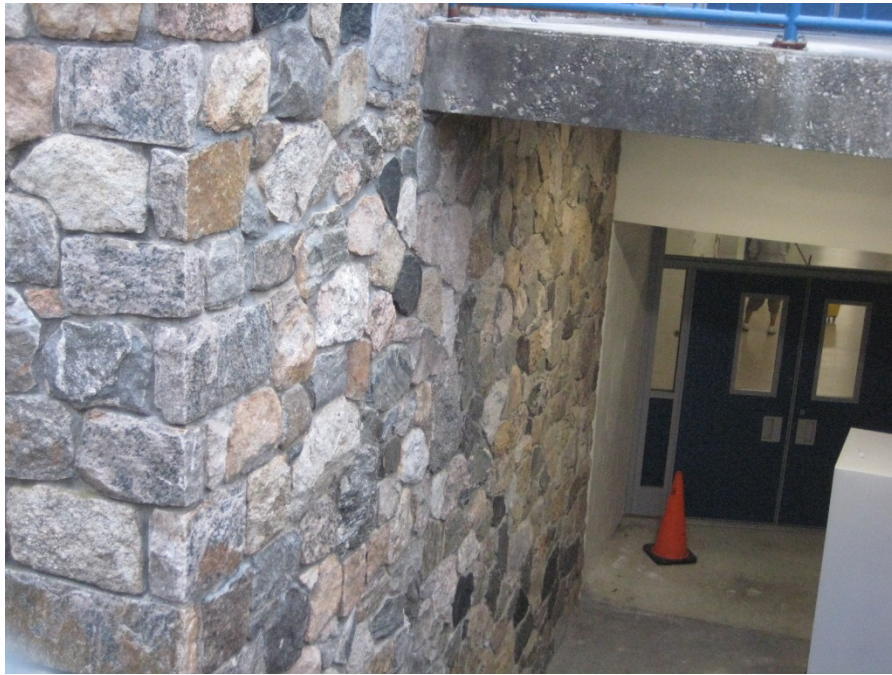
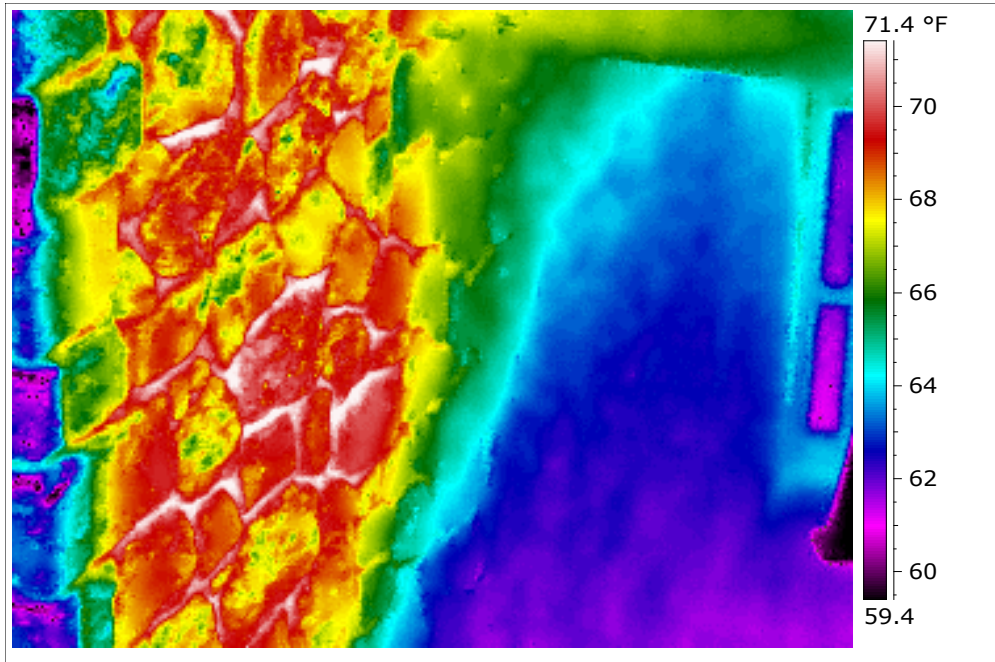
Thermogram # 6

Location of Target: Front of School - Northeast Entrance (Lower)

Target Shown: Wall area by stair landing

Problem Category: Conduction Loss

Recommendation: **WALL** - Overall, the majority of the sidewall area exhibited very good performance with only minor areas of conduction loss. In many of the thermograms, the overall infrared patterns were quite consistent with only occasional and small thermal anomalies. However, there were periods of sunshine during the day preceding the testing and this can have an effect on the imagery. Therefore, in this Thermogram, the temperature increases noted could be at least partially caused by residual solar gain. When construction techniques are relatively uniform throughout a structure, and in situations where solar loading may be a factor, the west, south and east exposures may exhibit increases in temperature related to solar gain, while north elevations will typically be less affected.
