# FACILITIES NEEDS ASSESSMENT

## STAMFORD PUBLIC SCHOOLS

## Facilities Needs Assessment of ROGERS ELEMENTARY SCHOOL

**EMG Project #:** 88166.09R-007.017  
**Date of Report:** August 28, 2009  
**On site Date:** February 19 and 20, 2009

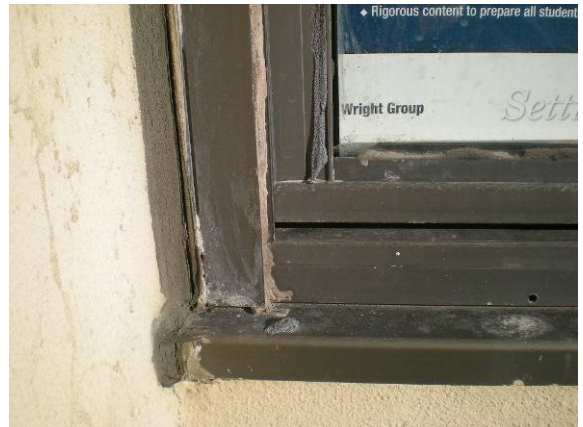
Photo #6: Condition of window sealant and gasket

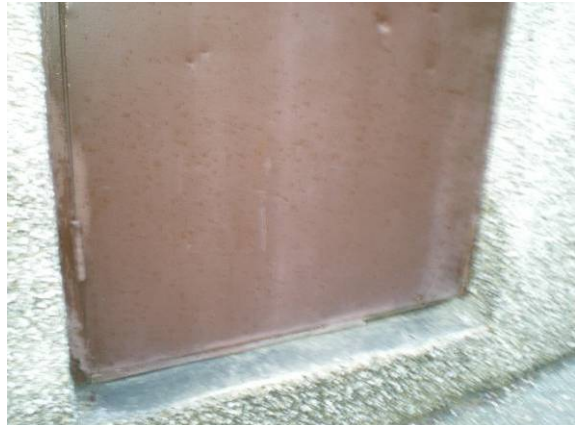
Photo #21:	Condition of small roll up door
------------	---------------------------------

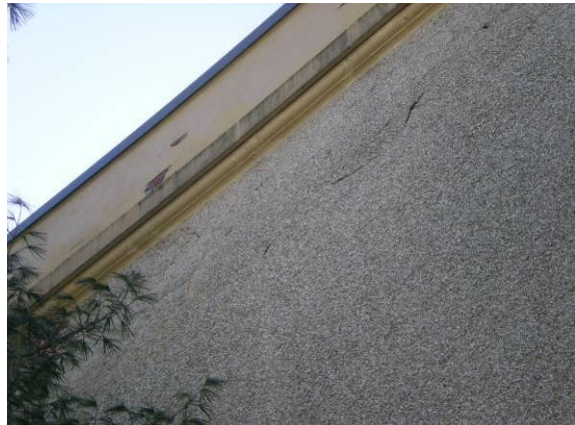
Photo #23:	Spalling at cornice
------------	---------------------

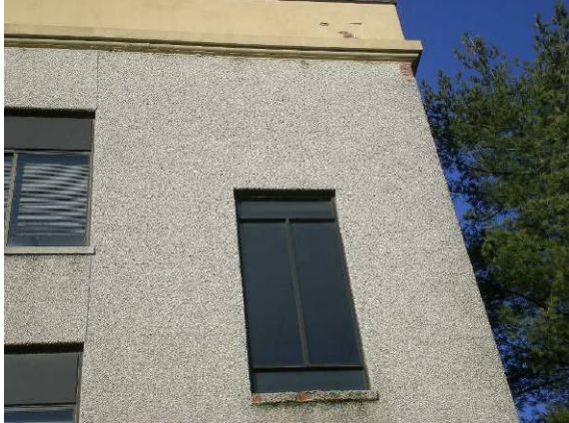
Photo #25: Spalling of heavy skim coat at window sill, elevation and cornice

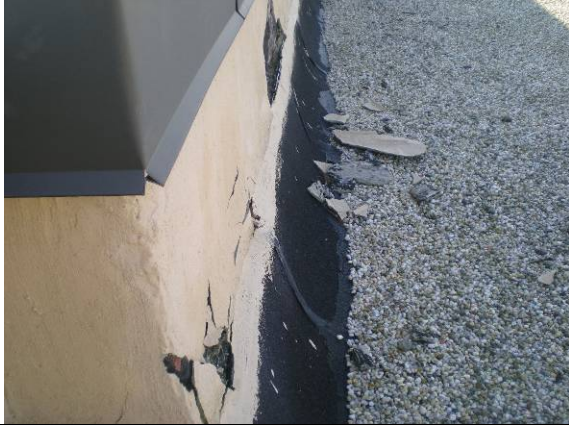
Photo #31:	Spalling at parapet
------------	---------------------

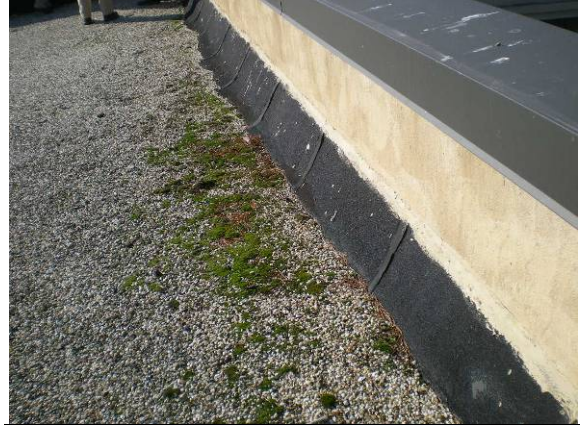
Photo #32:	Moss build up
------------	---------------

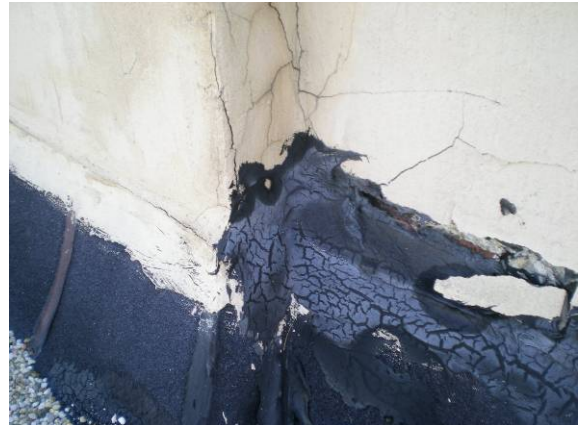
Photo #34:	Cracked roofing compound and coating at parapet
------------	---

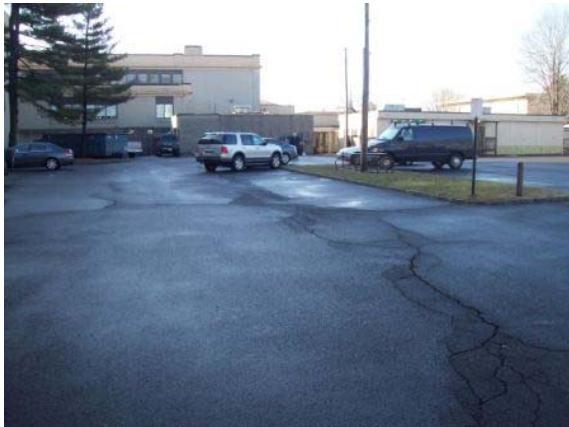
Photo #39: Alligator cracking in north parking lot

5.2	1271	Replace asphalt curbs	10	3	7	270	LF	\$14.63	\$3,950	\$3,950							\$3,950				\$3,950
5.2	1268	Cut & Patch asphalt	10	9	1	800	SF	\$3.86	\$3,084	\$3,084	\$3,084										\$3,084

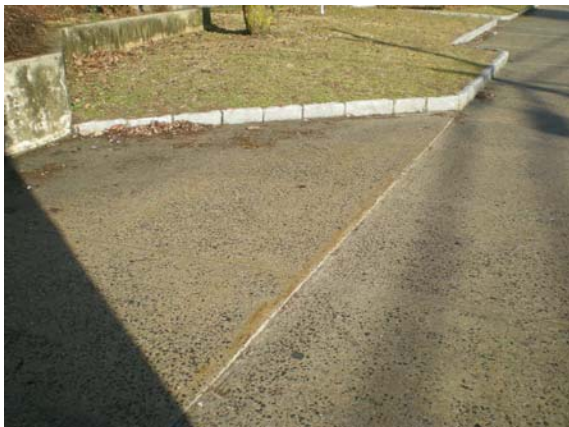
Photo #41: Tripping hazard near main entrance

5.2	1270	Remove & replace 4' wide concrete sidewalk	25	24	1	20	LF	\$40.65	\$813	\$813	\$813										\$813
5.3	5700	Rogers - Site drainage improvement budgetary allowance	0	0	0	1	EA	\$100,800.00	\$100,800	\$100,800											\$100,800

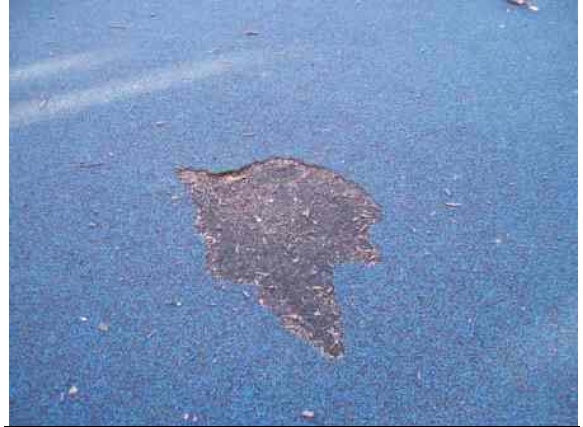
Photo #44: Damage to rubber playground surface

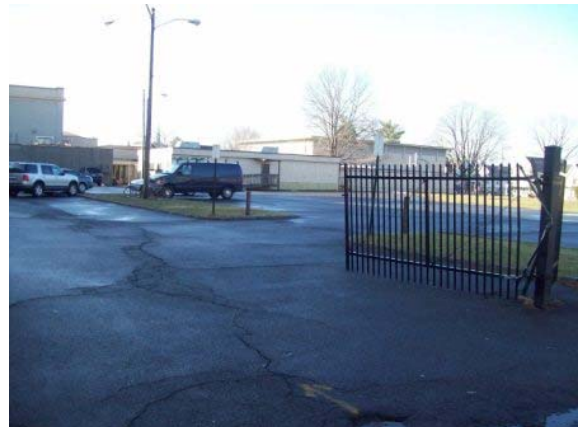
Photo #48: Damaged gate at north entrance

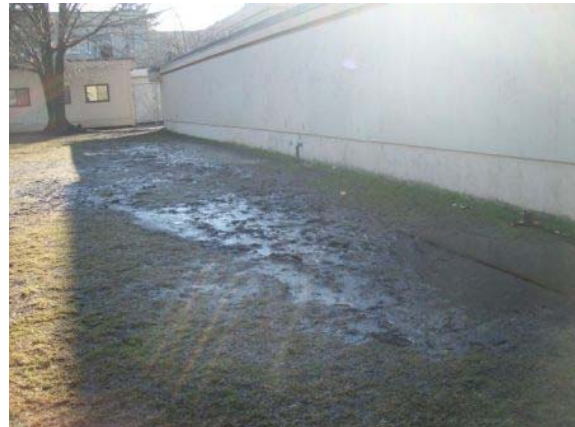
- Maintenance personnel reported inadequate drainage along the west elevation of the building at the visitor parking lot. Flooding reportedly occurs at the entrance doors and heavy ponding occurs along the exterior cafeteria wall during periods of heavy rain. This indicates that the storm drains in the area may have inadequate capacity. It is recommended that a drainage study be performed in order to determine the required drainage capacity recommend any necessary upgrades to prevent ponding and flooding in the area. The cost of the drainage study is included in the Replacement Reserves Report. A budgetary cost allowance to correct drainage concerns is included in the Replacement Reserves Report. The drainage study will determine the appropriate corrective action and estimated cost.

Photo #52: Ponding at adjacent to building near building at soccer field

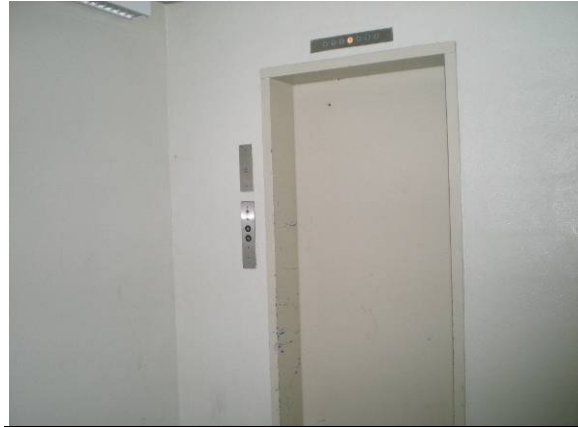
Photo #62: Elevator without Braille on jams

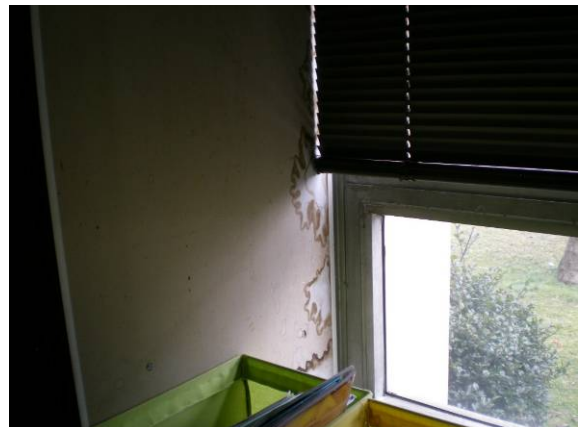
Photo #66: Evidence of water staining due to broken window sealant

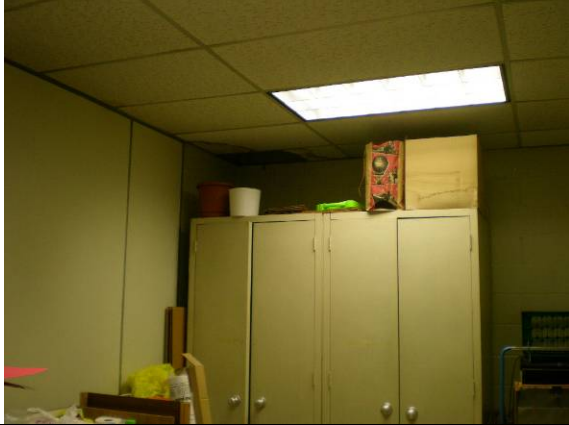
Photo #67: Roof leak off storage area off classroom B1

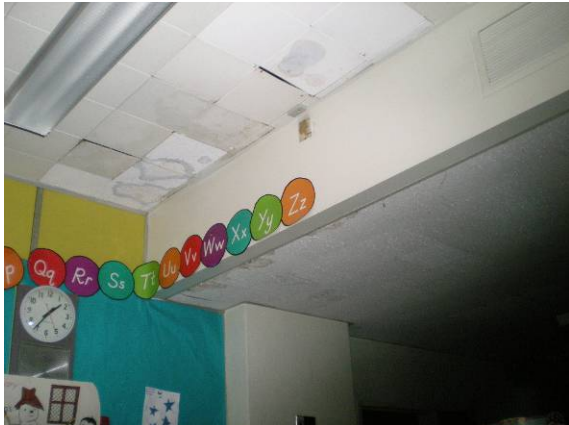
Photo #69: Evidence of leaks

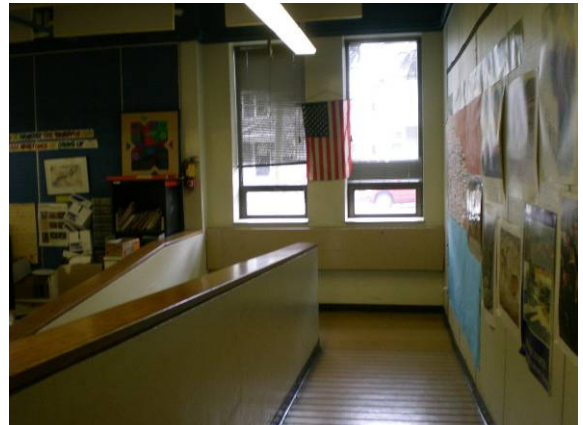
Photo #72: Ramp access to art rooms – no railings

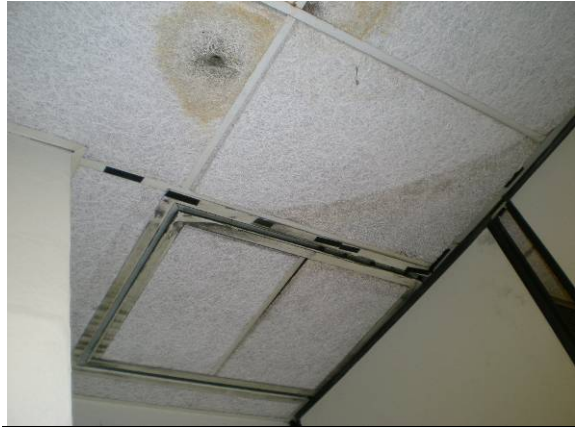
- Based on the numerous locations of isolated suspect mold, a mold assessment should be conducted by a health and safety professional with experience performing microbial investigations. In addition, the source of this moisture should be addressed in order to prevent future mold problems. The estimated costs of corrective action shall be determined as part of the mold assessment recommended. See Section 3.3 for further information. The estimated costs are included in the Replacement Reserves Report.

Photo #74: Suspect mold at ceiling in room off cafeteria

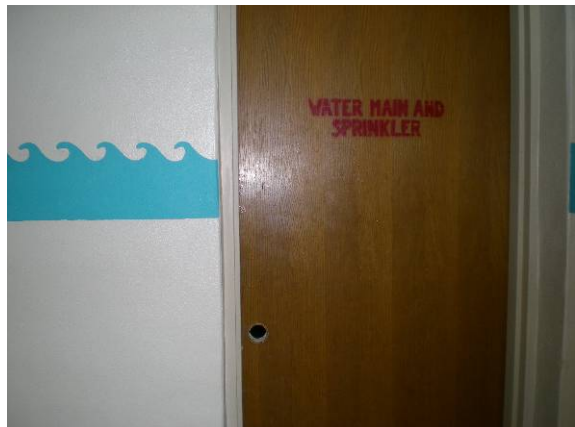
Photo #78: Life safety issue – missing door hardware at sprinkler room

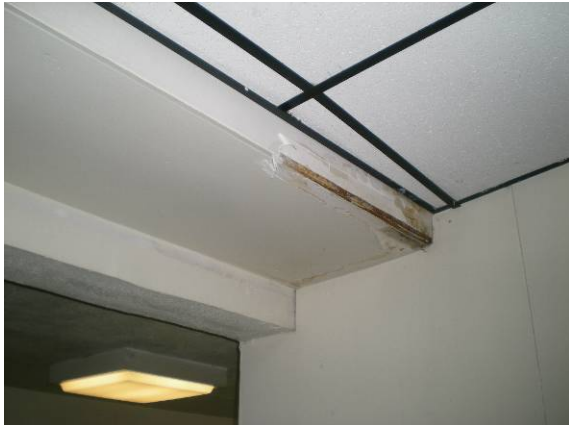
Photo #81: Roof leak at juncture between building and modular wing

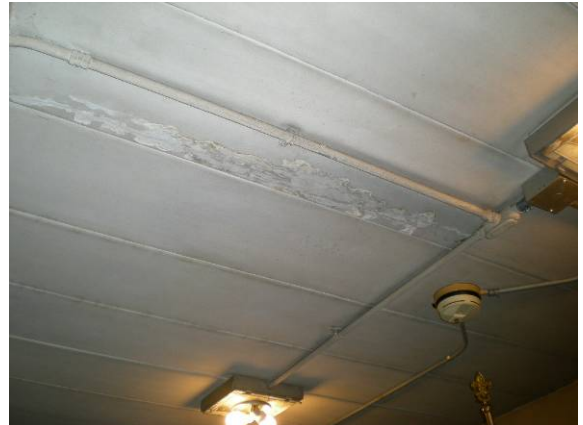
Photo #82: Leaking evidence at area north of gymnasium
