Initial Assessment—Photographic Log

Client: City of Stamford Mold Task Force

Job Number: S-2087-033

Site: Strawberry Hill School

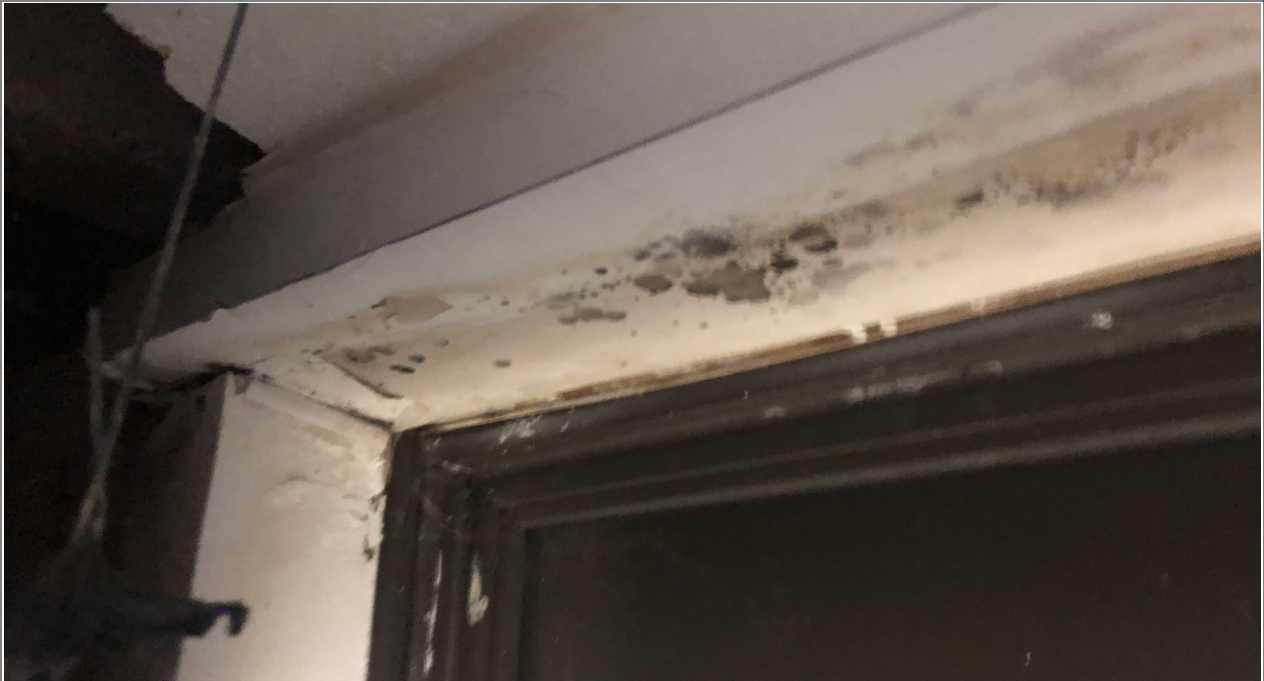
Photograph No.: 3	Date: 11/15/18	Direction Taken: —
Description: Room 403— Mold Growth on Drywall at Window Header

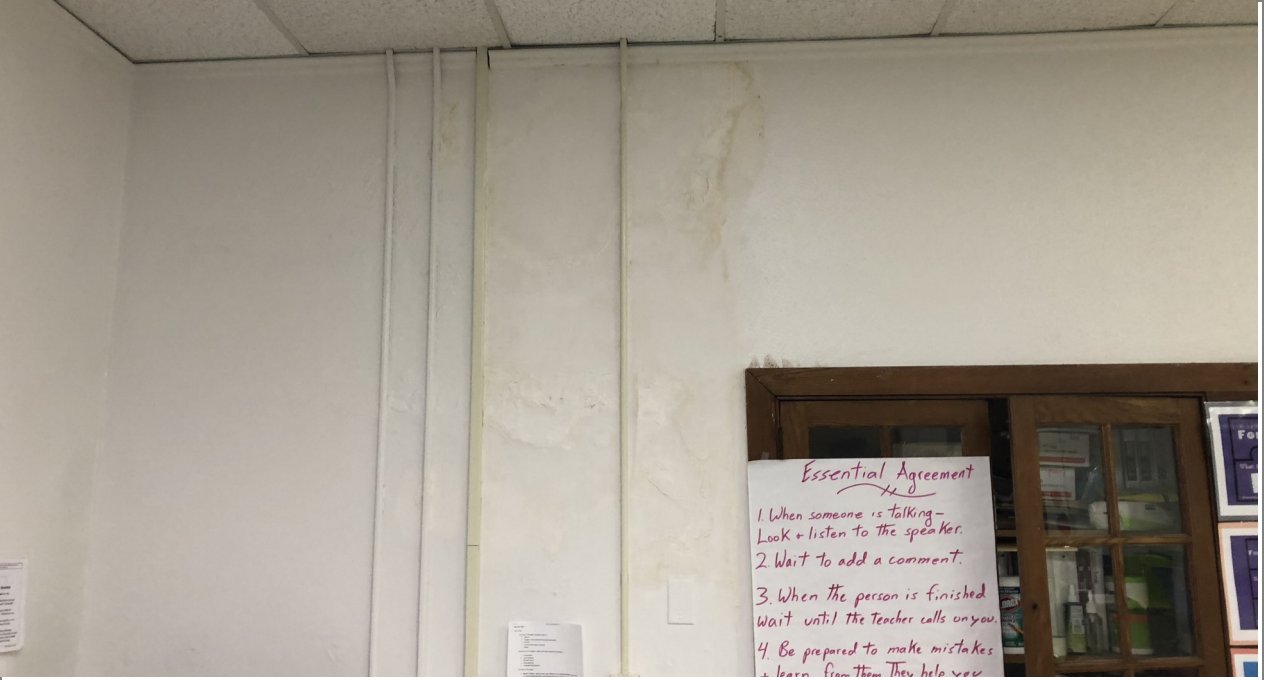
Photograph No.: 4	Date: 11/15/18	Direction Taken: —
Description: Room 405 — Water Damage

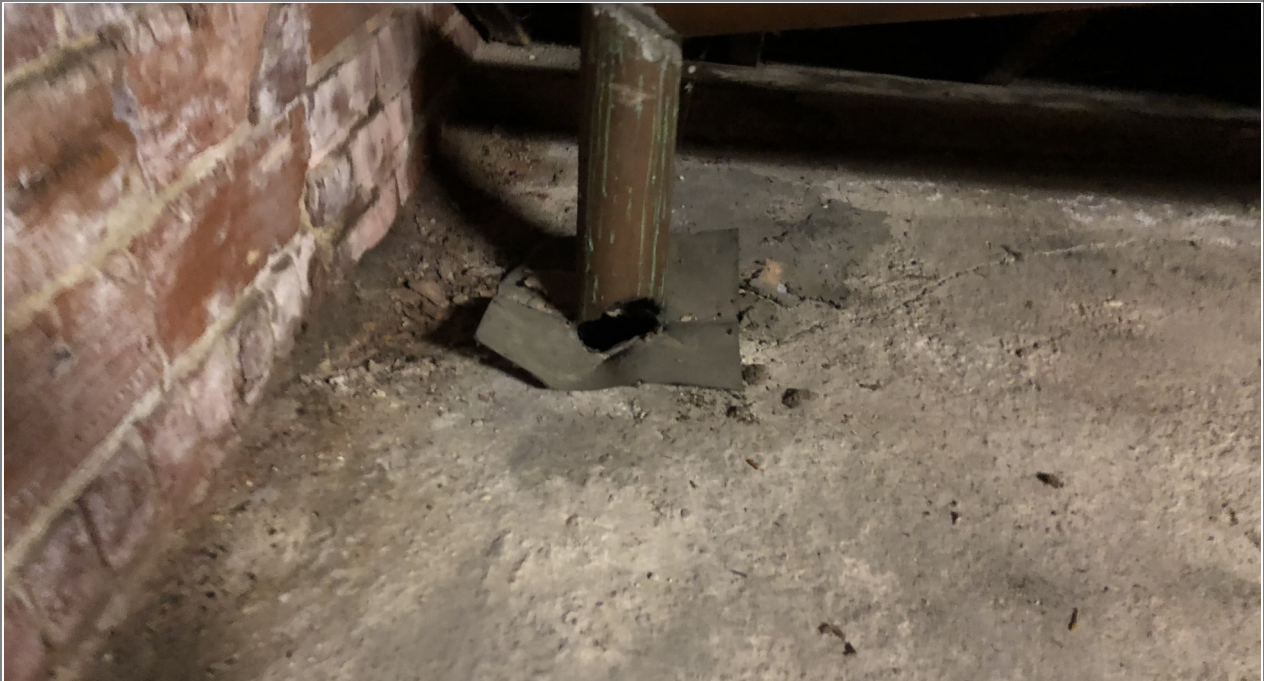
Photograph No.: 5	Date: 11/15/18	Direction Taken: —
Description: Attic above Room 405— Disconnected Roof Drain Piping
