Infrared Thermographic Building Envelope Analysis

LOCATION: Roxbury Elementary
Stamford, CT

CONDUCTED ON: April 17, 2019

This report summarizes the findings of the Infrared Building Envelope Analysis performed at the Roxbury Elementary School, Stamford, CT, performed on April 17, 2019.

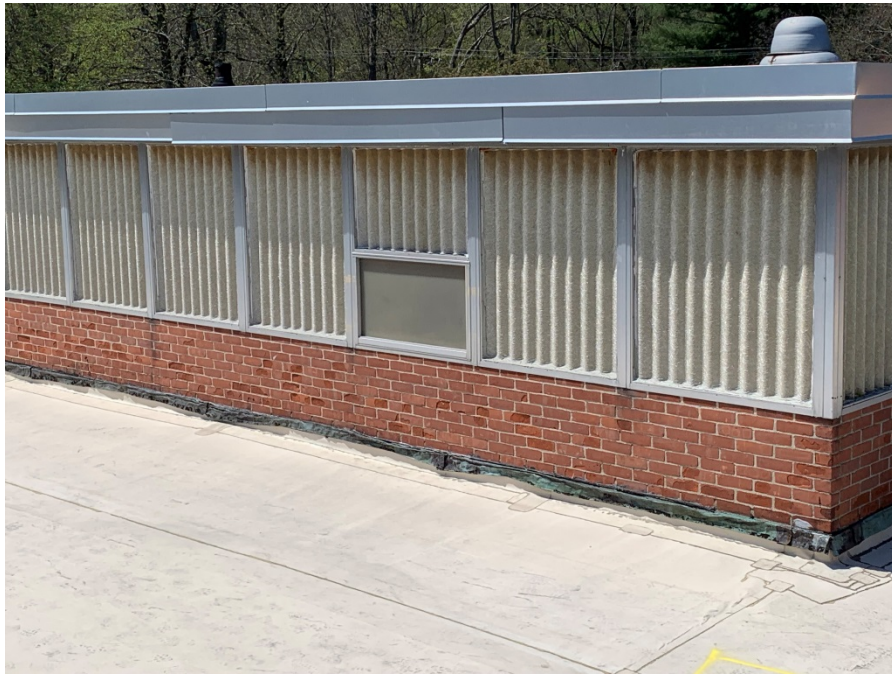
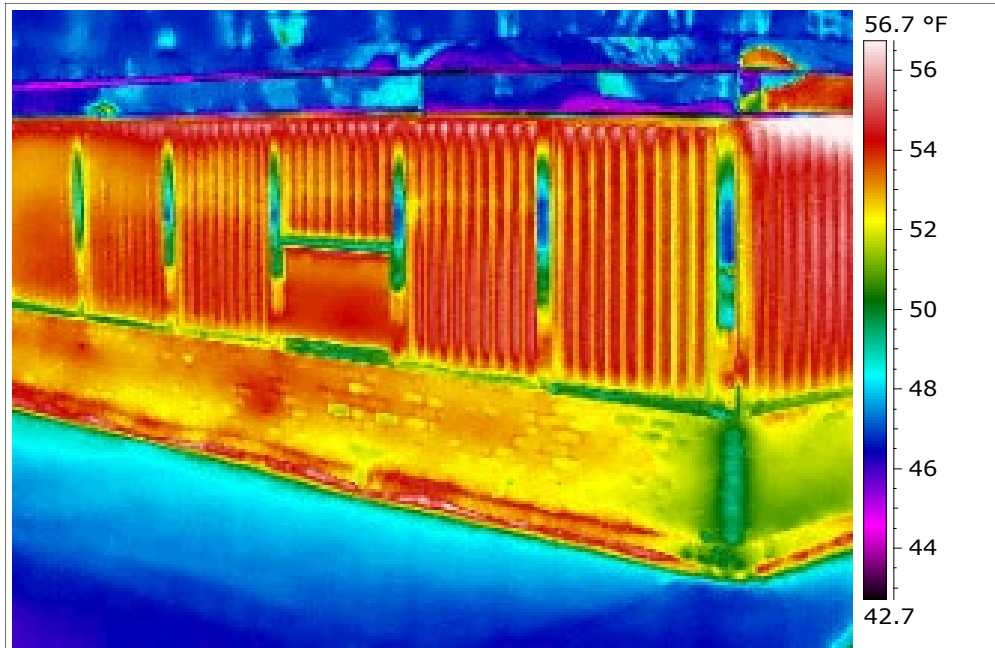
Thermogram # 1

Problem Category: Air Leakage – exfiltration & Conduction Loss

WALL - Overall, the majority of the sidewall area exhibited typical performance with occasional areas of conduction loss through the brick. The overall infrared patterns were quite consistent with only occasional thermal anomalies. However, there were periods of sunshine during the day preceding the testing and this can have an effect on the imagery. Therefore, in this Thermogram, the temperature increases noted on brick wall could be at least partially caused by residual solar gain. When construction techniques are relatively uniform throughout a structure, and in situations where solar loading may be a factor, the west, south and east exposures may exhibit increases in temperature related to solar gain, while north elevations will typically be less affected.

WALL - Overall, the majority of the sidewall area exhibited in Thermograms #1, 2, 5 & 6 show typical performance with occasional areas of conduction loss through the brick. The overall infrared patterns were quite consistent with only occasional thermal anomalies. However, there were periods of sunshine during the day preceding the testing and this can have an effect on the imagery. Therefore, in these Thermograms, the temperature increases noted on brick wall could be at least partially caused by residual solar gain. When construction techniques are relatively uniform throughout a structure, and in situations where solar loading may be a factor, the west, south and east exposures may exhibit increases in temperature related to solar gain, while north elevations will typically be less affected.

Recommendation: **WALL** - There are significant conduction losses through the sidewall in this area. Some of the warmer areas may be caused in part by moisture in the wall materials. If possible, the construction of this wall should be physically investigated to determine if moisture is present or if the wall is insulated, and if the insulation has been properly installed. Although there are significant heat losses here, retrofitting sidewalls can involve substantial expense. There may not be a practical, cost-effective way to reduce these conduction losses. It may be prudent to perform a comprehensive cost-benefit analysis to determine the return on investment (ROI) and advisability of any retrofits designed to reduce these conduction losses.

WALL/ROOF - It appears that there may be both air leakage and conduction at the top of the wall in this area. In order to devise a practical and cost-effective retrofit, a thorough physical examination of the joints and penetrations near the top of the building should be performed. High-quality long-lasting materials (e.g. caulking, backer rod, expanding foam insulation, etc) should be employed to reduce or eliminate any gaps allowing warm air exfiltration. Reducing these air leakage losses will result in increased occupant comfort and lowered heating costs. Any areas of poorly installed or insufficient insulation could also be addressed at this time.

WALL/ROOF - It appears that there may be both air leakage and conduction at the top of the wall in Thermograms #1, 3, 4, 5 & 6. In order to devise a practical and cost-effective retrofit, a thorough physical examination of the joints and penetrations near the top of the building should be performed. High-quality long-lasting materials (e.g. caulking, backer rod, expanding foam insulation, etc) should be employed to reduce or eliminate any gaps allowing warm air exfiltration. Reducing these air leakage losses will result in increased occupant comfort and

WALL – In Thermograms #1 – 6, there are significant conduction losses through the sidewall in these areas. Some of the warmer areas may be caused in part by moisture in the wall materials. If possible, the construction of this wall should be physically investigated to determine if moisture is present or if the wall is insulated, and if the insulation has been properly installed. Although there are significant heat losses here, retrofitting sidewalls can involve substantial expense. There may not be a practical, cost-effective way to reduce these conduction losses. It may be prudent to perform a comprehensive cost-benefit analysis to determine the return on investment (ROI) and advisability of any retrofits designed to reduce these conduction losses.

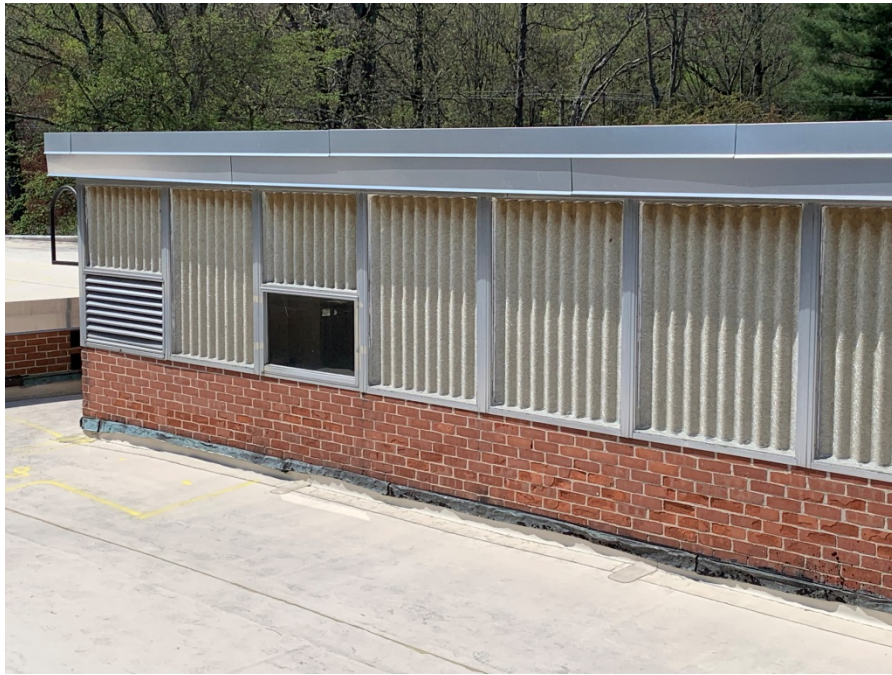
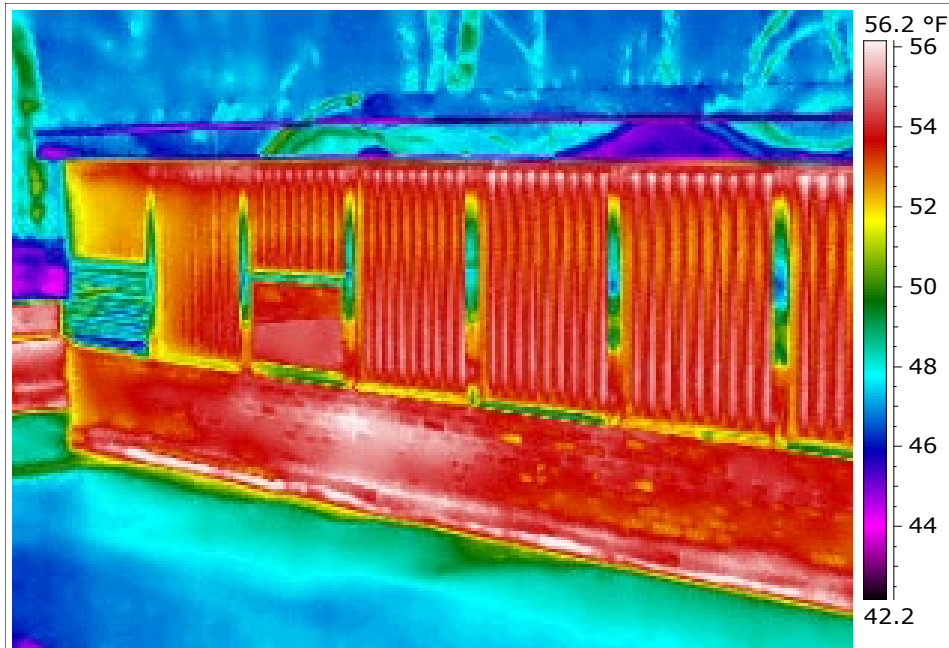
Thermogram # 2

Problem Category: Air Leakage – exfiltration & Conduction Loss

WALL - Overall, the majority of the sidewall area exhibited typical performance with occasional areas of conduction loss through the brick. The overall infrared patterns were quite consistent with only occasional thermal anomalies. However, there were periods of sunshine during the day preceding the testing and this can have an effect on the imagery. Therefore, in this Thermogram, the temperature increases noted on brick wall could be at least partially caused by residual solar gain. When construction techniques are relatively uniform throughout a structure, and in situations where solar loading may be a factor, the west, south and east exposures may exhibit increases in temperature related to solar gain, while north elevations will typically be less affected.

Recommendation: **WALL** - There are significant conduction losses through the sidewall in this area. Some of the warmer areas may be caused in part by moisture in the wall materials. If possible, the construction of this wall should be physically investigated to determine if moisture is present or if the wall is insulated, and if the insulation has been properly installed. Although there are significant heat losses here, retrofitting sidewalls can involve substantial expense. There may not be a practical, cost-effective way to reduce these conduction losses. It may be prudent to perform a comprehensive cost-benefit analysis to determine the return on investment (ROI) and advisability of any retrofits designed to reduce these conduction losses.

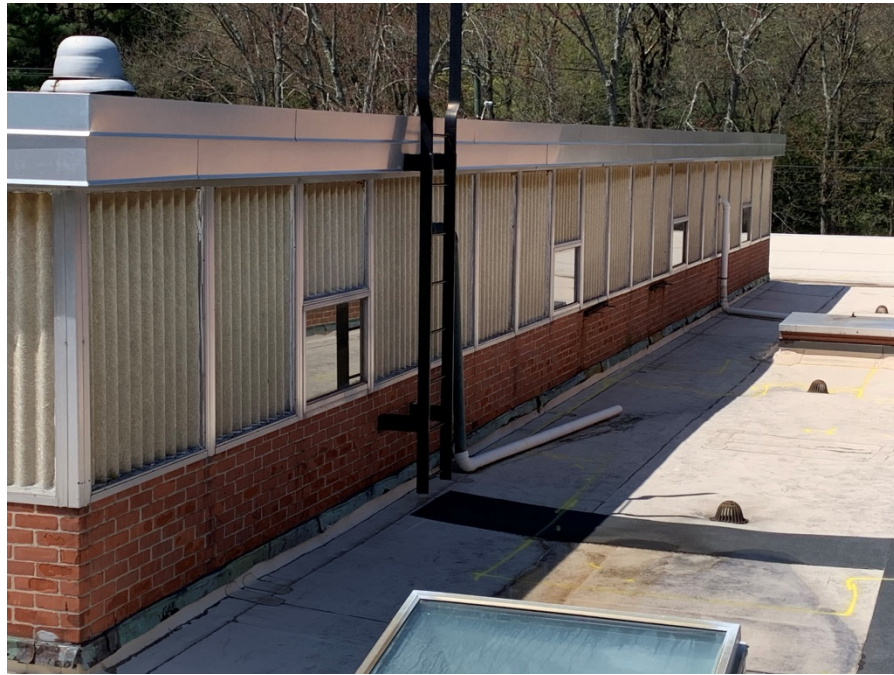
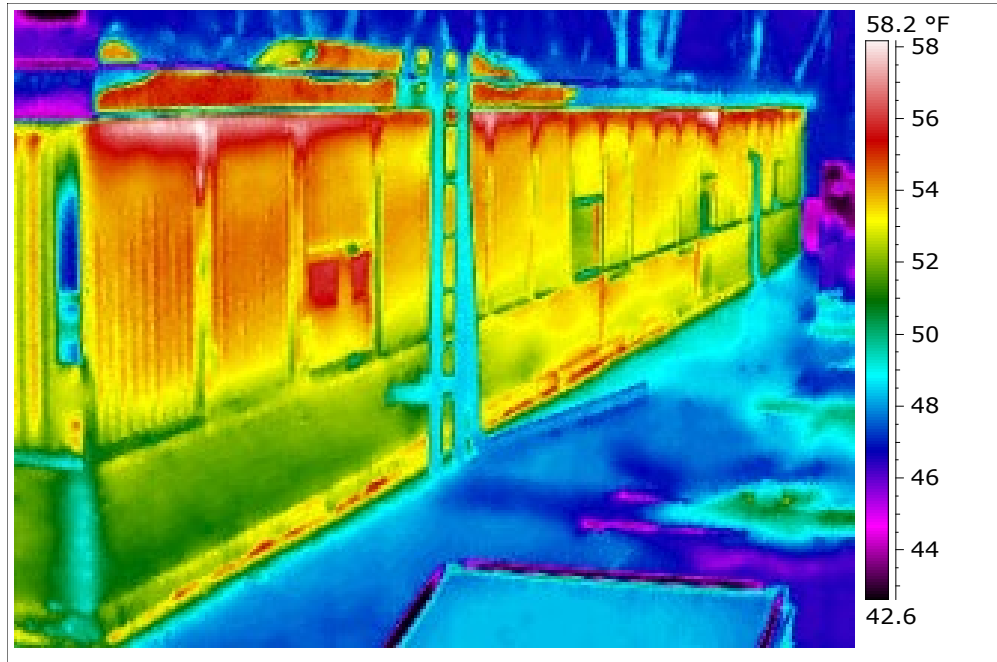
Thermogram # 3

Problem Category: Air Leakage – exfiltration & Conduction Loss

Recommendation: WALL - There are significant conduction losses through the sidewall in this area. Some of the warmer areas may be caused in part by moisture in the wall materials. If possible, the construction of this wall should be physically investigated to determine if moisture is present or if the wall is insulated, and if the insulation has been properly installed. Although there are significant heat losses here, retrofitting sidewalls can involve substantial expense. There may not be a practical, cost-effective way to reduce these conduction losses. It may be prudent to perform a comprehensive cost-benefit analysis to determine the return on investment (ROI) and advisability of any retrofits designed to reduce these conduction losses.

WALL/ROOF - It appears that there may be both air leakage and conduction loss in this area. In order to devise a practical and cost-effective retrofit, a thorough physical examination of the joints and penetrations near the top of the building should be performed. High-quality long-lasting materials (e.g. caulking, backer rod, expanding foam insulation, etc) should be employed to reduce or eliminate any gaps allowing warm air exfiltration. Reducing these air leakage losses will result in increased occupant comfort and lowered heating costs. Any areas of poorly installed or insufficient insulation could also be addressed at this time.

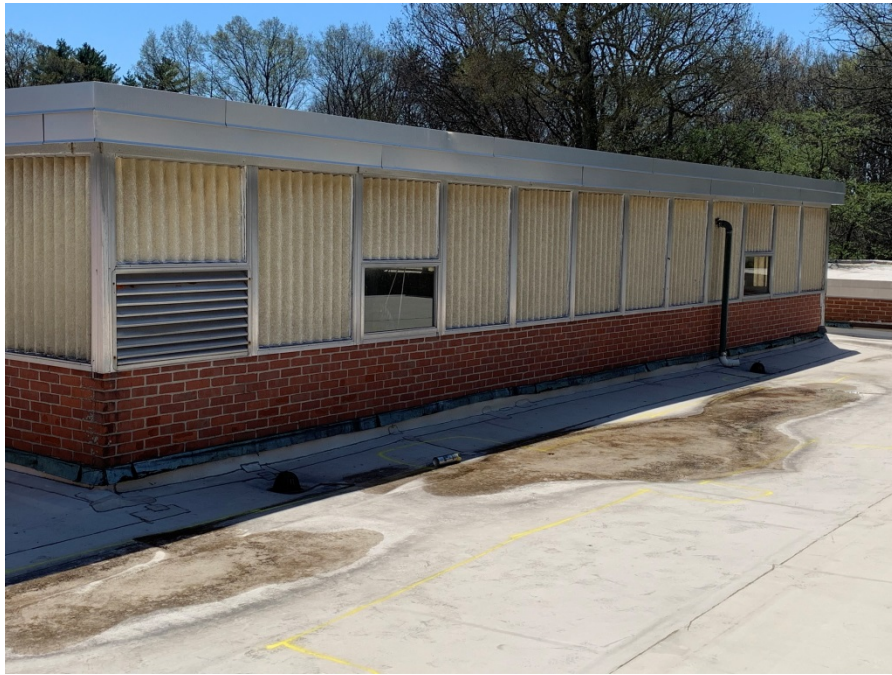
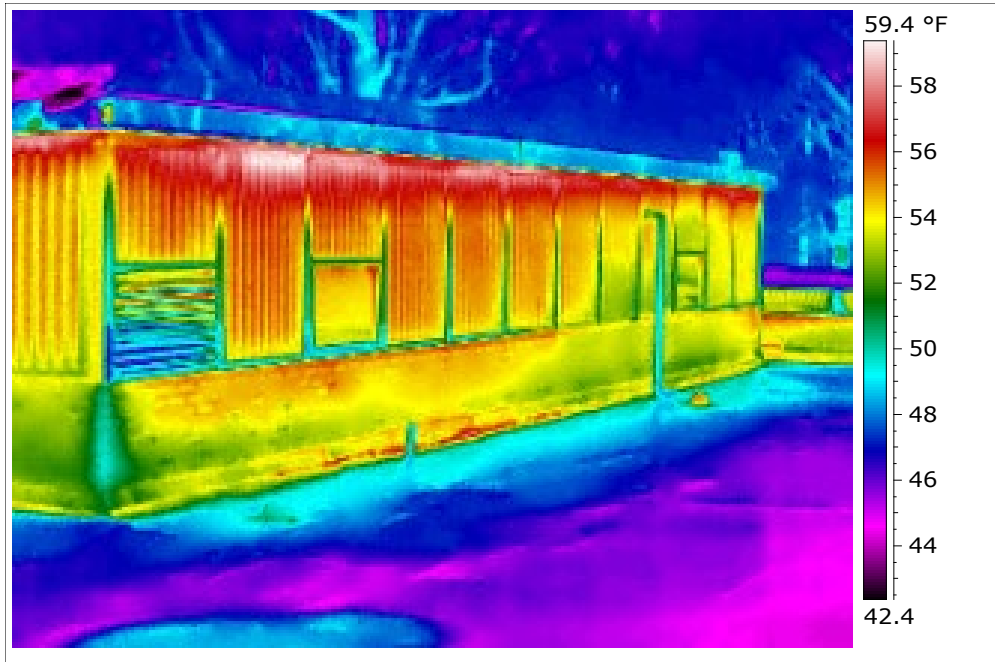
Thermogram # 4

Problem Category: Air Leakage – exfiltration & Conduction Loss

Recommendation: WALL - There are significant conduction losses through the sidewall in this area. Some of the warmer areas may be caused in part by moisture in the wall materials. If possible, the construction of this wall should be physically investigated to determine if moisture is present or if the wall is insulated, and if the insulation has been properly installed. Although there are significant heat losses here, retrofitting sidewalls can involve substantial expense. There may not be a practical, cost-effective way to reduce these conduction losses. It may be prudent to perform a comprehensive cost-benefit analysis to determine the return on investment (ROI) and advisability of any retrofits designed to reduce these conduction losses.

WALL/ROOF - It appears that there may be both air leakage and conduction loss in this area. In order to devise a practical and cost-effective retrofit, a thorough physical examination of the joints and penetrations near the top of the building should be performed. High-quality long-lasting materials (e.g. caulking, backer rod, expanding foam insulation, etc) should be employed to reduce or eliminate any gaps allowing warm air exfiltration. Reducing these air leakage losses will result in increased occupant comfort and lowered heating costs. Any areas of poorly installed or insufficient insulation could also be addressed at this time.

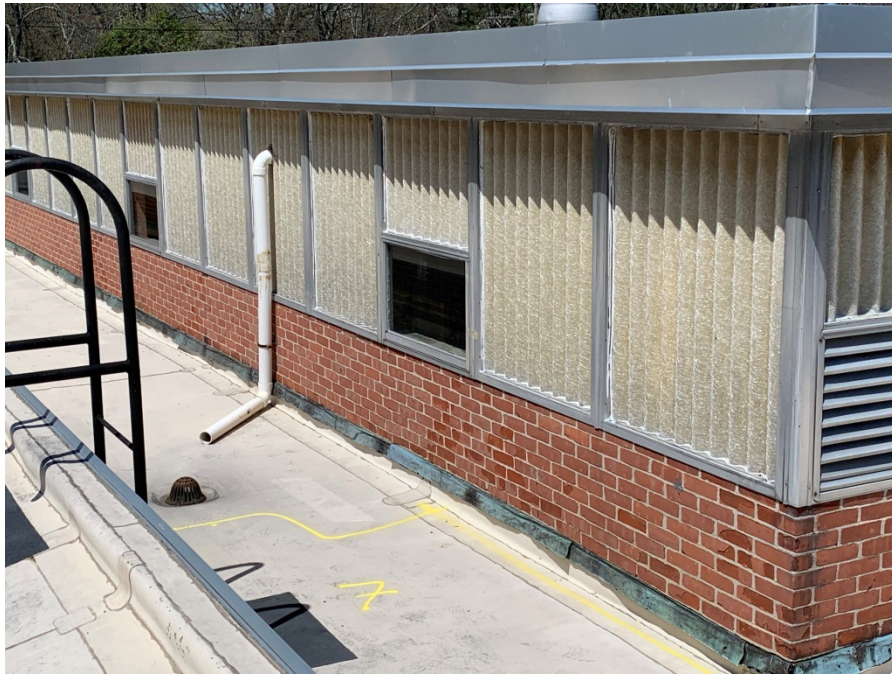
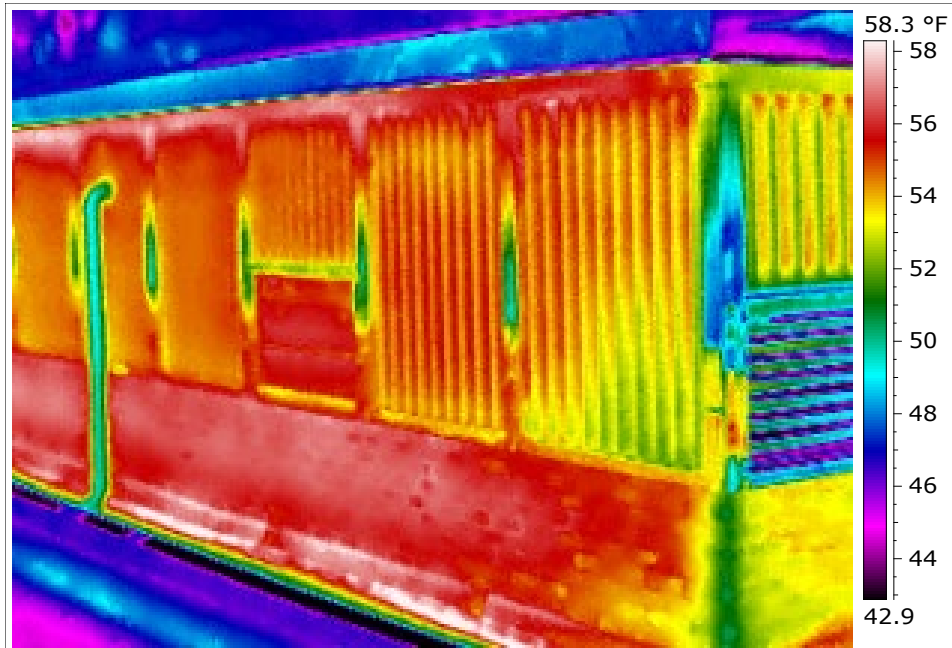
Thermogram # 5

Problem Category: Air Leakage – exfiltration & Conduction Loss

WALL - Overall, the majority of the sidewall area exhibited typical performance with occasional areas of conduction loss through the brick. The overall infrared patterns were quite consistent with only occasional thermal anomalies. However, there were periods of sunshine during the day preceding the testing and this can have an effect on the imagery. Therefore, in this Thermogram, the temperature increases noted on brick wall could be at least partially caused by residual solar gain. When construction techniques are relatively uniform throughout a structure, and in situations where solar loading may be a factor, the west, south and east exposures may exhibit increases in temperature related to solar gain, while north elevations will typically be less affected.

Recommendation: WALL - There are significant conduction losses through the sidewall in this area. Some of the warmer areas may be caused in part by moisture in the wall materials. If possible, the construction of this wall should be physically investigated to determine if moisture is present or if the wall is insulated, and if the insulation has been properly installed. Although there are significant heat losses here, retrofitting sidewalls can involve substantial expense. There may not be a practical, cost-effective way to reduce these conduction losses. It may be prudent to perform a comprehensive cost-benefit analysis to determine the return on investment (ROI) and advisability of any retrofits designed to reduce these conduction losses.

WALL/ROOF - It appears that there may be both air leakage and conduction at the top of the wall in this area. In order to devise a practical and cost-effective retrofit, a thorough physical examination of the joints and penetrations near the top of the building should be performed. High-quality long-lasting materials (e.g. caulking, backer rod, expanding foam insulation, etc) should be employed to reduce or eliminate any gaps allowing warm air exfiltration. Reducing these air leakage losses will result in increased occupant comfort and lowered heating costs. Any areas of poorly installed or insufficient insulation could also be addressed at this time.

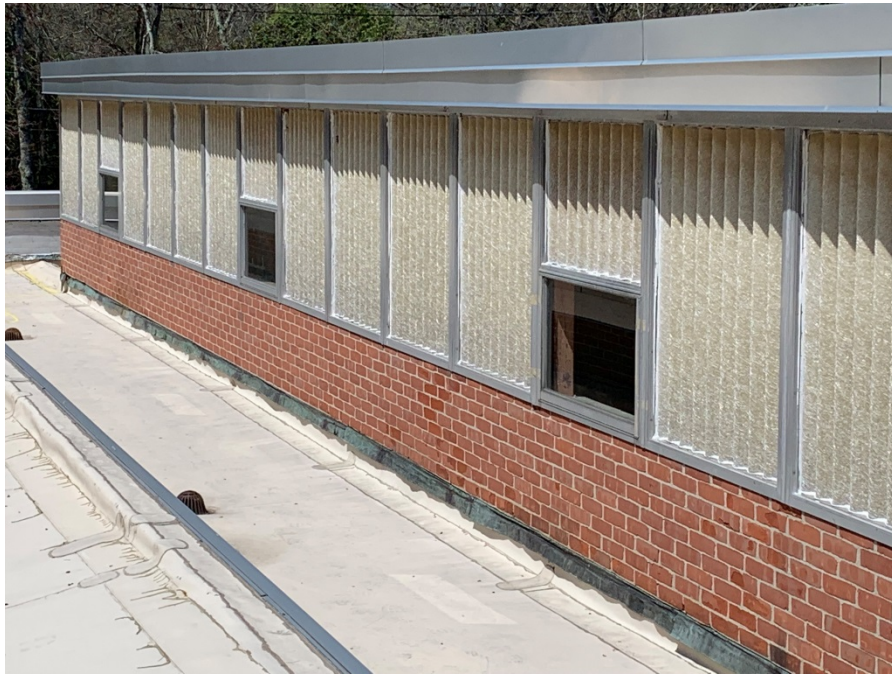
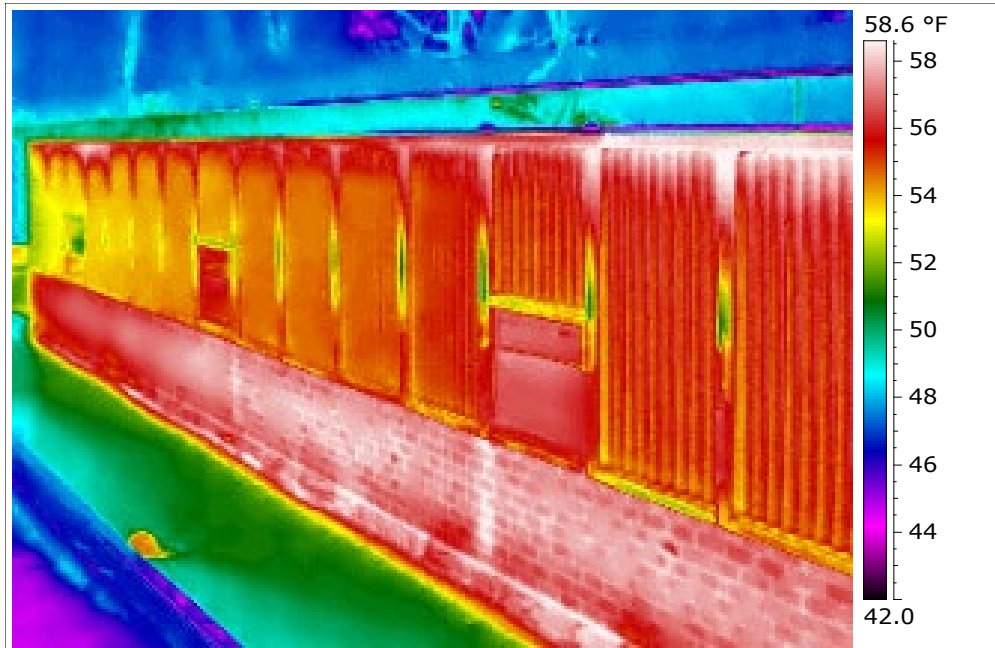
Thermogram # 6

Problem Category: Air Leakage – exfiltration & Conduction Loss

WALL - Overall, the majority of the sidewall area exhibited typical performance with occasional areas of conduction loss through the brick. The overall infrared patterns were quite consistent with only occasional thermal anomalies. However, there were periods of sunshine during the day preceding the testing and this can have an effect on the imagery. Therefore, in this Thermogram, the temperature increases noted on brick wall could be at least partially caused by residual solar gain. When construction techniques are relatively uniform throughout a structure, and in situations where solar loading may be a factor, the west, south and east exposures may exhibit increases in temperature related to solar gain, while north elevations will typically be less affected.

Recommendation: WALL - There are significant conduction losses through the sidewall in this area. Some of the warmer areas may be caused in part by moisture in the wall materials. If possible, the construction of this wall should be physically investigated to determine if moisture is present or if the wall is insulated, and if the insulation has been properly installed. Although there are significant heat losses here, retrofitting sidewalls can involve substantial expense. There may not be a practical, cost-effective way to reduce these conduction losses. It may be prudent to perform a comprehensive cost-benefit analysis to determine the return on investment (ROI) and advisability of any retrofits designed to reduce these conduction losses.

WALL/ROOF - It appears that there may be both air leakage and conduction at the top of the wall in this area. In order to devise a practical and cost-effective retrofit, a thorough physical examination of the joints and penetrations near the top of the building should be performed. High-quality long-lasting materials (e.g. caulking, backer rod, expanding foam insulation, etc) should be employed to reduce or eliminate any gaps allowing warm air exfiltration. Reducing these air leakage losses will result in increased occupant comfort and lowered heating costs. Any areas of poorly installed or insufficient insulation could also be addressed at this time.

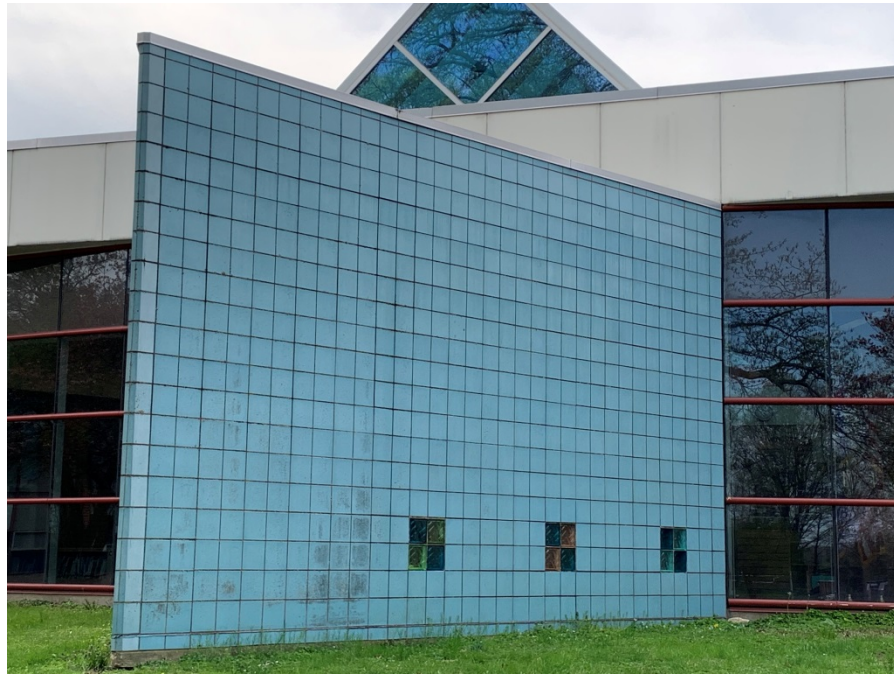
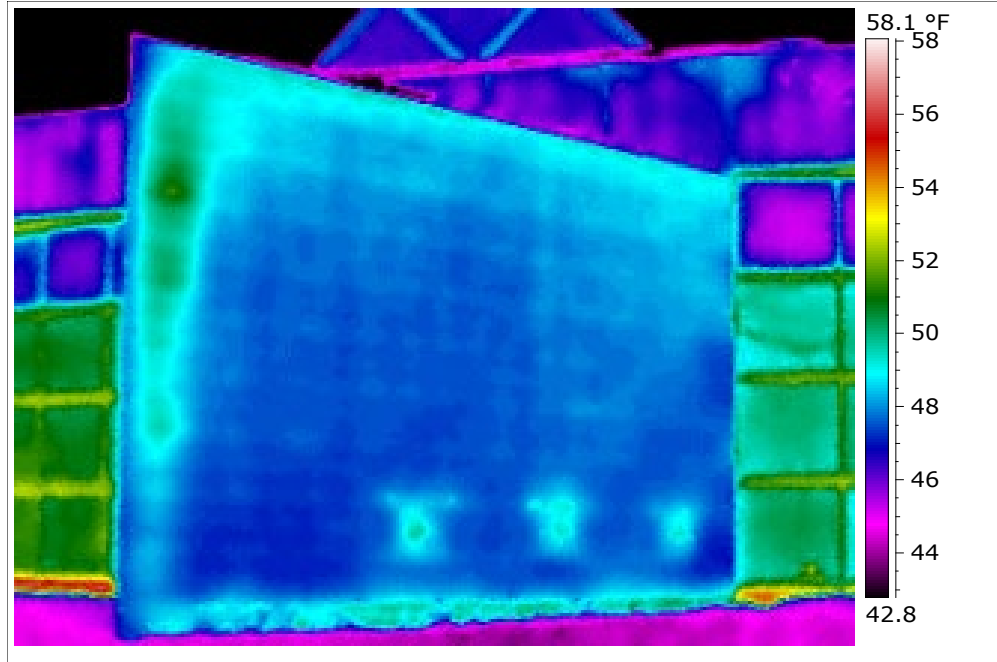
Thermogram # 7

Problem Category: Conduction Loss

Recommendation: The top corner (south end) of this wall displays an unusual anomaly that may indicate a moisture buildup in this area. Invasive testing in this area may be required to determine the presence or absence of moisture. It is also possible that air leakage (exfiltration) is occurring through the joints of the cladding in this area.

WALL - In Thermograms 7 & 8, the top corner (south end) of this wall displays an unusual anomaly that may indicate a moisture buildup in this area. Invasive testing in this area may be required to determine the presence or absence of moisture. It is also possible that air leakage (exfiltration) is occurring through the joints of the cladding in this area.

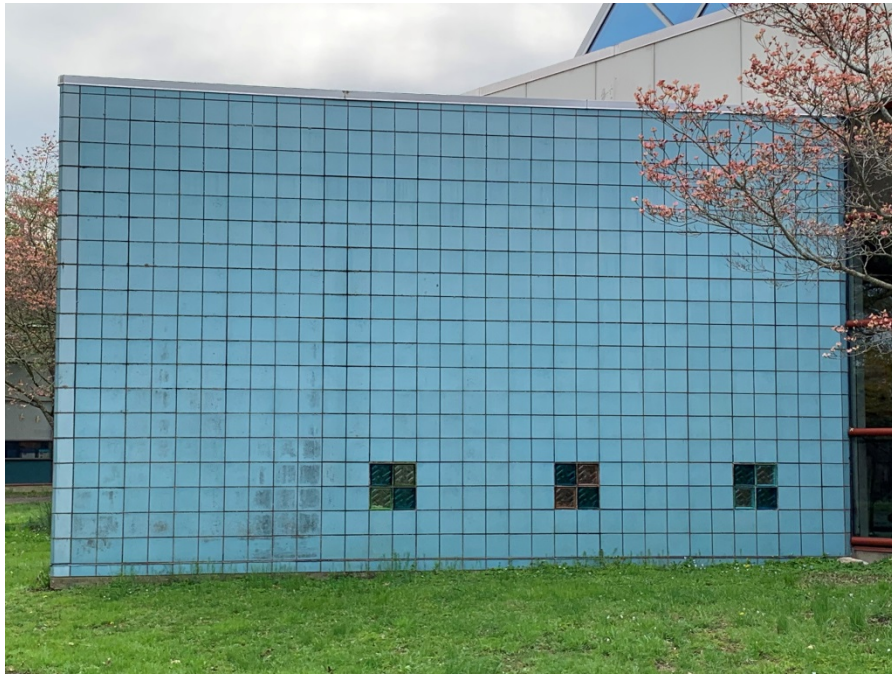
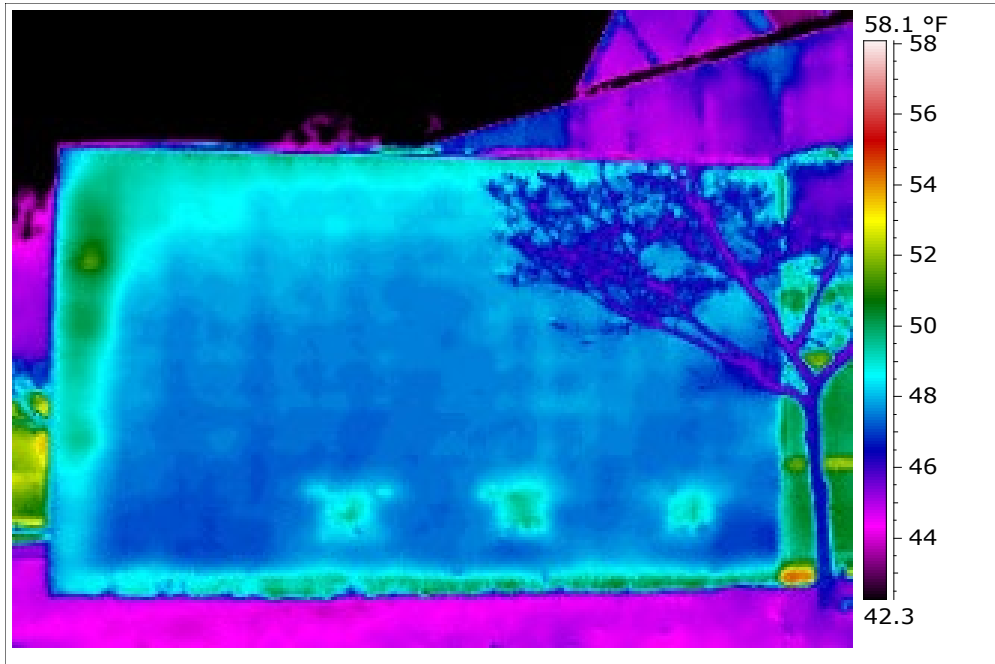
Thermogram # 8

Problem Category: Conduction Loss

Recommendation: The top corner (south end) of this wall displays an unusual anomaly that may indicate a moisture buildup in this area. Invasive testing in this area may be required to determine the presence or absence of moisture. It is also possible that air leakage (exfiltration) is occurring through the joints of the cladding in this area.
