# FACILITIES NEEDS

### FACILITIES NEEDS ASSESSMENT OF ROXBURY ELEMENTARY SCHOOL

751 West Hill Road  
Stamford, Connecticut 06902

**EMG Project #:** 88166.09R-006.017  
**Date of Report:** August 28, 2009  
**On site Date:** March 25, 2009

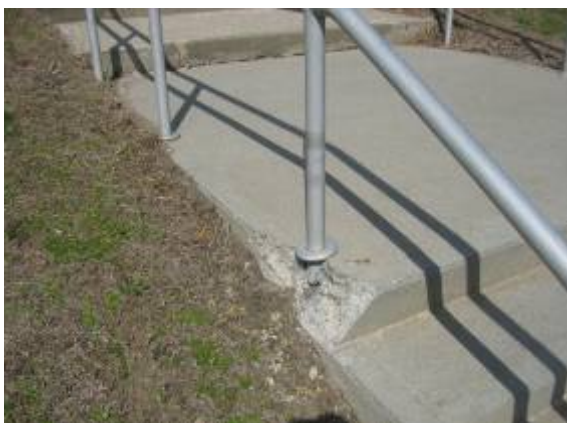
Photo #10: View of cast in place concrete steps at the end of the 200 corridor, whose metal tread noses are becoming dislodged.

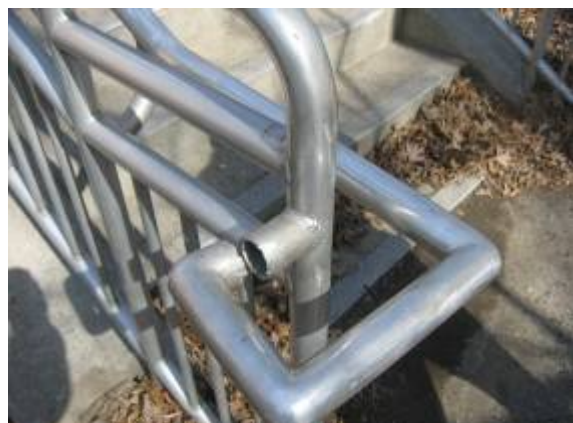
Photo #11: View of damaged handrail connection on stairs at the end of the 400 corridor.

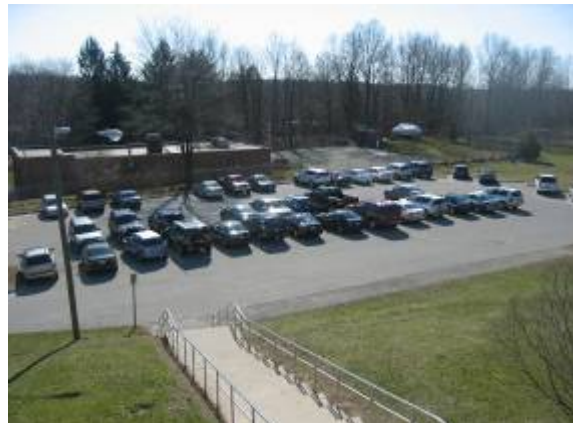
Photo #15: View of deteriorated concrete curbing along the main entry drive.

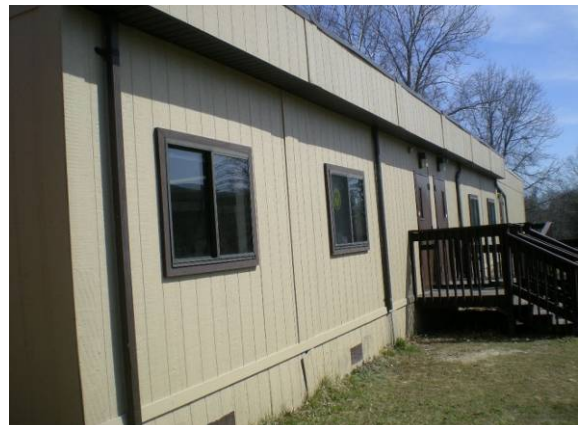
Photo #77: Link between 500 wing and north end modular addition note damaged corner

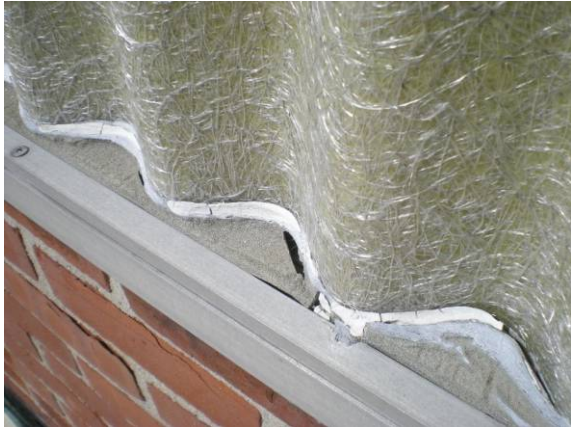
Photo #91:	Common condition at gym clerestory – broken seals
------------	---

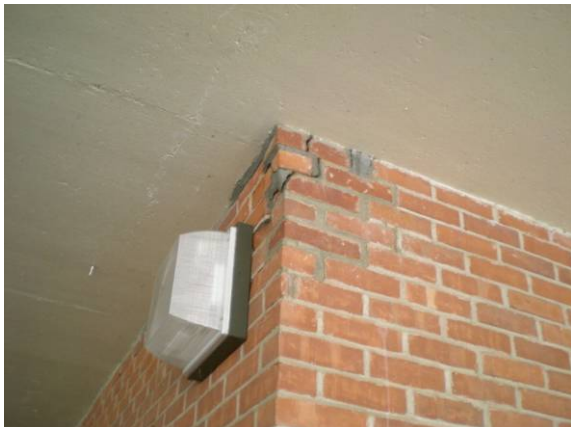
Photo #93:	Dislodged brick veneer near from entrance
------------	---

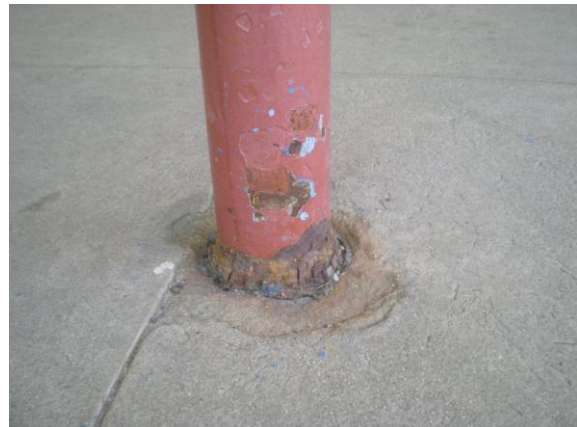
Photo #94:	Typical condition of column base at main entrance
------------	---

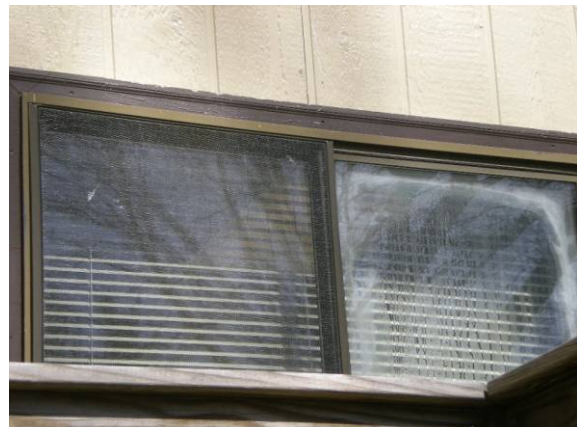
Photo #96:	Broken seals at windows on south modular addition
------------	---

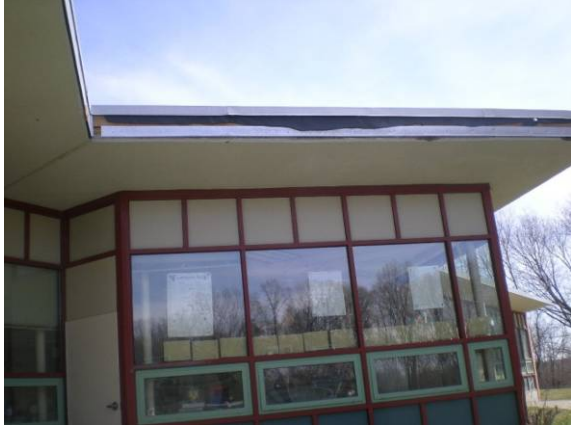
Photo #97: Missing fascia panels

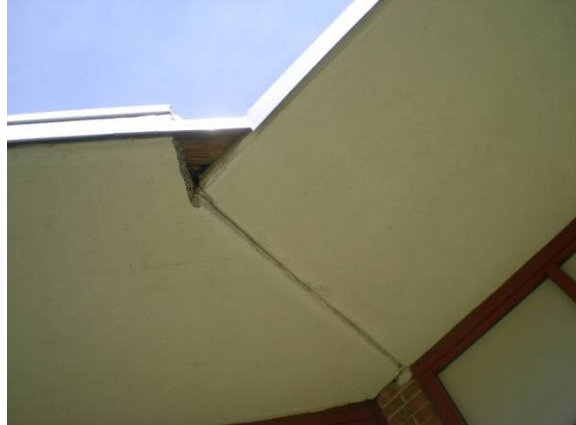
Photo #98: Spalled concrete soffit panel

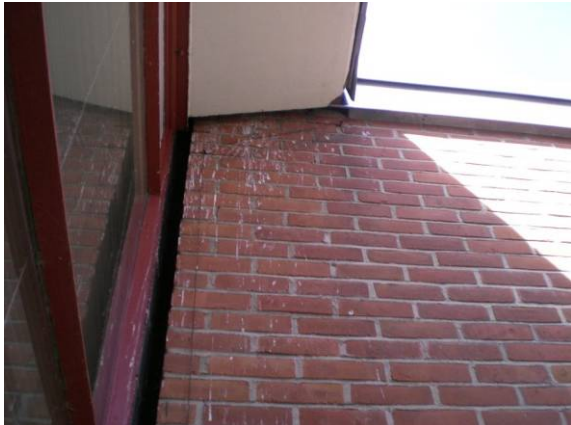
Photo #99: Gap at junction between 200 wing and main office section – evidence of birds

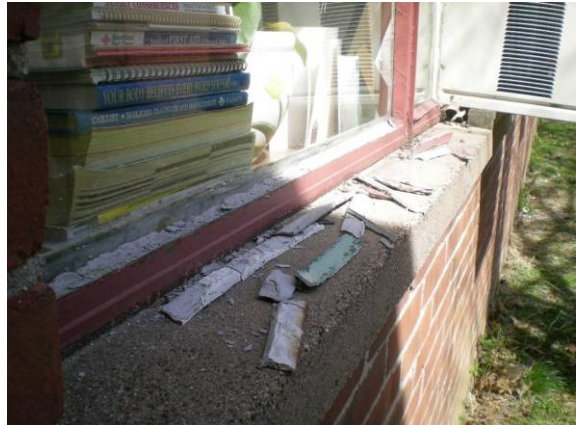
- The exterior of the single paned window system has severely deteriorated paint and window mastic. The debris is on the window frames and sills and on the ground where children play. A lead abatement specialist should be retained to analyze the situation, determine the possibility of lead content and provide recommendations. The estimated cost to retain a lead abatement professional is included in the Replacement Reserves Report.

Photo #100: Condition of original windows

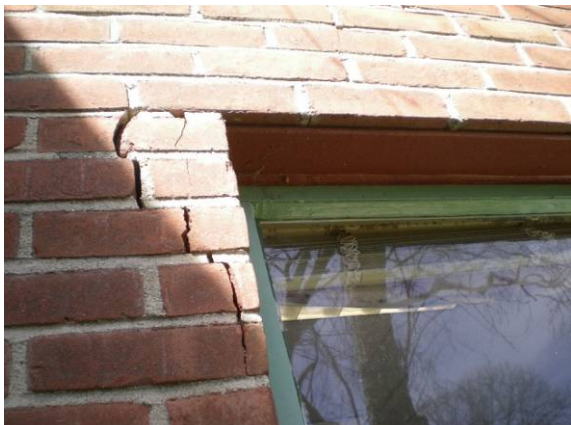
Photo #101: Settlement cracking at brick veneer

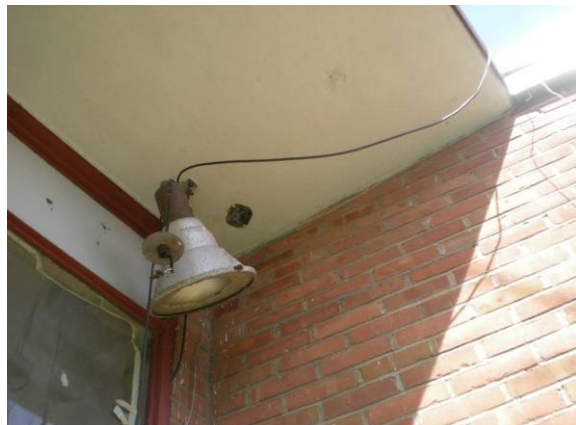
Photo #102: Damaged security light

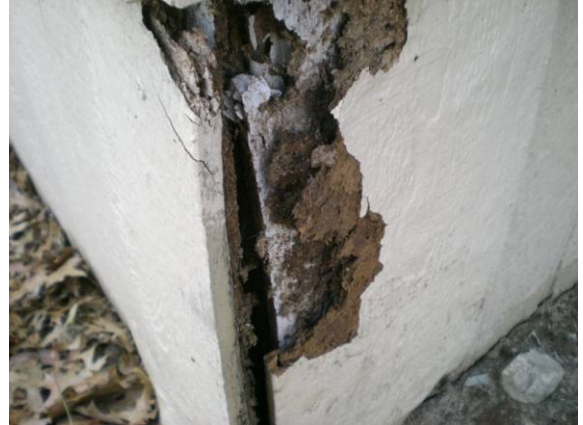
- Suspect termite damage was observed at the 4<sup>th</sup> grade modular addition. Wet and deteriorated engineered wood was observed at the north side of the addition. A local, licensed exterminator must be retained to treat the property as required to eliminate the pest and associated threat. The estimated cost of this work is included in the Replacement Reserves Report. In addition to this work, an annual termite inspection program must be instituted. A cost allowance for minor structural repairs is discussed in Section 6.2.

Photo #104: Suspect termite damage at north modular addition

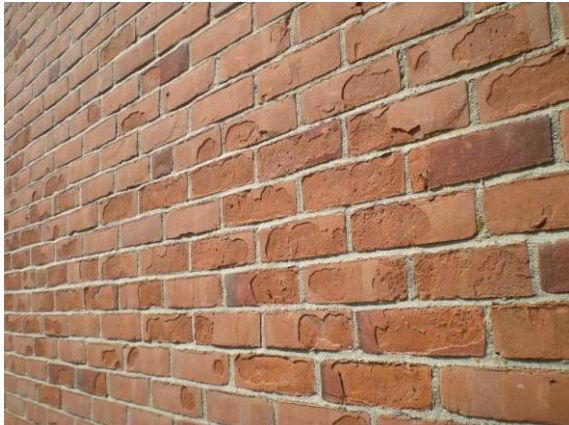
Photo #105: Soft brick at 500 wing

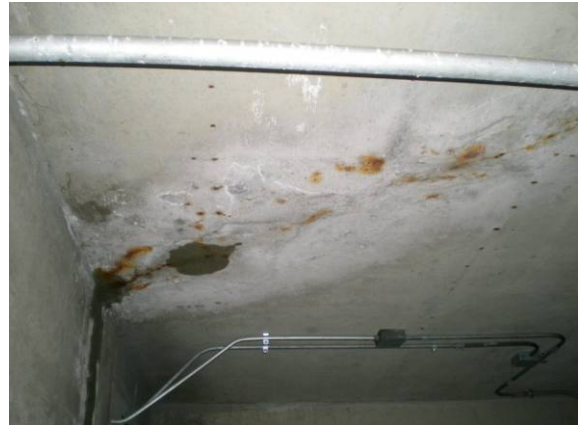
Photo #106: Crack and water infiltration of raised concrete landing at basement access

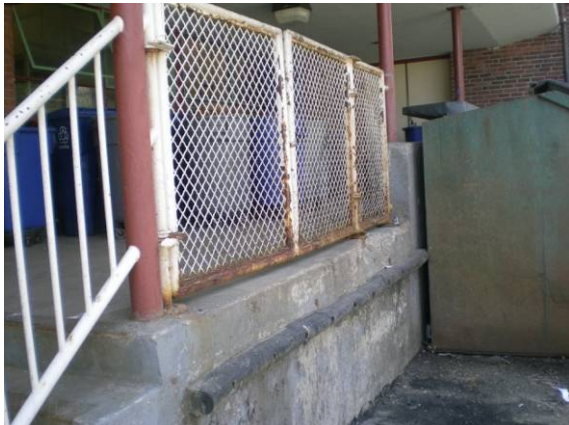
Photo #107: Loading dock gate and bumper condition

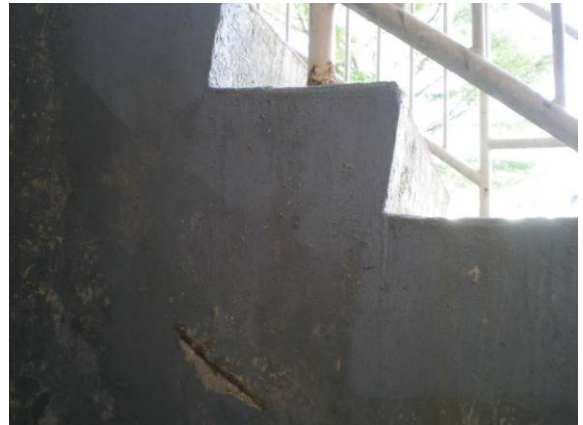
Photo #108: Railing and stair condition at loading dock

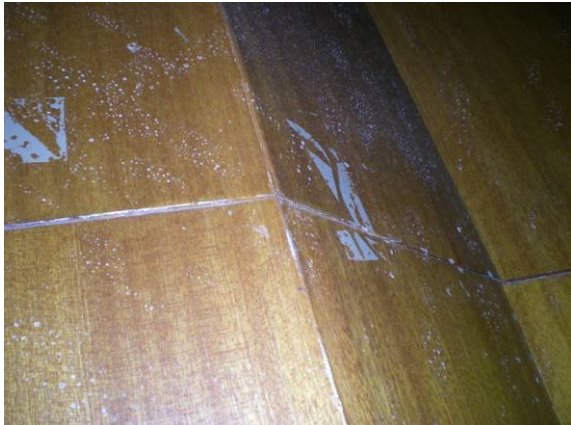
Photo #111: Condition of thin veneer wood panels in Auditorium

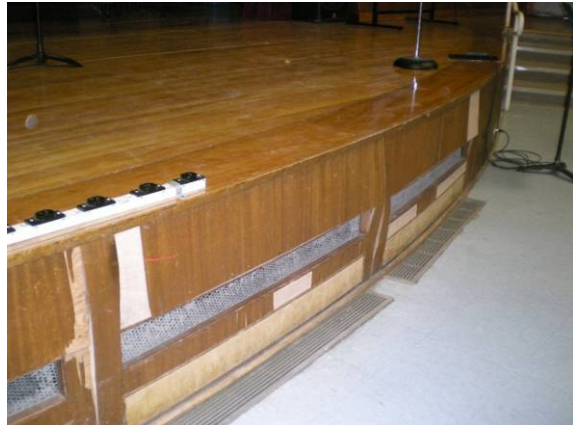
Photo #112: Condition of thin veneer wood panels in Auditorium stage

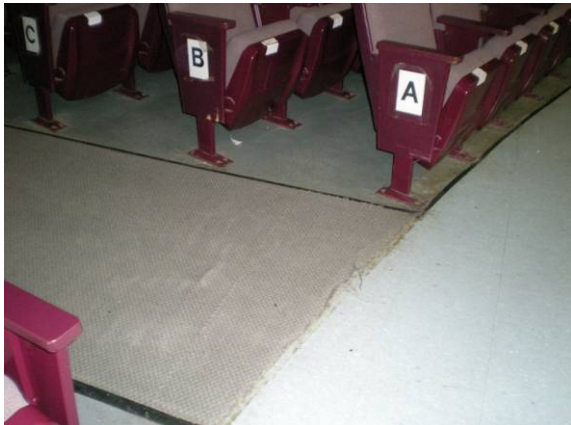
Photo #113: Condition of carpet at auditorium

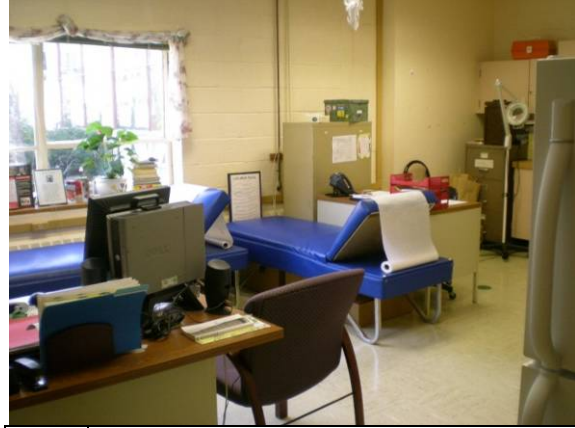
Photo #116: Tight conditions at Nurse's office

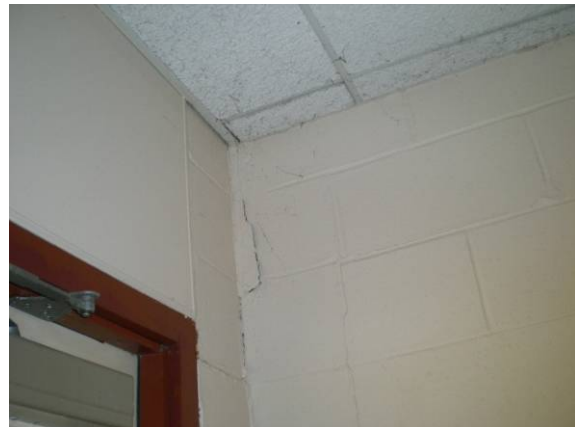
Photo #124: Settlement cracking in corridor at far northwest corner

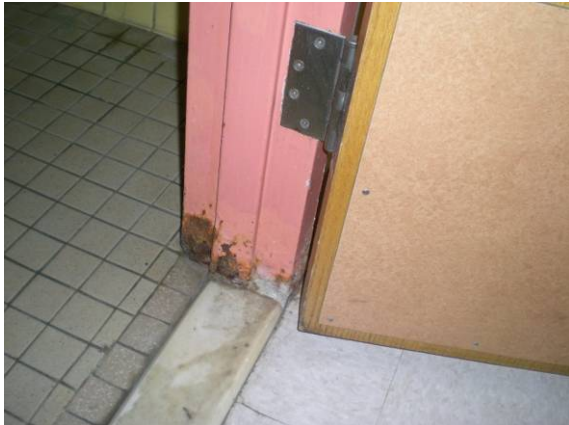
Photo #129: Rusted condition of door frame at restroom within classroom

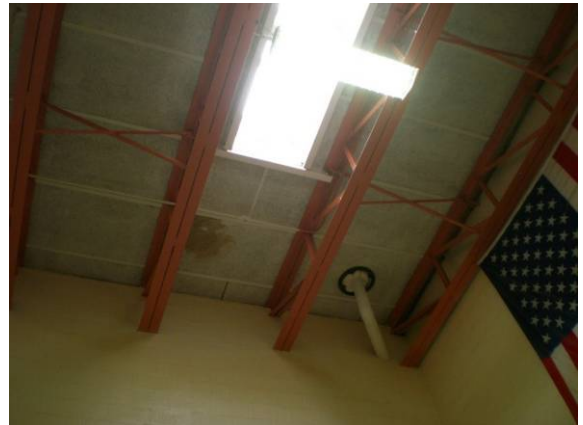
Photo #132: Reportedly inactive roof leak in cafeteria

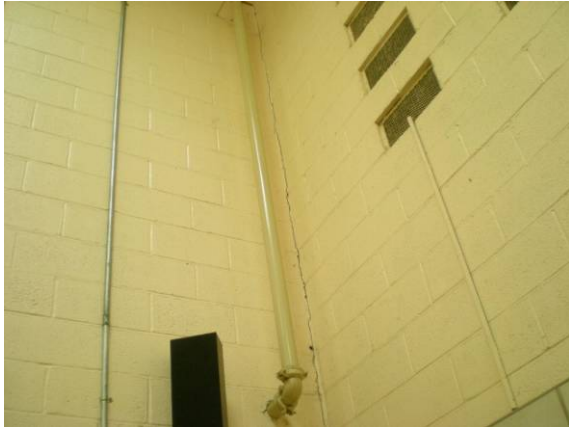
Photo #133: Settlement crack in cafeteria

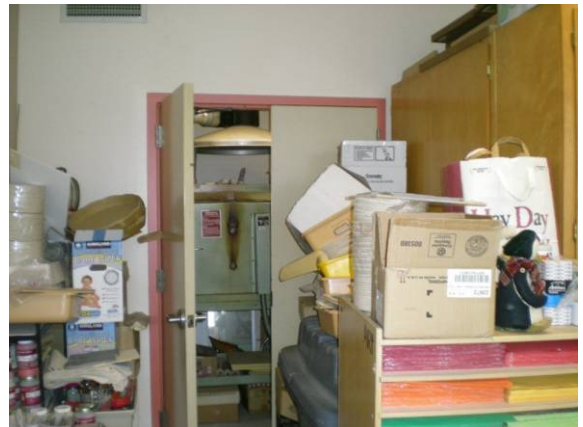
Photo #136: Kiln in art room – non-functional
