# Infrared Thermographic Roof Moisture Analysis

**LOCATION:** Roxbury Elementary  
Stamford, CT

**CONDUCTED ON:** April 17 & 23, 2019

**PERFORMED BY:** Jeff Demeter, Certified Thermographer

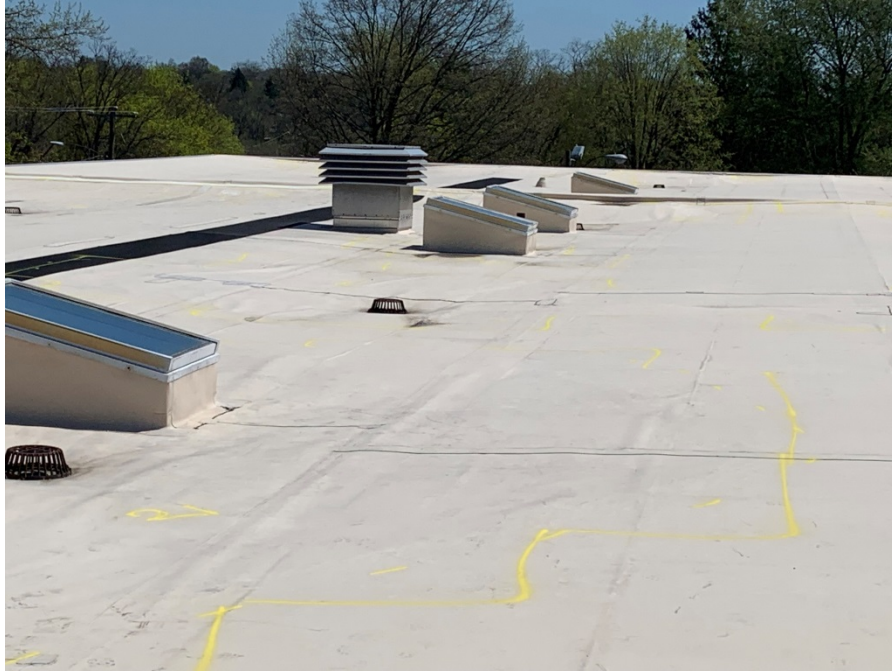
Wet Area #21

Control Photo:  
Visible Light  
Image

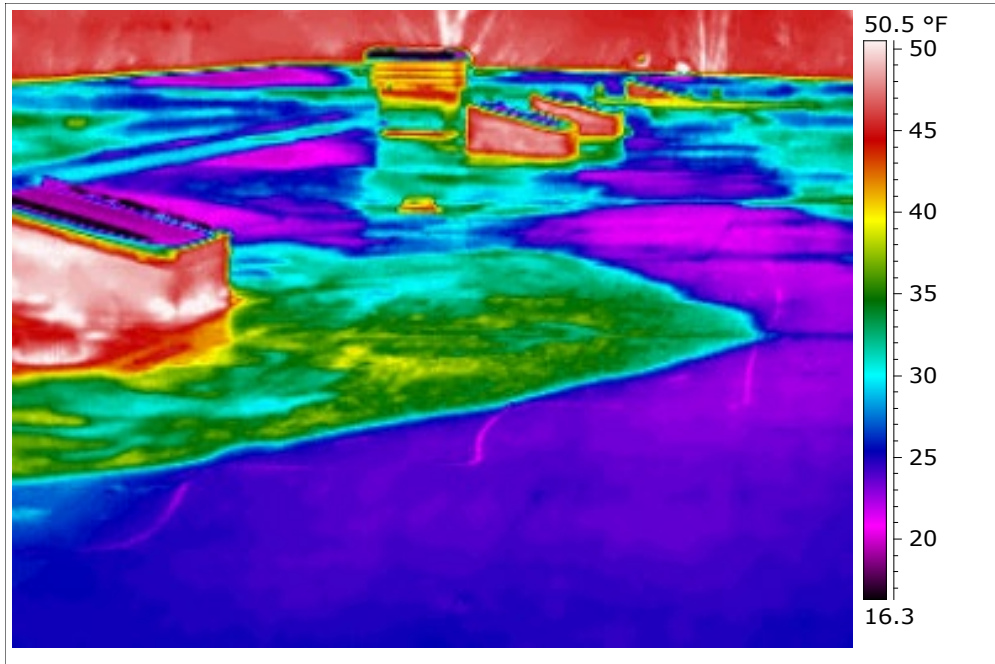
Thermogram # 1

Thermogram:  
Infrared  
Image

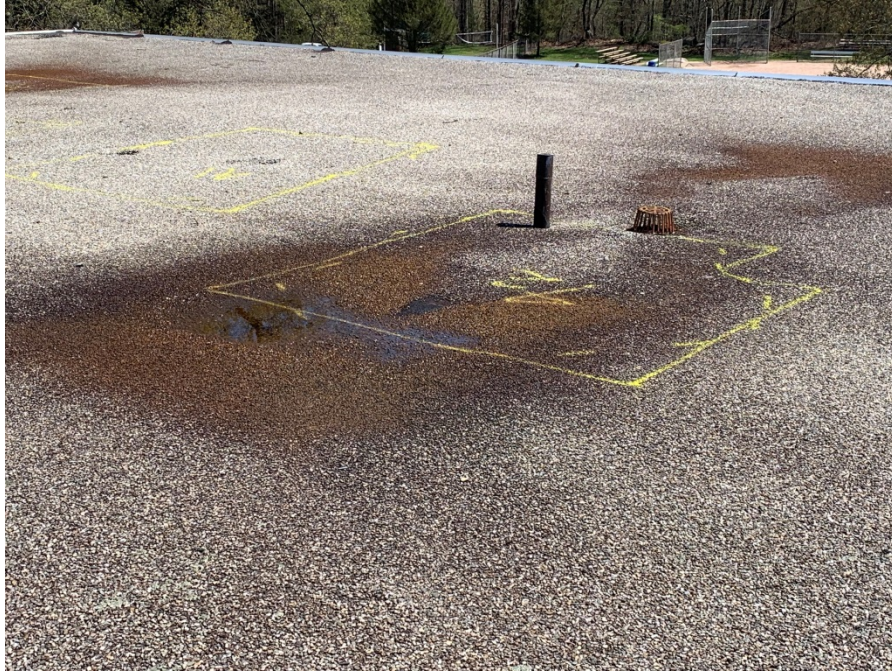
Wet Area #42

Control Photo:  
Visible Light  
Image

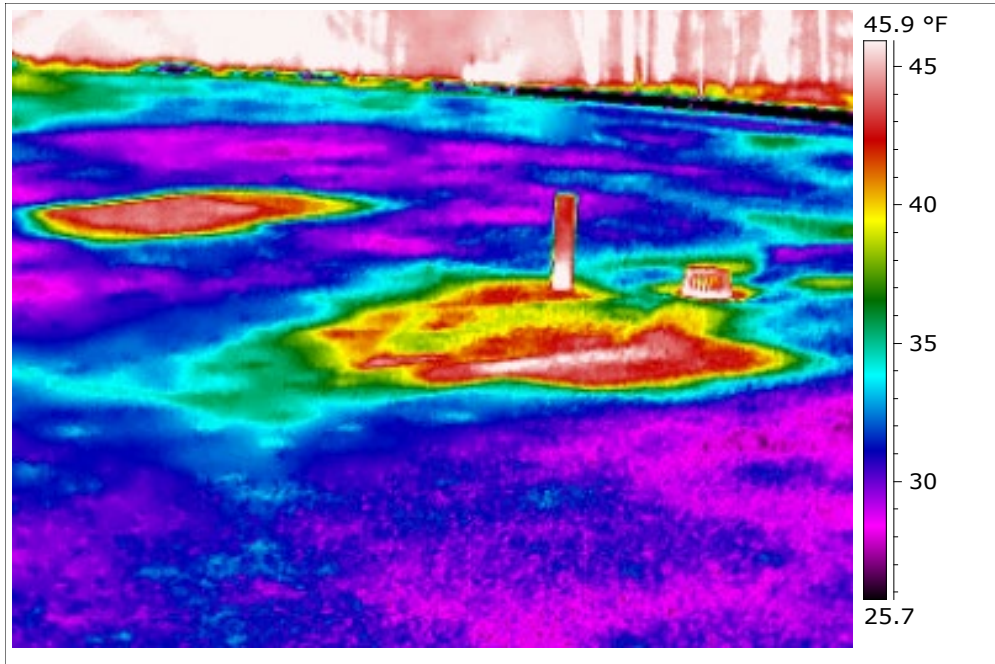
Thermogram # 2

Thermogram:  
Infrared  
Image

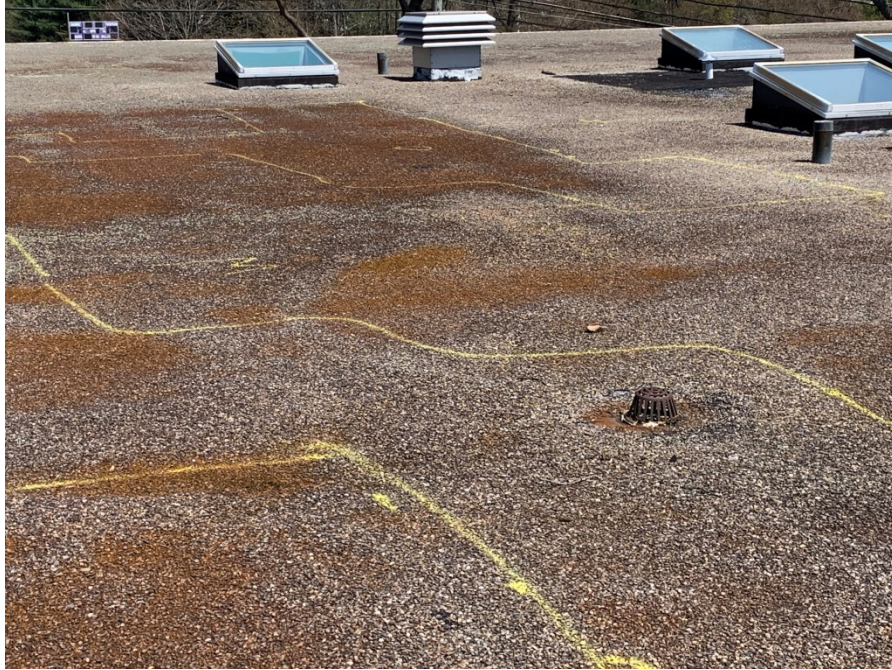
Wet Area #63

Control Photo:  
Visible Light  
Image

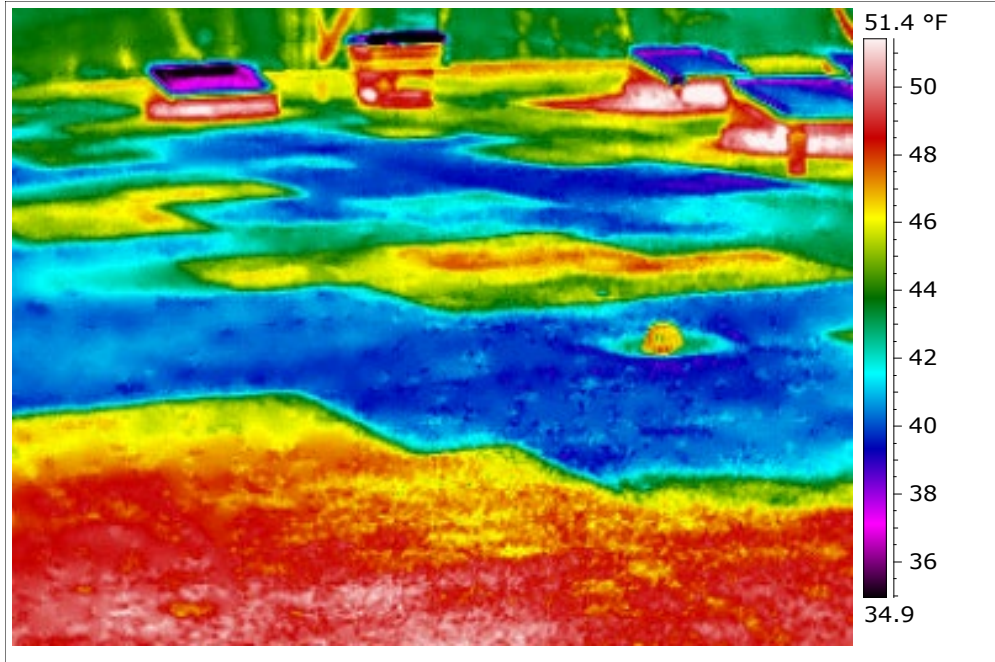
Thermogram # 3

Thermogram:  
Infrared  
Image

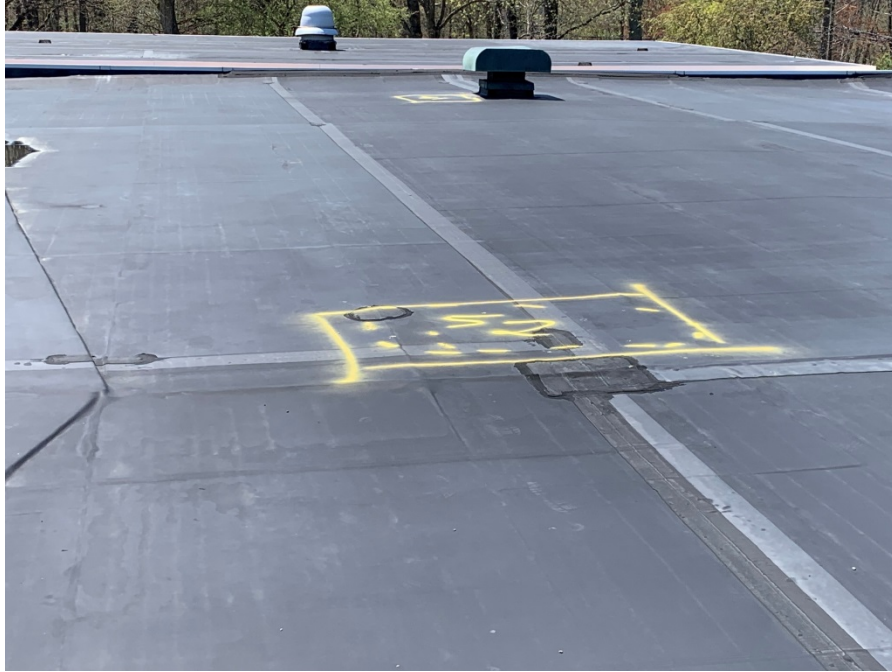
Wet Area #52

Control Photo:  
Visible Light  
Image

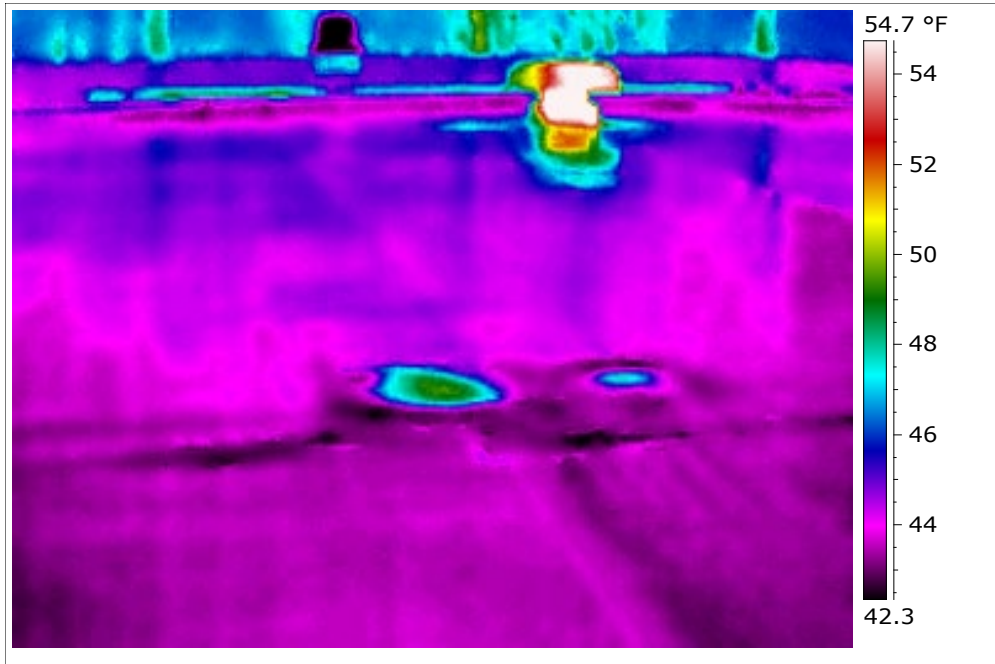
Thermogram # 4

Thermogram:  
Infrared  
Image

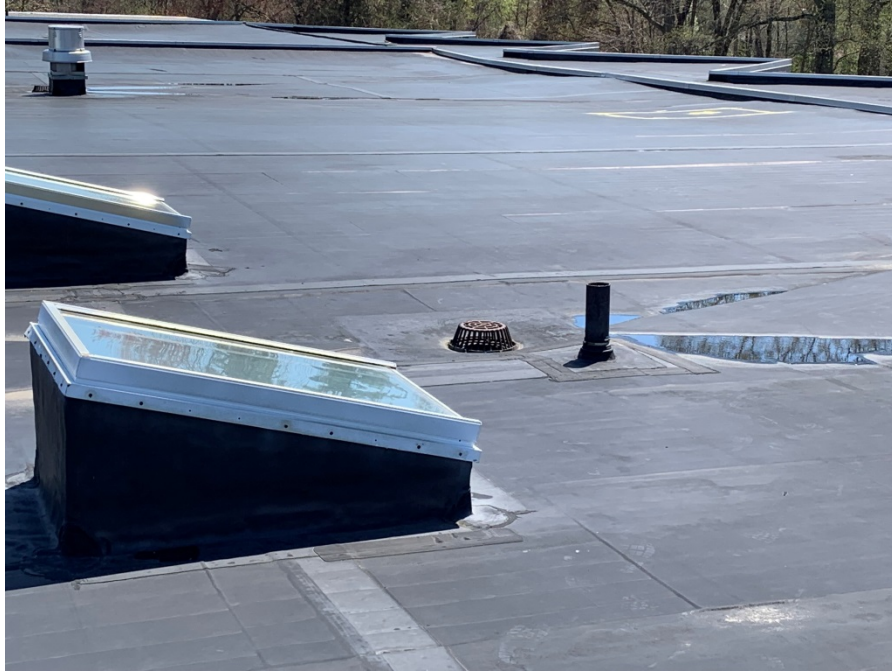
Wet Area #46

Control Photo:  
Visible Light  
Image

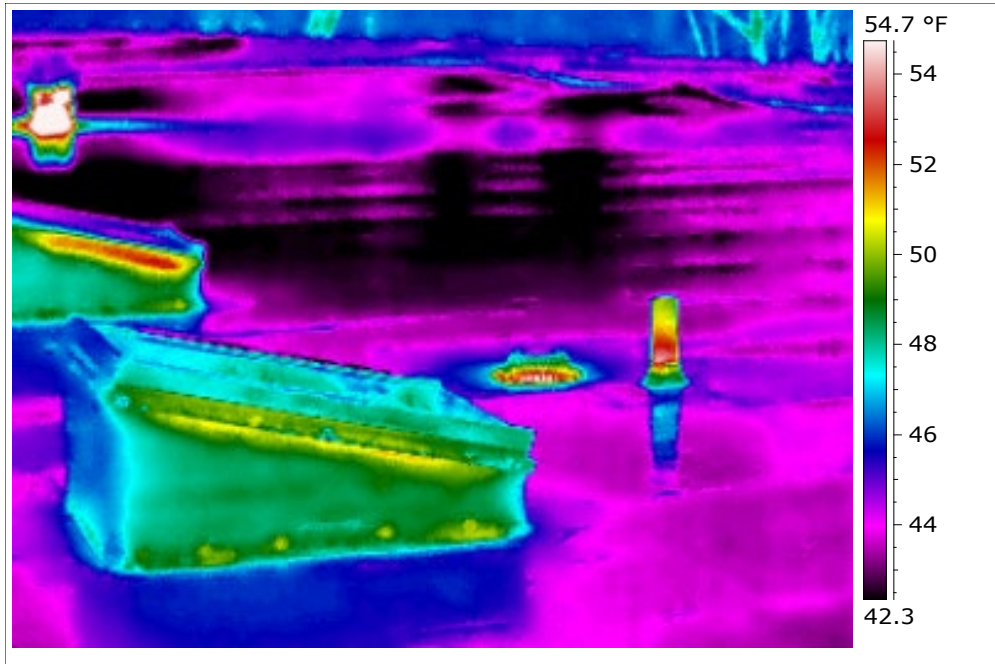
Thermogram # 5

Thermogram:  
Infrared  
Image

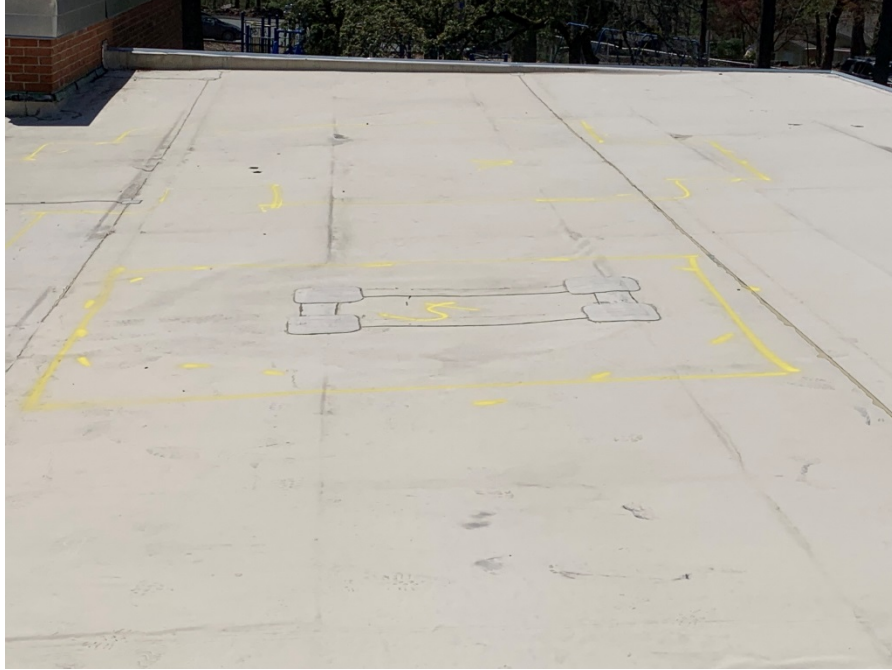
Wet Area #5

Control Photo:  
Visible Light  
Image

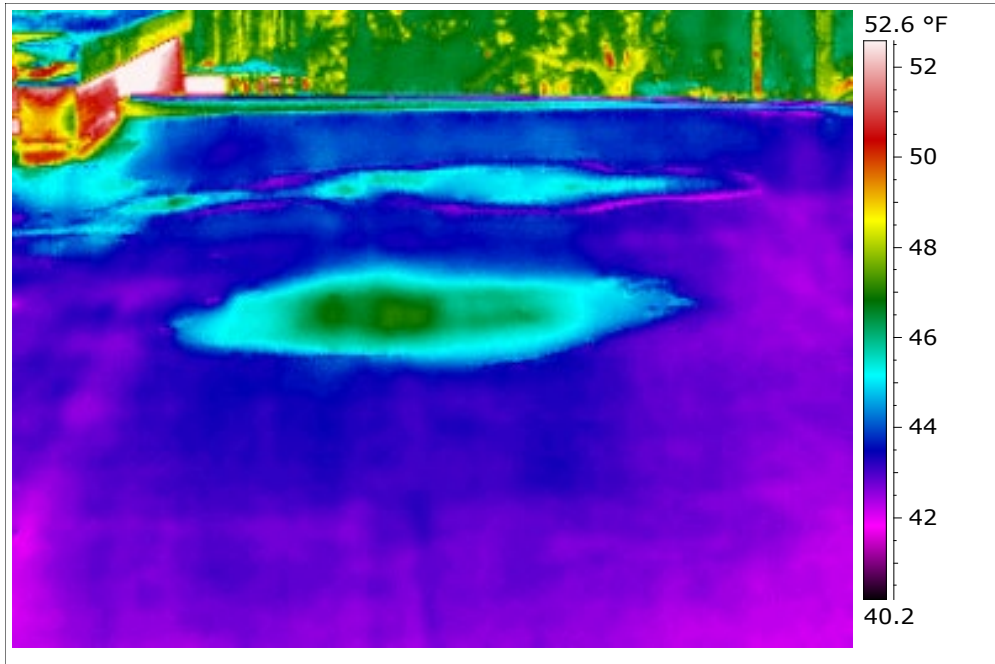
Thermogram # 6

Thermogram:  
Infrared  
Image
