M. Gottfried, Inc.

DATE: February 28, 2019

RE: Roof Report and Repair and Maintenance Proposal
Roxbury School
Stamford, CT

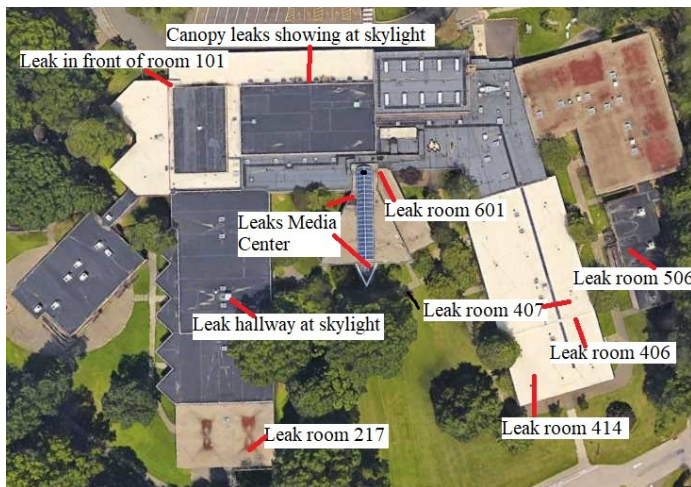
Locations of existing leaks

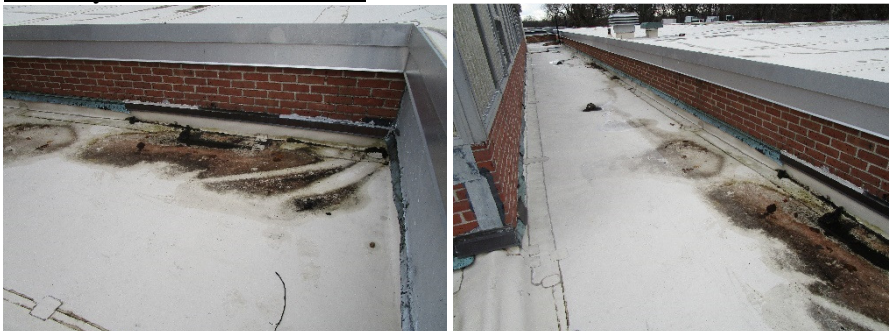
Hallway in front of room 101

The leak in front of room 101 falls near the base of a wall Where roof F meets roof F-1. The membrane is dirty, wrinkled. It also looks like a field lap may be open. This area needs to be thoroughly cleaned, inspected and all holes, open laps and corners properly repaired.

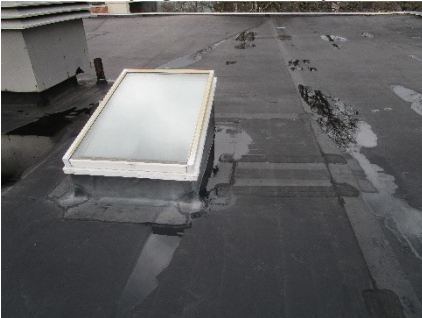
Leak at skylight in hallway

The leak at the hallway skylight is in roof section G. This roof has an active Firestone warranty. We need to repair some of the corners on the curb and do some caulking to stop this roof leak. This repair is covered by the warranty.

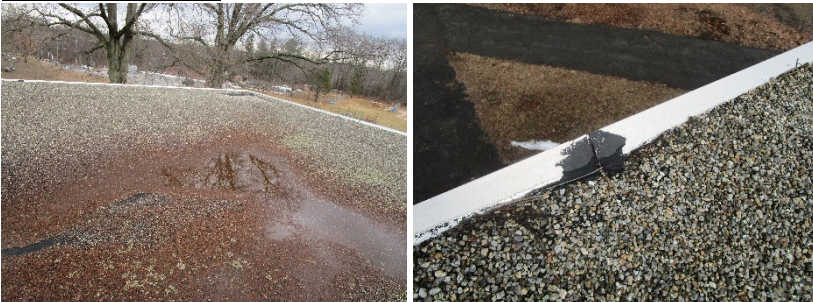
Leak in room 217

The leak in room 217 is located in the gravel BUR of roof section H. The leak could be from open joints in the perimeter edging or in a crack or hole under the ponded water. We would need to scrape back the gravel, patch the open joints in the edging near the leak and check for then patch any holes or cracks over the leak area.

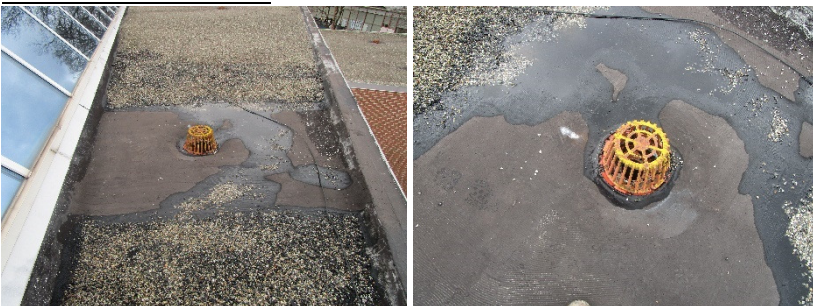
Leak in Media Center

One of the leaks in the media center (roof J) is at the drain on the roof L side. It looks like the area around the drain drain has been coated numerous times with roofing cement in an attempt to stop the lead. Through the coating, we can see some of the lead flashing from the drain. It looks worn out. We would recommend removing the old lead and completely reflashing the drain.

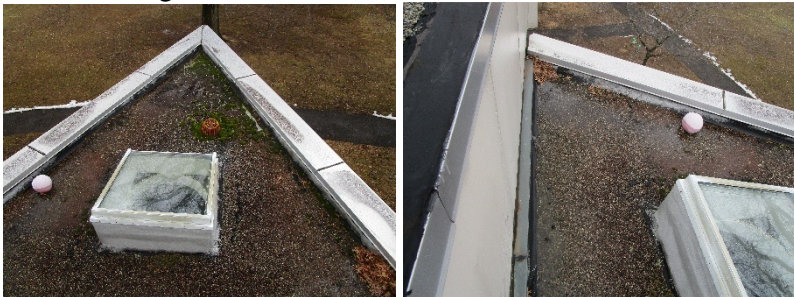
Leak at triangle roof end of Media Center

The small triangle roof at the end of the Media Center, (roof M) is having leaks under the expansion joint where this roof meets the main roof. The expansion joint needs to be reflashed.

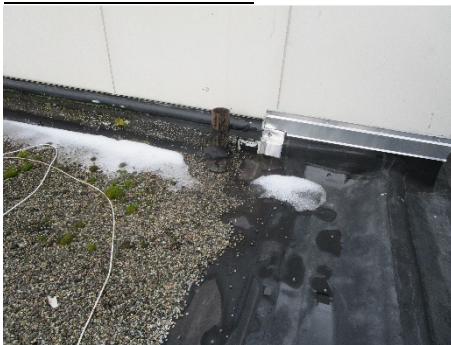
Leak over room 601

The leak at room 601 (roof section K) lies under the joint of the gravel roof and the membrane roof next to the vent pipe. The gravel must be swept back from the vent and the vent and tie-in flashing inspected and repaired.

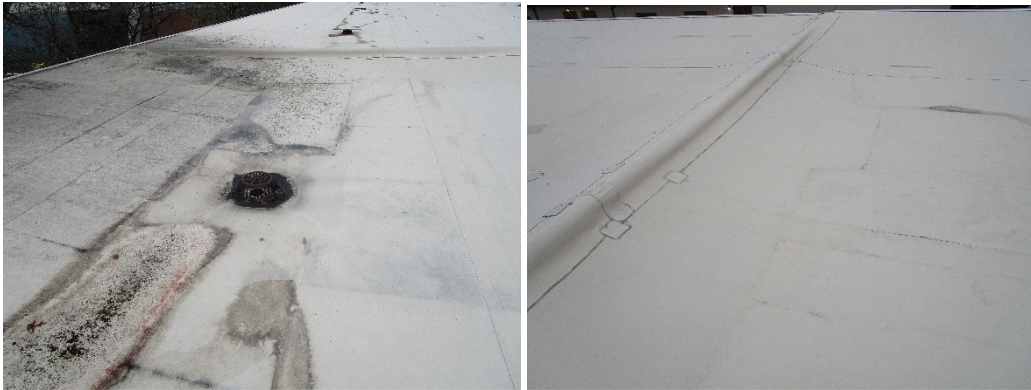
Leak in room 406, 407 and 414

The leak in the above rooms fall in roof section C. This roof is covered by a Firestone warranty. The leaks in this area fall near a drain and the expansion joint. There is also a leak more to the end of the roof. When looking at this roof we found many open laps and corners. We also found areas that appeared to “feel wet”. We have spoken to the Firestone service coordinator who issued the repair purchase order for this roof and they said they are only responsible to repair the 3 active leaks. I told them about the other issues and stated that it is the owner’s responsibility to maintain the roof, including patching holes, overlaying laps that are starting to open, etc., Accordingly the repair of the three active leaks; around the drain, expansion joint and field of the roof will be covered by Firestone unless a hole or damage is causing them. The other issues found on the roof will be described and shown in the maintenance and repair section of this report.

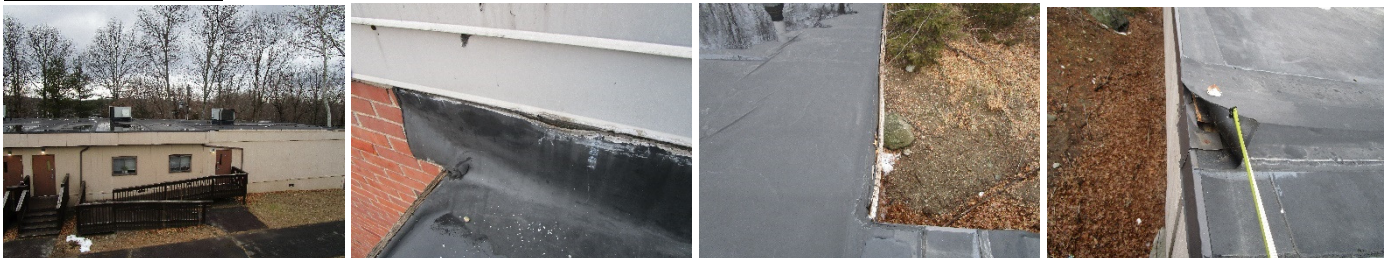
Leak in room 506

Room 506 lies in roof section A. There are numerous items that can be causing leaks on this roof from open edging, open laps falling flashing, open curb corners, etc., We were asked not to include repairs on this roof in our report/proposal.

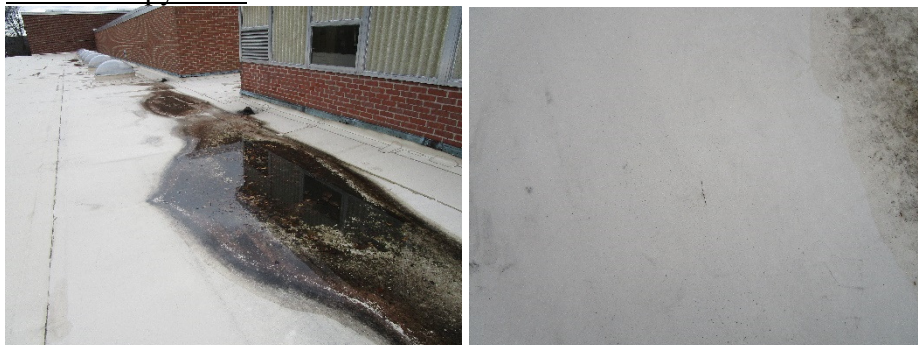
Front Canopy leaks

The Front canopy (part of roof section F), is having water issues. Stains are evident at the skylights and there are soft areas in the roof. It is reported that this moisture from the canopy roof may be traveling on the underlying concrete slab and migrating into the building. Repairs, recommendations, and observations of possible non-roof related entry points for water will be discussed in the maintenance and repair section of the report. There are a couple of slices in the membrane in front of the above puddle that will be patched as part of the active leak repairs, however no other “active leak repair” work to the membrane will be included in this section.

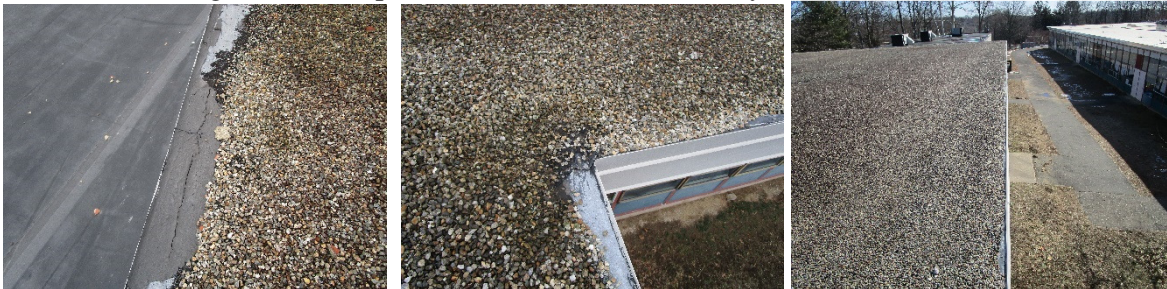
The perimeter edge flashing is showing its age. The flashing paper is cracking, splitting and breaking.

As the membrane cracks and splits, water can work its way into the structure. The deterioration increases after freeze thaw cycles, and the condition worsens at an accelerating rate. To guard against the water infiltration the ballast along the perimeter needs to be scraped back and the edge flashing overlaid with two plies of roofing cement and reinforcing fabric (one 6" reinforcing fabric set in roofing cement followed by a 12" reinforcing fabric set in roofing cement, then a coating of roofing cement over the completed repair. The ballast would then be redistributed in the topping of roofing cement.

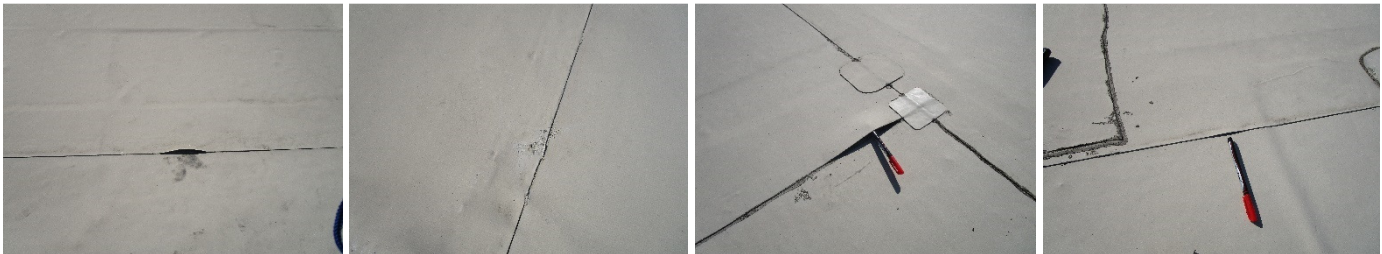
We found many fishmouths, lifting or unadhered field laps and patches on this roof section. These can let water into the roofing system. Some may be causing leaks, others are leaks waiting to happen. Some of the "soft areas" or suspected wet areas may be water entering at these openings and collecting on the deck below the insulation. This may also account for some of the bowed insulation. All laps need to be probed on this roof. As a precaution, all laps, both open and as well as those that may appear "tight" should be overlaid to ensure no water can enter any field laps.

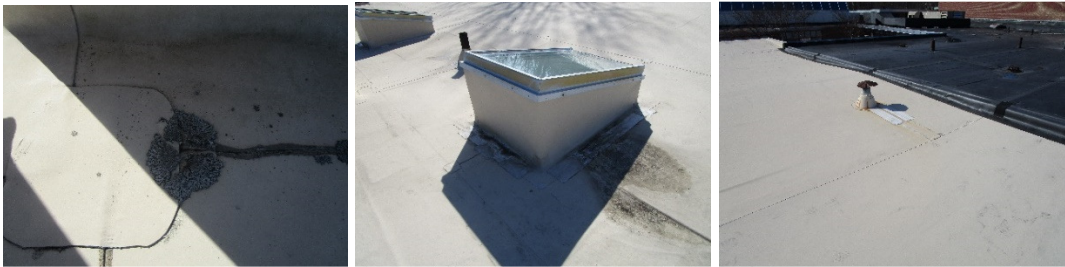
We found that some of the laps have been caulked in an attempt to seal them as have patches on the membrane and curb flashings. All of these items need to be checked and overlaid with new flashing membrane.

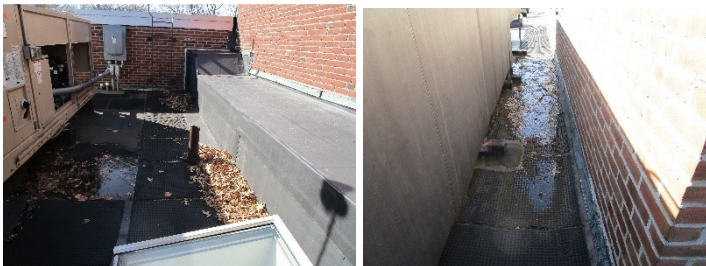
Debris needs to be removed from this roof area. There are a lot of nooks and areas where leaves and debris can collect. The alley way shown above gets a lot of roof traffic and the insulation has crushed. The area (approx. 20' x 3') should be cut out, new insulation with a high density coverboard, and new EPDM membrane installed.

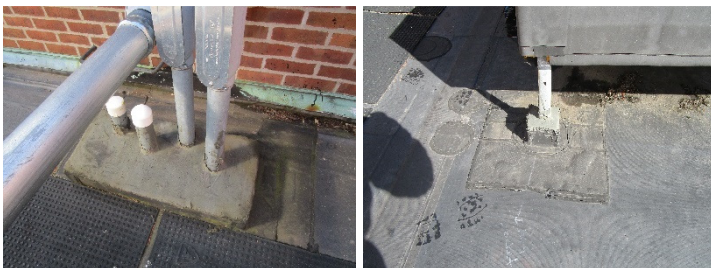
The filler on some of the penetration pockets has shrunk and pulled away from some of the penetrations. All penetrations pockets need to be checked, topped off with new sealer, and restripped to the roof if necessary.

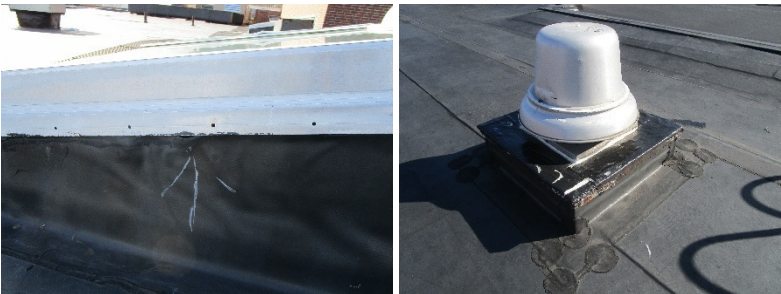
Flashing on some of the curbs is slipping down and leaving a gap water can enter. All curbs need to be checked and any flashing problems repaired. There is also a fan that looks like it was "fitted" to go on an existing curb. The top has been coated and caulked. This needs to be inspected and reflashed if necessary.

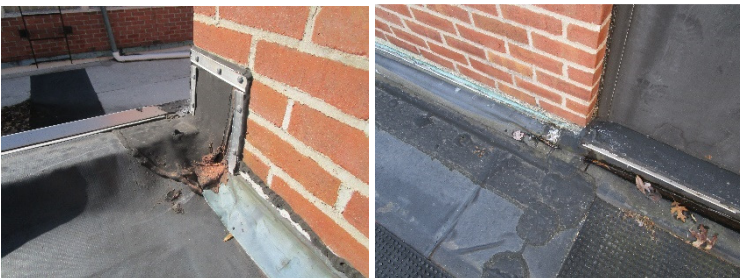
All termination flashings must be checked. We found corners where the membrane has torn free of the termination bar or pulled away from termination under doors. Open perimeter termination is an access point for rain or water running down walls to enter the structure. All perimeter flashing needs to be checked and repaired if necessary.

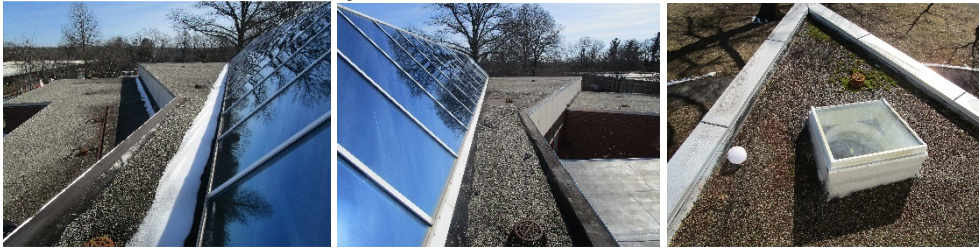
Media Center Roof J and adjacent roofs L, M and K

The media center and adjacent roofs are all older gravel surfaced built-up-roofs. There are a few leaks on these roofs that are addressed in the active leak section. This area deals with the preventative maintenance needed to keep these roofs performing as best as they can.

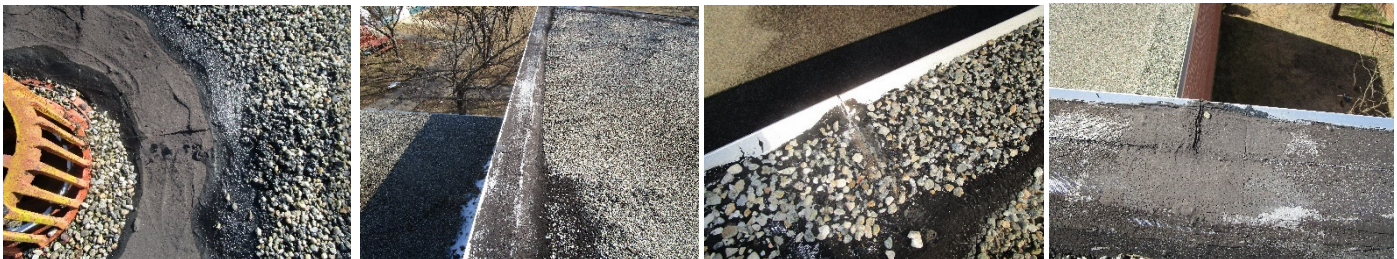
Similar to what was discussed for roof area B, the roof perimeter, drain and penetration flashings are showing age. The stripping on the edging is wearing thin and cracking. The joints between the pieces of edging are cracking and open. These areas should be scraped and overlaid with new 2-ply membrane in a similar fashion to area B.

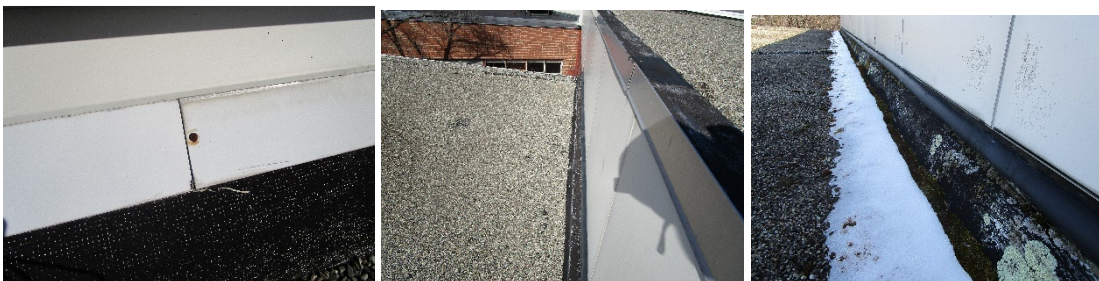
Base flashing between the roofs is also showing wear and tear with holes, worn through areas and open joints. The base flashing needs to be cleaned and overlaid with the 2-ply repair.

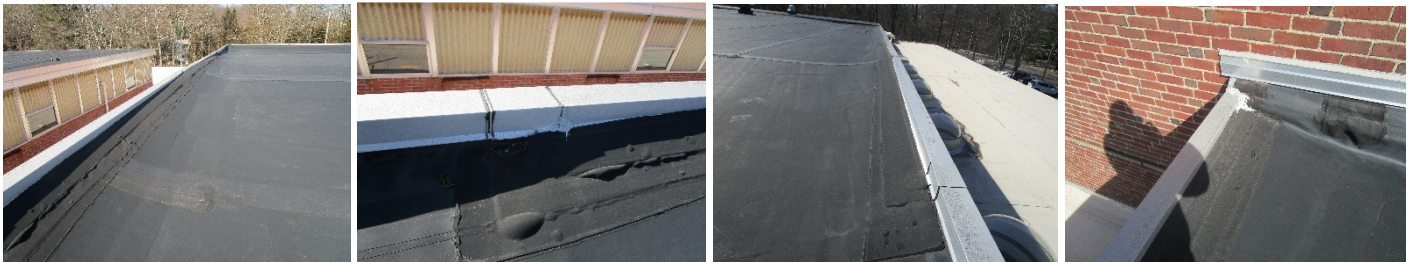
Roof area E has a large slope in its insulation. At the high points, the insulation come even or very close to the top of the parapet wall. There is a coping on the parapet wall. Additional blocking was not installed to keep the coping above the insulation high points. At these areas the membrane was flashed to the back of the coping, or the coping flange turned out and stripped. The problem is the joints in the coping at these areas are taking in water. Water coming in the joints gets behind the base flashing. We could see water come out from the membrane stripping. To stop water from getting in the joints of the coping in these areas need to be flashed in with EPDM flashing membrane. The open vertical flashing at the transition between “edge stripping” also needs to be caulked closed. In addition, we found the same conditions where the coping meets the higher wall of section D-1. This corner also needs to be properly repaired.

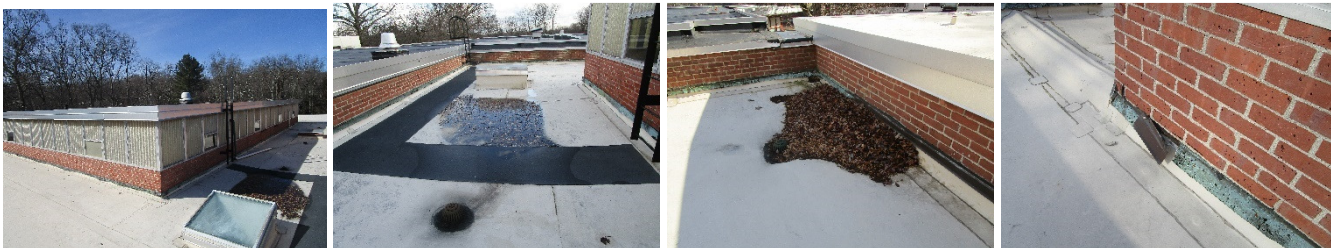
Roof area F is an adhered Firestone TPO similar to area C, but no warranty was given to us for this area. The roof can almost be separated into two areas; the canopy with the skylights in front of roof E, and the area that surrounds roof F-2.

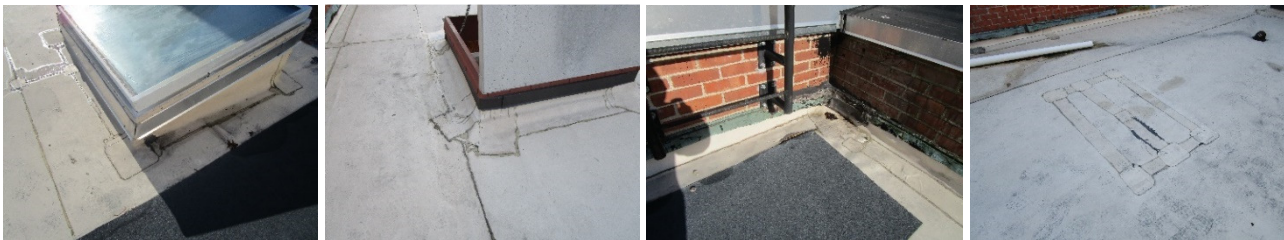
We did see open corner flashing, corners with multiple pieces rather than a proper wrap, some open laps and patches that have been caulked. Curbs, laps, flashing and patches need to be probed and overlaid with new material if open or starting to lift and separate.

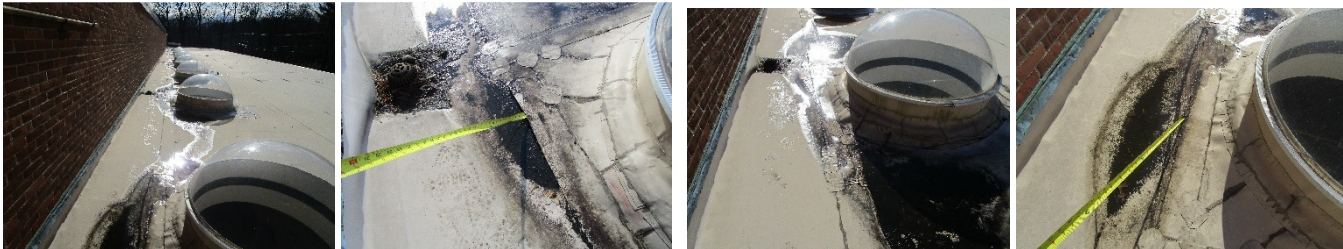
The portion of roof area F with the skylights is in poor shape. The roof is very dirty around the skylights and the flashing on many of the skylights is opening, Soft area were also noticed on this area of roof.

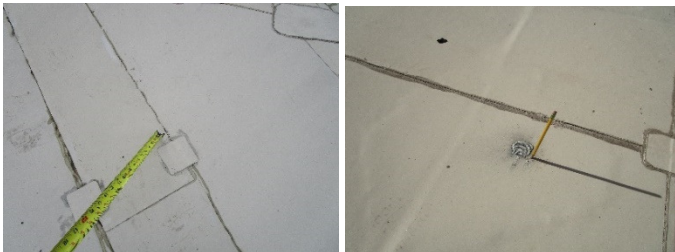
In addition to the problems by the skylights, open laps and holes were found. It appears that attempts to "fix" these with caulking have been tried. This entire area needs to be cleaned. All laps and flashings need to be probed and overlaid where necessary. The skylights should be reflashed. All holes must be properly flashed.

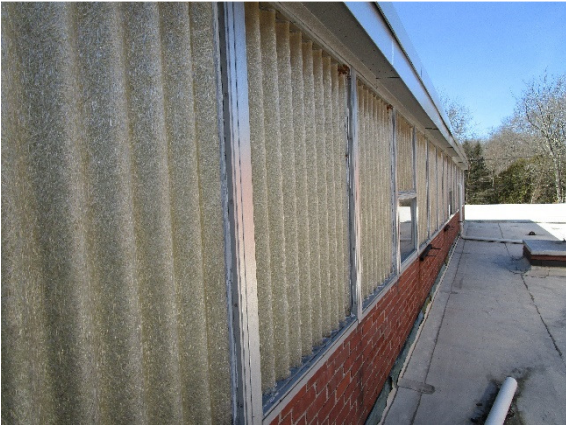
One other observation on roof F needs to be discussed. We were told that there may be a moisture problem on the on the inside areas of the walls of roof E and F-2. These walls are masonry and have old corrugate panels in a metal frame on top of the masonry. It may be possible that water is entering the brickwork and soaking through or getting in the masonry from the panels and metal frame. It is possible that this water travels down to the concrete deck where it finds its way inside. This issue should be investigated by the school's architect.

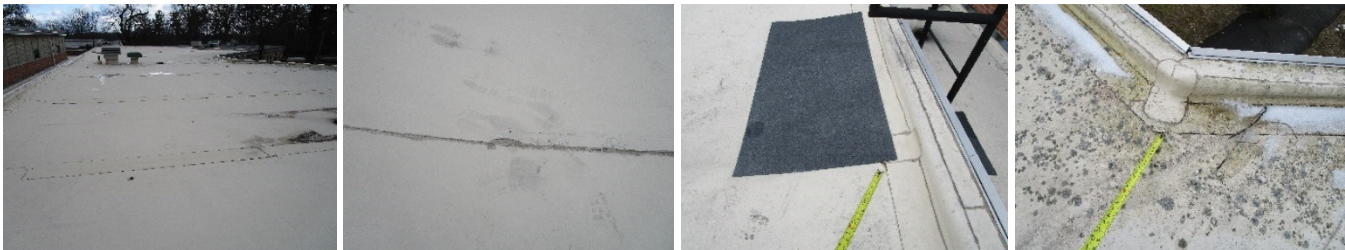
Similar to the other roofs of this type we found some open laps, corners and flashing. In addition to the hole shown at the corner of the walkway pad at the ladder, the insulation under the pad is crushed. We recommend cutting out the pad, removing crushed insulation, installing new insulation with a high density coverboard and installing new membrane and a new walkway. For the balance of the roof, the laps and flashing on this roof need to be probed and overlaid if found to be opening, lifting or bridging.

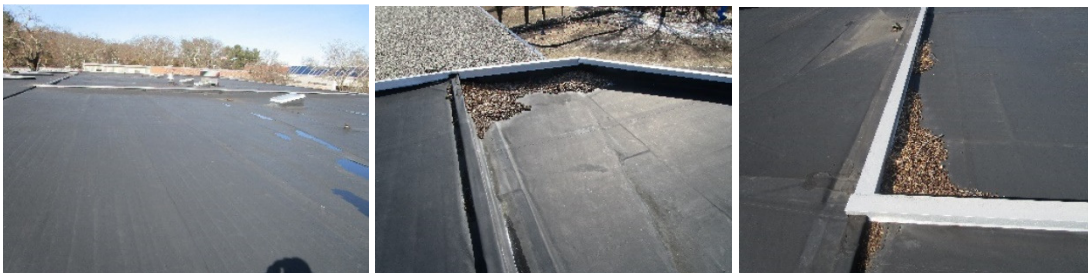
Roof G and G-1 are warranted adhered Firestone EPDM roofs. Outside of the one leaking skylight (noted in the active leak area), the roof is in good condition.

The roof should be walked, the minor amount of debris should be removed, and all laps and flashings checked and patched if cracking or bridging.

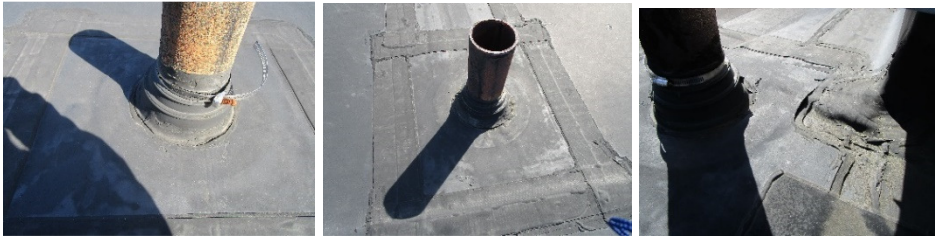
We did notice some cracking at vent pipes as well as some corners and patchwork that should be cleaned and overlaid with new membrane.

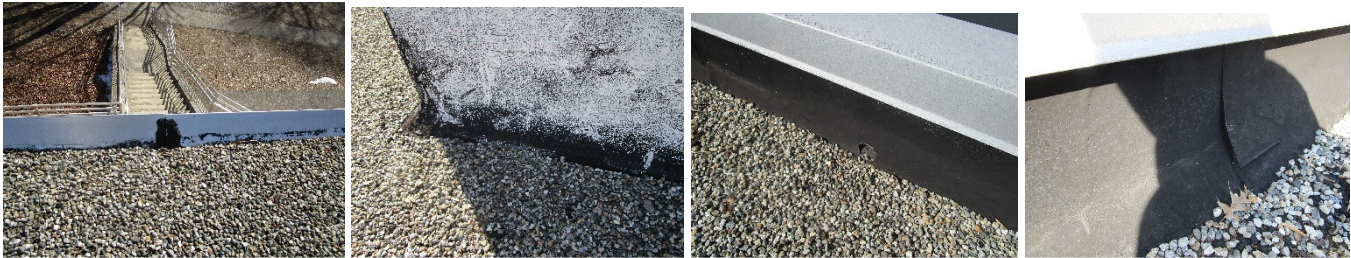
These are examples of open edging, worn base flashing, holes in flashing and open flashing that we found on this roof area. Gravel should be scraped back from these items and the flashing repaired with 2-ply repair procedure previously discussed.
