Infrared Thermographic Roof Moisture Analysis

LOCATION: Springdale Elementary
Stamford, CT

CONDUCTED ON: May 6 & 7, 2019

PERFORMED BY: Jeff Demeter, Certified Thermographer

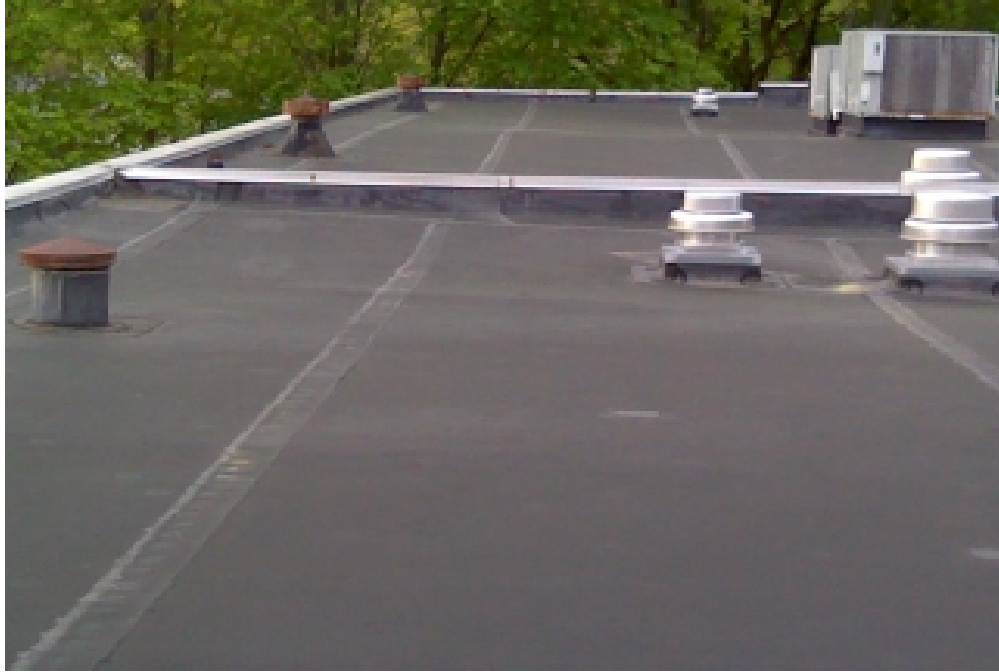
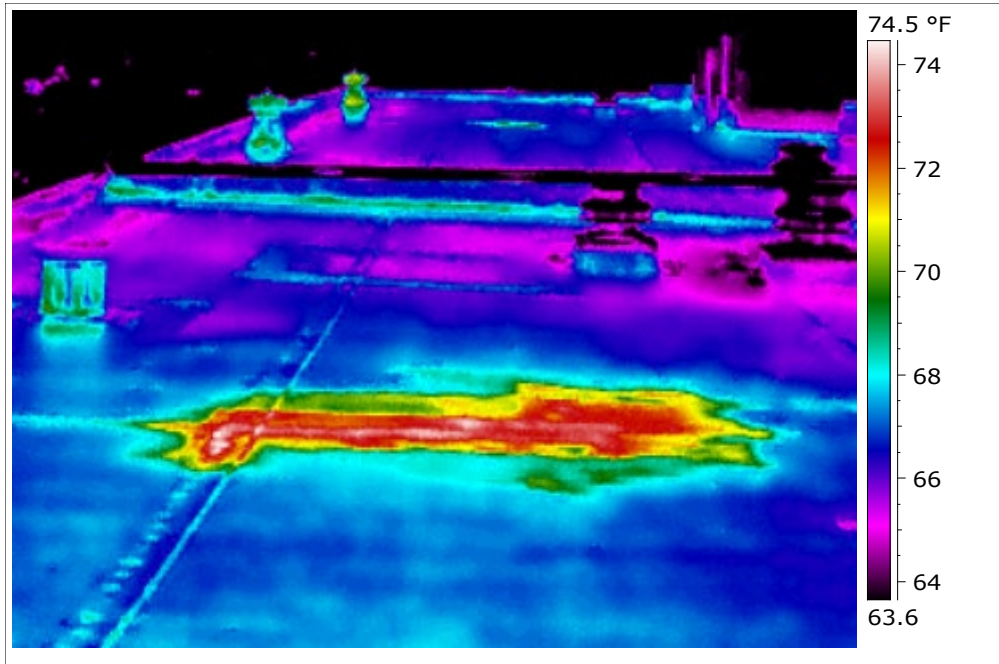
Thermogram # 1

Wet Area #1

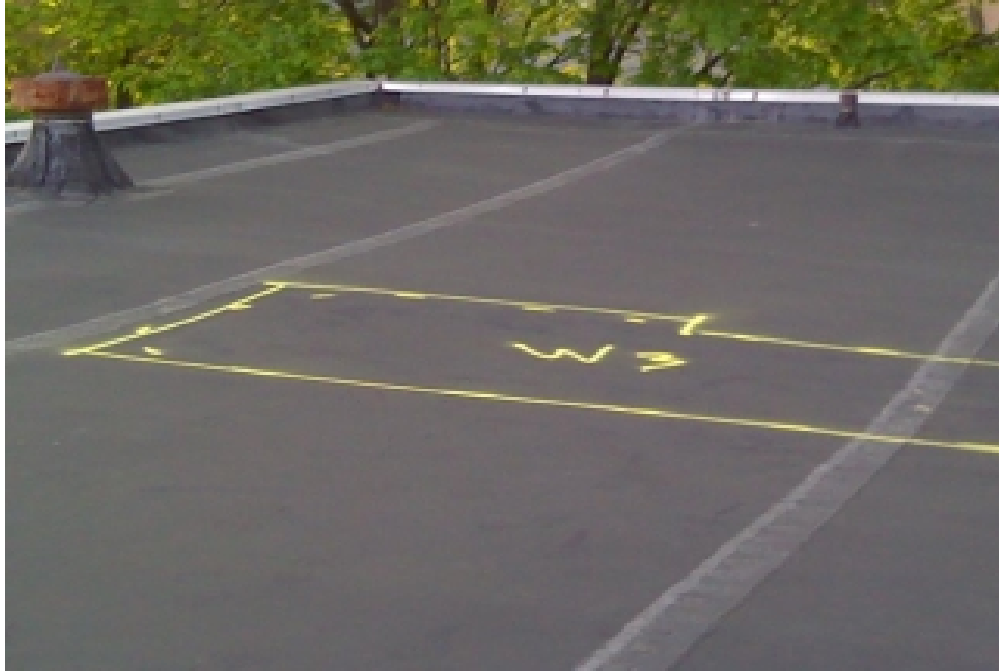
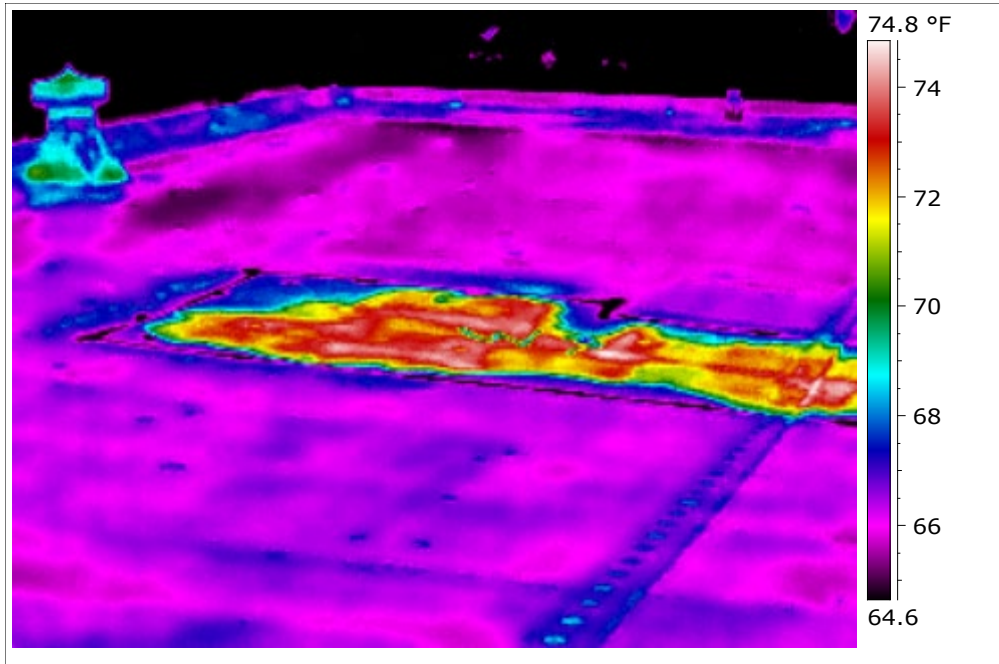
Thermogram # 2

Wet Area #3

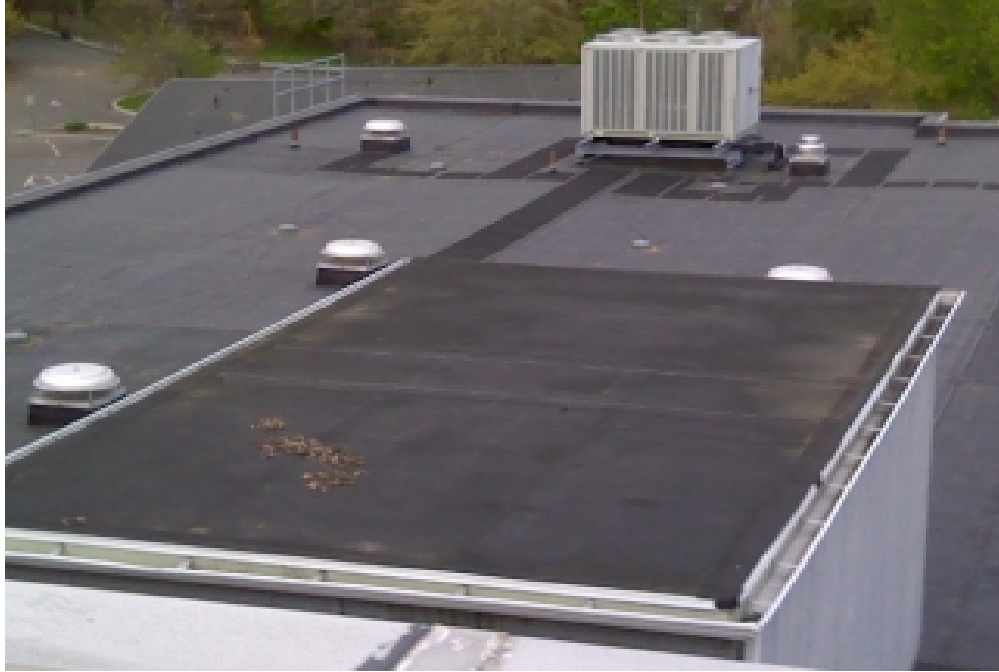
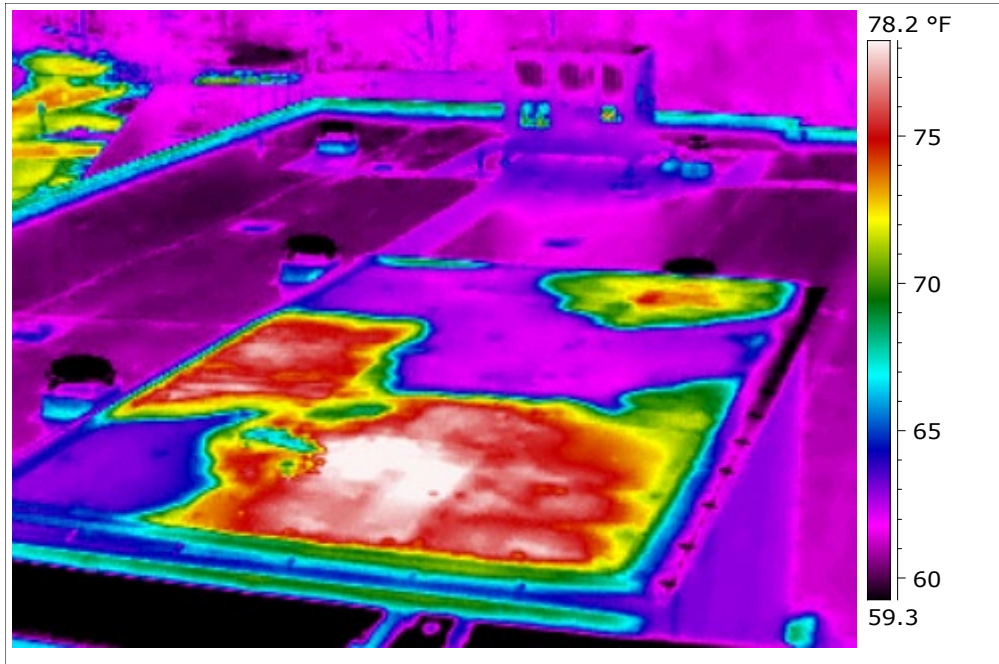
Thermogram # 3

Wet Area #17

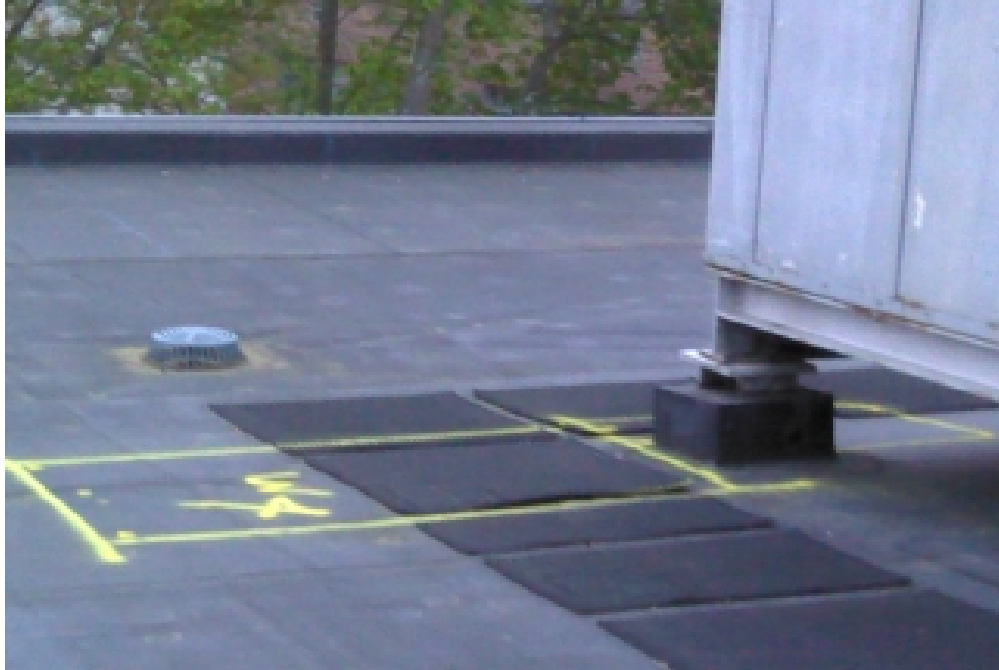
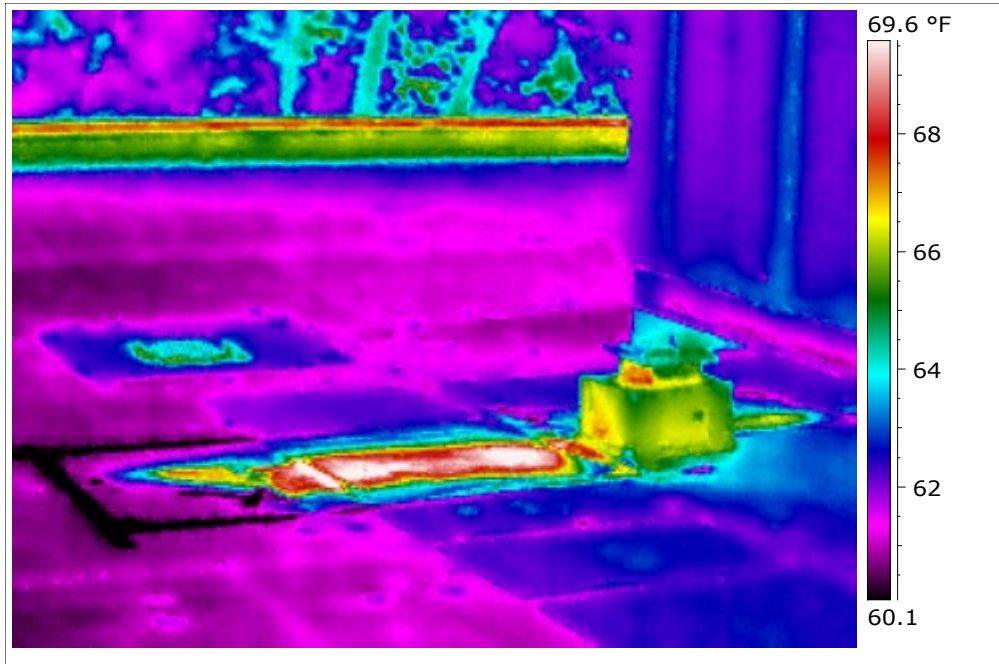
Thermogram # 4

Wet Area #4

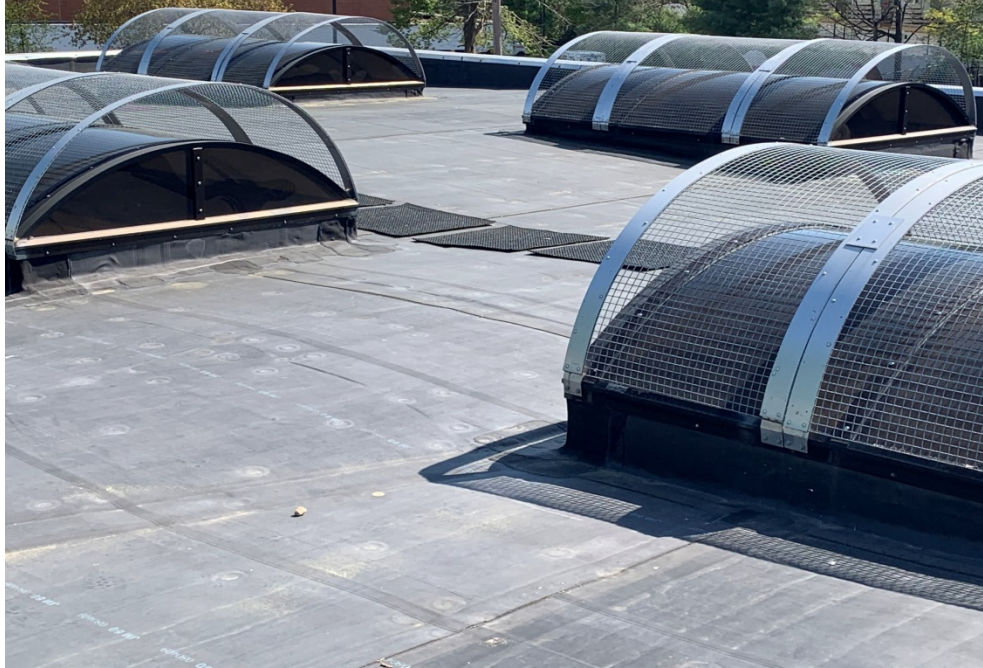
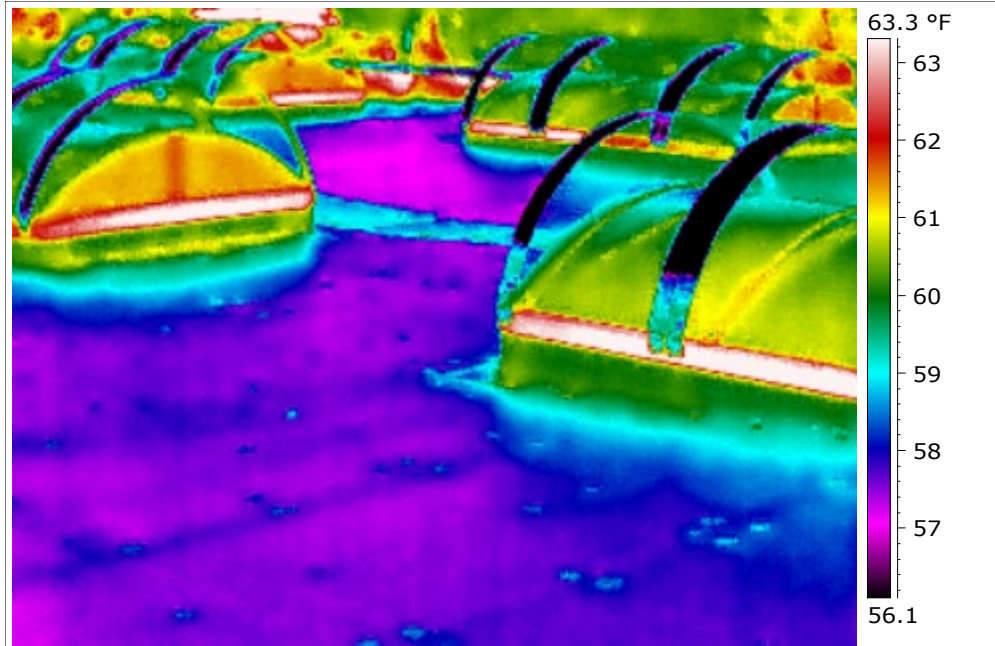
Thermogram # 5

Dry area of roofing

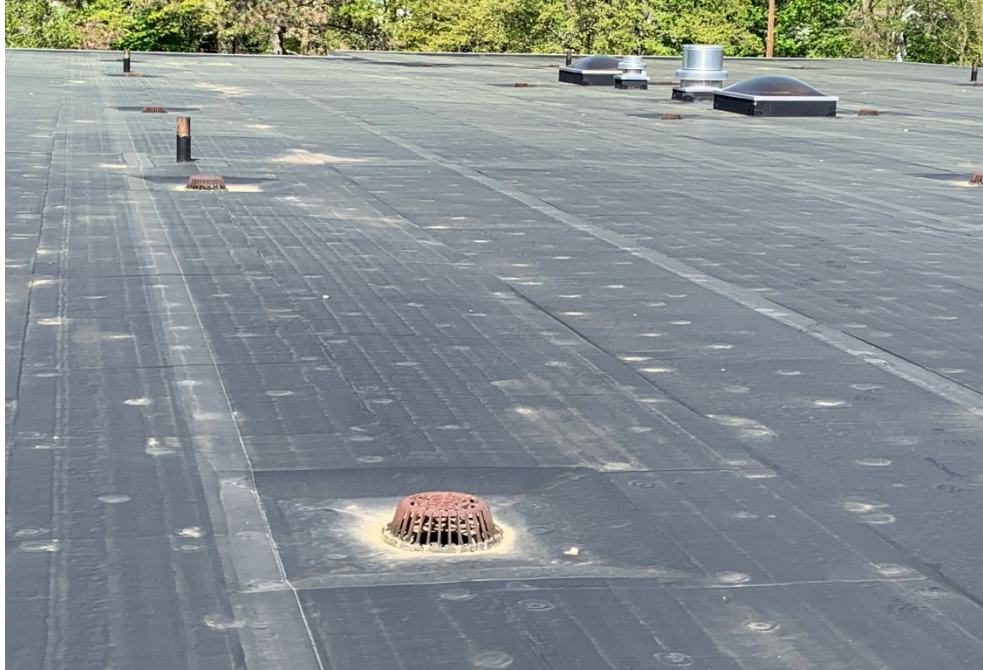
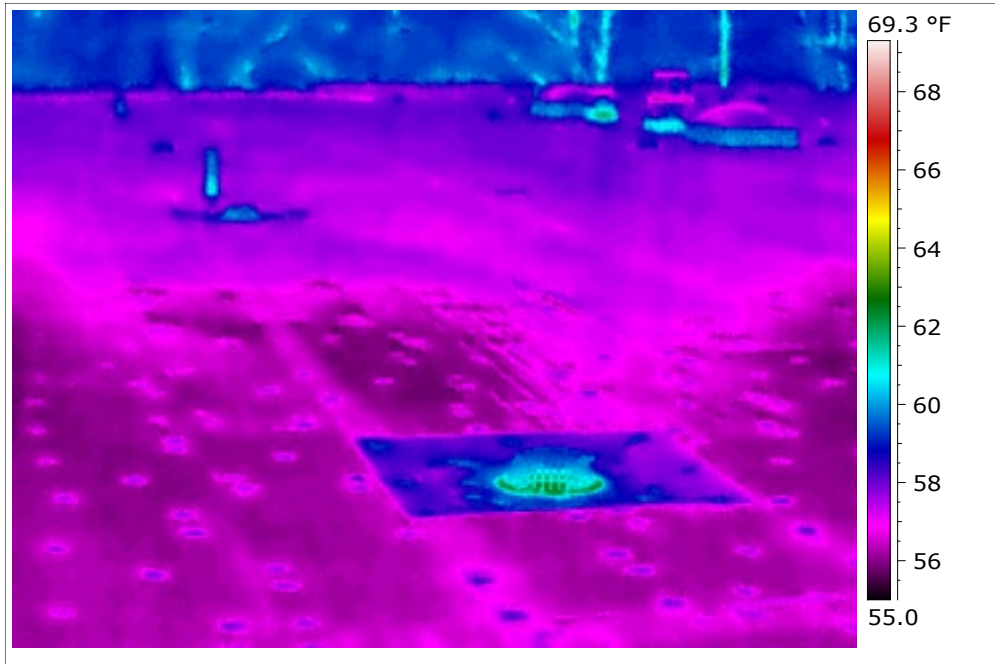
Thermogram # 6

Dry area of roofing

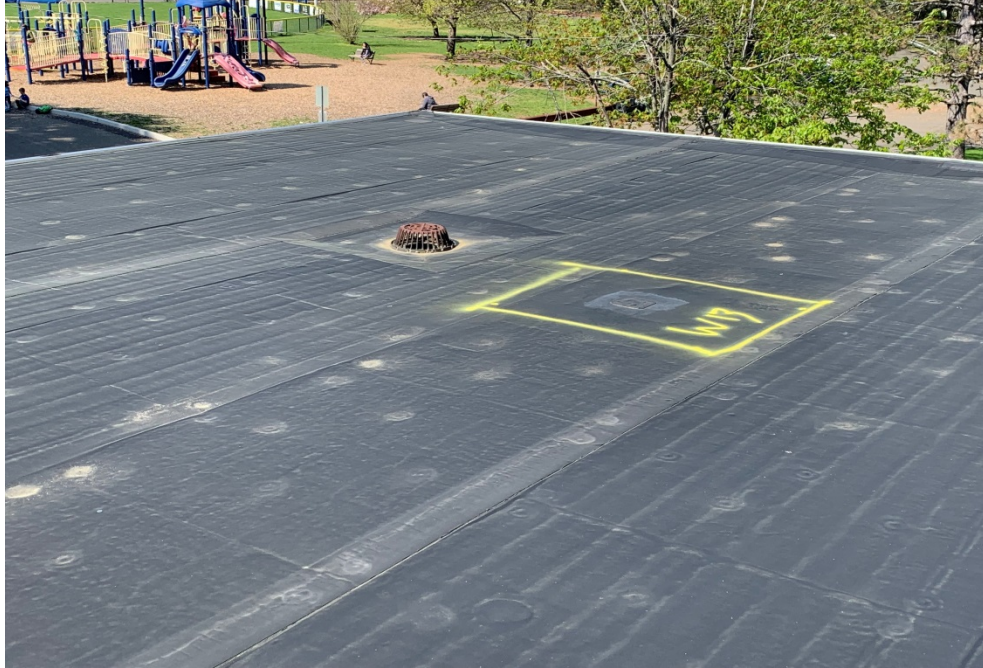
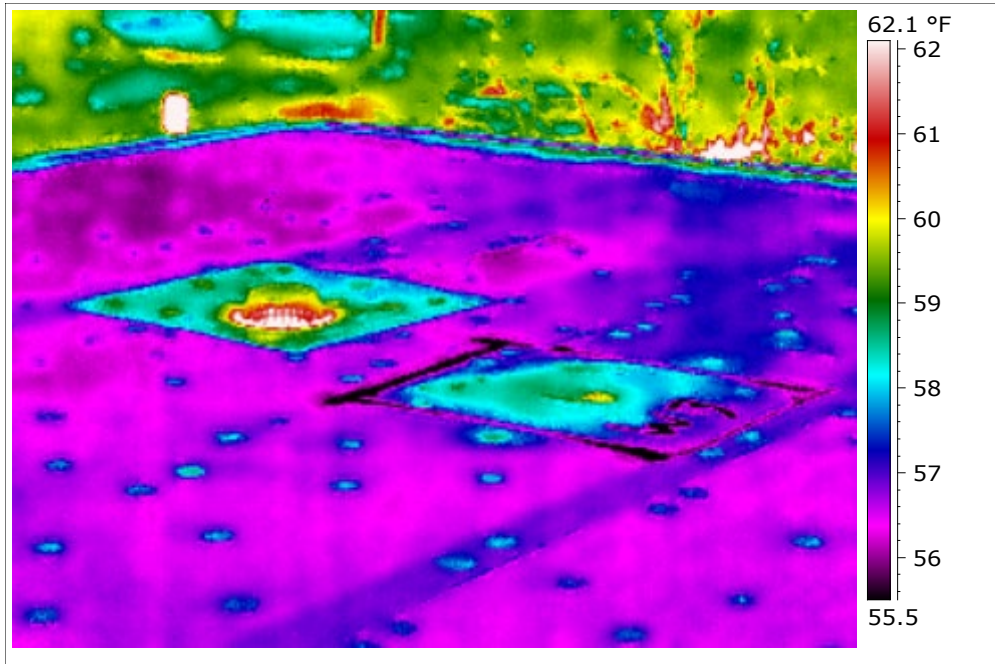
Thermogram # 7

Wet Area #7
