# Infrared Thermographic Roof Moisture Analysis

**PERFORMED FOR:** Viking Construction  
1387 Seaview Ave.  
Bridgeport, CT 06607

**LOCATION:** Stillmeadow Elementary  
Stamford, CT

**CONDUCTED ON:** May 6 & 7, 2019

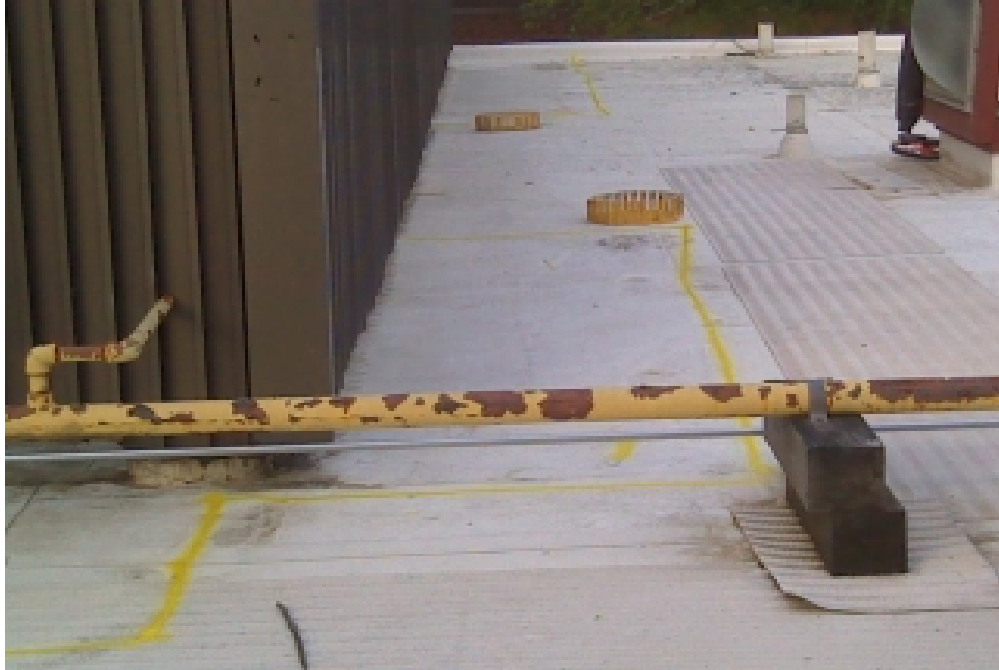
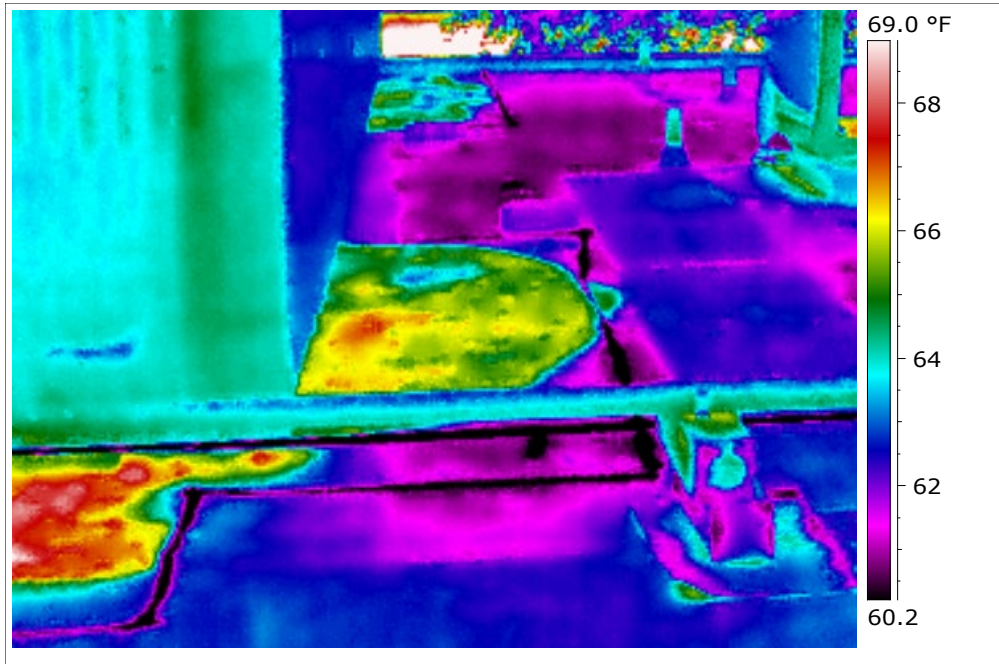
Thermogram # 1

Wet Area #1

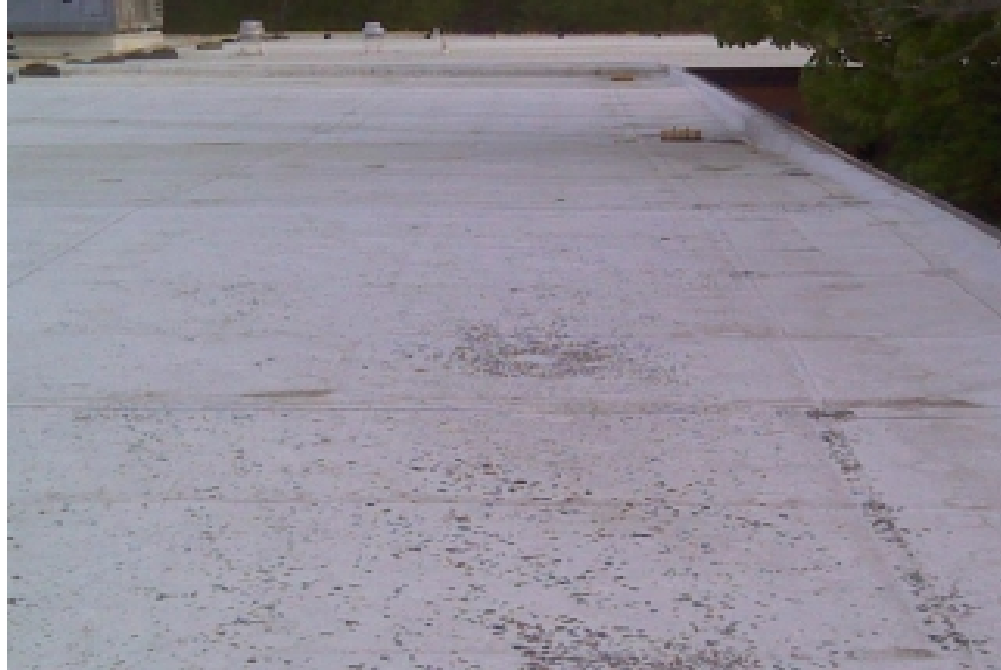
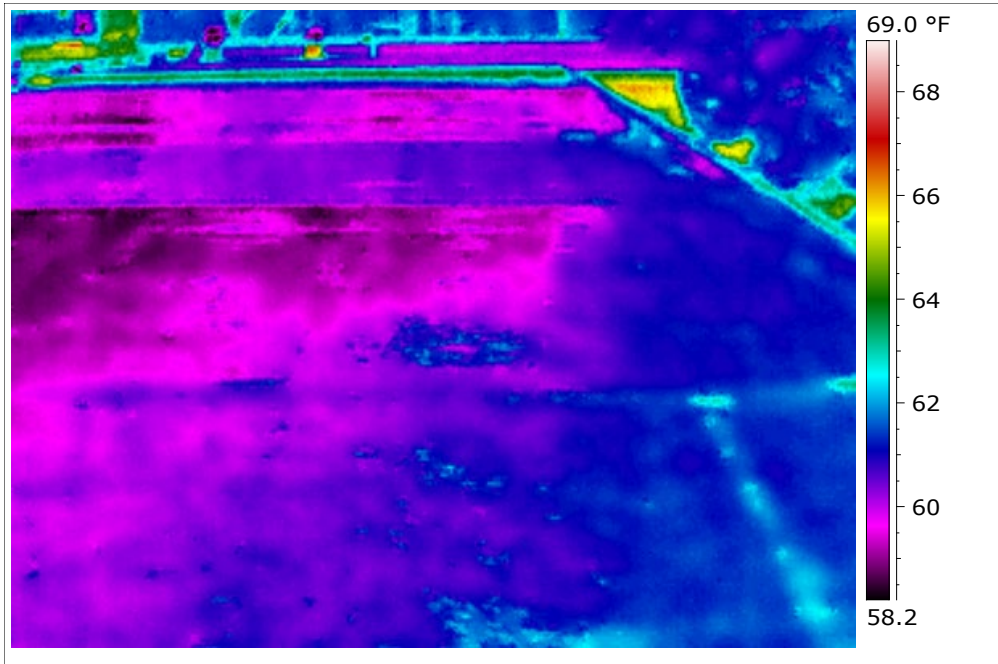
Thermogram # 2

Dry area of roofing

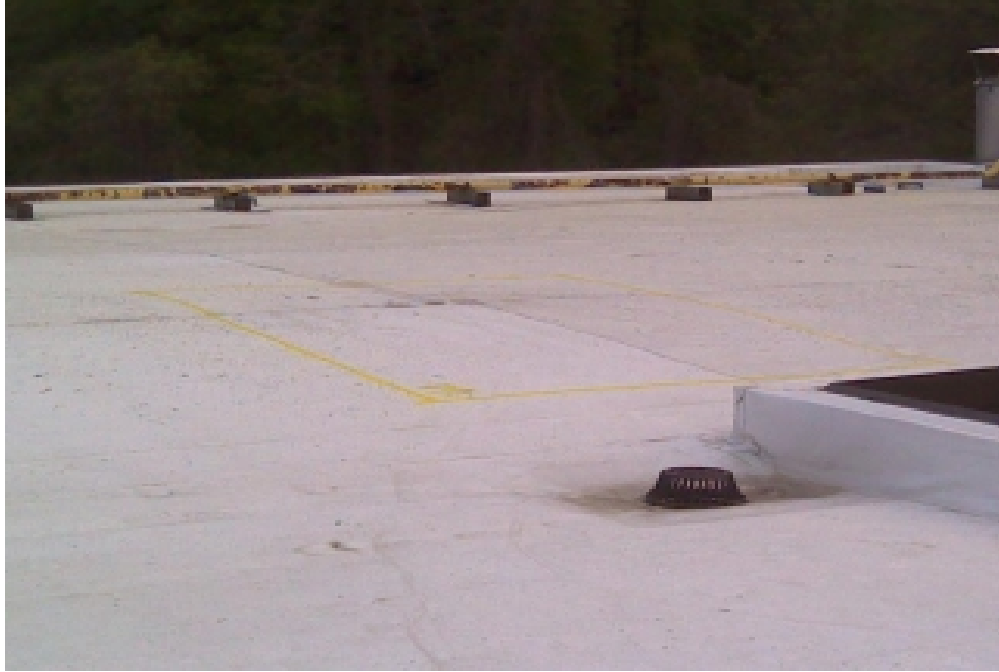
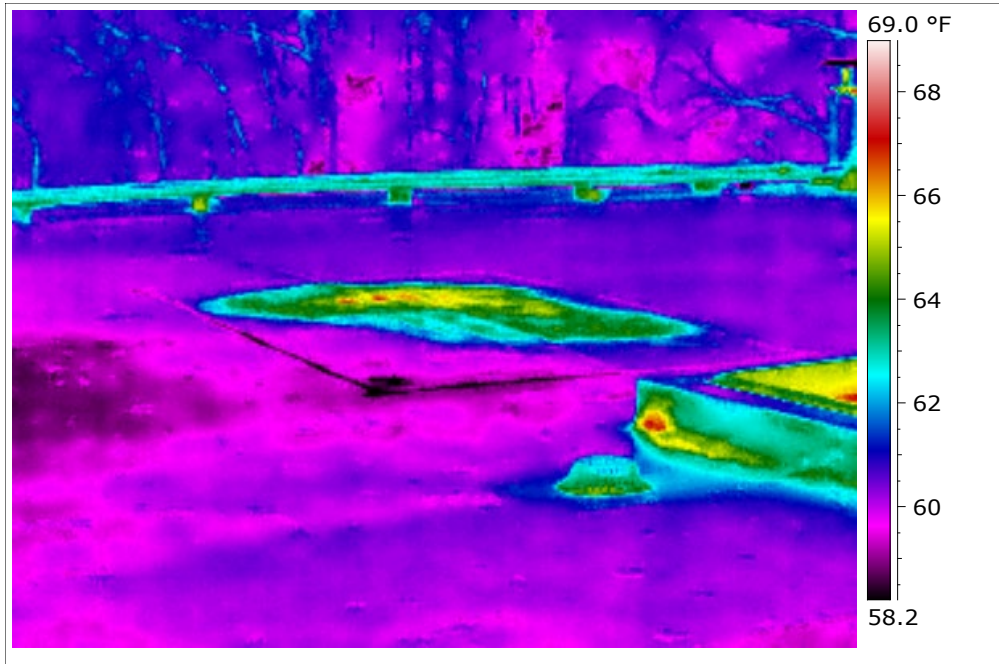
Thermogram # 3

Wet Area #3

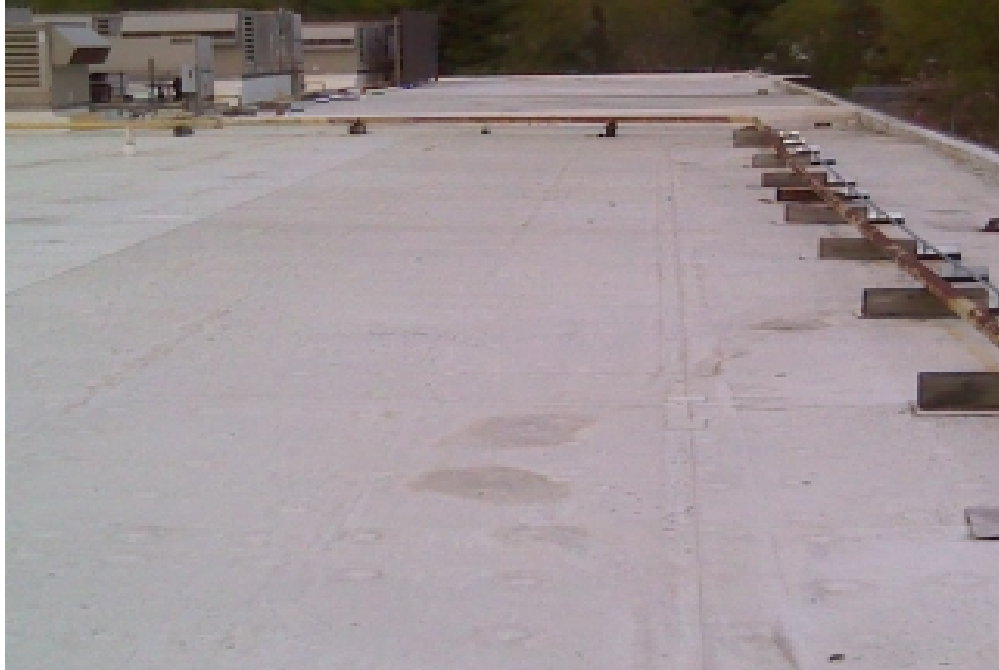
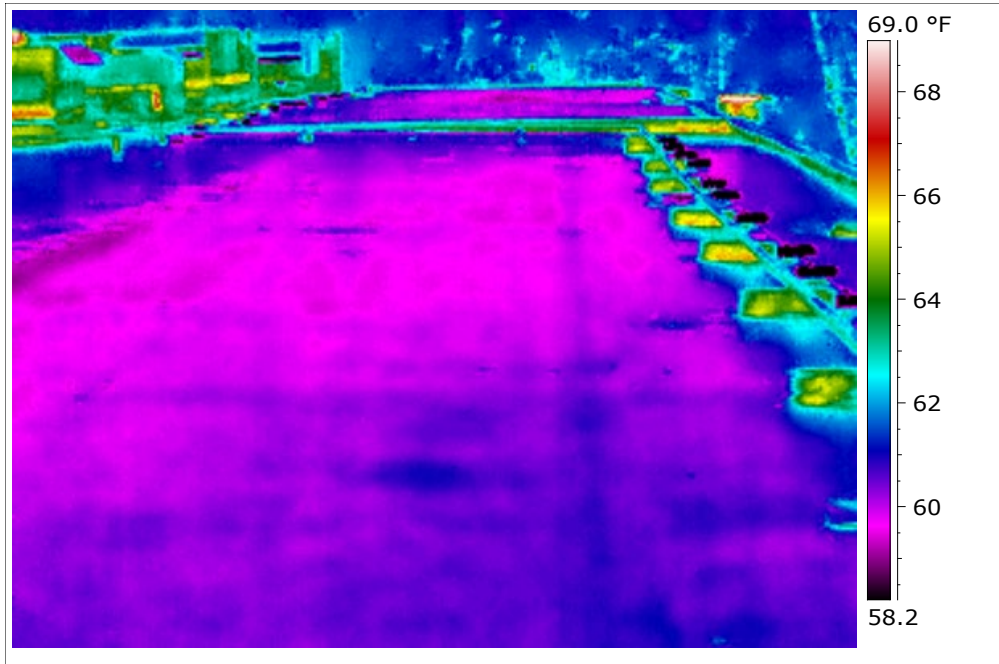
Thermogram # 4

Dry area of roofing

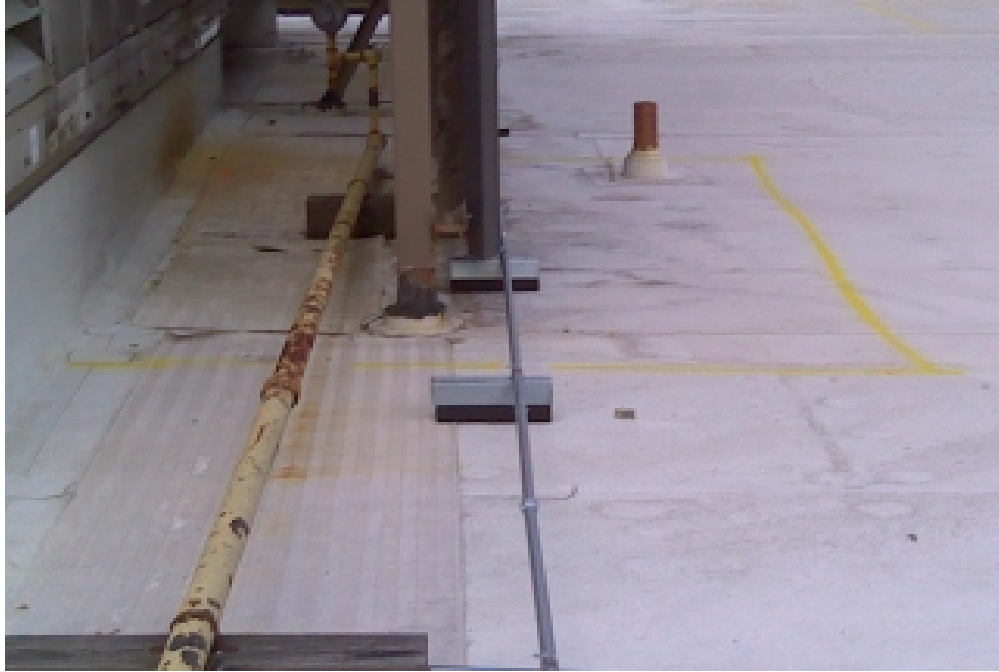
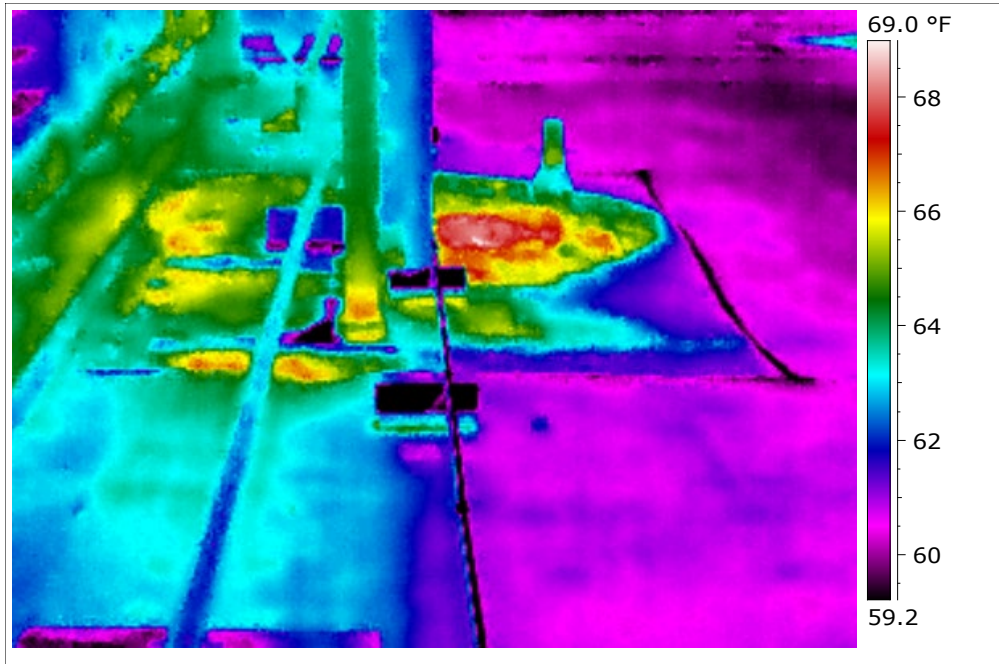
Thermogram # 5

Wet Area #5

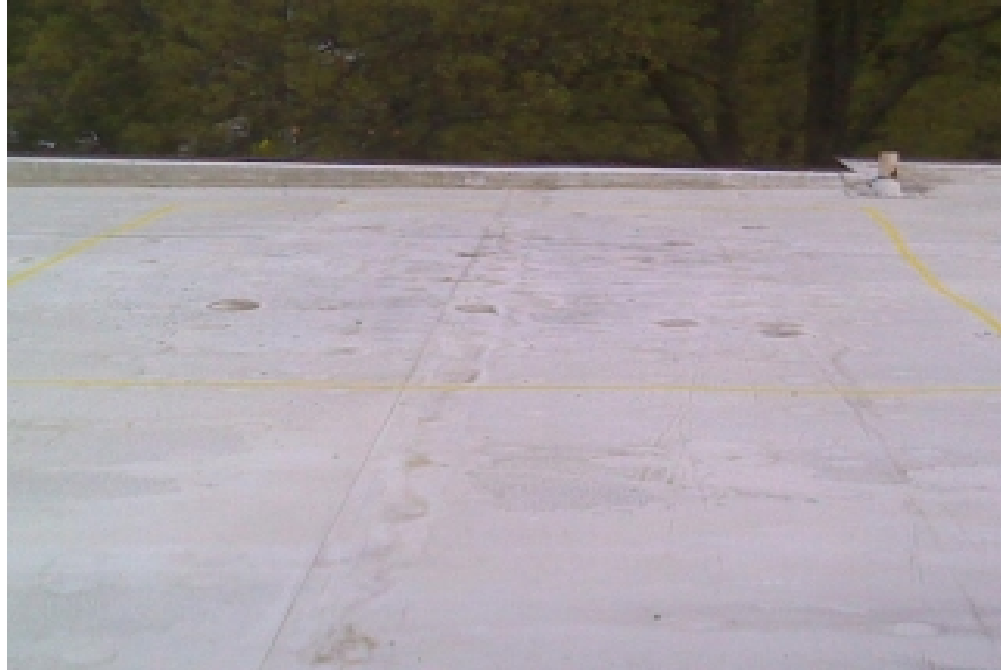
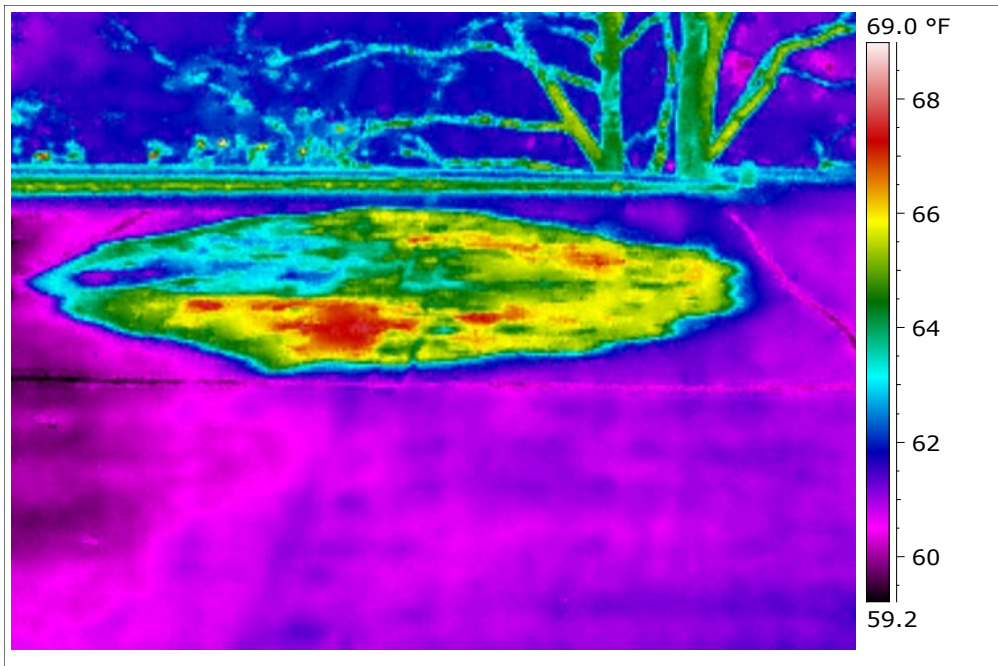
Thermogram # 6

Wet Area #6

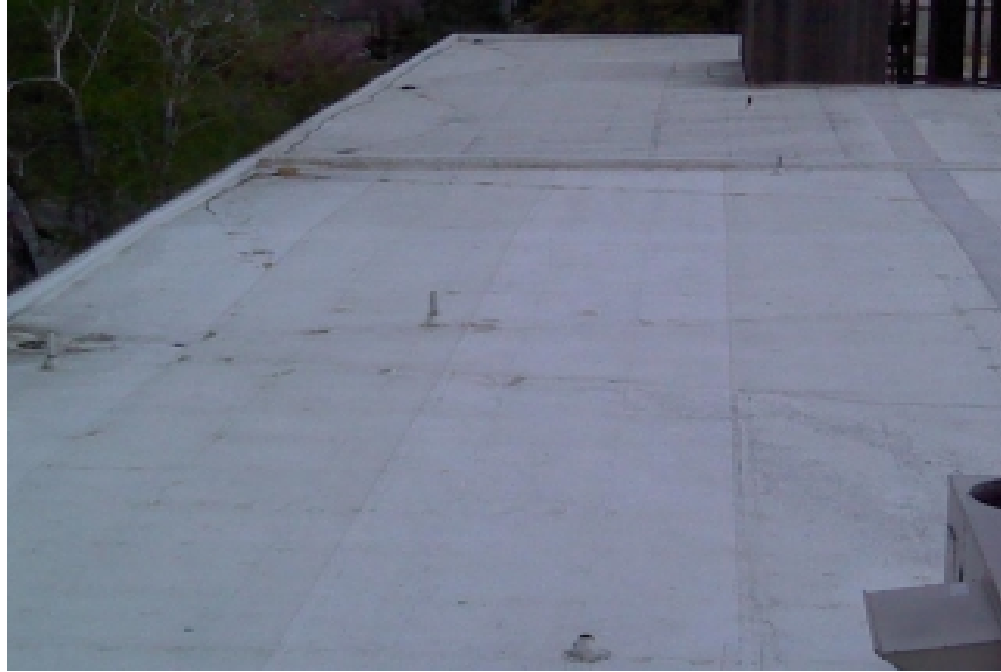
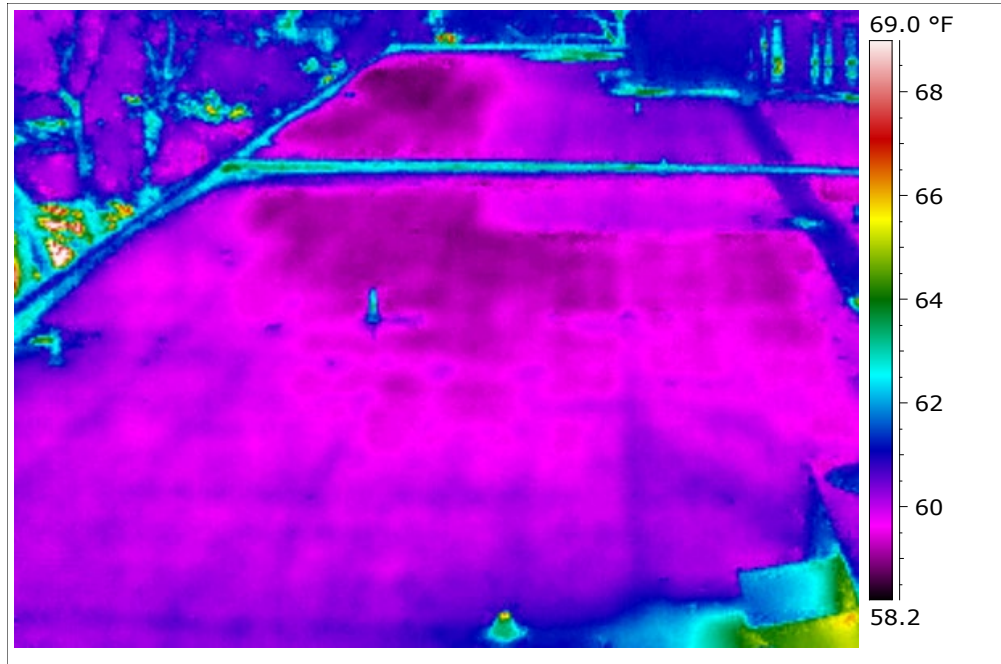
Thermogram # 7

Dry area of roofing

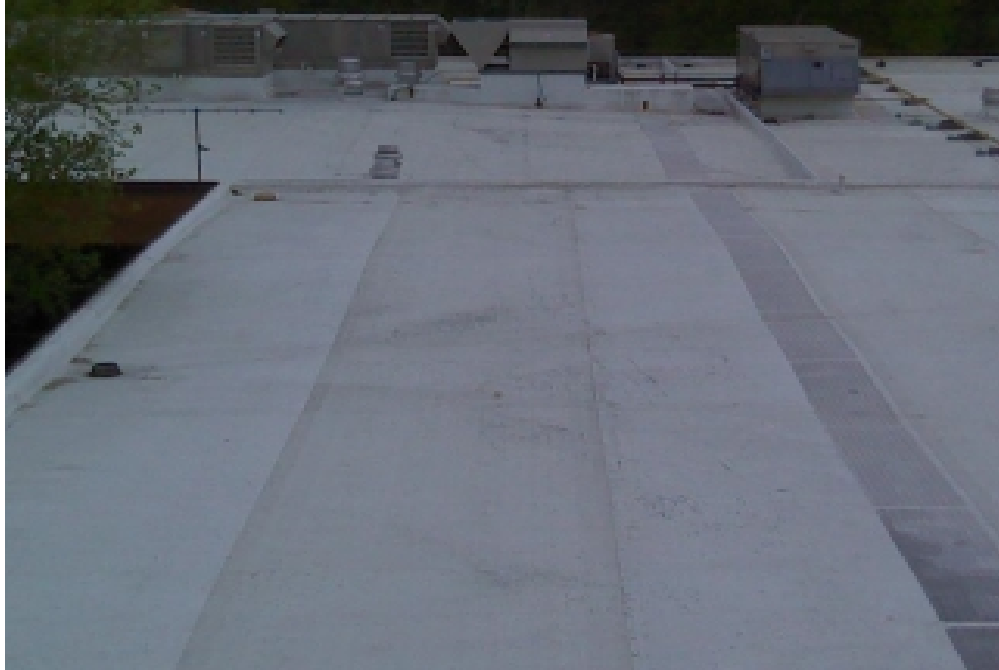
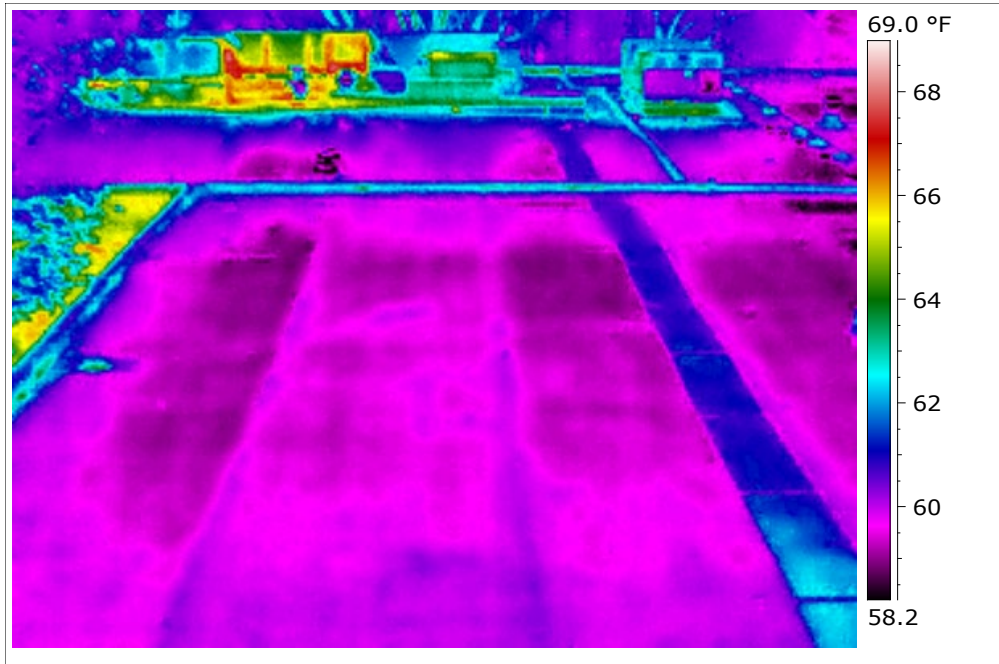
Thermogram # 8

Dry area of roofing

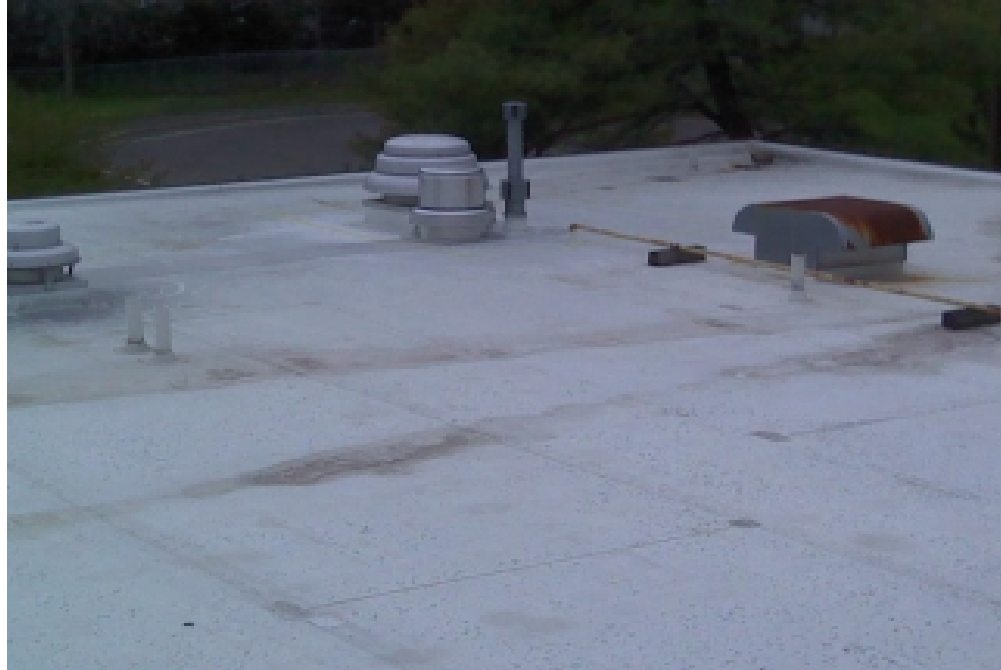
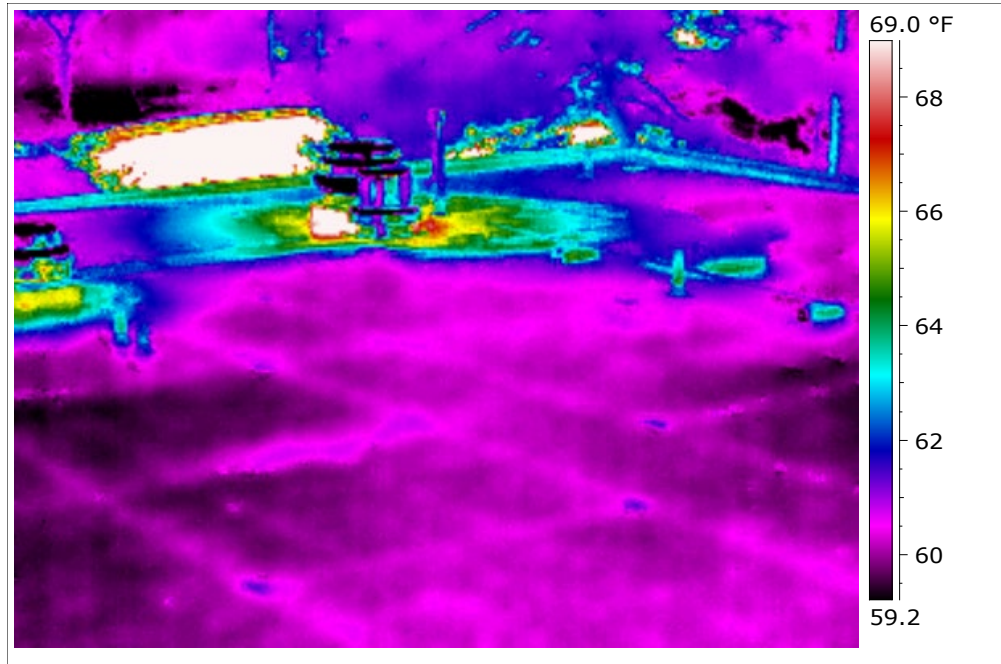
Thermogram # 9

Wet Area #22

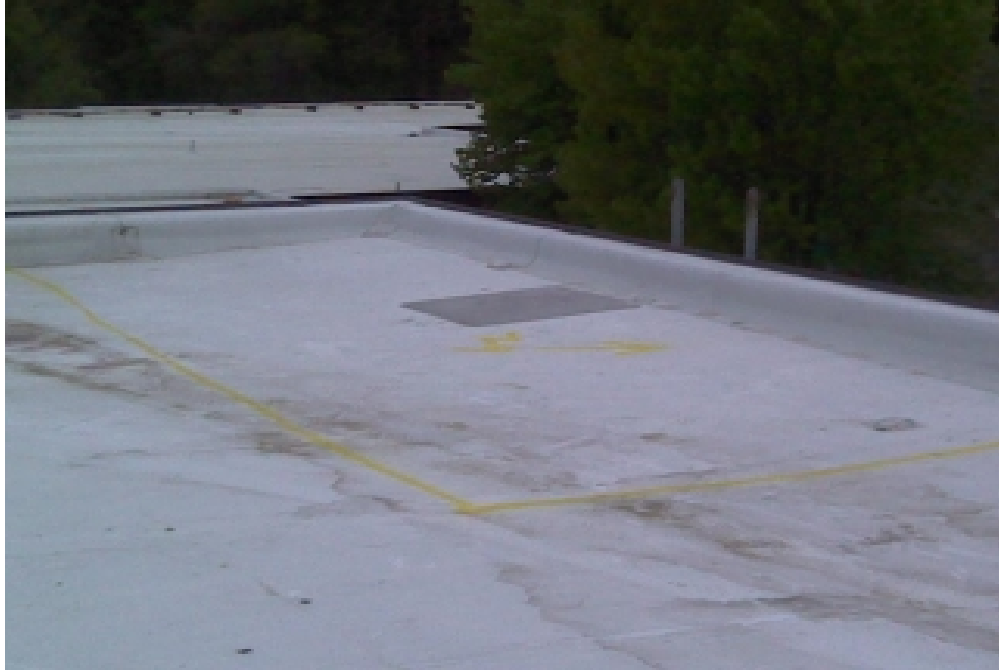
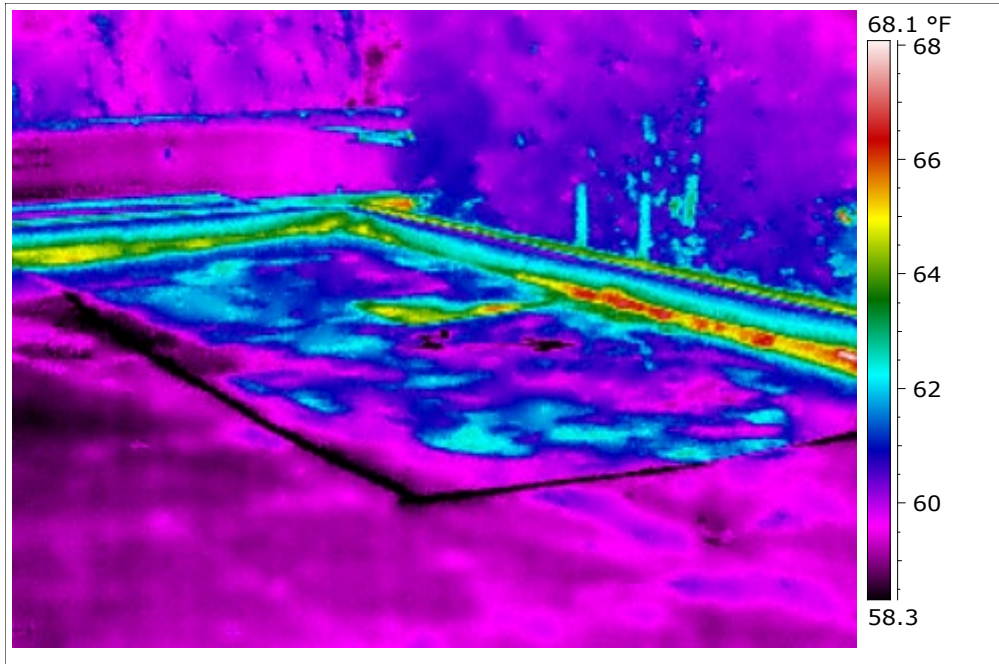
Thermogram # 10

Wet Area #23
