Toquam Magnet Elementary School

Exterior Façade Investigation

398 Glenbrook Road
Stamford, CT 06906

FINAL Report
November 12, 2019

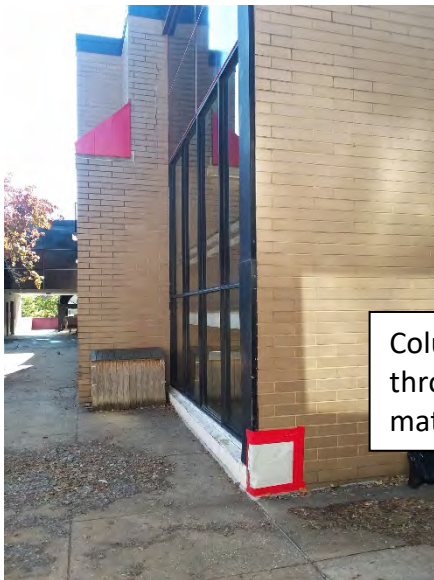
P2-1

There is a column buried within the wall about 8 inches back from the metal cover. It is wrapped in the same plastic flashing use for the through wall flashing. There are no weeps and no through wall flashing within the wall at this location. There is a stair behind this location leading to the lower level. The steel is exposed in some areas and it's starting to rust. There are brick ties attached to the steel column that are rusted and which protrude through the plastic flashing. The plastic flashing is not lapped properly to prevent water from migrating behind the flashing. The plastic flashing is rigid and brittle. The sealants at the metal cover are completely delaminated from the metal. There are small vertical fractures in the face of the brick above the test probe.

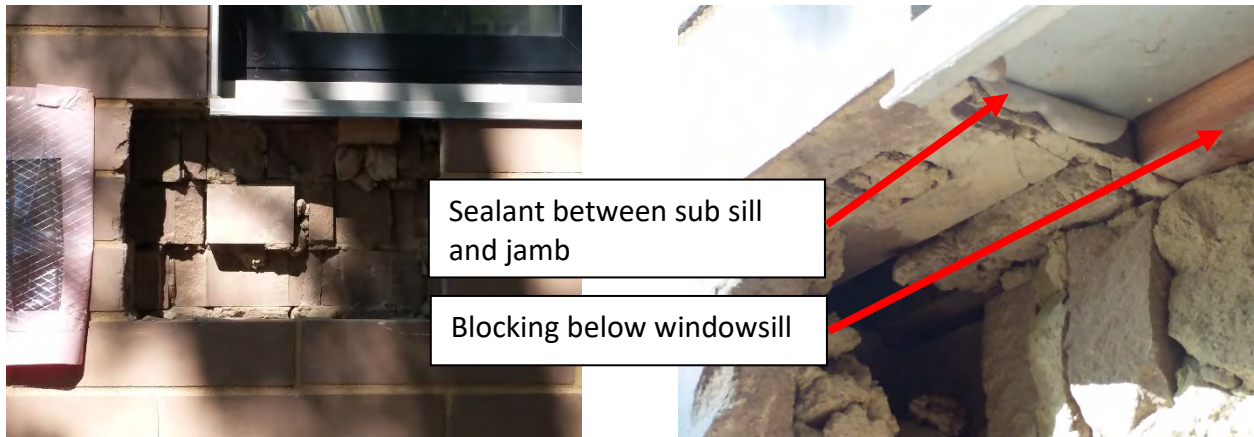
P3-1

Probe is located at the bottom left corner of the east most window at the media center. This window was not included on the original drawings. There is no under sill flashing. There does not appear to be any leaking through the subsill of the window. Sealants around the subsill are still spongy and adhered to the adjacent materials. There is no water resistive barrier behind the brick. The wall is made up of both 4 inch and 8 inch thick bricks. Mortar has fallen out to the interior of the building exposing the interior of the building at this test probe. The wall is 8 inches thick below the window opening and constructed of one wythe of 8 inch thick brick.

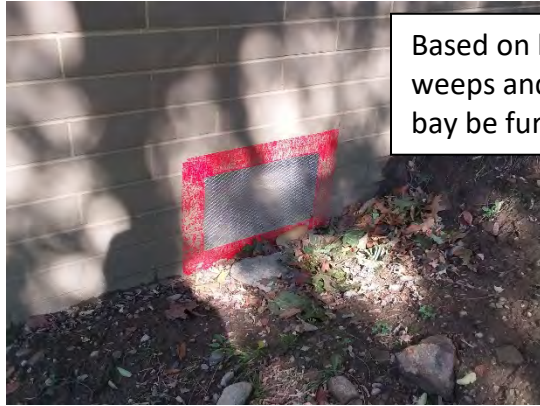
Probe is located at grade elevation below the window to the media center. There are no weeps at this area of the wall. Grade is sloping up from left to right across the base of the building. There is no water resistive barrier within the wall assembly. Some wire reinforcing bar was found within the grout line at the top of the probe. Cells of brick are grouted solid at grade elevation and open above grade elevation.

Based on building elevations, weeps and through wall flashing bay be further below grade.

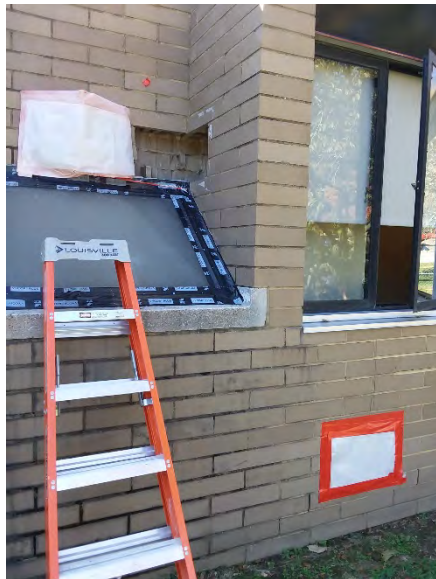
P 6-1

This probe is located above a skylight, at the back corner of the recess between classrooms E304 and E305. The skylight at this location allows daylight down into the lower level kindergarten indoor play area. This area is constructed of both 4, 8 and 12 inch thick brick. When the plastic protecting the opening was peeled back there was a large amount of humid and mildew smelling air that came out of the opening. The flashing across the top of the skylight only penetrates 1/2 in into the brick veneer. There are no through wall flashing or Weeps at the top edge of the skylight. The sides of the Skylight do not have any flashing let into the brick veneer. Sealant is the only water resistive barrier at the perimeter of the skylight. The sealant is cracked along the entire length.

Probe 6: Wall Section 5 on A11 Skylight details 27 & 28 on A21 – Wall construction at this probe is substantially similar to the wall section and details provided for this condition. The interior wall type is identified to be F on Sheet A5. Wall Type F is identified to be ½" GWB on 3 5/8" metal studs. Side wall between classroom windows and skylight, show in elevation 2 on A17 is identified to be exposed brick on the interior of the classroom. Probe shows that this wall is constructed of 12" thick brick with no water resistive barrier within the wall.

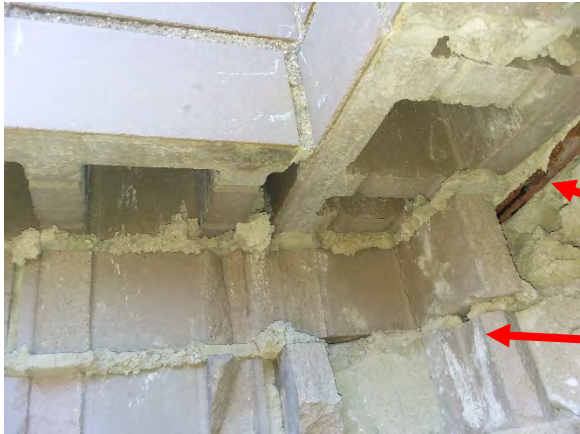
Rusted metal Unistrut

Efflorescence in block cells

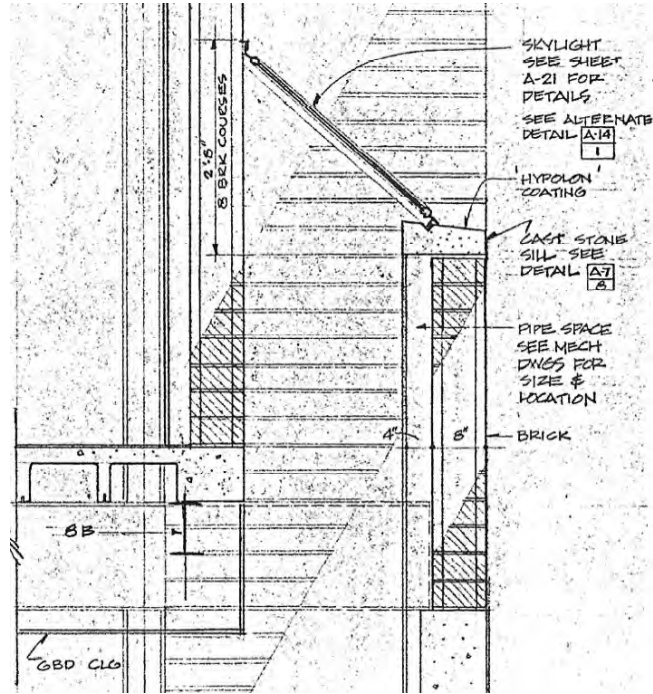
Wall Section 5 on Sheet A11

Probe 1: There are no wall sections of this typical condition of the building. A similar condition may be found in wall section 5 on A11. This wall section is taken at the skylight over the kindergarten indoor play area. This Section shows the skylight condition and the base of wall condition at grade and transitioning to a foundation wall. It also shows a metal stud and gypsum wall board (GWB) finish on the interior below the skylight. Interior Elevations for the classroom inside of this probe location calls for a metal stud and GWB finish (10/A17). Wall Type J is indicated on A4 for the wall at this probe location. This wall type calls for ½" GWB and insulation in the stud cavity. Section 5 on A11 does not show any base through wall flashing or weeps. These are provided at this probe location, but the weeps are located above the base of the through wall flashing, which would not allow water within the cavity to escape through the weep. 5 on A11 calls for a 4" cavity with 8" exterior brick. Brick thickness found at the probe is consistent with the detail. Insulation and size of wall cavity inside of the 8" brick was not determined during our investigation. Other walls section for the building call for a clear silicone coating on the exterior face of the exterior brick. This product is intended to waterproof the exterior surface of the grout and brick, preventing water from infiltrating into the building. This product is not permanent and must be maintained to ensure water does not migrate through the brick and mortar and to the interior of the building.

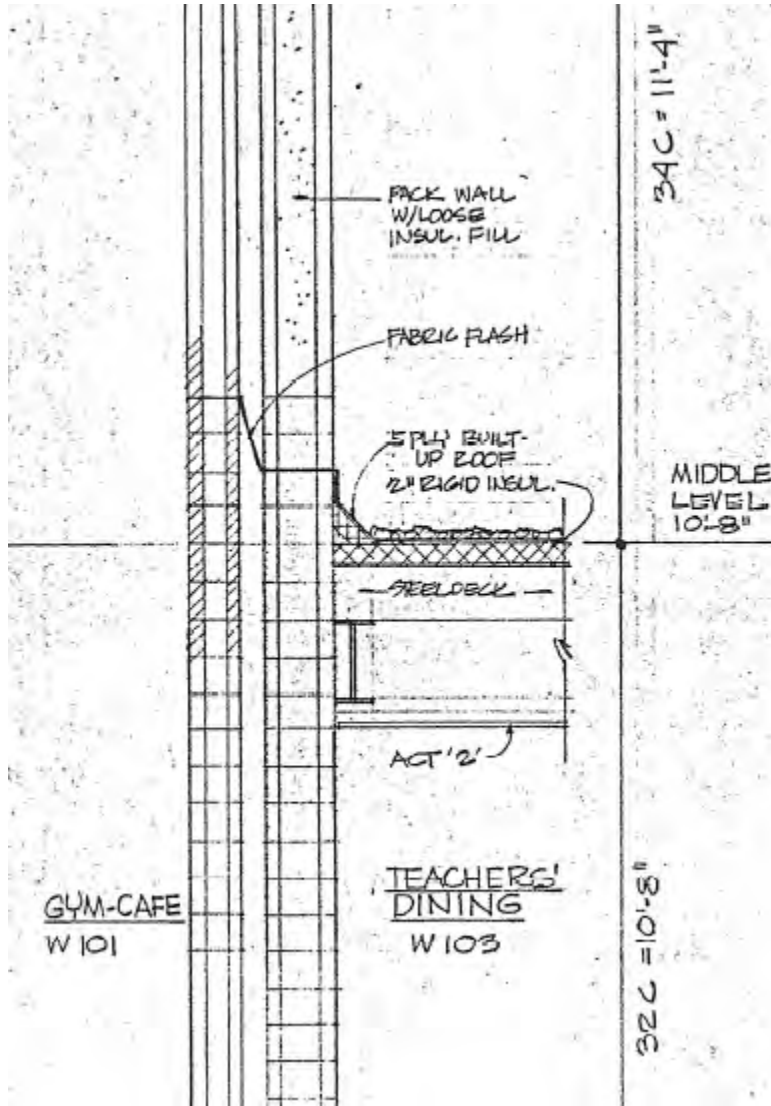
Partial Wall Section 11 on A13

Probe 8: Wall Section 11 on Sheet A13 – Wall construction at this probe is substantially similar to the wall section. The wall section calls for loose insulation fill within the outer wythe brick cells which was not observed at the probe.

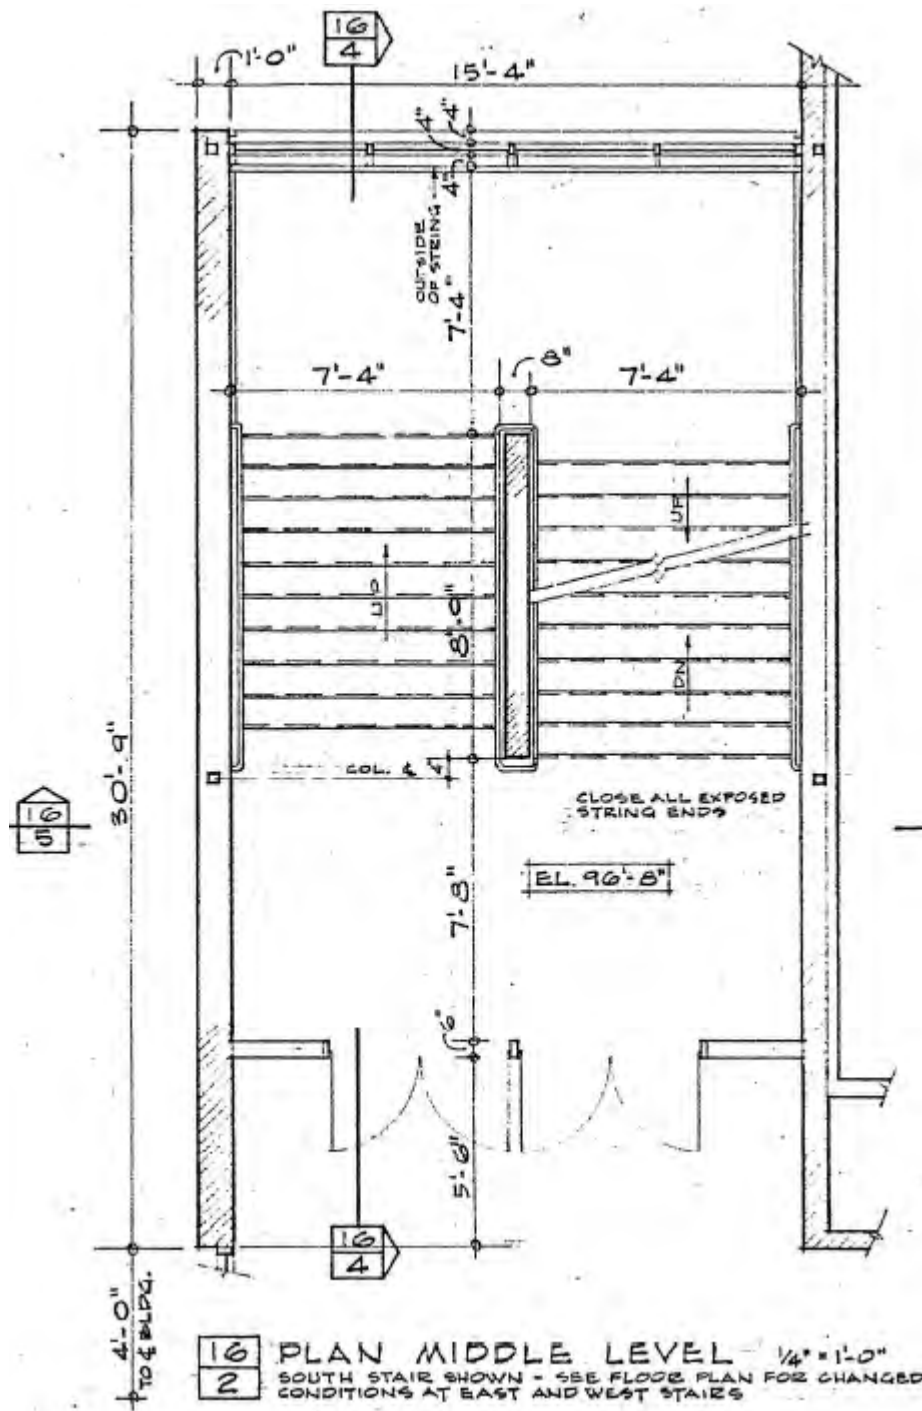
Probe 2: Plan 2 on Sheet A16 – The stair plans show the location of the square column within the outside corner of the masonry wall. No wall sections or details have been found in the drawings provided to indicate the intended construction of the wall at this probe location. Stair plan seems to imply that this wall is a single, 12" thick brick. Probe appears to indicate that the wall is constructed of an 8" thick exterior brick layer and potentially a 4" thick interior brick layer. The lack of weeps at the base of the wall and from what was observable in the test probe, it is unlikely that there is a water resistive membrane within this wall assembly.

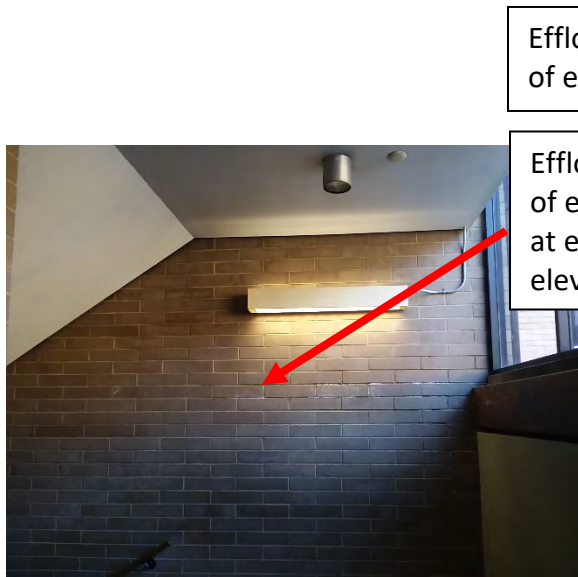
1-1

2. Water staining and efflorescence is observed on the interior side of exterior walls of storage and similar enclosed spaces located above grade.
3. Metal building components (access panels, electrical panels, heating system piping, etc.) within enclosed spaces (closets, chases, etc.) along the exterior walls of the building are corroded.

Efflorescence on interior of exterior wall.

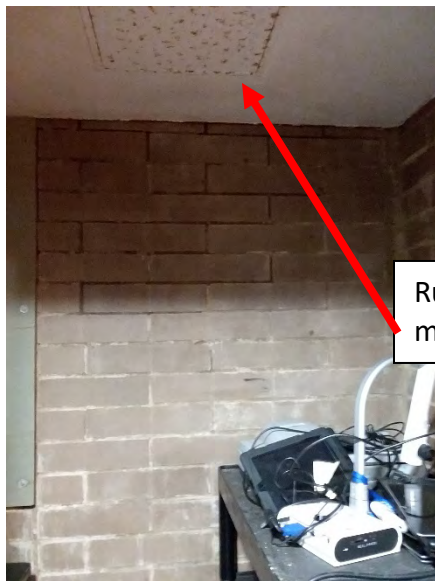
3-1

4. Interior brick near the exterior walls or window openings are cracked.
5. Cast-in-place foundation walls at the east side of the kindergarten indoor play area were not well consolidated.

Cracked bricks

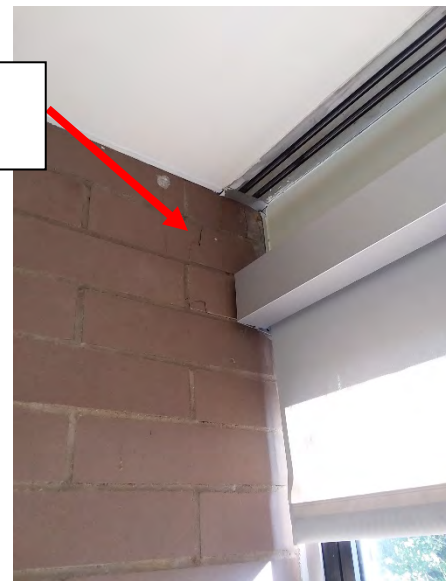
4-1

Rust on interior metal materials

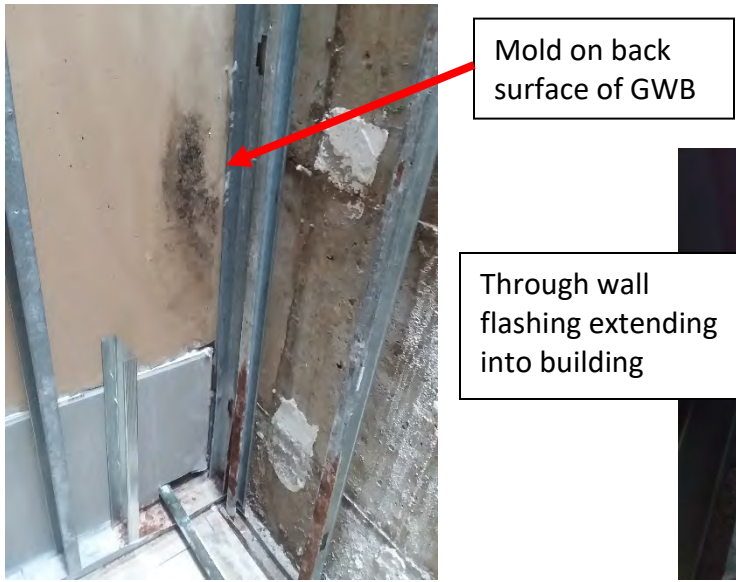
7-1

6. Cold formed galvanized metal studs along the exterior wall of the kindergarten indoor play area have minimal to severe corrosion.
7. Mold impacted drywall was observed in the kindergarten indoor play area.

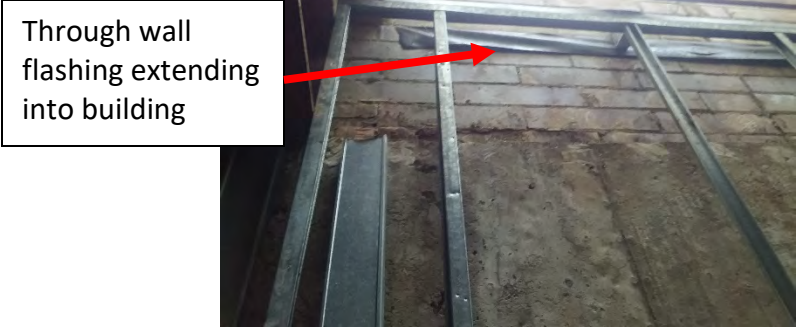
8-1

8. A black sheet material was observed at the window wells of the kindergarten indoor play areas, at about grade elevation, coming through the grout joint of the exterior wall. This material would be concealed behind the metal stud and drywall finish.

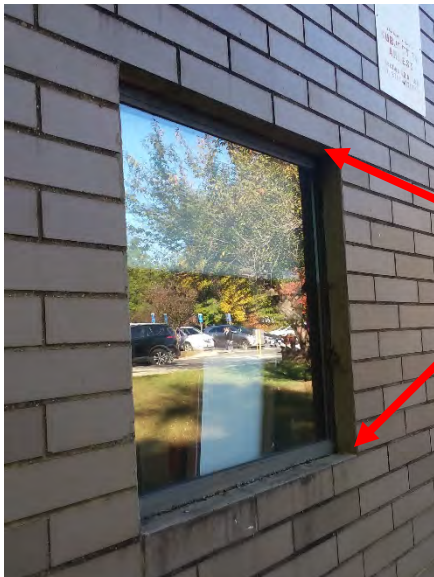
2-1

- 2. Sub sills are missing at window openings of the main office and principal's office.
- 3. Lintels are missing at window openings of the main office and principal's office.

Lintel not observed

No sill over brick

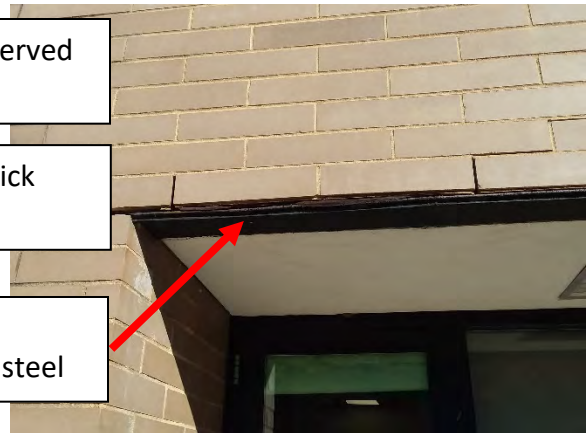
4-1

- 4. Lintels over kindergarten classrooms at interior courtyard: exposed edge of steel are rusted, delaminating and, in areas, rust has caused the welded steel plate below to deflect.

Rusting and delaminating steel

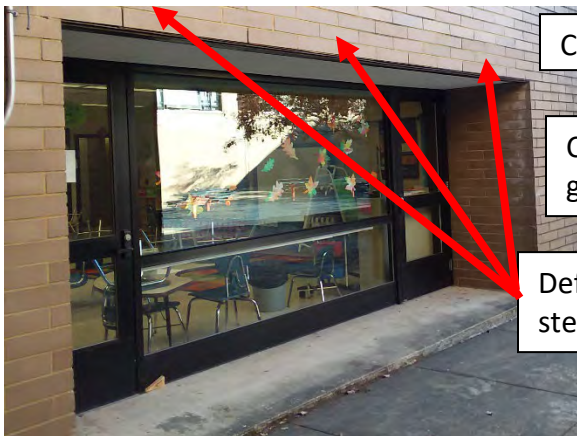
Cracked sealant

Cracked window gasket

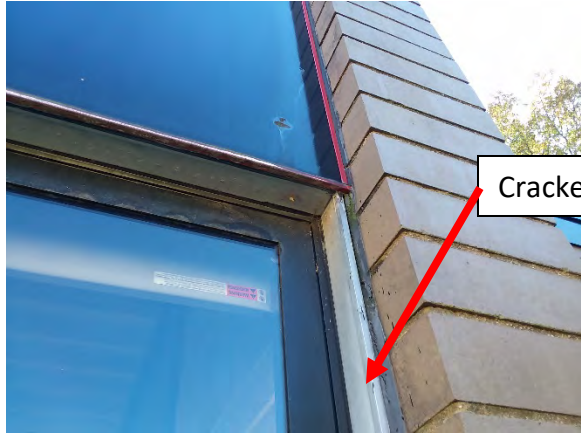
5-1

- 5. Sealants around window and door openings are rigid, cracking, and delaminating from adjacent materials.
- 6. Aluminum window frame finish is worn, exposing the bare frame material.

Cracked sealant

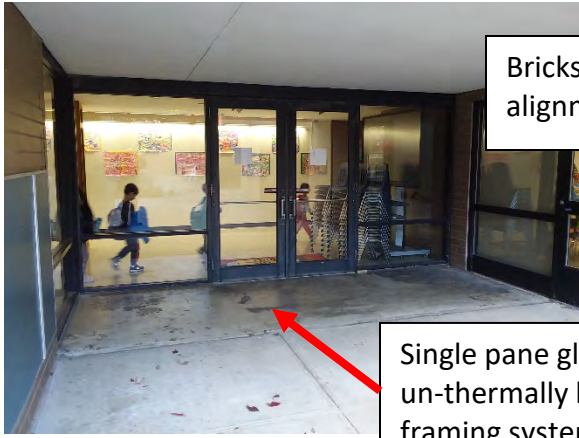
12-1

- 10. Red frames around black panels is damages at multiple locations.
- 11. Seals of the glazing at typical classroom windows are cracked and missing.
- 12. Window systems are not thermally broken and do not use insulating glass which during cold weather may lead to excessive condensation forming on the interior of the windows, damaging interior finish material adjacent to the windows.

Single pane glazing and un-thermally broken framing system

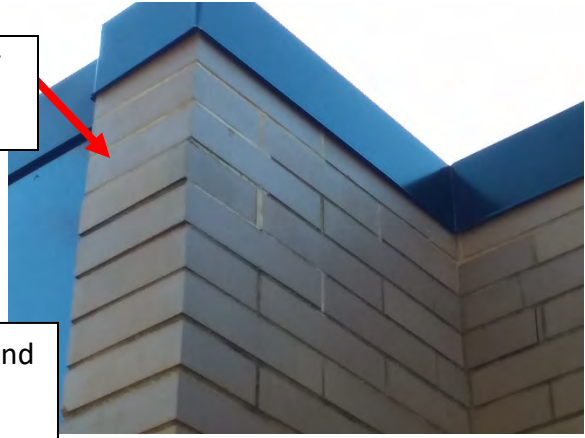
14-1

- a. Brick at the upper portion of these walls are cracked.
 - b. Brick have been pushed out of alignment with the brick below.
- 15. Brick and mortar joints in the major brick wall areas are in disrepair.

Bricks out of alignment

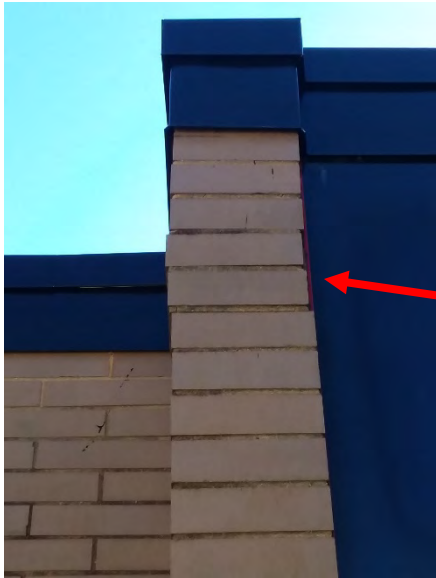
Bricks cracked and out of alignment

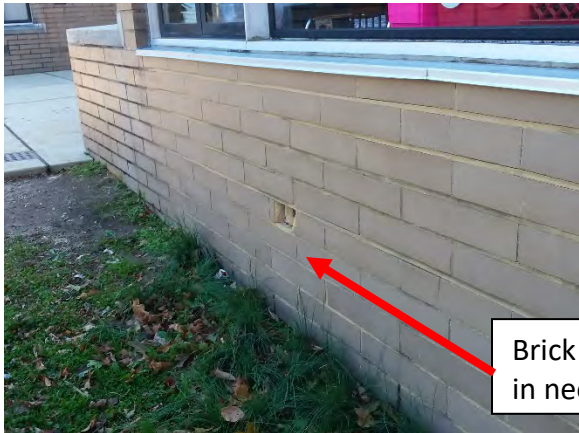
15-1

Brick and mortar in need of repair

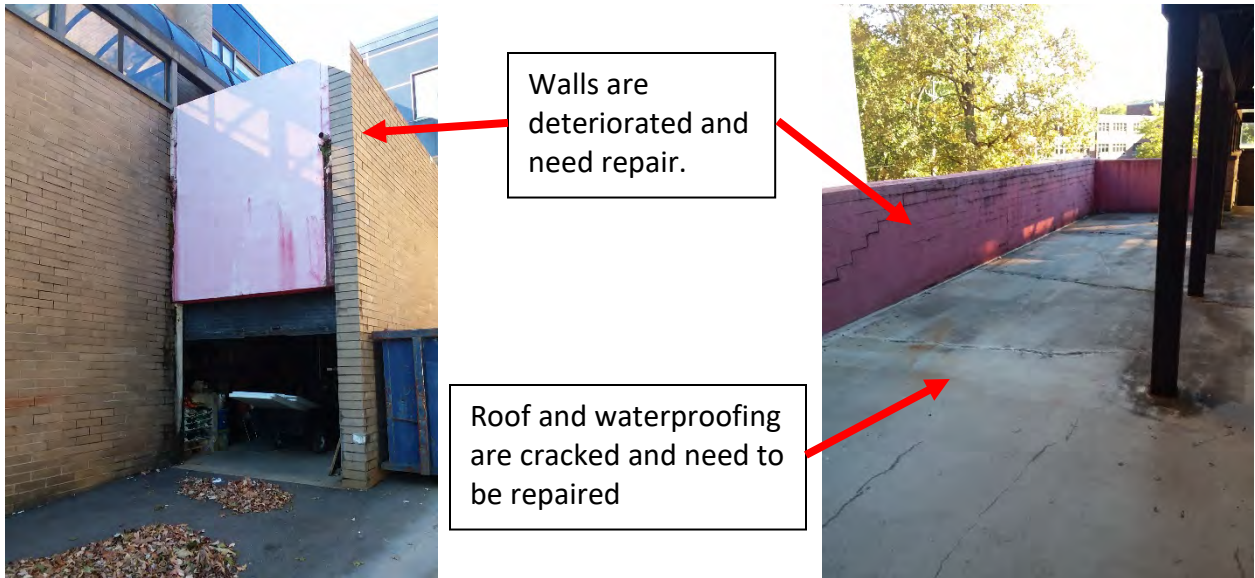
18-1

- 18. Brick walls around the grounds garage and adjacent exterior stair need extensive restoration.
- 19. Steel structure of exterior barrel vault skylight needs to be repaired and painted.

Walls are deteriorated and need repair.

Roof and waterproofing are cracked and need to be repaired

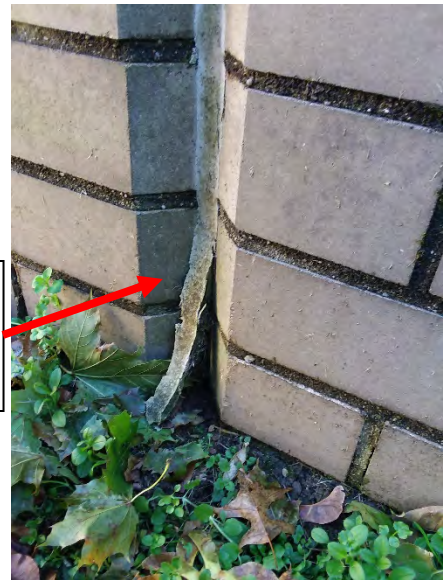
26-1

- 25. Precast concrete cap between Classrooms E301 and E302: Pipe penetration through it is sealed with foil face tape.
- 26. Expansion joint between Classrooms N301 and N302 needs to be repaired.

Repair expansion joints

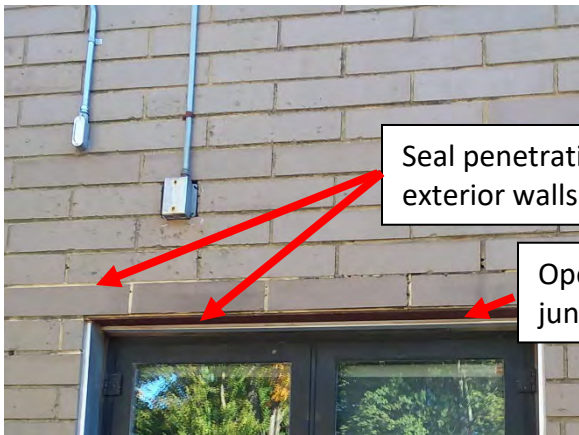
27-1

Open junction box

Seal penetration in exterior walls

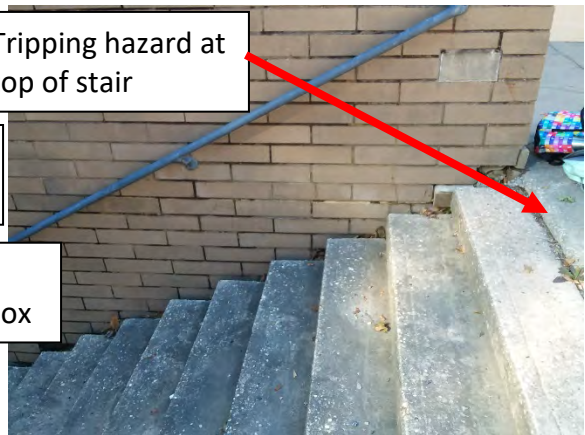
28-1

Tripping hazard at top of stair

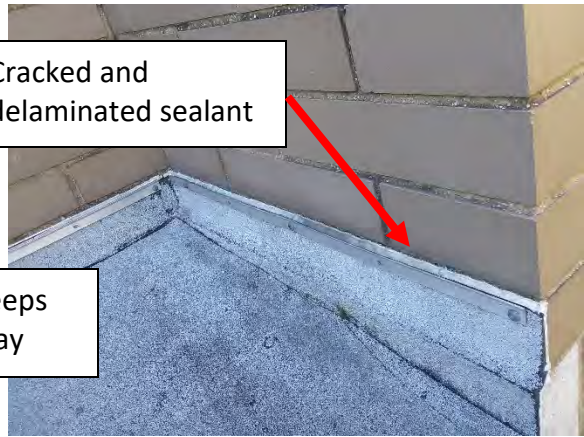
30-1

30. At the alcove between Classrooms E301 and E302, sealants around top edge/term bar of the modified bitumen roofing are cracked and delaminating.
31. The skylight between Classrooms E302 and E303 has been repaired with flashing tape. This is a temporary fix.

Cracked and delaminated sealant

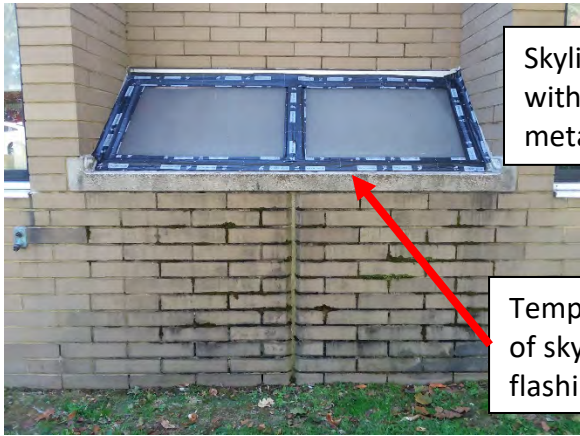
31-1

Temporary repair of skylight with flashing tape

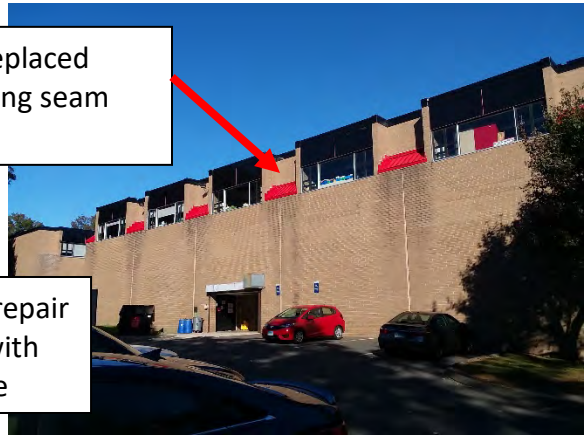
32-1

32. Original skylights along the west and east sides of the West Wing, the north side of the South Wing, and the West side of the east Wing have been replaced with a red standing seam metal roof. The only skylights that have not been replaced are at the east side of the East Wing.

Skylights replaced with standing seam metal roof.

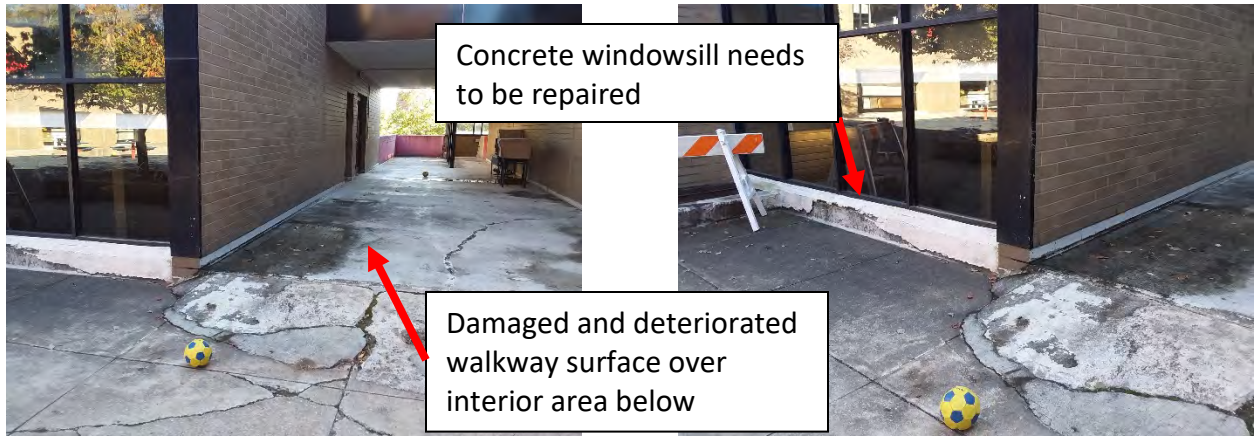
33-1

33. The South Courtyard exit's concrete floor surface and waterproofing traffic coating are cracked and in disrepair.
34. At the West, South and East building stairs:

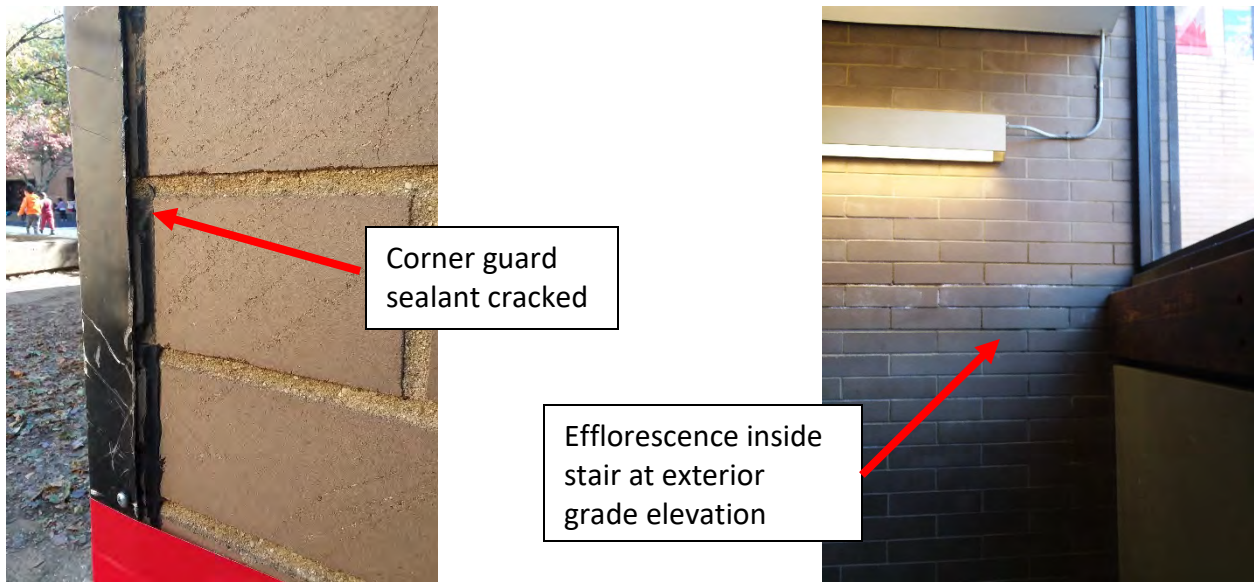
34-2

- a. The parge coat at the base of the storefront windows is spalled and needs repair.
 - b. Exterior metal corner guards are damaged and sealants to brick are cracked and open.

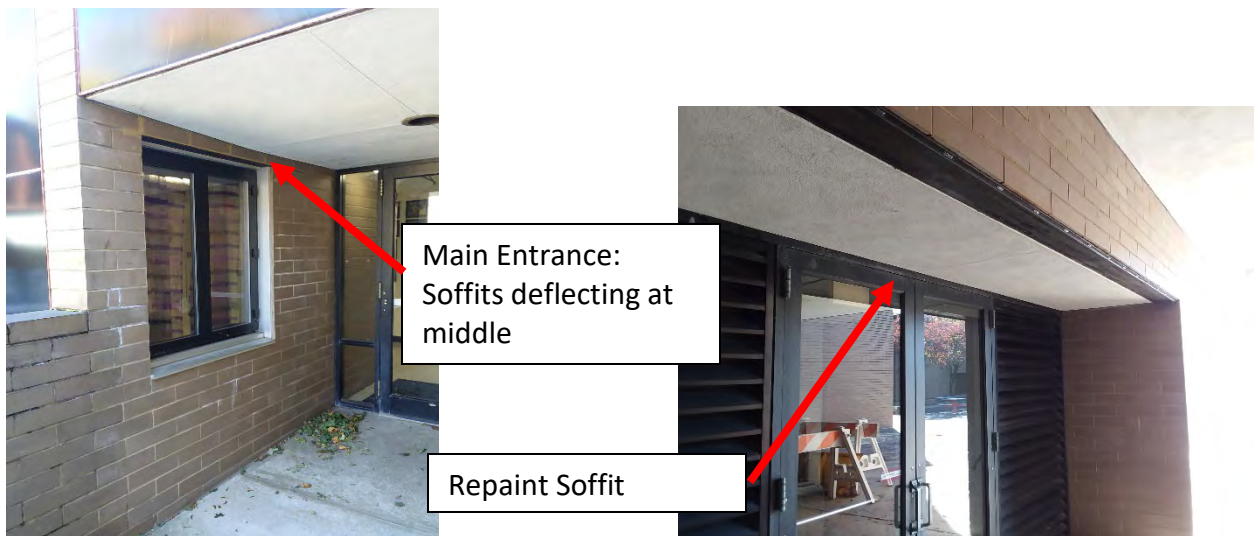
35-1

- c. Efflorescence is observed on the interior face of the exterior walls at around the ground elevation.
35. Exterior soffits are in generally good condition needing minimal scraping and repainting.

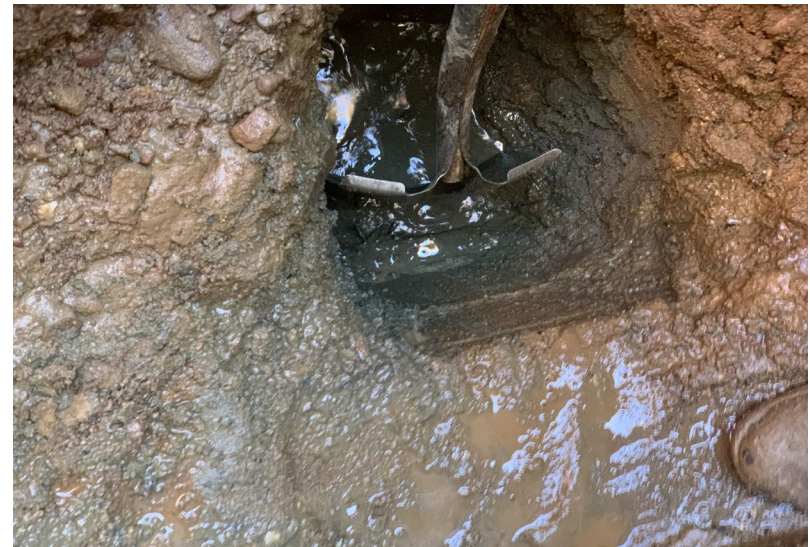
Photo # 4: Hand dug to expose 20-inch deep footing and no perimeter drain.

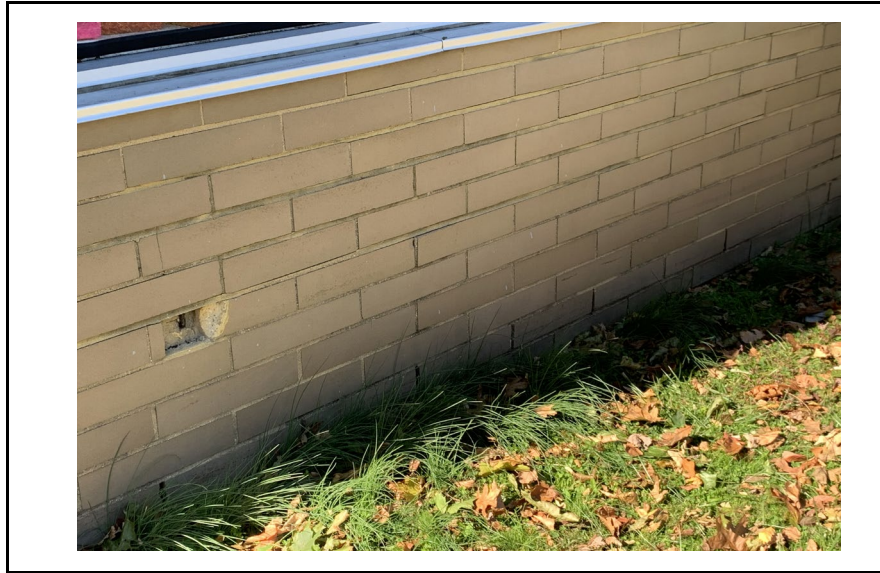
GeoInsight Environmental Strategy & Engineering	Photo # 5: Loose and dislodged bricks will require re-pointing.
	Photo # 6: Stockpiled spoils considered Fill (well-graded and likely till-derived).

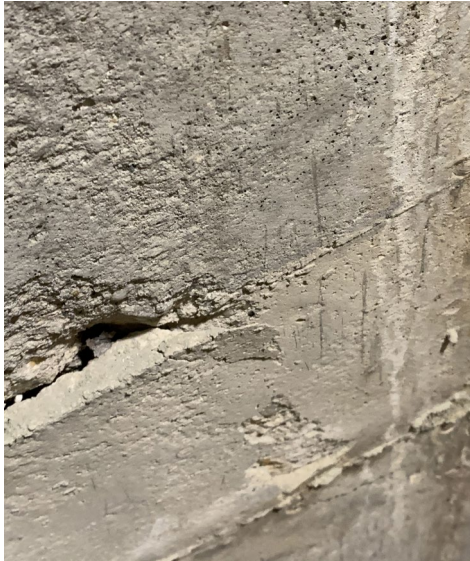
Photo # 9: Pitting and cracking of interior foundation wall.
