Toquam Magnet School

City of Stamford

SUMMER 2019 WORK

Figure 3.1

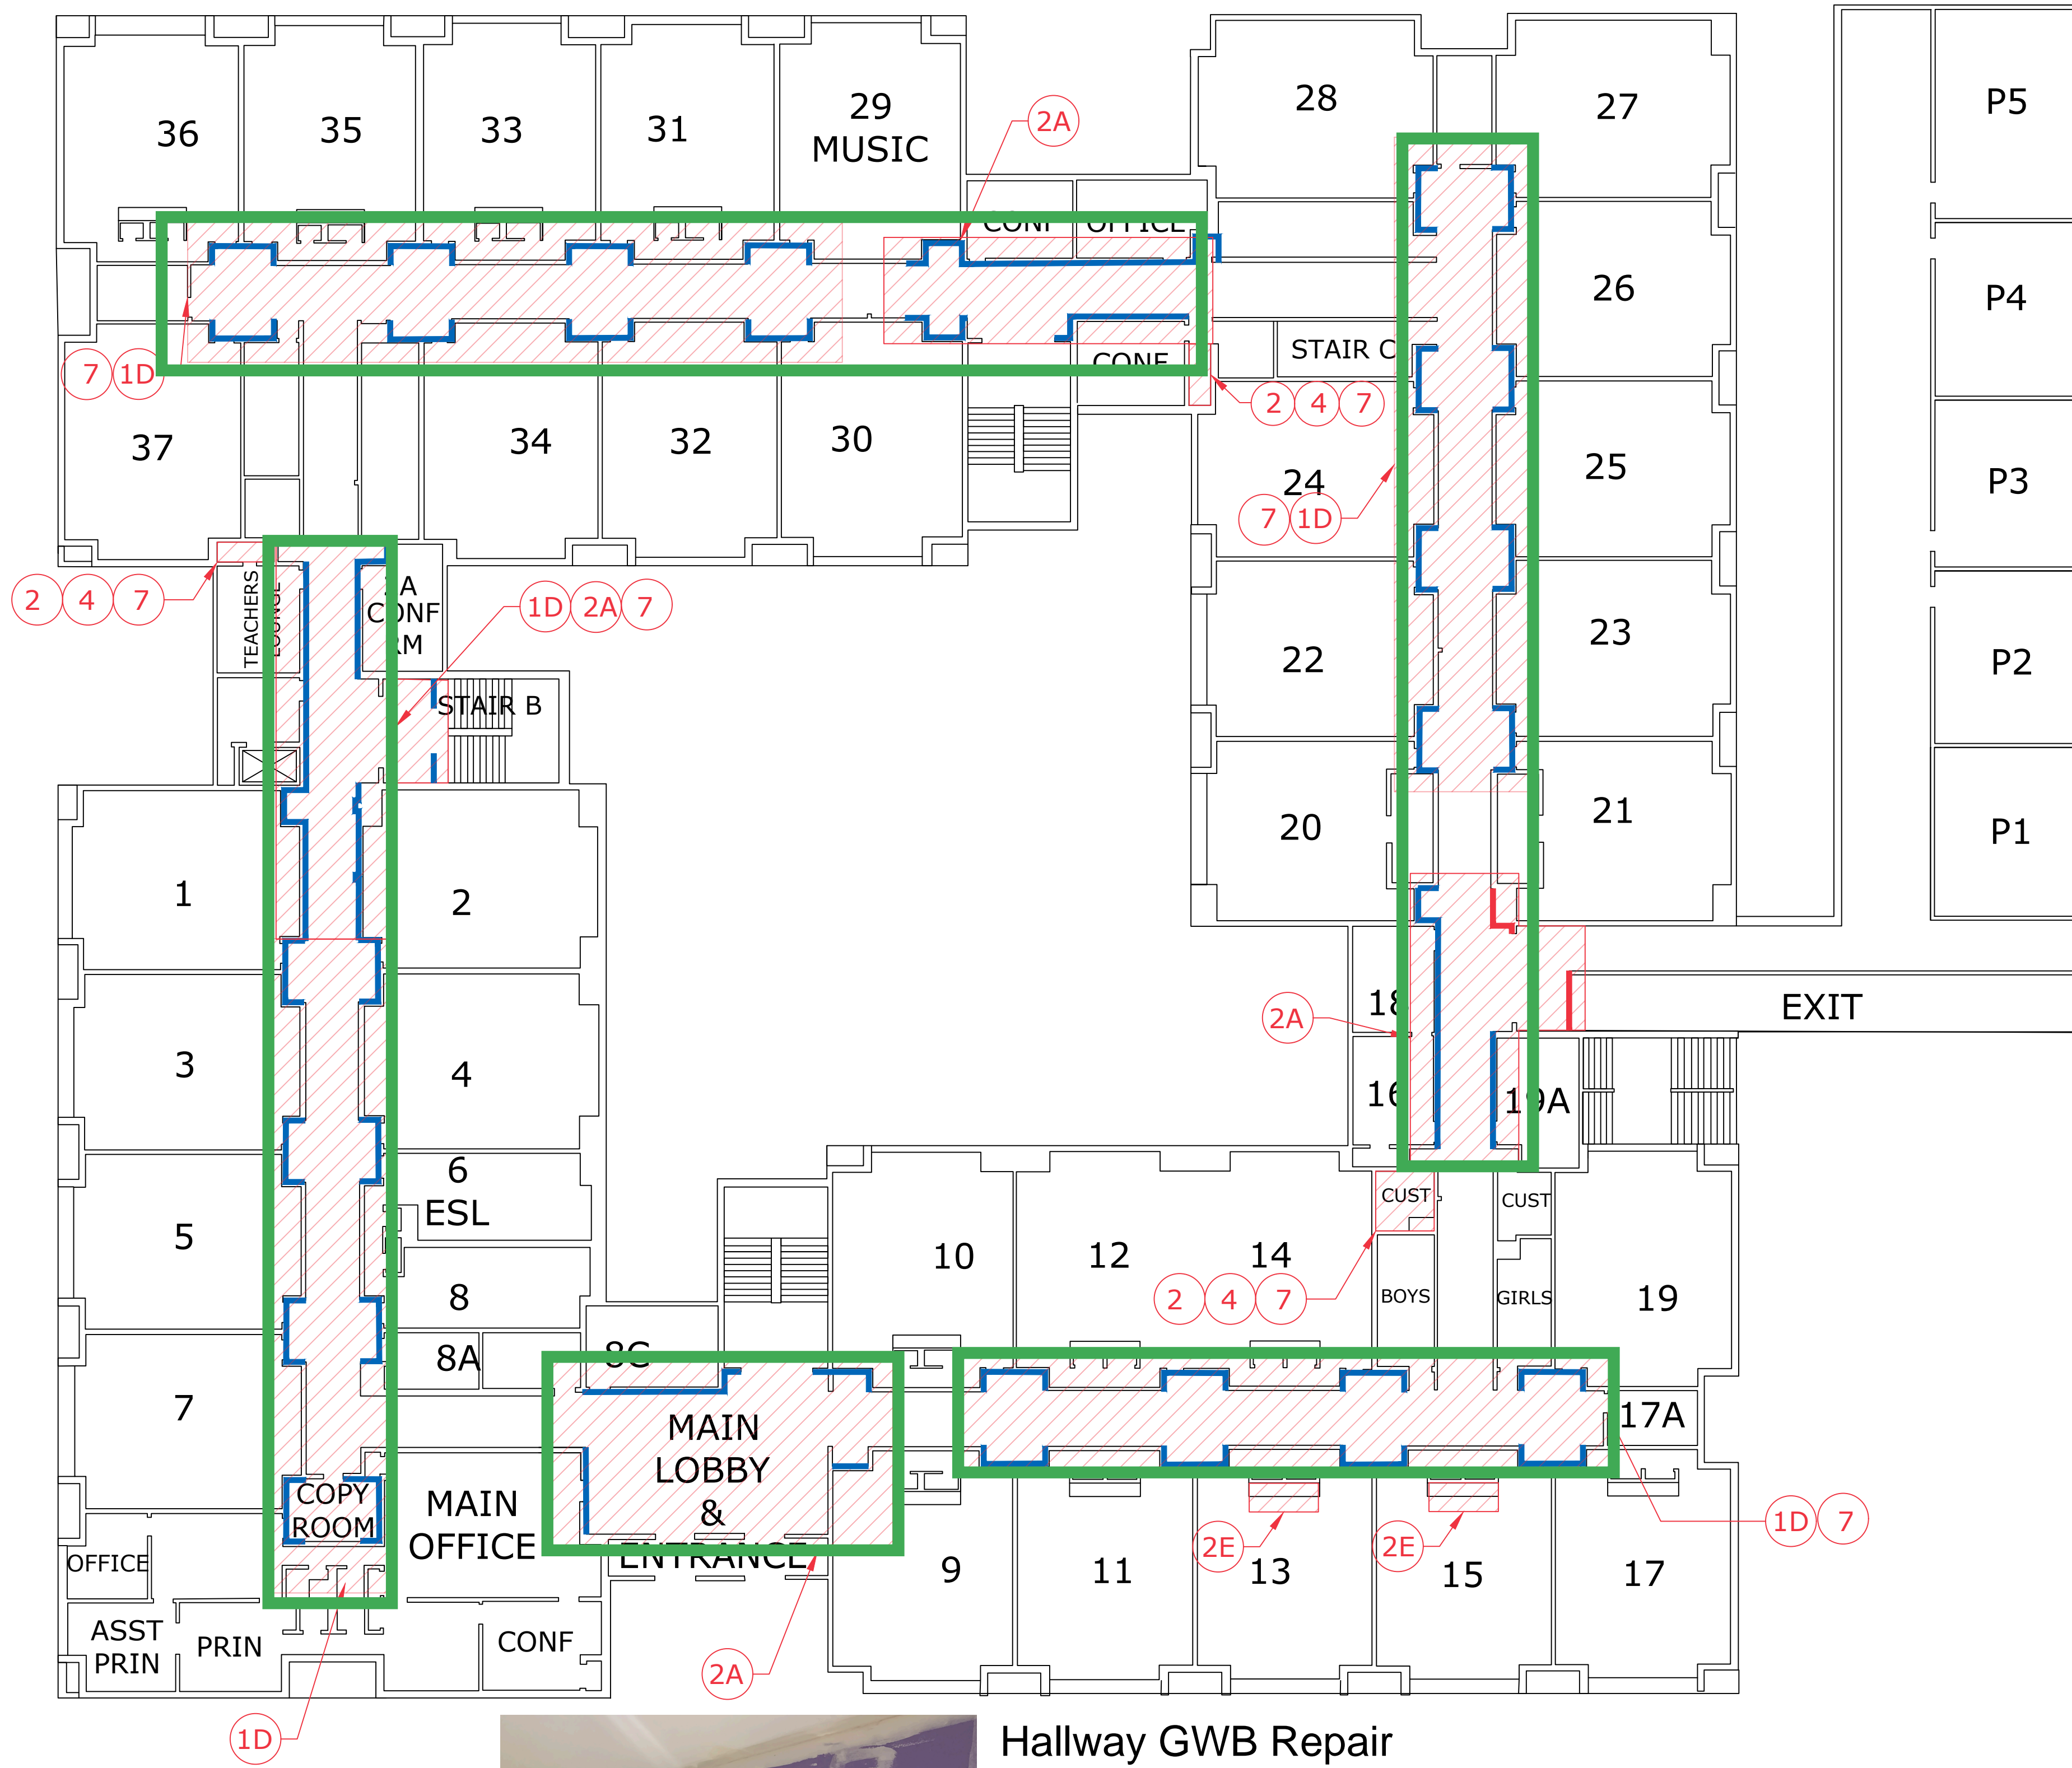
Top Level Hallways and Skylights:

AOC 08, AOC 10, AOC 19 - AOC 21, and AOC 24

Replaced mold impacted drywall in Upper Level Halls outside entryways of classrooms

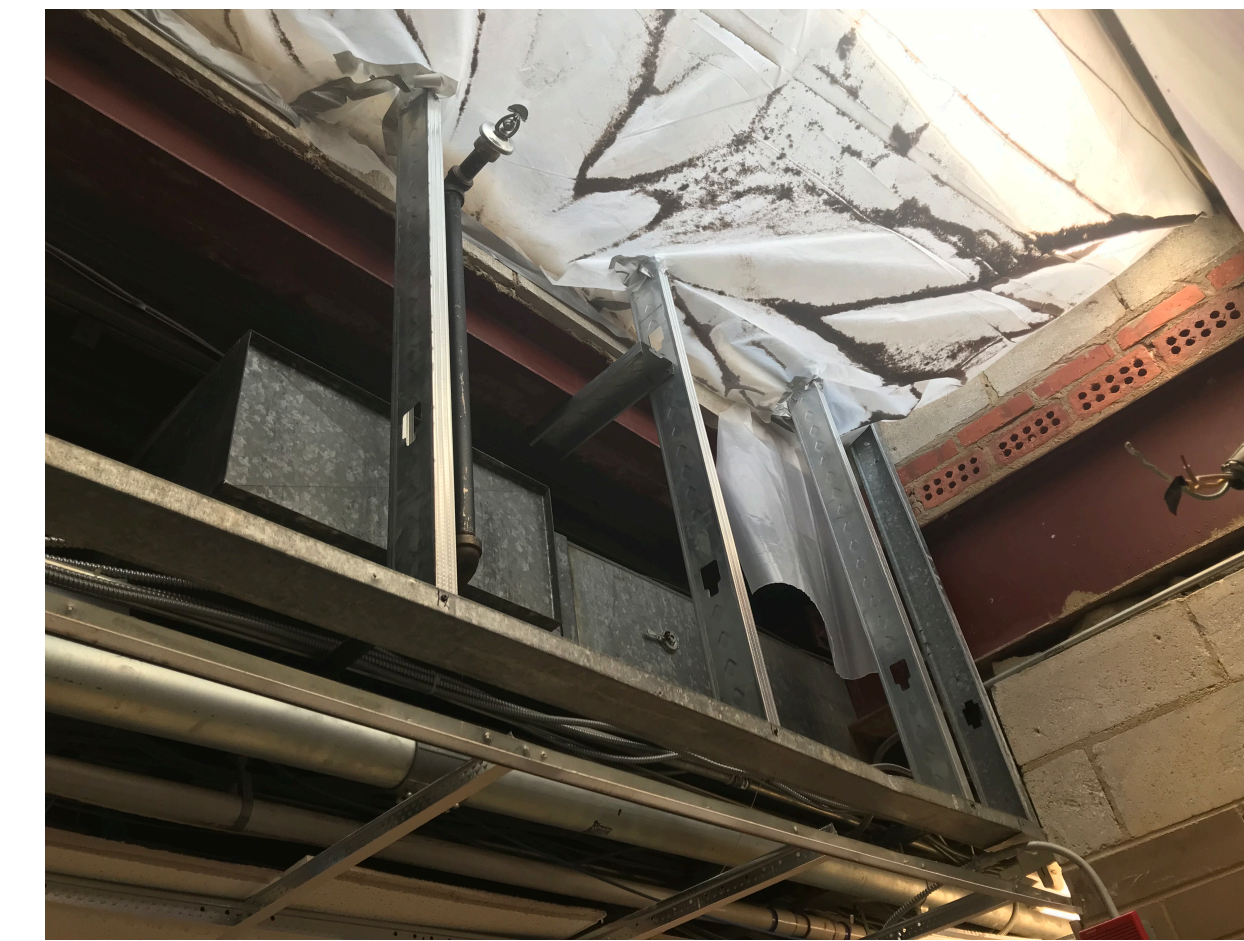
Hallway GWB Repair under skylight framing

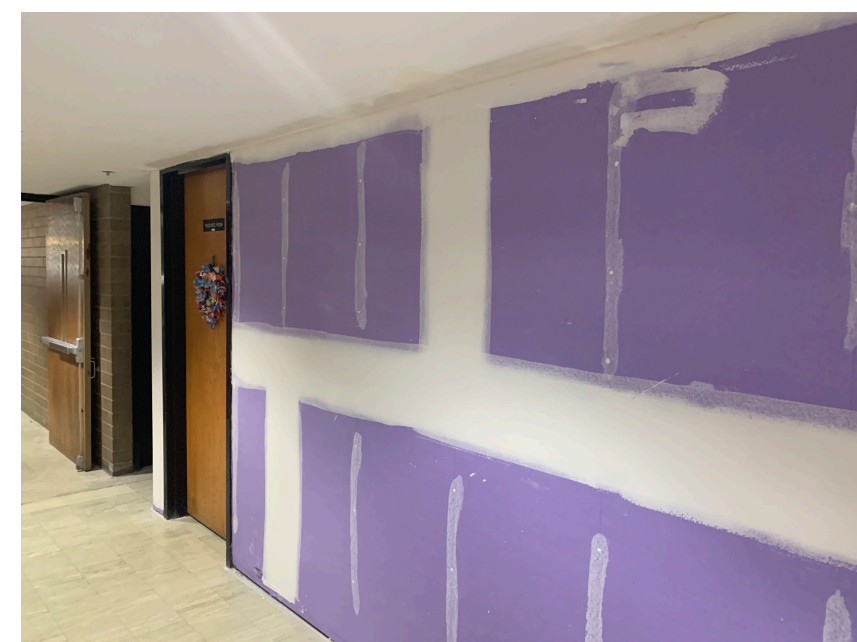
Hallway GWB Repair between Rooms 1 and 7
