M. Gottfried, Inc.

RE: Roof report and repair quotation
Toquam Elementary School
123 Ridgewood Avenue
Stamford, CT 06906

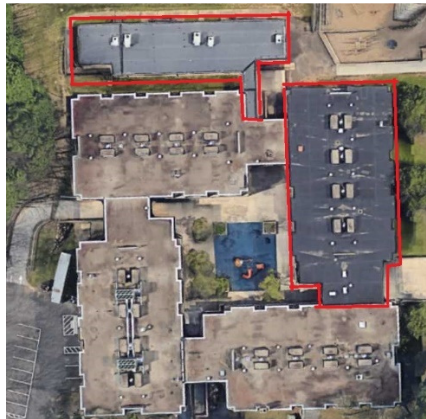
Toquam School underwent a reroofing project this past summer. The two roofs outlined in red represent the roof areas that were **not** reroofed this summer and are the focus of this report.

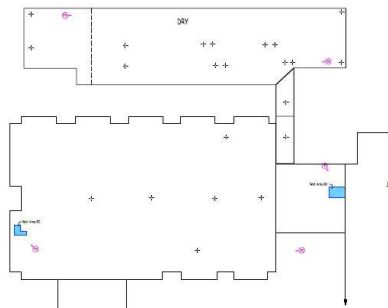
The above drawing from the infra-red scan performed on the roof does not appear to mark the found wet areas on the appropriate roof sections. The roof properly shows the “front EPDM” (light gray) roof,

and then shows the connecting gravel roof, not the “older EPDM” roof. The shown gravel BUR roof was part of the summer roofing project. When we performed our inspection, we found Wet area #2 on the EPDM roof that was not part of the summer project, but, did not see wet area#1. The markings for wet area #1 might have worn off or was in a different area.

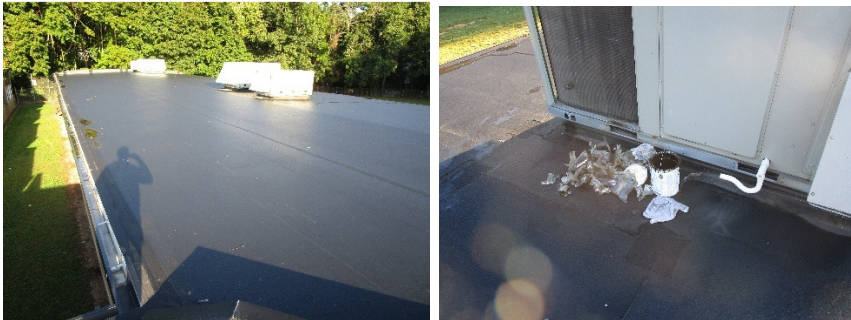
Lower roof

We did not find any items in need of repair on the lower roof level. We did however find garbage and debris by a unit. These need to be removed before they can blow around and cause damage. Servicemen working on the roofs should be asked to remove their garbage. These should not be left on the roof.

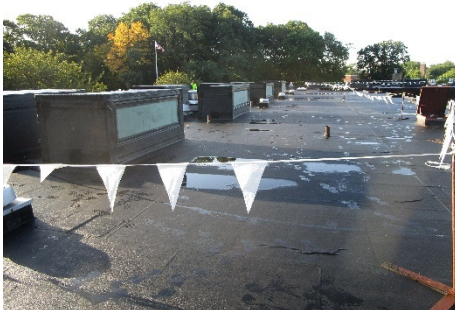
Remaining EPDM Roof

The remaining EPDM roof is in very good shape and only needs a few minor repairs. The roof was flagged off during our inspection because the old BUR roofs on top of the raised light penthouses were being reroofed.

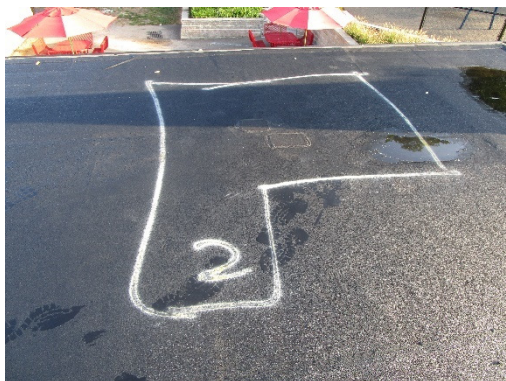
Wet area #2

As discussed above, wet area # 2 is the only found area marked on the roof from the moisture scan. It appears the wetness came from holes. There are a few patches in the roof in this area.

- Cleaning and removing all debris from the roofs.
- Cutting out and replacing wet area #2, if wet area #1 is located, that area will also be replaced.
- Inspecting the field of the roof, flashings and perimeter edge and patching any holes that are found.
- Checking existing patches and overlaying them if necessary.
- Installing a slip sheet of membrane between the sleepers of an HVAC unit and the roof.
- Replacing the damaged skylight dome.

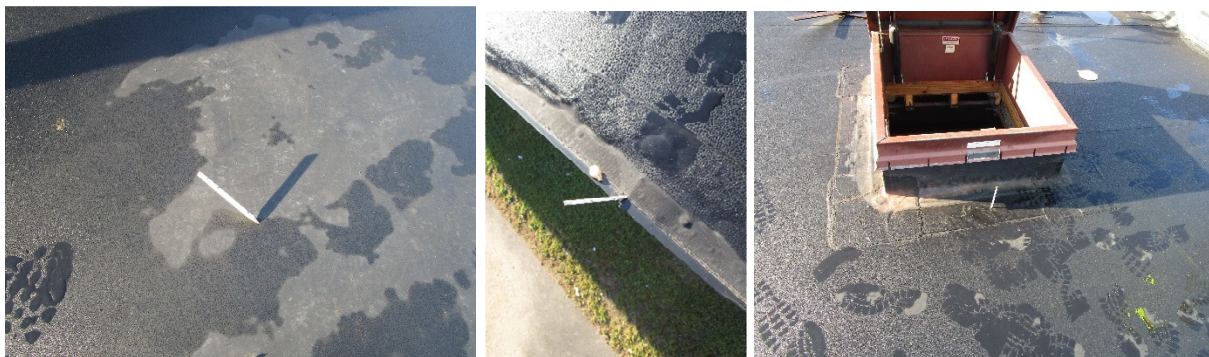
Holes

We found a few holes in the roof membrane during our inspection. These occurred in the field of the roof, at the perimeter edge and at curbs. The entire field of the roof, curbs and perimeter edge must be checked, and any holes or damage repaired before more water enters the roof system.

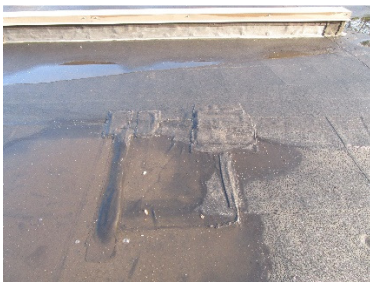
Patches in the roof should be closely examined, especially if they fall within ponding water, to make sure that the laps are tight and not starting to peel. If any looseness is suspected, the laps should be overlaid with PS flashing as a precaution.

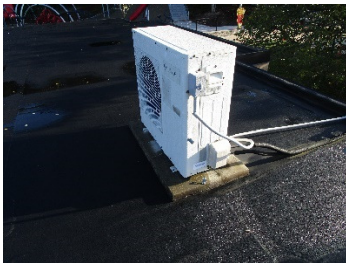
Unit pads sitting directly on the membrane

A slip sheet of membrane should be placed between the sleepers for this unit and the roof membrane. The separation sheet is important to prevent rubbing of the membrane by the sleepers. It is also a requirement of all roof manufacturers.
