WESTOVER MAGNET ELEMENTARY SCHOOL STATUS UPDATE

412 Stillwater Avenue

Mold Task Force

March 6, 2019

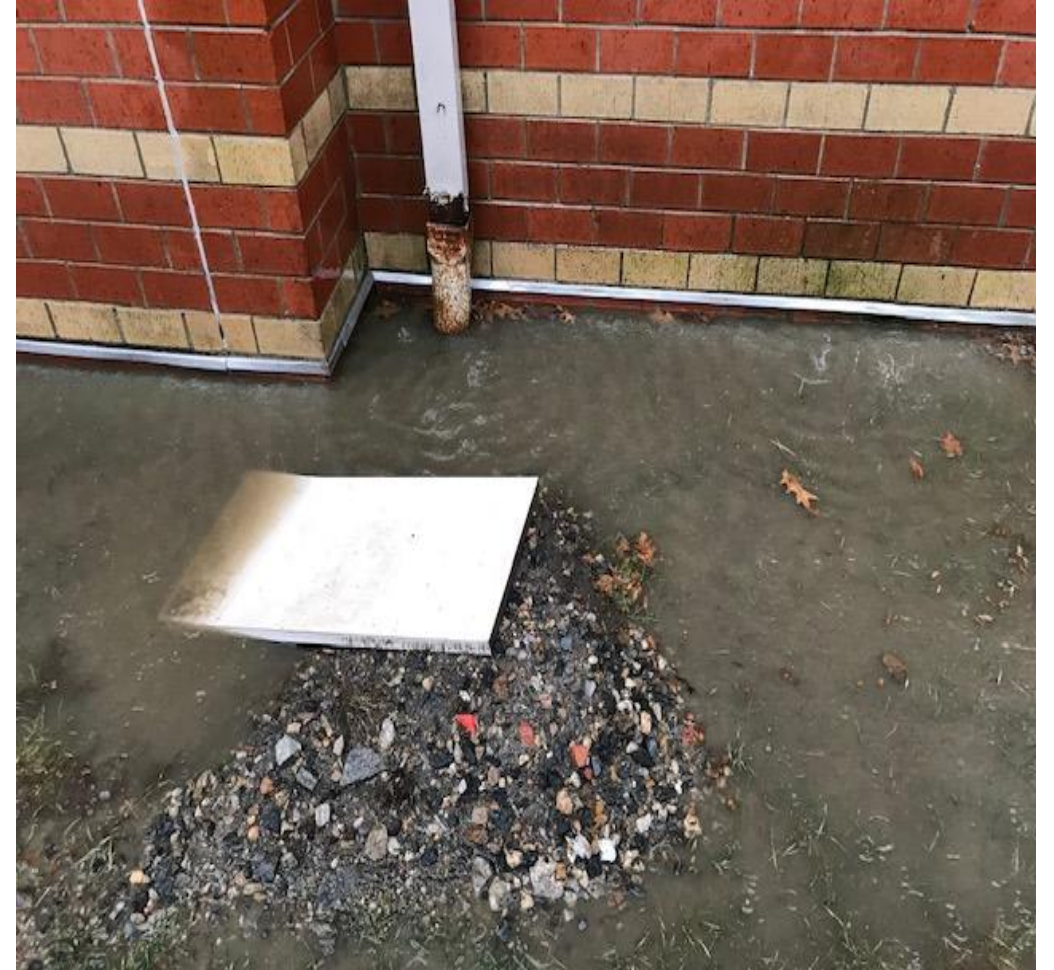
- At the North and West side of the building, the fire access road is at or near the finished floor in the building and traps/directs water towards the building – this water may infiltrate the layer of fill between the slab bottom and the vapor barrier and be trapped
- Preliminary calculations indicate that the tributary area has the potential to direct a quantity of water to the site that **greatly exceeds the capacity** of the storm drainage system to convey off the site

- Lower the fire access road elevation and change grade to pitch away from building
- Repair/replace roof gutter and downspout drainage

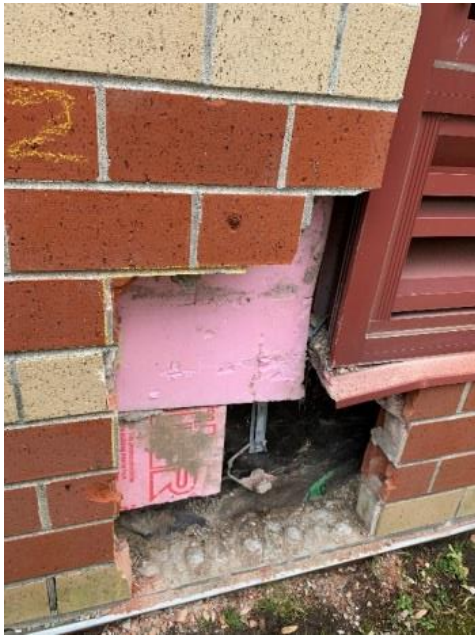
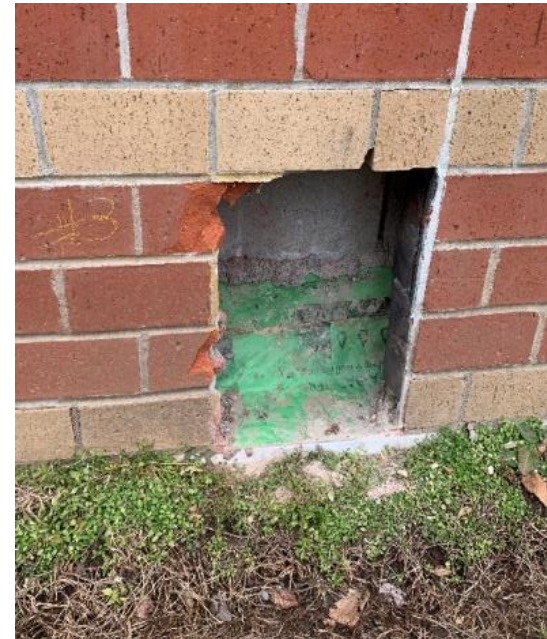
Existing Conditions/Findings – Wall **probe** holes opened in 4 locations

- Observations confirmed that construction was consistent with design documents
- Water intrusion concerns at wall sealants and exterior doors

- Repair/replace cracked masonry and replace exterior sealants at expansion joints, windows, doors and louvers
- Repoint failed mortar joints
- Insulate wall cavities at exterior framed walls
- Reseal all window, storefront and door perimeter joints

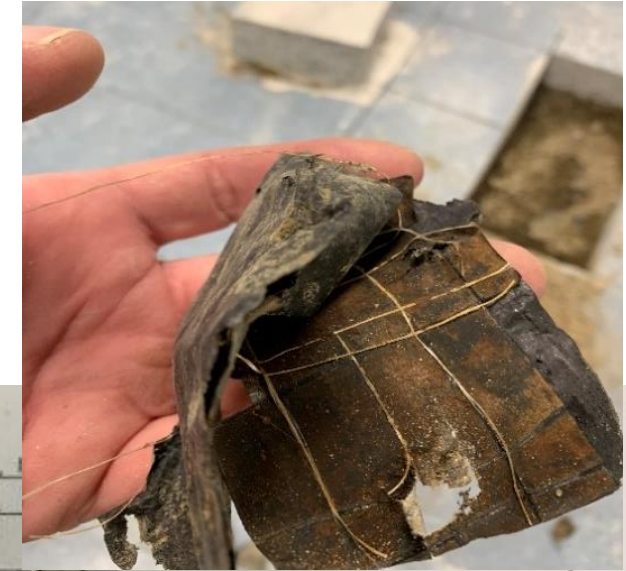
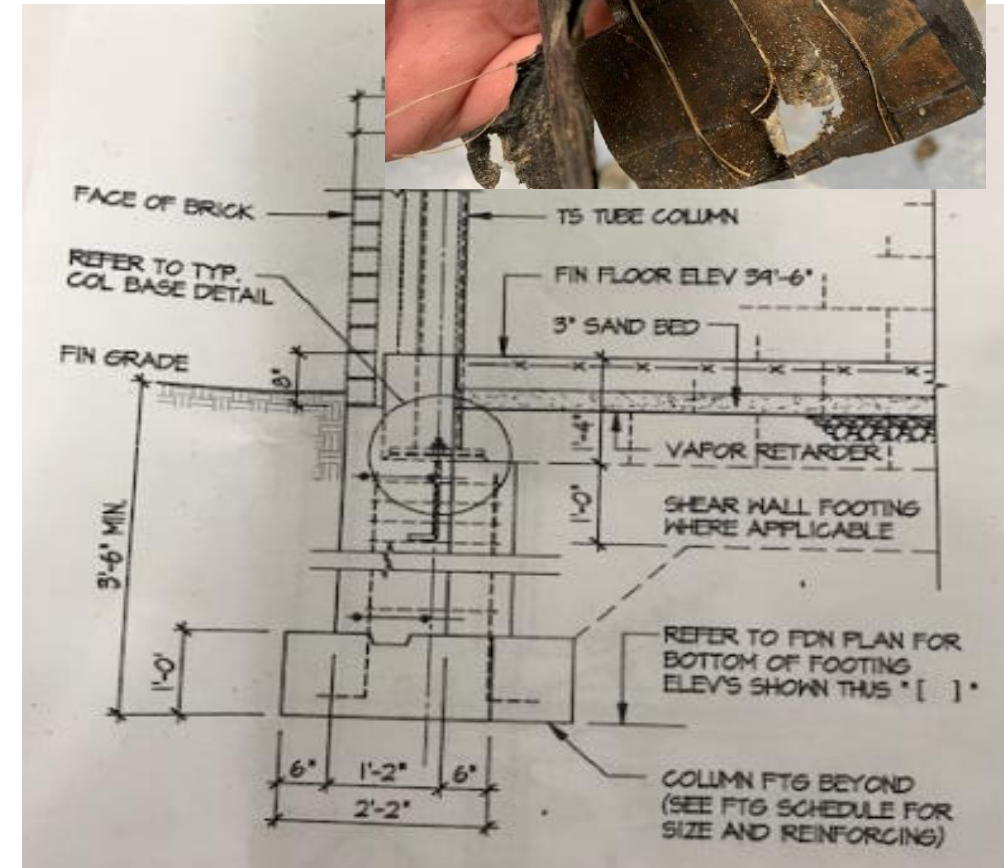
- Water infiltration via the slab on grade construction of first floor - water weeping into the wall cavities from the slab is trapped by the GWB and vinyl wall covering which contributes to mold growth on surface of GWB
- VCT flooring is delaminating from the concrete slab in multiple locations (west wing first floor and lobby areas adjacent to exterior doors)
- Vapor barrier and sand/gravel layering is consistent with the design documents

- Based on the results of the RH testing, a moisture mitigation plan will be developed, which is likely to include the addition of a moisture barrier between the concrete and Vinyl Composition Tile (VCT) flooring

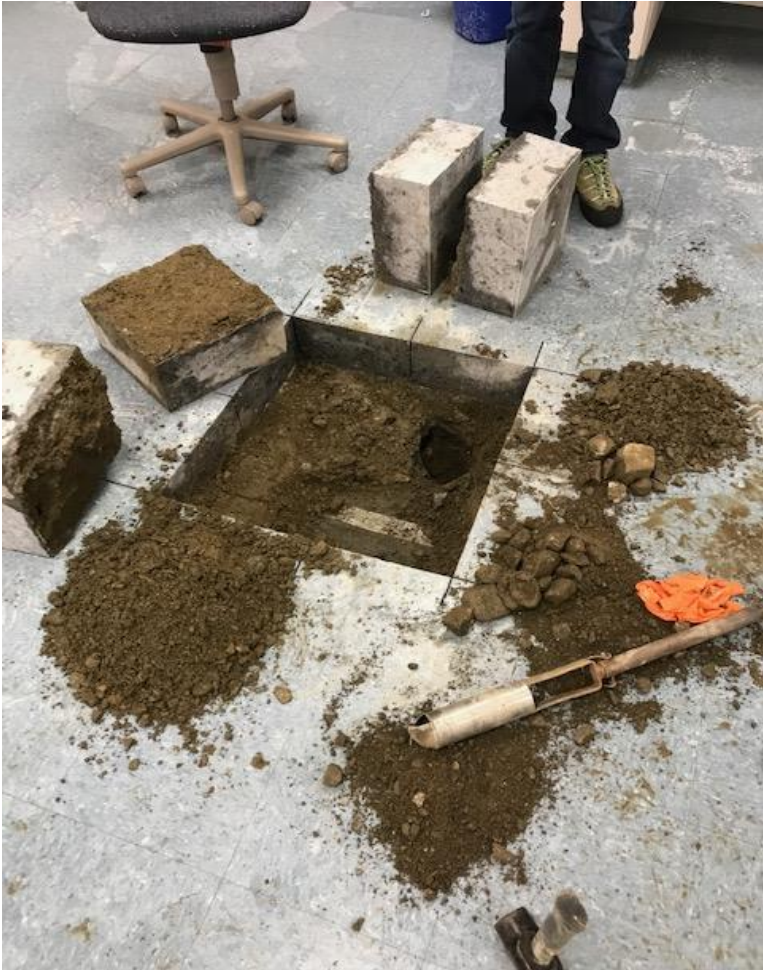
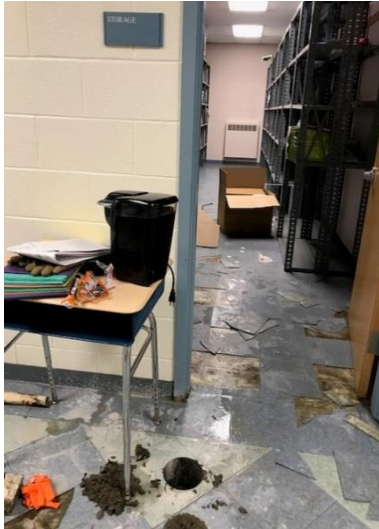
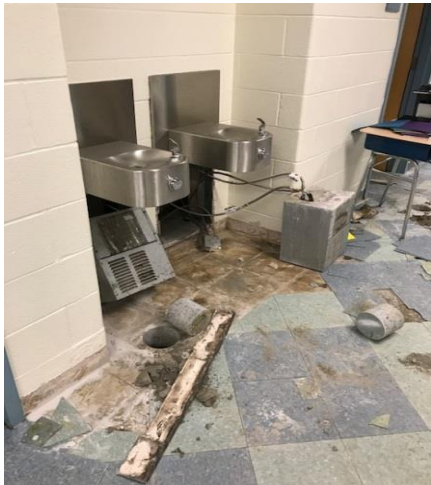
The observed conditions of the concrete slab and directly below the slab were generally as follows (from top down):

- Concrete Slab – 5 to 8-inches thick, lightly reinforced.
- Granular Fill - approximately 2- to 3-inch thick layer of fine to coarse sand between the bottom of the slab and the underlying vapor barrier.
- Vapor Barrier – The vapor barrier was observed to be present at all saw cut and core locations and consisted of black, fiber-reinforced plastic sheeting.
- Granular Fill – the granular fill consisted of fine to coarse sand, with trace silt and some fine to coarse gravel.

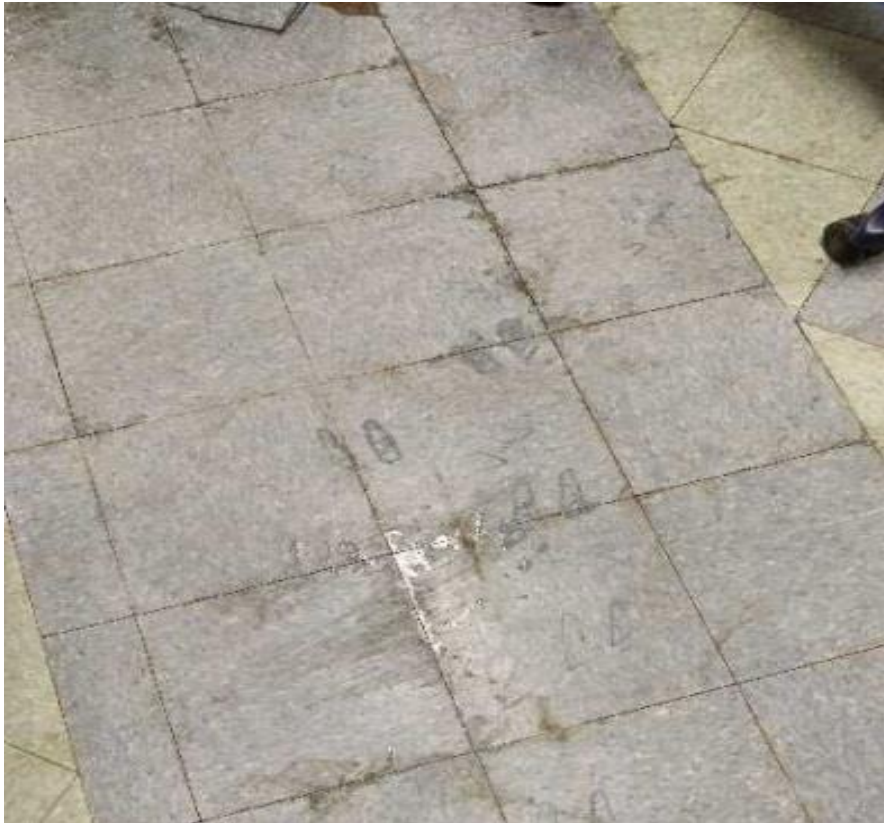
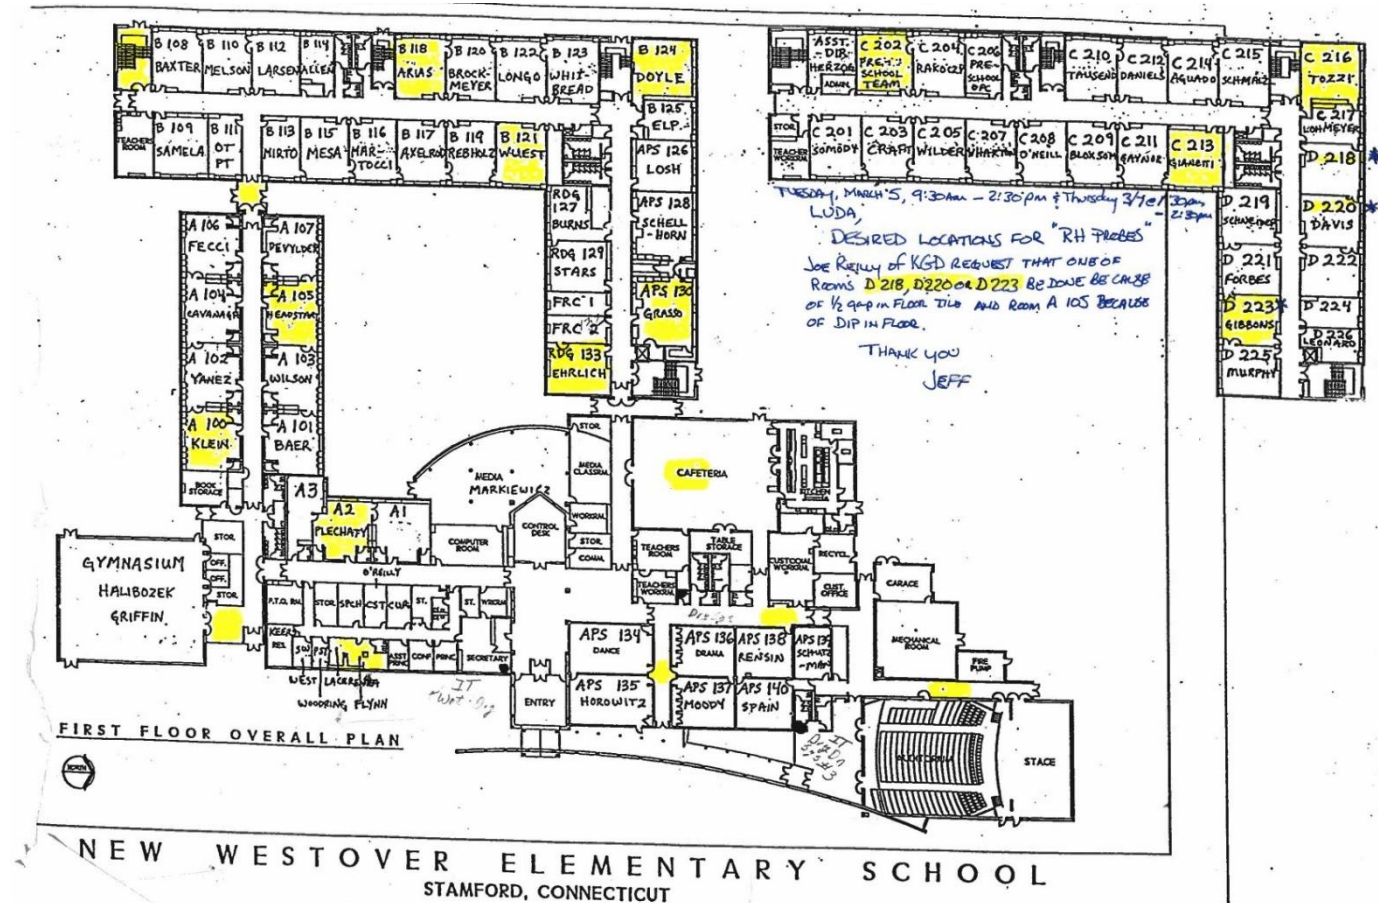
16 tests on 1st floor, and 4 tests on 2nd floor

- Conducted Relative Humidity (RH) probe tests on foundation slab

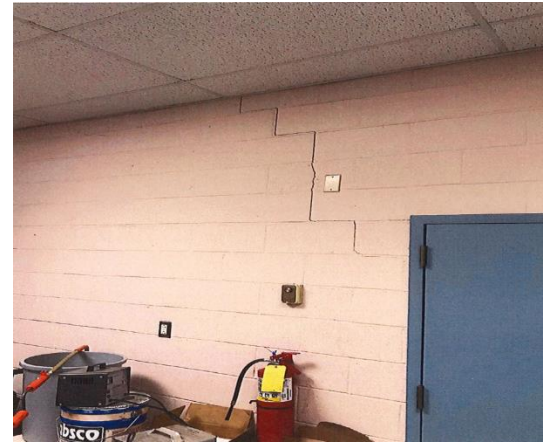
Custodial Area

- Foundations for the building appear to be in “very good condition” with “no red flags”
- The steel frame supporting the second floor and roof is also in “excellent condition”
- Structural review encountered cracking in CMU and concrete slab – These conditions appear to be typical settling, expansion and shrinkage related defects – there is NO indication of structural failure

- Replace cracked CMU
- Repoint mortar joints
- Proper fill and sealing of expansion cracking in floor slabs

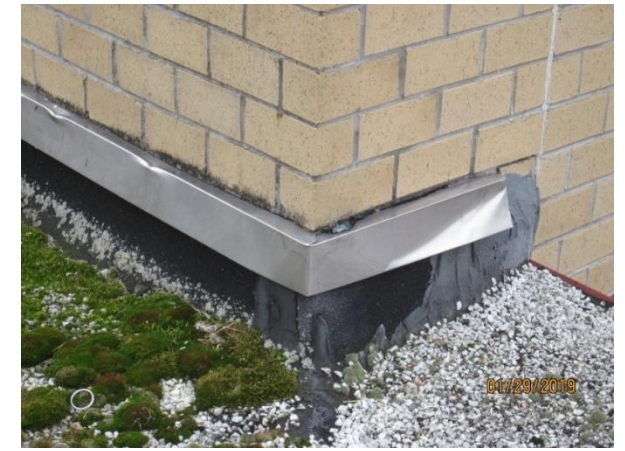
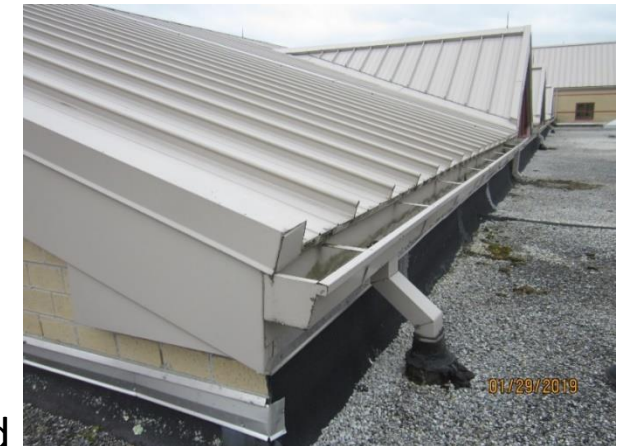
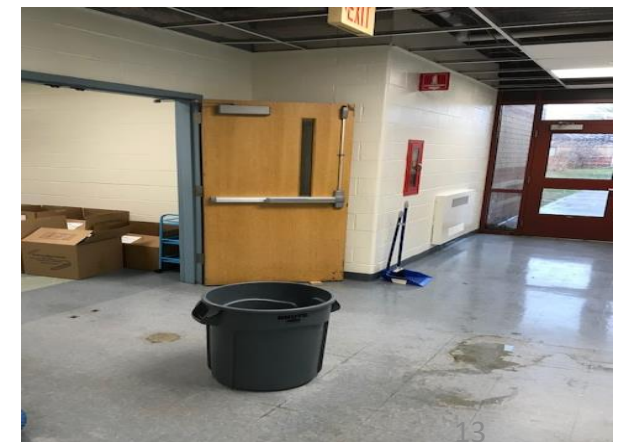
- 7-inch wide external gutters have failed
- Probes cut into flat roof revealing construction installation consistent with contract documents – no indication of water infiltration
- Flat roofs have isolated blisters and expansion joint deficiencies
- Sloped metal roofs have loose, rusting screws

- Replace gutters with seamless construction
- Replace roof leaders and provide new catch basins at grade to create an air break and receive leader runout
- Replace rusting screws with stainless steel screws and washers
- Implement all recommendations based on infrared roof scan of flat roof

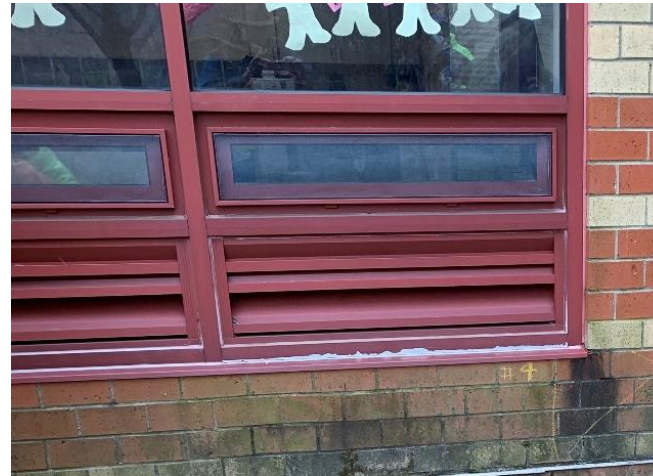
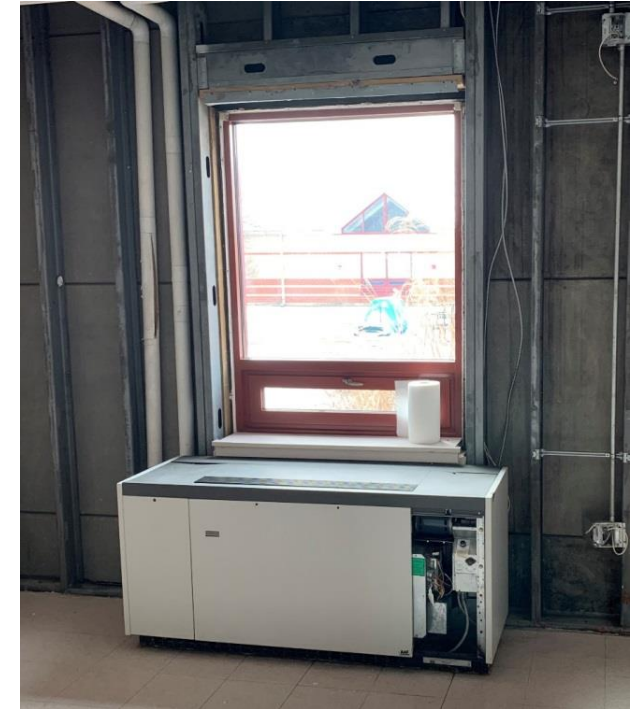
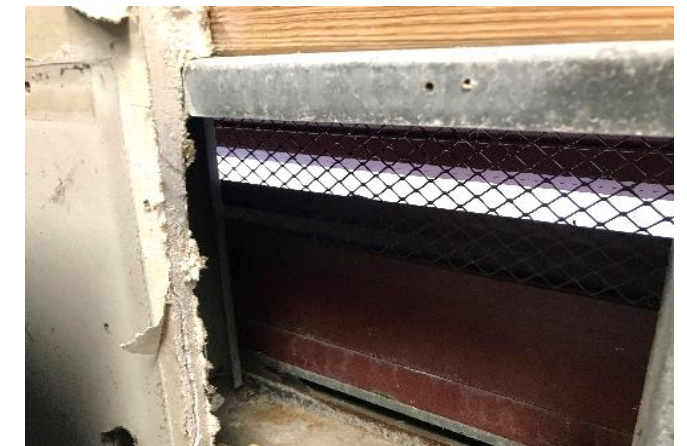
- Improper sealing around unit ventilators and intake louvers
- Coil deterioration observed consistently throughout unit ventilators
- Improper balancing of air
- The HVAC system does not appear to have any method to remove the relief air from the ceiling plenum

- Replacement of in-kind unit ventilators
- Seal louver perimeter.
- To achieve proper balance - install new relief ductwork and fans
- Install new variable volume rooftop units in lieu of constant volume for better circulation in common areas
- Replace all pipe insulation
- Supplemental ventilation system should be added to treat the large common spaces.
- Commission system – complete air and water balancing to ensure all systems functioning per design

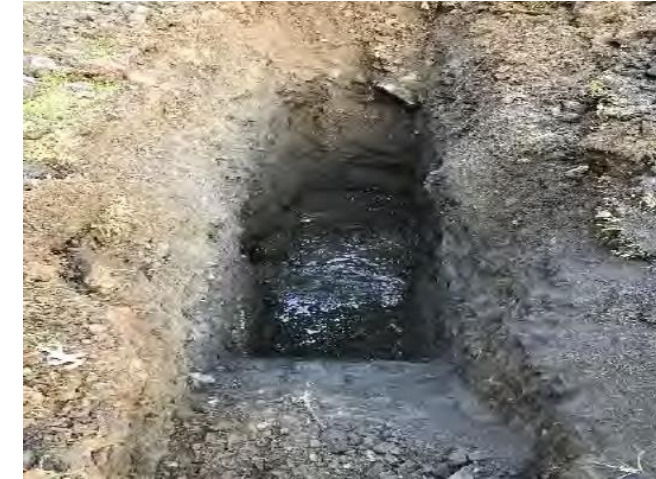
First floor finish slab elevation is 39.5.
Ground water elevation is 32.0 at TP-2.

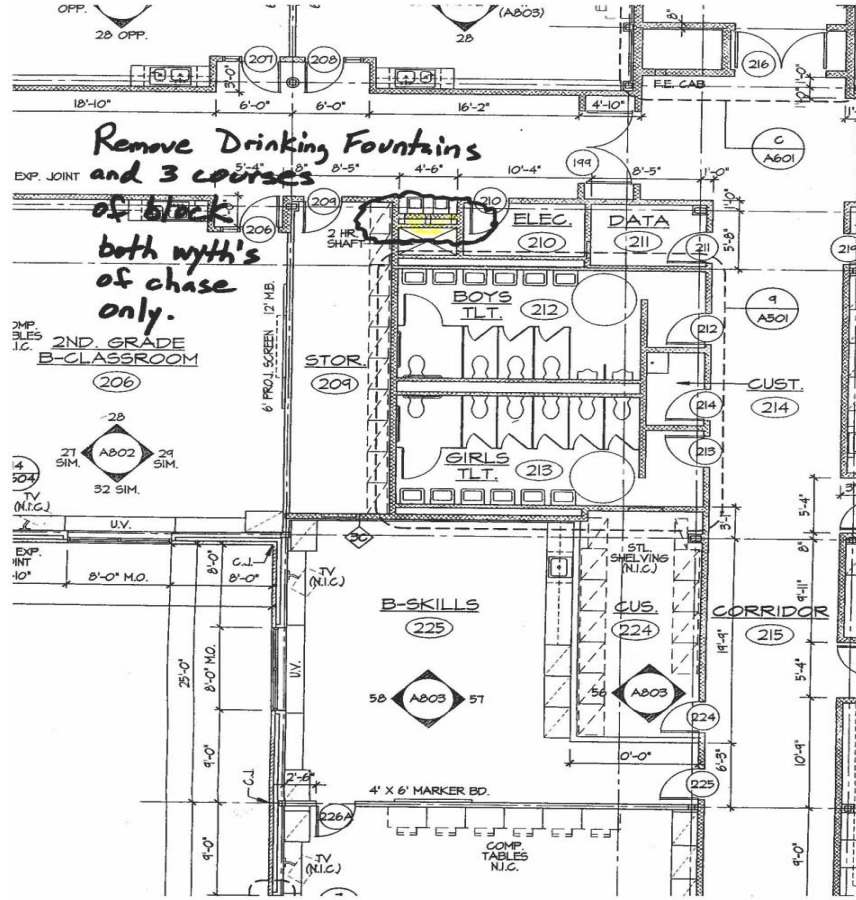
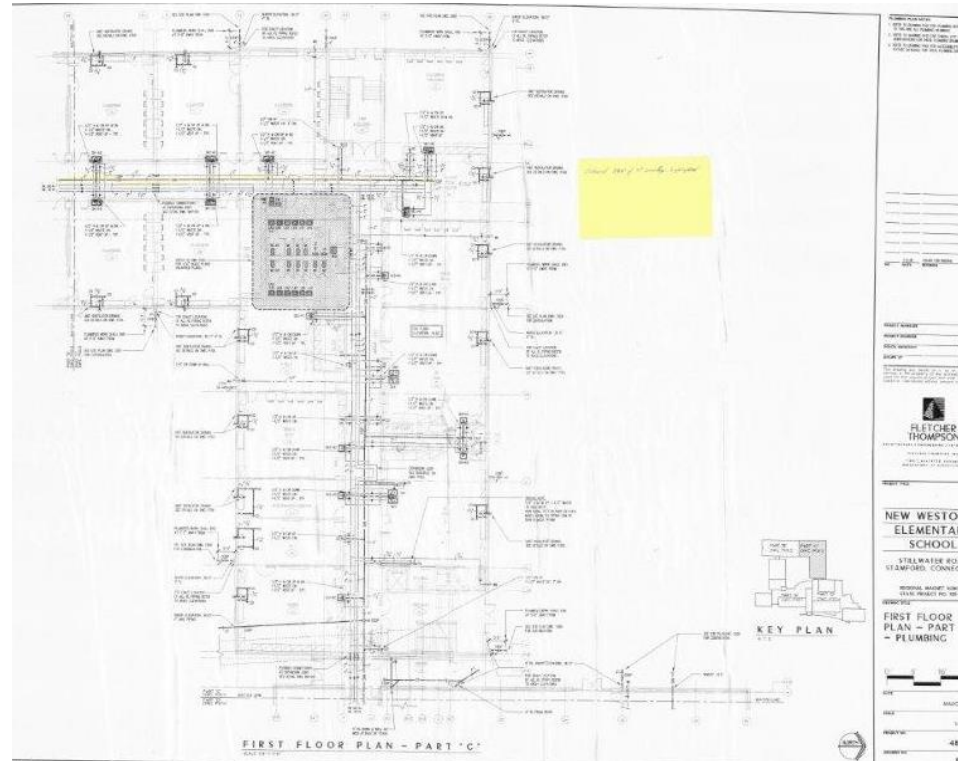
The attached highlighted sanitary line was examined by One Vac. A total of 284 feet was videoed. The pipe was in good condition, no breaks or cracks were found.
