WESTOVER SCHOOL

AAF AZ Herman Nelson Unit Ventilator (s) 70 units

Building is closed due to mold and in remediation process. The following conditions were discovered during planned random sampling and general operating inspection on November 20, 2018.

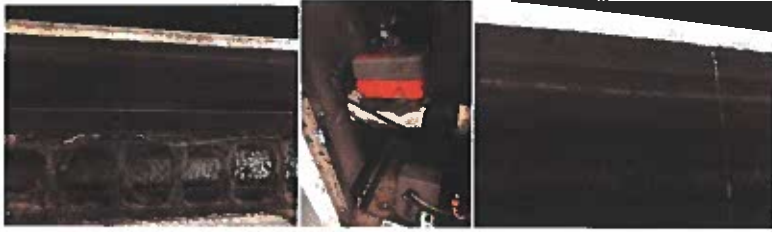
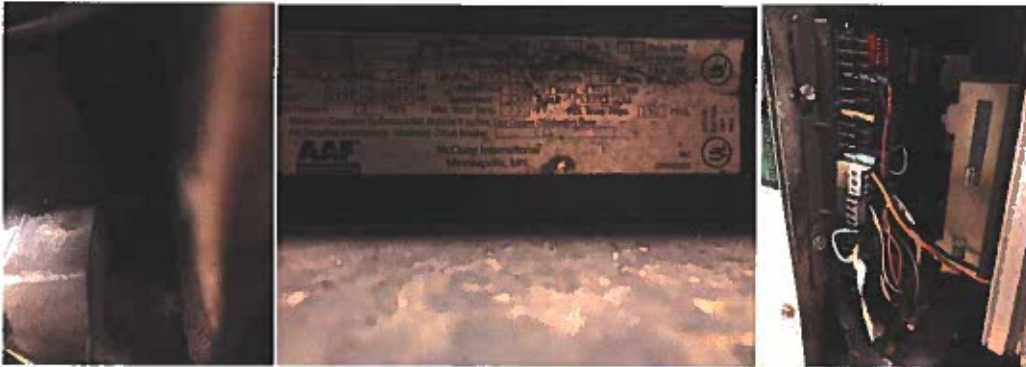
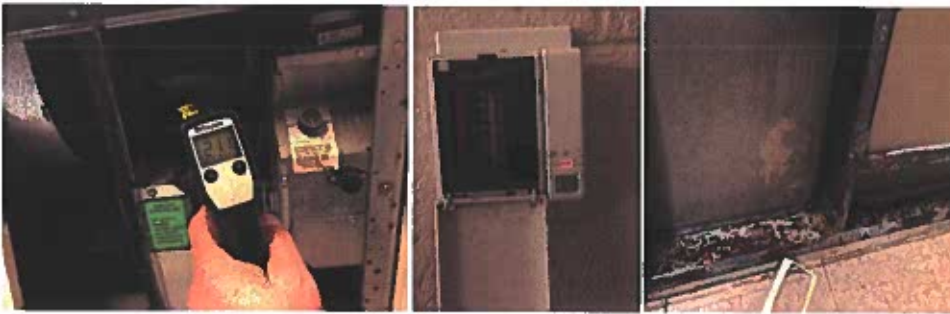
APS130 ART ROOM: UV #41: Inspected UV and Tested Operation

Tested operation of outside air damper actuator results **Fail (stuck in closed position)**

Noted Motor surface temperature running Hot @ 211F!

Unit and coil are fouled in fair to poor condition relative to their years in service

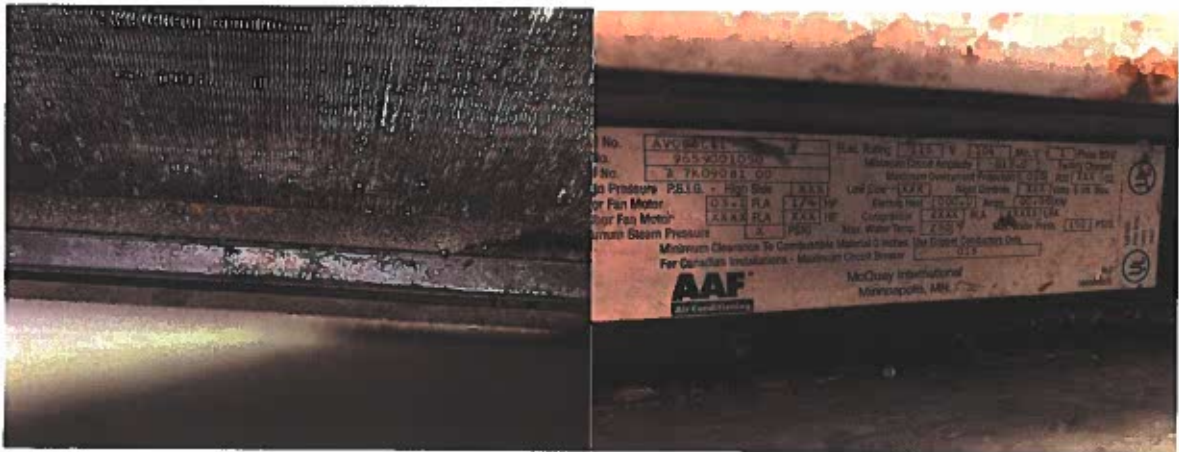
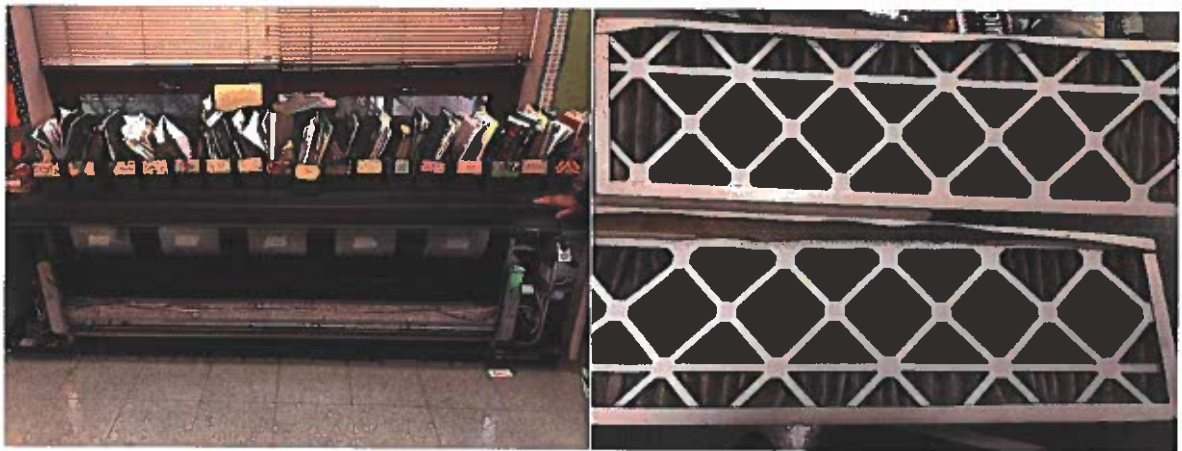
Room D219: UV #63: Inspected UV and Tested Operation

Tested operation of outside air damper actuator results: **Fail (stuck in closed position)**

Unit and coil are fouled in fair to poor condition relative to their years in service

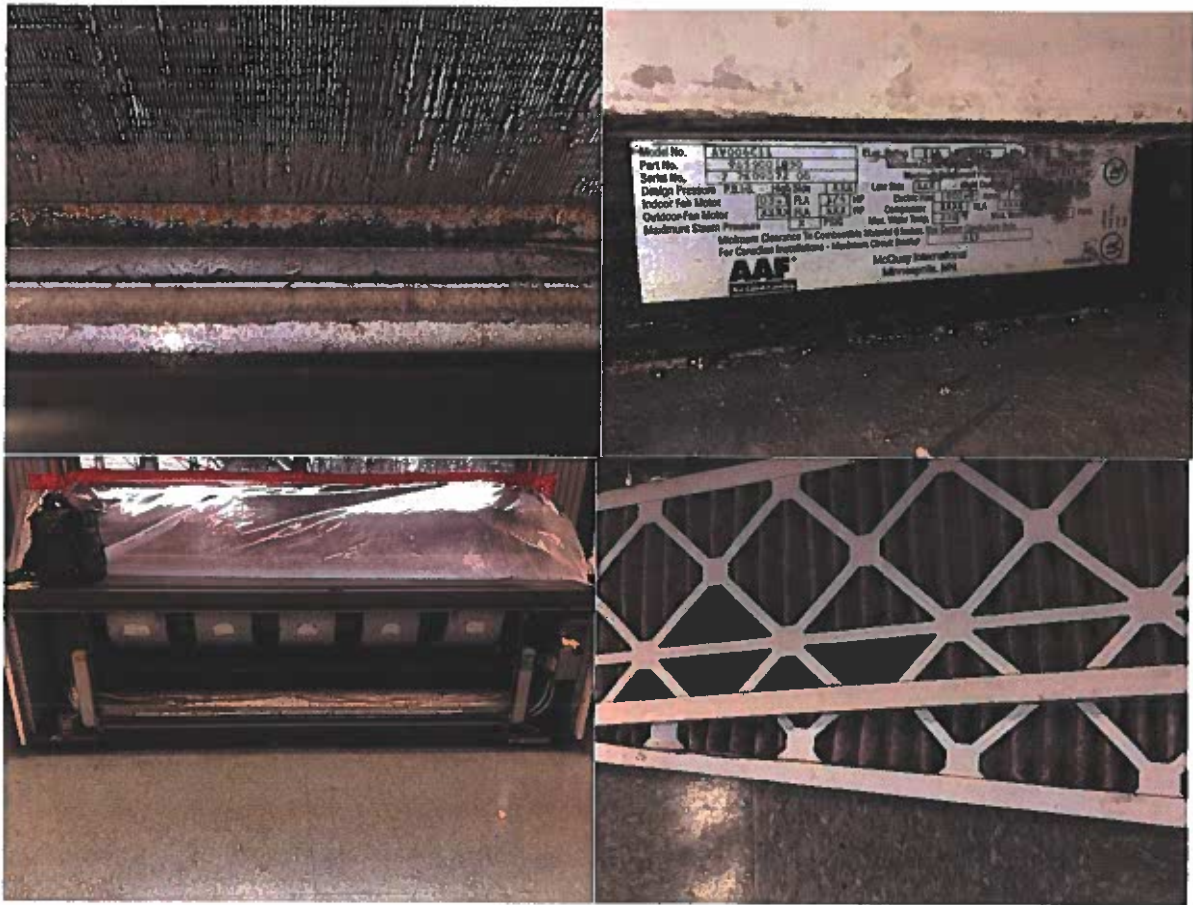
Room C213 UV #63: Inspected UV and Tested Operation
 Unit model AV006C11 Part # 9659001050 Serial # 7 7K09072 00
 Unit status: cover on occupied heat - running fan only
 JCI technician utilized HVAC PRO program on lap top and tested operation hot water / chill water actuator valve results: **Fail**
 Tested operation of outside air damper actuator results: Pass
 Indoor Fan Motor FLA = 3.1 Amps @ 115 VAC: Pass
 Noted Motor surface temperature running typical (140°-175°)
 Unit and coil are fouled in fair to poor condition relative to their years in service
Unit NOT operational for heating at this time

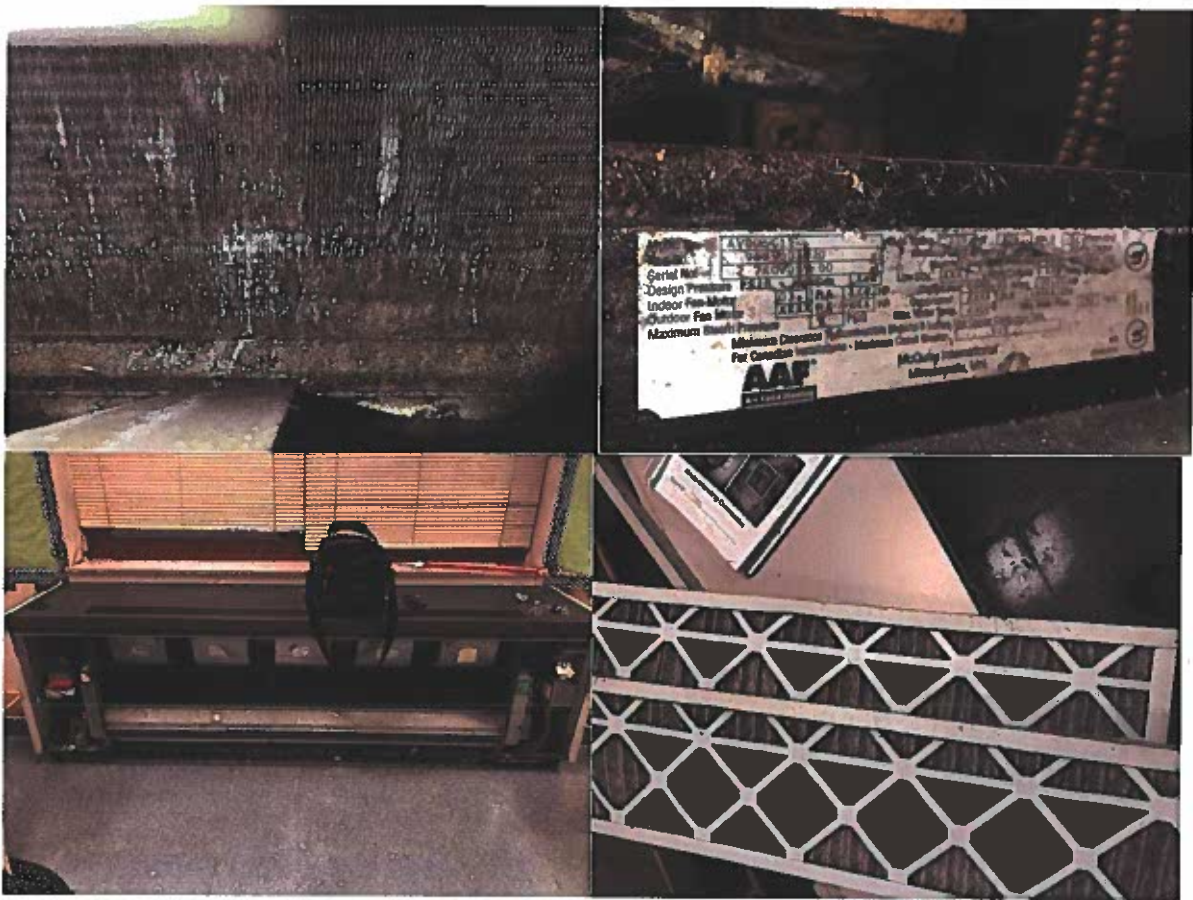
Room B109 UV #23: Inspected UV and Tested Operation

Unit and coil are fouled in fair to poor condition relative to their years in service

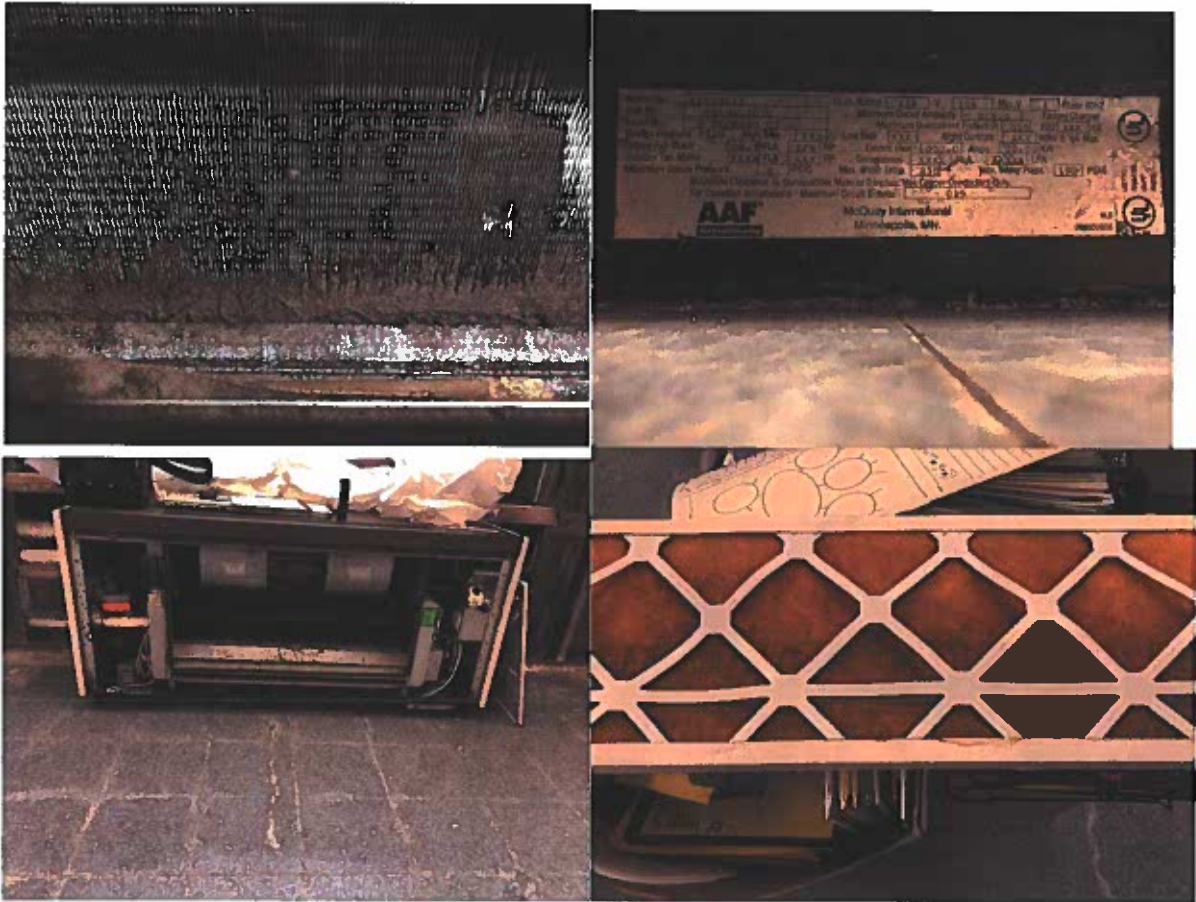
Room B125 UV #30: Inspected UV and Tested Operation

Unit and coil are fouled in fair to poor condition relative to their years in service

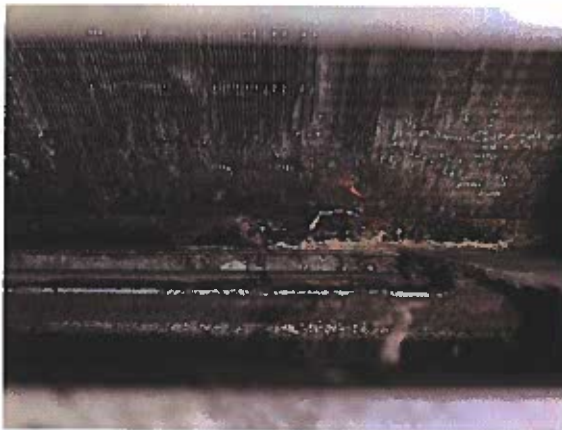
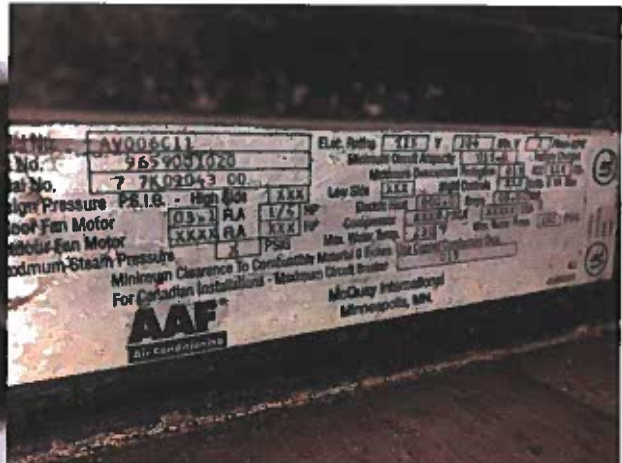
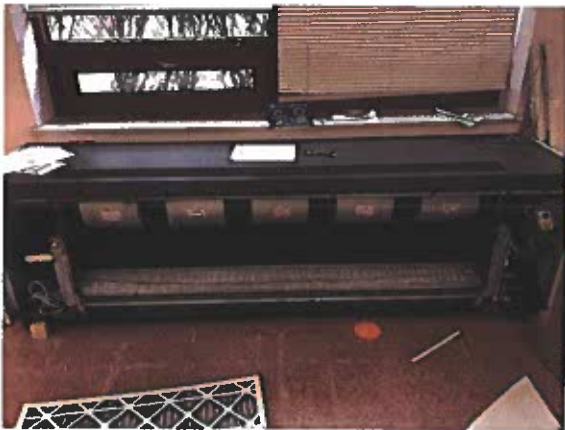
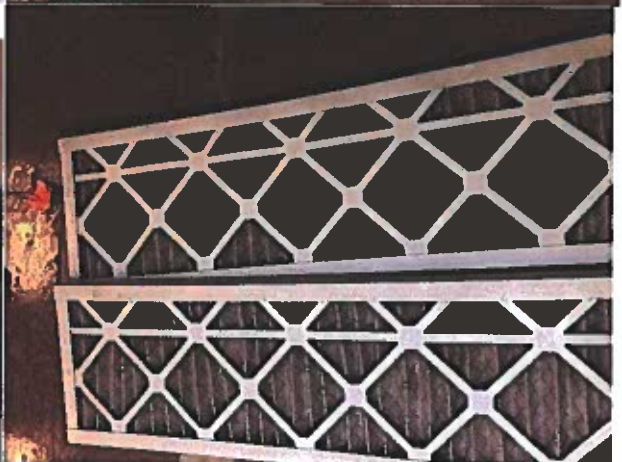
Room A104 UV #10: Inspected UV and Tested Operation

actuator valve results: **Fail—the heating valve has been removed and unit is piped directly, and the BMS control is also failed. Unit is inoperable at this time.**

Unit and coil are fouled in fair to poor condition relative to their years in service

Unit is NOT operational for heating at this time

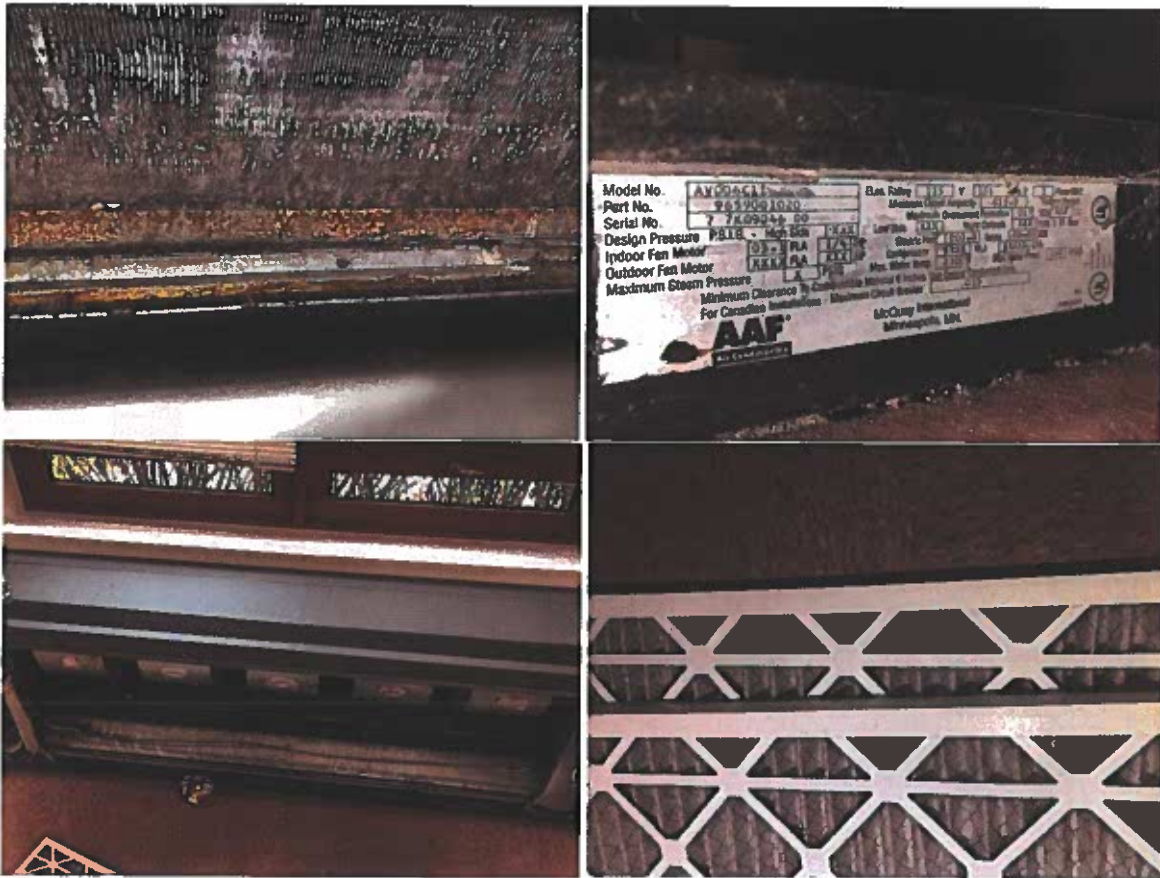
Room A102 UV #11: Inspected UV and Tested Operation
Unit model AV006C11 Part # 9659001020 Serial # 7 7K09046 00
Unit status: cover on occupied heat - running fan only
JCI technician utilized HVAC PRO program on lap top and tested operation hot water / chill water actuator valve results: Pass
Tested operation of outside air damper actuator results: Pass
Indoor Fan Motor FLA = 3.1 Amps @ 115 VAC: Pass
Noted Motor surface temperature running typical (140°-175°)
Unit and coil are fouled in fair to poor condition relative to their years in service
Unit operational for heating at this time

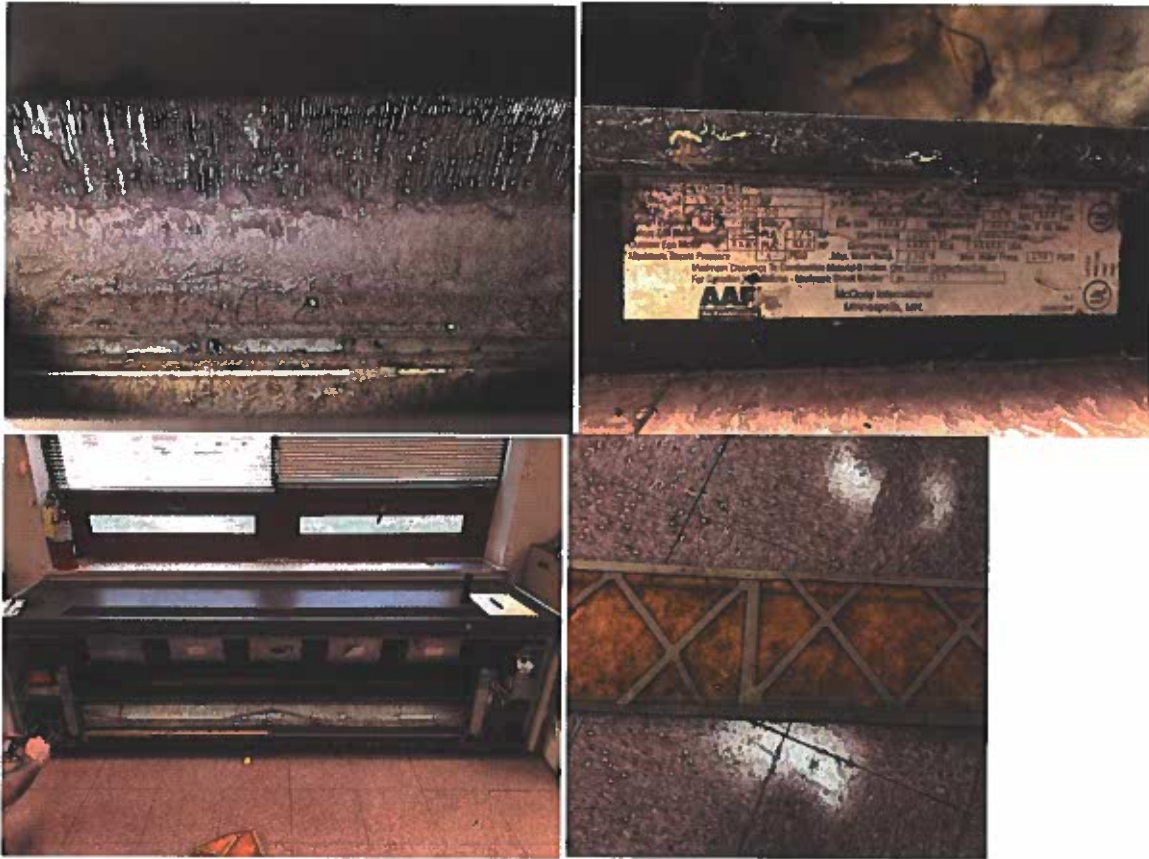
Room FRC1 UV #7: Inspected UV and Tested Operation

Unit and coil are fouled in fair to poor condition relative to their years in service
