FACILITIES NEEDS

ASSESSMENT

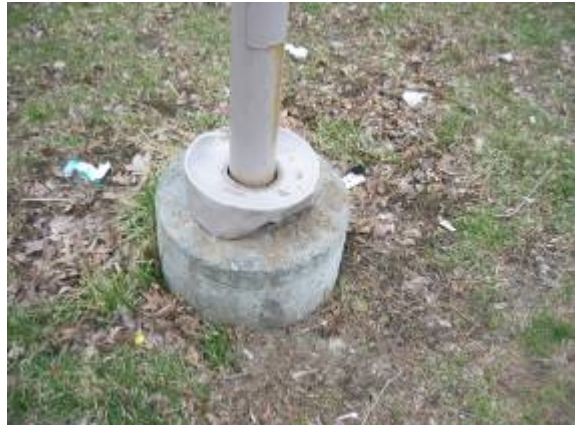
Photo #4: View of damaged base of pole mounted lighting fixture.

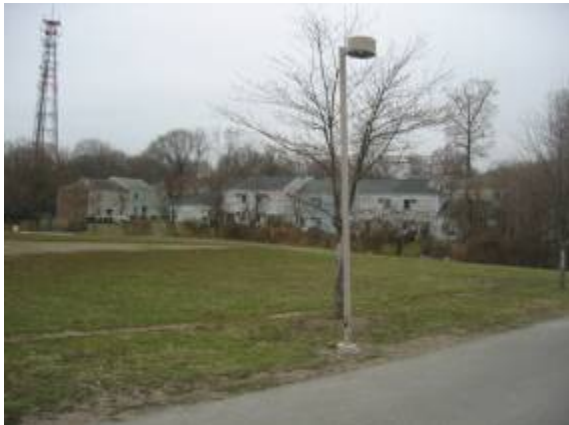
Photo #5: View of damaged pole mounted lighting fixture.

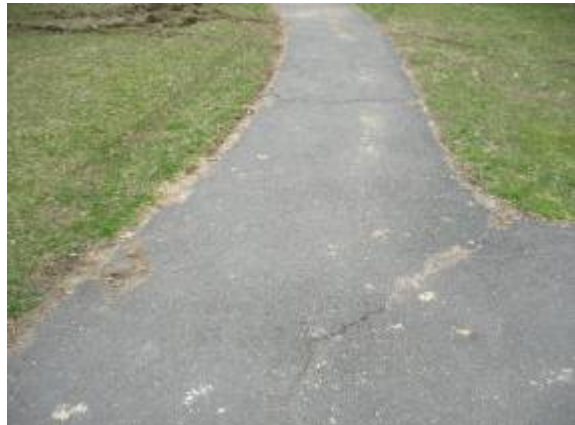
Photo #6: View of asphalt paved sidewalks.

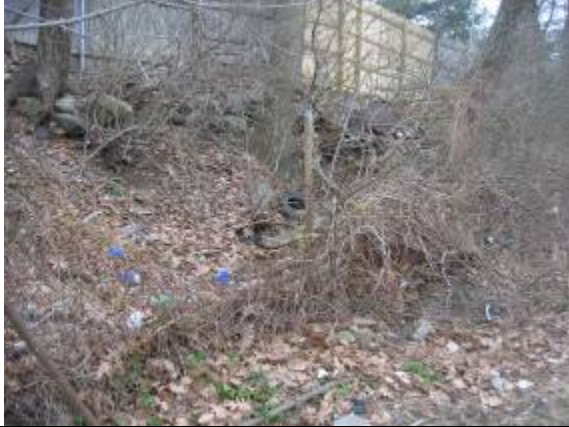
Photo #13: View of damaged chain link fencing system.

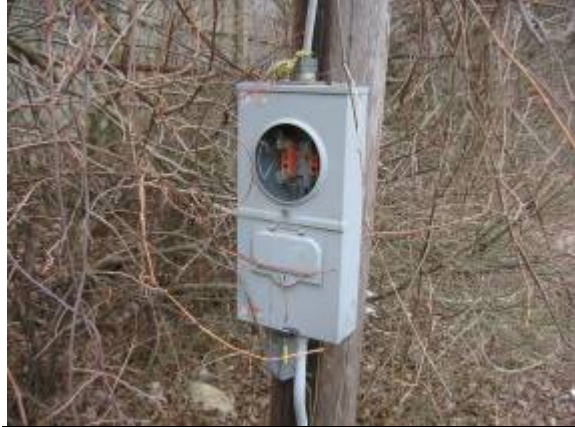
Photo #14: View of abandoned electrical service metering equipment.

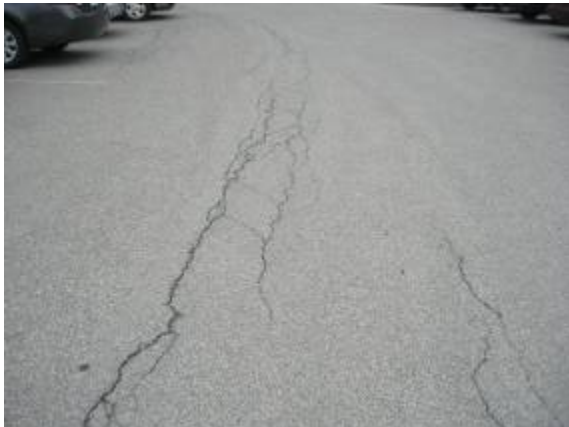
Photo #17: View of deteriorated asphalt parking lot.

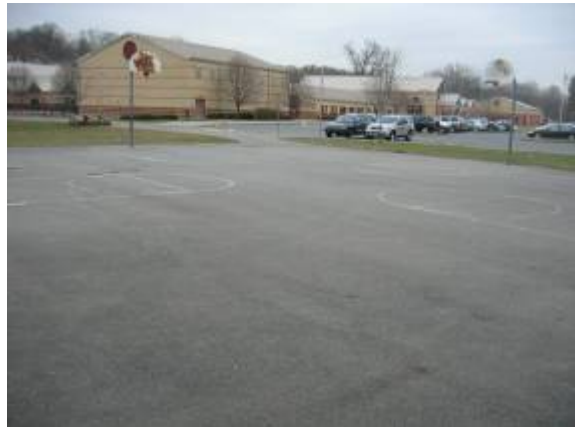
Photo #18: View of asphalt paved basketball court.

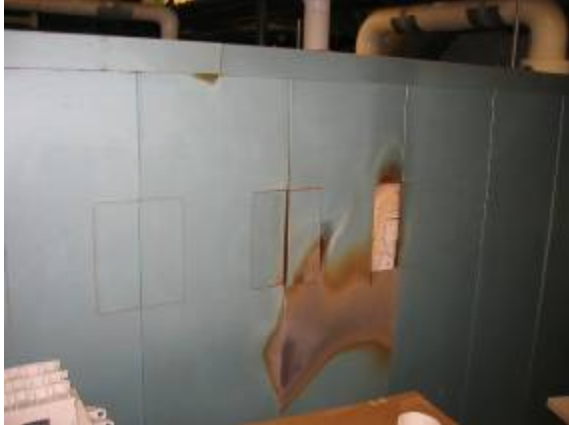
Photo #25: View of damaged portion of Boiler No. 1.

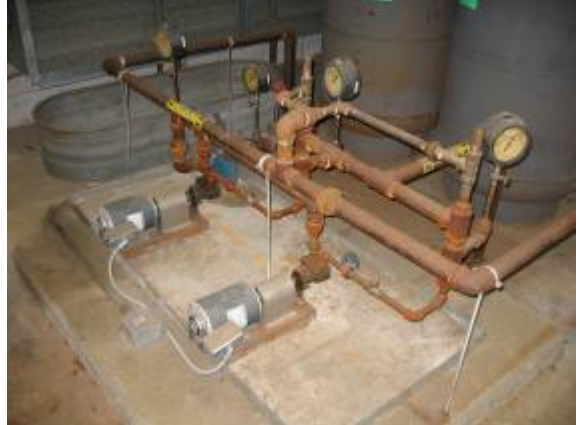
Photo #26: View of fuel oil circulation pumps.

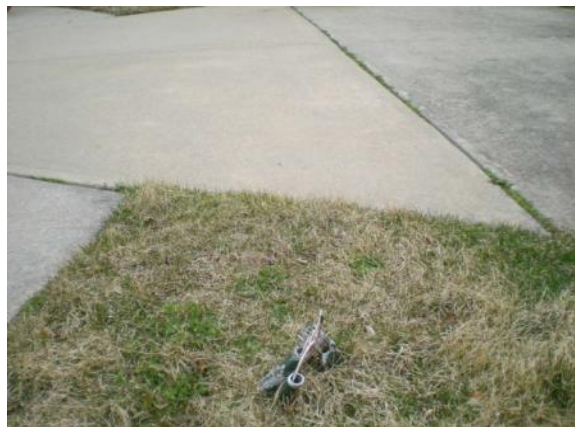
Photo #64: Damaged electrical receptacles in courtyard

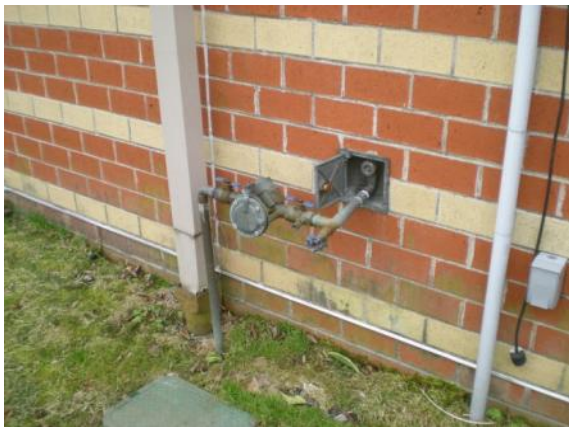
Photo #65: Irrigation outlet in courtyard

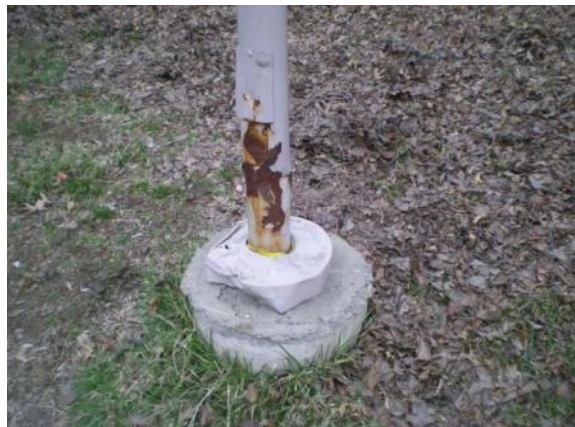
Photo #66: Moderate to severely damaged light pole

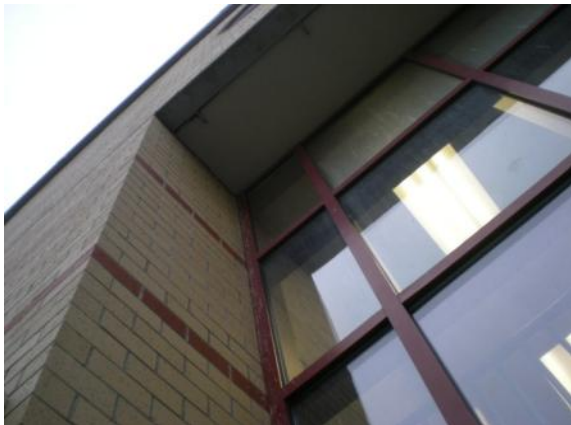
Photo #75: Area of birds infiltrating open joints at rear

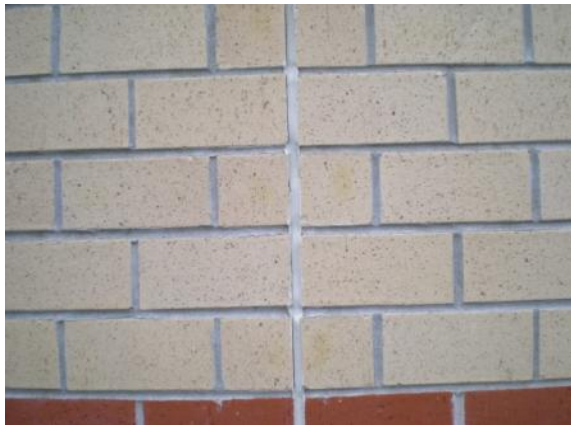
Photo #76: Separation of control joint

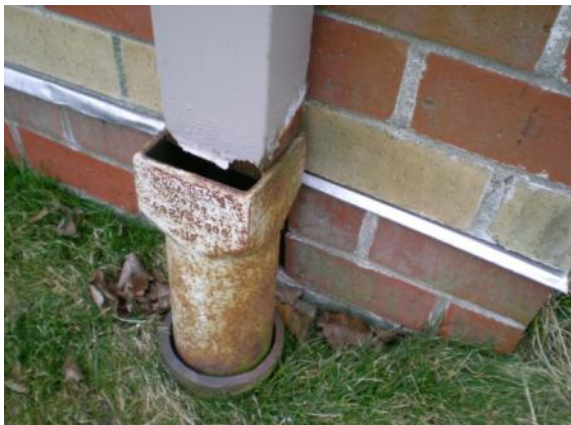
Photo #77: Condition of downspout

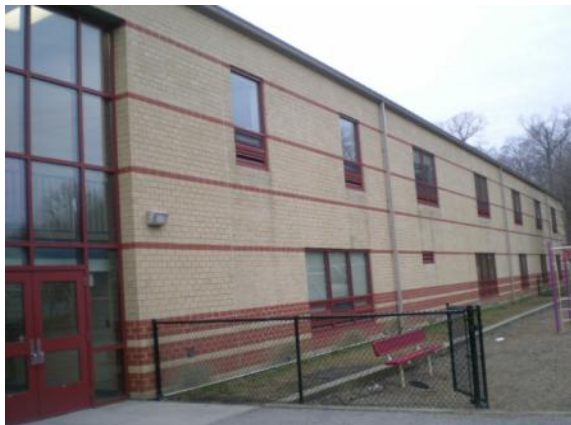
Photo #78: North elevation

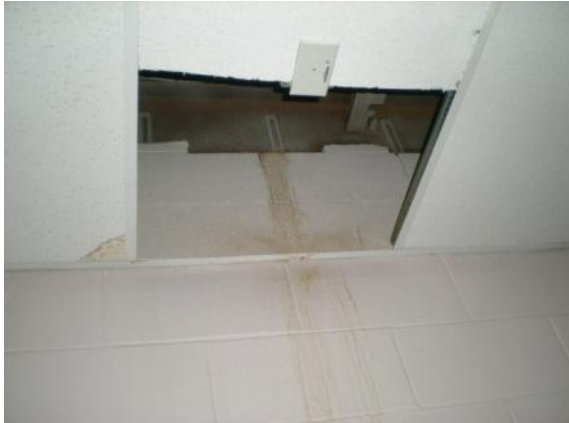
Photo #91: Active leak in side area off main lobby

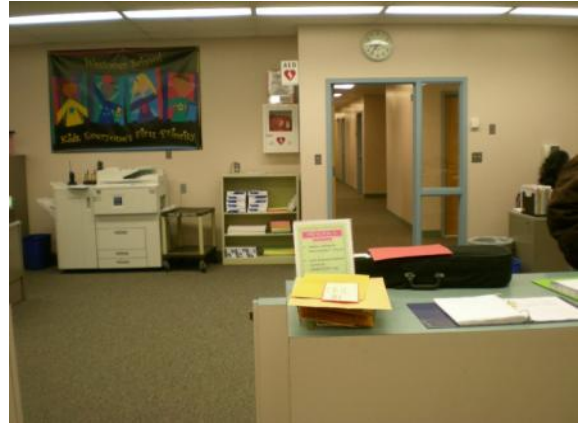
Photo #92: Main office area

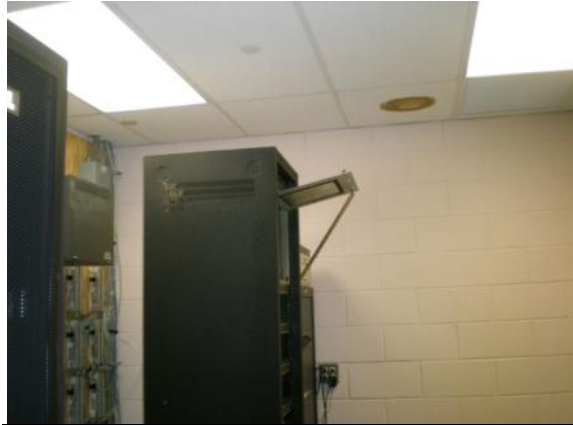
Photo #104: Leak in Media Center server room

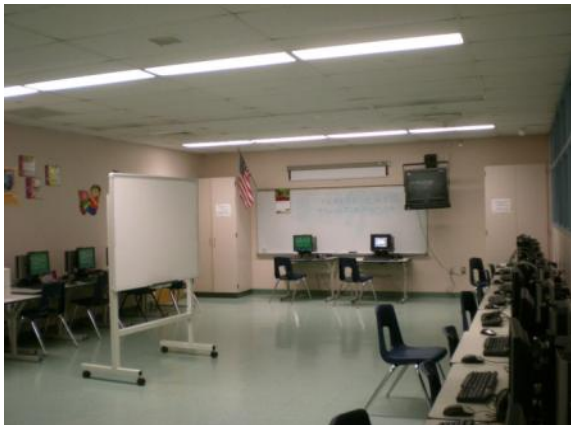
Photo #105: Computer lab

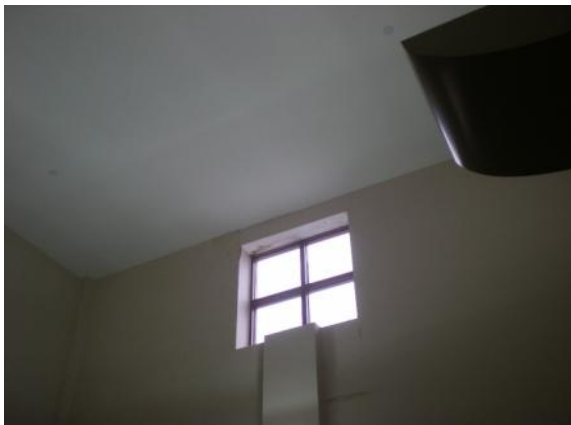
Photo #107: Active leak at high window in FRC3

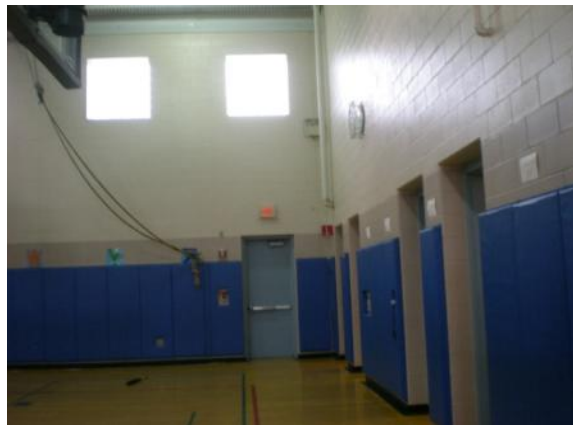
Photo #108: Gymnasium

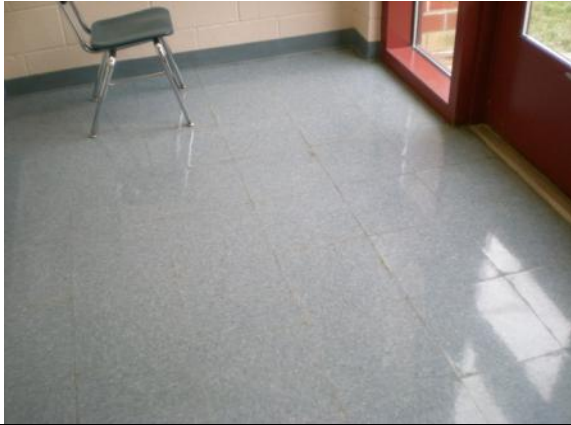
Photo #115: Deteriorated edges of vinyl tile from moisture

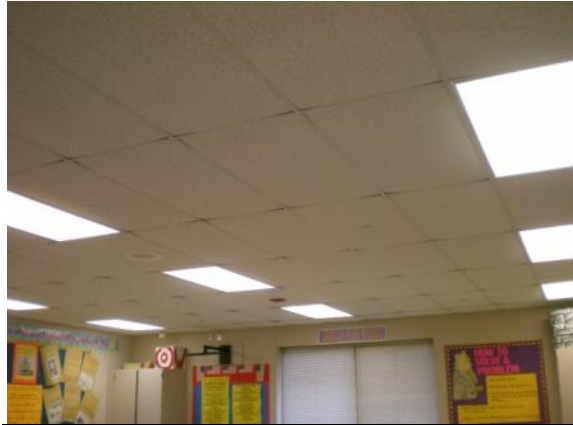
Photo #116: Bulging and cupping acoustic tile

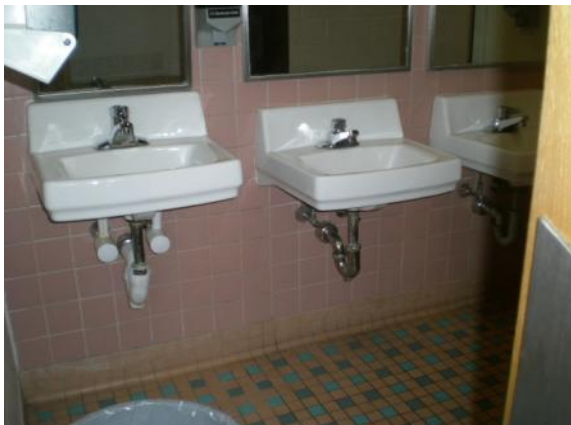
Photo #119: Missing drain pipe insulation

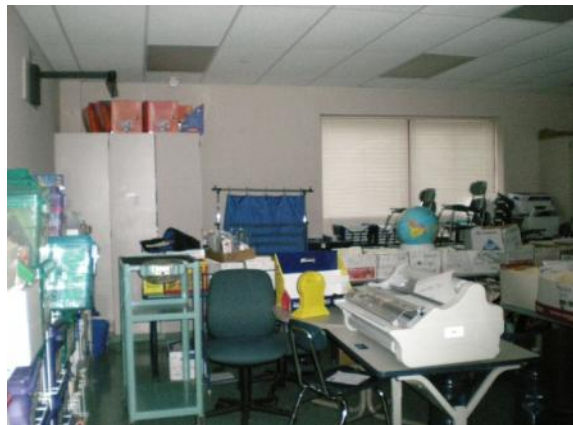
Photo #120: Classroom space used for storage

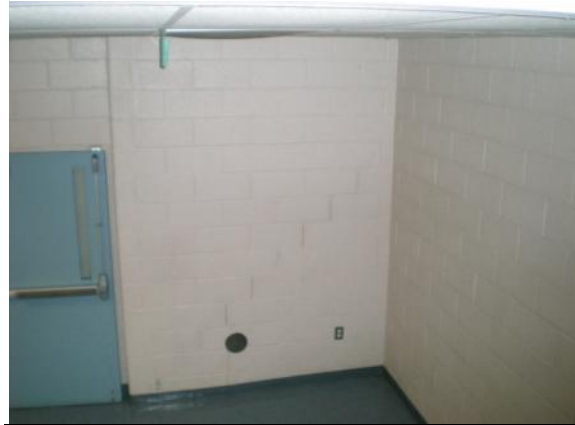
Photo #122: Stair step cracking

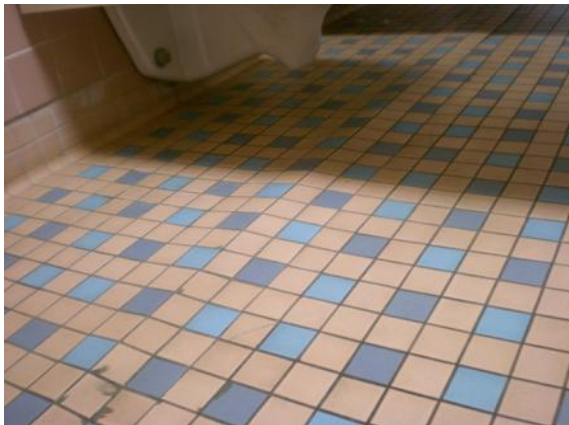
Photo #123: Bulging ceramic tile

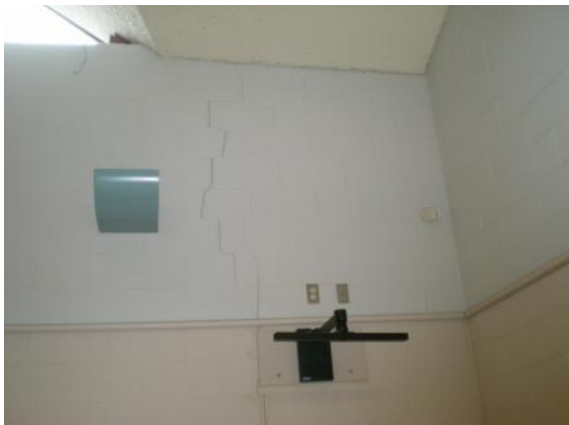
Photo #125: Cracking in concrete masonry units

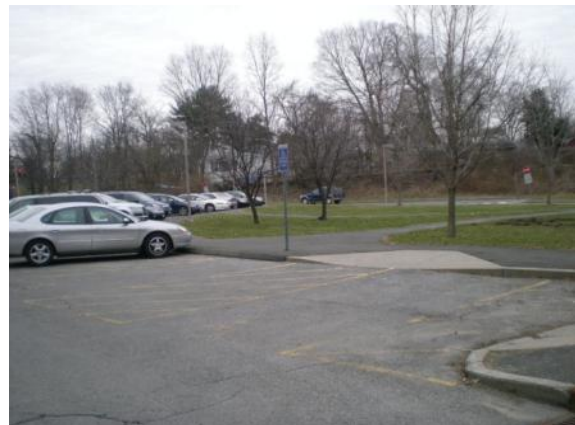
Photo #126: Missing post sign for ADA stall

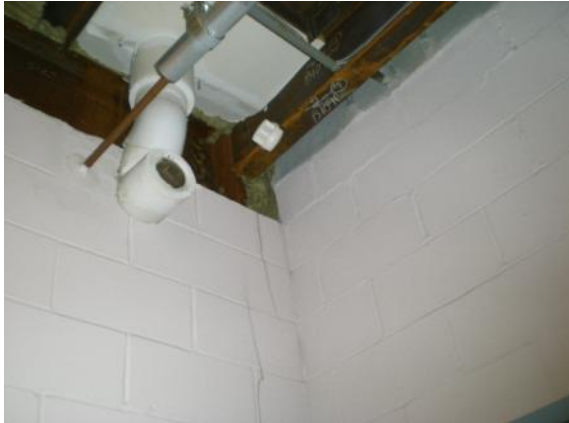
Photo #127: Cracking through block and exposed structure

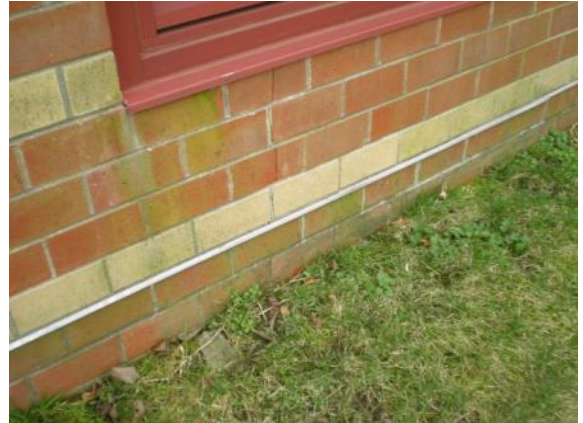
Photo #128: Cracking at brick veneer

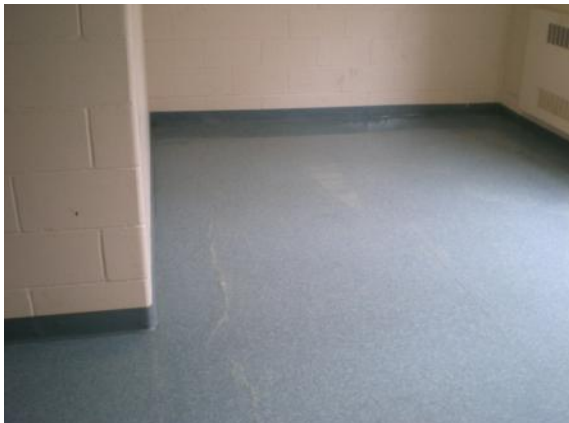
Photo #129: Cracking slab under flooring finish

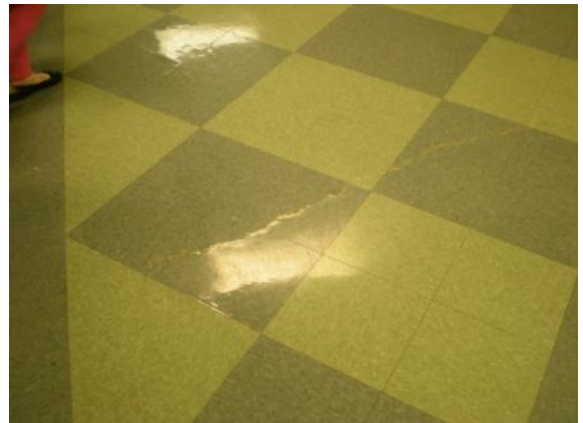
Photo #130: Cracking slab under vinyl tile flooring finish

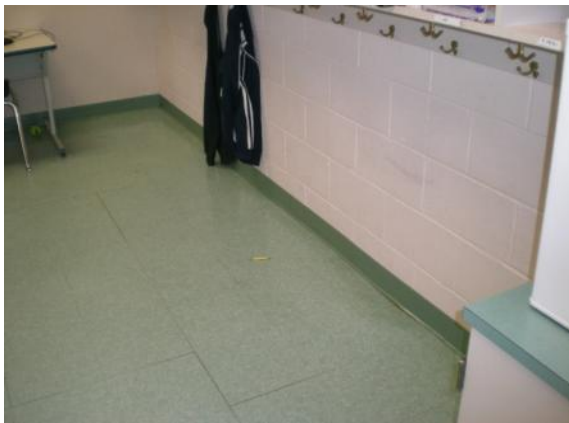
Photo #131: Separated vinyl tile and dip in slab at 2nd floor classroom

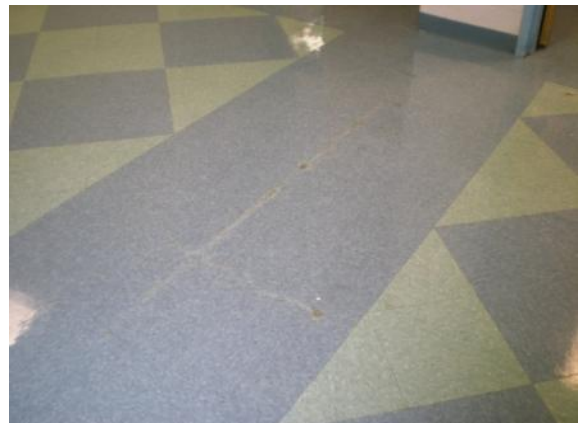
Photo #132: Cracking slab under vinyl tile flooring finish

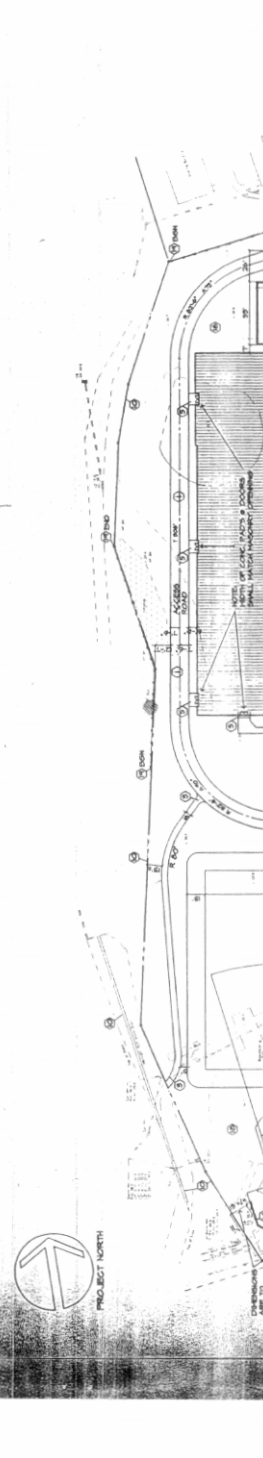
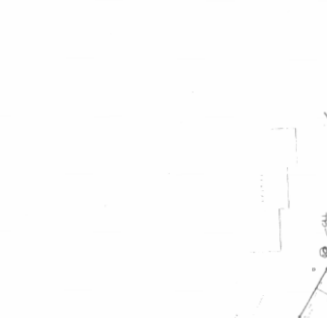
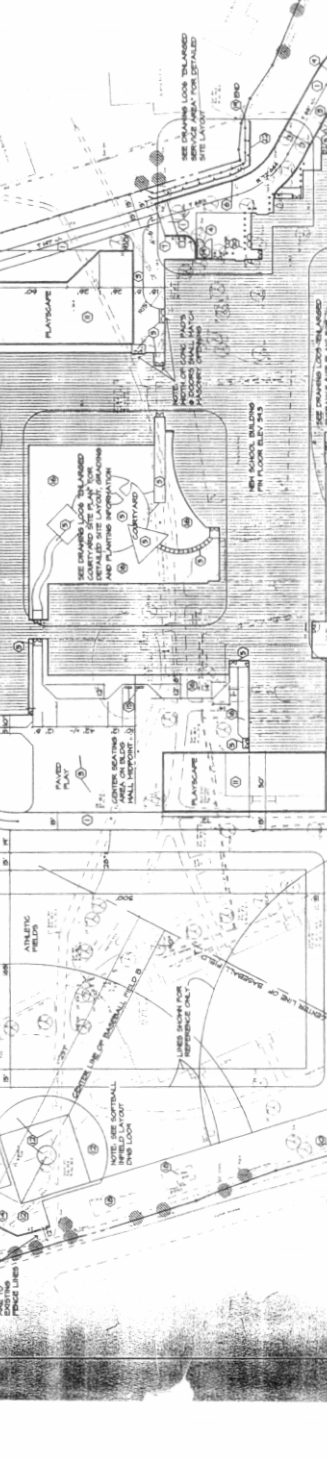
**APPENDIX C:
SUPPORTING DOCUMENTATION**
