# FACILITIES NEEDS ASSESSMENT

## STAMFORD PUBLIC SCHOOLS

## Facilities Needs Assessment of CLOONAN MIDDLE SCHOOL

**EMG Project #:** 88166.09R-009.017  
**Date of Report:** August 27, 2009  
**On-site Date:** April 1, 2009

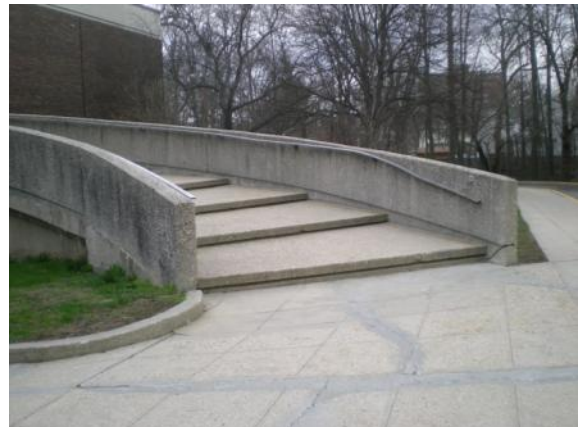
Photo #6:	Front entrance – main stair with damaged/loose stair rail and spalled concrete at base of stair
-----------	---

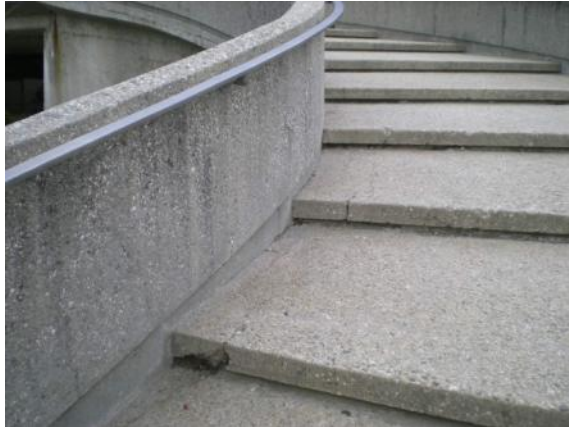
Photo #7: Cracked stair treads at front entrance main stair

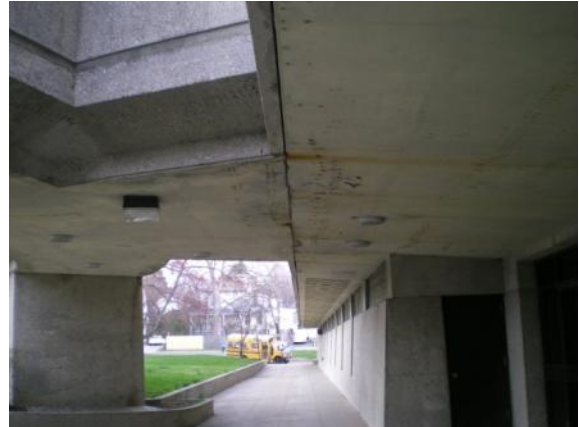
Photo #8: Exposed rebar, spalling and water infiltration evidence under main stair connection to main entrance

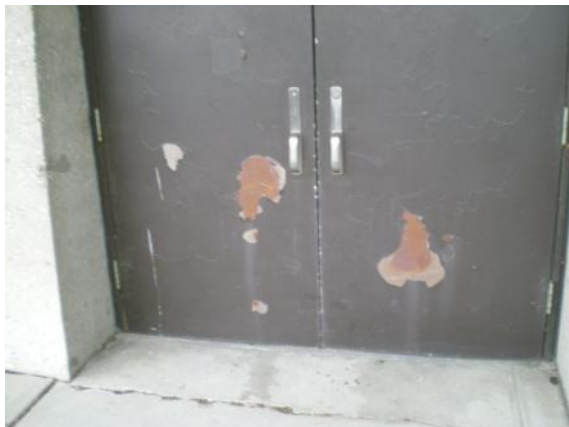
Photo #9: Condition of service doors

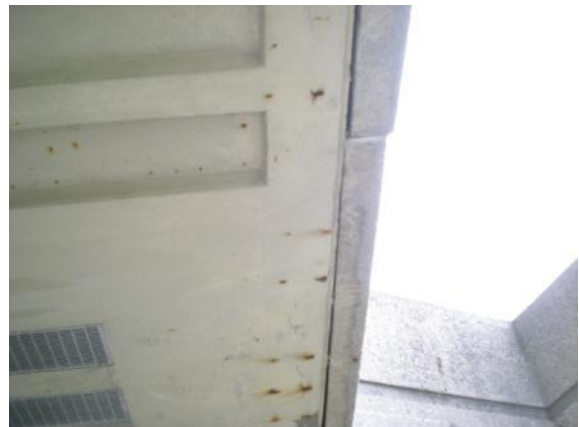
Photo #10: Exposed rebar at soffit and horizontally shifted precast concrete panel at front

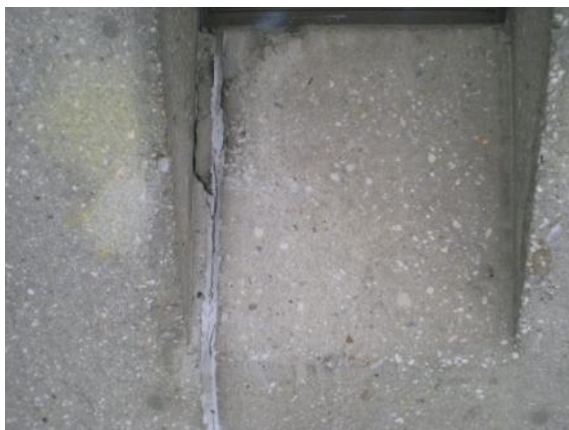
Photo #11: Condition of control joints under windows

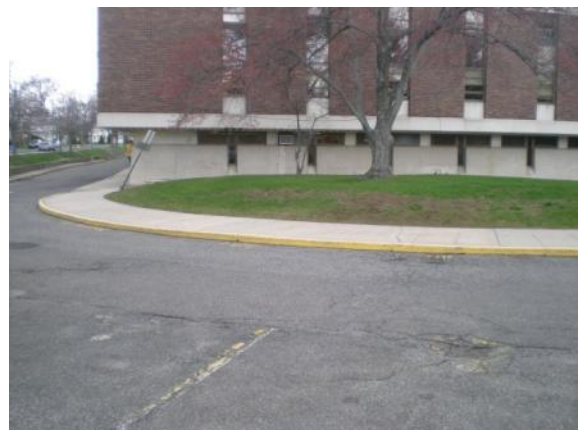
Photo #12: Severely faded ADA designated parking at front with no curb cut near stalls

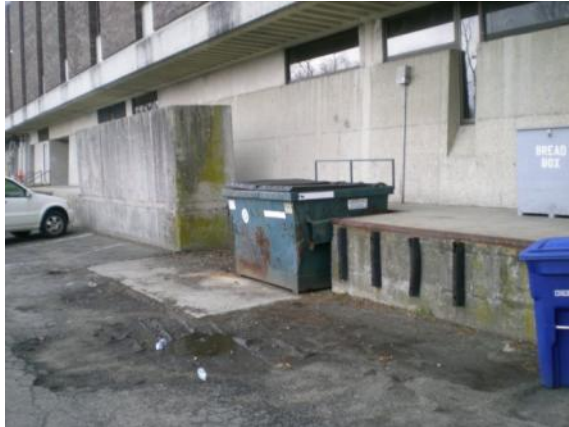
Photo #13:	Loading dock conditions
------------	-------------------------

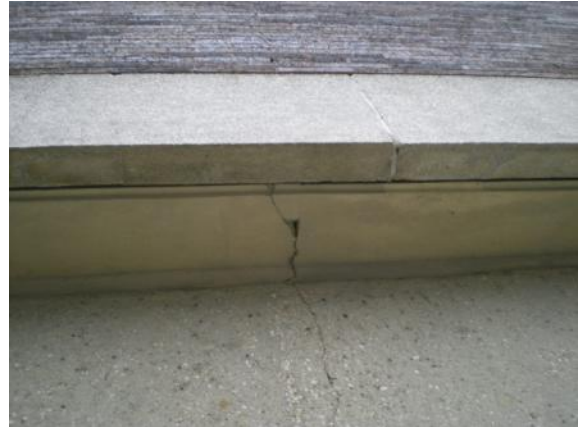
Photo #14:	Cracks at fascia and soffit
------------	-----------------------------

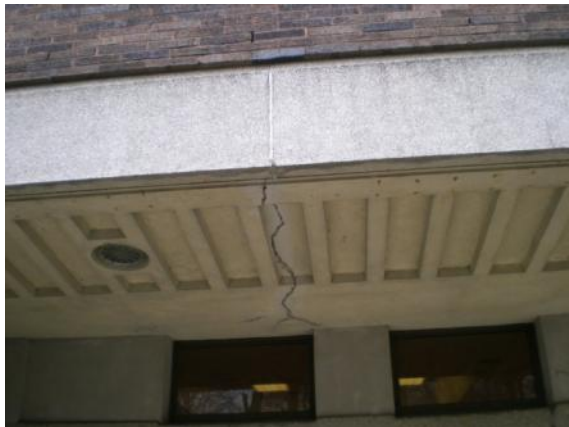
Photo #15:	Cracks at soffit
------------	------------------

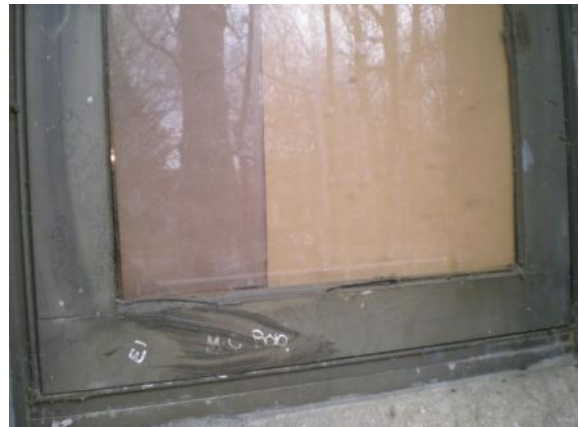
Photo #16:	Condition of window sealant and glazing compound
------------	--

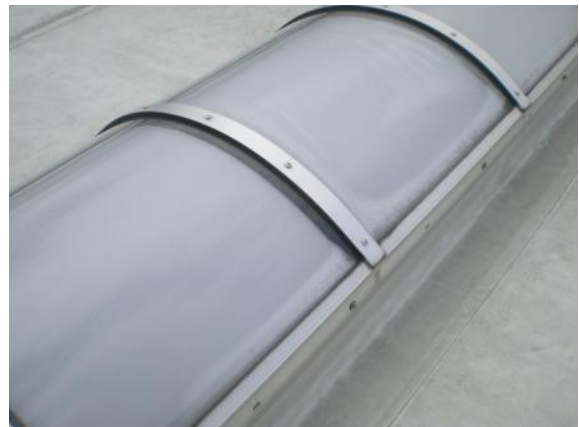
Photo #18:	Broken seals on barrel type skylights
------------	---------------------------------------

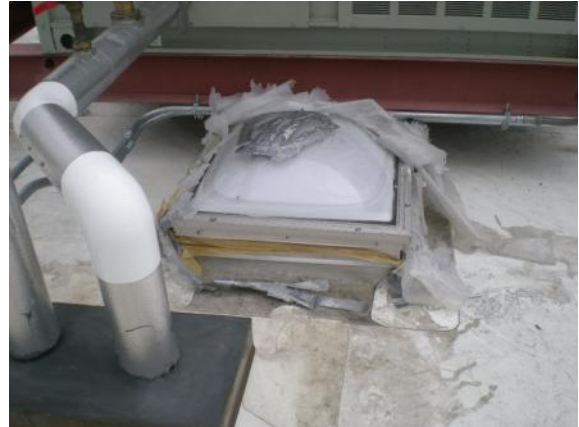
Photo #20: Broken skylight

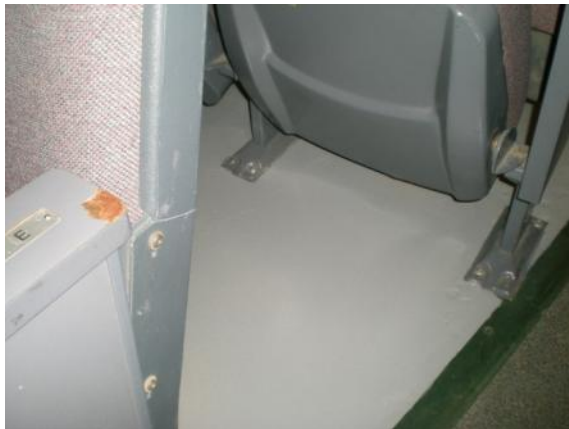
Photo #27: Broken chair backs in auditorium

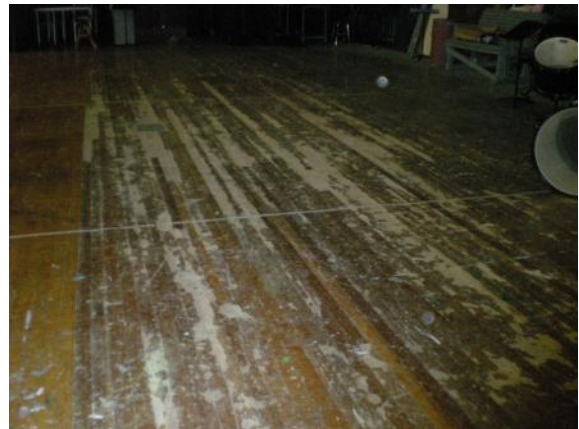
Photo #28: Worn stage in auditorium

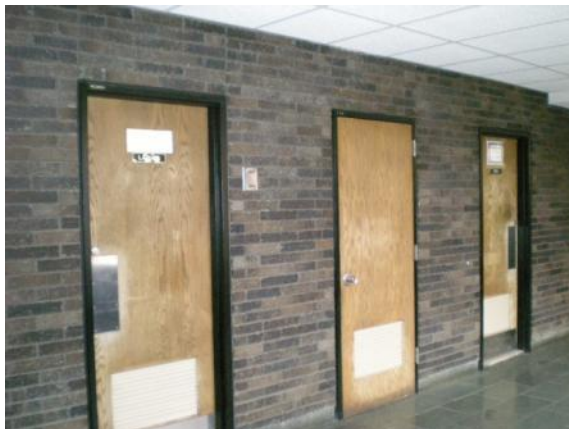
Photo #29: Common area restrooms with high thresholds

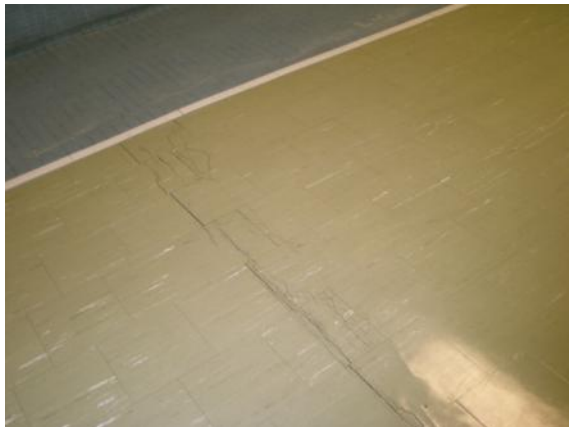
Photo #39: Cracks in flooring finished with suspect asbestos tile

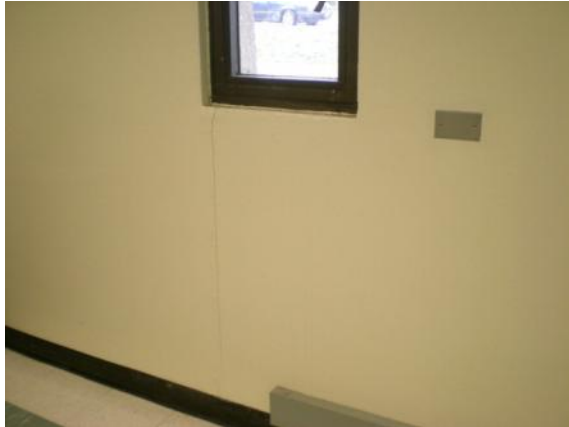
Photo #43: Crack at wall under window

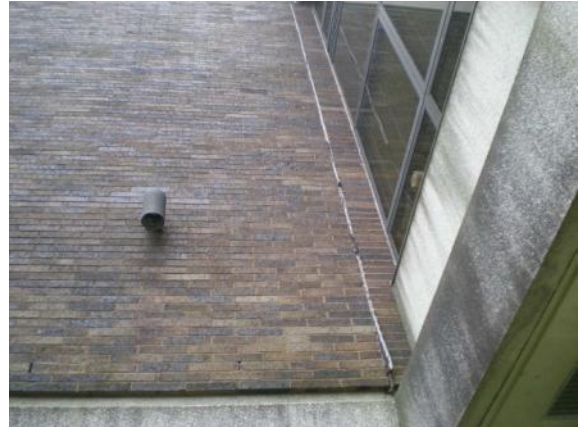
Photo #44: Condition of control joint

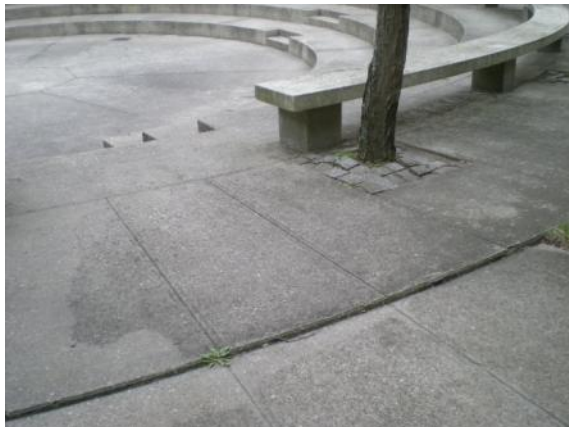
Photo #45: Vertical displacement at courtyard creating tripping hazards

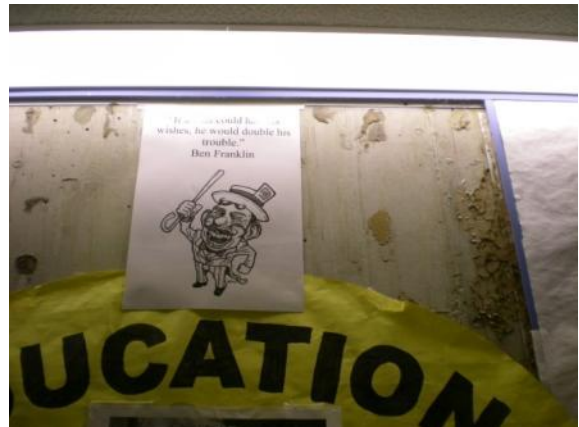
Photo #46: Moisture reported to penetrate wall and damaging wall finishes

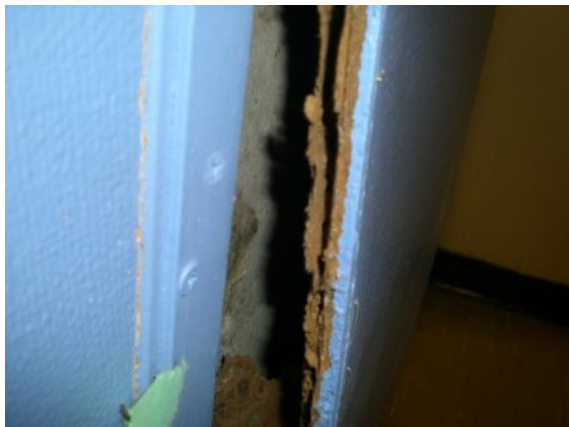
Photo #47: Moisture reported to penetrate wall and damaging wall finishes

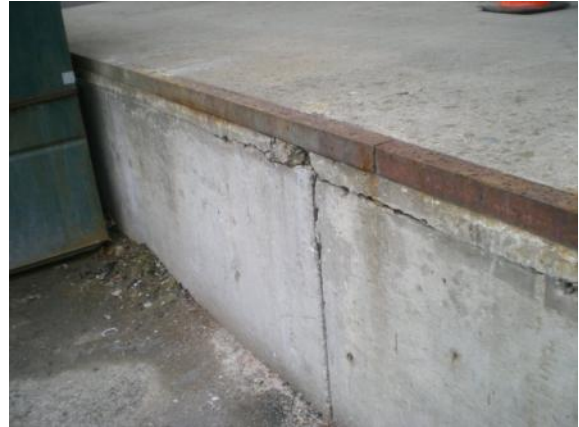
Photo #50: Loading dock conditions

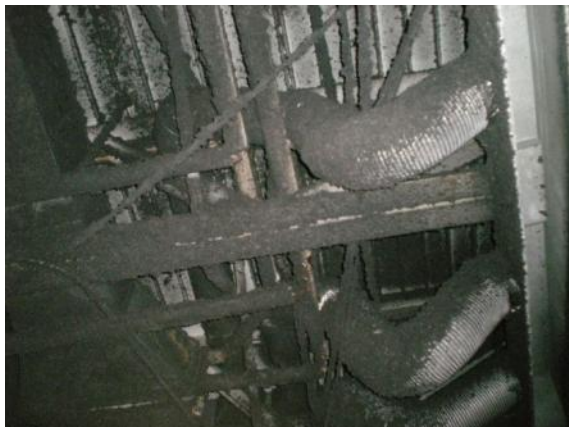
Photo #53: Fire-proofing in auditorium condition

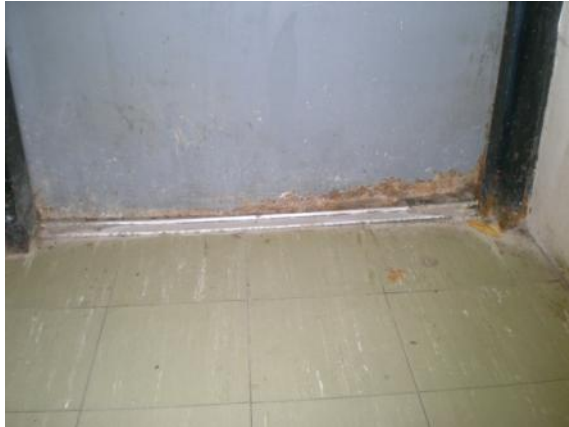
Photo #61: Rusted service doors and frame with evidence of water infiltration near music rooms

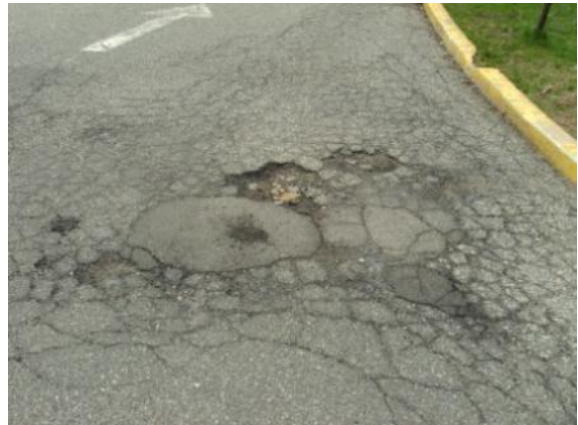
Photo #72:	Asphalt deterioration entering east drive lane
------------	--

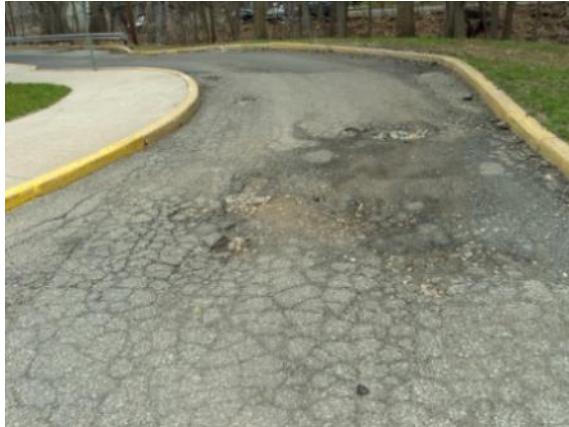
Photo #73: Asphalt deterioration entering east drive lane

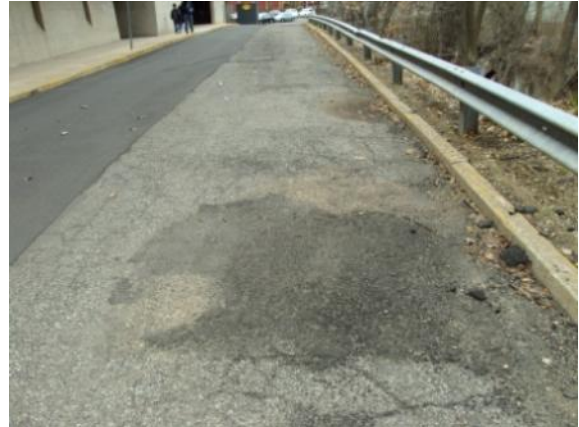
Photo #74: Asphalt condition along right side of east drive lane

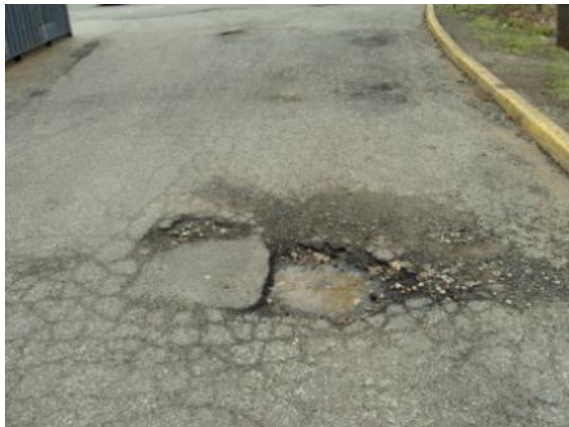
Photo #75: Asphalt deterioration at the rear of the east drive lane

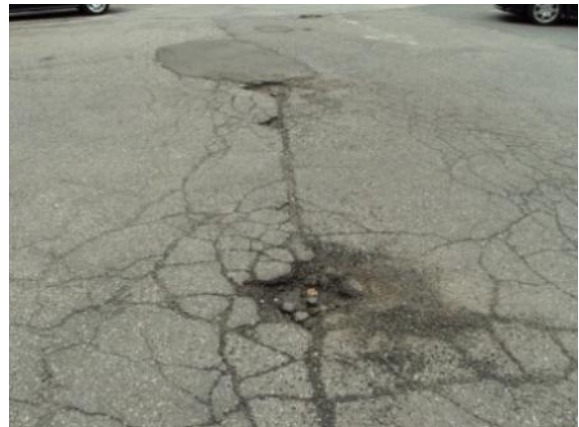
Photo #76: Asphalt deterioration at rear parking lot

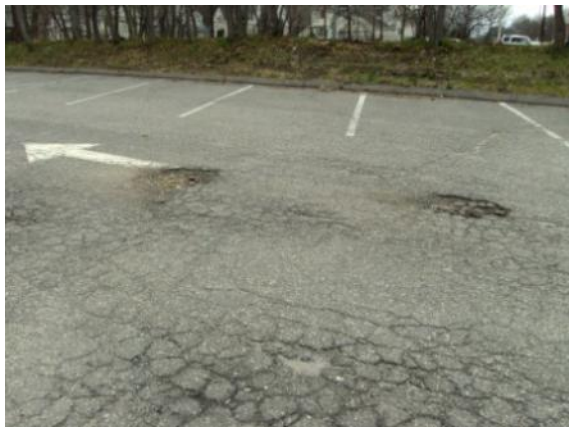
Photo #77: Asphalt deterioration at rear parking lot

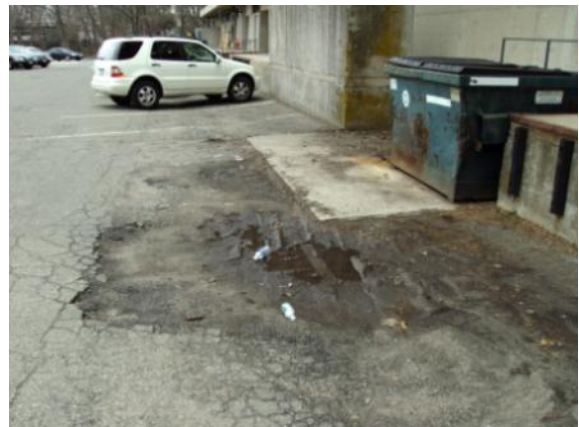
Photo #78: Asphalt deterioration adjacent to rear dumpster

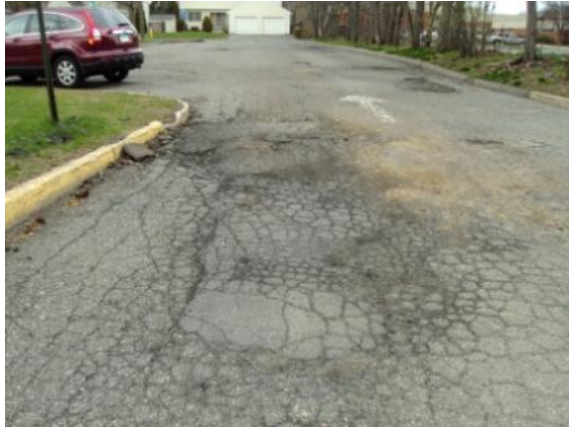
Photo #79: Asphalt deterioration and condition at northwest corner parking area

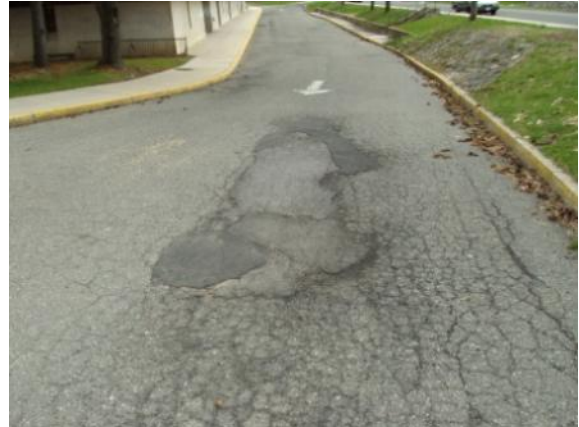
Photo #80: Asphalt condition at rear of west drive lane

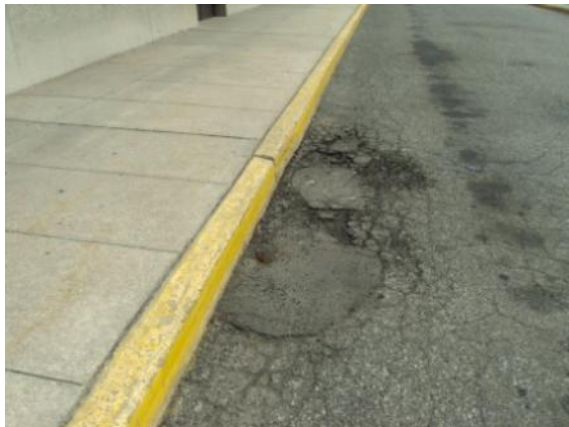
Photo #81: Asphalt deterioration at west drive lane

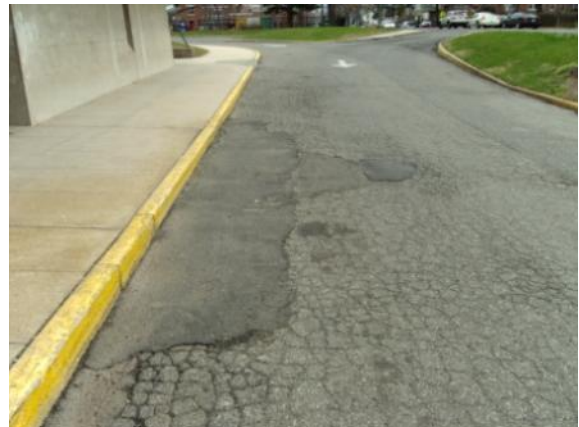
Photo #82: Asphalt deterioration at west drive lane

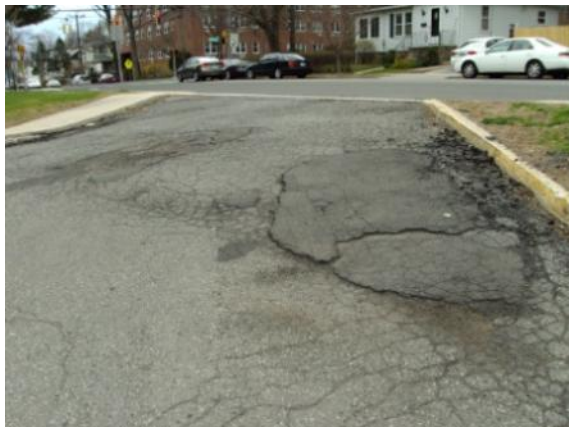
Photo #83: Asphalt deterioration entering from Powell Place

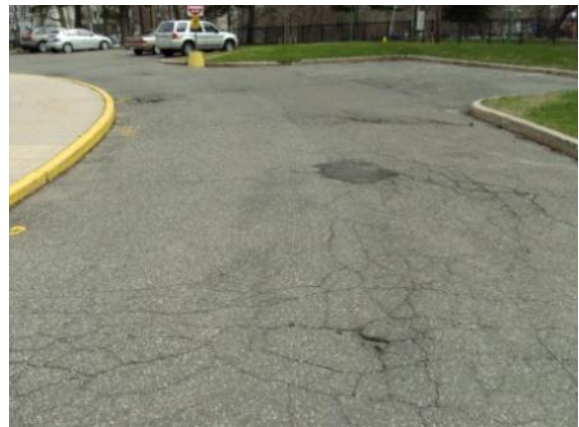
Photo #84: Asphalt condition at front parking area and drive lane

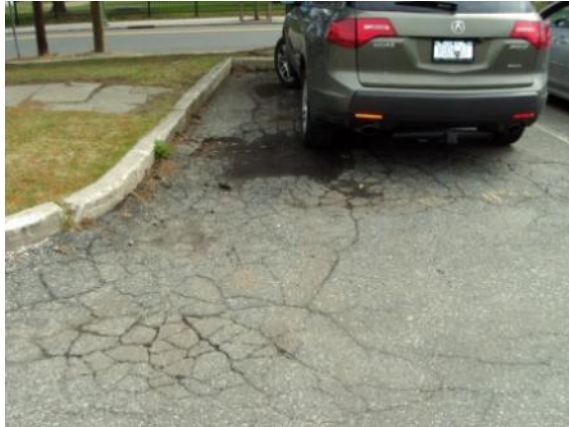
Photo #85: Asphalt deterioration at front parking area

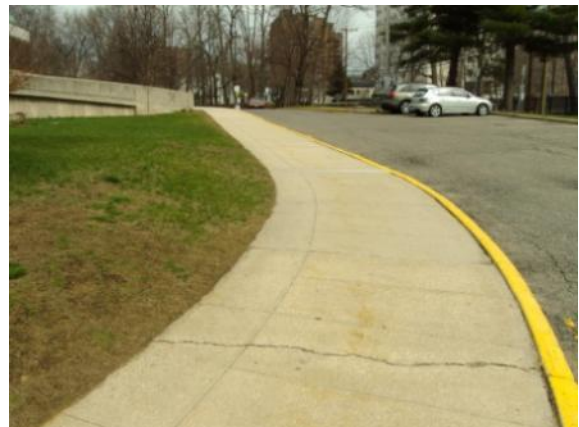
Photo #90: Concrete sidewalk at front of building (note cracking)

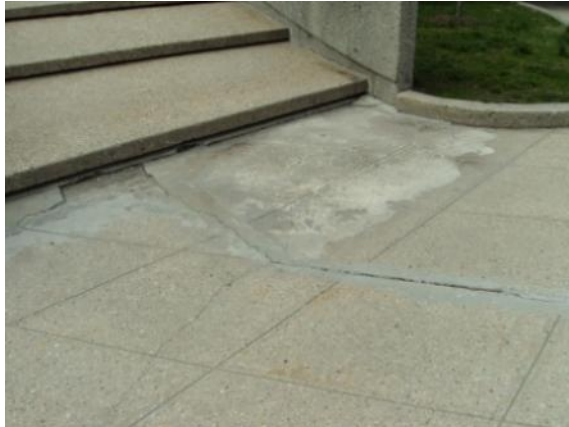
Photo #91: Concrete sidewalk front elevation with repair area that is cracking and deteriorating

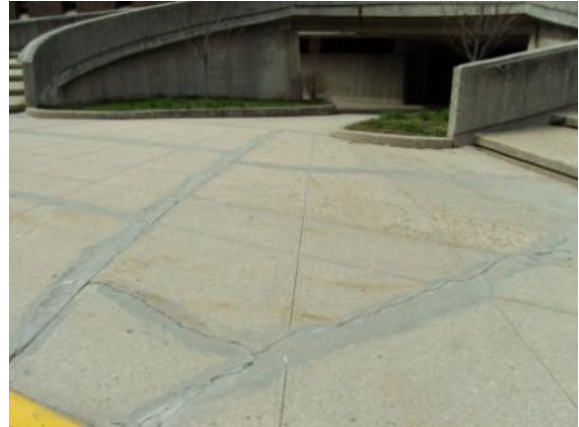
Photo #92: Cracking at concrete sidewalks at front elevation

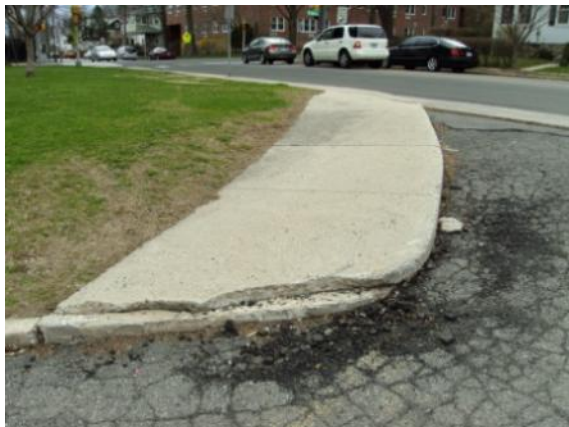
Photo #93: Deterioration at concrete sidewalk and curbing at west elevation

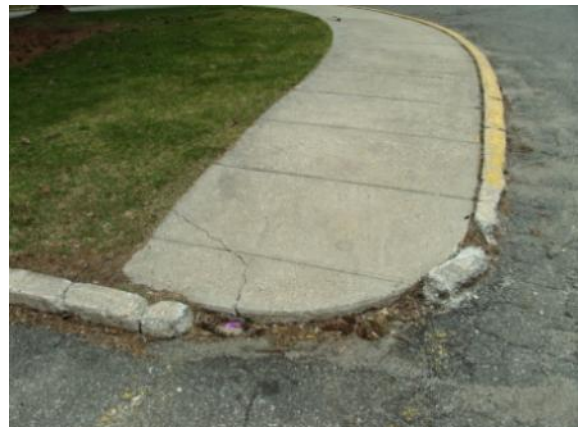
Photo #94: Tripping hazard and deterioration at concrete sidewalk and curbing at rear of building

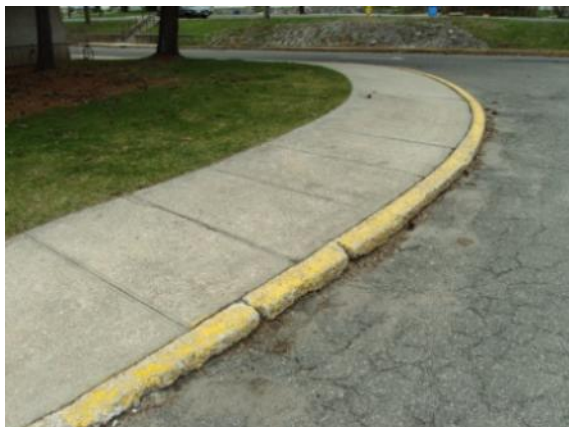
Photo #95: Settlement of concrete sidewalk and deteriorating curbing at rear of building

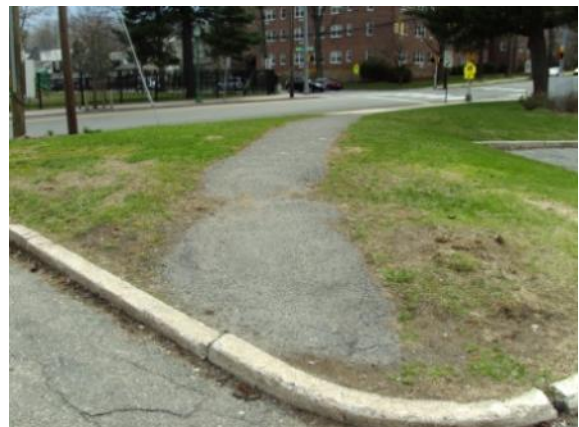
Photo #96: Asphalt sidewalk condition at front elevation

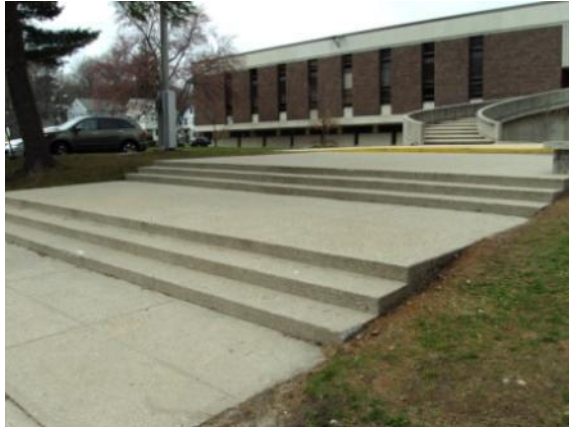
Photo #97: Concrete steps at front elevation (note missing handrails)

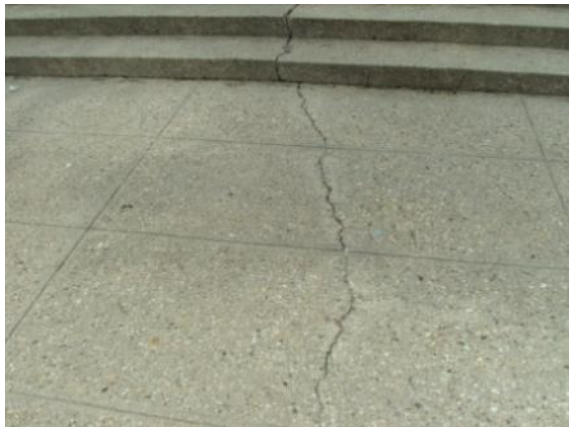
Photo #99: Cracking at front concrete steps/sidewalk

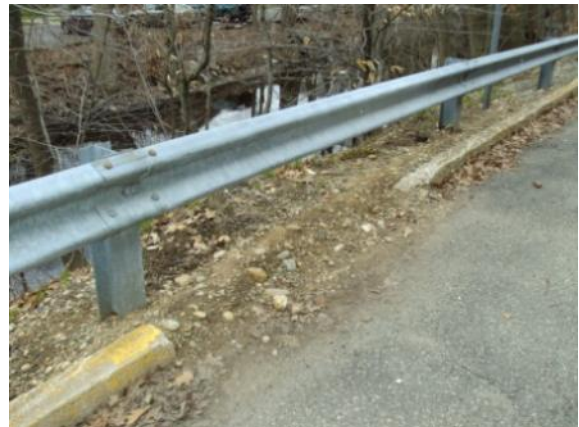
Photo #100: Deteriorating/missing section of concrete curbing along east drive lane

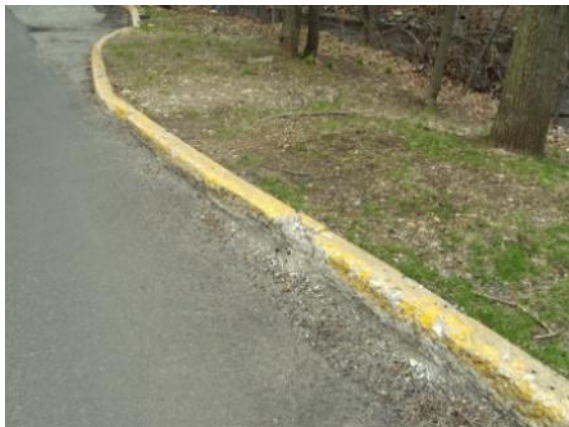
Photo #101: Deteriorating concrete curbing along east drive lane

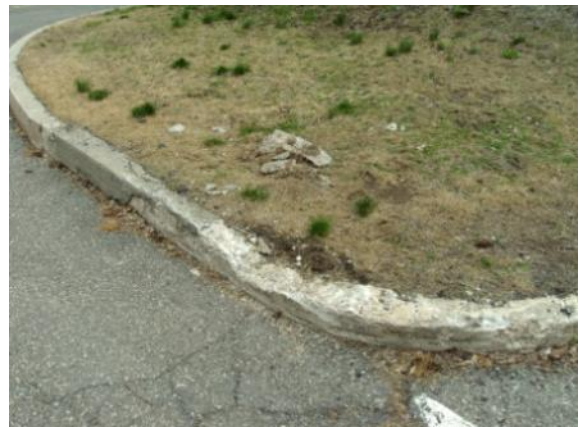
Photo #102: Deteriorating concrete curbing at rear of building

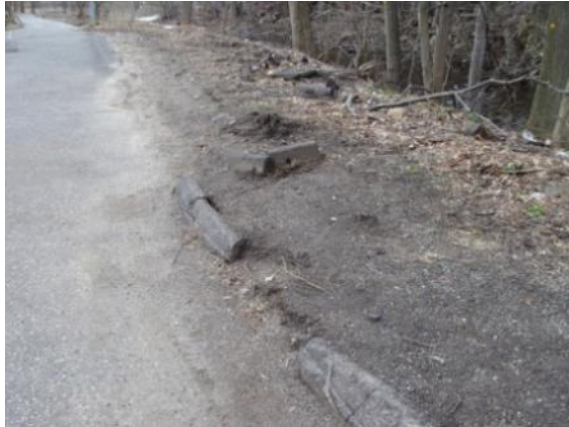
Photo #103: Deteriorating, missing and displaced asphalt curbing at east elevation

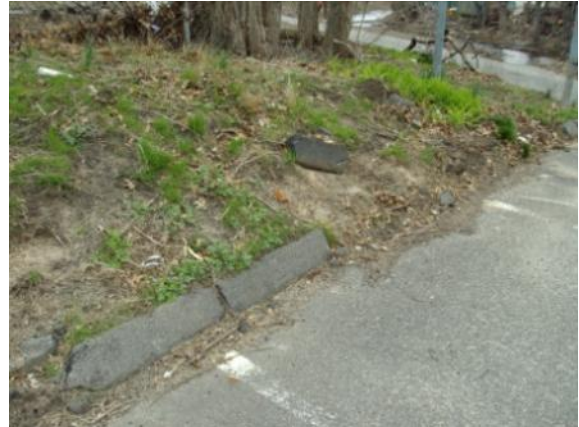
Photo #104: Deteriorating, missing and displaced asphalt curbing at rear parking lot

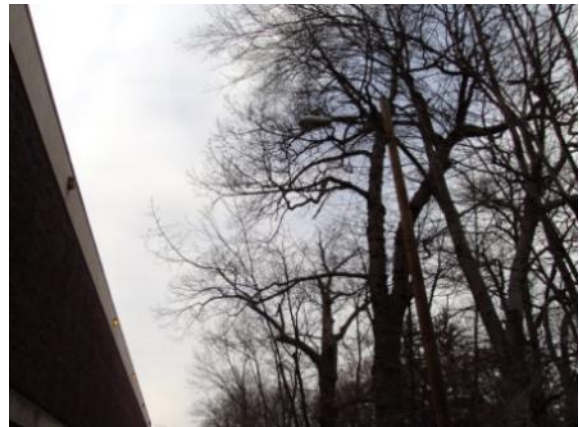
Photo #112: Wood pole light and overgrown trees along east elevation

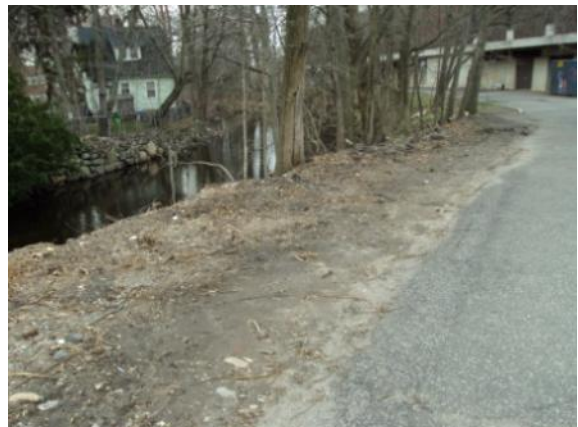
Photo #120: Landscape condition along east elevation (adjacent to river)

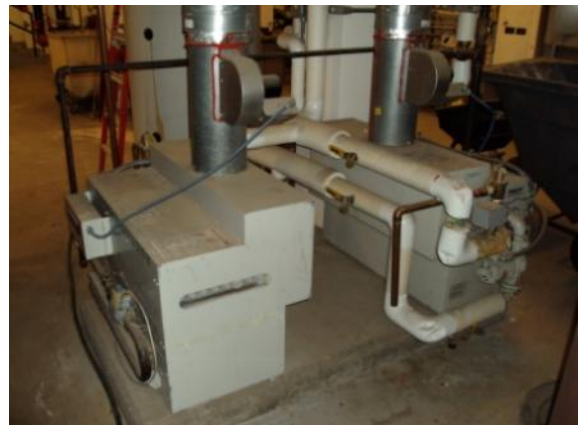
Photo #150: Domestic hot water boilers

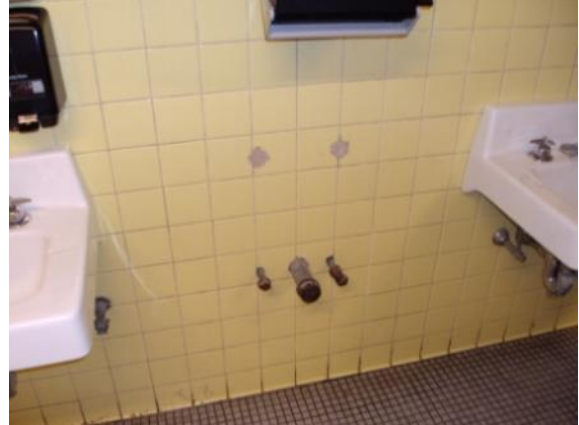
Photo #158: Boys locker room missing a lavatory sink

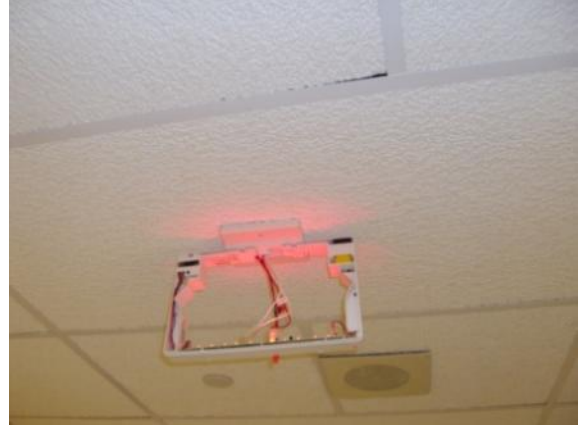
Photo #194: Damaged exit sign at ground floor corridor
