Initial Assessment—Photographic Log

Client: City of Stamford Mold Task Force

Job Number: S-2087-033

Site: Cloonan Middle School

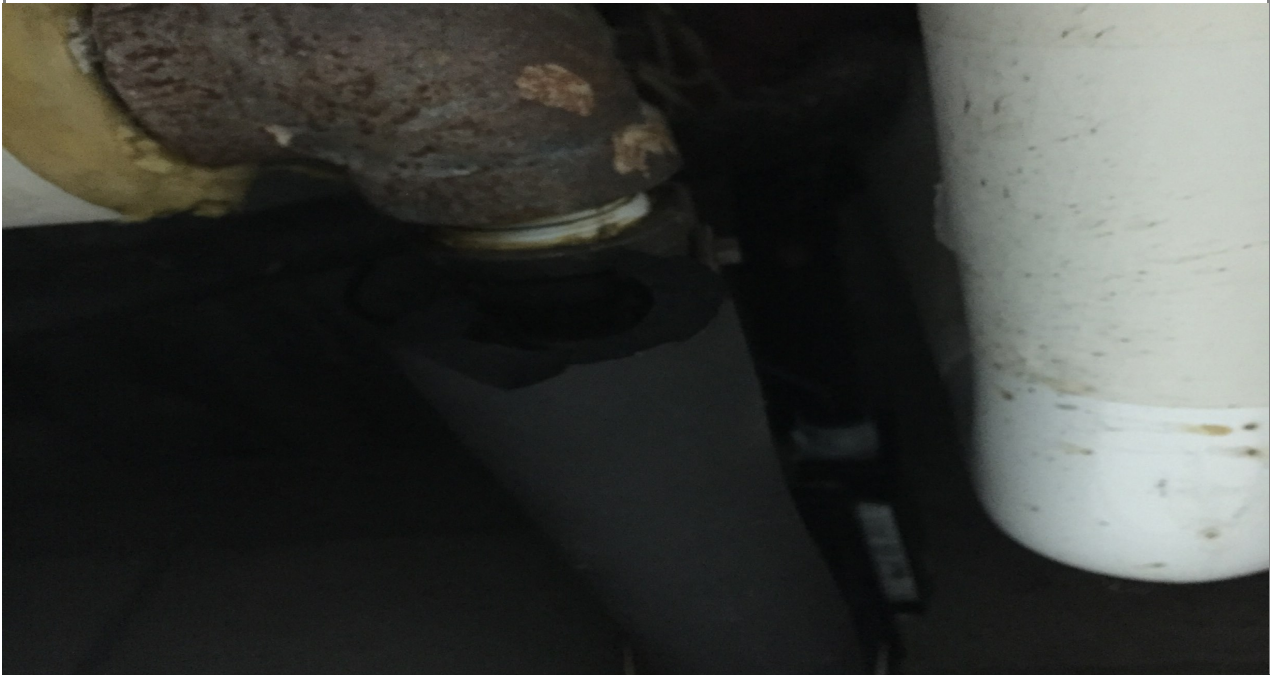
Photograph No.: 13	Date: 11/13/18	Direction Taken: —
Description: Uninsulated pipe above stained ceiling—Room 213

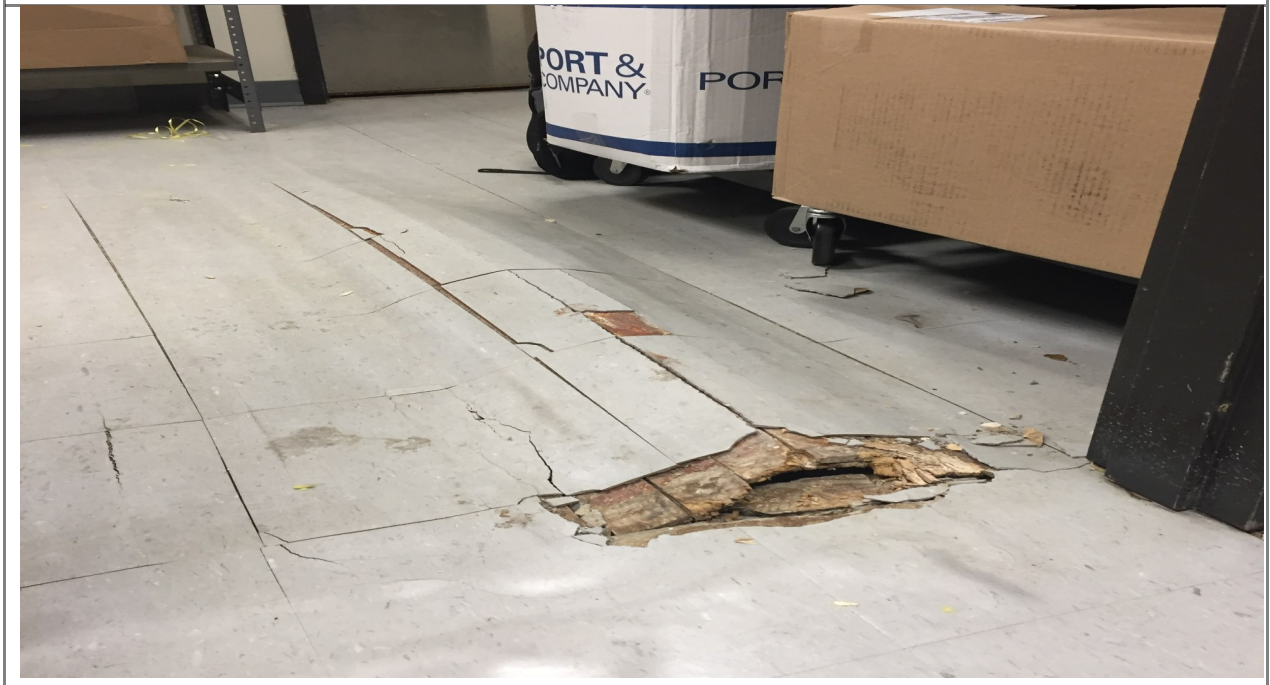
Photograph No.: 14	Date: 11/13/18	Direction Taken: —
Description: Water damaged wood floor—PTO Room

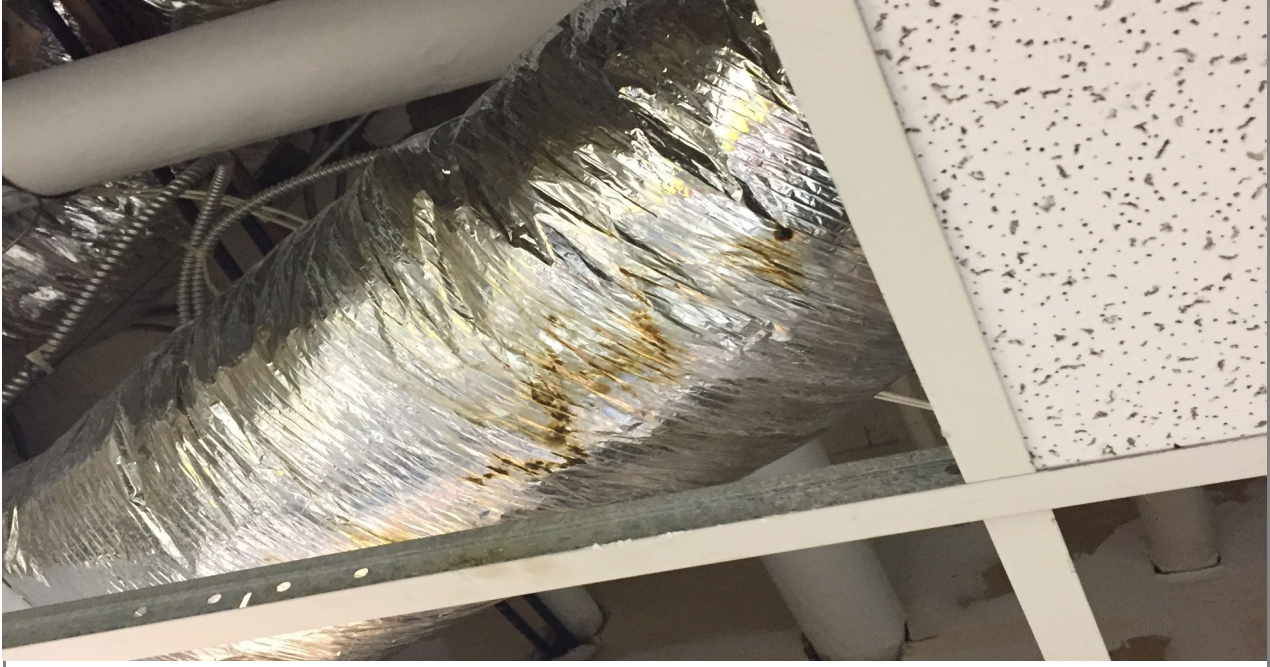
Photograph No.: 15	Date: 11/13/18	Direction Taken: —
Description: Stained fiberglass flex duct and missing ceiling tiles—PTO Room

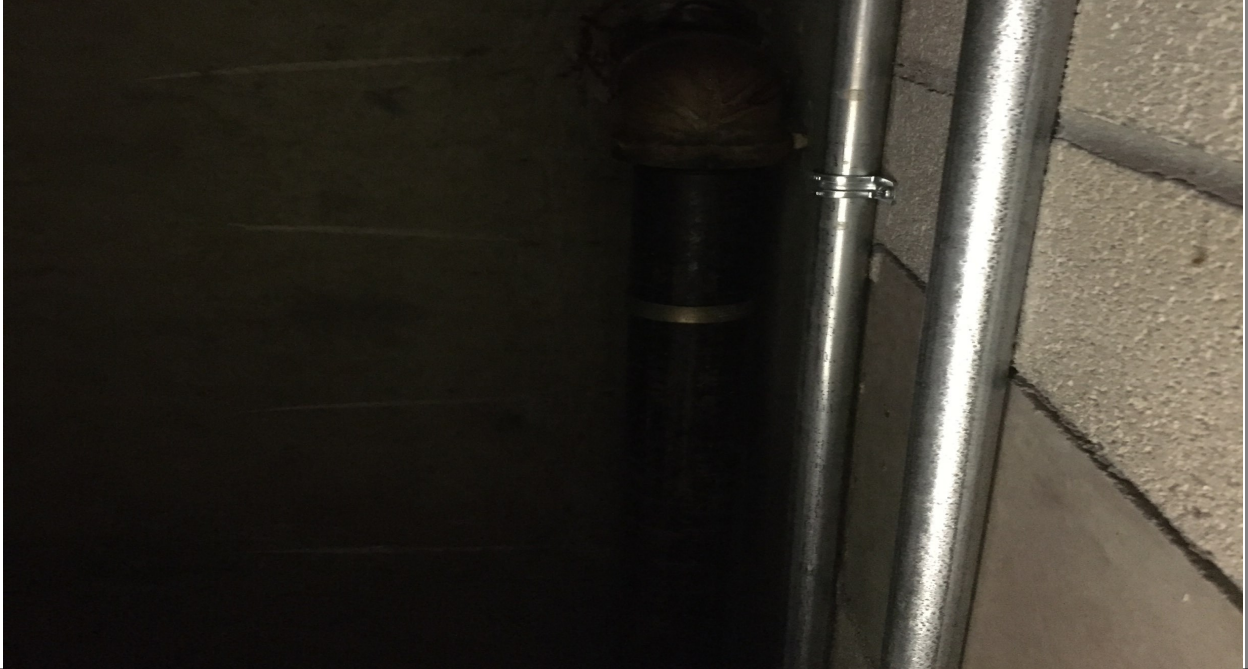
Photograph No.: 19	Date: 11/13/18	Direction Taken: —
Description: Above stained ceiling tile outside PTO Room
