Infrared Thermographic Roof Moisture Analysis

PERFORMED FOR: Viking Construction
1387 Seaview Ave.
Bridgeport, CT 06607

LOCATION: Dolan Middle School
Stamford, CT

CONDUCTED ON: May 22 & 24, 2019

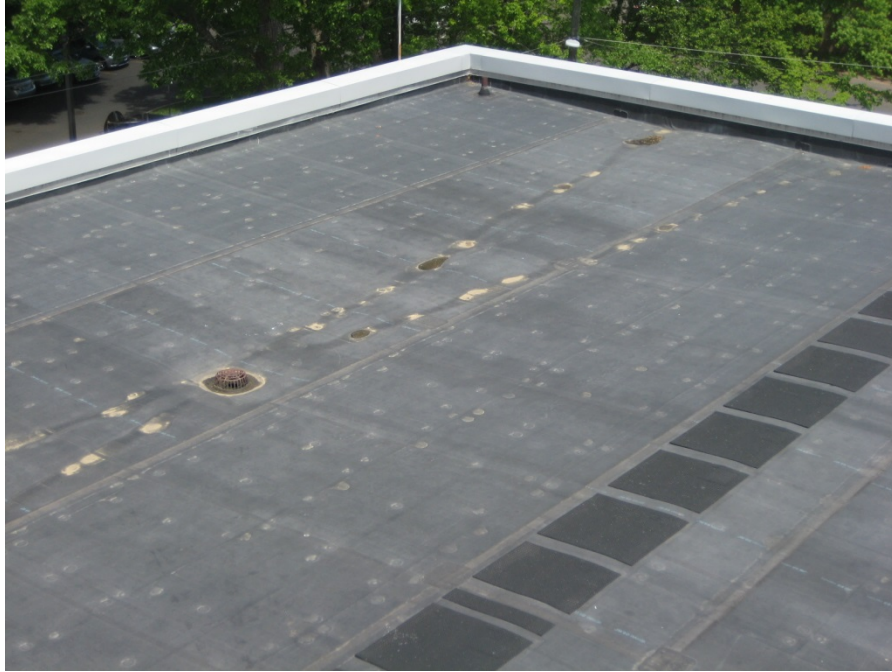
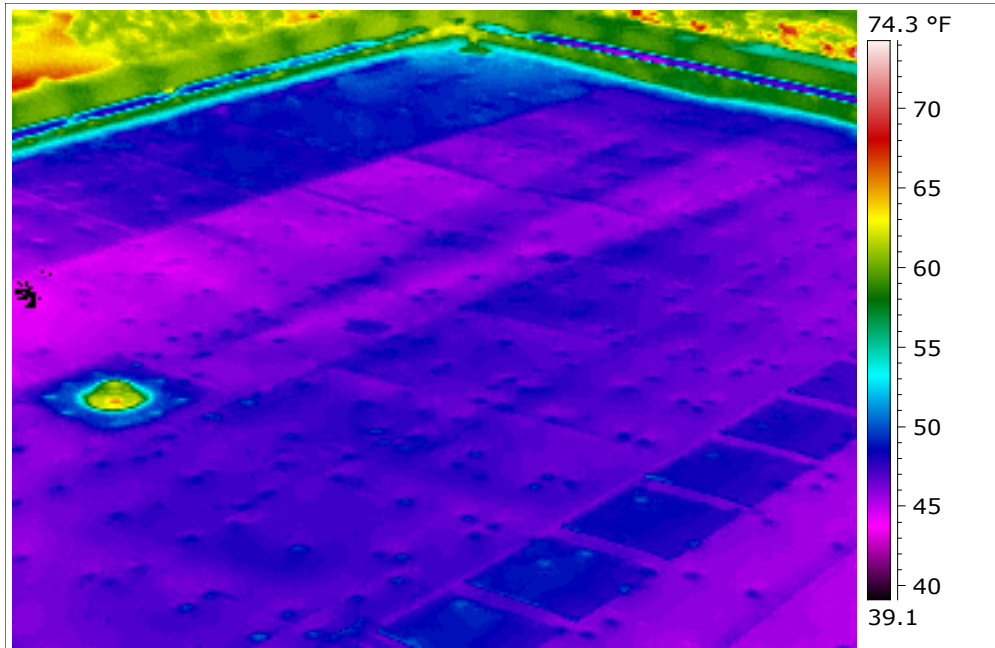
Thermogram # 1

Dry area of roofing

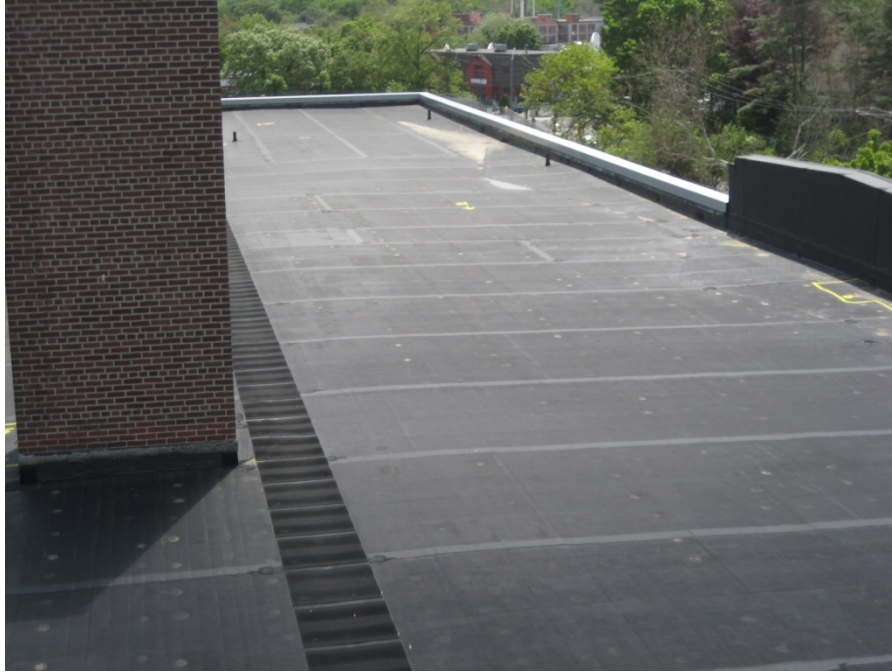
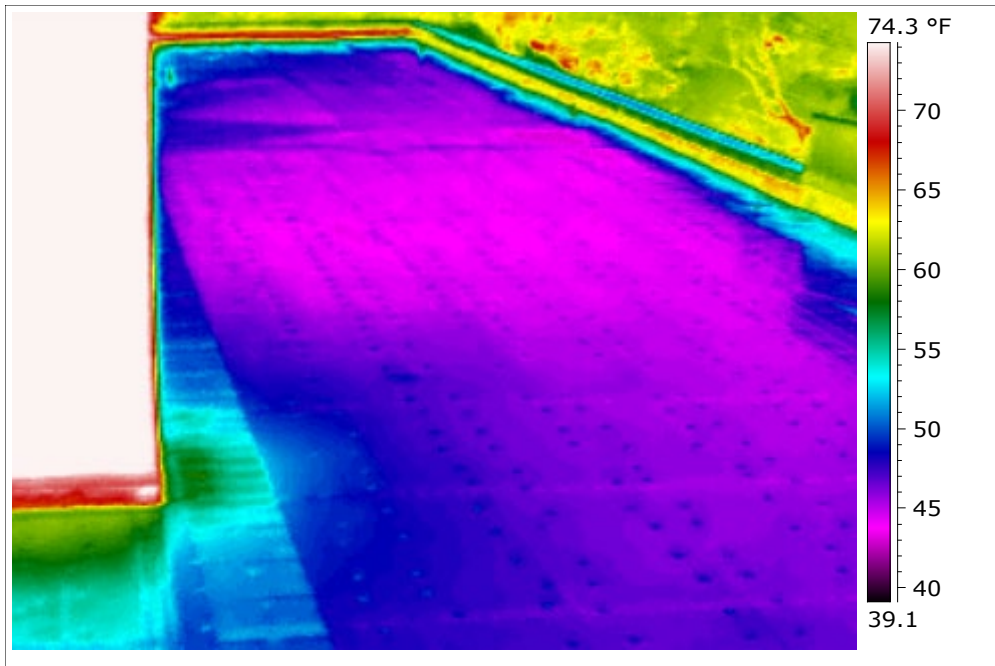
Thermogram # 2

Dry area of roofing

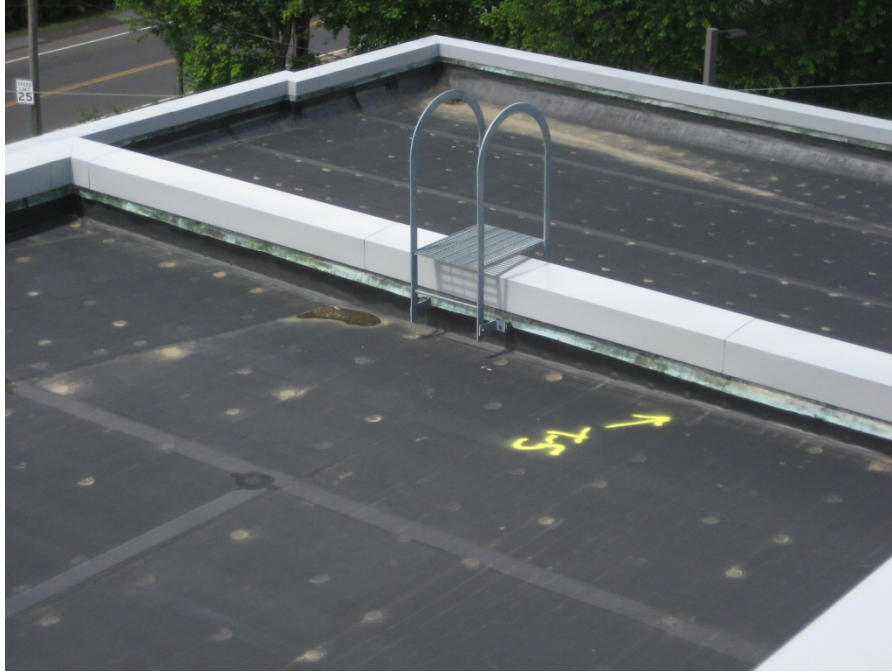
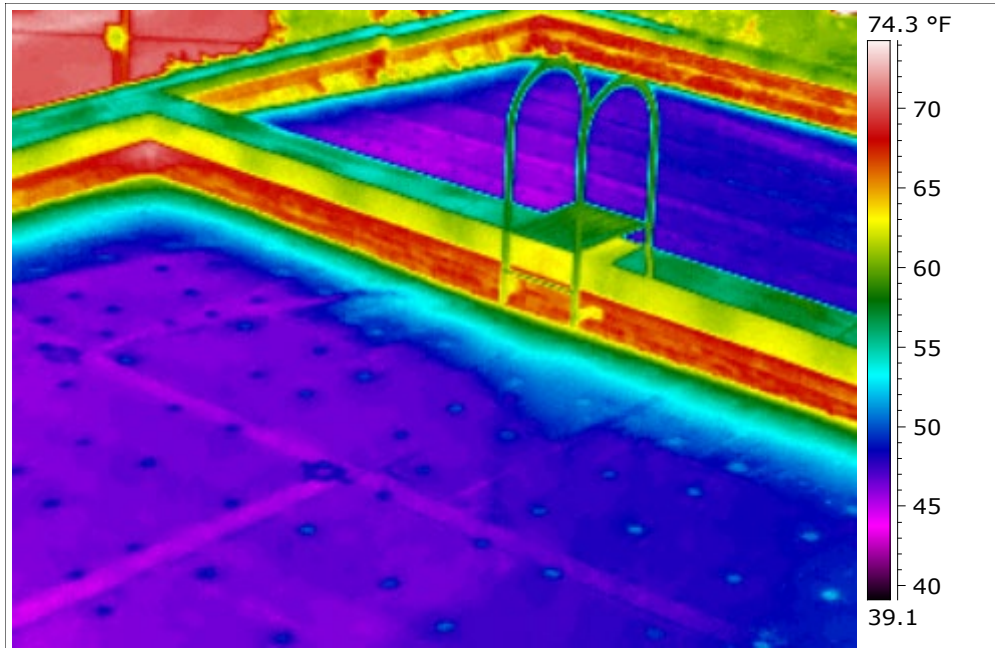
Thermogram # 3

Dry area of roofing

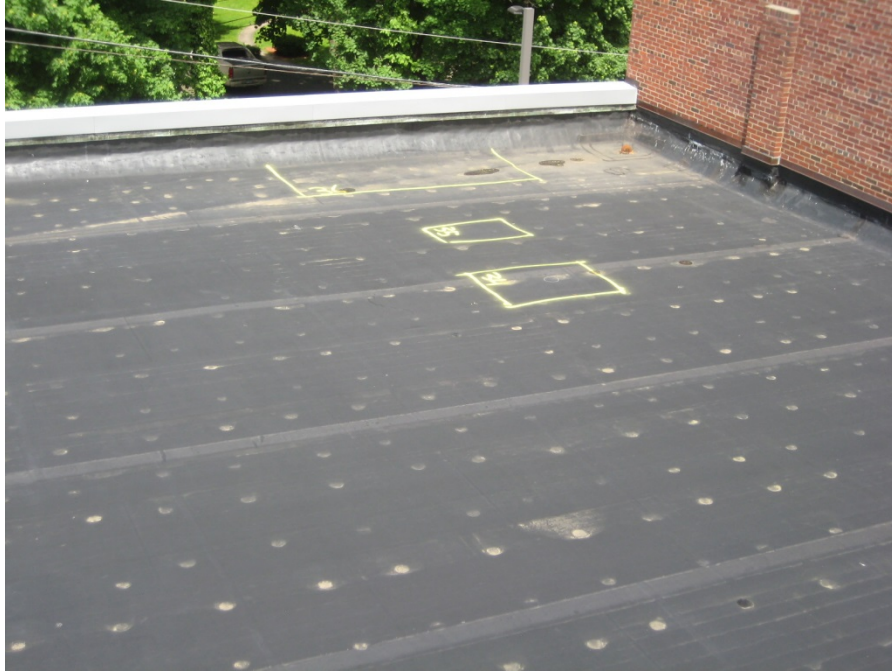
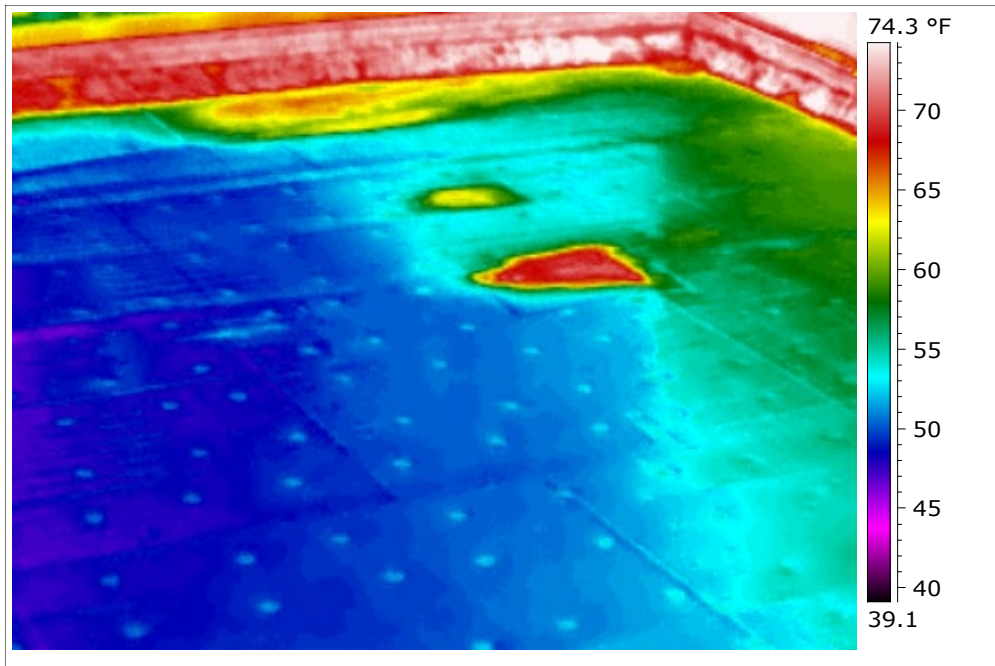
Thermogram # 4

Wet Areas #

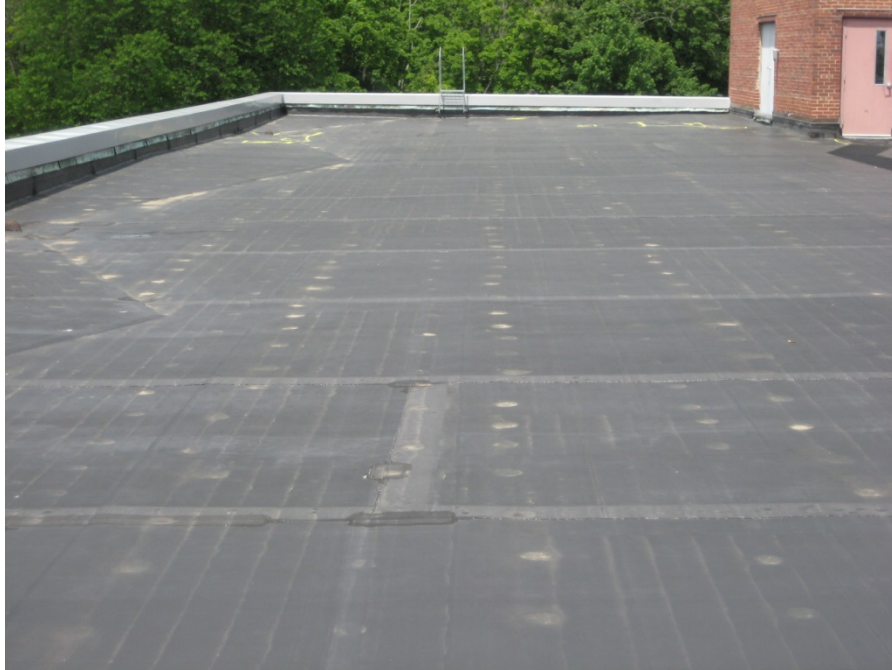
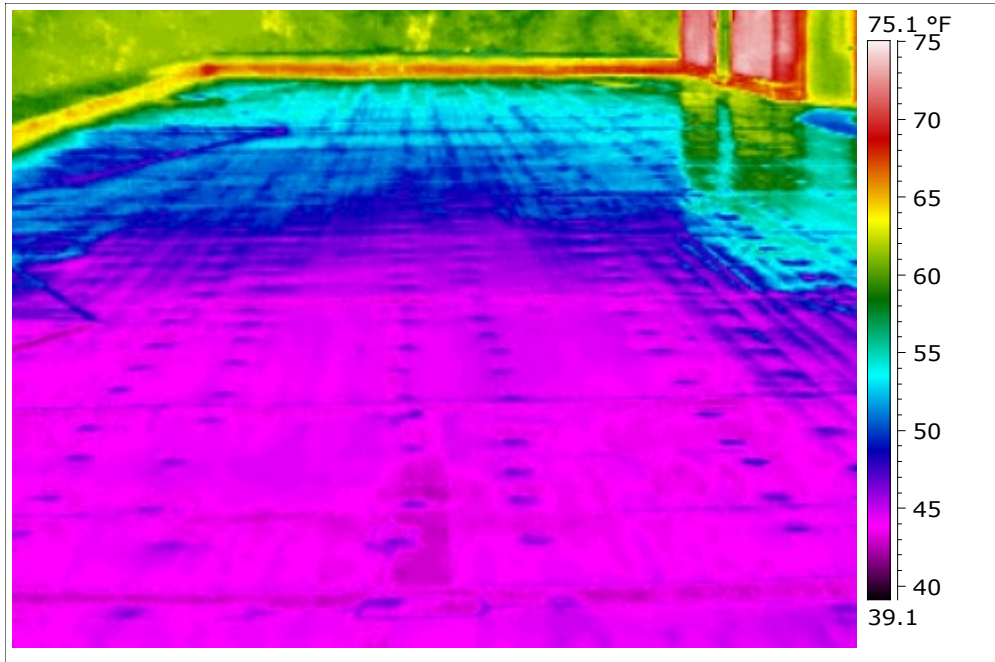
Thermogram # 5

Dry area of roofing

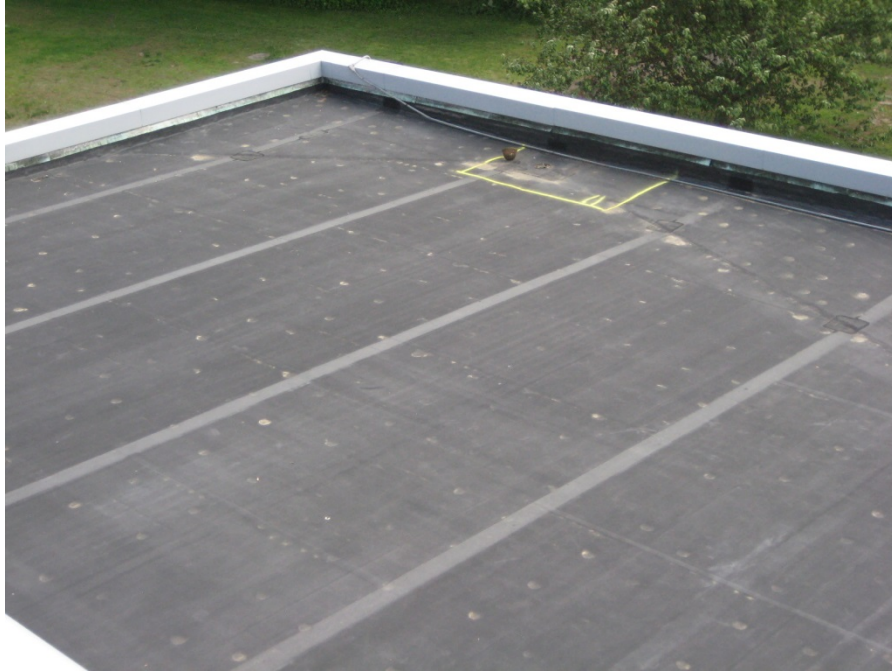
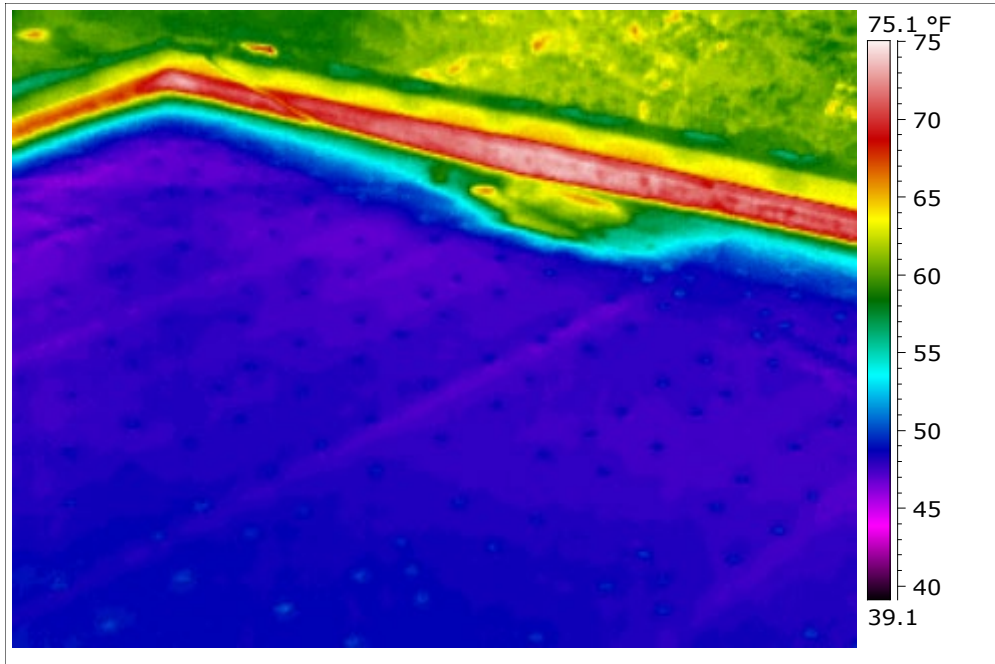
Thermogram # 6

Wet Area #18

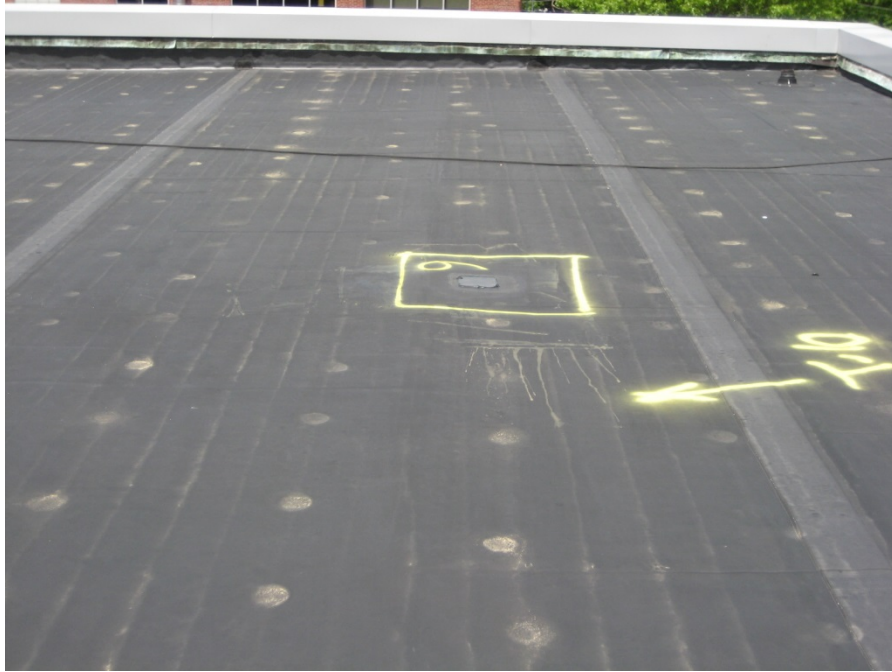
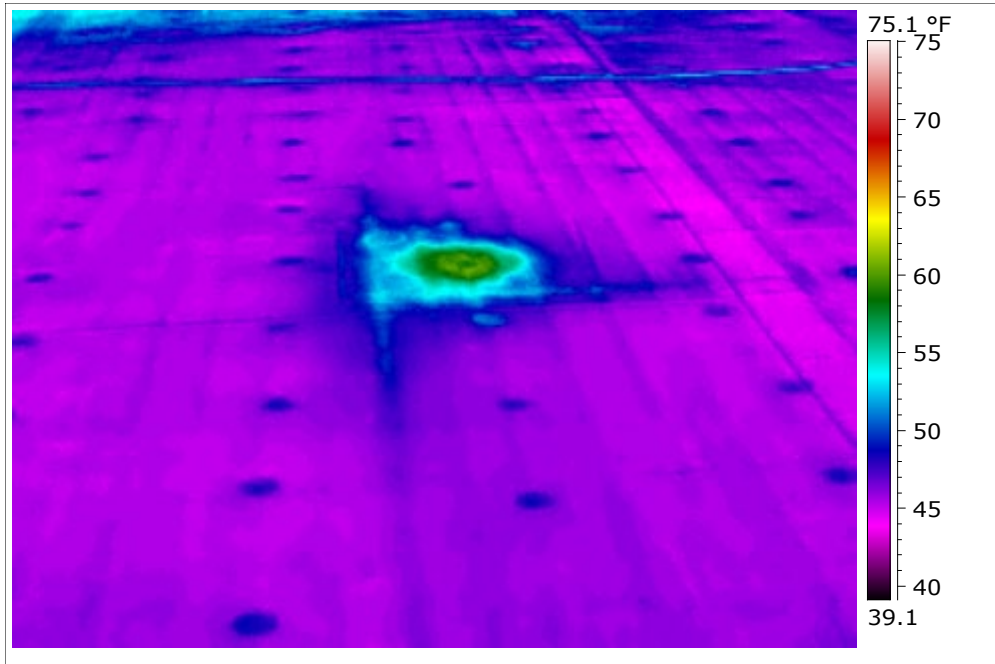
Thermogram # 7

Wet Area #6

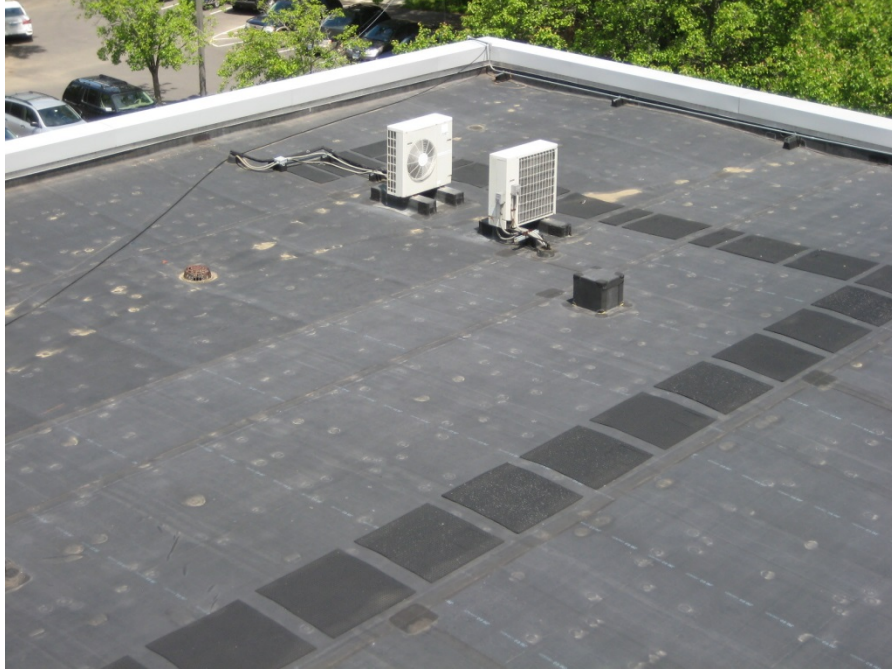
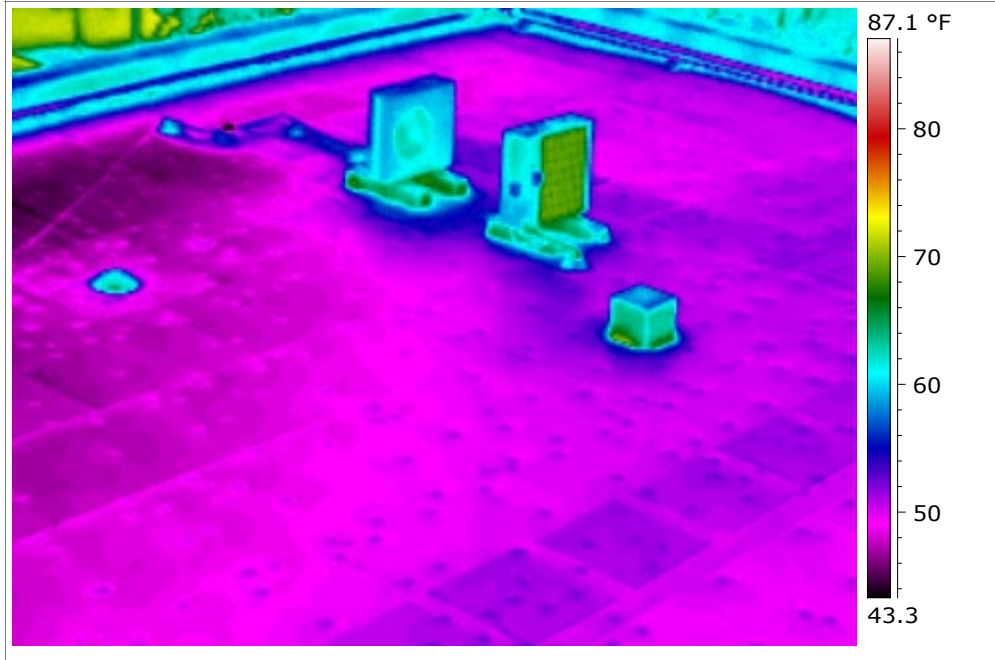
Thermogram # 8

Dry area of roofing

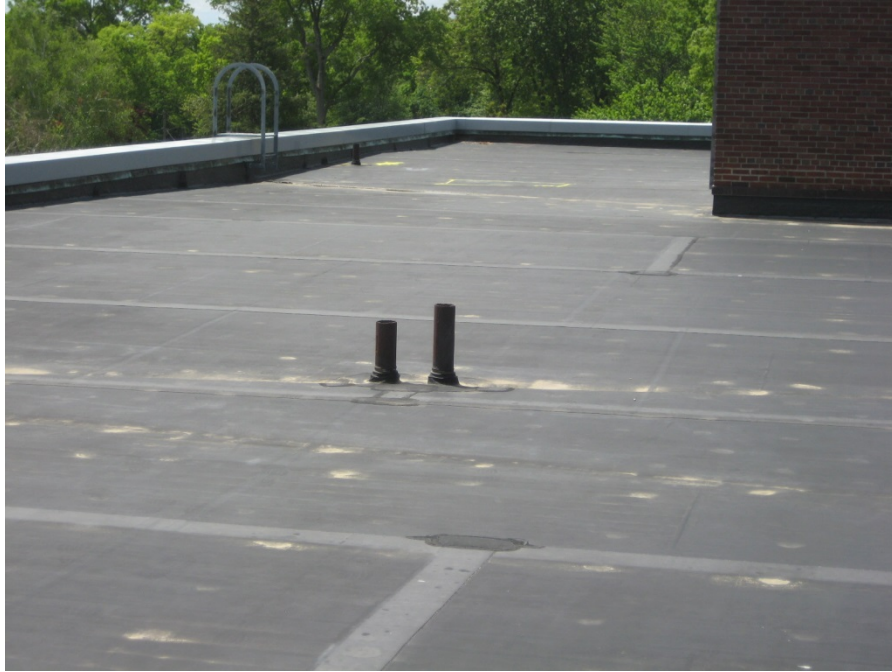
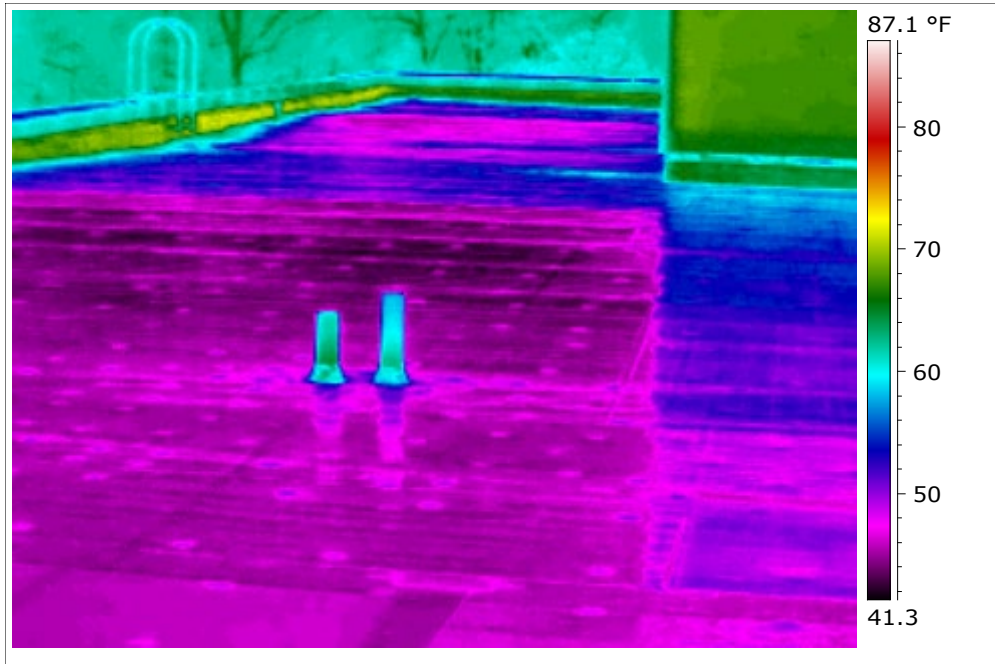
Thermogram # 9

Dry area of roofing
