M. Gottfried, Inc.

DATE: October 28, 2019

RE: Roof report and repair quotation
Dolan Middle School
51 Toms Road
Stamford, CT 06906

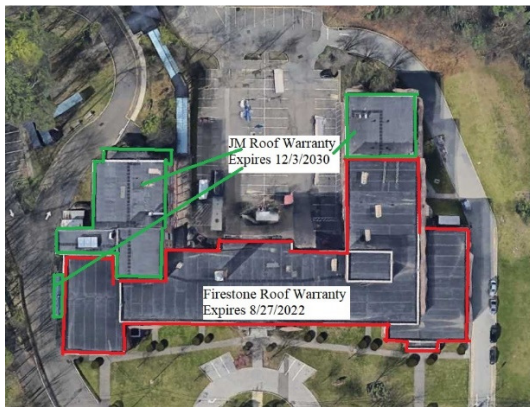
Map showing active roof warranties

All of the roof levels at Dolan Middle School have active manufacturers warranties. The area outlined in red on the map is covered under a 20-year Firestone warranty that will expire in August of 2022. The areas outlined in green on the map are covered under a 20-year JM warranty that will expire in December of 2030. A new elevator penthouse (not shown on the map) was installed in 2017. It has a 20-year Firestone roof warranty that will remain in effect until 2037. Since this roof is new and has no issues, all of the discussion found in this report will deal with the main Firestone and JM roofs.

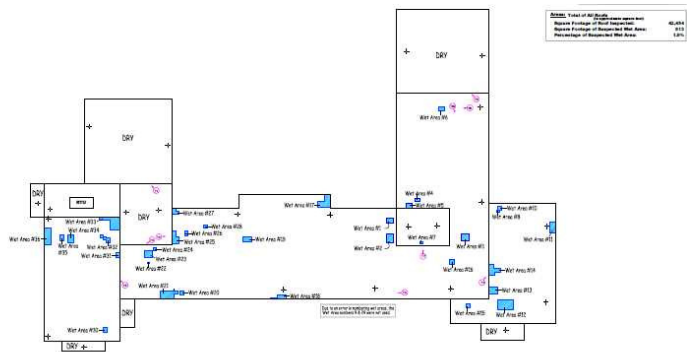
Map from Infra-red scan showing wet areas

The roofs are all in good shape, however the moisture scan revealed 34 areas of wetness in the roofing systems. Many of these can be attributed to holes in the membrane. Most of these are near walls or parapets and have been patched. The main Firestone roof was installed in 2002 and the JM in 2010. It appears that subsequent to those years, masonry work was performed on the parapets and some rising walls. Coping and in some instances, EPDM membrane, was installed over the parapets. We can assume that this project was performed due to masonry and parapet leaks. It is possible that some of the moisture found in the scans originated from the problems that this project addressed. Some of the holes may also have occurred during the project.

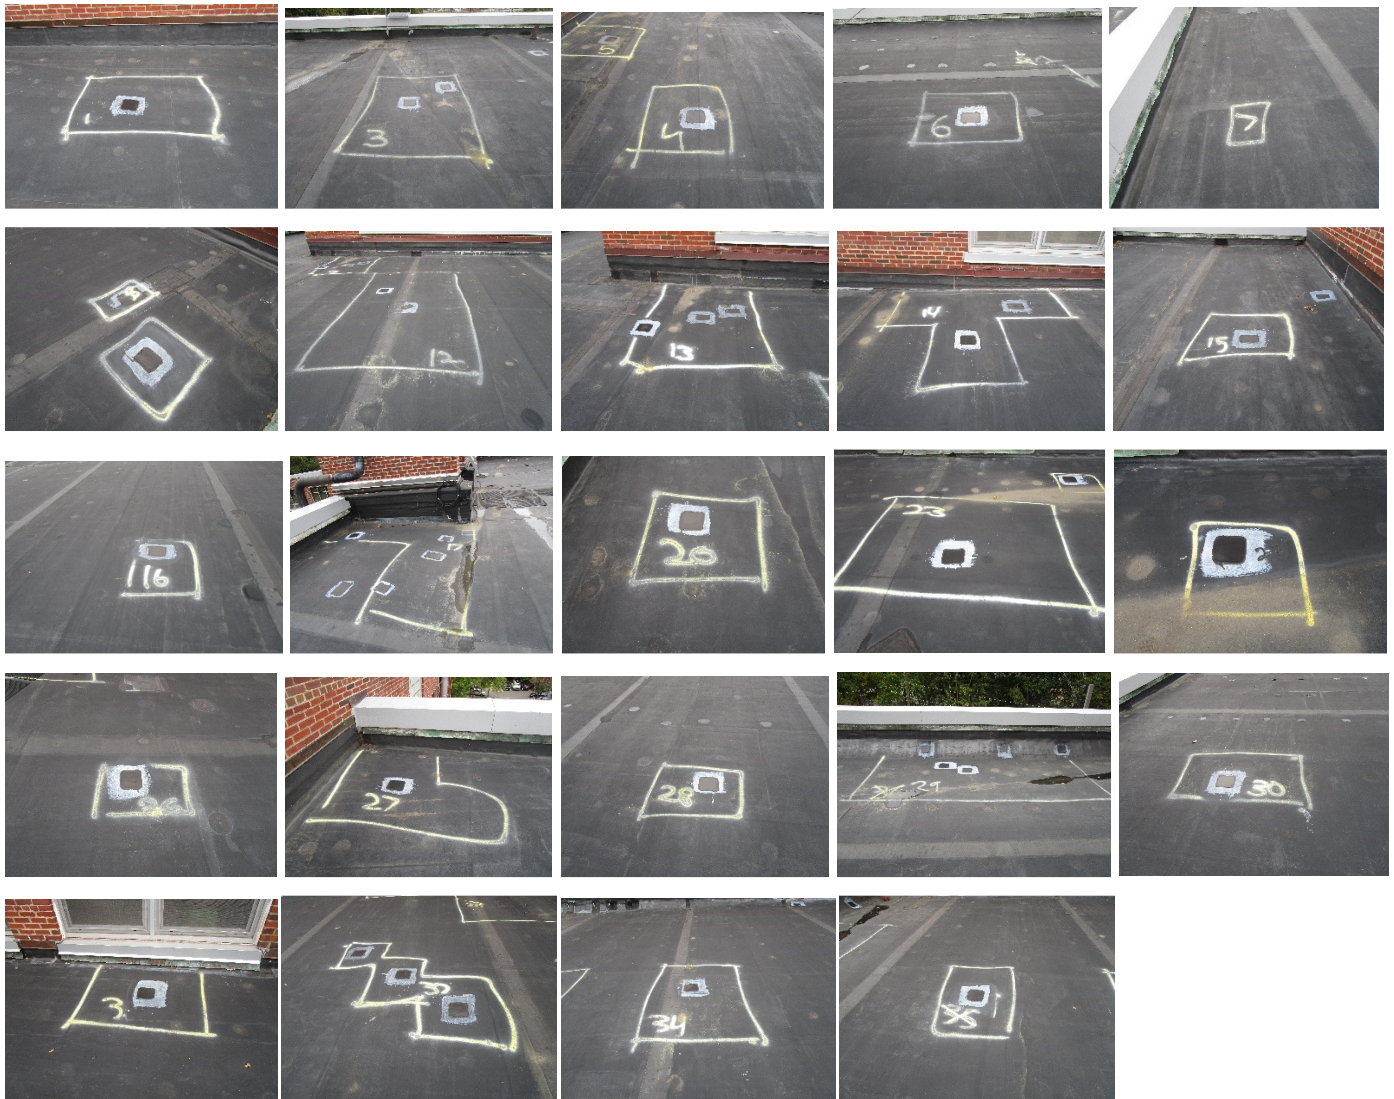
As noted above many of the wet areas were caused by holes in the roof membrane.

Wet areas #1, #3, #4, #5, #6, #7, #8, #12, #13, #14, #15, #16, #17, #20, #23, #26, #27, #28, #29, #30, #31, #32, #34 and #35 all are found around areas that had had holes that have been patched.

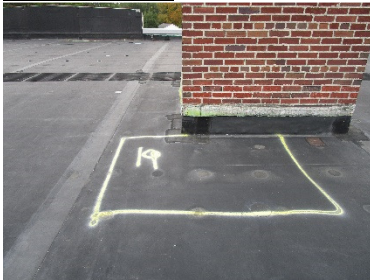
Wet area #19 lies at the base of a chimney. All the corners, membrane flashing, metal counterflashing, and caulking must be checked. If these are found to be “tight”, after the wet area is replaced, the masonry work will need to be inspected and repaired by others.

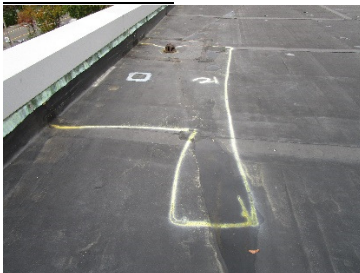
Wet area #21 surrounds and area containing a patch and a drain. It is by a wall with new coping. Water could have gotten in from the hole, loose drain flashing, or even the wall prior to the coping project. All the membrane possibilities will be addressed when the marked area is removed and replaced.

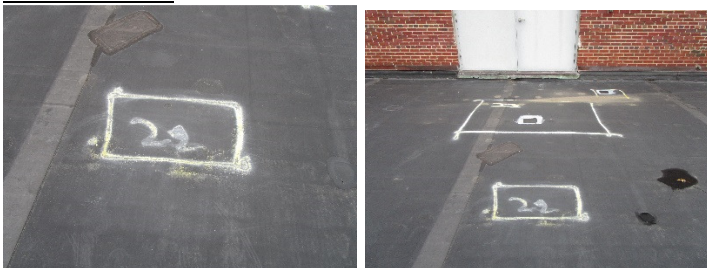
Wet area #22 may be from a small pin hole in the roof membrane. It also lies on a direct line from the penthouse door where other holes and wet areas were found. In addition to replacing the wet areas, the door flashing and door itself must be looked at as a possible point of water entry.

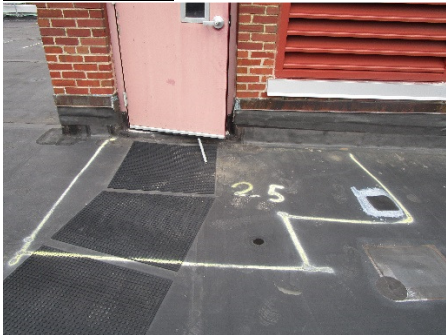
Wet area #25 lies in front of another penthouse door. Even though a hole has already been patched, it looks like the water infiltration starts at the door and flows out. The door and door flashing may have to be address at this area as well. All door frames, caulking, weather stripping, saddles, on doors leading out onto the roof should be examined, repaired and made watertight by others.

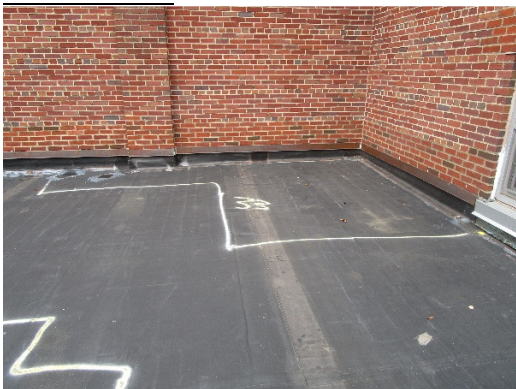
Wet area #33 lies in a corner of a rising masonry wall. There are two patched holes on the down slope side of the marked area, but it appears that the water may have come form the wall or window. It looks like the masonry and reglet was redone during a previous project. It is possible that the water infiltrated the system prior to that project.

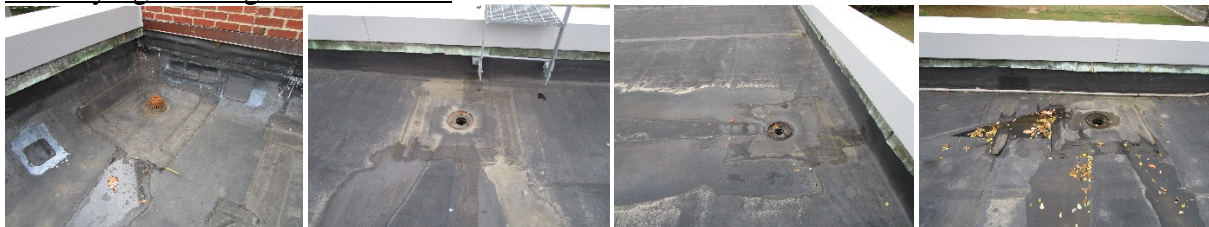
Overlying flashing around drains.

As noted in the wet area section, many of the drains are flashed with a target patch, and then the target patch is flashed with a 5" strip of membrane. In many instances, where the flashing material is found in ponding water or low spots around the drain, it is starting to lift. All the flashing membrane around the drains should be cleaned and overlaid with new larger membrane to prevent the chance of water infiltration.

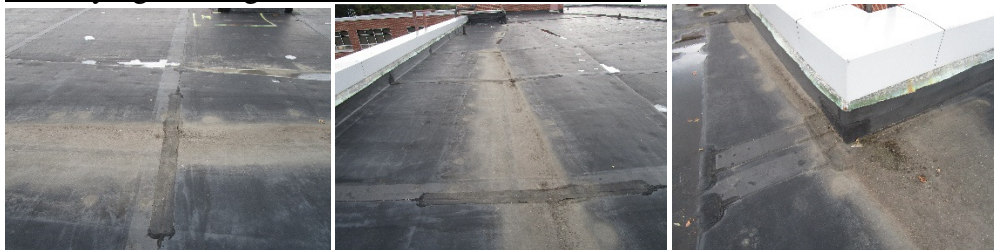
Overlying flashing in other areas that hold water

There are a few other areas on the roof that look like they tend to pond a little water. We found evidence of peeling on the flashing overlaying laps in these areas. To help protect the laps, they should be cleaned and overlaid with new wider membrane flashing.

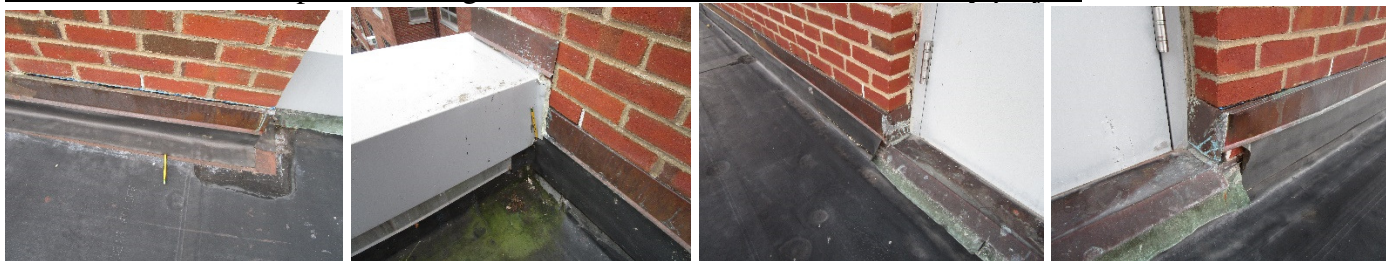
Fishmouths and incomplete detailing in the membrane added in the masonry project

As part of the masonry/coping project, it appears that new membrane base flashing was installed over the original base flashing in some locations. We found fishmouths present in some the laps where the new membrane is seamed to the original roof. In addition, corners were not installed on the membrane nor was vertical termination. This left open gaps where water can get in. All the new base flashing must be checked, any fishmouths patched, missing corners installed, and vertical ends of membrane properly terminated.

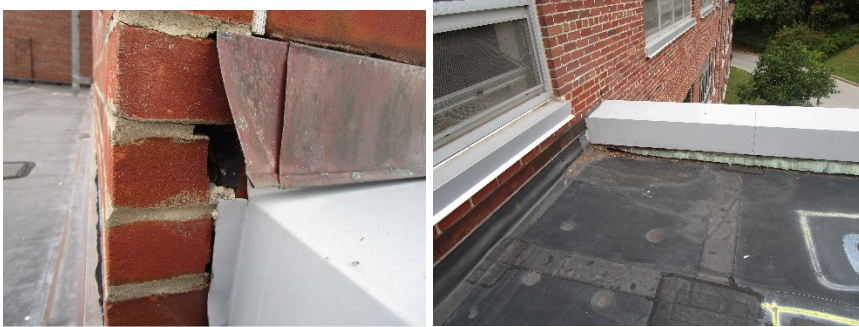
Metal terminations at new coping

The new coping from the masonry/coping project is not being terminated in many locations. The ends of the metal coping are only turned against the wall. Many are not fastened or caulked. This leaves open joints where the metal meets the wall. The coping turn-outs should be set in caulking and pinned where possible, and the exposed metal to masonry joint caulked.

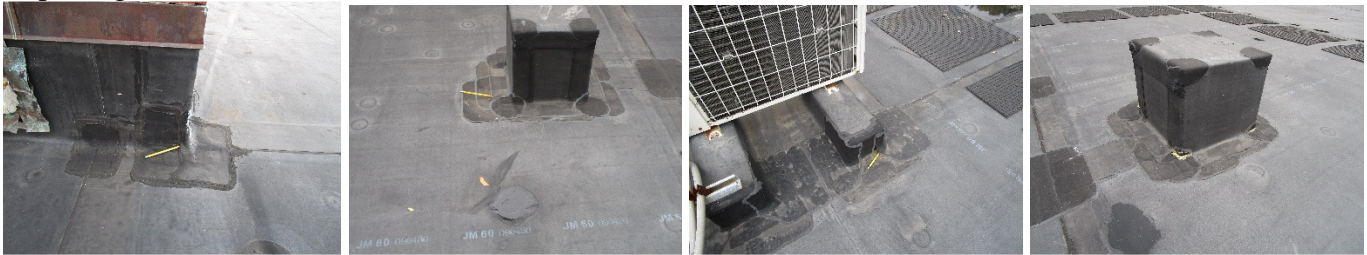
Repairing corners

All corners on curbs, sleepers, wall flashing, etc., must be checked and properly patched if they are starting to open. On one curb, it appears that ropes were tied around the base. The remnants of the yellow line are cut into the corners on the base of the curb. These must be patched as well.

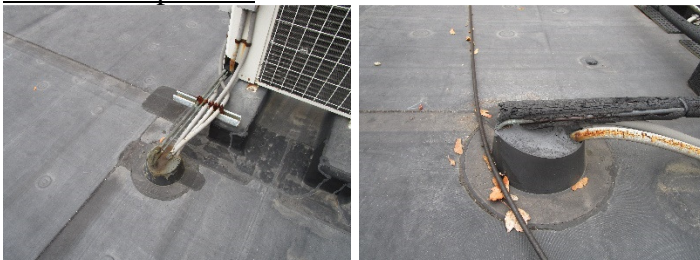
Penetration pockets

All penetration pockets must be checked. In some instances, the conduits or lines in the pockets are very close together or touching the edge of the pocket. When this occurs, the pourable sealer cannot flow

between the penetrations or the penetration and the pocket. This leaves voids that water can enter. The penetration pockets where this is occurring should be removed and new larger pockets installed. All other pockets must be checked, and filler added if needed. One other item to point out is the flexible conduit found in some of these pockets is starting to rust through the coating. If the crack goes all the way through, water can enter the conduit and flow directly into the building. These types of conduits should be monitored and coated or replaced (by others) if their condition worsens.

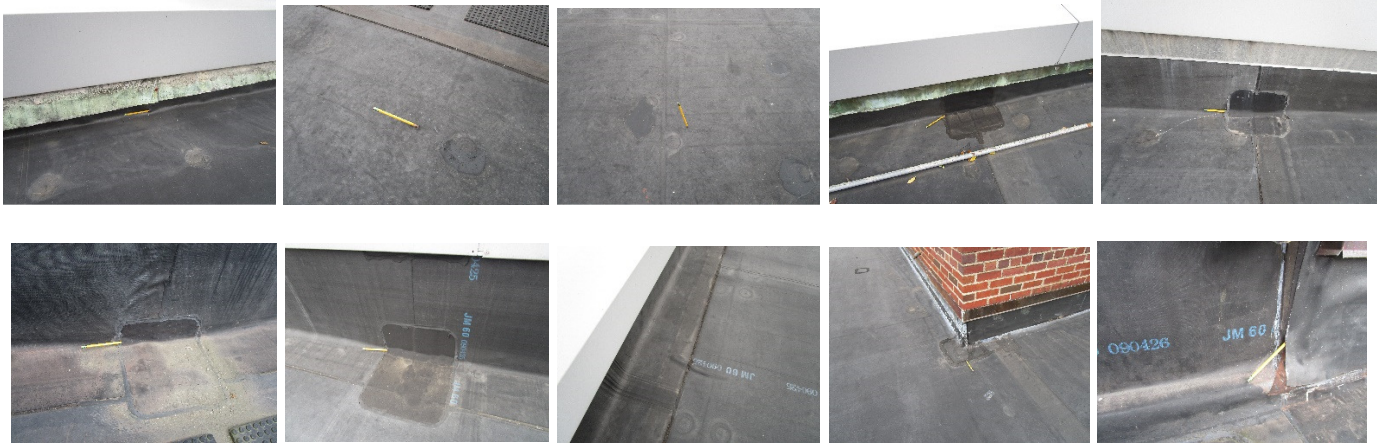
Holes and fishmouths in the roof membrane

Some holes, fishmouths in patches, and open flashing laps were found in the roof. These must be patched to prevent water infiltration.

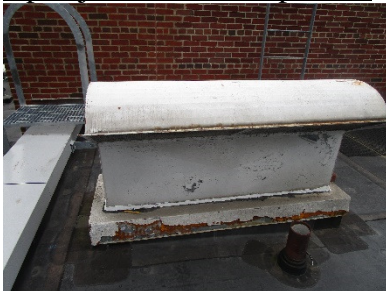
Open joints in roof top items

The caulking where the vent meets the roof curb is opening and can let water in. The old caulking should be cleaned out and new caulking installed. The curb metal below the caulk joint should be coated with a bituminous resin flashing material to keep it from deteriorating further.

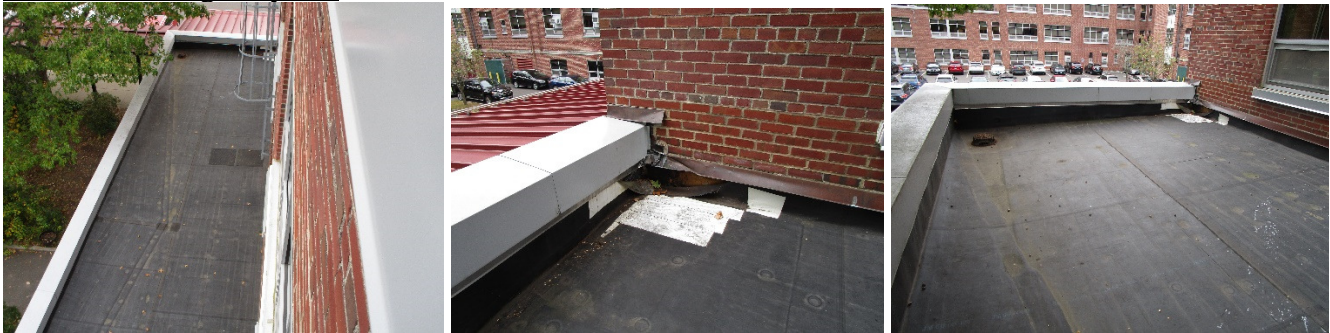
Low roof damaged by fire

Within the last couple of years (prior to the new elevator and metal roof project) an electrical line/tree came down on the above end roof and there was a small fire. The membrane was never properly repaired and the base flashing against the wall has fallen in the corner. Unfortunately, this roof is not shown on the infra-red scan map. By the condition of the membrane and the fallen base flashing, there is a strong possibility that there is water under the membrane from the fallen corner to the drain. This area should be cut out and replaced with new membrane and flashing.
