Infrared Thermographic Roof Moisture Analysis

PERFORMED FOR: Viking Construction
1387 Seaview Ave.
Bridgeport, CT 06607

LOCATION: Rippowam Middle School
Stamford, CT

CONDUCTED ON: May 15 & June 4, 2019

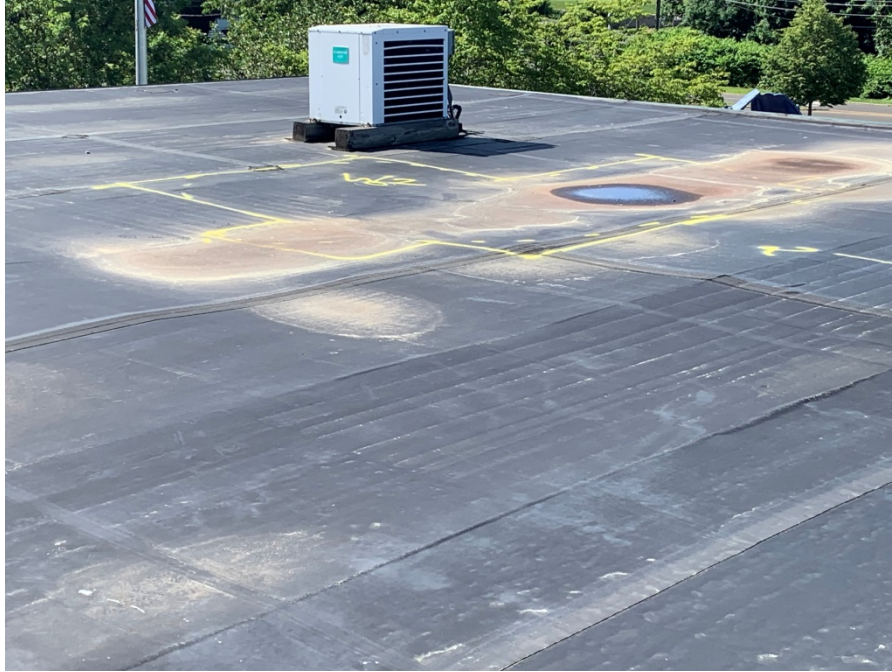
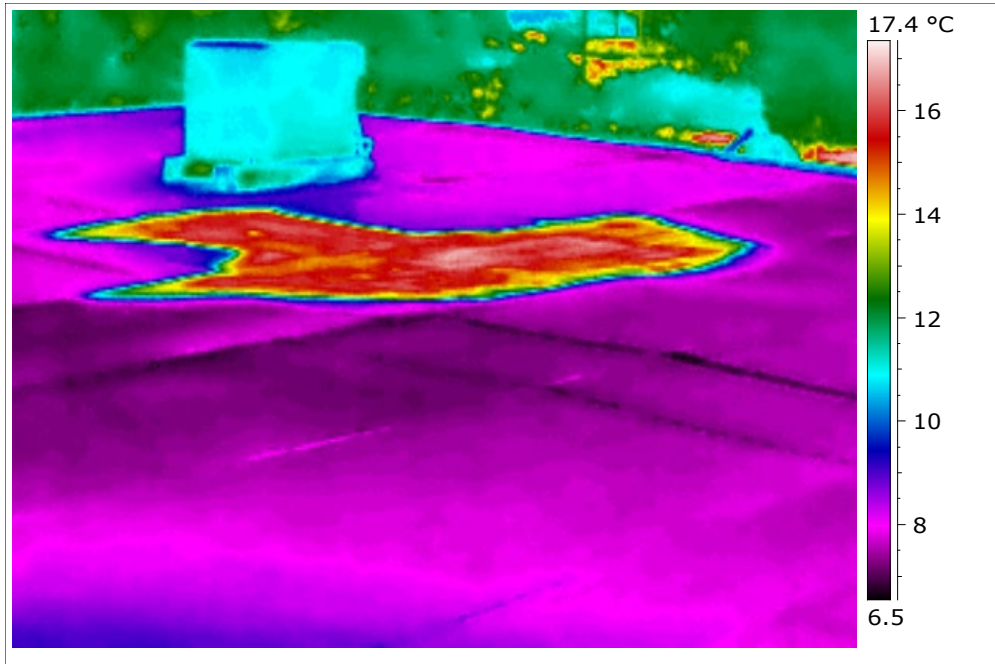
Thermogram # 1

Wet Area #2

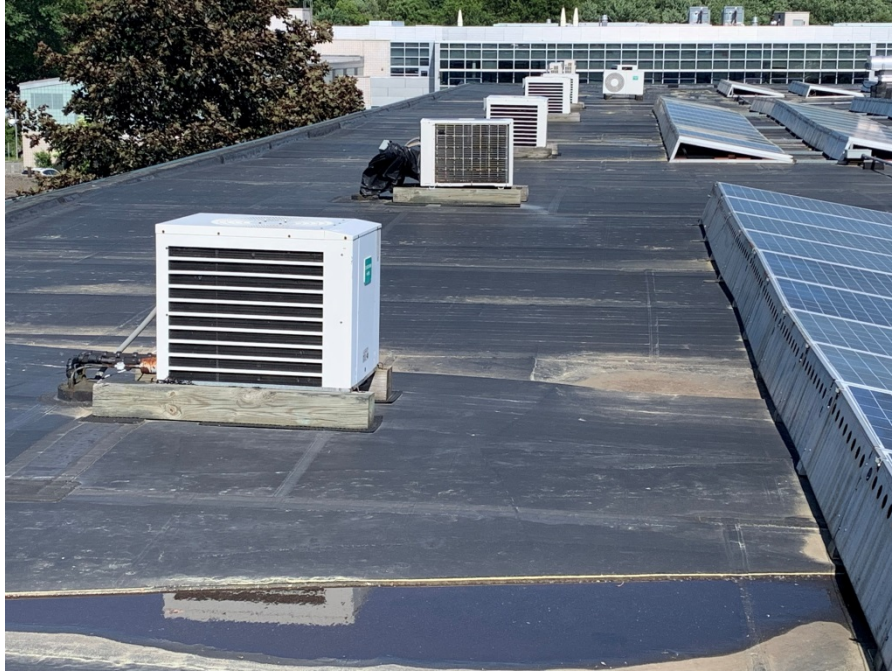
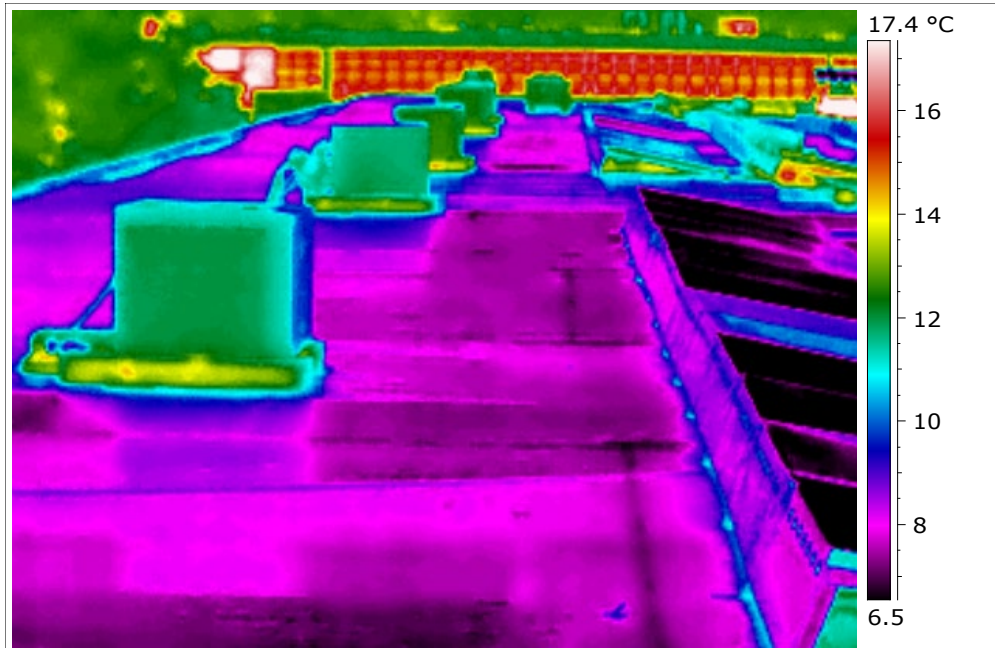
Thermogram # 2

Dry area of roofing

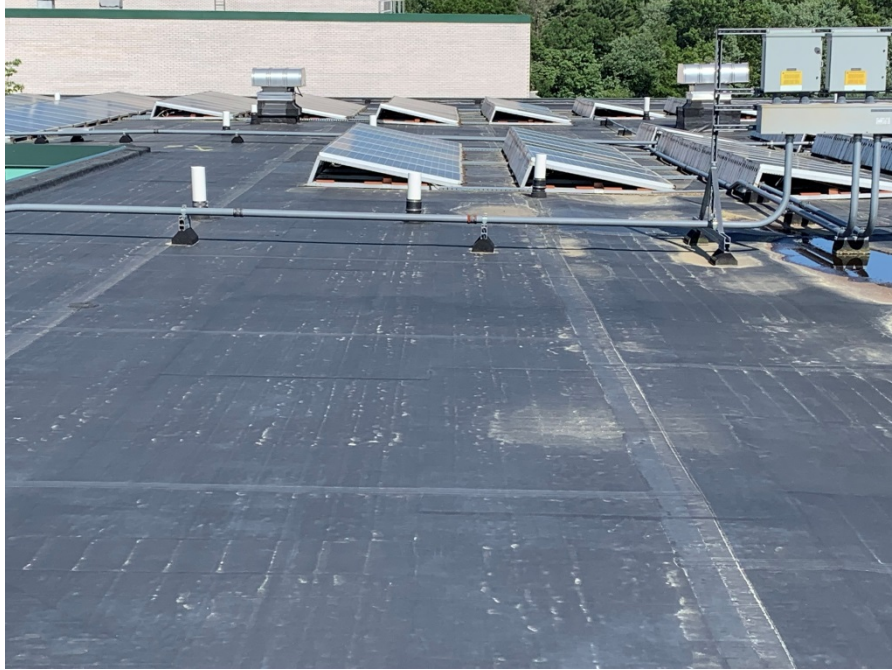
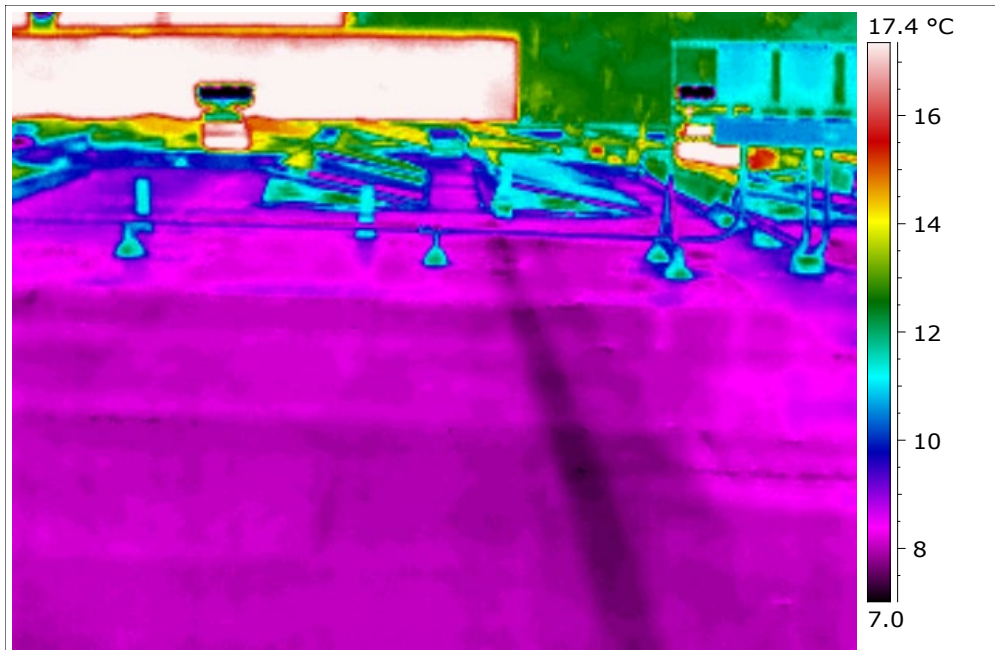
Thermogram # 3

Dry area of roofing

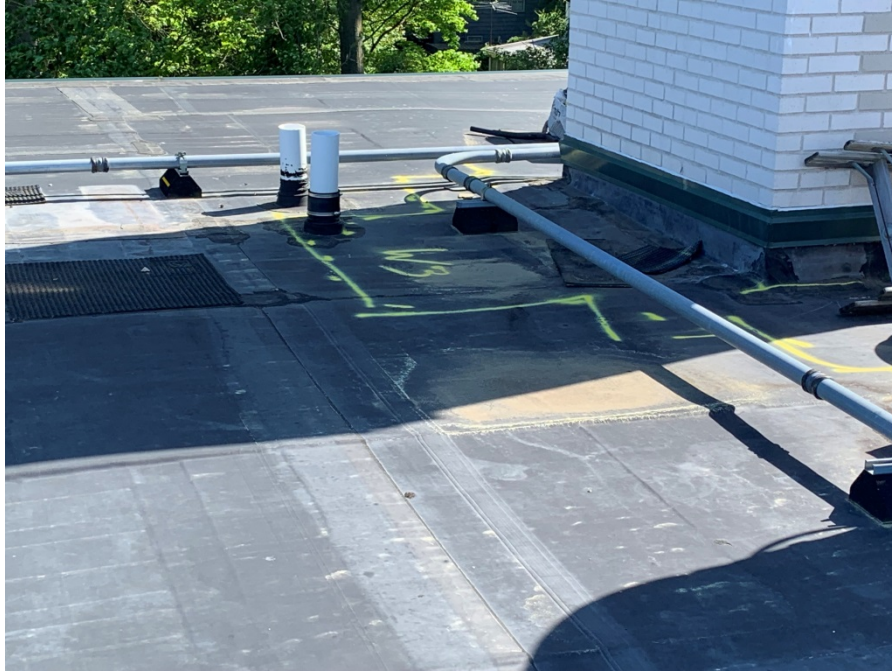
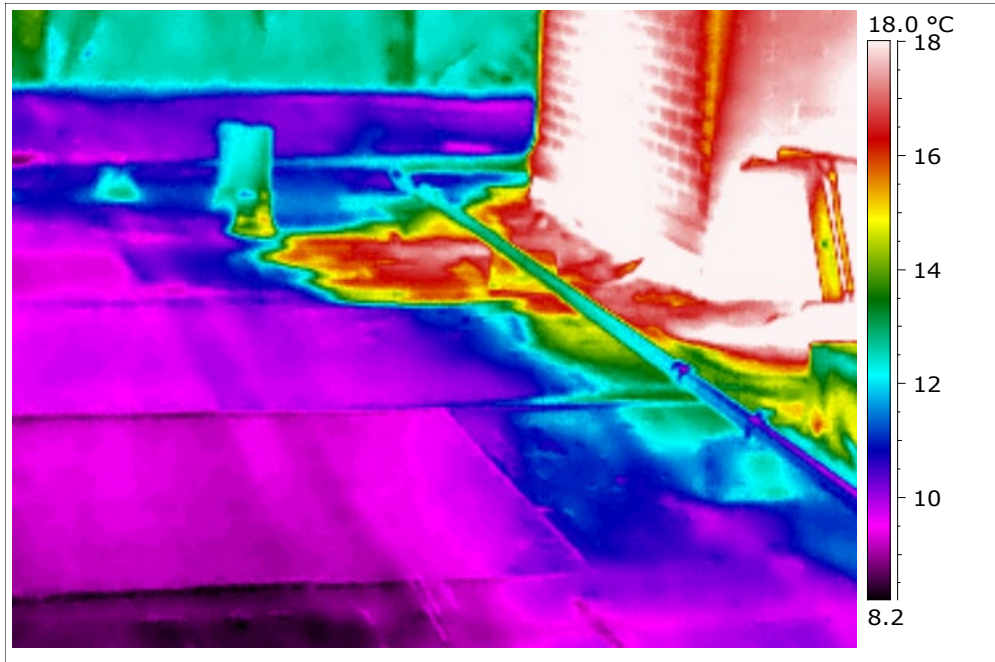
Thermogram # 4

Wet Area #3

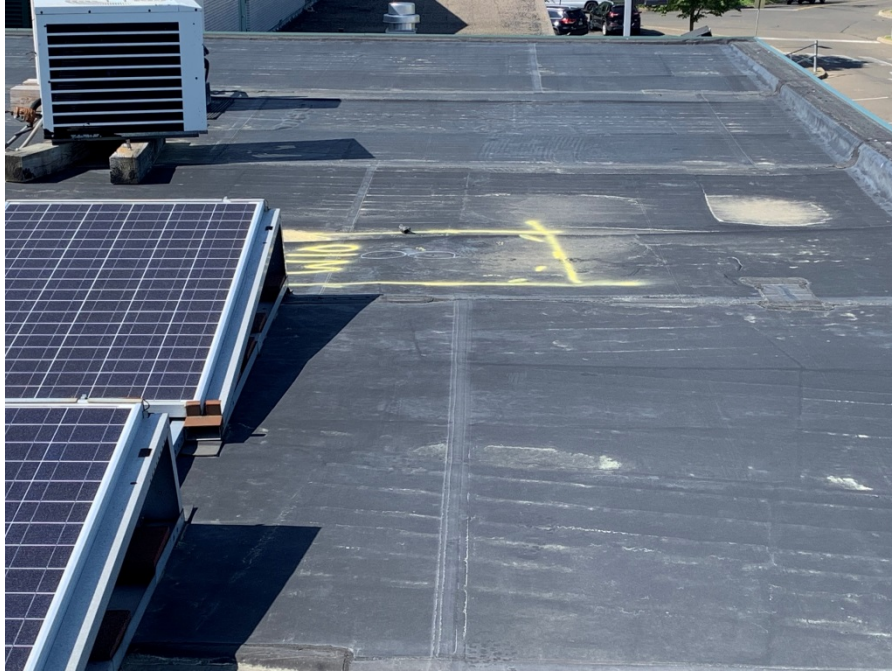
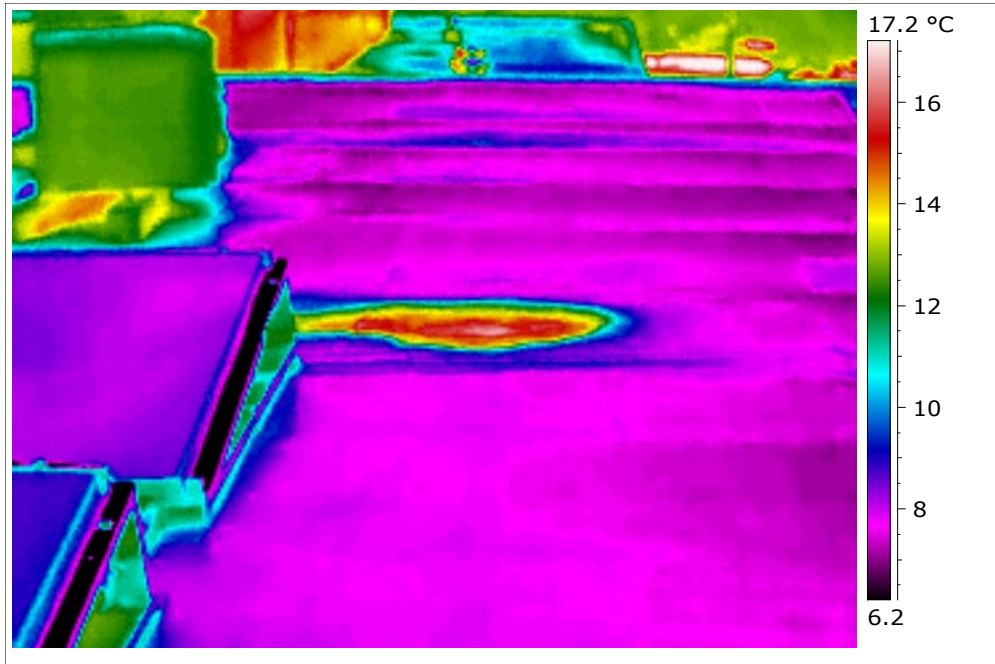
Thermogram # 5

Wet Area #10

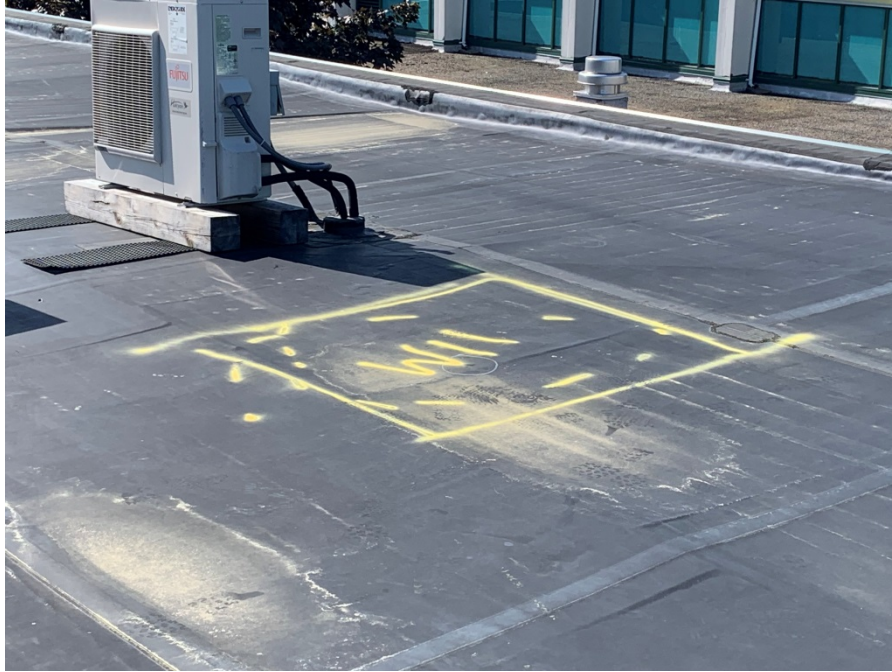
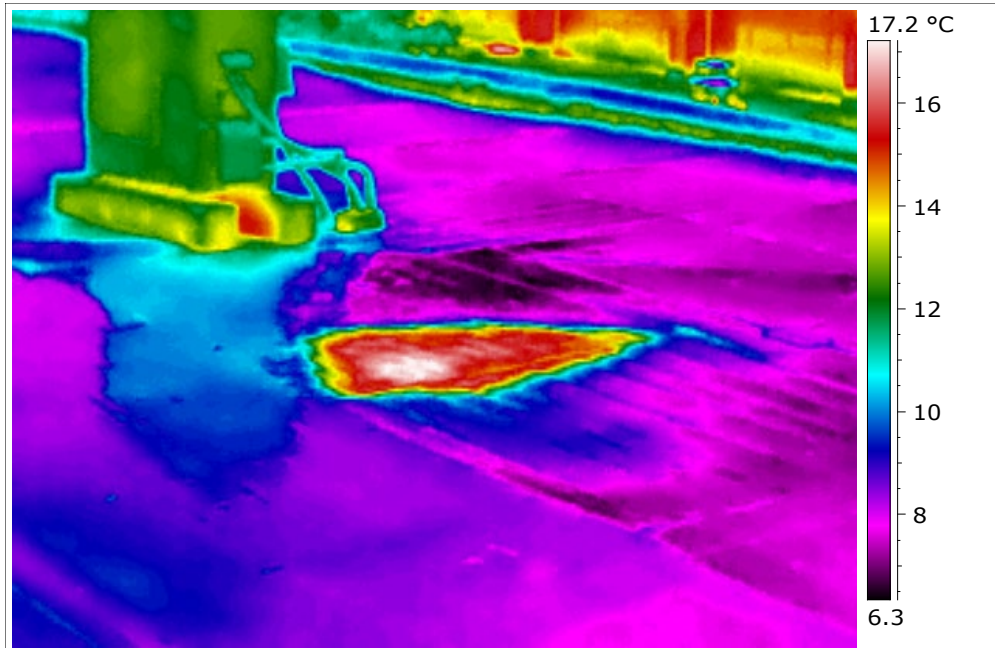
Thermogram # 6

Wet Area #11

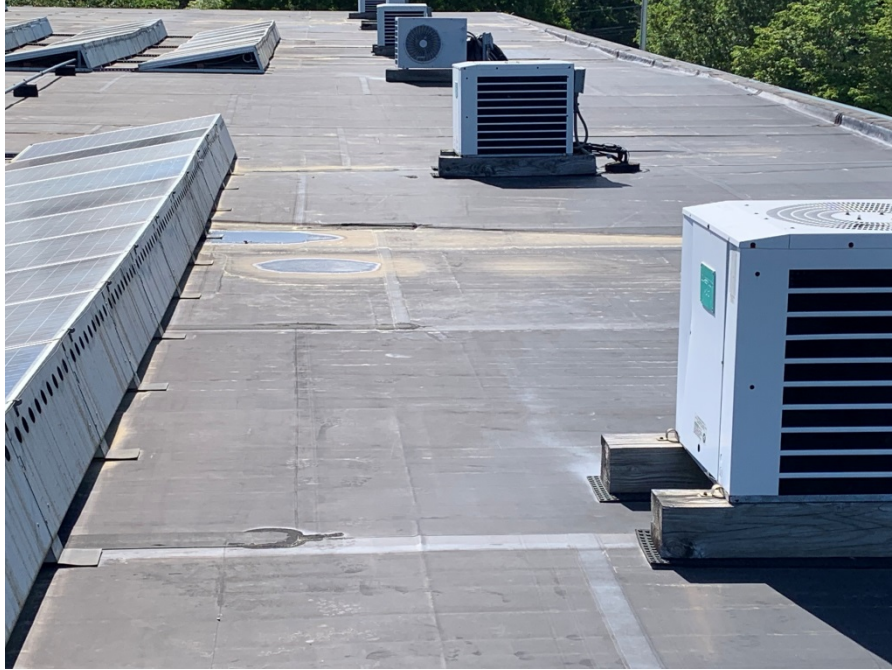
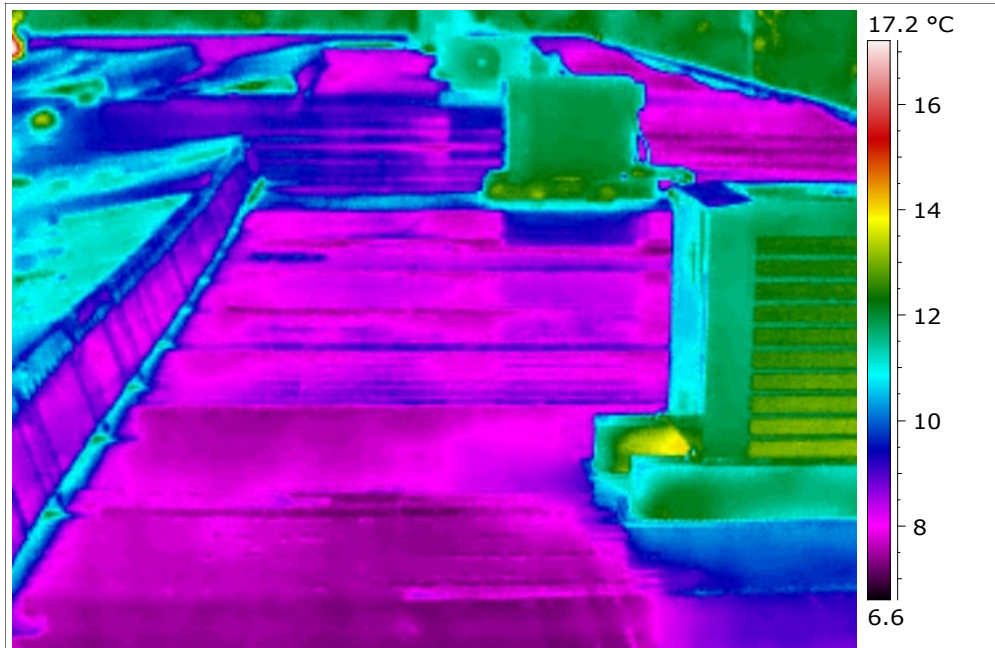
Thermogram # 7

Dry area of roofing

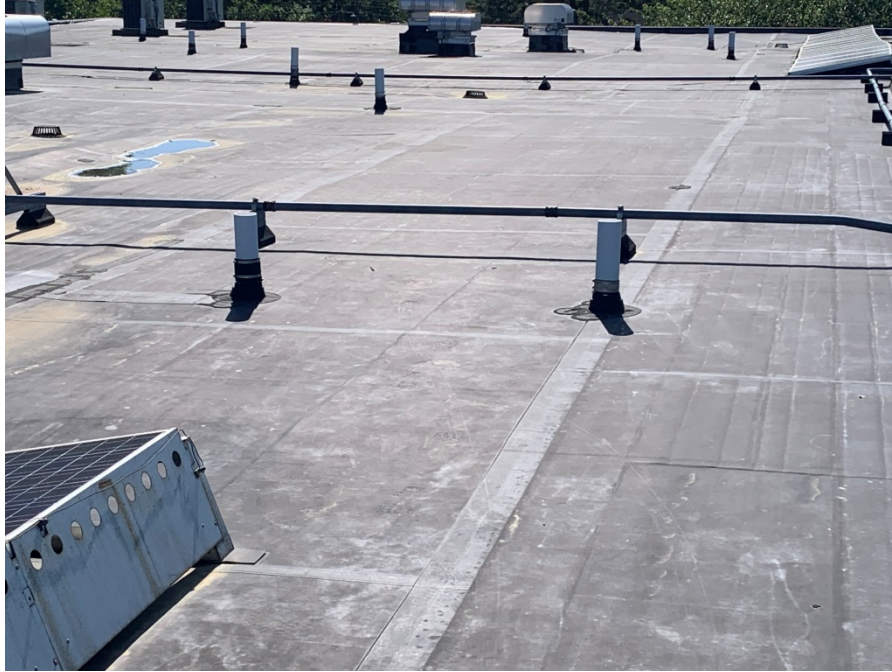
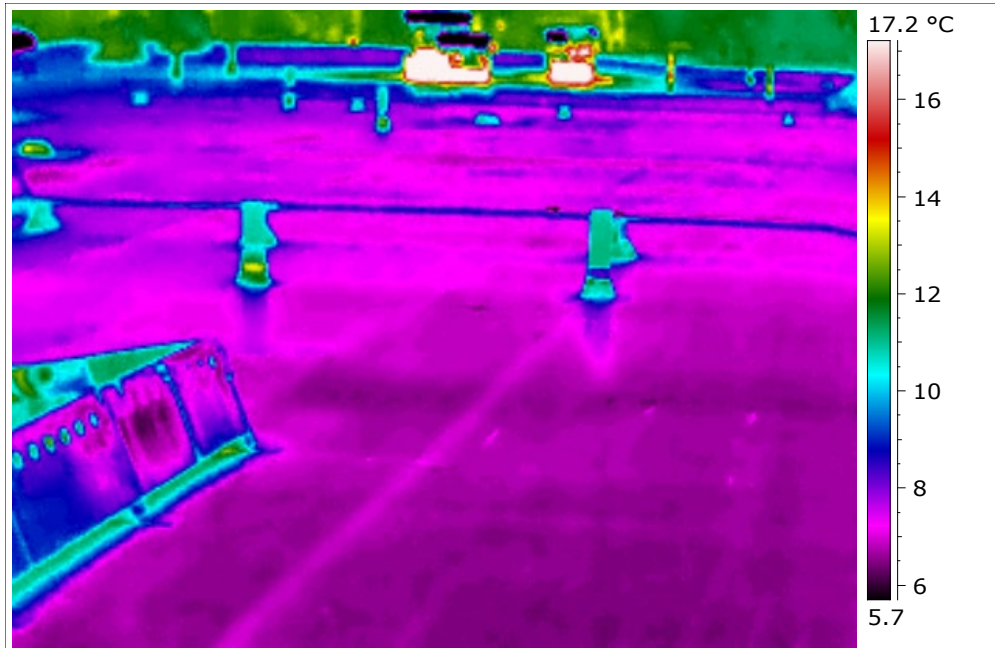
Thermogram # 8

Dry area of roofing

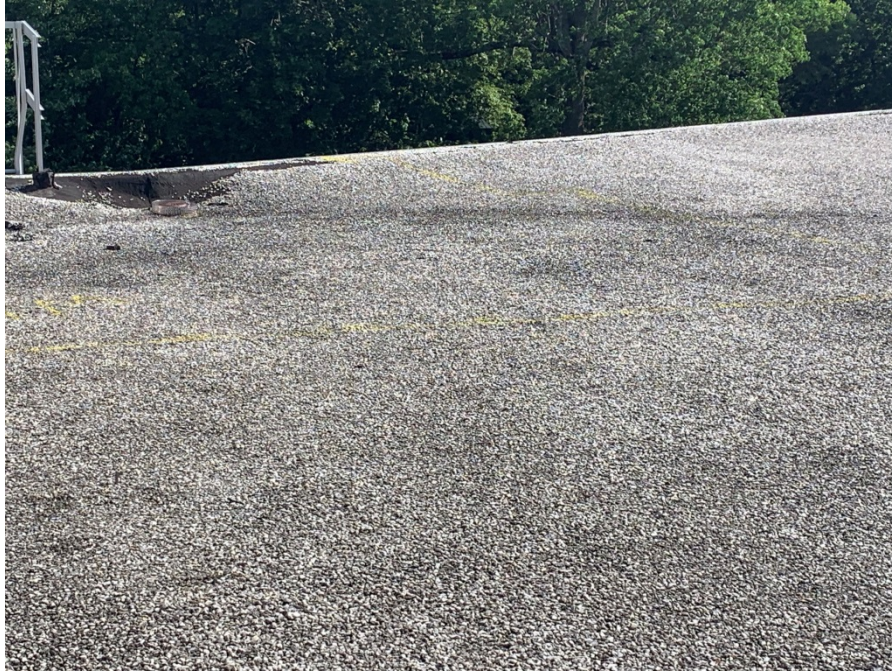
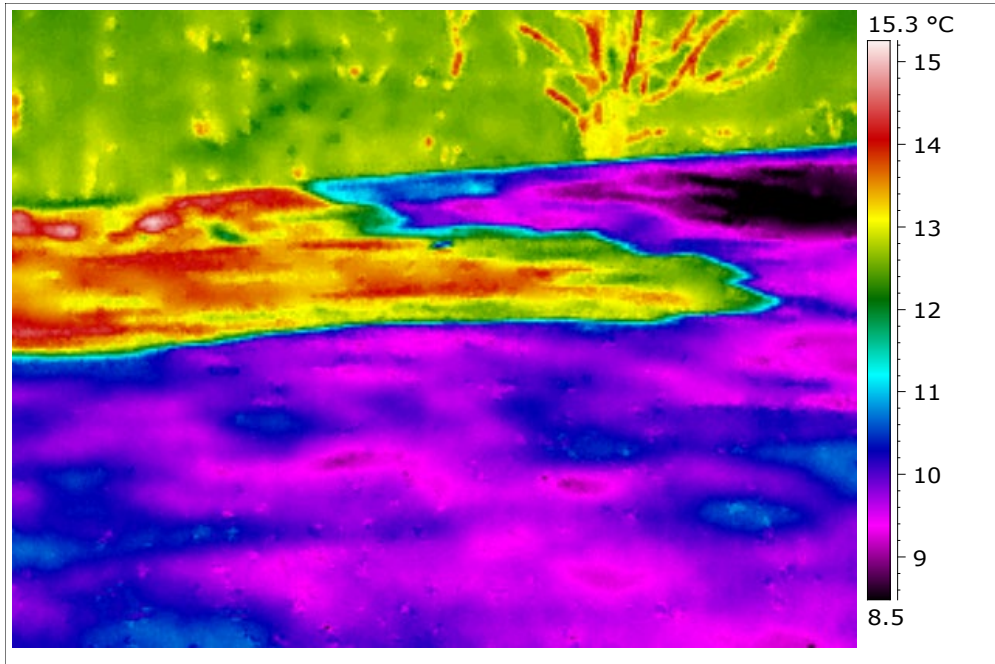
Thermogram # 9

Wet Area #17

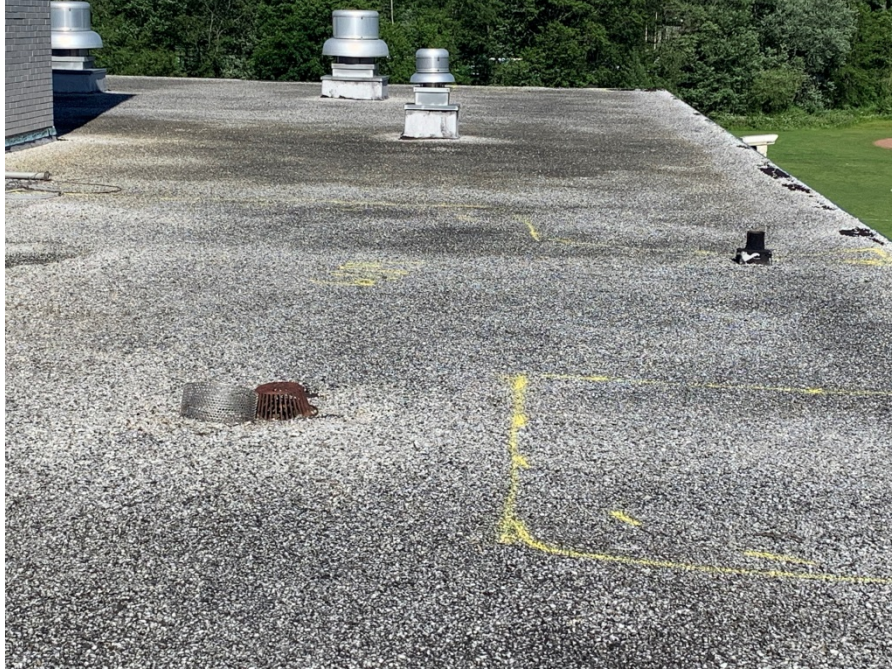
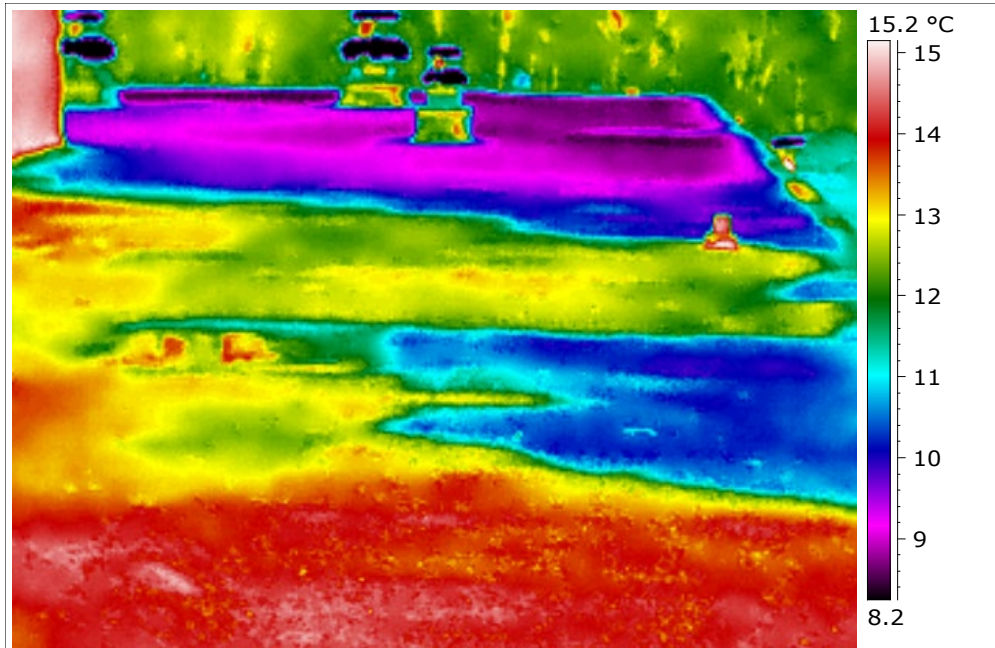
Thermogram # 10

Wet Area #19

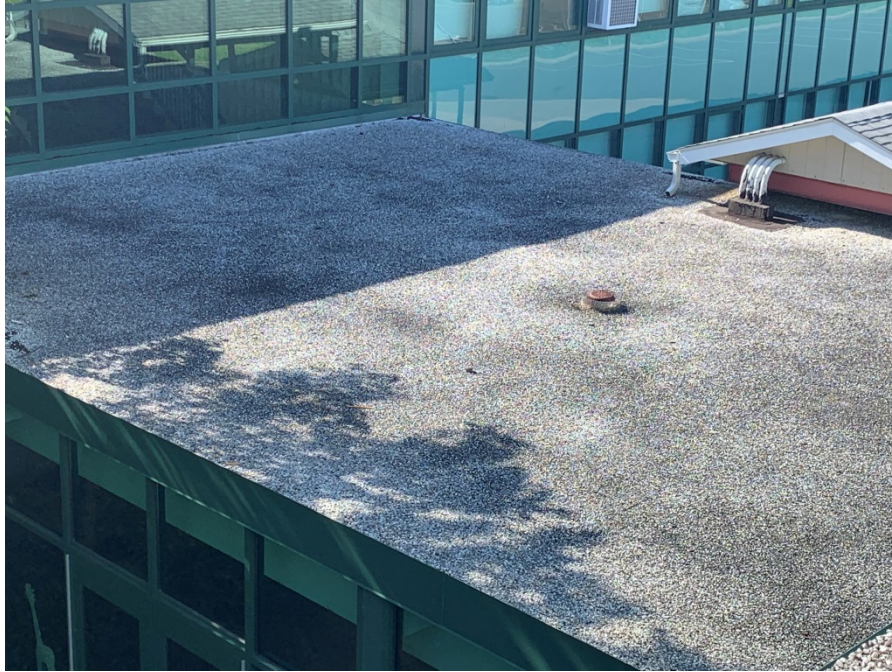
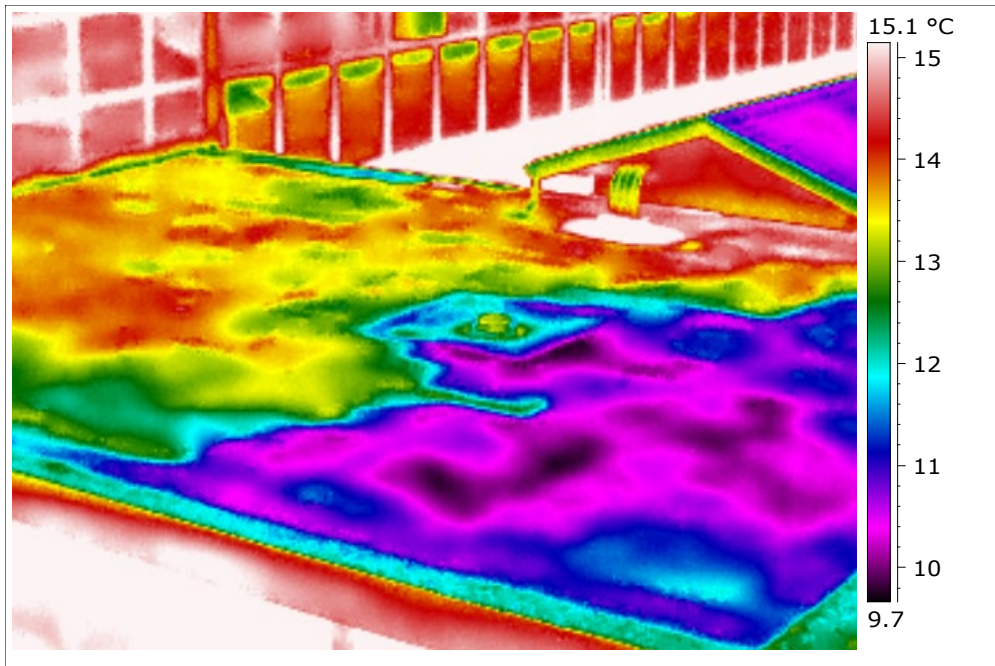
Thermogram # 11

Wet Area #15
