M. Gottfried, Inc.

RE: Roof report and repair quotation
Rippowam Middle School
381 High Ridge Road
Stamford, CT 06905

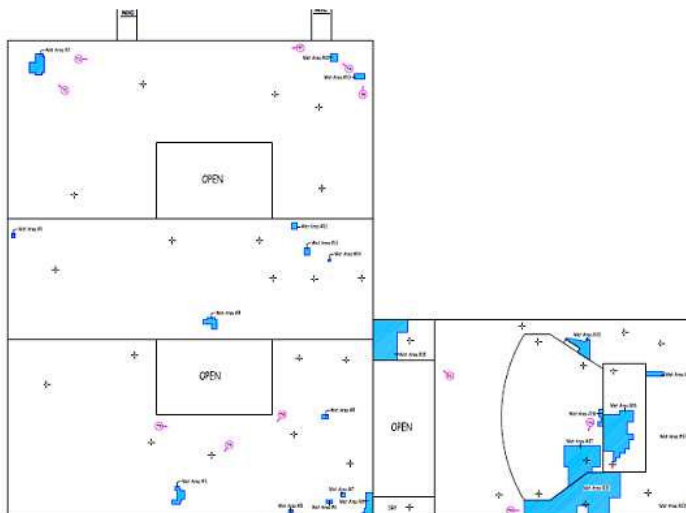
Roof moisture scan showing wet areas

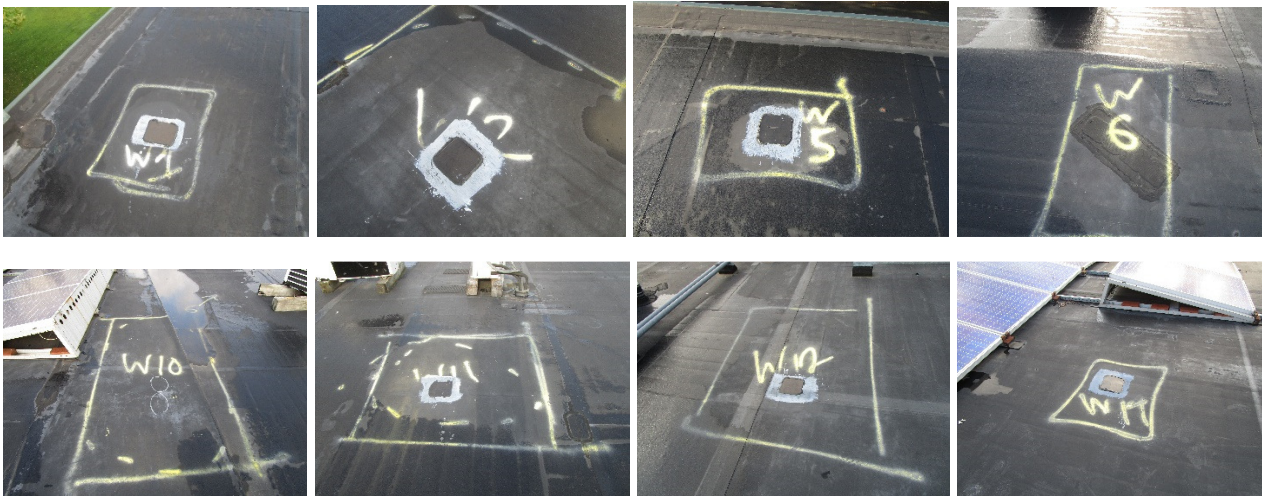
Holes in the roof

Holes in the membrane were found at wet areas W1, W2, W5, W6, W10, W11, W12, and W14. Most of these holes have been patched.

Some of the holes must have been present and unrepaired for a long time. The wet area #2 has spread to form a large area under a small hole.

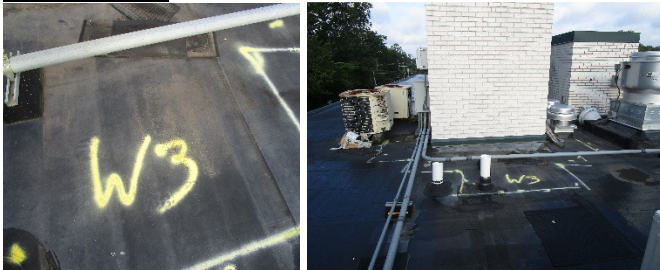
Wet area #3

Wet area number 3 goes around a chimney. We did not see any holes that may be causing the leak and suspect that the leak is coming from the chimney; either the counterflashing or the EPDM base flashing.

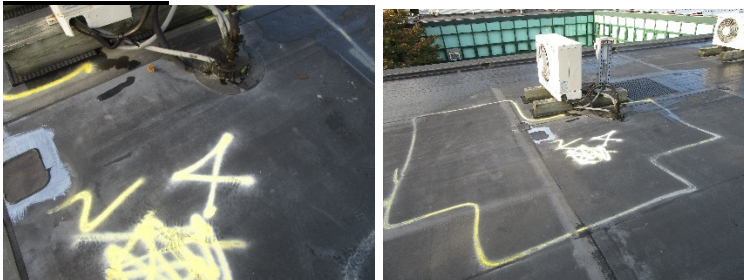
Wet area #4

Wet area number 4 looks to be coming from a penetration pocket and or a hole. As with other holes or points of infiltration, it has spread to a large area.

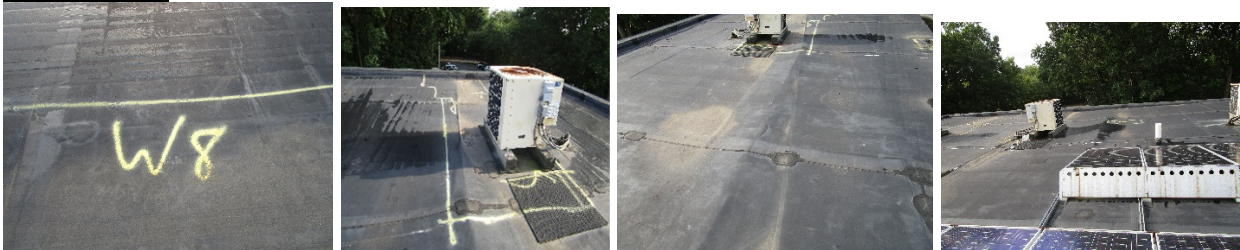
Wet area #8

Wet area 8 is found surrounding one of the units. The marked wet area is large. In addition, it appears that a large amount of water must have entered because the insulation has curled and pulled away from the deck and the roof membrane. The insulation on this roof has been adhered to the deck (we believe it is a tectum deck) using an insulation adhesive. If the facers of the insulation get wet from repeated or prolonged water infiltration, they can lose their integrity and come apart. Once unadhered from the deck or membrane the insulation can curl or cup as it continues to get wet. In this case it has grown and become unadhered in a large area.

1. Cut out all marked wet areas, install new insulation and new Firestone EPDM membrane. The entire area covering the area containing wet areas 5, 6 7 and 8 would be cut out and replaced.
2. Either remove and replace the loose area by the penthouse door or overlay it with ½” insulation and new membrane.
3. Walk the roof and repair any hole we find not in a marked area.
4. Check and repair penetration pockets.
5. Check and repair curb flashings.
6. Cut out and replace (if necessary) or fasten and patch the cupped areas.
7. Check and repair the expansion joint flashing.
8. Check and repair the “stained” area.
9. With the assistance of the appropriate trade to move the solar panel and stand, repair the noted damage under the panel.

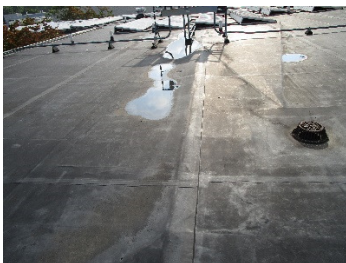
There is another large area of cupped insulation in front of the penthouse door even though it is not marked as "wet" something happened in this area at one time to cause the insulation to cup and become unadhered. It should be replaced and repaired as if it were a wet area.

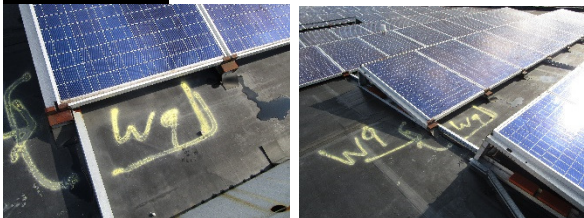
Wet area #9

Wet area number 9 appears to be coming from holes by or under the corner of a solar panel. Assistance to lift the panel, (by the appropriate trade), may be needed to repair the leak and or replace the wet insulation at this location.

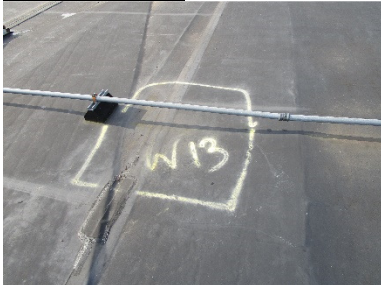
Wet area #13

No obvious hole was found at wet area 13. The old patch and lap need to be investigated further.

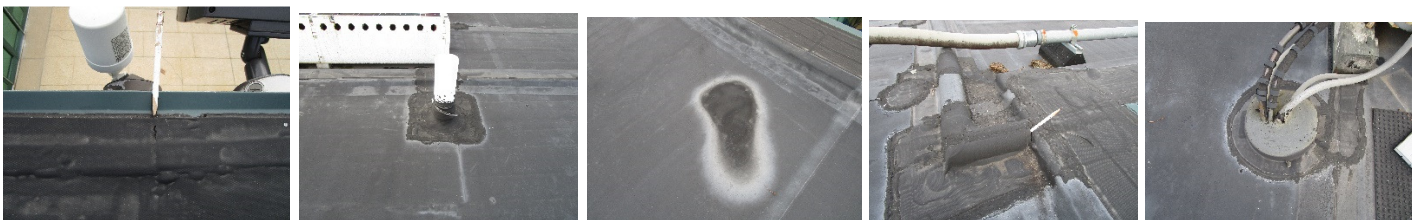
Other items on the EPDM roof not noted as wet on the EPDM roof but are potential sources of water infiltration.

We found other sources where water could be getting into the roofing system on the EPDM roof. Membrane flashing on the perimeter edge is cracked and joints between the metal are open, pipe flashing is starting to open, membrane has been affected by possible spills, cracks are present at the expansion joint flashing and penetration pockets are open. Comprehensive maintenance needs to be performed on this roof to seal all these issues and prevent water from getting in and causing problems.

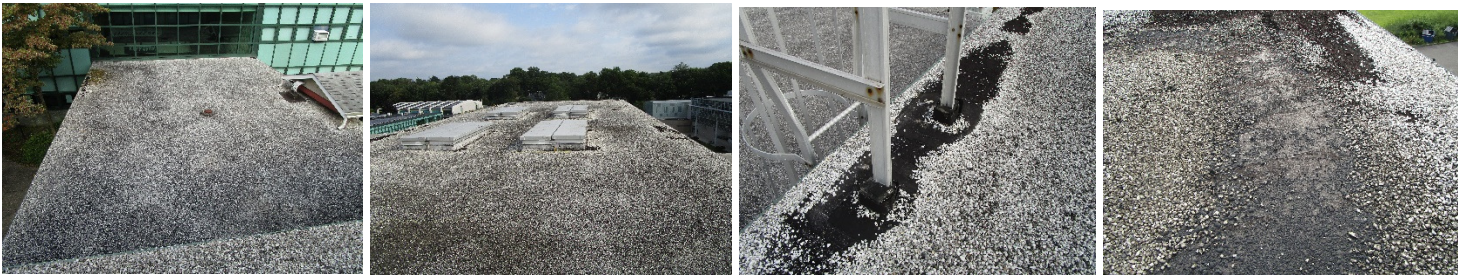
Even though they appear to be under warranty the gravel surfaced built-up-roofs on the connectors and auditorium roof are in fair condition. The moisture scan revealed that one of the connectors and the penthouse roof have extensive moisture under the roof membrane. The wet areas are large enough that removal and replacement of the roof *may* be more cost effective than performing removal and replacement of the wet areas along with maintenance on the balance of those roofs. If requested, we can provide replacement costs for the wet connector and penthouse roofs.

Connector roof -Wet area #

Penthouse roof – Wet area #

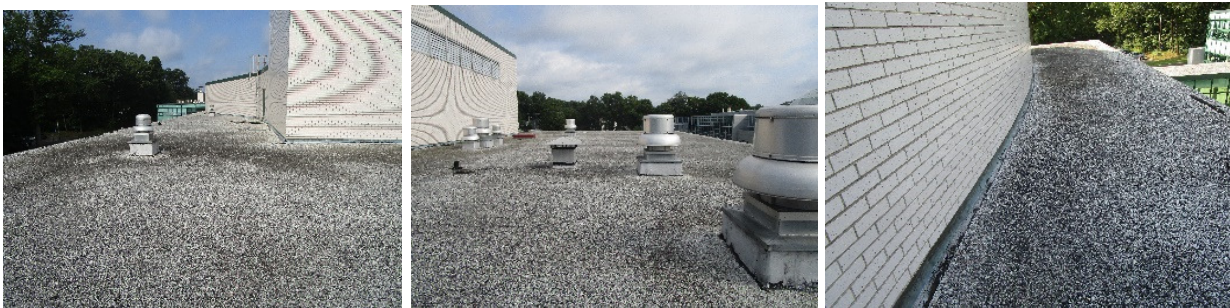
Main lower level and mid-level roofs over auditorium

The main level lower level roof and mid-level roof over the auditorium each have one large wet area and a few smaller ones.

2. Scrape the gravel from the marked wet areas. Inspect membrane for cracks, breaks, splits to determine the source of the suspected wetness. Repair the found issues with a modified bitumen patch as described above. Small wet areas (#'s 22, 23, 21, 20, 18 and possibly 17), may be removed and new insulation and the above described modified bitumen membrane patch installed over the insulation. Large areas wet areas (#'s 15, 19 and 16) will not be removed, and will only have the problems in the membrane patched.

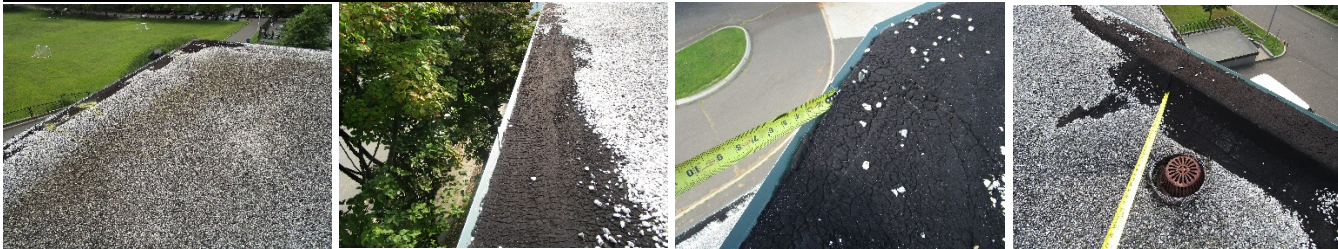
Dried and lifting perimeter membrane

The membrane at the perimeter of the roof has dried. The ballast has been scoured off in areas as well. In some spots the membrane is not stuck to the metal flashing and water is getting in. This is causing some of the wet spots at the perimeter. In addition to repairing the perimeter wet areas, the entire perimeter of the roofs should be checked and any open membrane at metal joints repaired. Where the membrane is lifting it should be resealed and re-stripped.

1. Check perimeter of roofs for unadhered membrane, cuts, breaks, worn out flashings, etc., Special attention shall be paid to marked areas (markings are already starting to fade from gravel,) to determine if an area needs to be cut out and replaced or only patched. Perimeter flashing shall be patched by:
Scraping back gravel, applying a layer of reinforcing fabric in roofing cement followed by a layer of granular surfaced modified bitumen membrane set in roofing cement. The perimeter of the repair would then be stripped in with strip of reinforcing fabric set in roofing cement followed by another coating of roofing cement. Ballast from the surrounding area would then be placed on the perimeter mastic stripping. The granular surface on the modified bitumen membrane would be the finish on that portion of the repair.

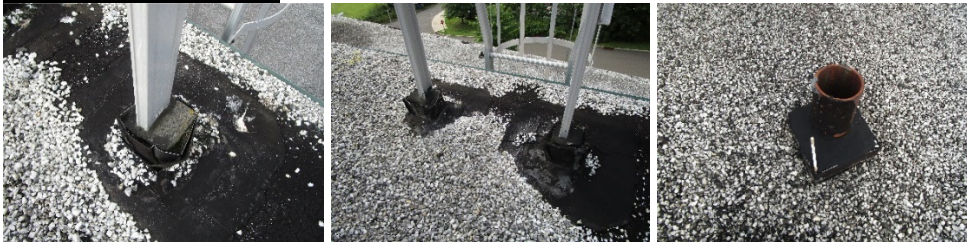
Penetration flashing

Many of the penetration pockets have failed and split open. Those that haven't split have had their filler shrink. This has left paths for water to enter the system.

3. Check, repair, refill and reflash as needed, all penetration pockets.
4. Check and repair as needed, all curb flashings. using reinforcing fabric, roofing cement and modified bitumen membrane. A bituminous resin flashing and reinforcing fleece may be used instead of the modified membrane depending on the conditions.

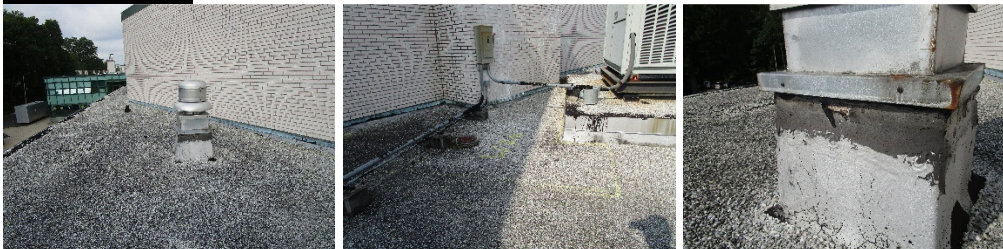
Curb flashing

All curb flashing needs to be checked. There are tears and worn out areas on some of the roof curbs. Holes, open corners, deteriorated membrane should be repaired.

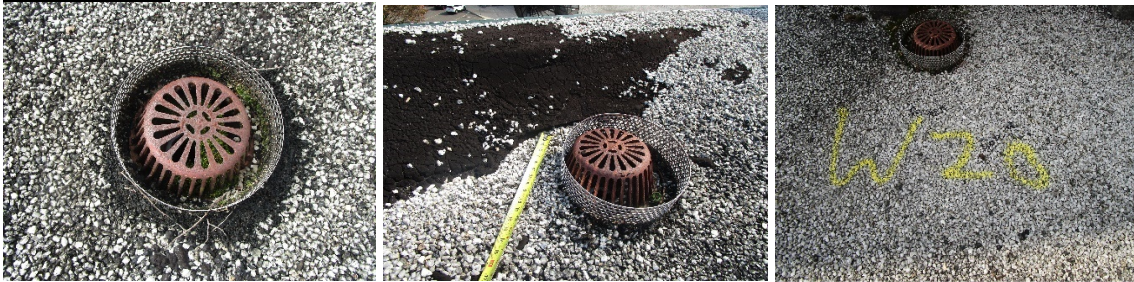
Roof Drains

All roof drains should be cleaned of debris and checked to see if the lead flashing is pitted or intact. Drains with marked wet areas should have the wet areas removed and be completely reflashed.

5. Clear surface debris from all roof drains. Check all drain flashings and reflash drains with new lead if necessary.
6. Cut a scupper in the edging of the small low roof off the mid-level. Fabricate, install and flash a roof scupper. Furnish and install a leader from the scupper to the main roof. Lay a splash block under the leader.

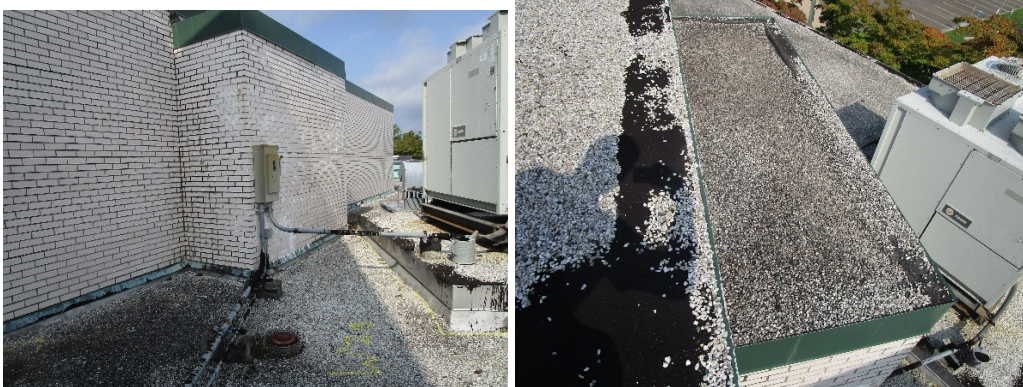
Small low row roof off mid-level roof

There is a small low roof on the side of the mid-level that has no drain or scupper. Water that builds up on it must flow over the edge. The brick on the walls below this roof shows signs of water damage. In addition, two marked wet areas, one at a drain, the other at a curb are close enough to this roof to be wet from water getting in the wall and traveling to the marked areas. A drainage scupper should be cut in the edge of this roof and a leader installed from the scupper to the lower roof to help stop water from cascading over the edge and possibly damaging and entering the wall.

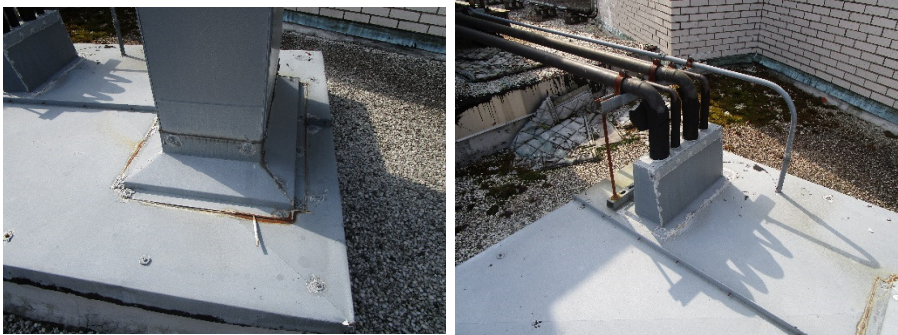
Miscellaneous items

There are also some miscellaneous items found on metal curbs. Some of these are just caulked to the curb and the caulk has worn out. These should be resealed with a PMMA membrane.

7. Check, caulk and reseal items on the metal curbs.
