FACILITIES NEEDS

STAMFORD PUBLIC SCHOOLS

SCOFIELD MAGNET MIDDLE SCHOOL

EMG Project #: 88166.09R-016.017
Date of Report: August 29, 2009
On site Date: April 16, 2009

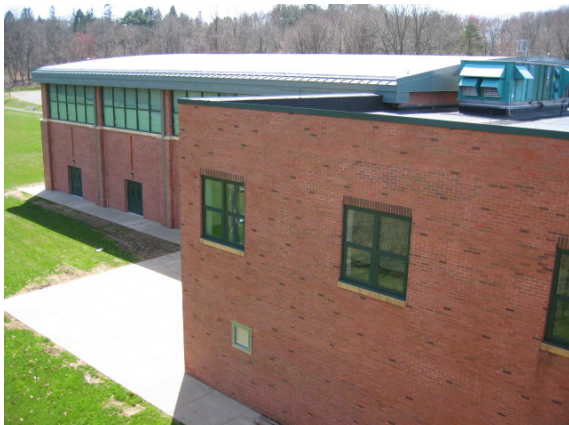
Photo #10: Two 2nd floor windows were observed to be shattered

6.6	4302	Replace 6' x 3' aluminum window upper floor	25	25	0	2	EA	\$2,232.72	\$4,465	\$4,465									\$4,465
6.6	4303	Horizontal Blinds aluminum 1" slats	7	7	0	1350	SF	\$6.49	\$8,760	\$8,760						\$8,760			\$17,520

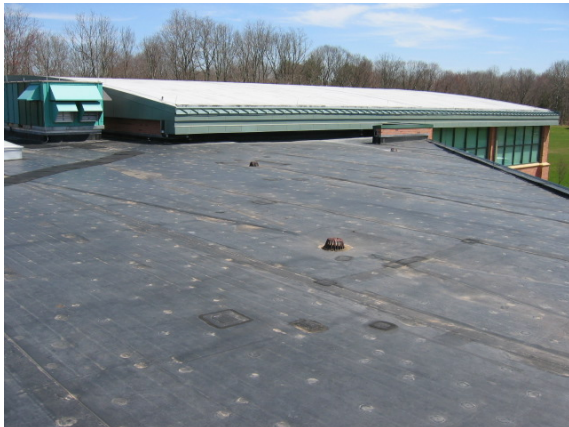
Photo #14: One section of roof edge fascia is missing, minor repairs are needed

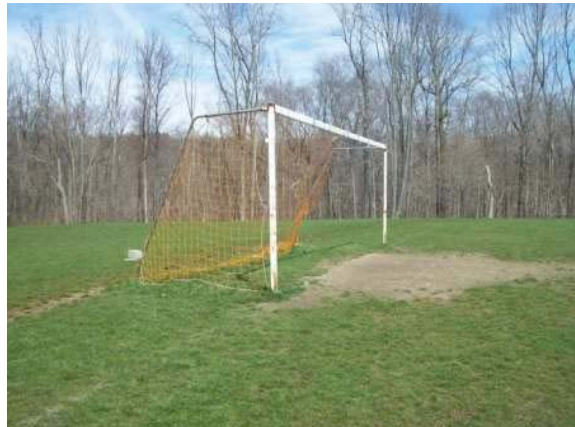
Photo #147: Barren grass on soccer field
