# Infrared Thermographic Roof Moisture Analysis

**PERFORMED FOR:** Viking Construction  
1387 Seaview Ave.  
Bridgeport, CT 06607

**LOCATION:** Scofield Magnet Middle School  
Stamford, CT

**CONDUCTED ON:** June 26 & 27, 2019

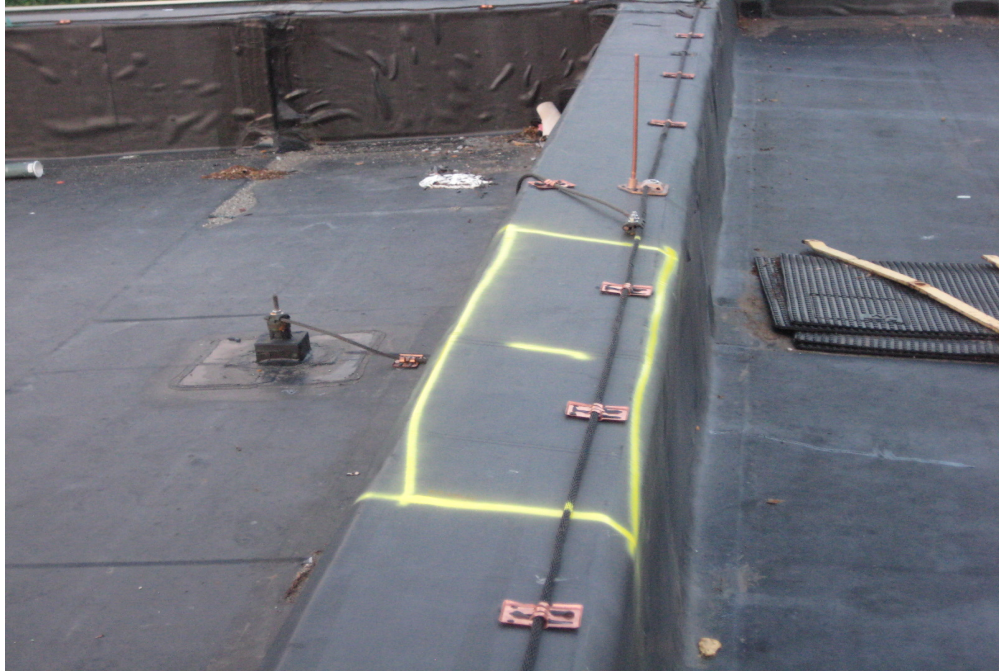
Wet Area #1

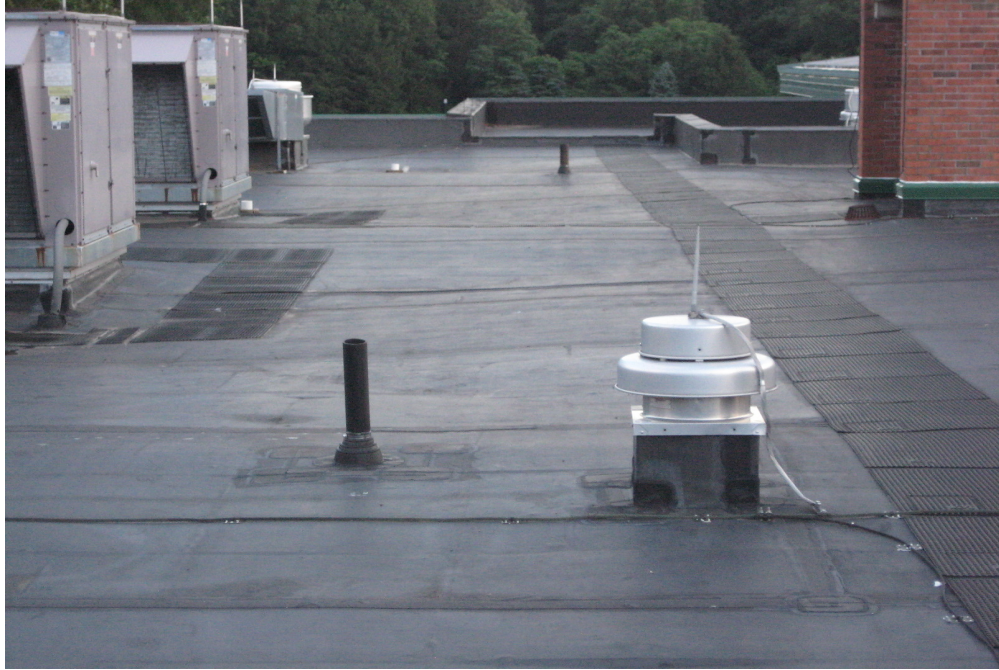
Dry area of roofing

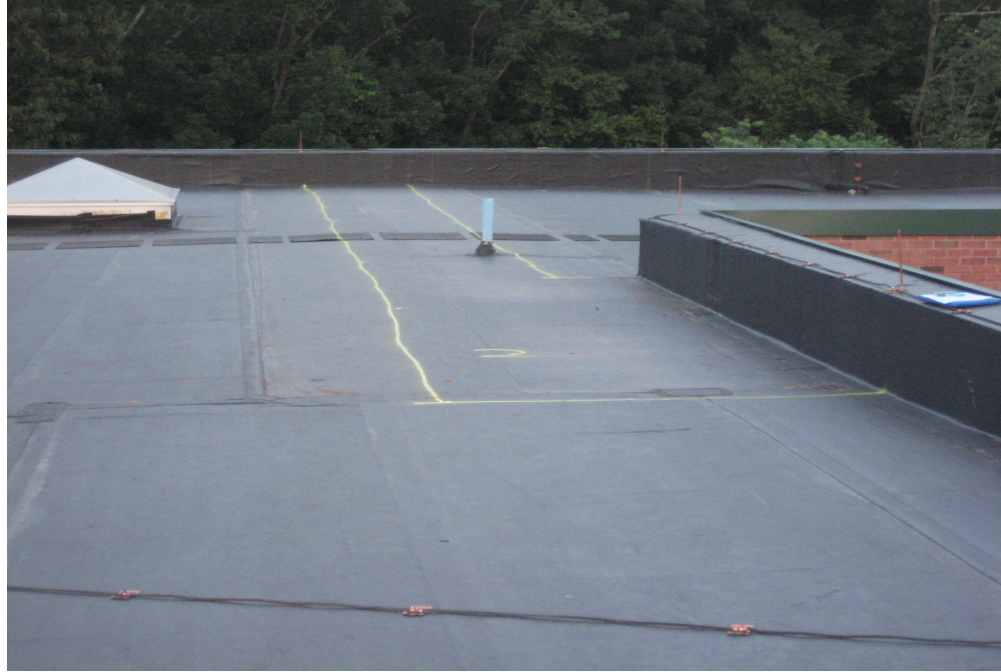
Wet Area #2

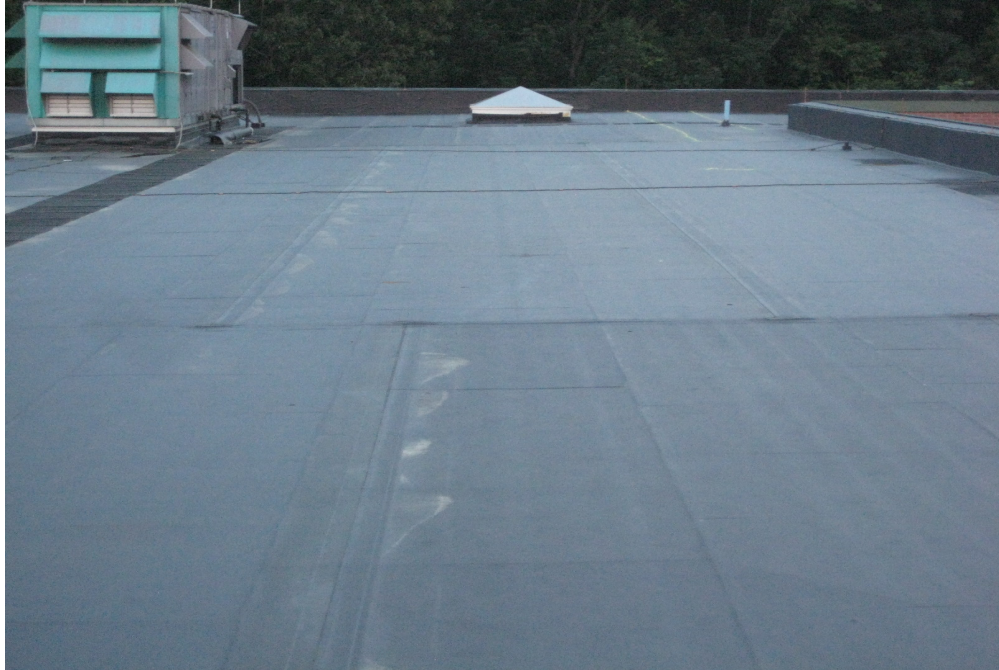
Dry area of roofing

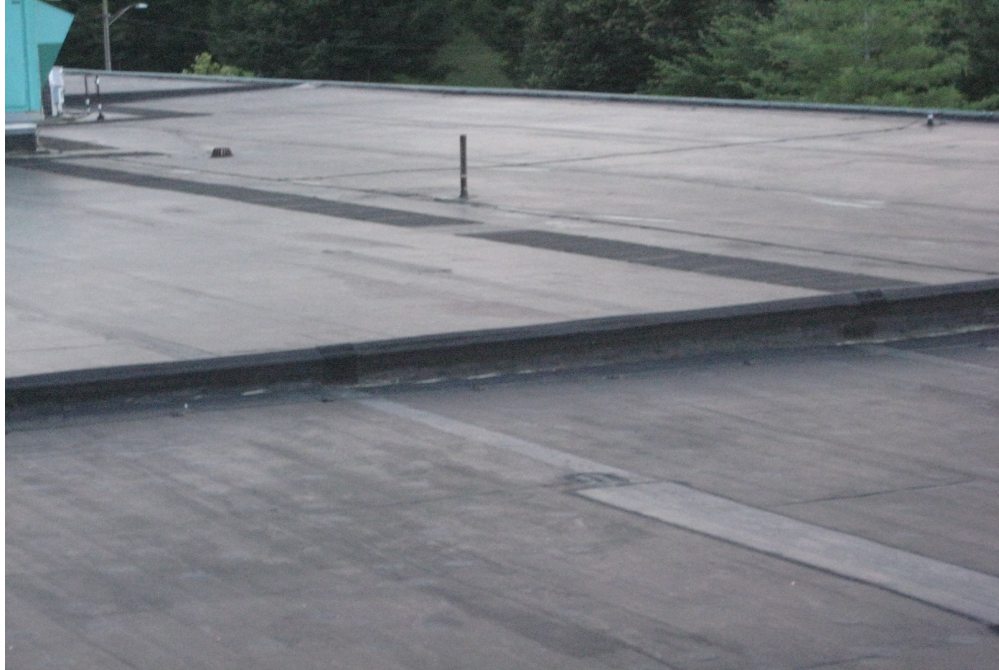
Dry area of roofing

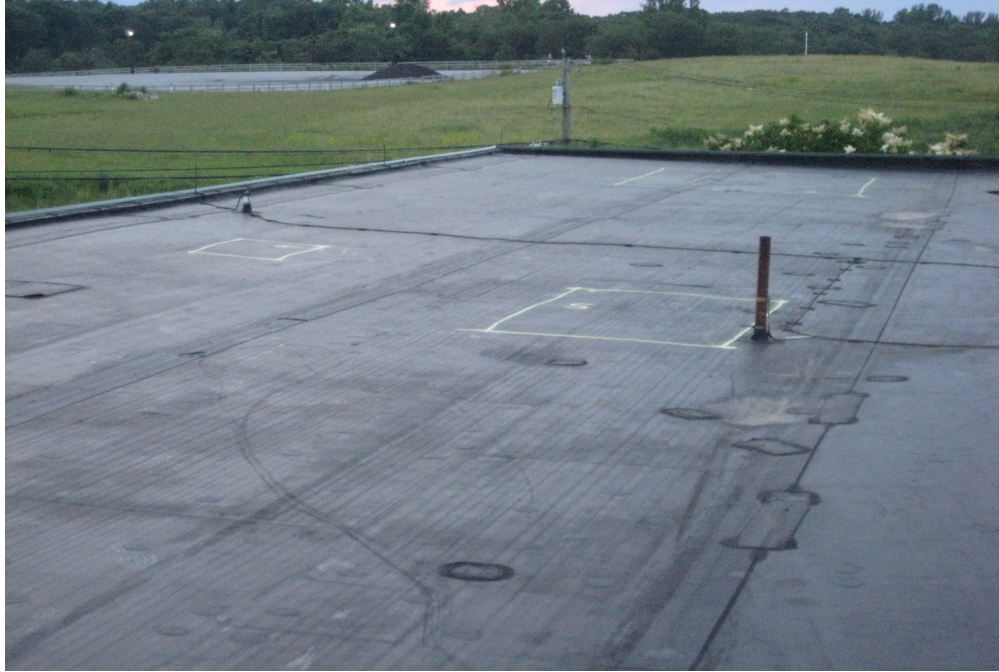
Wet Areas #4 & 5

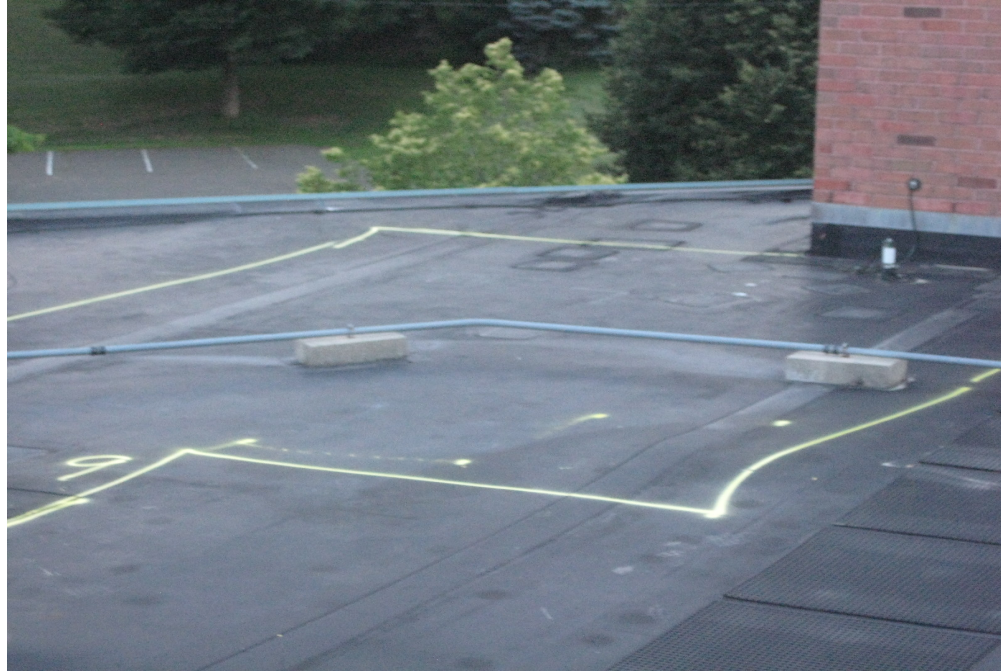
Wet Area #9

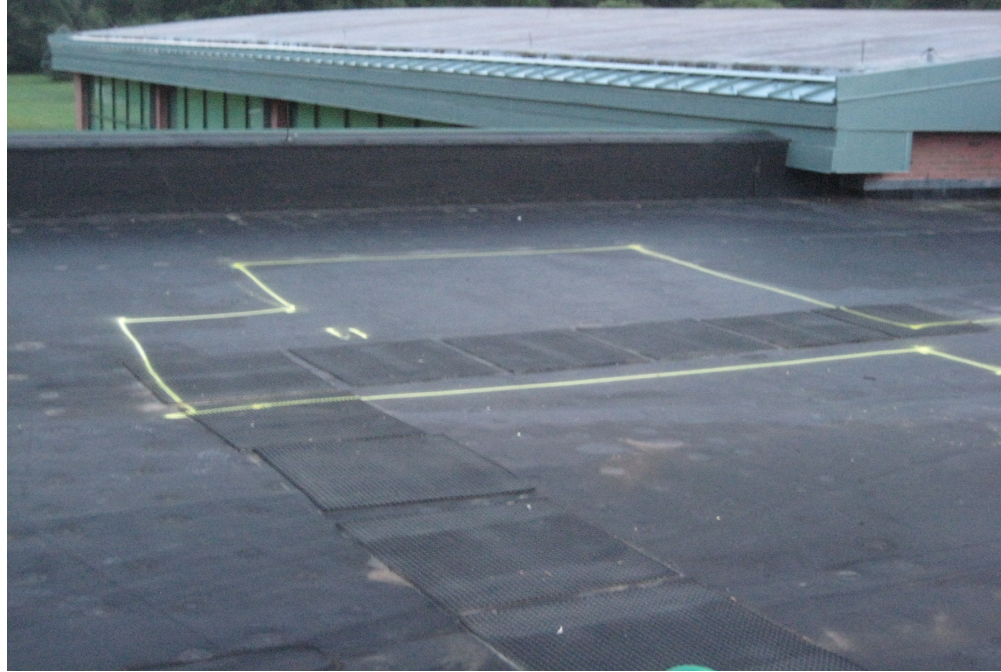
Wet Area #11
