M. Gottfried, Inc.

DATE: November 25, 2019

RE: Roof report and repair quotation
Scofield Magnet Middle School
641 Scofieldtown Road
Stamford, CT 06903

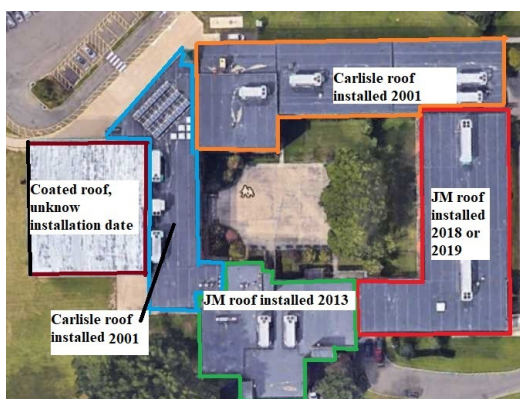
Roofs labeled with installation dates

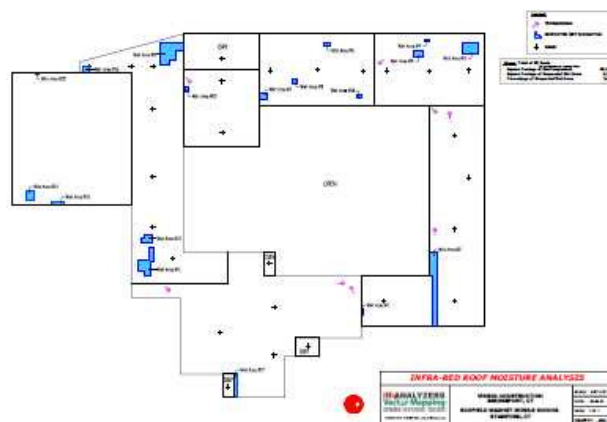
Areas of moisture shown on Roof Scan

The condition of the roofs on Scofield Magnet Middle School vary from very good to in need of replacement. The infrared scan revealed 18 areas of wetness, spread over almost all of the roof systems. The manufacturers used for the roofs on the school appear to be Carlisle and JM. The manufacturer on one area is unknown. Warranty information on the various roof areas is sketchy, but installation dates are known. There are two areas where Carlisle roofs are present. They are outlined in blue and orange. A 15-year Carlisle roof warranty was found that expired in 2016. Even though both areas may have been covered under this warranty, we broke them up because of the different condition of the roofs in each section. The Orange section is in good condition and can be repaired, the Blue has large wet areas, areas of loose membrane and other issues. Two roof areas are covered by JM roofs. The green area was installed in 2013. No warranty information was available for this roof, but it most likely had a 15 or 20-year warranty. The other JM roof was recently installed. The warranty status of this roof is unknown. If a warranty was issued for this work, repairing the wet areas found in the infra-red scan as well as items that might not be up to JM standards, should be performed at no charge to the school by JM or the installing contractor. This area will be discussed further in the report. The final roof area is an EPDM roof that had received a roof coating. No data was available on this roof.

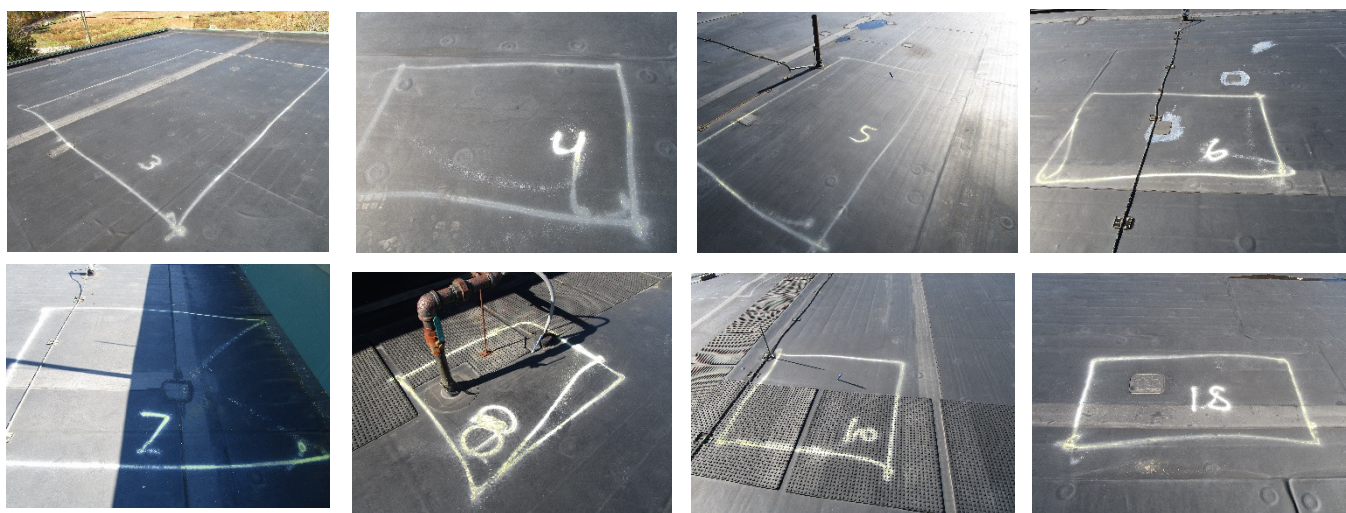
Wet areas

There were 8 wet areas found in orange section of the Carlisle roof.

All of the wet areas found on this roof appear to have come from holes and punctures in the roof membrane. Most of these have been patched, a few have not. The wet areas should be cut out and replaced with new insulation and membrane. Any penetration that is within the affected area would need to be reflashed.

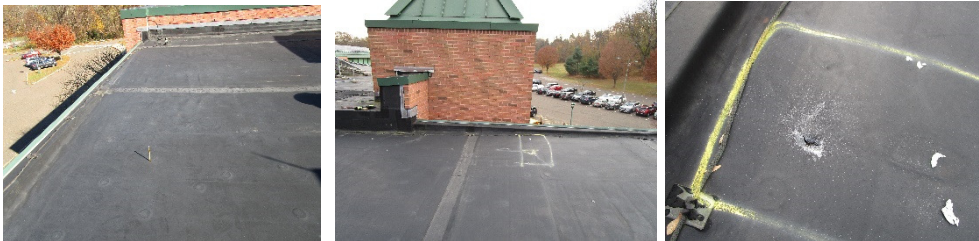
Holes in the roof

The roof must be checked for holes. Any hole that is found should be patched as soon as possible before moisture can get into the roofing system. There are also ripples present in the membrane between the marked hole and the wall. This should be investigated to see if there is a loose area of membrane present, or there are just lumps in the installation. We also found a hole in an outlined but un-numbered area.

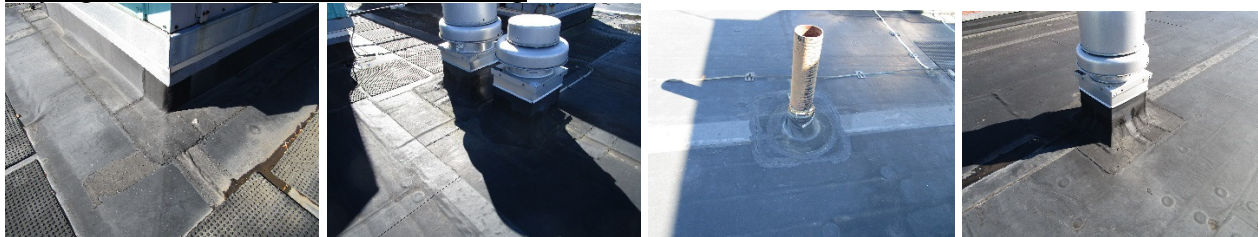
Drying out curb and penetration flashing

Many of the corner and penetration flashings are starting to dry out. To extend the life of the roof we would recommend cleaning, priming and overlaying the corners and flashing with new flashing membrane.

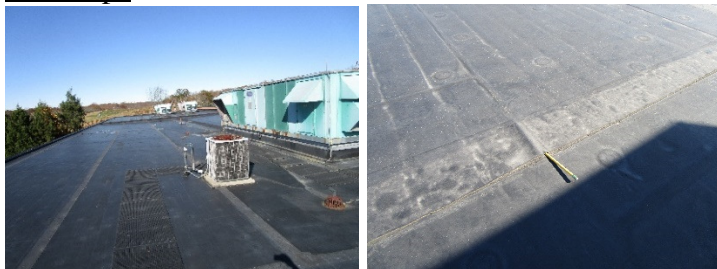
Field laps

Drying of the field laps and a few fishmouths in the laps were also seen. Overlay the field laps with new flashing membrane will cover the developing voids, protect the laps and extend their life.

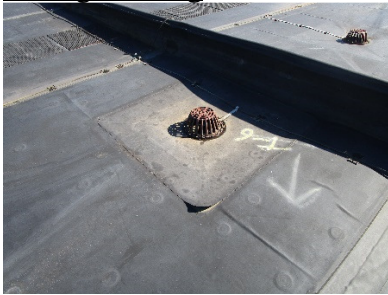
Lifting flashing

Some of the patches are lifting. These also need to be striped in with new flashing.

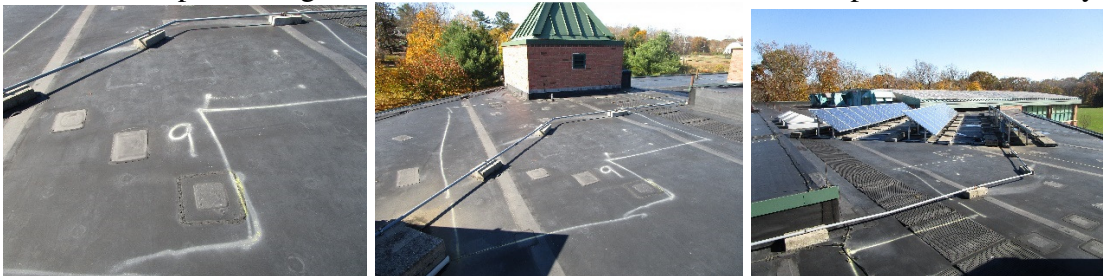
Wet area #9 spans a large corner of the roof section near the solar panels. It has many patched holes in it.

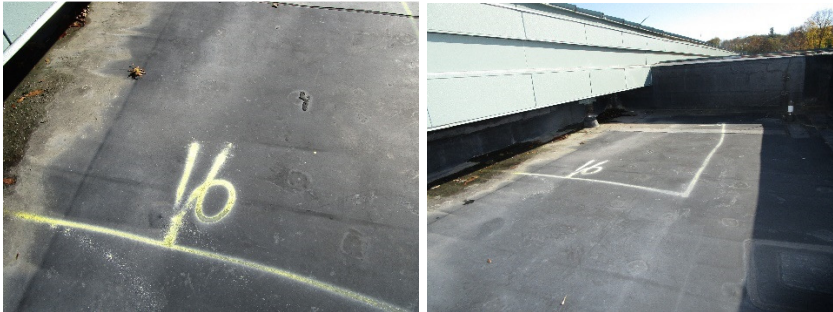
Wet area #16 is tucked under the corner where the Carlisle roof goes under the Coated roof.

This area needs to be scrubbed clean then any holes could be found.

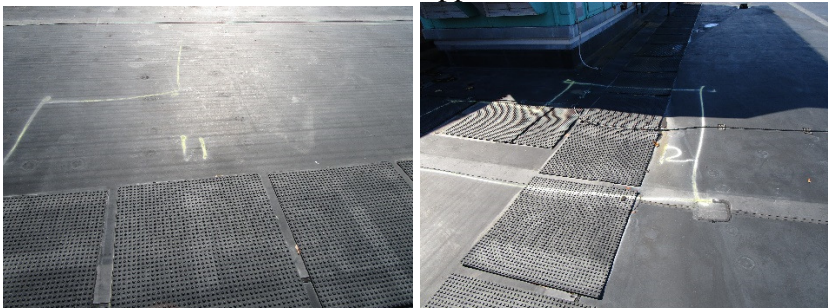
Wet areas #11 and 12 are on the opposite side of the roof.

Holes were found in these areas.

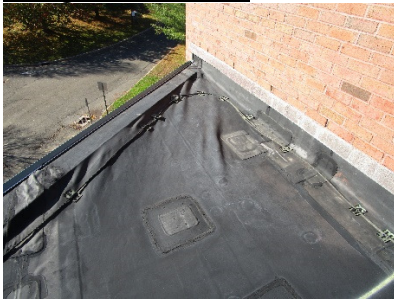
Bridged membrane

The field sheet as pulled away from the rising wall and outside curb. As the membrane continues to age and shrink, this problem will worsen.

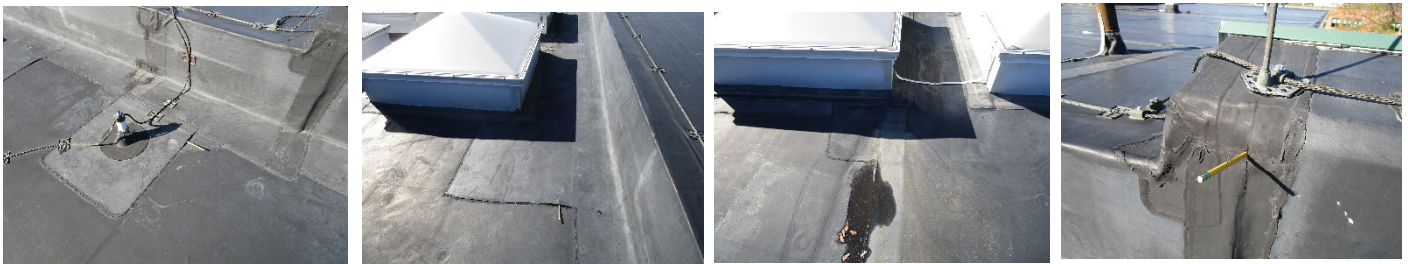
Lifting patches

Fishmouths and lifting patches are found on this roof area. If these open up all the way to the end of the lap a pathway for water to enter the roofing system develops and leaks may occur.

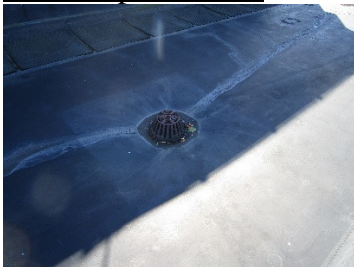
Soft sumps at drains

The drain sumps feel soft. It is possible that a fiberboard insulation was used to create the sump. This may have gotten wet and become “mushy”.

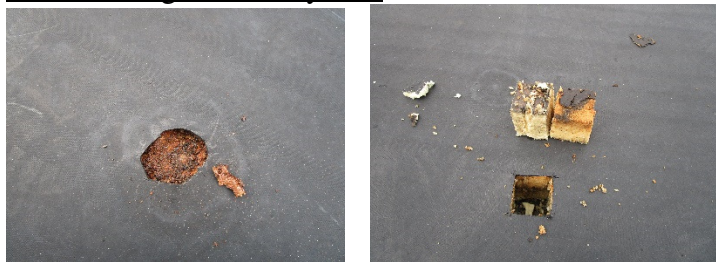
Water damage to roof system

We took a roof sample at an unadhered piece of membrane in a “non-wet” area of the roof. We found the insulation plate had rusted and the membrane deboned.

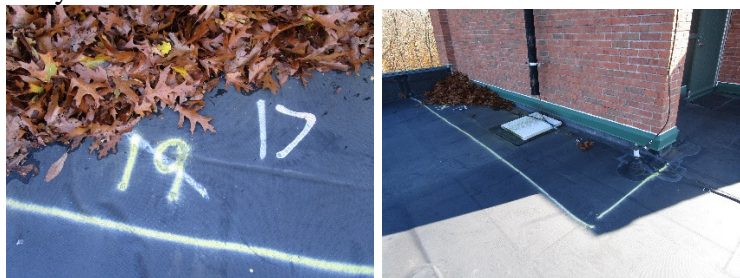
Only one wet area was found on the 2013 JM Roof.

The wet area follows along the stair wall. It is also a collection point for debris. We cannot tell if there are holes under the debris or concrete pad. When this area is removed and replaced, we can get a better idea if the moisture was from holes in the roof or is a wall issue.

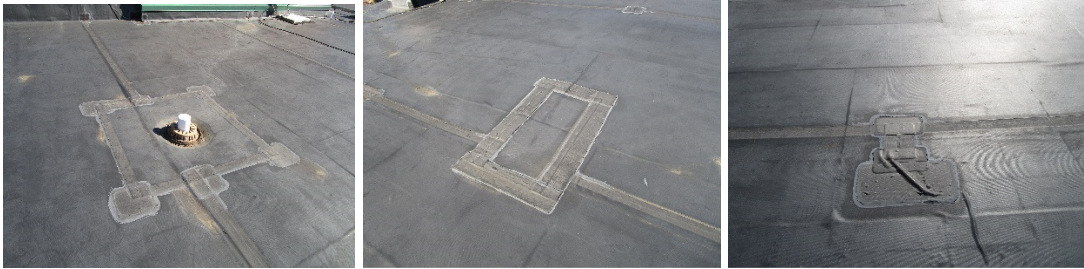
Overlaying areas of multiple patches and stripping

There are a few areas where cut areas have been overlaid with membrane, or patches have been installed at multiple points around a patch. These areas can be overlaid with new membrane as a secondary precaution.

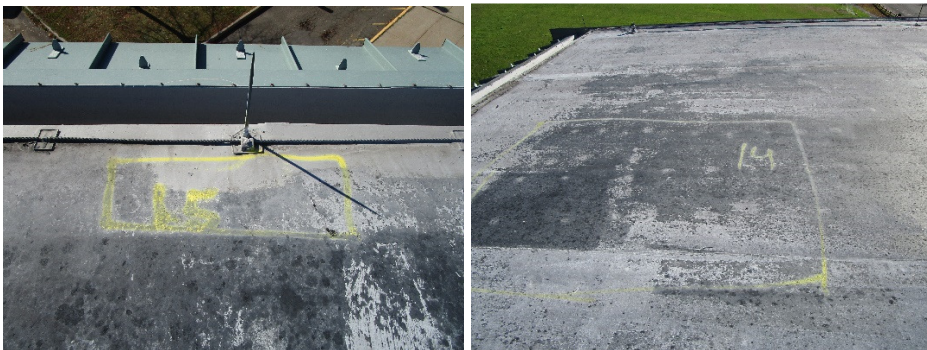
Coated EPDM Roof

This section of roof has 3 wet areas, # 13, 14 and 15. It is very difficult to see if there are holes that have caused the wetness due to the condition of the coating. Before cutting and replacing any of these wet areas, we would have to clean a test sample of membrane and perform an adhesion test with new membrane. If we get good results, proceeding with replacement of the wet areas can proceed. If adhesion is only moderate, a surface patch the marked areas may be recommended repair. This way the membrane is not cut (may create more problems if it cannot be properly sealed) and the surface patch can be monitored.
