# FACILITIES NEEDS ASSESSMENT

## STAMFORD PUBLIC SCHOOLS

## FACILITIES NEEDS ASSESSMENT OF TURN OF RIVER MIDDLE SCHOOL

**EMG Project #:** 88166.09R-014.017  
**Date of Report:** August 29, 2009  
**On-Site Date:** April 6 and 7, 2009

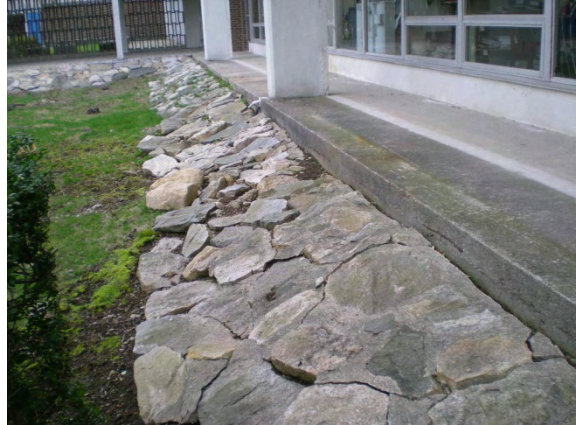
Photo #14:	Loose stones with deteriorated mortar along front and side entrances
------------	--

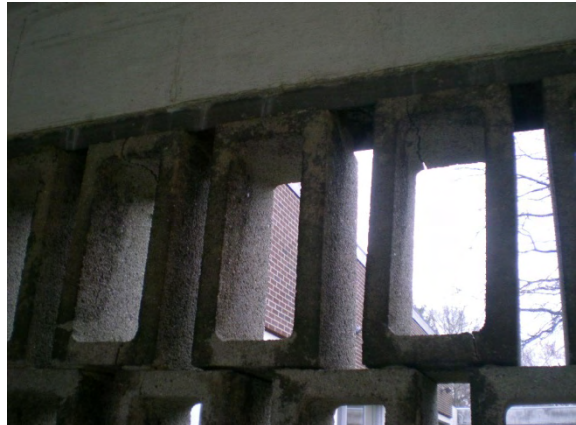
Photo #16:	Damaged concrete screen wall at west courtyard
------------	--

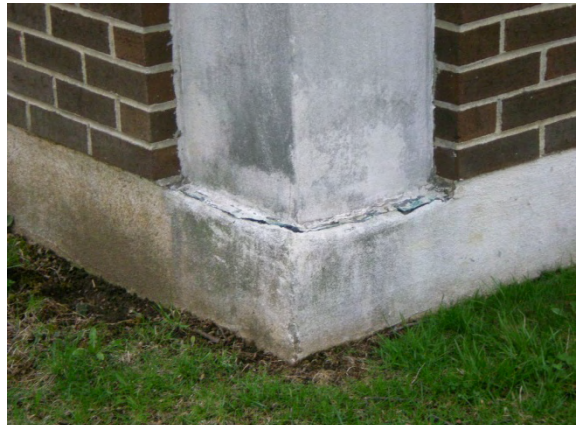
Photo #18:	Patched base of column enclosure
------------	----------------------------------

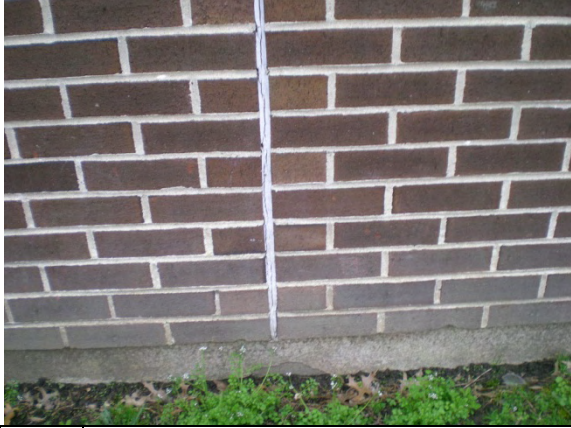
Photo #19: Deteriorated expansion joint

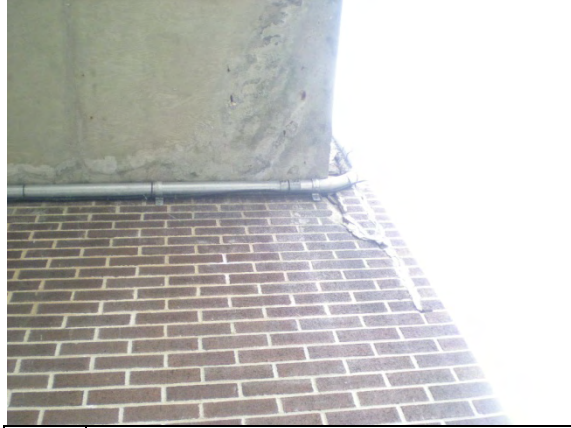
Photo #20: Spalling brick veneer under cantilevered fire exit balcony at north elevation

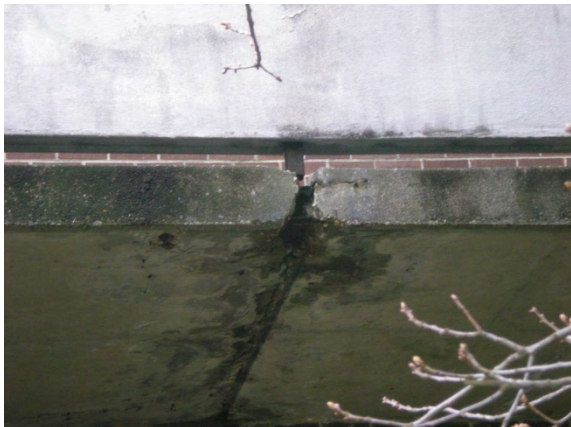
Photo #21: Corroded concrete and rusted through steel support at cantilevered balcony

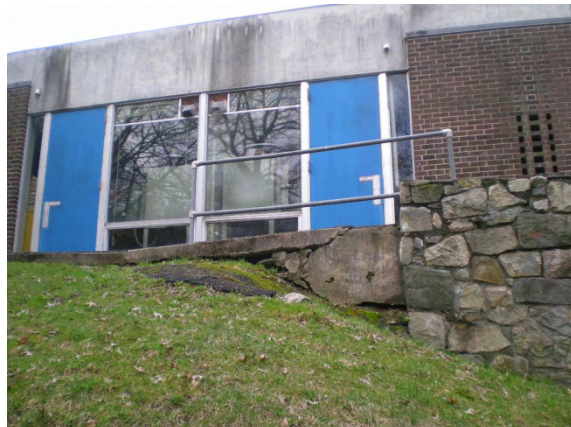
Photo #22: Damaged concrete sidewalk at connection to fire exit balcony

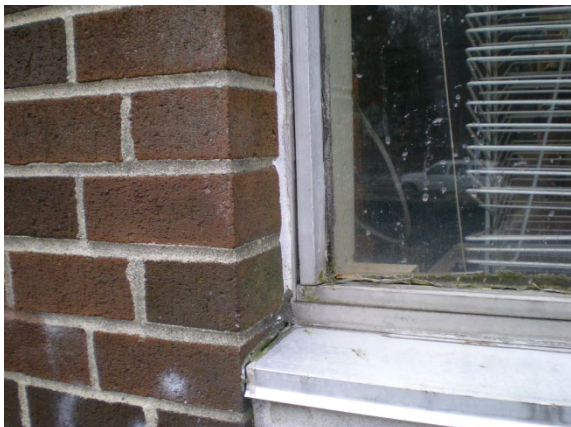
Photo #23: Deteriorated sealant

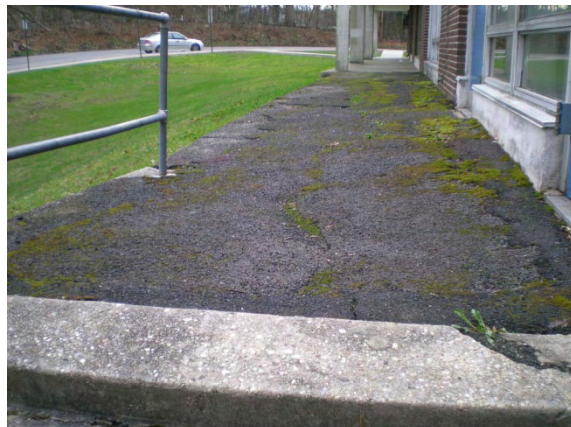
Photo #24: Asphalt overlay and open railing at sidewalk connection to fire exit balcony

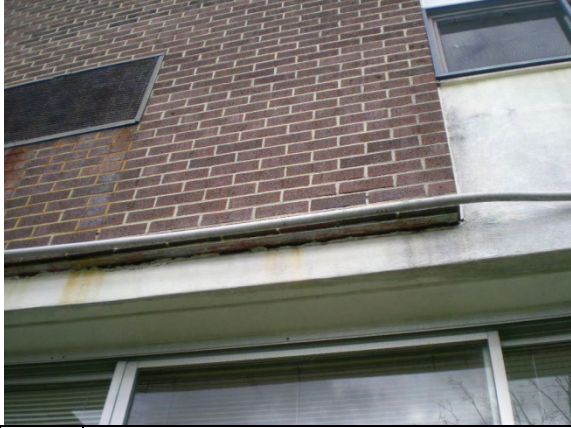
Photo #25: Rusting fan coil grille and rusting and deteriorating brick angle

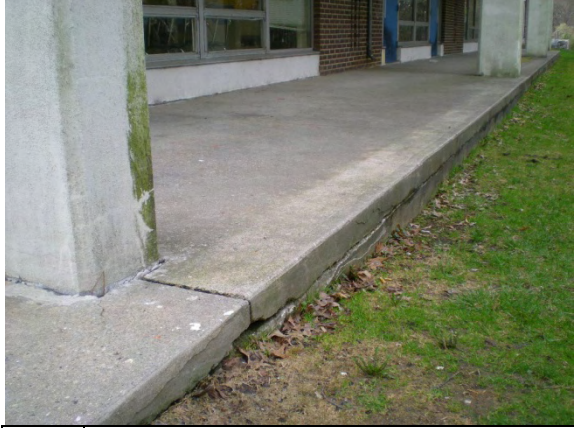
Photo #26: Damaged concrete slab at north elevation

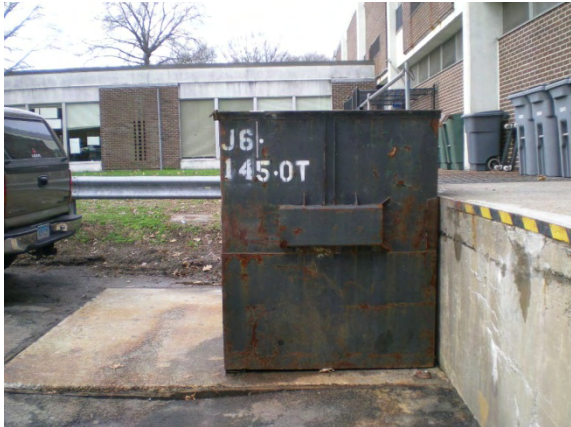
Photo #27: Loading dock area with no bumpers at dumpster and damaged concrete dock

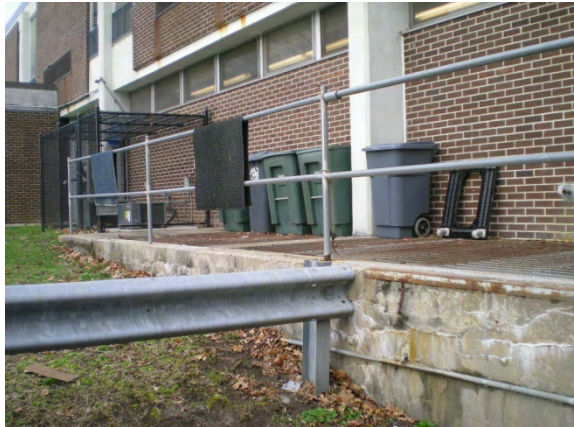
Photo #28: Spalled areas at loading dock

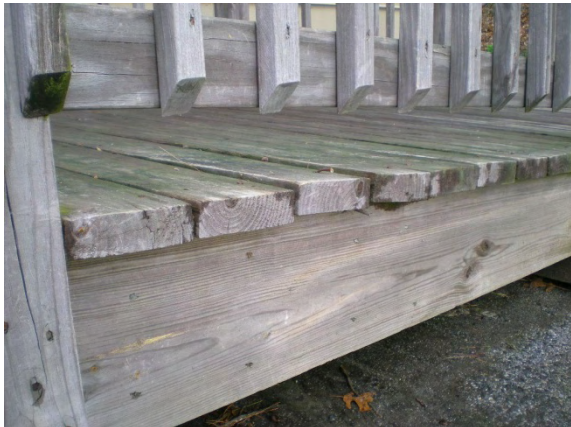
Photo #29: Warping floor boards at access ramp to modular addition

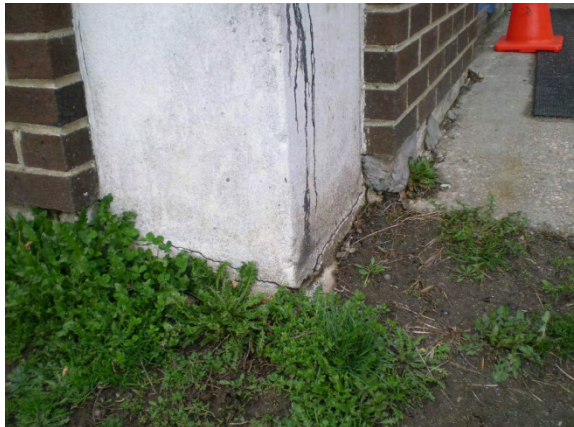
Photo #30: Cracked column base cover and foundation

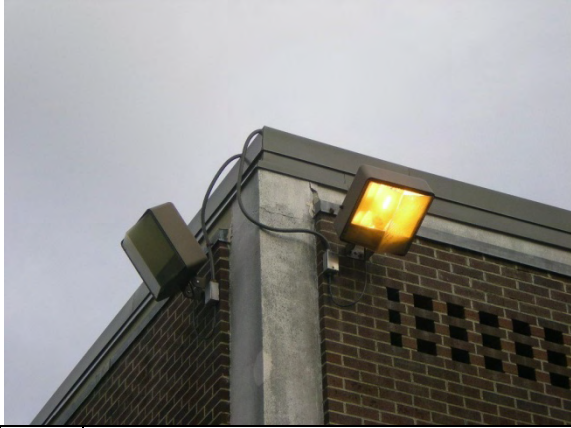
Photo #31:	Cracked column cover at top of building
------------	---

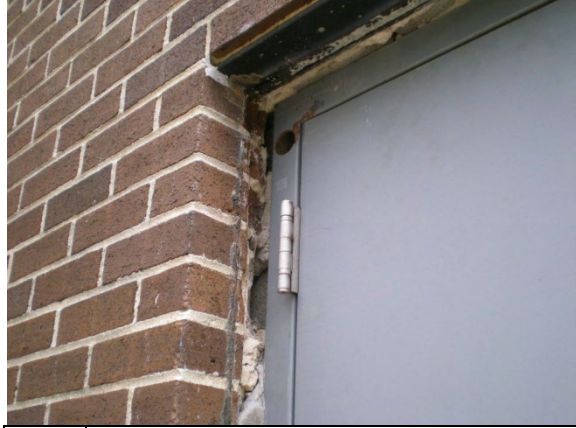
Photo #32:	Exposed cavity at service door frame.
------------	---------------------------------------

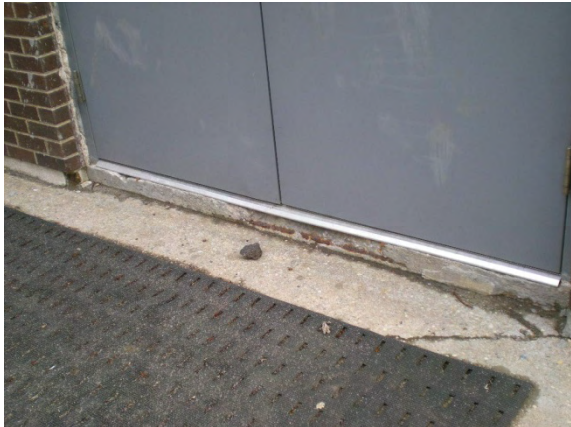
Photo #33:	Corroded and spalled concrete door sill at service door with exposed rebar
------------	--

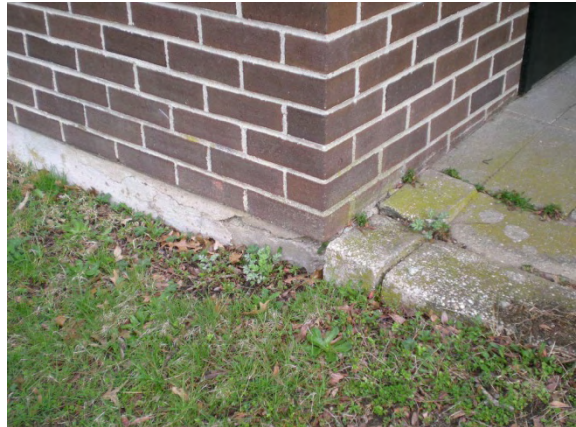
Photo #34:	Damaged foundation at southwest corner
------------	--

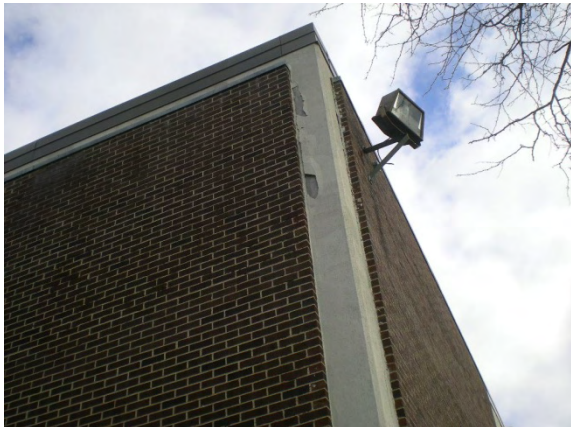
Photo #35:	Condition of paint at concrete structural covering
------------	--

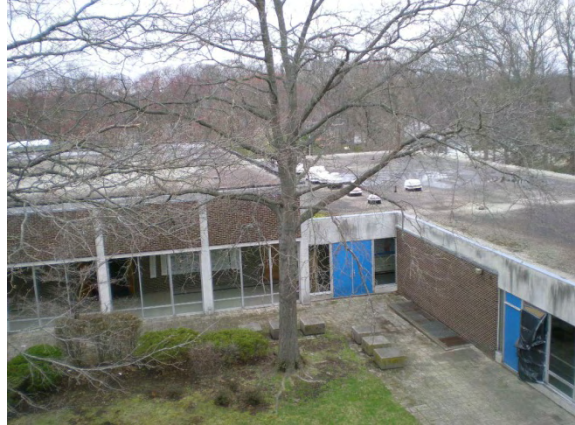
Photo #44: Courtyard elevations and roofs along classroom corridor and broken glass panel at right

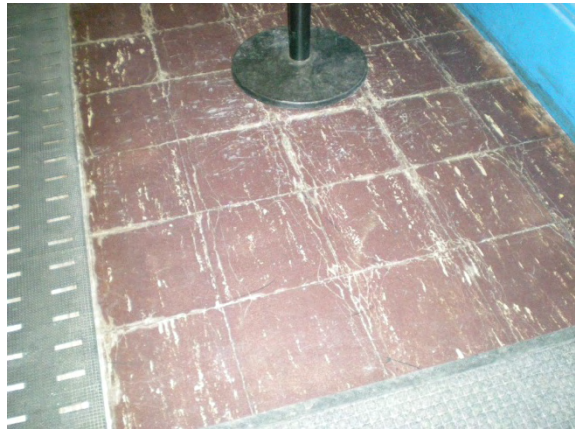
Photo #46: Condition of suspect asbestos tile flooring at main lobby

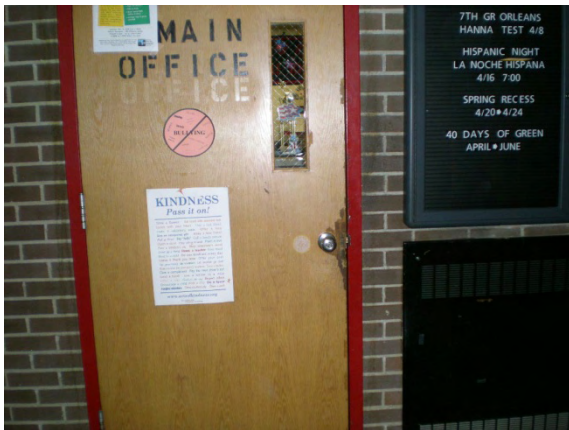
Photo #47: Main office entrance with knob handle hardware and damaged door

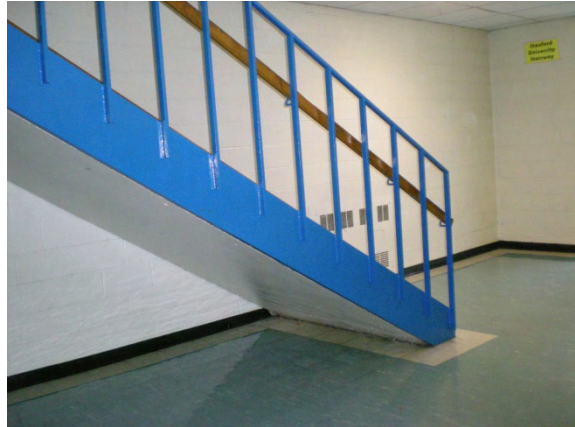
Photo #50: Non-compliant guardrail and handrail at stair

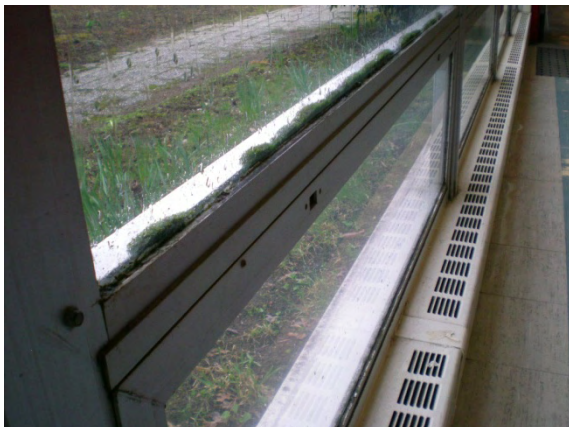
Photo #53: Condition of windows – showing moss growth

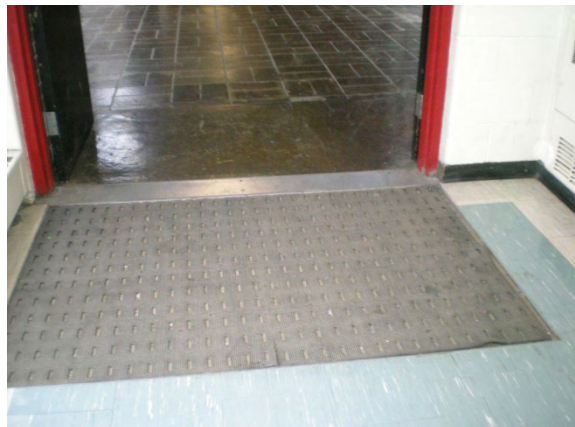
Photo #54: Curled recessed walk-off mat at north side entrance creating trip hazard

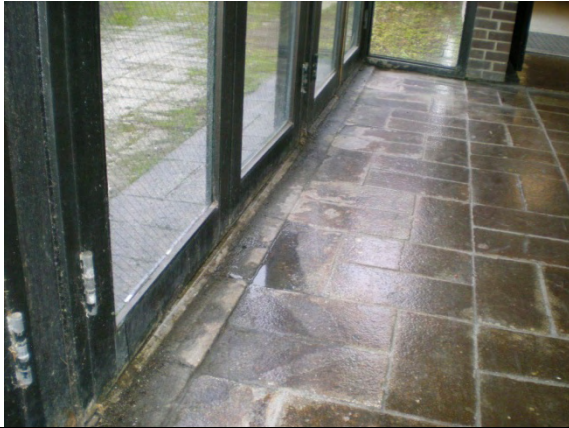
Photo #55: Water infiltration at north side entrance

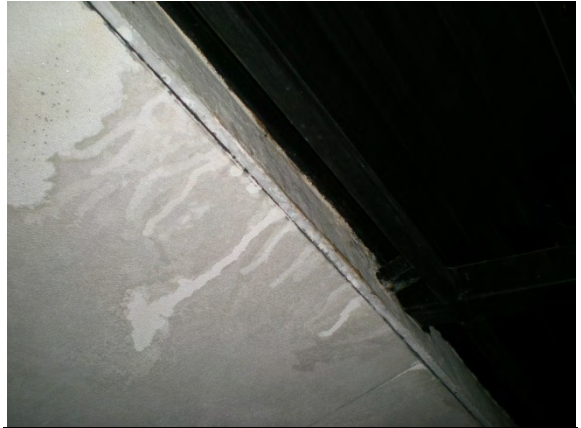
Photo #56: Evidence of water infiltration at ceiling of north side entrance

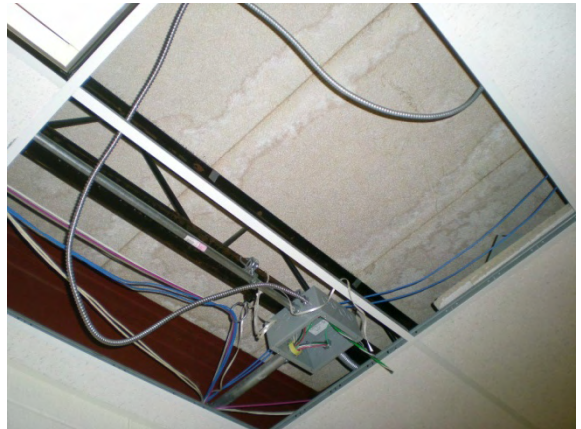
Photo #58: Exposed structure within classroom showing water stains

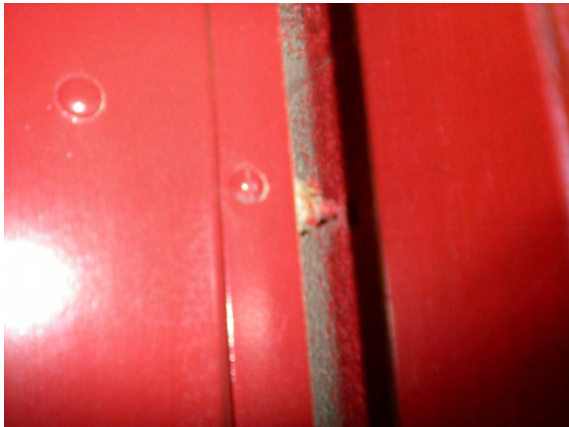
Photo #59: Loose bank of lockers – not securely attached into wall

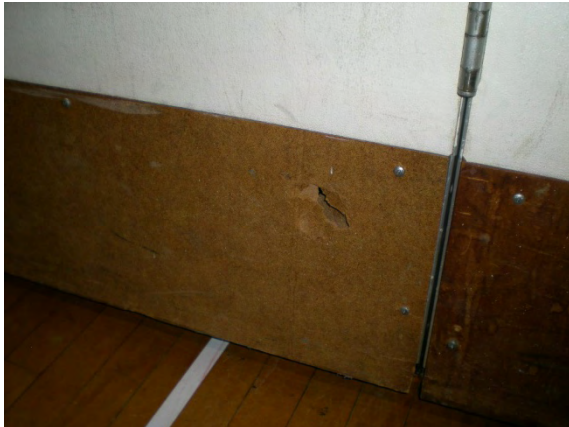
Photo #63: Condition of masonite at base of folding divider wall

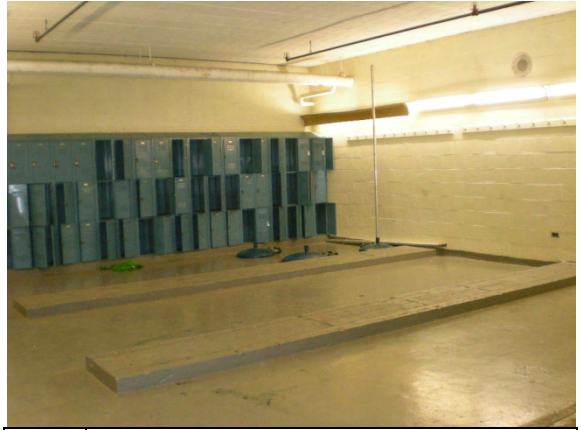
Photo #68: Boys' locker room with majority of lockers removed and damaged lighting

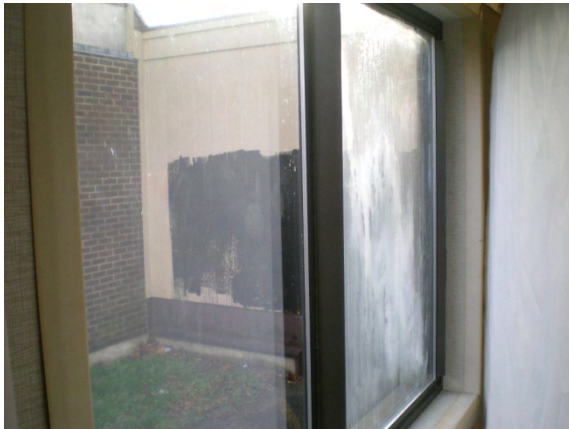
Photo #69: Broken seals at modular addition

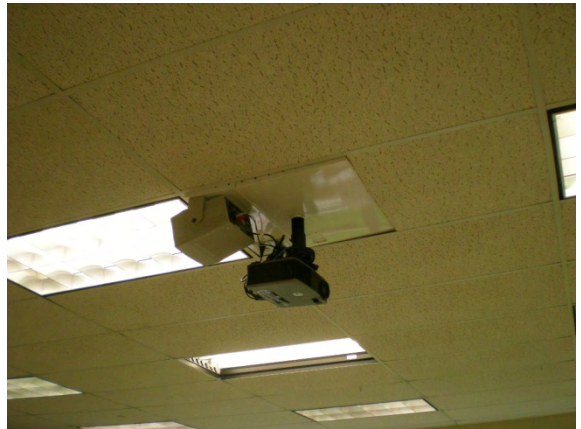
Photo #70: Loose Promethean projector

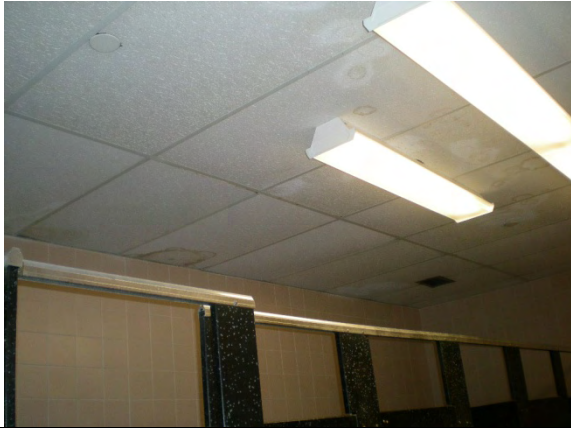
Photo #73: Water stains in student restroom

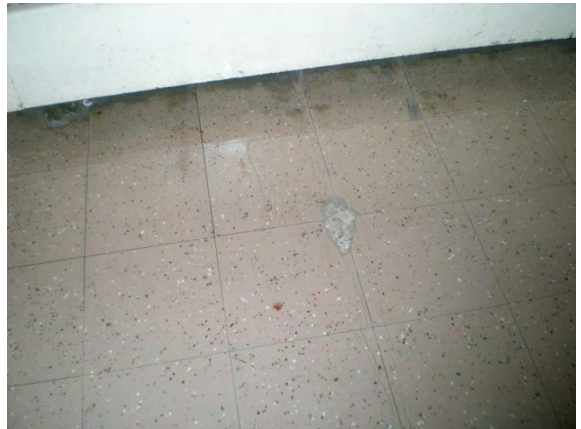
Photo #76: Suspect asbestos tile condition in classroom

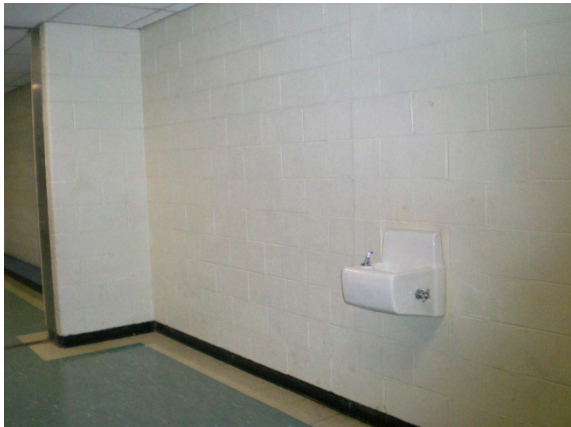
Photo #77: Projecting drinking fountain into path of travel. Also non-compliant due to twisting controls

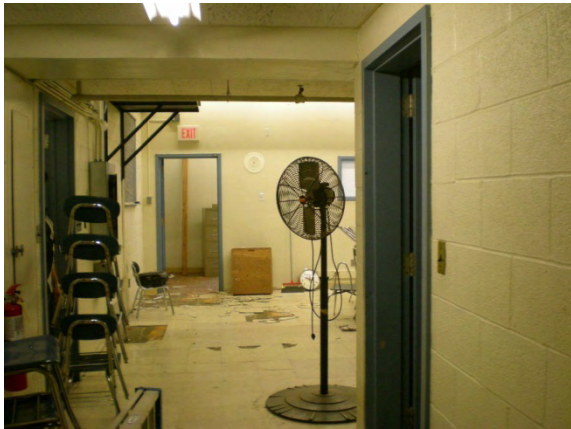
Photo #83:	Lower level classroom with damaged flooring undergoing renovation
------------	---

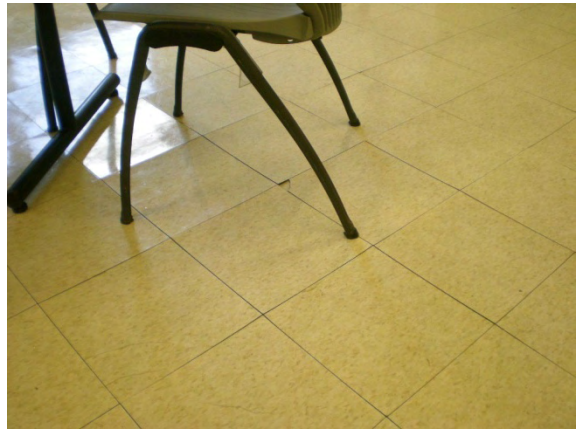
Photo #84:	Moisture damaged flooring in lower level classroom
------------	--

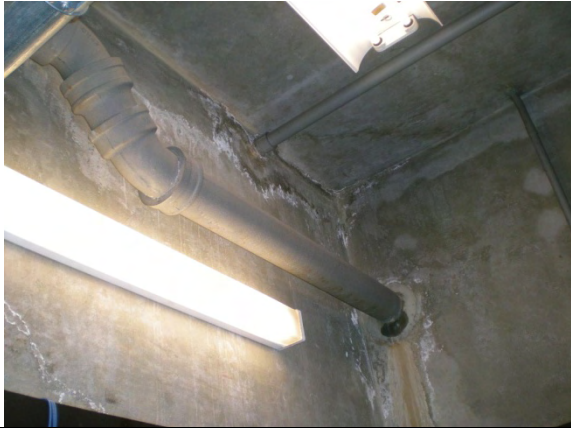
Photo #85: Moisture infiltration over main telephone equipment in basement

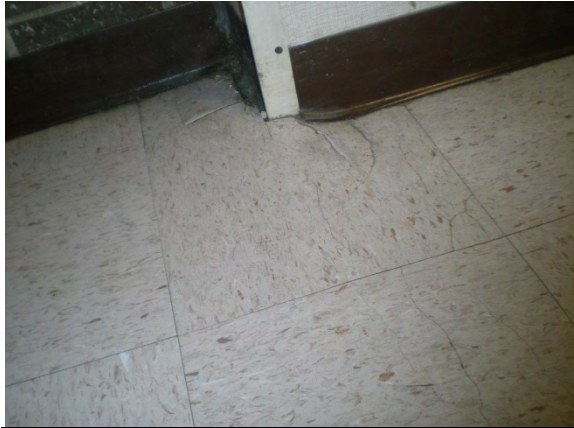
Photo #86: Heaving slab at connection to modular addition

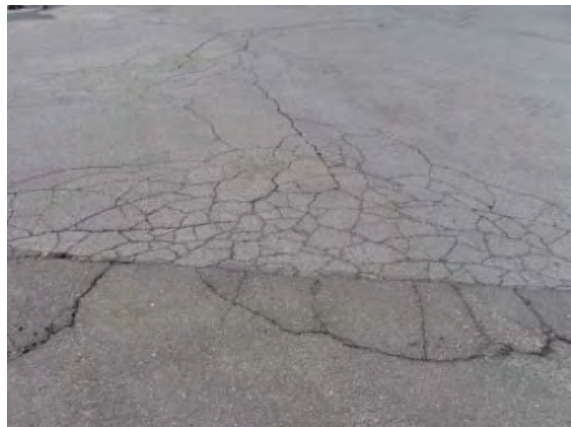
Photo #100:	Alligator cracking at asphalt pavement rear of building
-------------	---

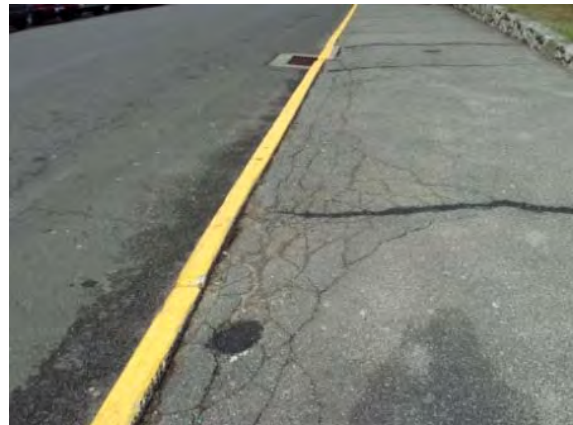
Photo #108: Asphalt deterioration and tripping hazard at the sidewalk

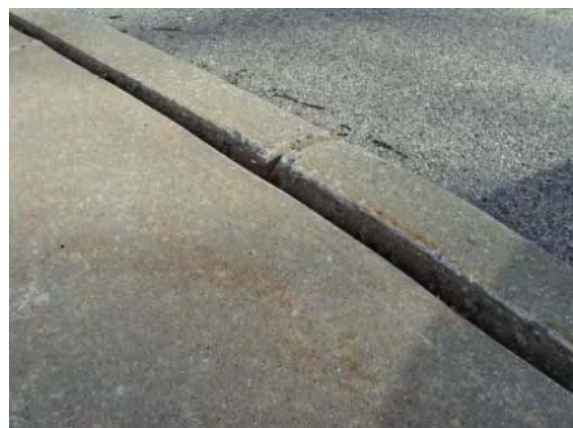
Photo #114: Tripping hazard at concrete sidewalk adjacent to rear drive lane

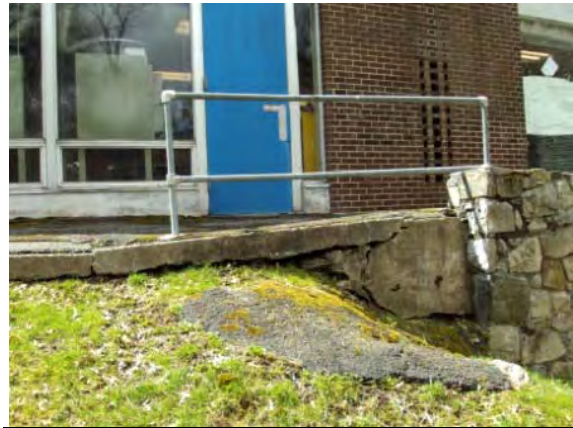
Photo #116: Collapsing concrete sidewalk at rear of building (adjacent to retaining wall)

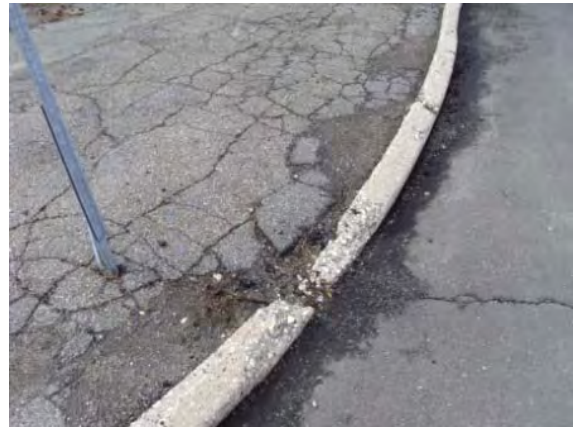
Photo #118: Deteriorated concrete curb at south elevation

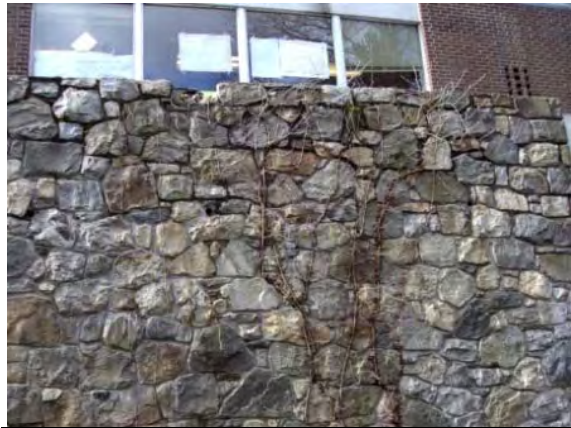
Photo #128: Deteriorated mortar and vine growth at rear stone retaining wall

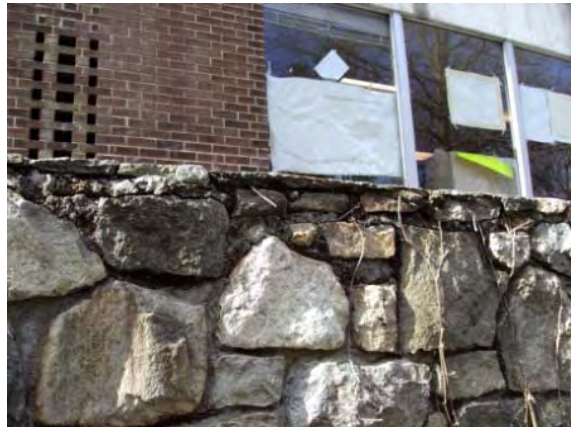
Photo #130: Deteriorated mortar at rear stone retaining wall

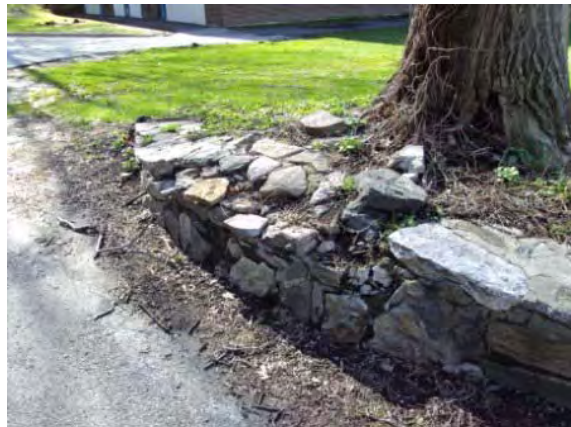
Photo #132: Deterioration at stone retaining wall along rear drive lane

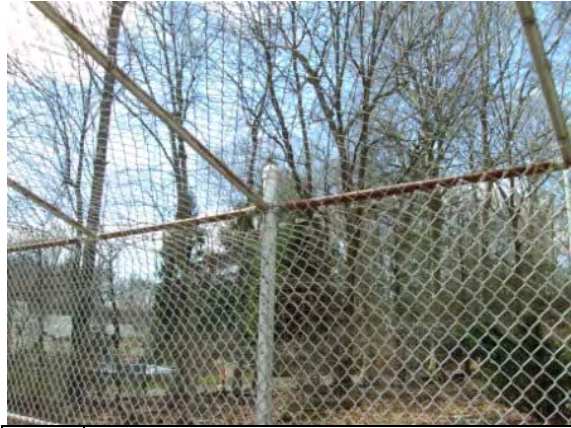
Photo #146: Loose fencing at backstop

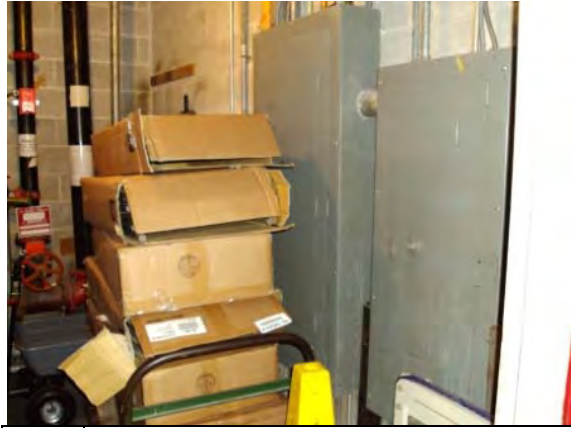
Photo #1340 : Blocked circuit breaker panels at fire suppression room

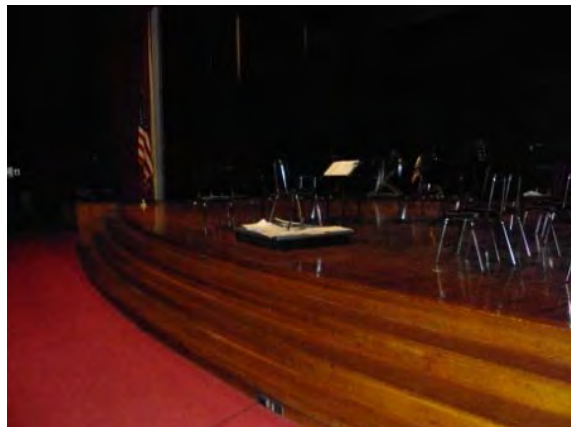
Photo #136: Auditorium stage requiring a wheelchair lift for accessibility
