M. Gottfried, Inc.

DATE: October 14, 2019

RE: Roof report and repair quotation
Turn of River Middle School
117 Vine Road
Stamford, CT 06905

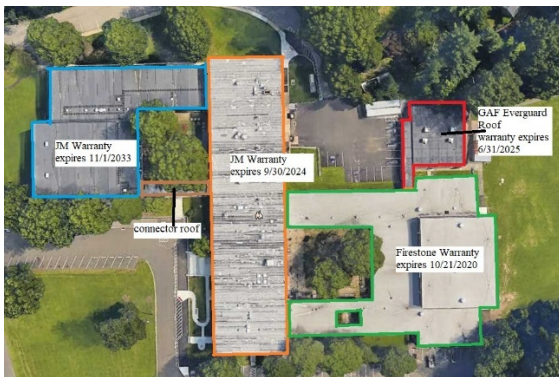
Roofs labeled with warranties if present

The roof areas at Turn of River Middle School can be broken up into 5 areas. The EPDM roof over the portable classrooms (outlined in red) have a GAF 20-year Everguard roofing system that will be in effect until 6/31/2025. The large modified bitumen system (outlined in green) has a Firestone 20-year warranty that will expire 10/21/2020. The long, modified bitumen system (outlined in orange) has a JM 20-year warranty that will expire in 2024. The large corner EPDM roof also has a JM roof with a 20-year warranty that will expire in 2033. The connector roof has a modified bitumen roof and does not appear to be under warranty.

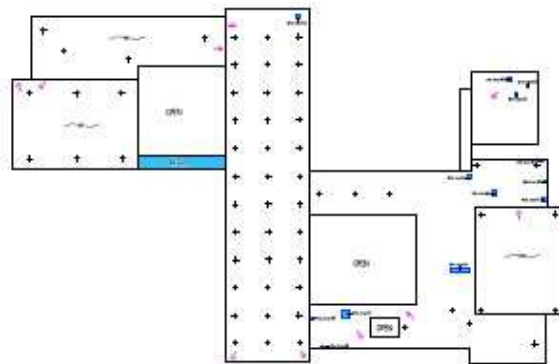
Areas of moisture shown on Roof Scan

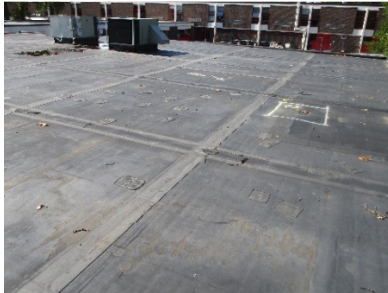
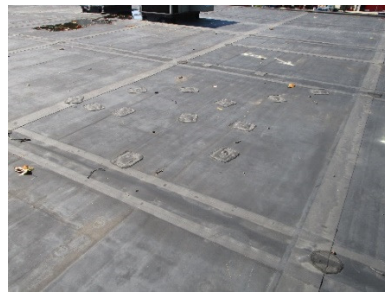
It looks like a tree limb or other problem might have occurred on this roof. There are areas with many patches present.

These patches were done using flashing membrane, rather than cured field sheet. Manufacturers require patches to be performed using the field sheet for longevity reasons. The flashing material when used as patches may tend to peel or lift over time. The large area of patches should be overlaid with new field sheet to; meet warranty requirements, repair any other holes that might have been missed and cover over patches that might lift.

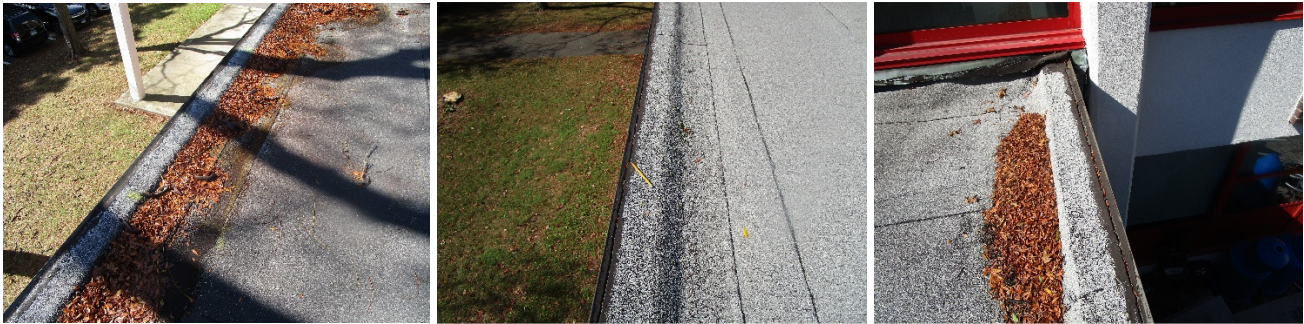
The perimeter membrane is aging, and the surface has minor cracks but that may not be causing the water infiltration. The laps should be checked, but the joint where the membrane meets the metal edging may be the source of the water leaks.

The joint between the end of the membrane and the edging is cracking and opening. This may be letting water into the system. The whole perimeter of this roof should be cleaned of debris and the cracked joint patched and filled with a liquid bitumen resin flashing membrane (Firestone Ultraflash).

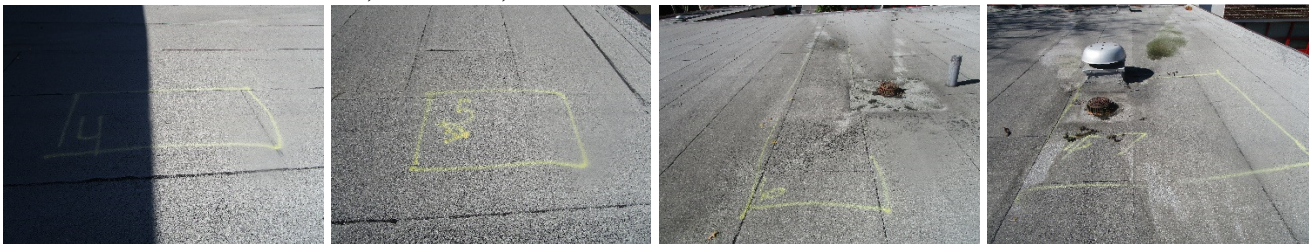
Some of the wet areas like 4, 5 6 and 7, fall with the field of the roof.

No obvious cause of the wetness is found, but, after replacing the wet areas, the laps and cracks in the surrounding membrane need to be checked and repaired as necessary.

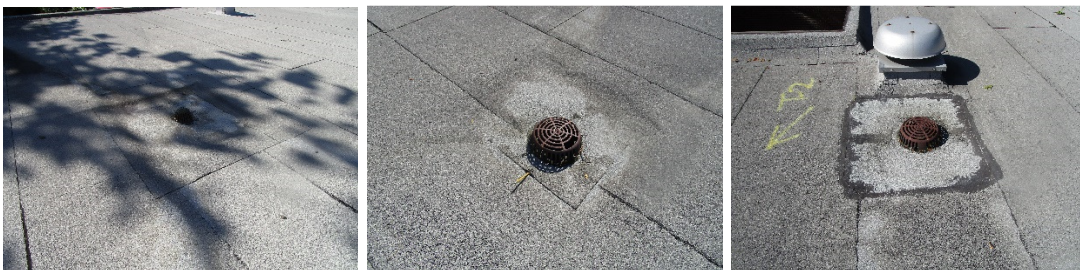
Areas 6 and 7 also fall near or around roof drains.

The membrane blow out patches and/or stripping around the blow out patches are loose at some of the roof drains. All drain flashing needs to be checked and resealed or stripped with Ultraflash and reinforcing fleece as needed.

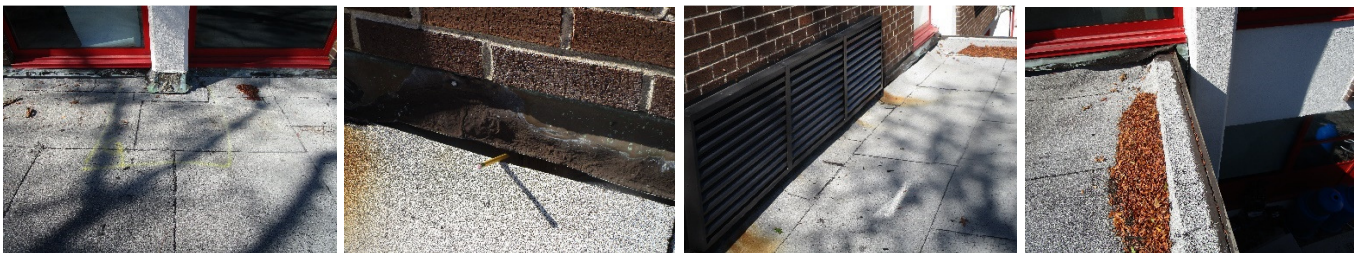
A problem area exists where the roof on either side of the courtyard meets the higher wall of the long building.

The membrane flashing is very low on these two walls. We were able to reach under the metal counterflashing and feel that the membrane had fallen back behind the cant strip. It is no longer adhered to the wall. This area is now open and can let water in, especially if snow builds up against the walls. In addition, the flashing at the windows, louvers and piers needs to be checked and repaired as needed. Wet area #9 lies against one of these locations.

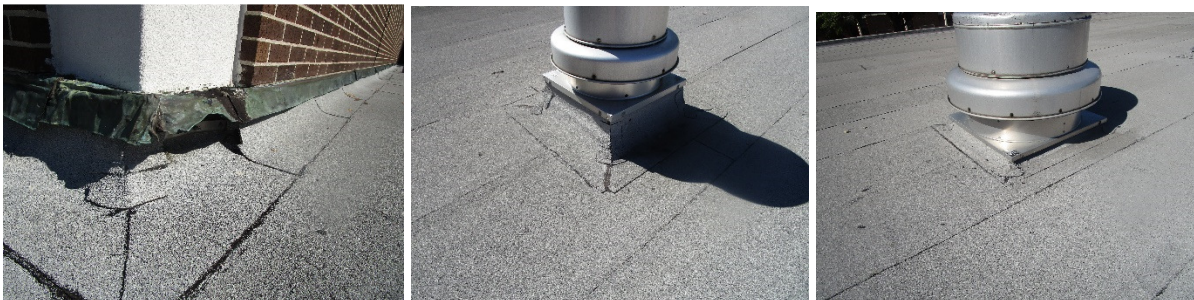
The Firestone roof also needs general maintenance and patching at curbs and corners.

All of the corners, both on walls and at curbs must be checked to see if they are starting to open. If they are, they need to be properly patched before leaks develop. Some of the curbs are very low. Particular attention should be paid to these curbs and their difficult flashing conditions.

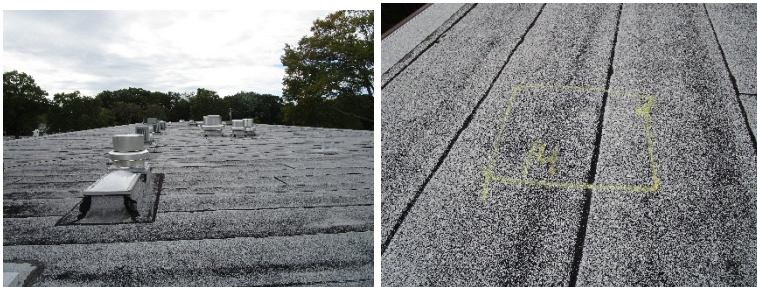
The Upper JM Modified Bitumen roof was installed in 2004 and has an active 20-year warranty. Only one small wet area #14, was found on this roof. (The infra-red scan drawing has this as #13. On the roof both the connector and this area are labeled #14)

leak area "14"

We are not sure what is causing this leak, but as with the Firestone roof, the laps, flashings, etc., need to be checked, and general maintenance needs to be performed.

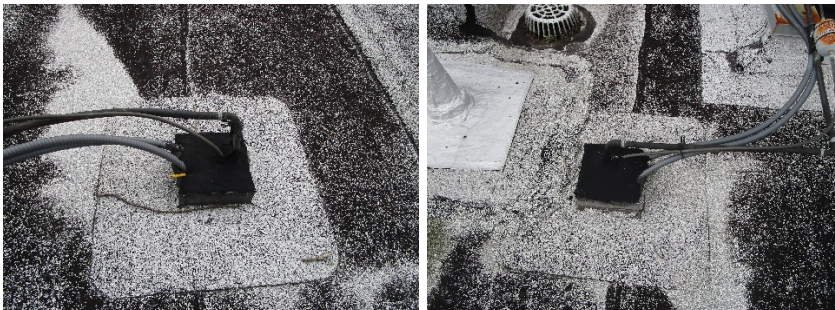
Penetration pockets on this roof level need to be checked and filled.

Voids or shrinkage in the filler can lead to water infiltration.

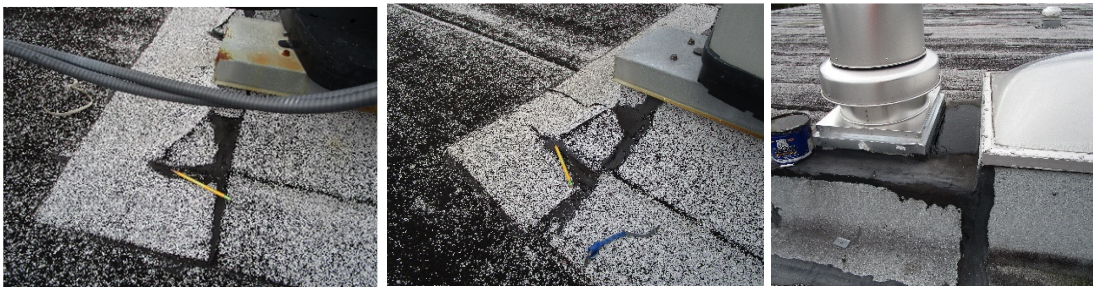
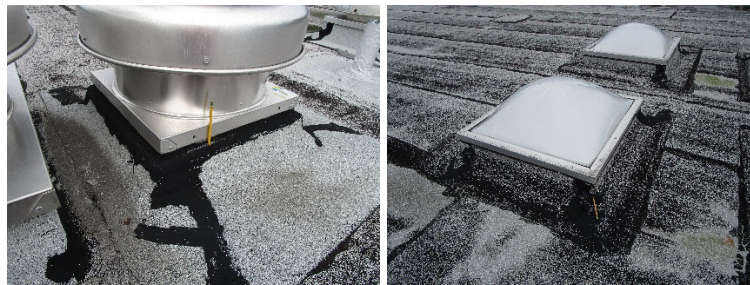
Curb flashing is starting to open and needs to be repaired.

Many of the corners on the fan curbs, skylight and vent curbs are starting to shrink and open. In addition, it looks like some of the “newer” curbs have no counter flashing and the top of the membrane is open or were sealed with a coating. These should be properly flashed/counter flashed and brought up to the warranty requirements.

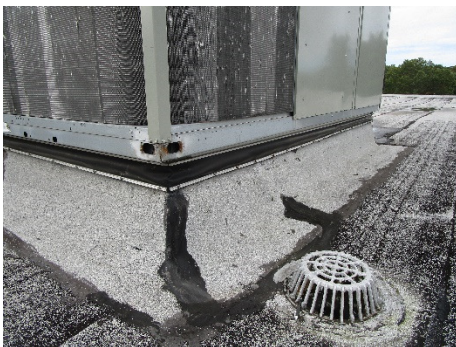
One of the HVAC curbs needs counterflashing.

The top of the base flashing on this curb is only nailed, no termination bar or counterflashing is present. The nails can not only loosen and rust, but the top edge of the flashing is vulnerable. A termination bar and/or a counterflashing should be installed to protect and secure the top edge of the base flashing.

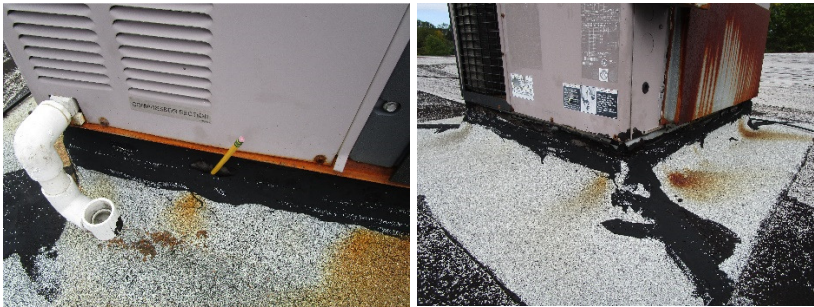
Problems also are present at the base flashing of one of the older HVAC units.

This curb is not properly flashed. The top of the membrane is open and the roofing cement that was used to seal the flashing to the curb has dried and has shrunk. The flashing should be properly sealed to the curb and a counterflashing installed if possible.

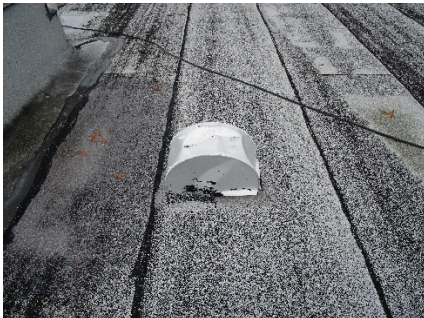
There is a gooseneck on the roof that should be replaced.

This gooseneck is dented and returns very close to the roof membrane. It should be removed and a new gooseneck that has the venting end higher off the roof should be installed.

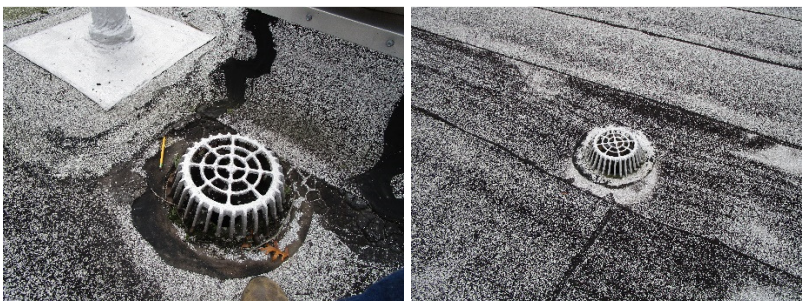
Drain flashings need to be checked.

Openings in the flashings were found at some of the drain. These need to be repaired.

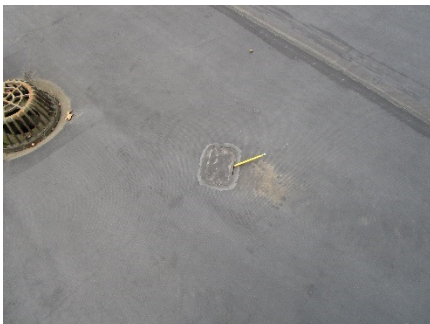
Patches have been applied to the roof.

Some patches have been applied to the roof membrane, most likely to repair a hole. Unfortunately, flashing material rather than cured field sheet was applied and it has started to peel. A proper repair using JM material should be applied over these patches.

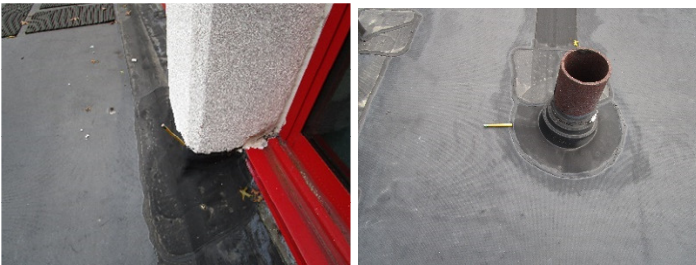
Non-terminated base flashings and penetration flashings with fishmouths are present.

We noted that some areas of wall flashing at the columns are not terminated or have opened. These areas need to be properly sealed and repaired. In addition, some fishmouths were found at pipe flashings. These must be sealed before water gets in.

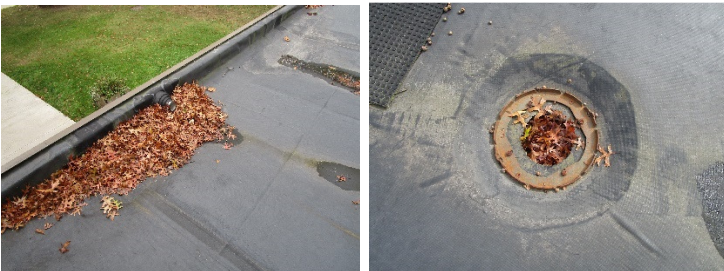
Debris needs to be removed from drains.

The roof needs to be cleaned of debris before it builds up and clogs scuppers and drains. Any missing drain baskets should be installed to prevent debris from going into and clogging pipes.

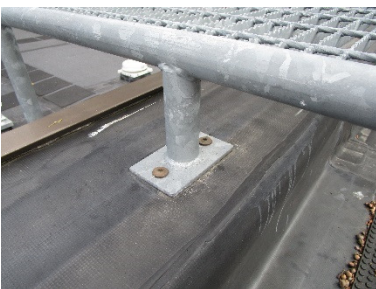
A roof ladder is present between the two levels of this roof. The ladder is bolted to the roof curb.

An access ladder was installed between the two roof levels. We cannot tell if water block was installed before the plate and fasteners were installed. As a precaution, we recommend flashing the plates and screw heads with JM materials.

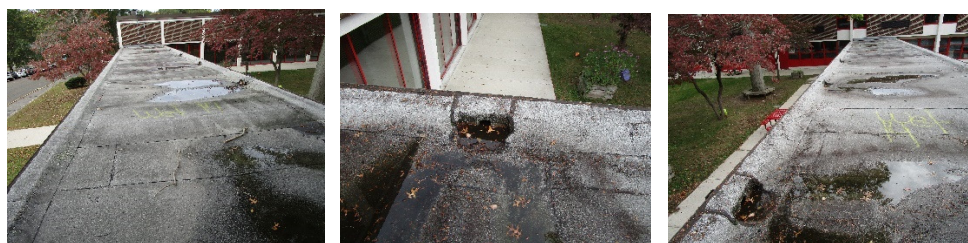
The connector is roofed with a modified bitumen roofing system. It is shown as completely wet on the infra-red scan. It is not known whether the connector roof was done in conjunction with either the JM or Firestone Modified Bitumen roofs or was a separate project. In either case, if the roof is soaked as noted in the scan report, it should be replaced. Because it is not over “occupied space”, it’s replacement may not be as important as other repair and maintenance work. Whether the roof is leaking, or the structure is showing signs of moisture infiltration may help in determining whether replacement or an attempt at repairs is undertaken. We can provide pricing for replacement upon request.
