**INFRA-RED ROOF MOISTURE ANALYSIS**

VIKING CONSTRUCTION  
 BRIDGEPORT, CT  
 STAMFORD HIGH SCHOOL  
 STAMFORD, CT

SCALE:	1/32"=1'-0"
DATE:	06-04-19
PAGE:	1 OF 1
DRAWN BY:	DMR
JOB#:	19231X19

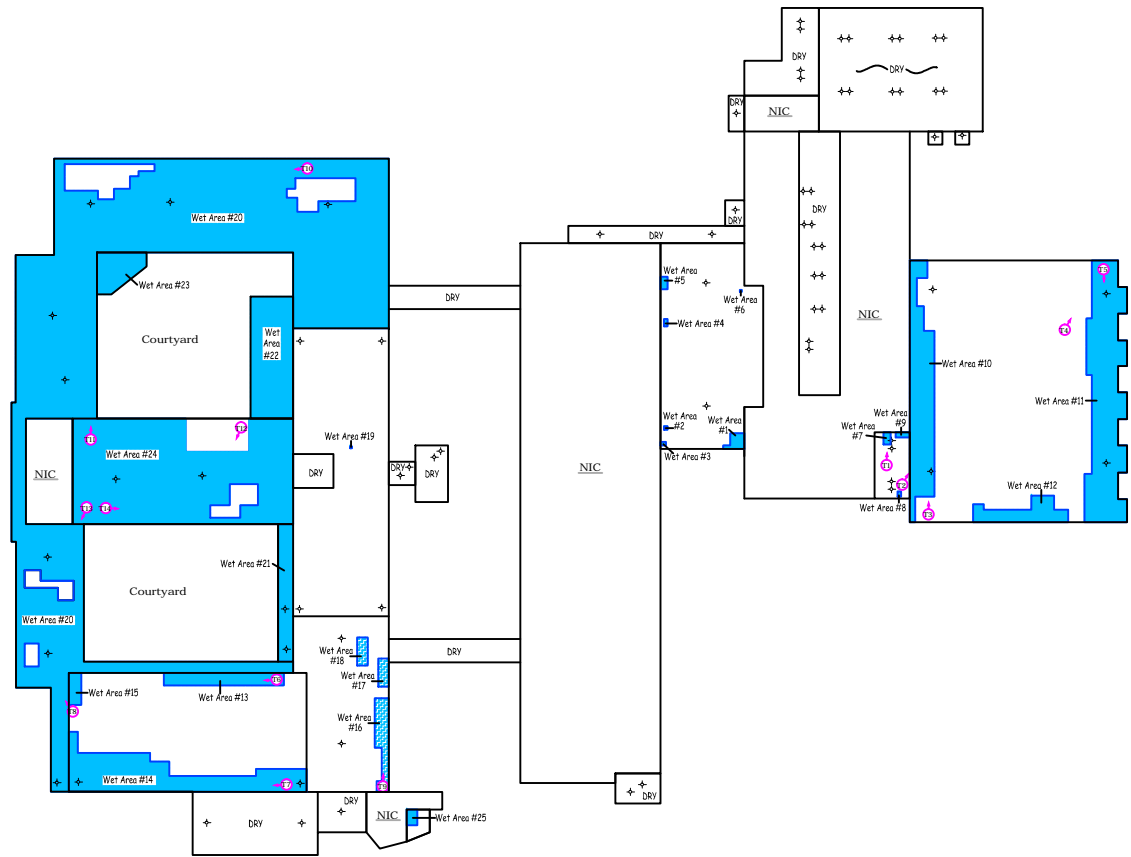
RANDOMLY INTERSPERSED MOISTURE (RIM)
-

SUSPECTED WET INSULATION

<b>Areas:</b>	Total of All Roofs	
	(in approximate square feet)	
	Square Footage of Roof Inspected:	109,153
	Square Footage of Suspected Wet Area:	15,675
	Percentage of Suspected Wet Area:	14.4%
	Square Footage of Suspected RIM Area:	534
	Percentage of Suspected RIM Area:	<1%
