Infrared Thermographic Roof Moisture Analysis

LOCATION: Stamford High School
Stamford, CT

CONDUCTED ON: June 4 & 5, 2019

IR Analyzers / Vector Mapping
65 Lyman Drive
Williston, VT 05495
(800) 879-1964

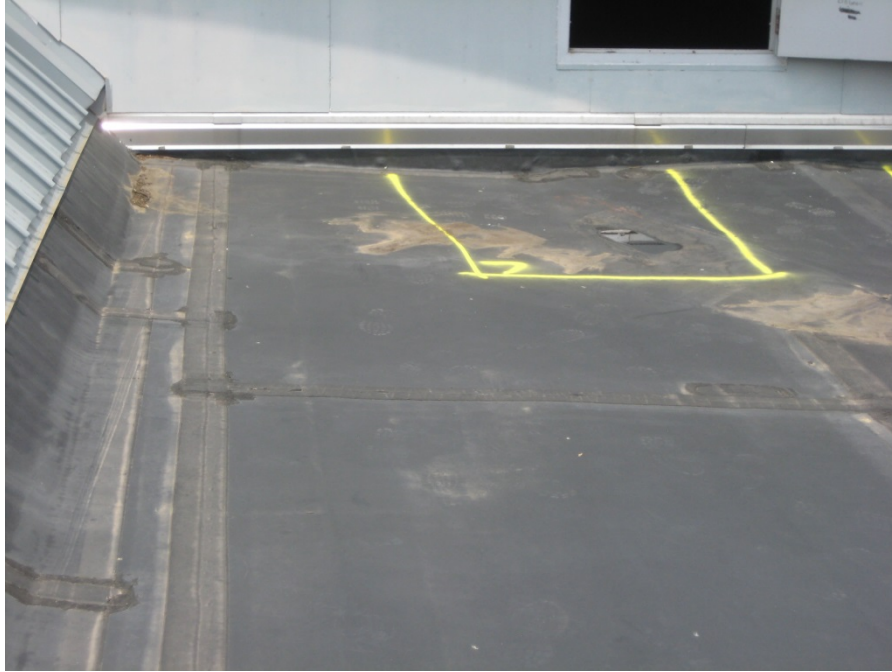
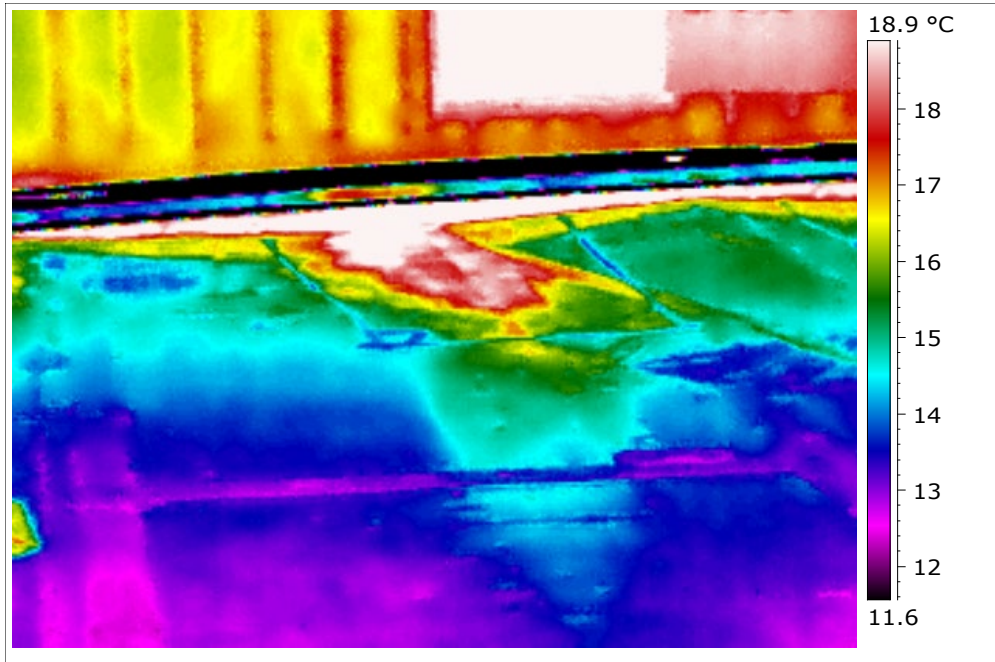
Thermogram # 1

Wet Area #7

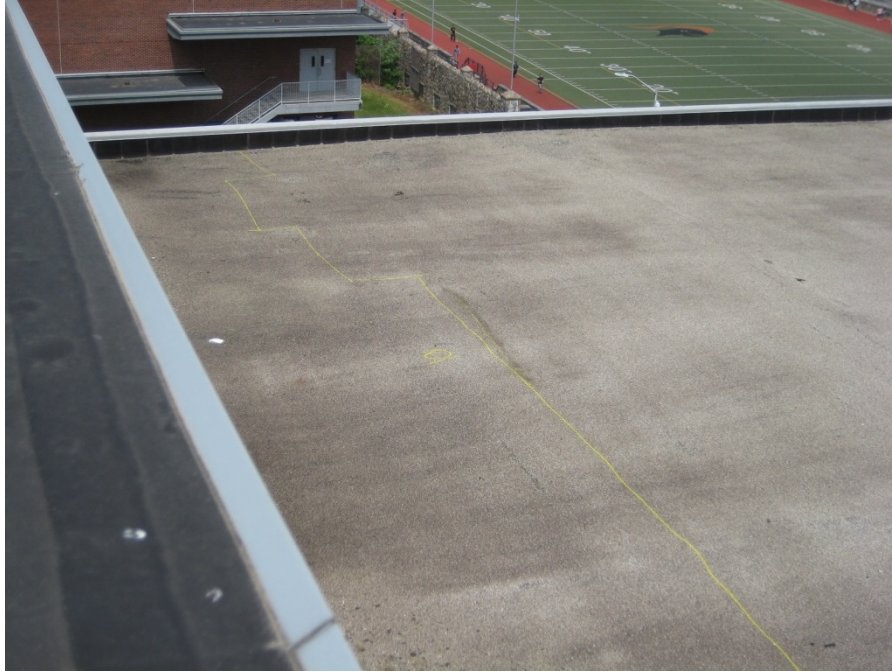
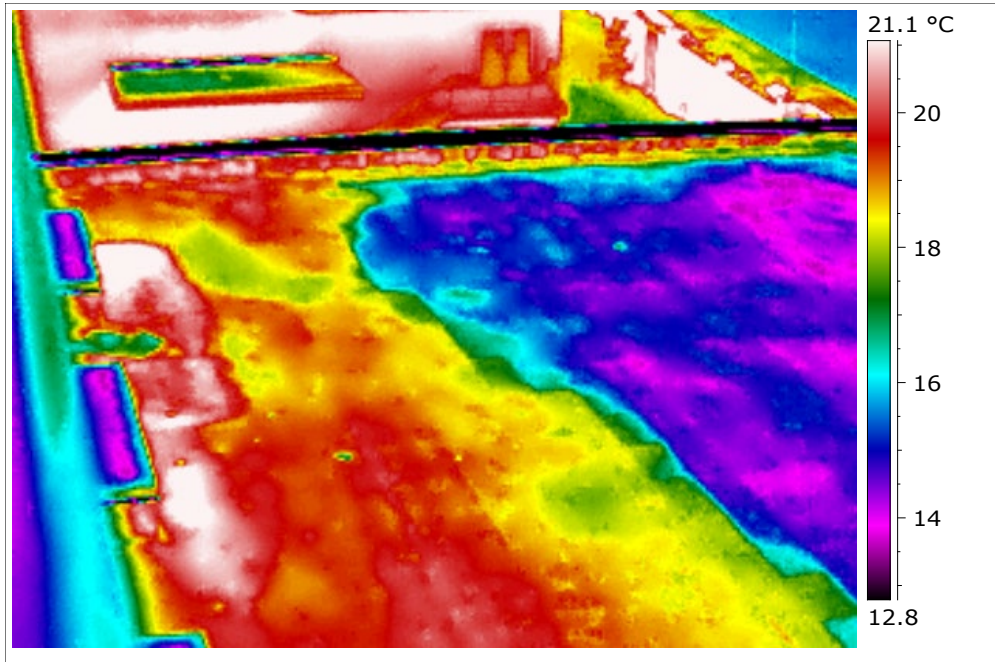
Thermogram # 2

Wet Area #10

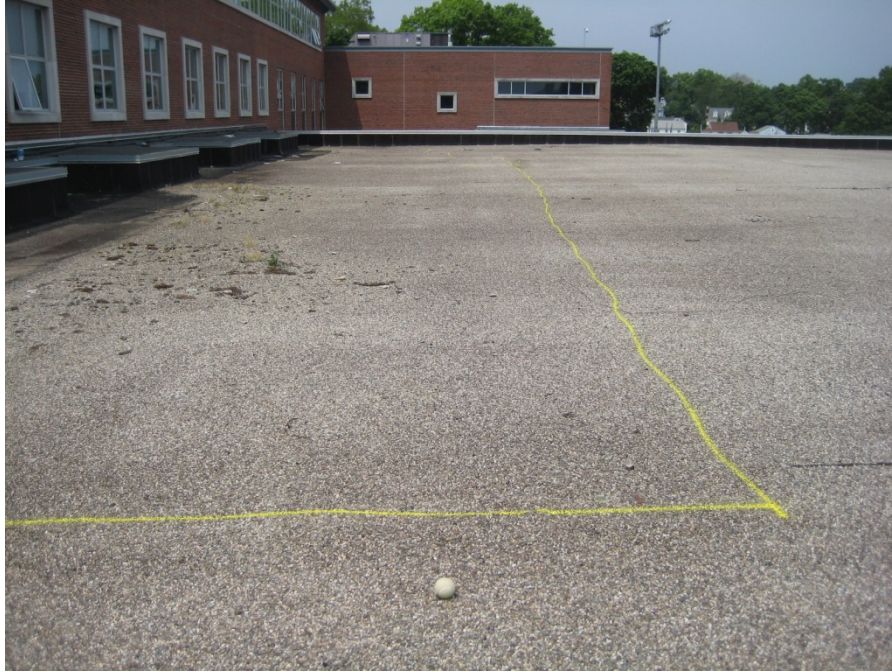
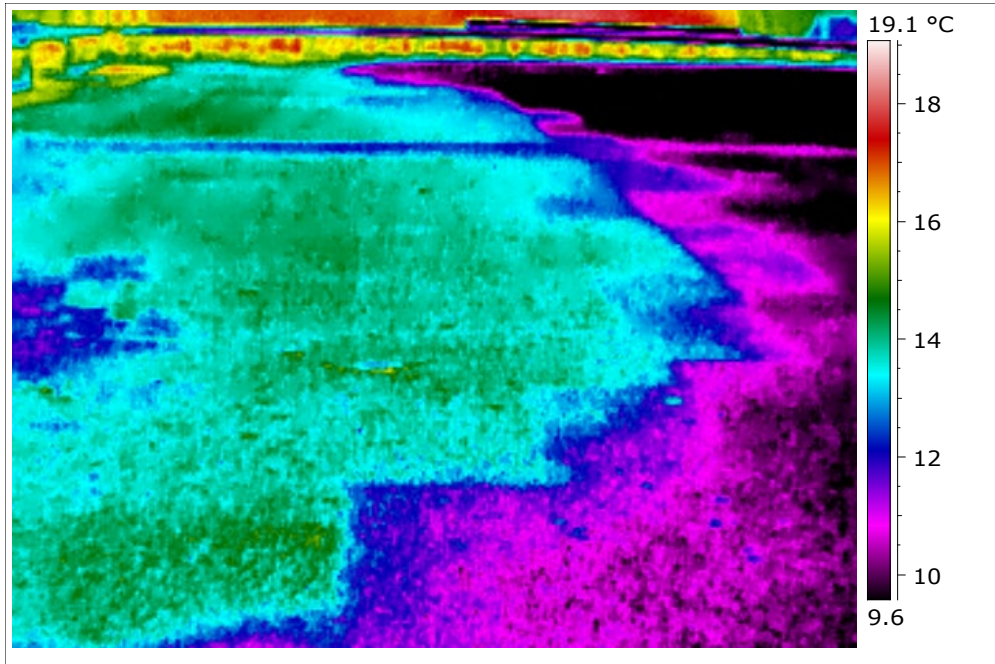
Thermogram # 3

Wet Area #10

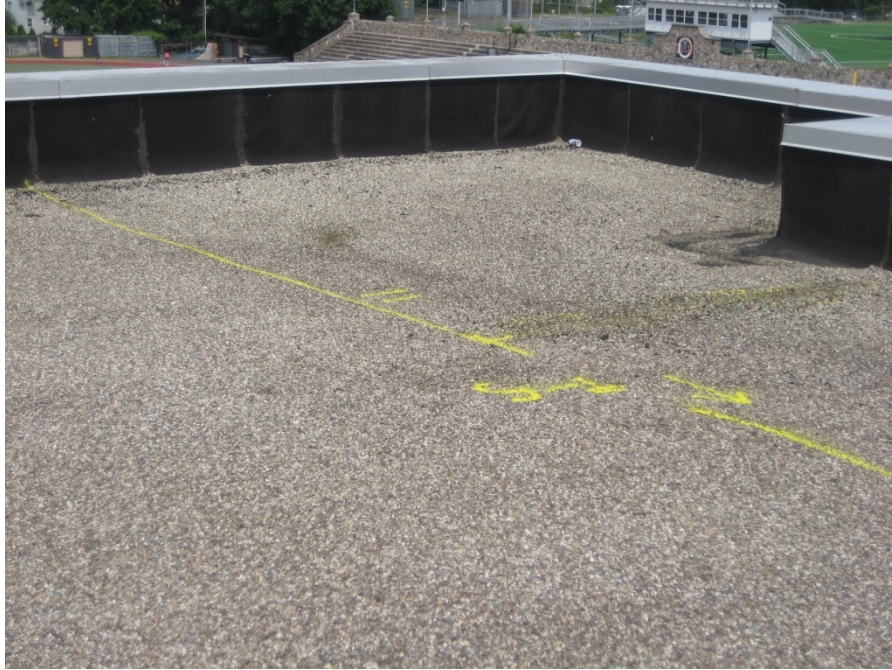
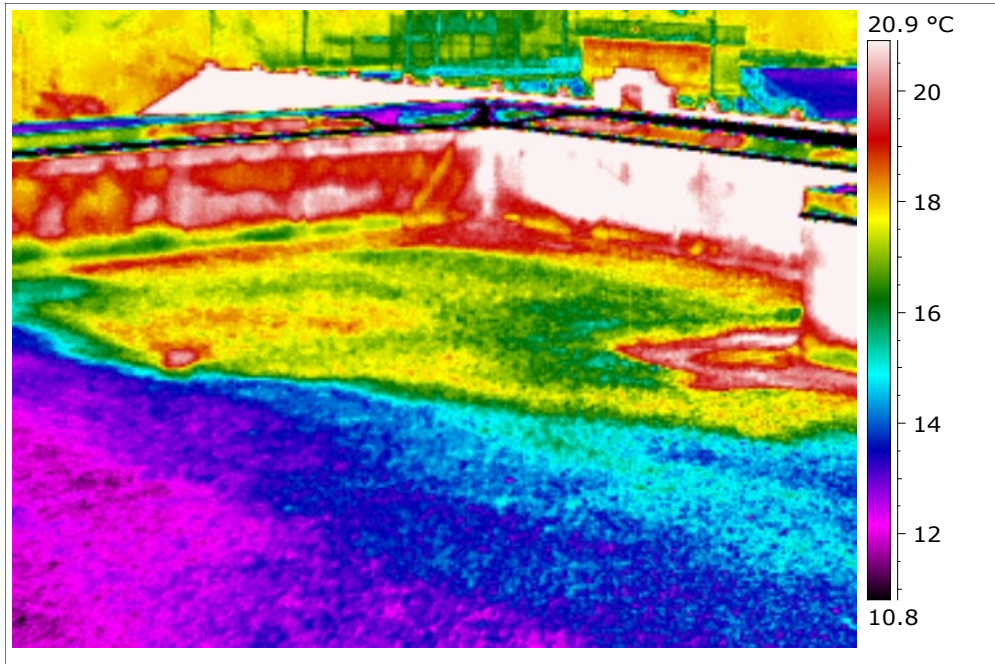
Thermogram # 4

Wet Area #11

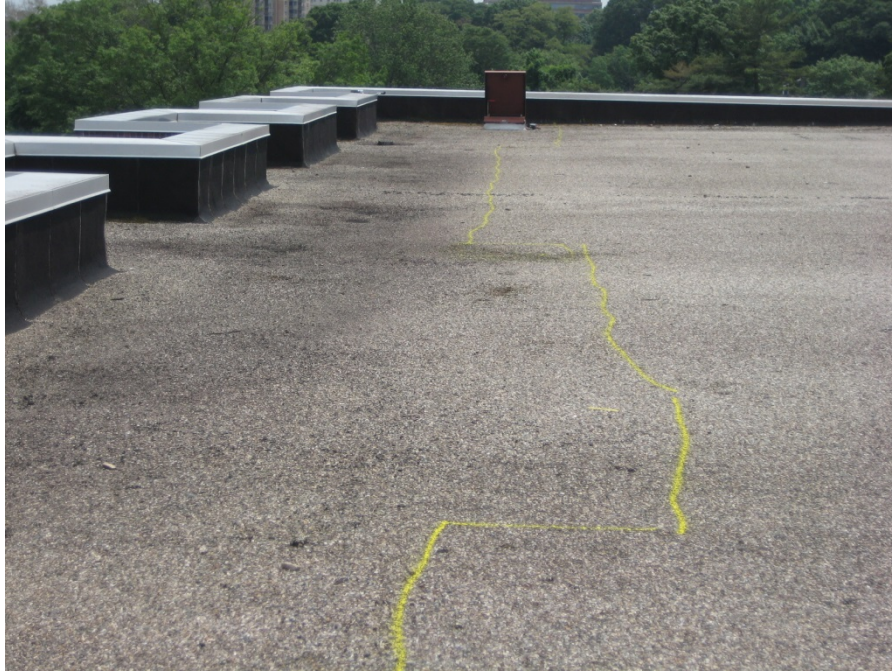
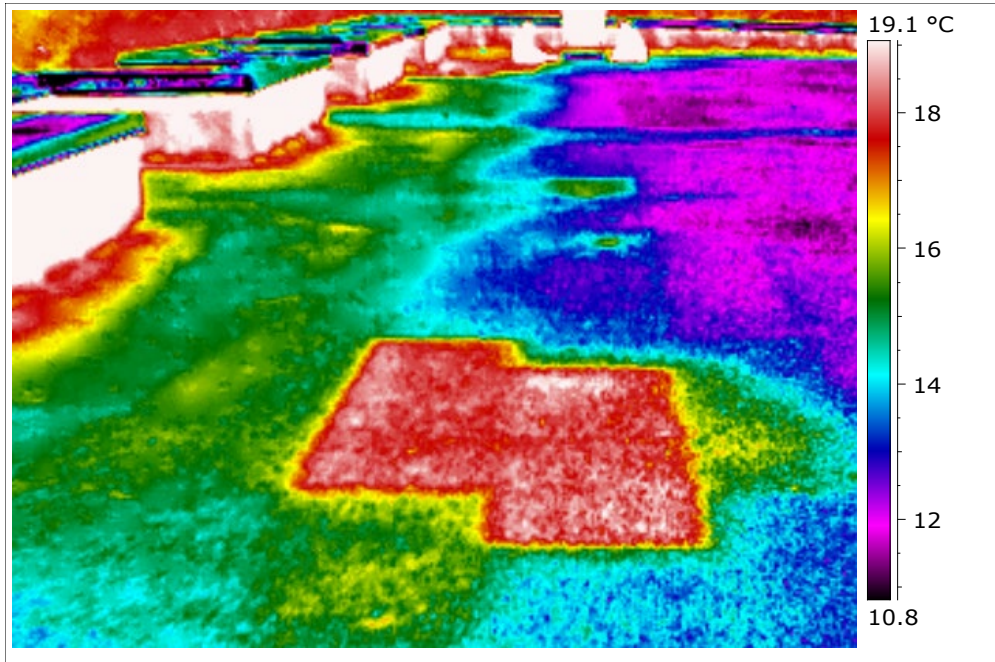
Thermogram # 5

Wet Area #11

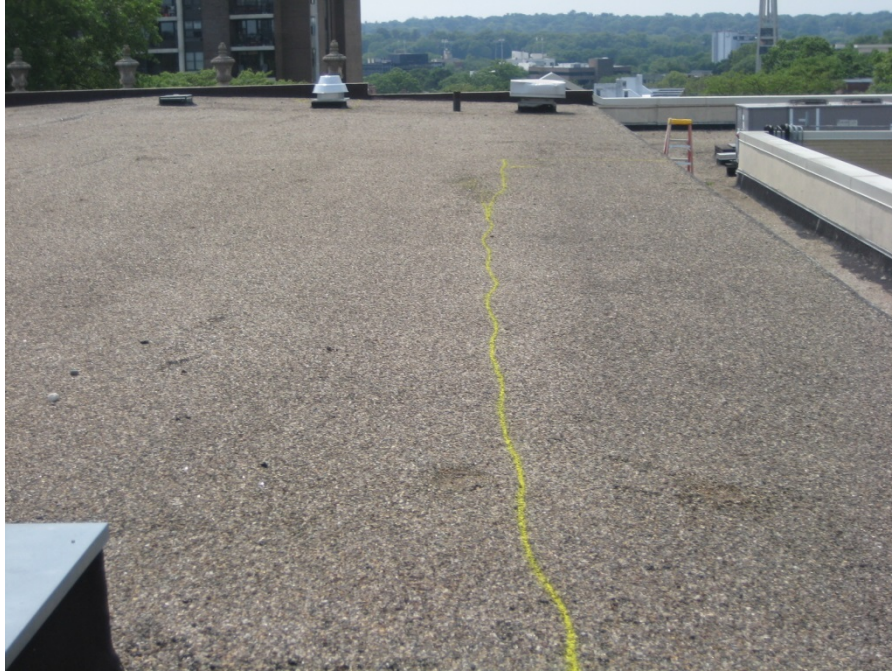
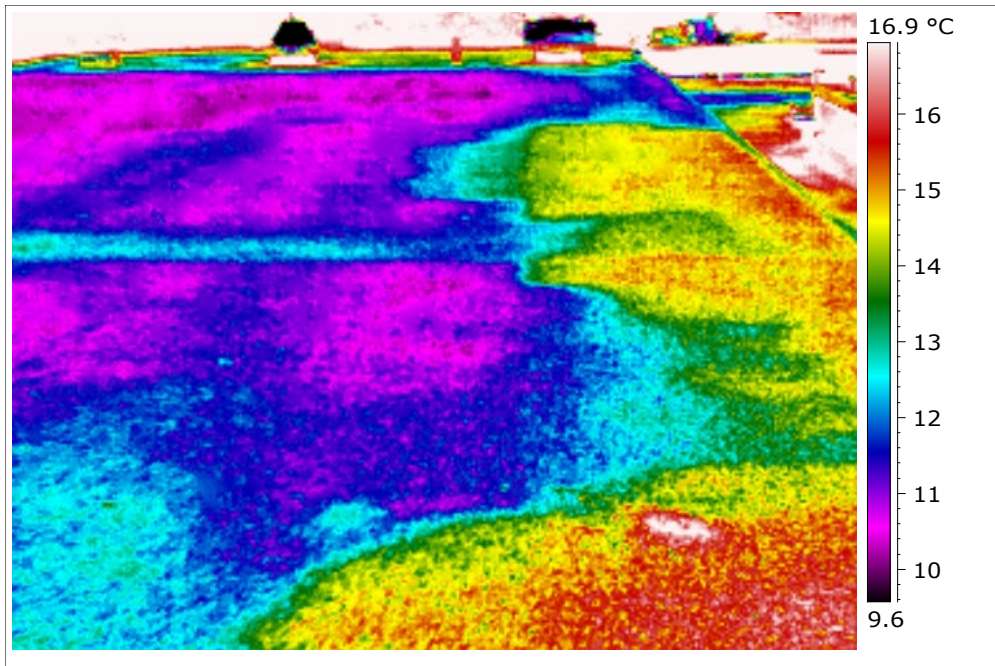
Thermogram # 6

Wet Area #13

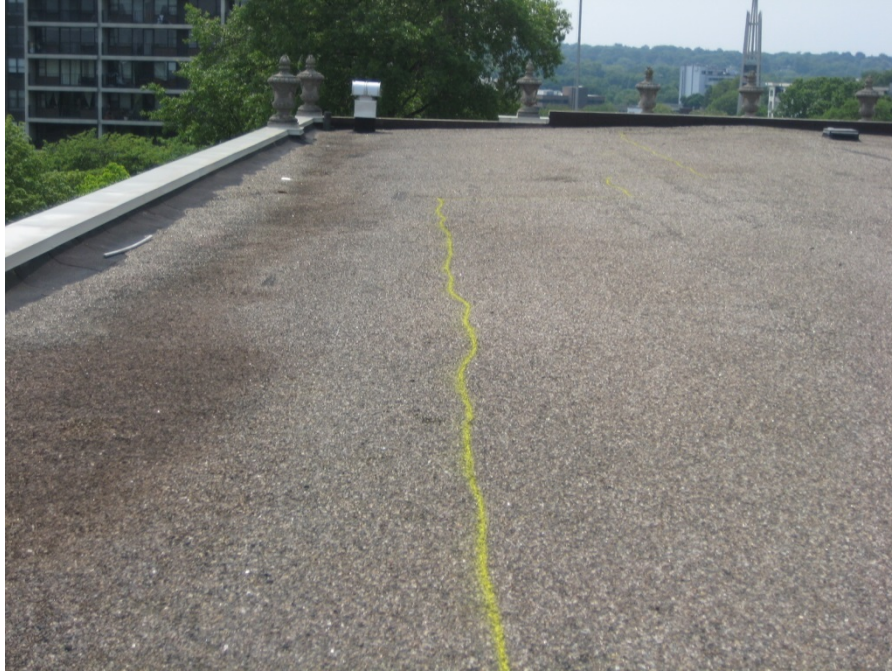
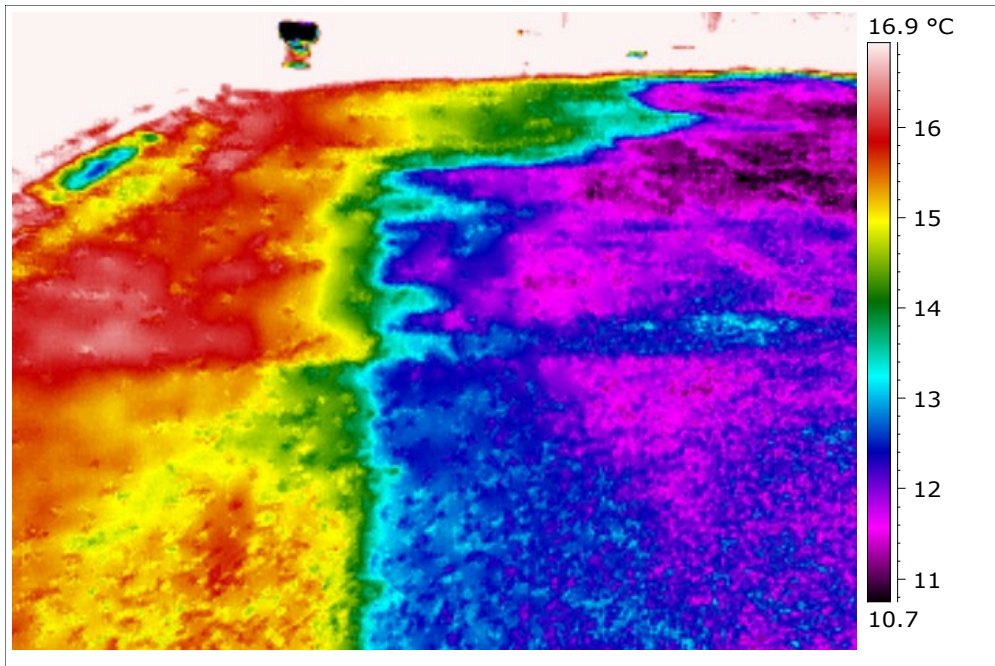
Thermogram # 7

Wet Area #14

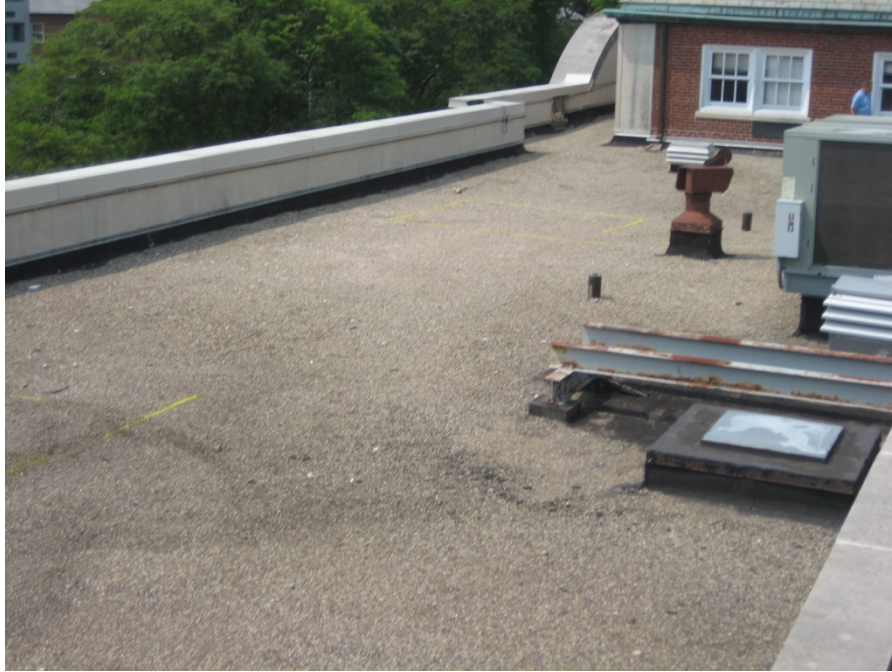
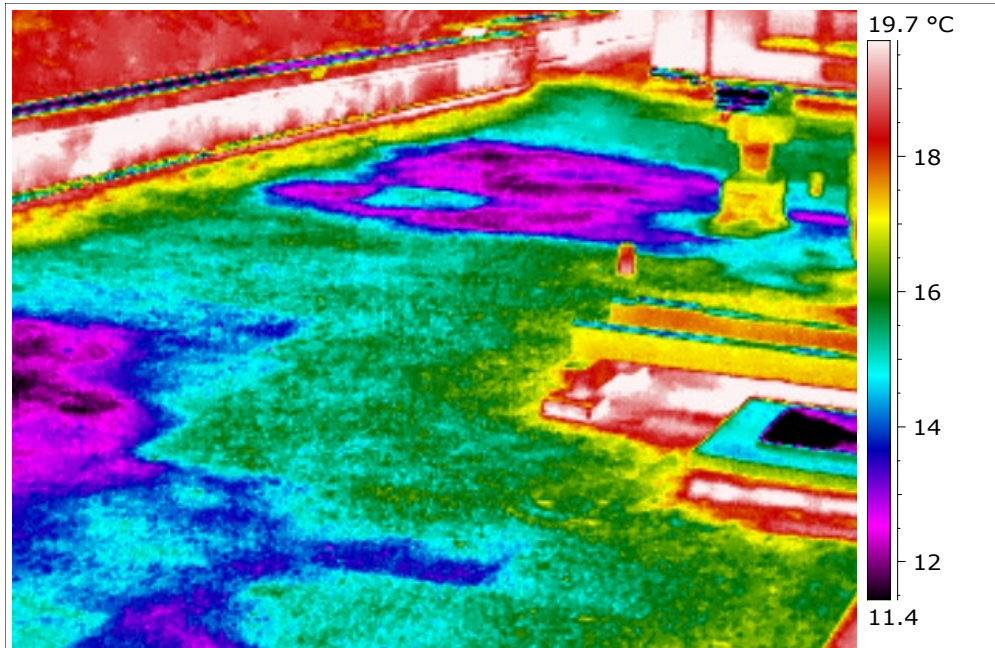
Thermogram # 8

Wet Area #20

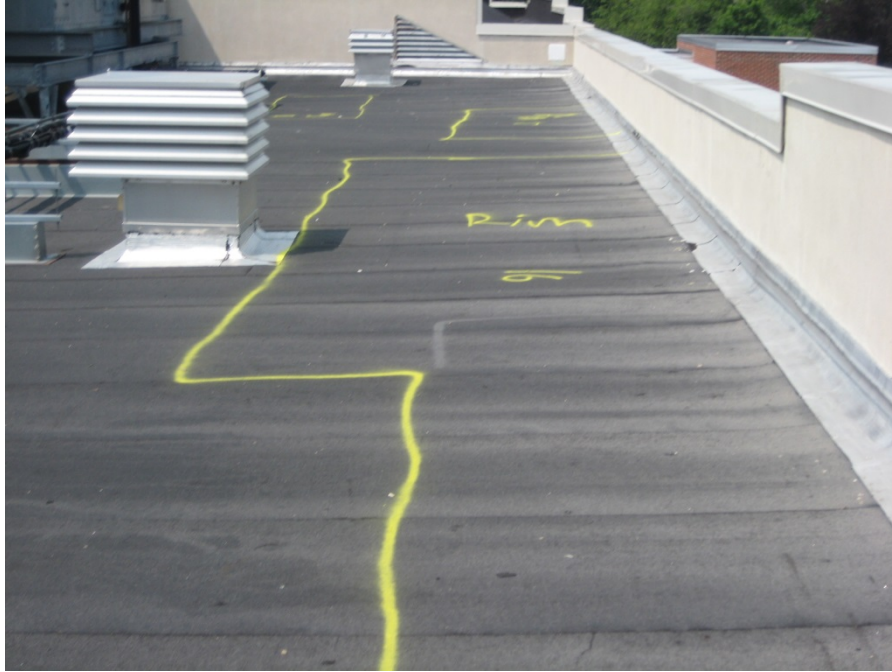
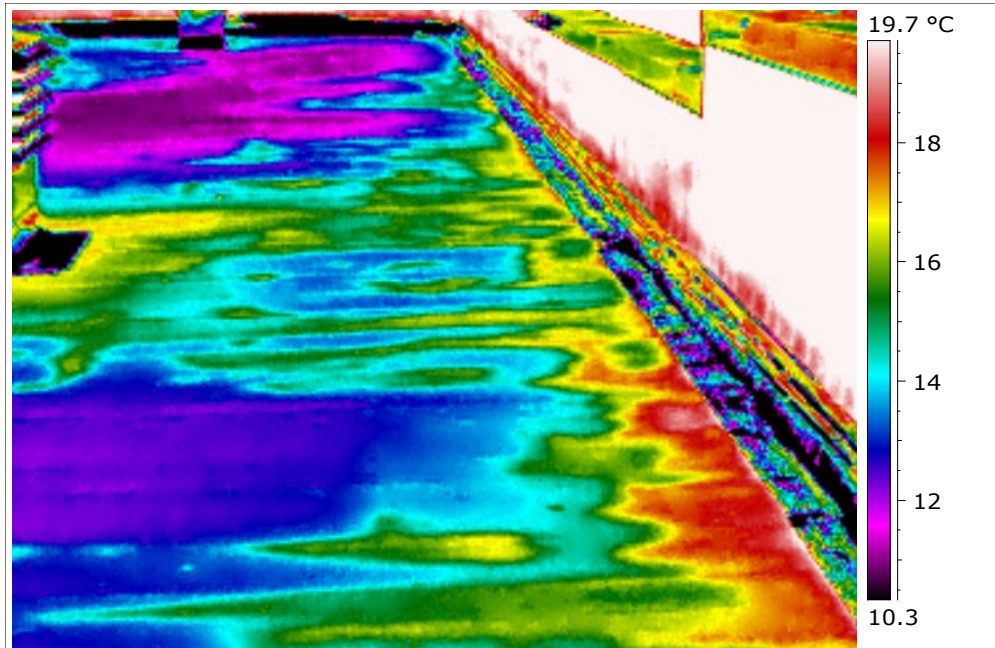
Thermogram # 9

Wet Area #16

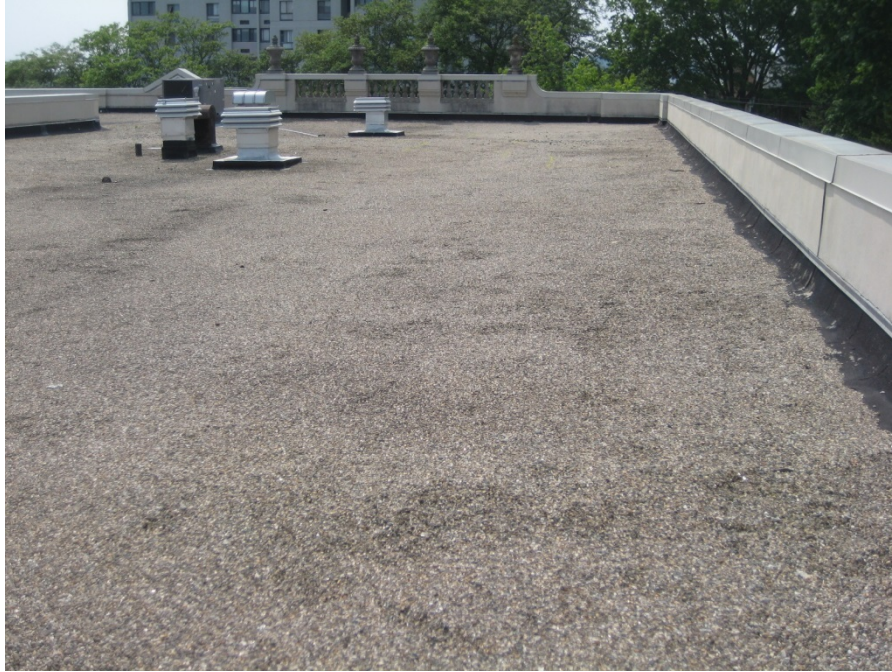
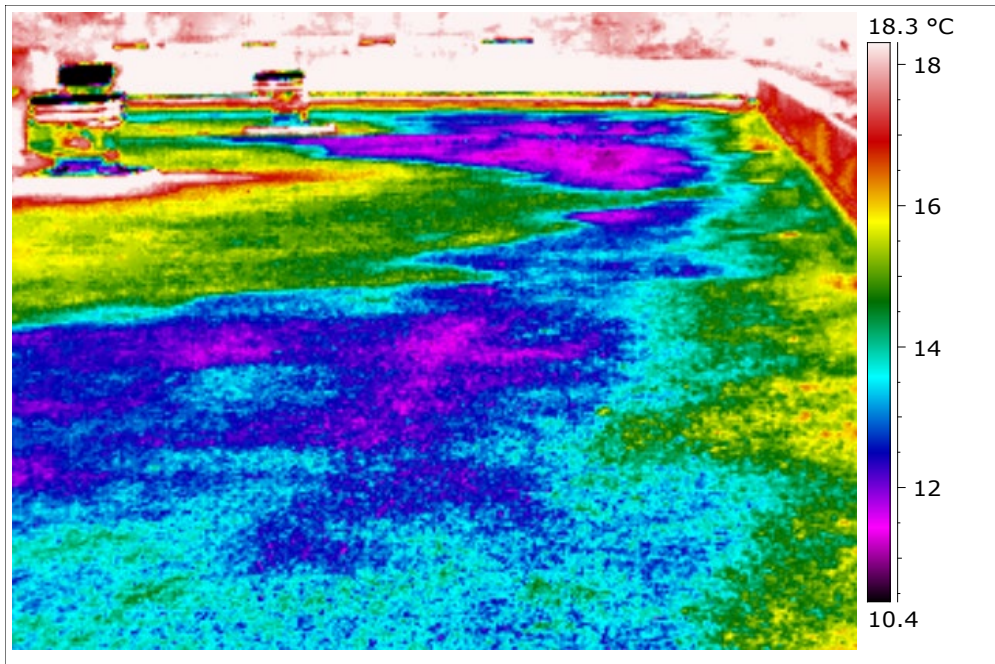
Thermogram # 10

Wet Area #20

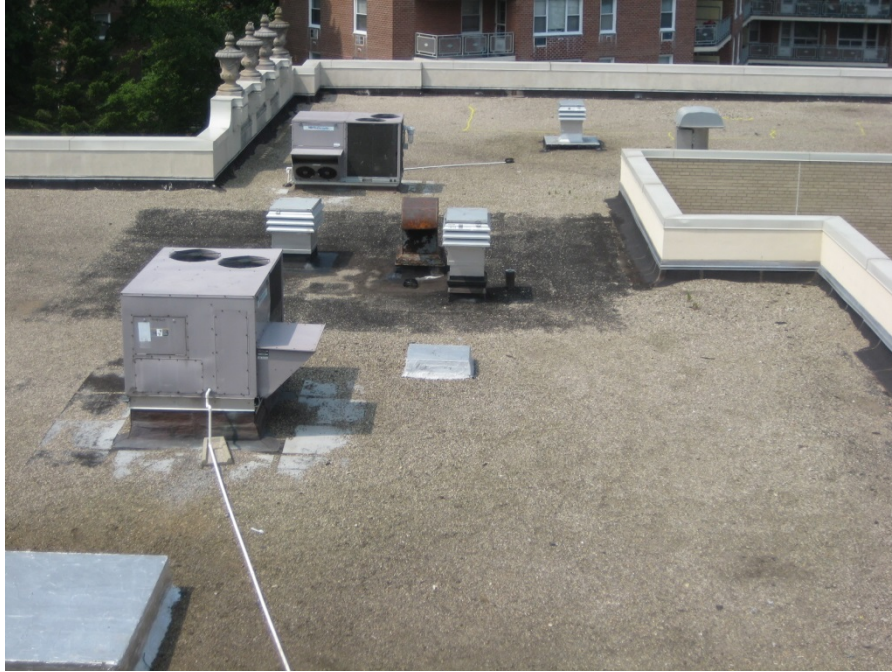
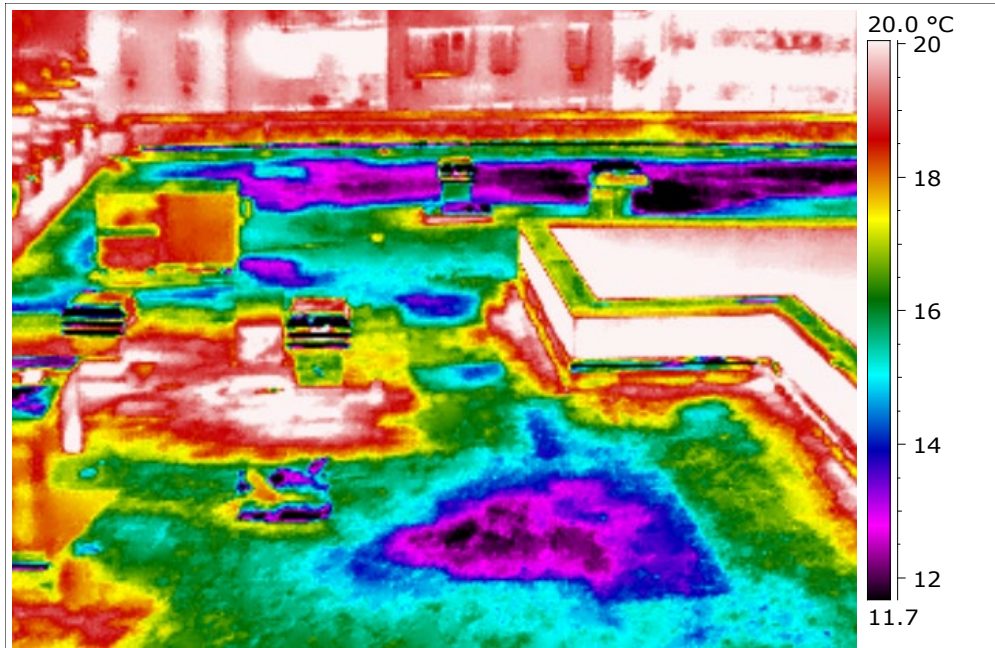
Thermogram # 11

Wet Area #20

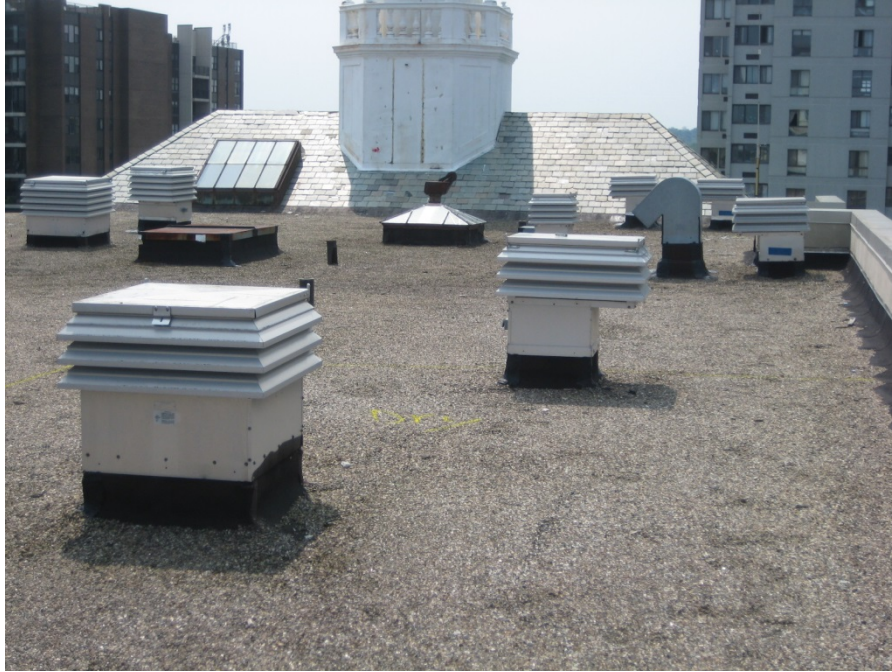
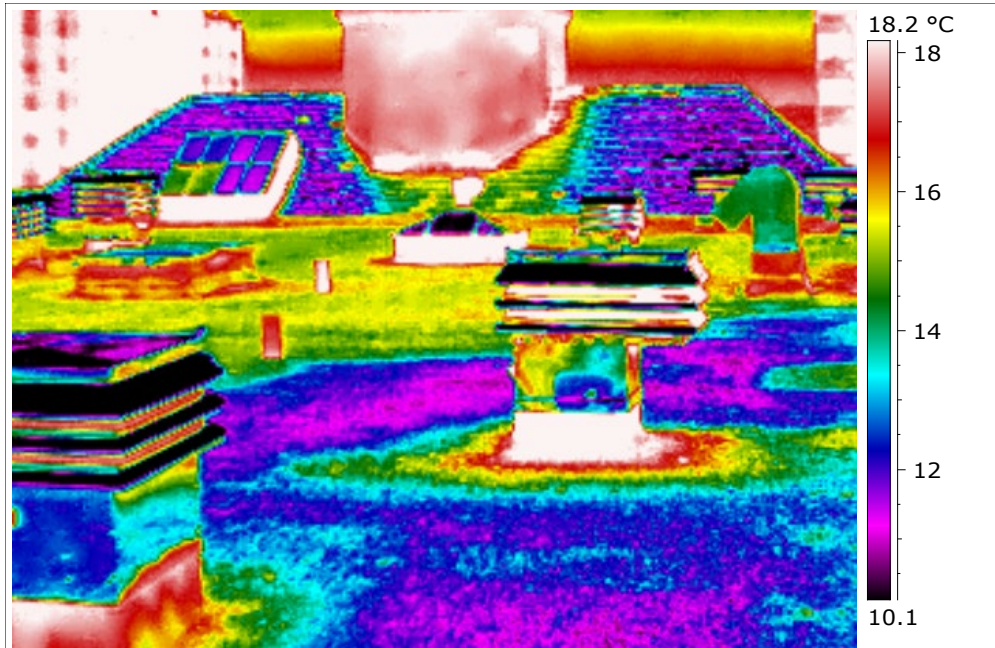
Thermogram # 12

Wet Area #24

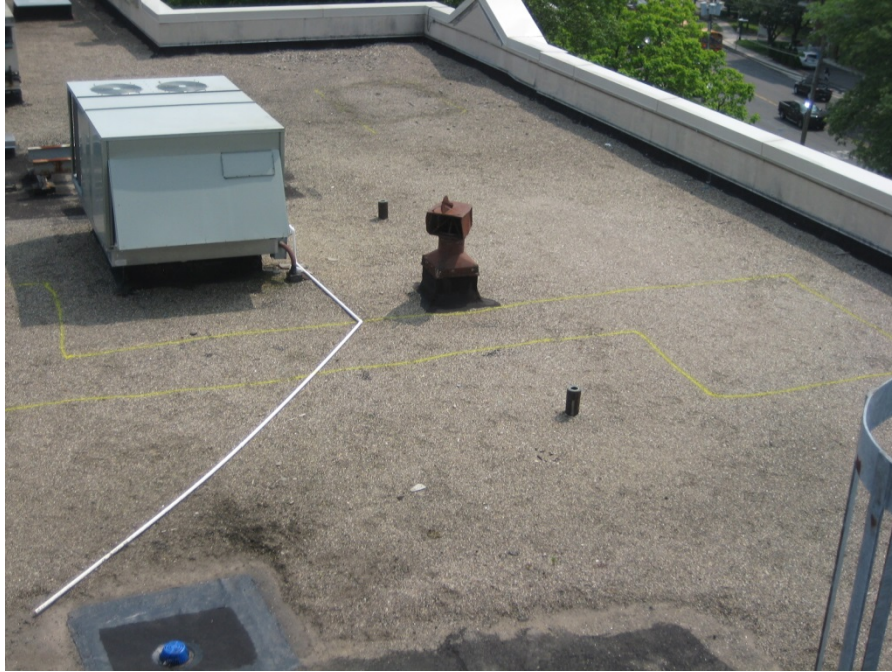
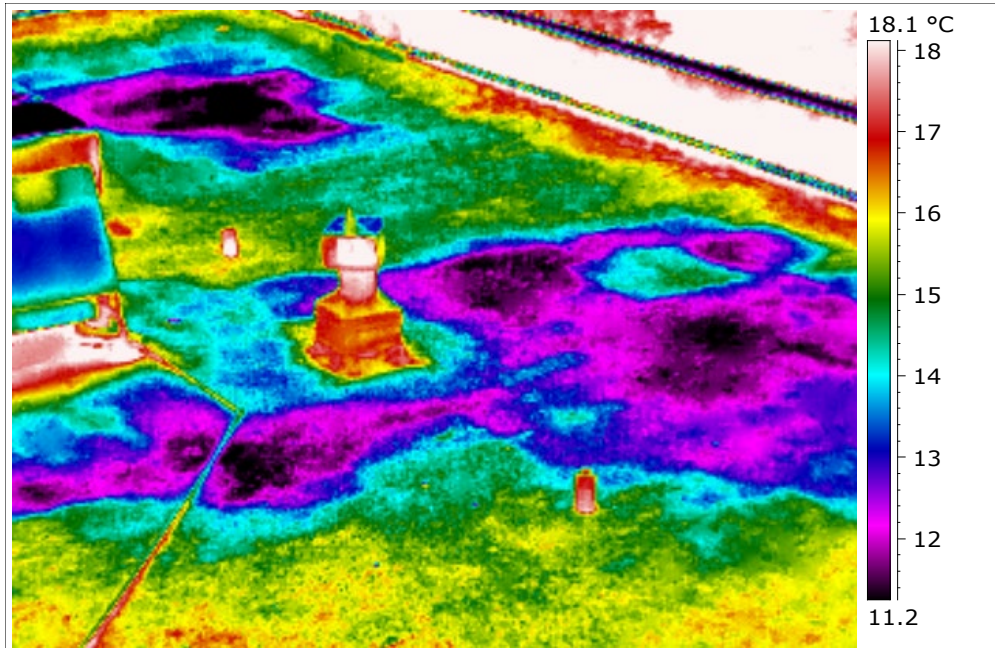
Thermogram # 13

Wet Area #20

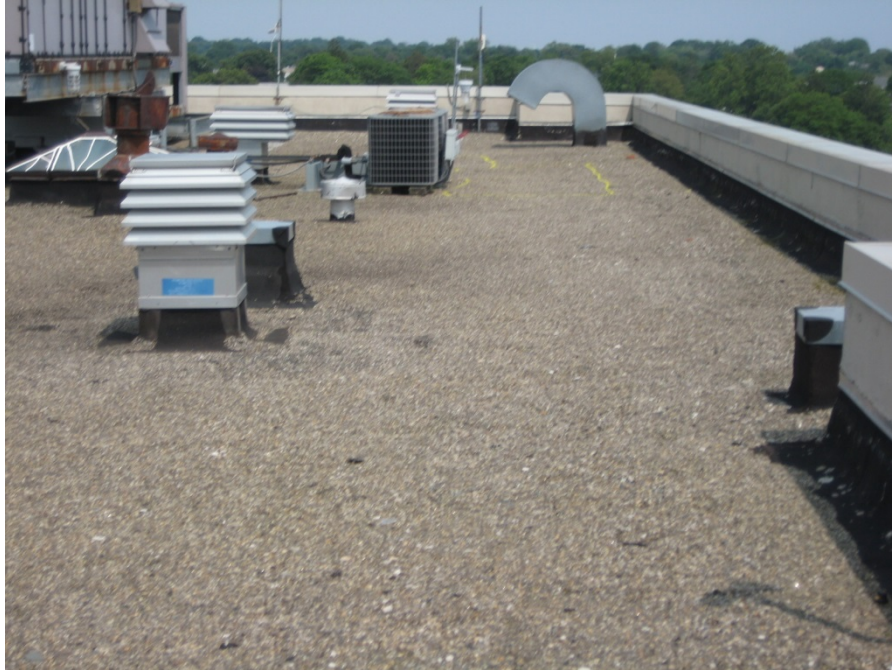
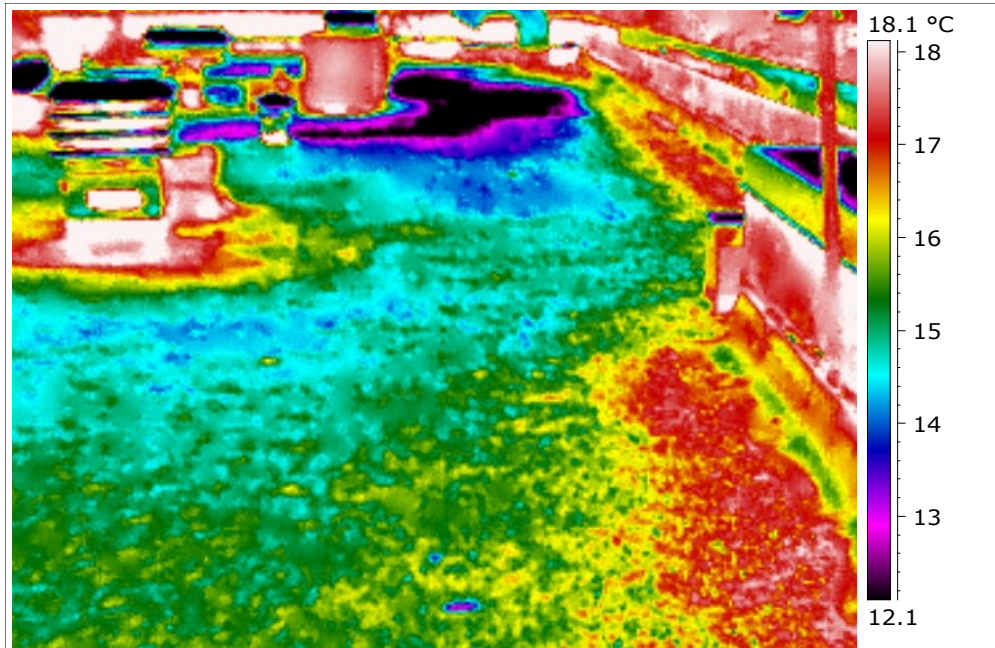
Thermogram # 14

Wet Area #24
