FACILITIES NEEDS ASSESSMENT

STAMFORD HIGH SCHOOL

55 Strawberry Hill Avenue
Stamford, Connecticut 06902

EMG Project #: 88166.09R-021.017
Date of Report: August 30, 2009
On site Date: April 8 - 10, 13, 2009

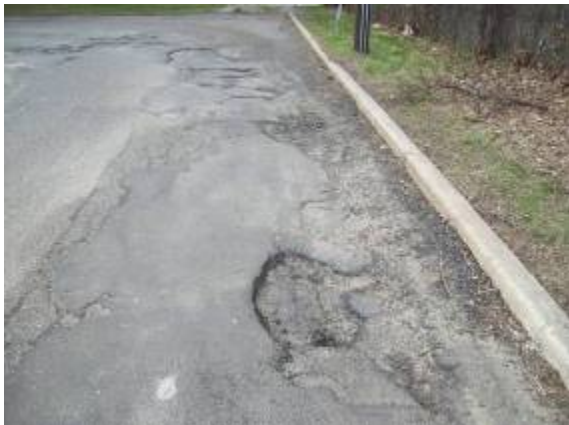
Photo #11: Typical asphalt damage

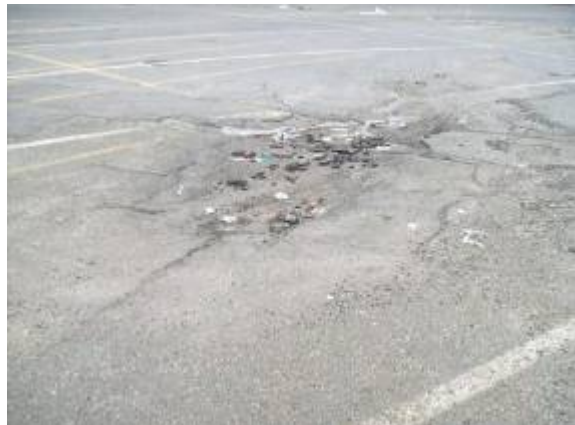
Photo #12: Typical asphalt damage

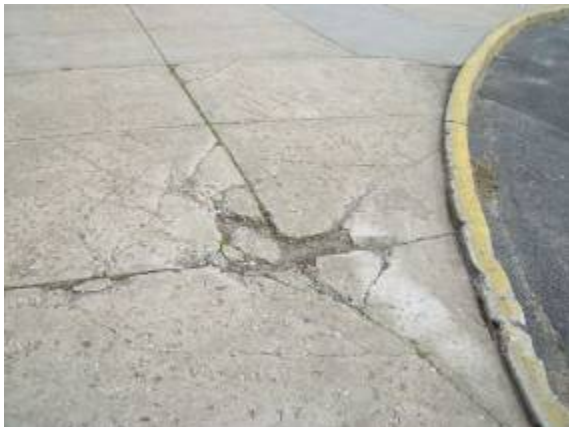
Photo #16:	Sidewalk damage near gymnasium
------------	--------------------------------

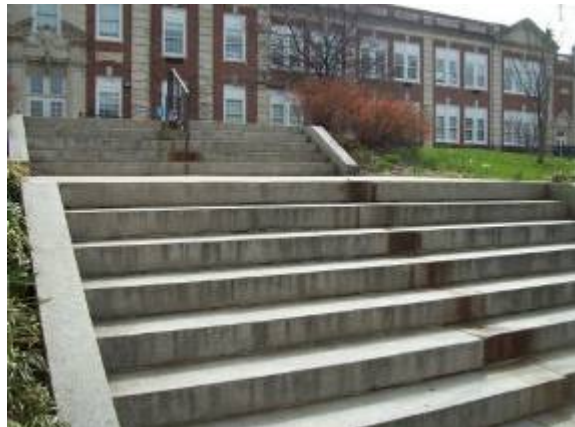
Photo #17:	Sidewalk damage near gymnasium entrance
------------	---

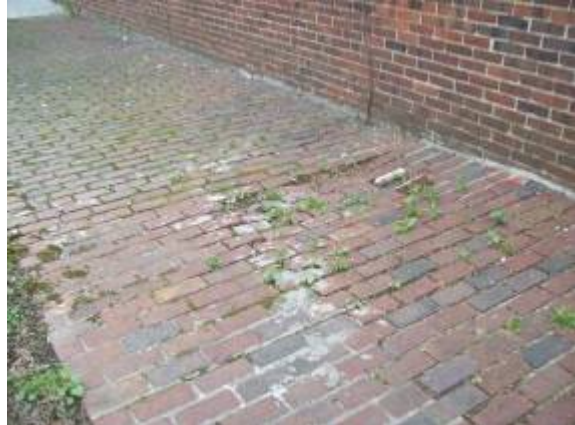
Photo #20: Damaged brick pavers

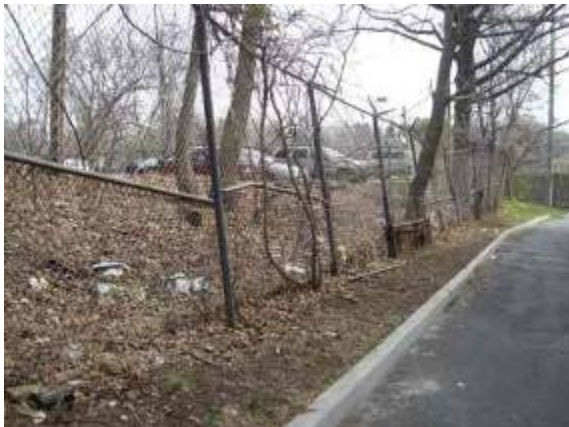
Photo #34: Damaged fencing in student parking lot

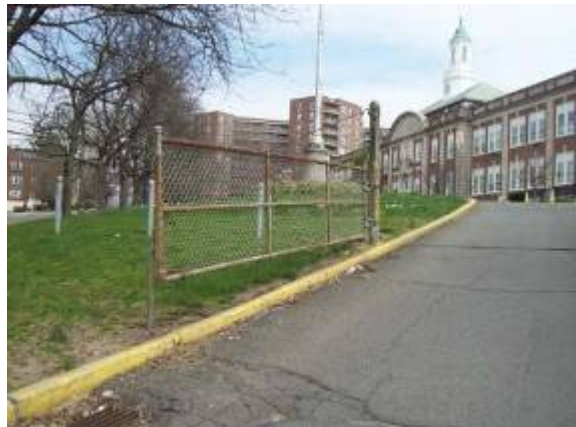
Photo #35: Damaged fencing along north property line

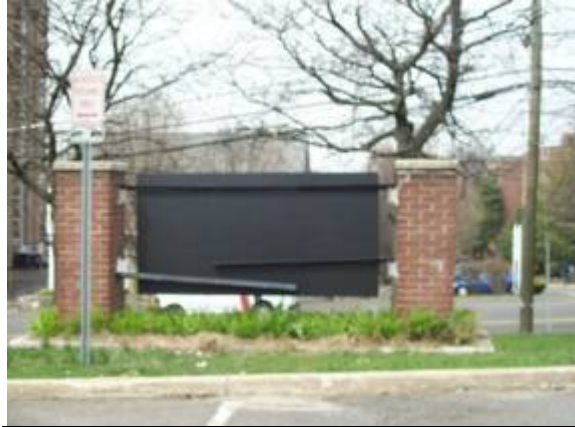
Photo #38:	Minor damage to signage
------------	-------------------------
