Initial Assessment—Photographic Log

Client: City of Stamford Mold Task Force

Job Number: S-2087-033

Site: Arts Program—Rise

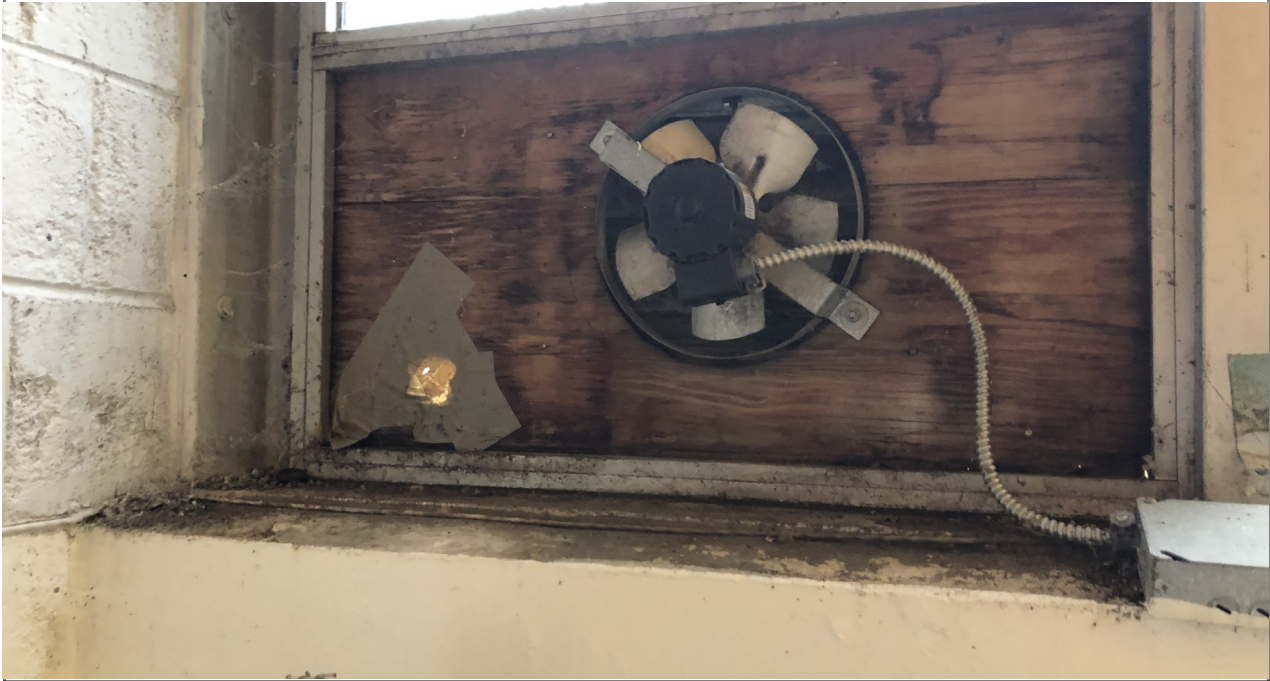
Photograph No.: 5	Date: 11/15/18	Direction Taken: —
Description: Black Mold Growth on Plywood—Alternative Room

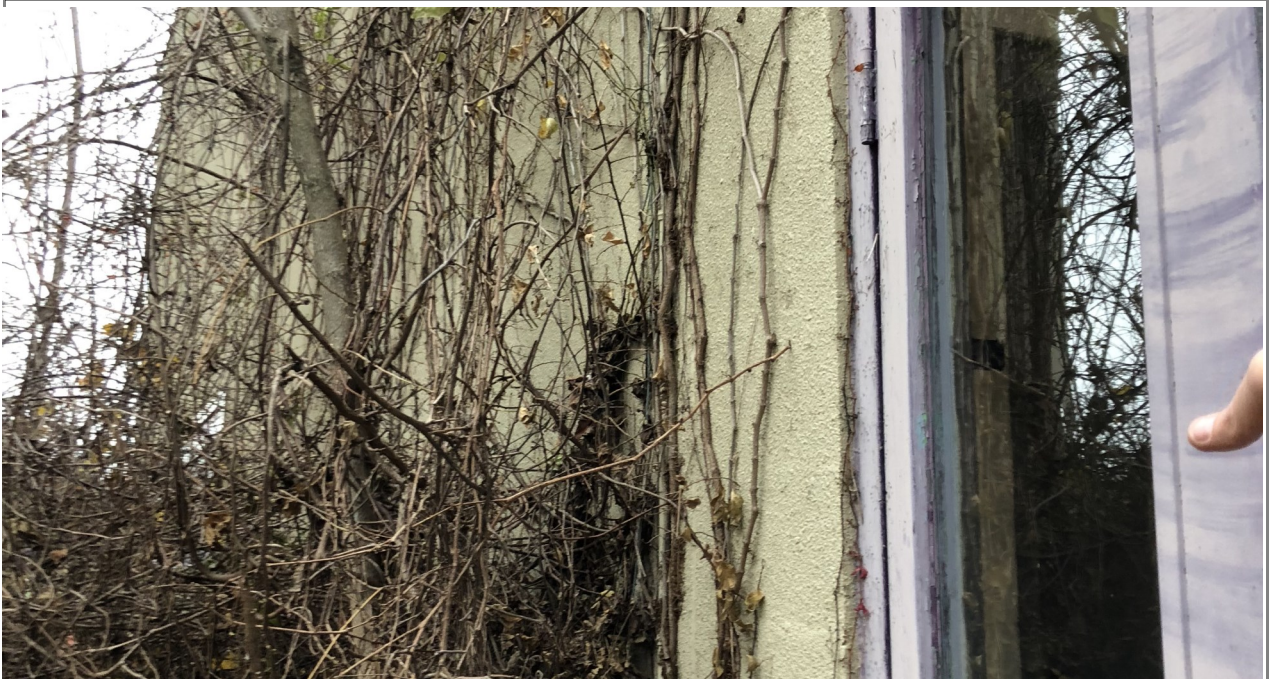
Photograph No.: 6	Date: 11/15/18	Direction Taken: —
Description: Vegetation on Exterior Wall—Alternative Room

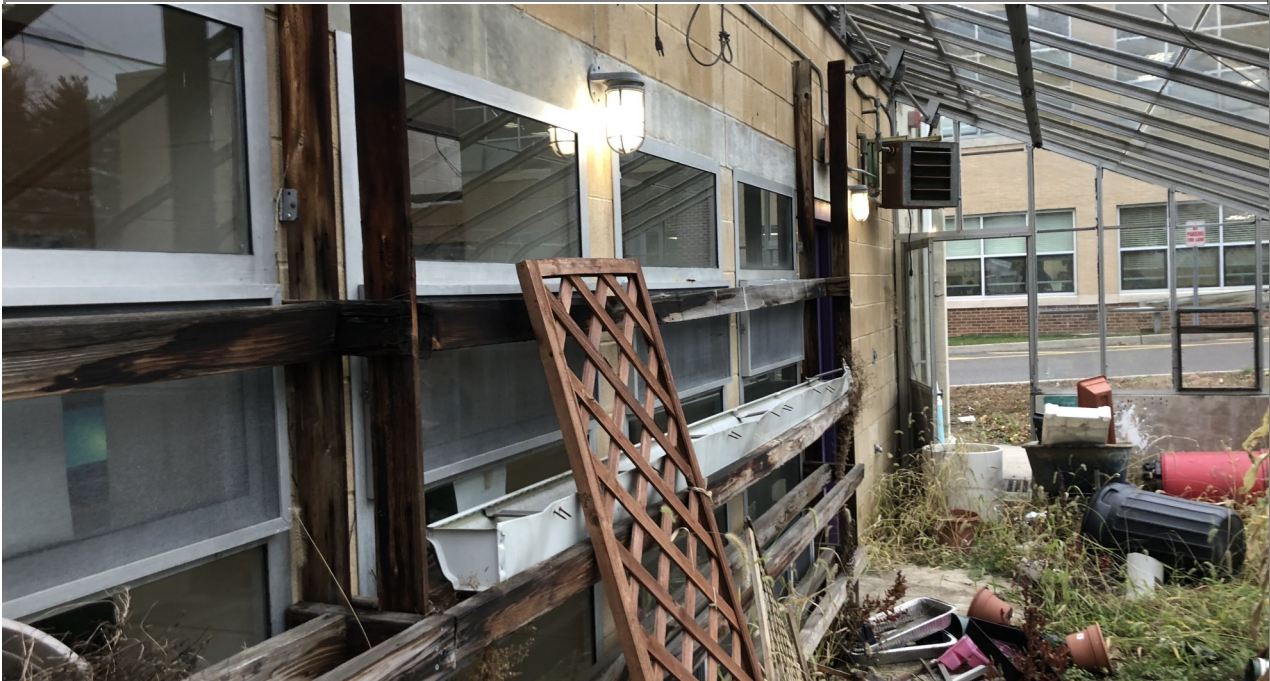
Photograph No.: 7	Date: 11/15/18	Direction Taken: —
Description: Water Stained Wood inside Greenhouse

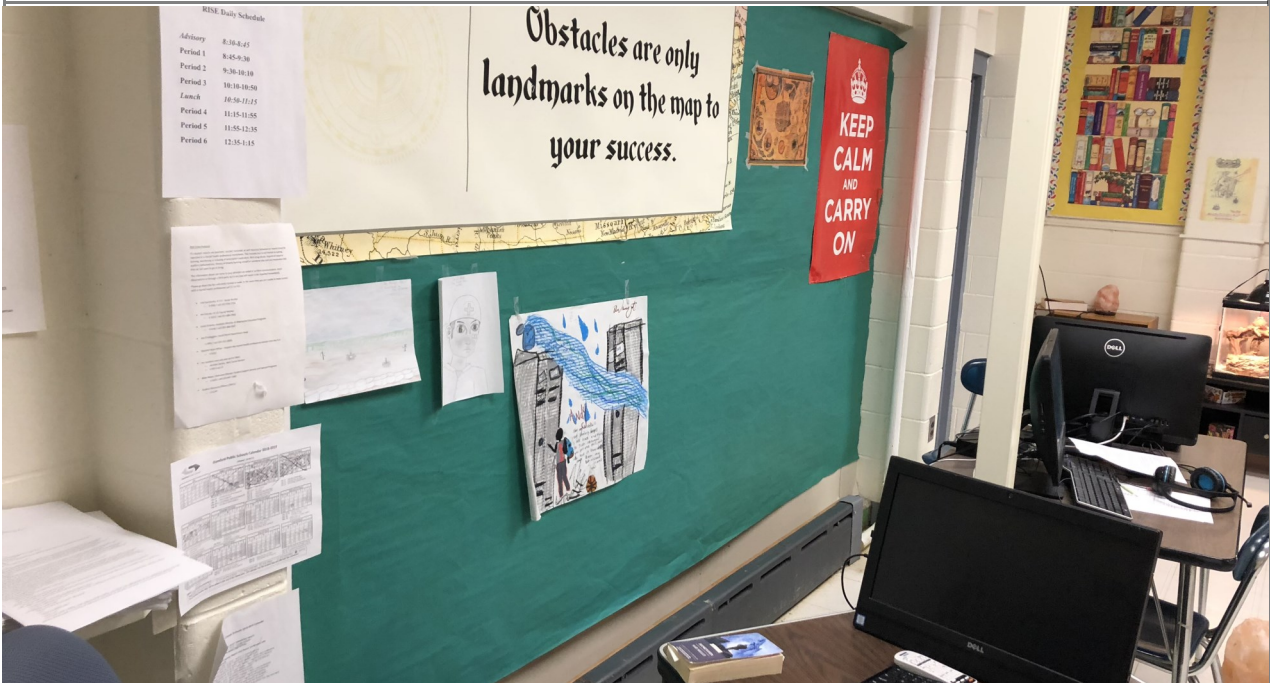
Photograph No.: 15	Date: 11/15/18	Direction Taken: —
Description: Drywall at Former Window—Classroom 1

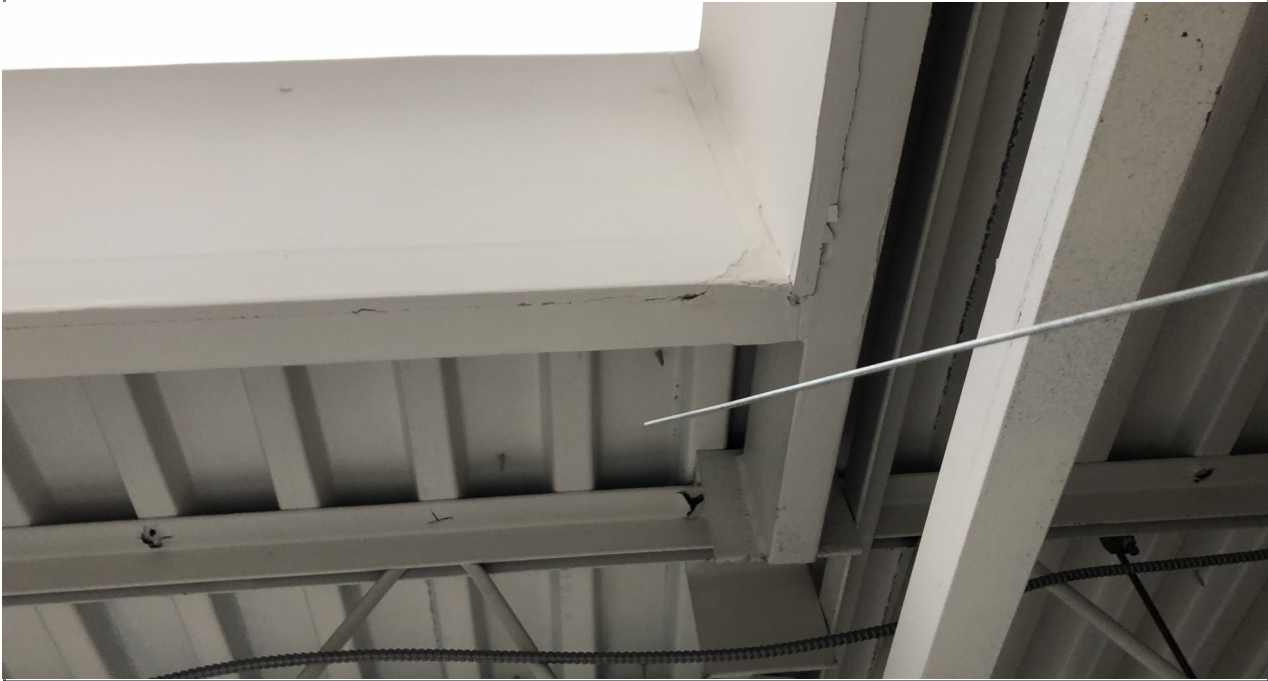
Photograph No.: 17	Date: 11/15/18	Direction Taken: —
Description: Water Damaged Skylight Above Ceiling Tiles—Classroom 3

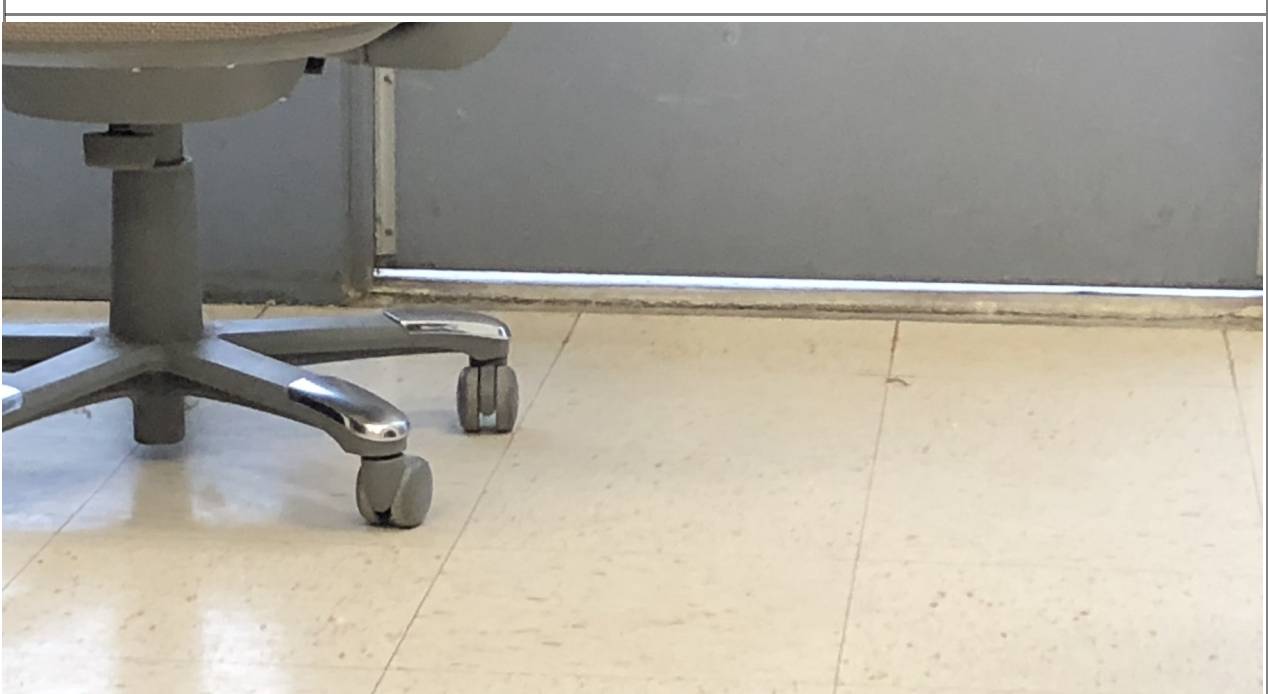
Photograph No.: 18	Date: 11/15/18	Direction Taken: —
Description: Gap at Exterior Door—Classroom 3
