Mold Assessment — Photographic Log

Client: City of Stamford Mold Task Force

Job Number: 28-2087-033G

Site: Westhill High School—Agriculture Science Building

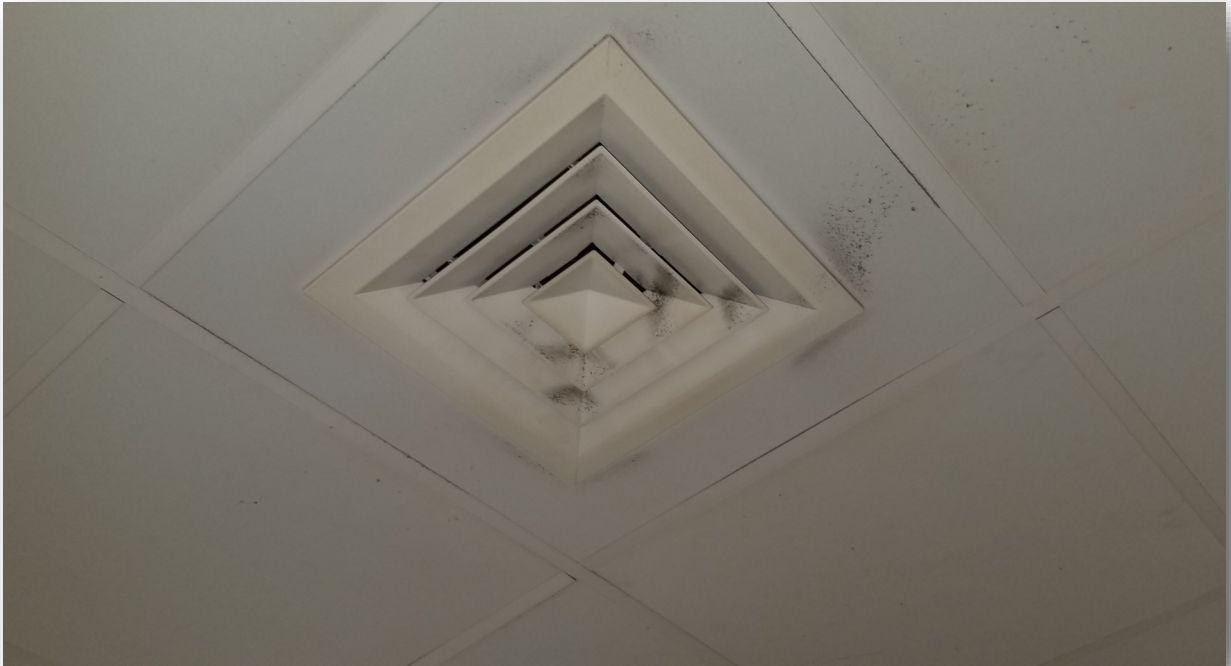
Photograph No.: 6	Date: 2-26-19	Direction Taken: NA
Description: Second Floor—Media Center—Dirty Supply Air Diffuser
