M. Gottfried, Inc.

RE: Roof report and repair quotation
Westhill High School
125 Roxbury Road
Stamford, CT 06902

As per your request we went to the above school to perform an inspection of the roofs, and, using the Infrared Thermographic Roof Moisture Analysis Report as a guide, look for possible sources of water leaks in the noted "wet area". We also were to perform test cuts, if necessary, to verify the wetness and determine the roof components in those areas. We were also asked to provide pricing on replacing the wet area, and to provide a recommendation and pricing for roof maintenance.

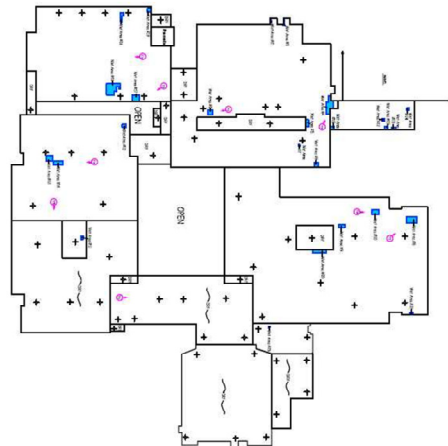
Area of moisture shown on Roof Scan

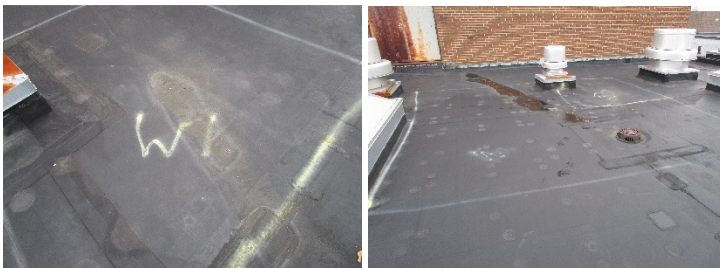
Wet area #1

Holes were found in wet area #1.

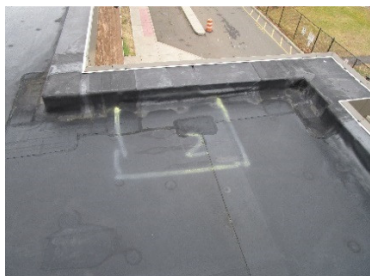
Wet area #2

We did not see any holes in this area. There is a T-patch over the intersection of 2 field laps that may be causing the problem. The other cause could be water migrating back from the edging

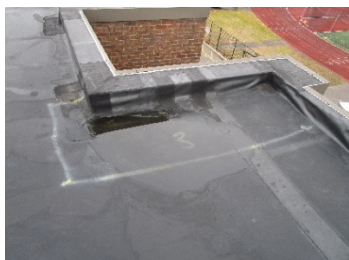
Wet area #3

Moisture at wet area #3 may be coming in from the patches at the corner or on the perimeter curb. We can also see that membrane is coming loose from the curb in this area.

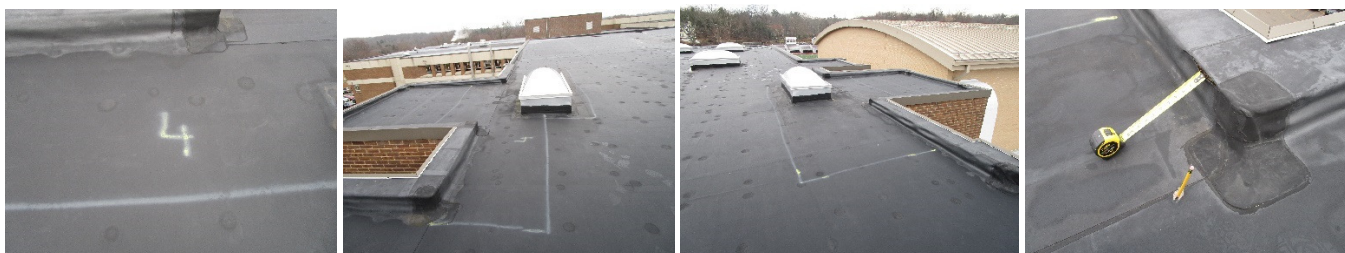
Wet area #4

It is difficult to pinpoint the source of wet area #4. There is a skylight, flashing corners and the same edge detail found at other perimeter wet areas. An open cut is also present on the perimeter curb. Some of the insulation appears to be lifting in this area as well. All these conditions would be addressed when the wet area is removed and replaced except the perimeter edging condition. The edge condition will be discussed in the maintenance portion of the report.

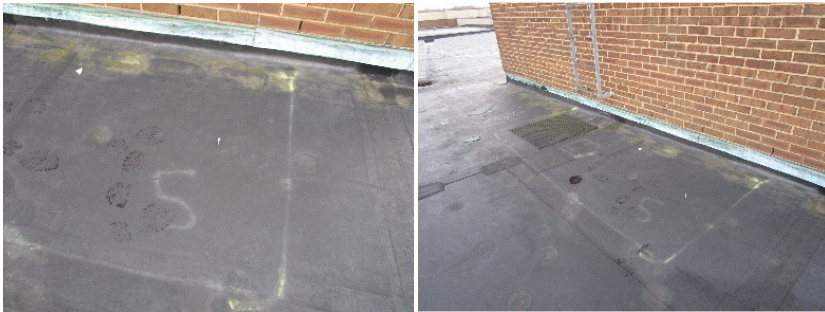
Wet area #5

Holes were found in area #5. These are marked in the picture with the white screws.

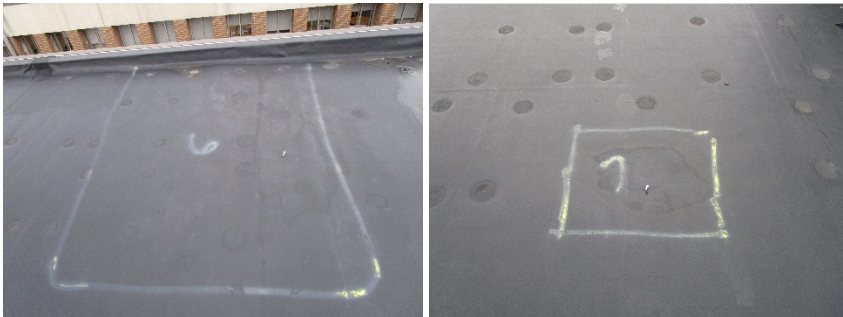
Wet area #6 and #7

Holes were found in this area.

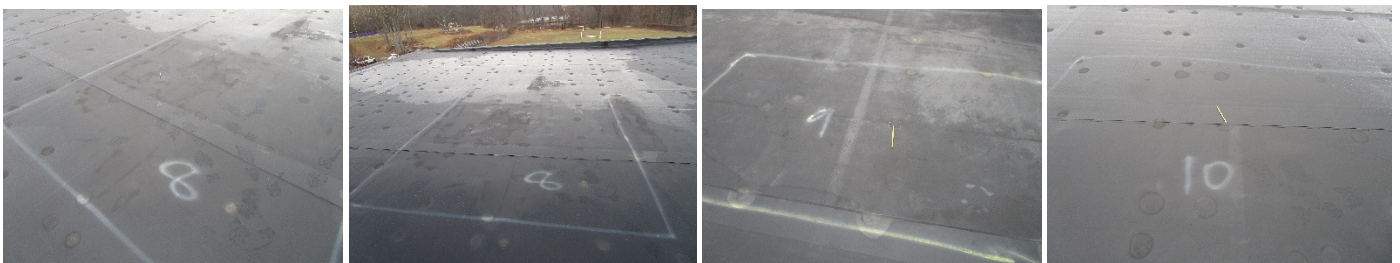
Wet areas #8, #9, #10, #20 and #21 are found on roof L

Areas 8, 9 and 10 all have holes in them. These like all holes should be patched before the wet areas spread.

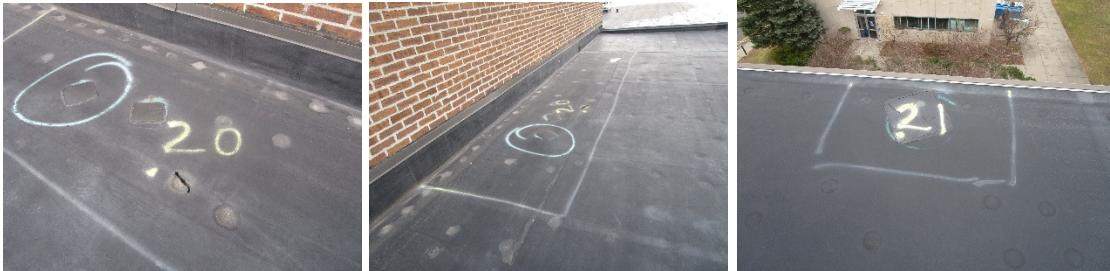
Areas 20 & 21 have a combination of holes that have been patched and holes that are not patched.

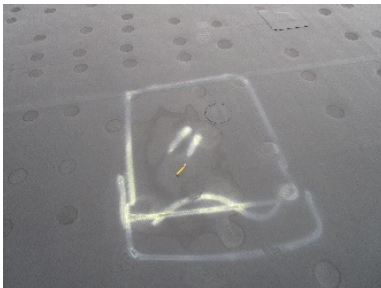
Wet area #11 lies on the penthouse of roof area E. A hole is present within the wet area.

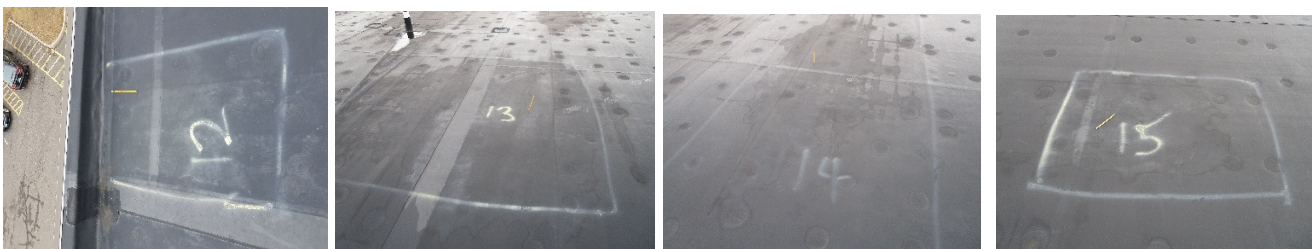
Areas #12, #13, #14 and #15

Holes are present in all of these marked areas.

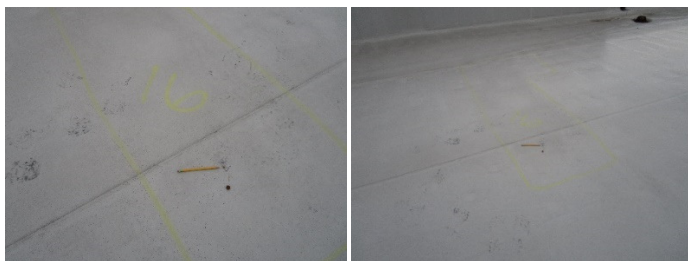
Wet area #16

A hole is present in this area.

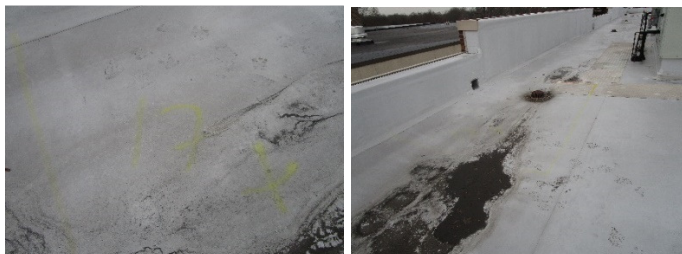
Wet area #17

Leak area #17 is by a drain against the parapet wall. The roof area must be cleaned to see if there are holes in this area. We also noticed that the blocking under the top of the parapet wall on this roof appears to be soft when you press on it. Moisture may be getting in from the edge system. This item needs further investigation.

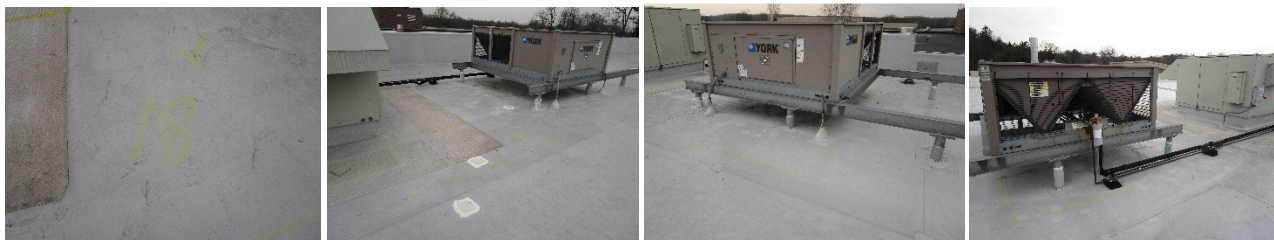
Wet area #18

Area #18 is a large area that goes from one unit and stretches to another. There are many patches in this area. It is possible that additional holes are present or that the moisture came from the holes before they were patched.

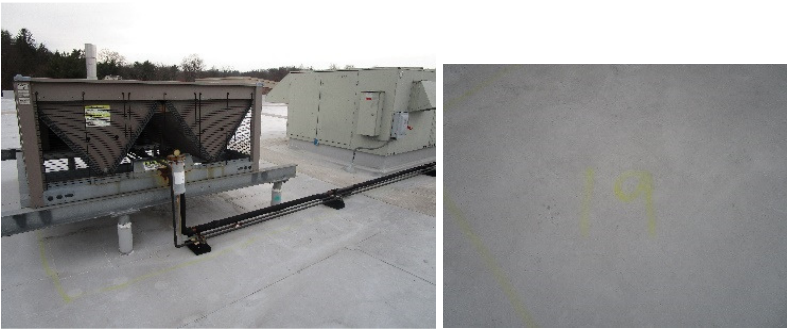
Wet area #19 has holes present in the membrane

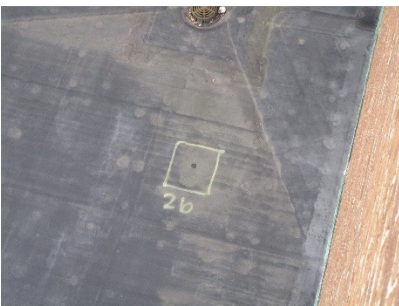
Wet area #26 is found on roof C at the side of the auditorium

A hole in the roof membrane is causing this wet area

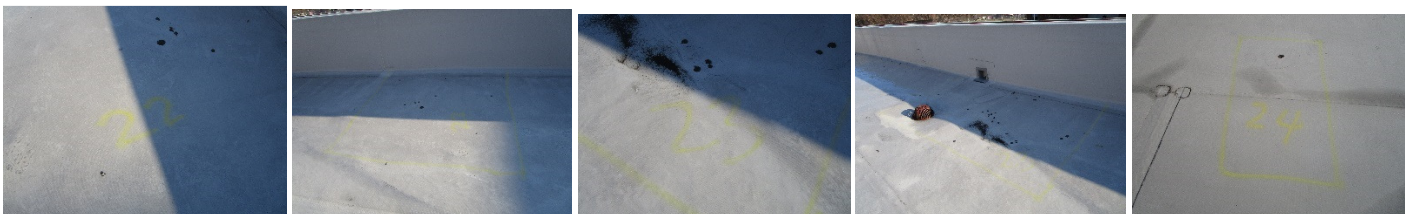
Wet area #22, #23 and #24

Wet areas #22, #23 and #24 are found where many holes are present in the membrane. Black caulking has been placed over many of the holes.

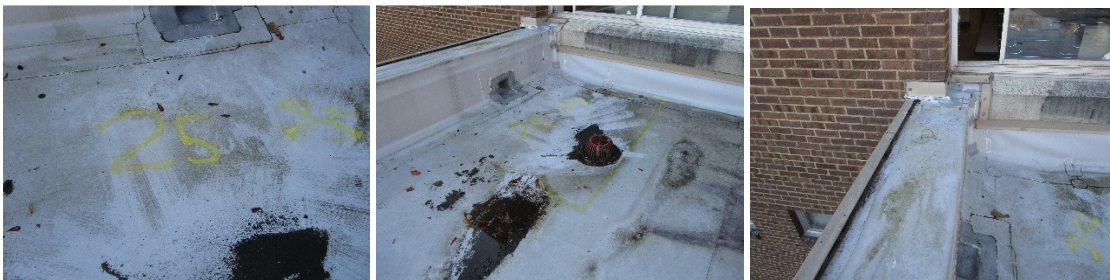
Wet area #25

Area #25 is found in the corner by a roof drain and scupper. It also lies below the window and parapet wall flashing. It is quite possible that water is getting into this area from the windows or any of the mentioned items. When the wet area is removed and replaced, it may be easier to track the path of the water and address any non-roofing items that may be contributing to the water infiltration.

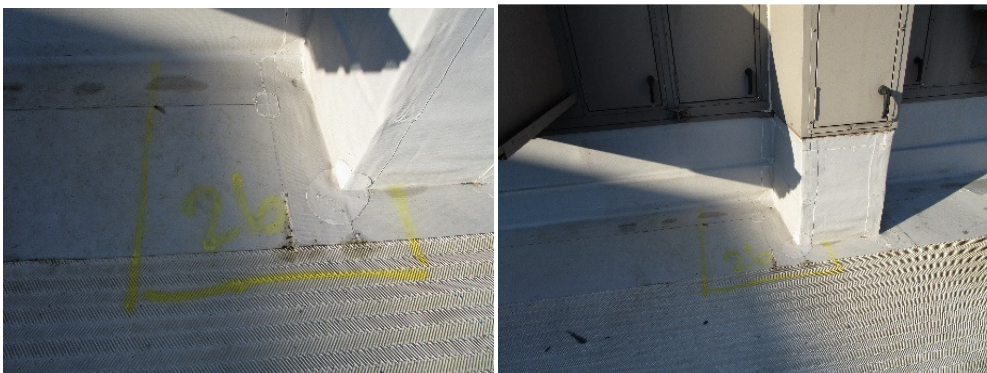
Wet area #26A

It is difficult to visually locate the source of water infiltration at area #26A. It falls at the base of a unit and along side a walkway pad. When this area is replaced, if the unit still remains suspect, a mechanical contractor may be needed to look at the unit.

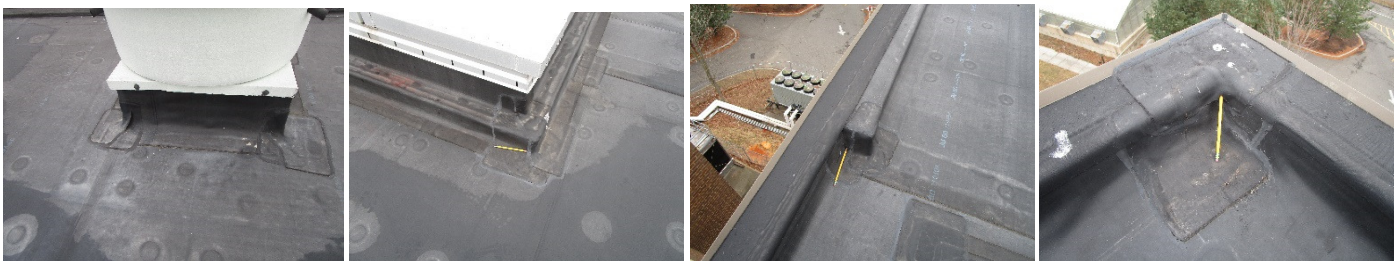
Open corners and flashing

We found corners in the flashing of roof curbs and the perimeter edge curb are starting to bridge or open. These should be properly patched before the breach goes all the way through and water can get into the roofing system.

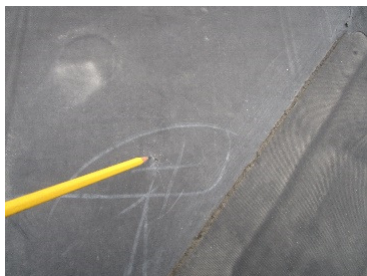
Holes

Holes were found in Roof A. These must be repaired to prevent water infiltration and possibly leaks.

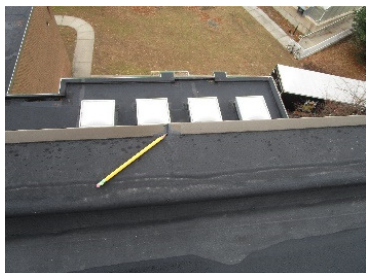
Open joints at the perimeter edging

The vertical roof side joints in the perimeter edging should be checked to see if they are open and water can get in. Installing a patch over the joint would prevent water from entering the gap.

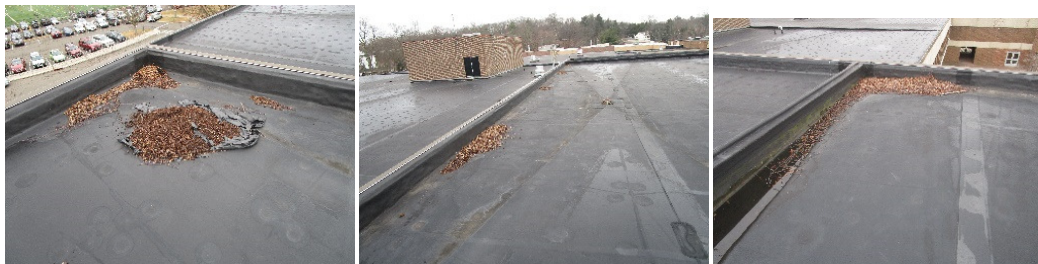
Debris on roof

Debris should be cleaned from all roofs. Debris can clog drains and items in debris may cause holes when blown around in wind.

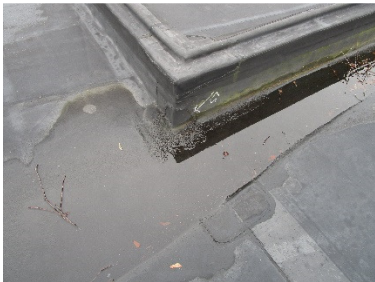
Ponding at base flashing

The corners at areas that hold water should be cleaned and another layer of membrane installed over the existing corner. This will help protect the detail from the accelerated aging effects of water longer.

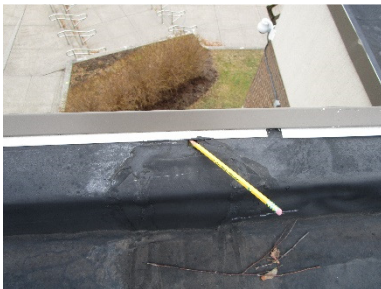
Holes by edging

The perimeter of the roof should be inspected and any holes at the edging properly repaired.

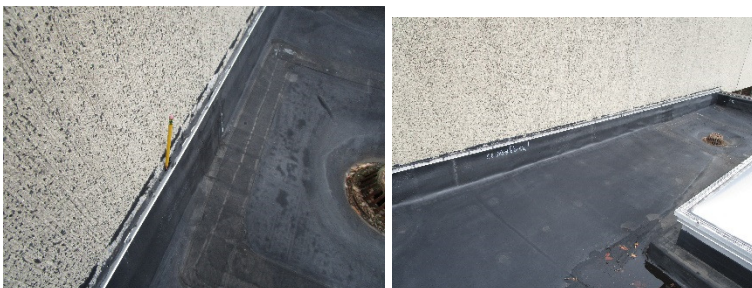
Gaps forming at top of the termination bar

The caulking at the top of the termination bar is wearing out and water may run down the wall and get behind the flashing. This detail should be recaulked.

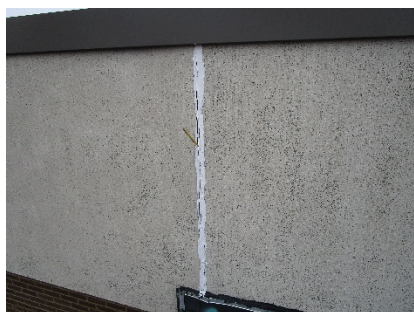
Vertical caulk joints in wall above termination bar

All caulk joints should be inspected and repaired by the appropriate trade. Open joints above roof flashing can allow water to enter the wall system and bypass the roofing termination.

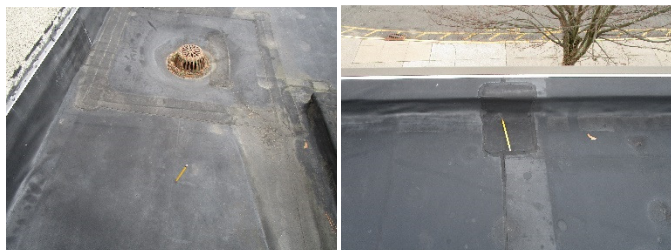
Holes and patches with cuts and holes

Holes and cuts in the roof system will allow water to enter and need to be properly sealed.

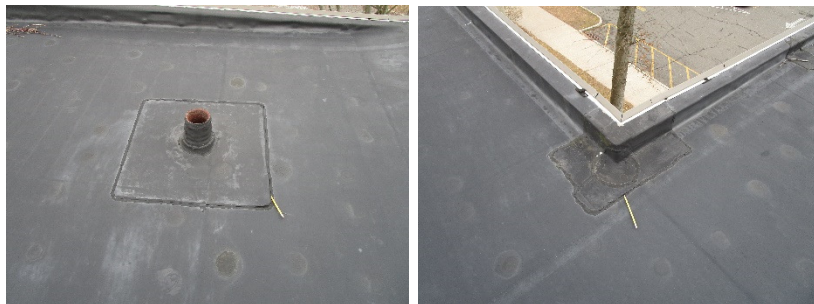
Flashing starting to lift

Some patches are starting to peel and lift. If the peeling goes all the way back to the penetration water can enter the roofing system. All corners and patches should be inspected and repaired as needed.

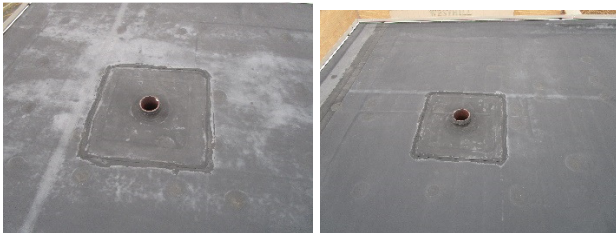
Low vents

There are a number of vents that are very low to the roof. In addition to making flashing difficult, it also puts the top of the pipe well below any snow accumulation. This can let water in the pipes. In addition, the height of pipes may affect their efficiency. A mechanical contractor should evaluate this condition to see if extensions should be added to the pipes. If so, the pipes would then need to be reflashed.

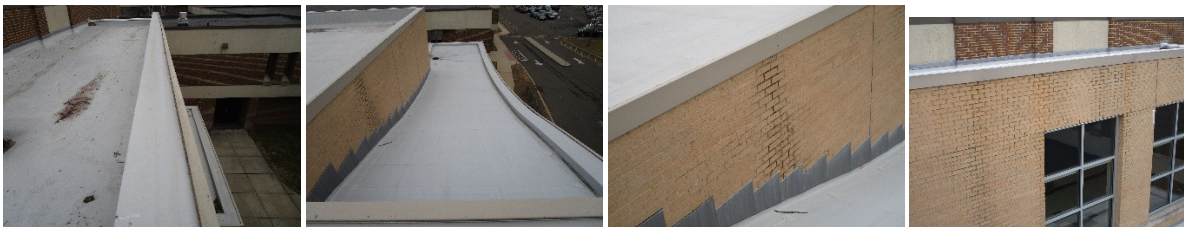
Roof edge detail

As mentioned in the wet area section, the blocking at the top of the parapet wall of this roof area feels soft. In addition, we can see water stains on the outside of the wall below the edging. It is possible that water is getting under the edging from the roof side, then running down the wall and possible getting under the membrane. This condition needs further investigation to see if nothing is wrong, sealing the back edge of the metal fascia system is all that is needed, or if a much bigger repair of the condition is needed.

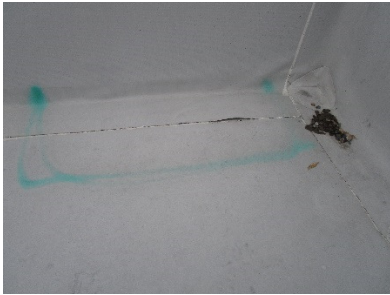
Open laps

This area of open lap at the base flashing has been marked on the roof. It needs to be repaired before water enters the roofing system.

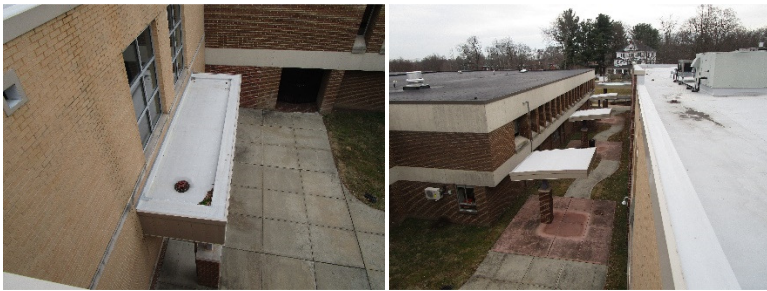
Roofs 1,2,3 and the canopy between roofs E and F

The low entry and canopy roofs between roofs E and F were not inspected.

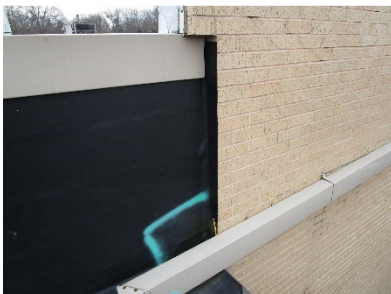
No vertical termination

There does not appear to be any vertical termination where the roof membrane turns onto the brick. This detail should be investigated further to see if additional metal work is needed.

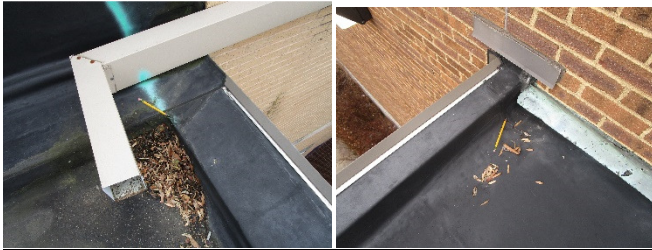
Open flashing in corners

Opening fishmouths are found in the corners on this roof. The debris should be removed, all the corners and flashing inspected, and repairs made if any open flashing is found.

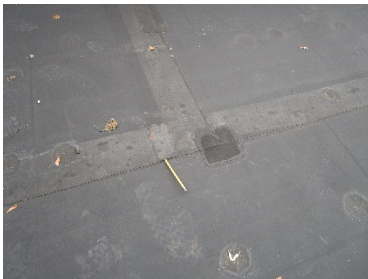
Fishmouth in lap

The lap is starting to open and should be patched before the passage for water gets all the way to the back of the lap.

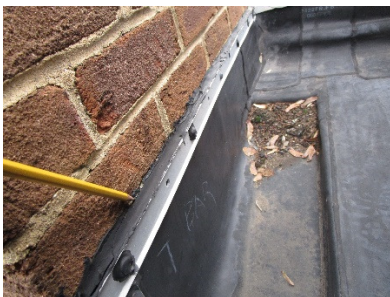
Termination bar caulking

We found some gaps in the caulking above the termination bar. These areas should be recaulked to prevent water from getting behind the base flashing.

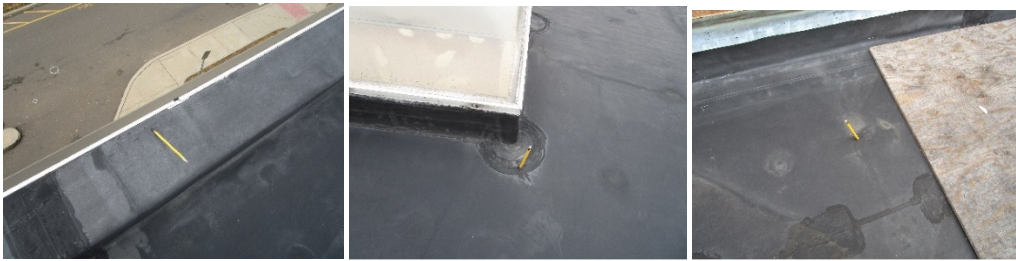
Holes

The roof must be inspected, and all holes need to be patched. In addition to holes on the parapet curb, the edging should be inspected to see if a bead of sealant is needed at the back edge.

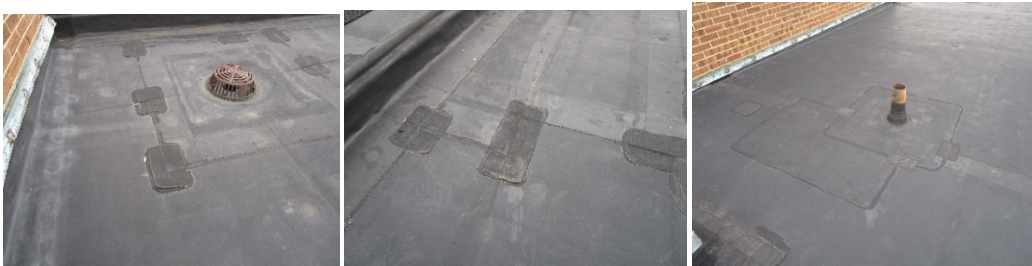
Lifting patches and loose flashing

All patches and flashings need to be inspected on this roof. Where patches and flashings are loose or lifting, they need to be properly repaired before they peel back enough for water to enter the roofing system.

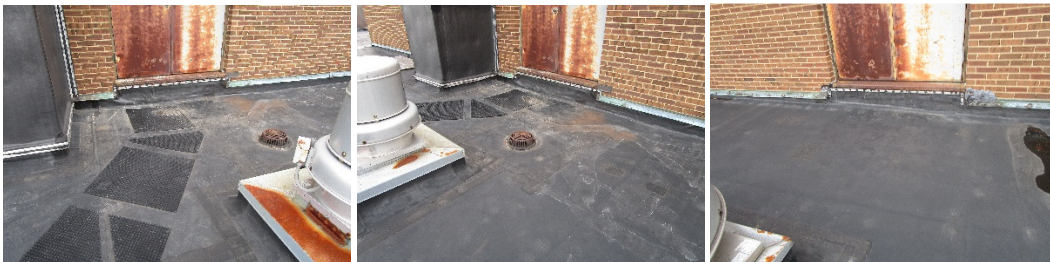
Crushed insulation at doors to the penthouse

When walking on the roof in front of the penthouse the insulation feels soft. We believe it has been crushed from roof traffic. The damaged insulation should be removed and replaced with new insulation that has a coverboard. The high density coverboard will allow the roof to stand up better to roof traffic.

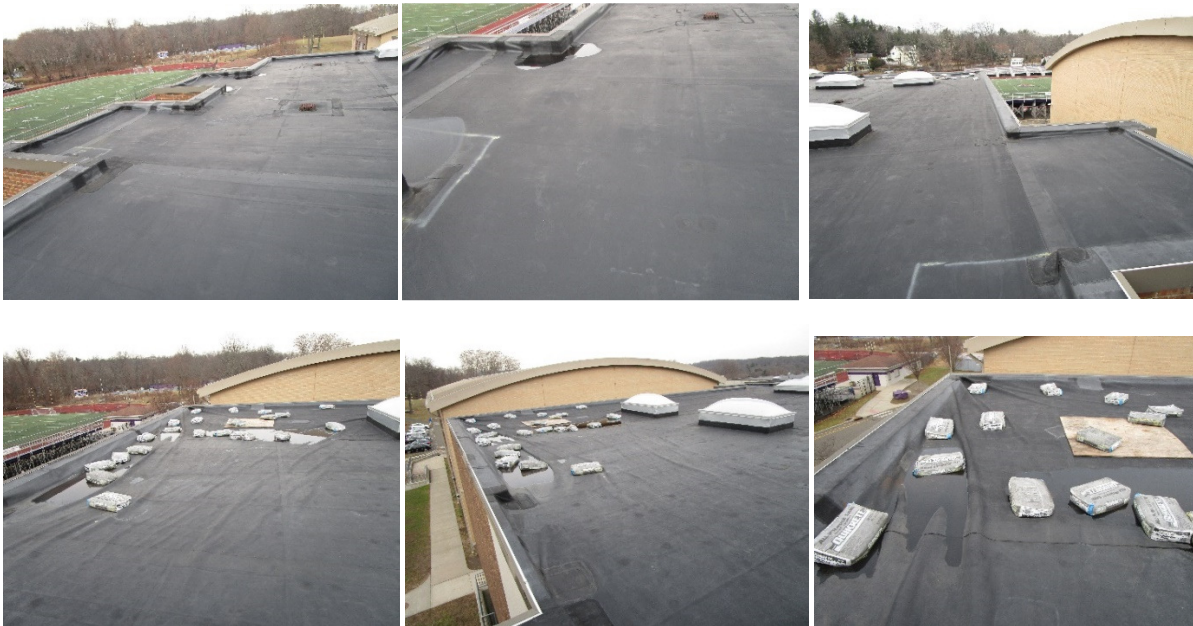
Loose area of roof

A corner of this roof on the field side next to the small gym has come loose. It start near wet area #2, goes to the end of the building down the side facing the small gym and ends at wet area #4. The area is currently being held down by bags of cement mix. This acts as a temporary securement of the membrane, but the area should be properly repaired before the delamination spreads. This is a serious issue and it should be addressed. The loose membrane should be removed, and the underlying insulation inspected to see if it is also loose. If loose or wet, it should be removed and replaced. If the insulation is dry and secure, a coverboard should be installed over the area and new membrane installed.

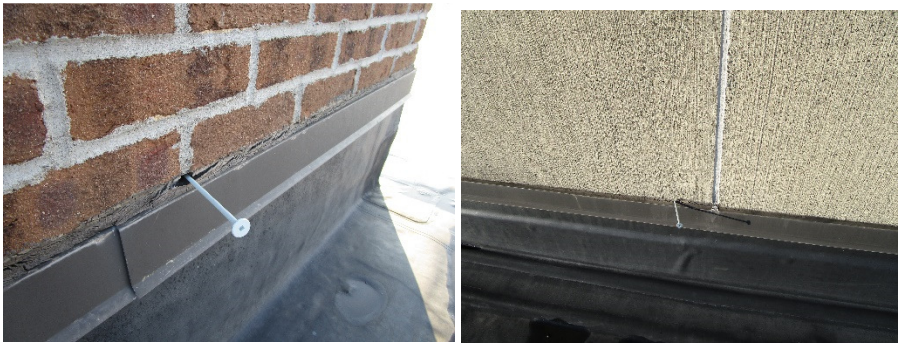
Caulking at reglet

All reglet caulking should be inspected and recaulked as needed.

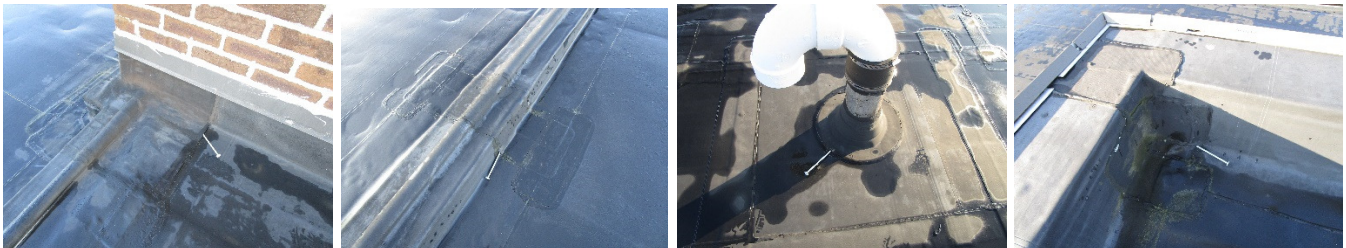
Open flashing and patches

Open and bridged corners, patches, penetration flashings, etc., need to be properly patched before water can find its way into the roofing system.

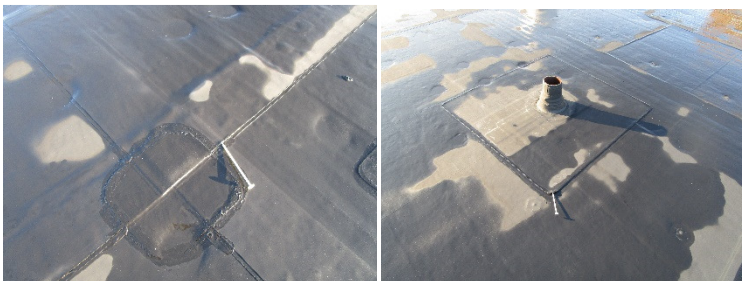
Fishmouth near patches and loose membrane patches

Loose membrane patches and fishmouths in laps need to be sealed.

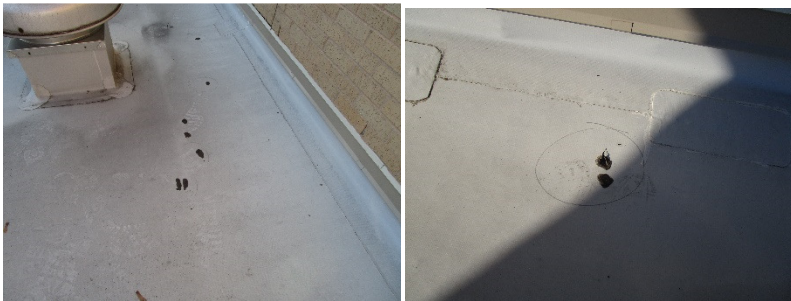
Holes in roof

As noted in the wet area section, there are many holes in this roof. It appears that black caulking has been put over many of them, a proper repair should be made.

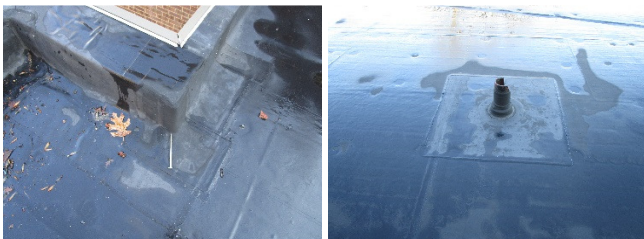
Open corners and membrane patches

Holes in flashing and open membrane flashing need to be repaired. In addition, the broken pipe may need to be repaired (by others).

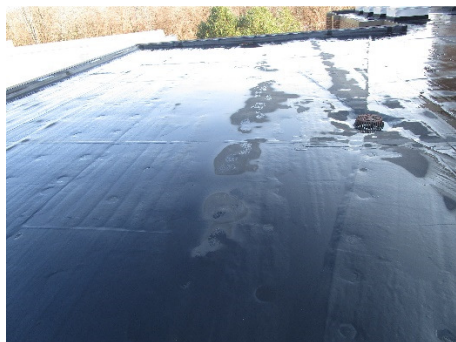
Area of lifting roofing

A section of this roof approximately 25'x5' is lifting. Test cuts should be made to determine the condition of the underlying insulation. If it is dry and the insulation intact, the roofing should be secured, either by installing fasteners and plates or mechanically fastening a coverboard then installing new membrane. If the insulation is no longer sound, it should be replaced, and then new membrane installed.
