FACILITIES NEEDS

ASSESSMENT

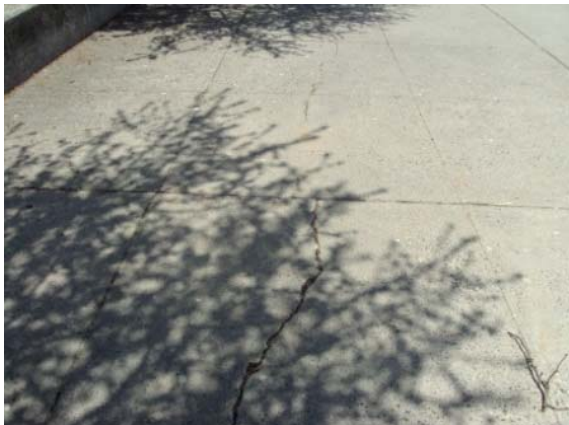
Photo #17: Cracking at concrete sidewalk at front of building

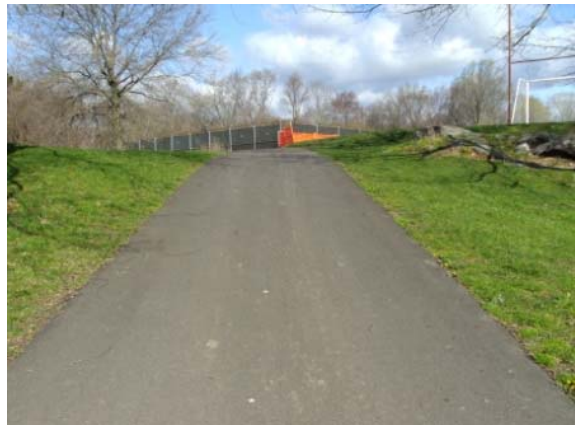
Photo #18: Asphalt sidewalk leading to practice soccer field and tennis courts

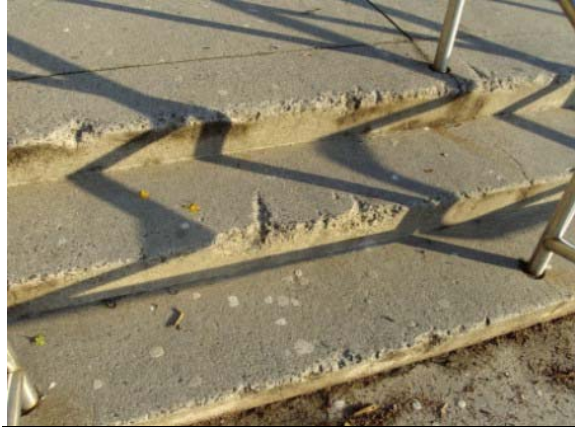
Photo #20:	Damaged concrete steps
------------	------------------------

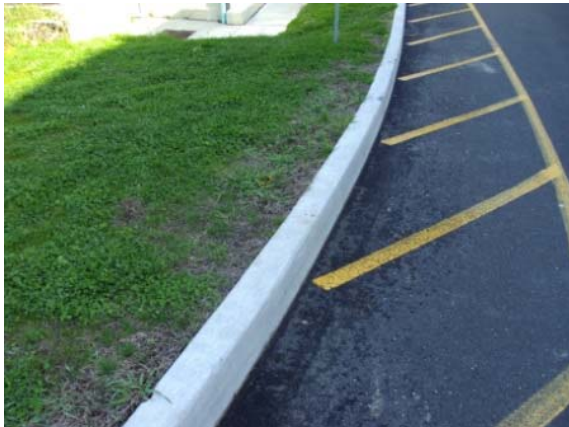
Photo #21:	Concrete curbing
------------	------------------

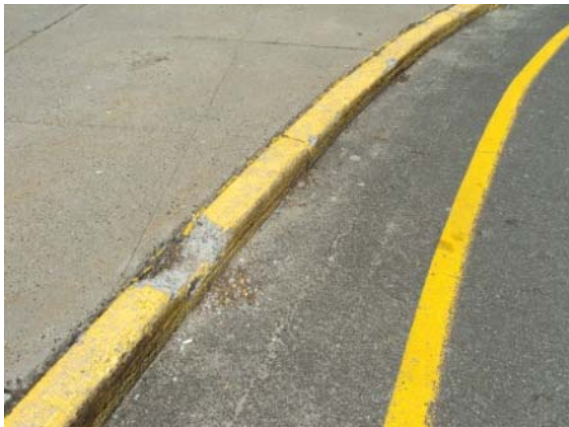
Photo #23:	Deteriorated concrete curbing along front drive aisle
------------	---

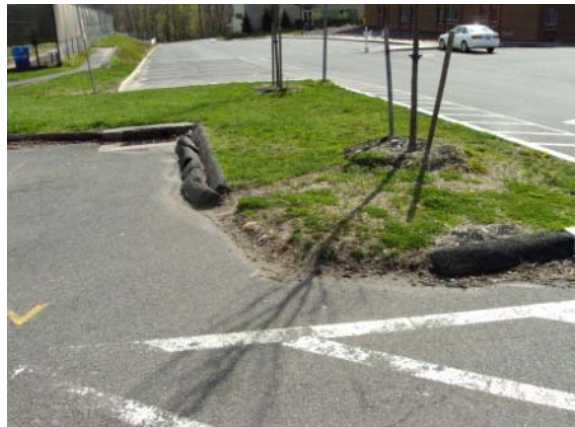
Photo #24:	Deteriorated and displaced asphalt curbing adjacent to baseball field
------------	---

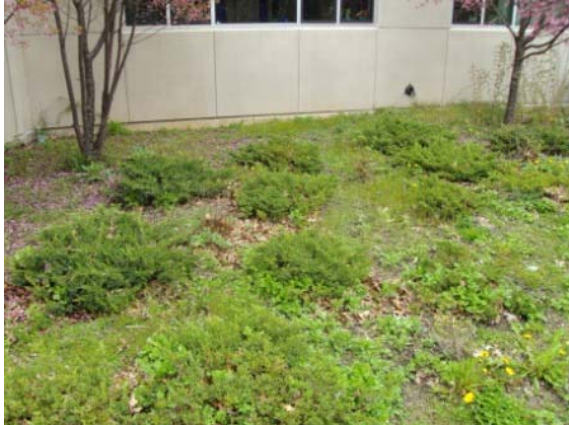
Photo #25: Landscaping sloped towards foundation wall at New AgriScience Building

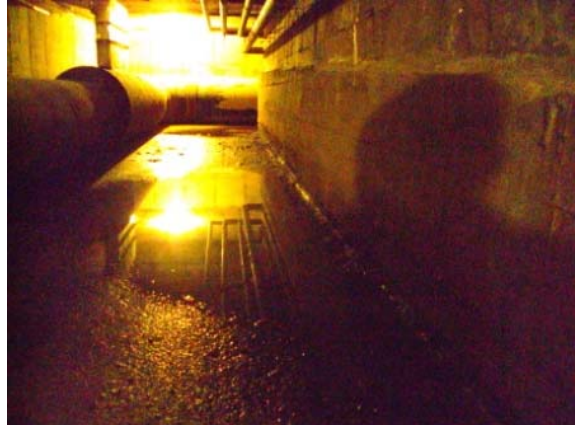
Photo #26: Water in tunnel below pool from overflowing sump pump basin, due to non-operational sump pump

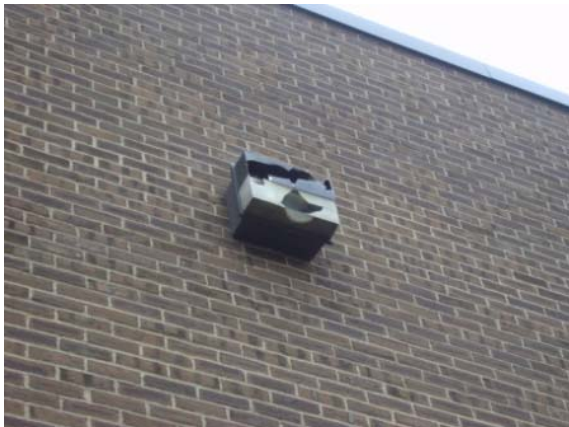
Photo #35: Damage building-mounted wall light at west side elevation of the building

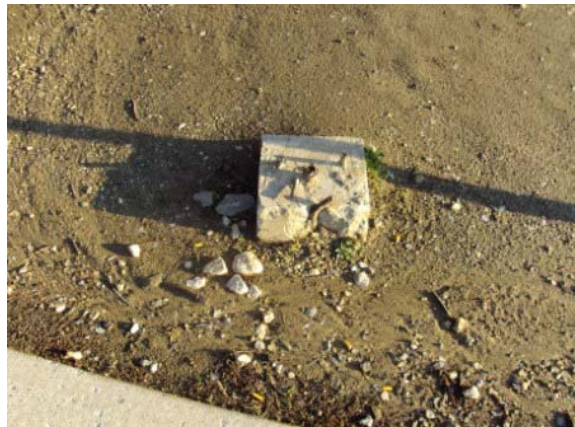
Photo #36: Abandoned pole light concrete base at front sidewalk

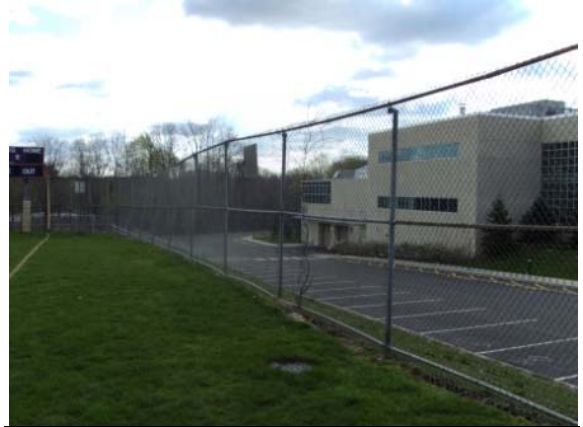
Photo #38: Chain link fencing condition at baseball field

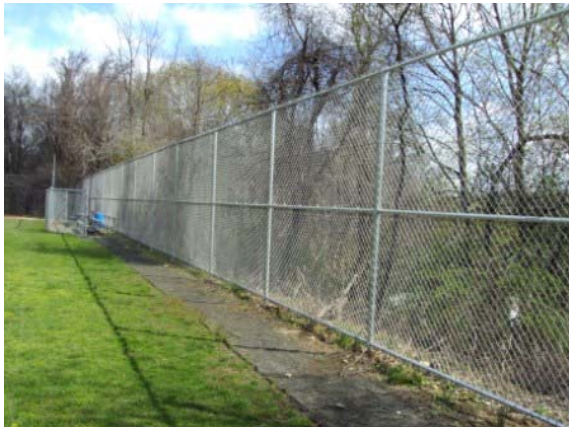
Photo #39: Chain link fencing at softball field

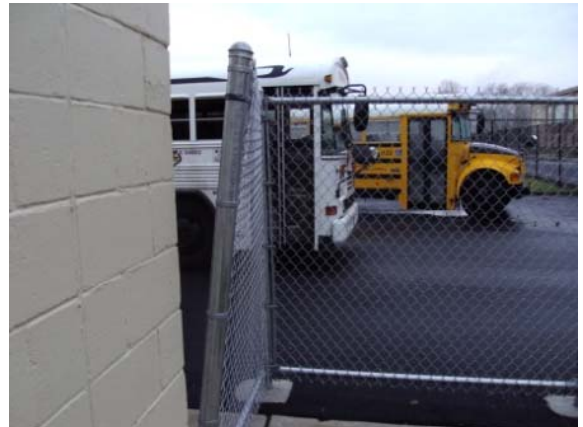
Photo #40: Damaged fence pole adjacent to Old AgriScience Building

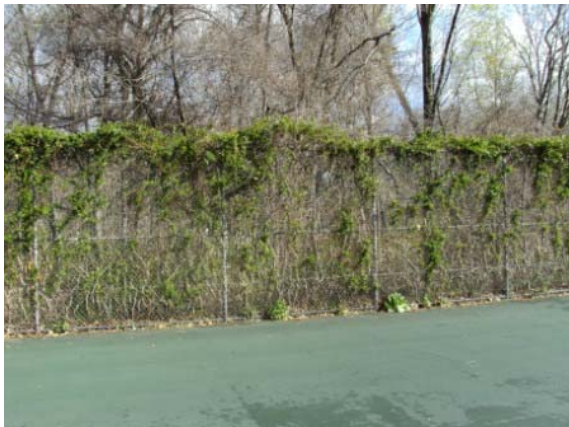
Photo #41: Chain link tennis court fencing

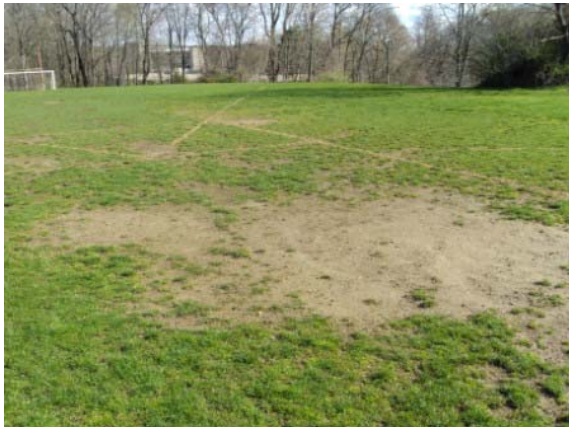
Photo #51: Practice soccer field condition

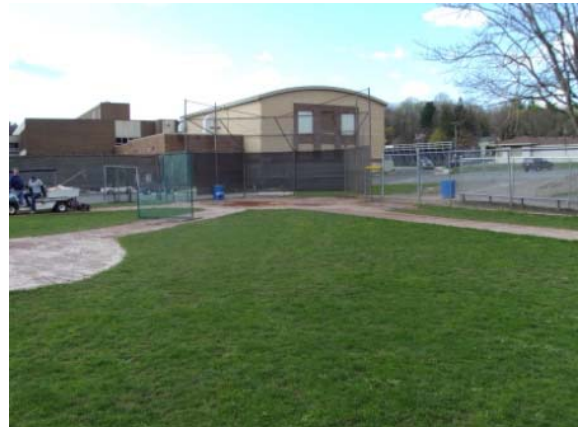
Photo #52: Baseball field

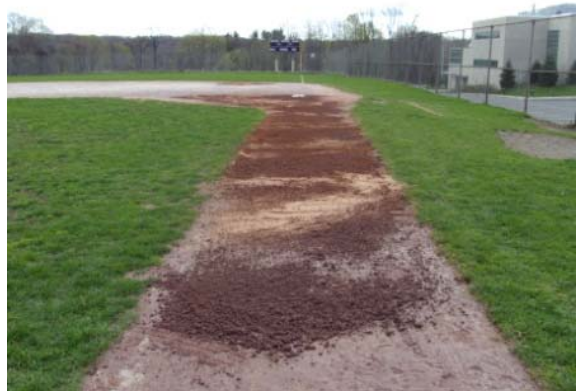
Photo #56: Infield repairs to baseball field by custodial staff

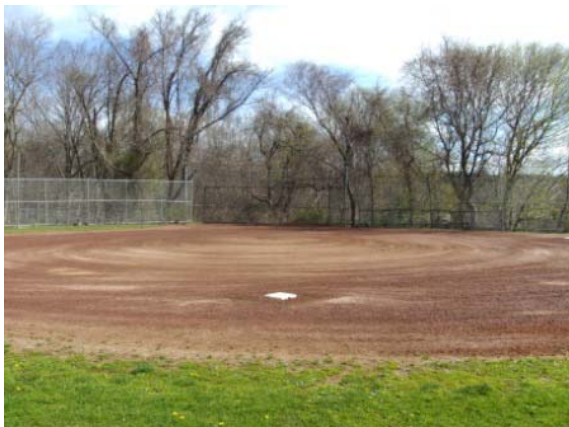
Photo #57: Softball field

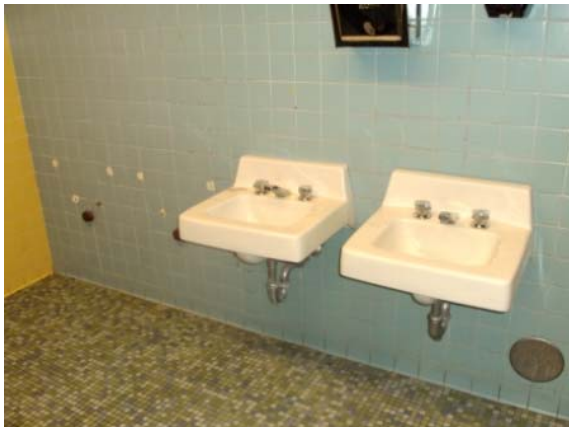
Photo #107: Common area restroom lavatory sinks with two missing sinks

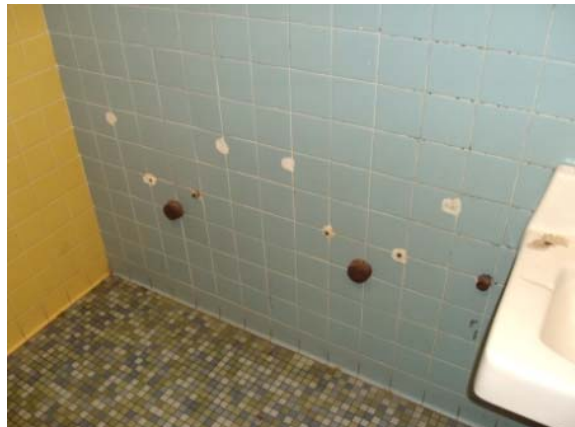
Photo #108: Common area restroom missing two lavatory sinks

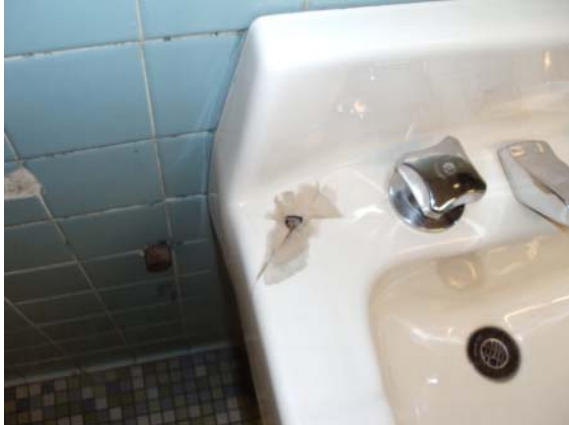
Photo #109: Common area restroom with broken lavatory sink

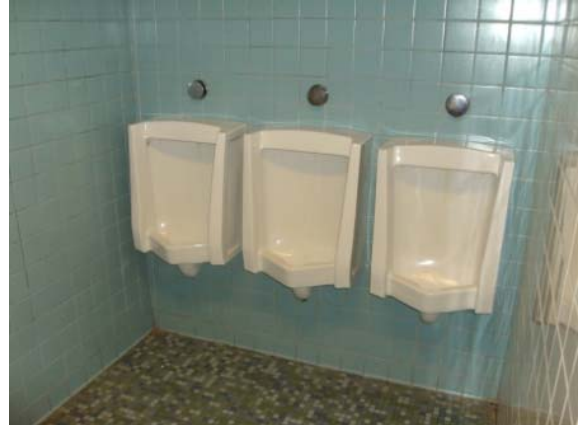
Photo #110: Boys common area restroom urinals

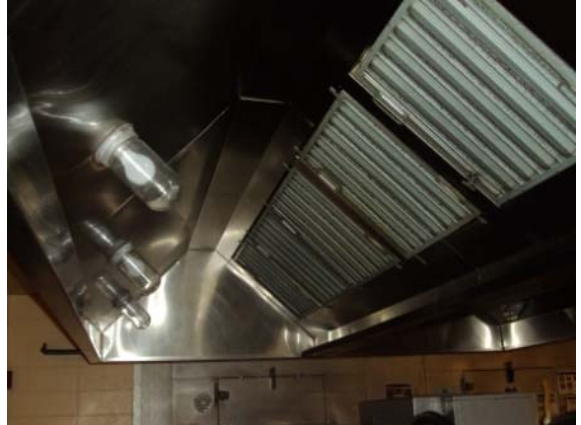
Photo #146: Missing sprinkler heads above portion of kitchen hood

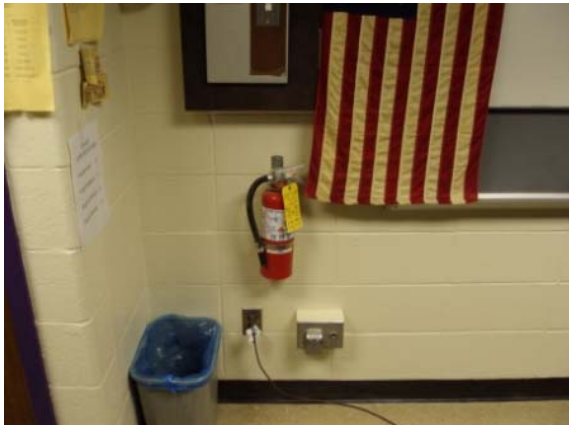
Photo #147: Fire extinguisher in classroom

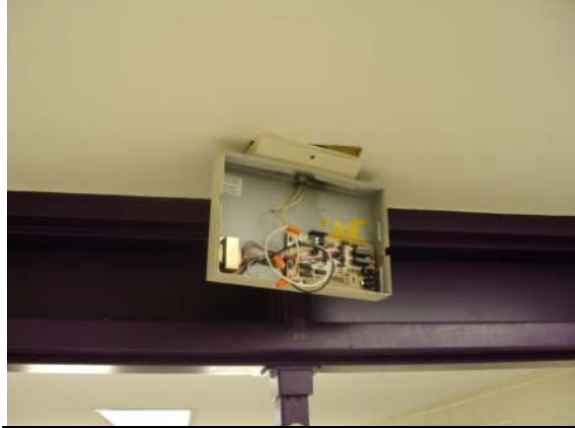
Photo #152: Broken exit sign at common area

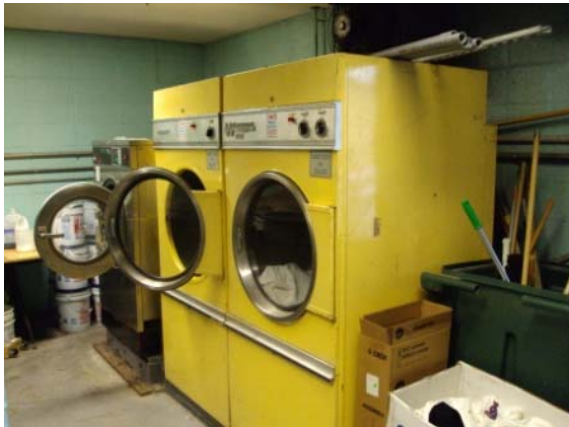
Photo #153: Commercial washer and dryers adjacent to rear loading dock

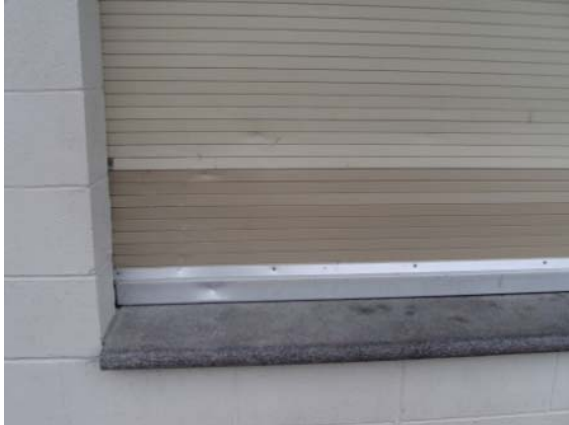
Photo #163: Damaged roll-up door

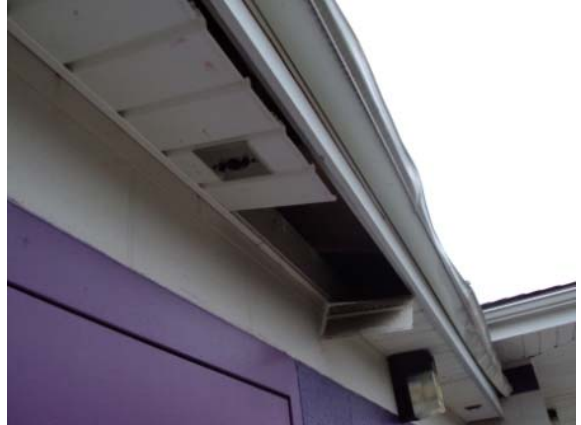
Photo #164: Damaged gutter and soffit

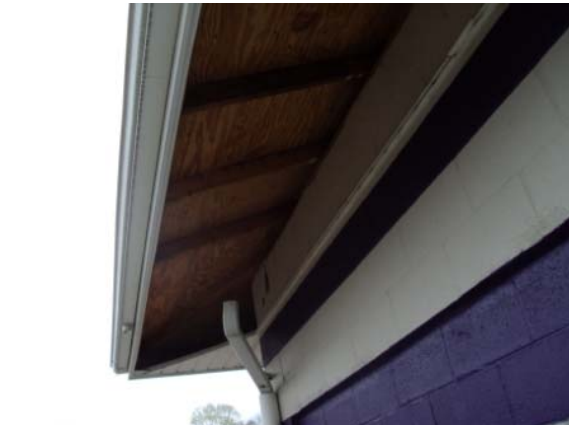
Photo #165: Unattached downspout and missing soffit

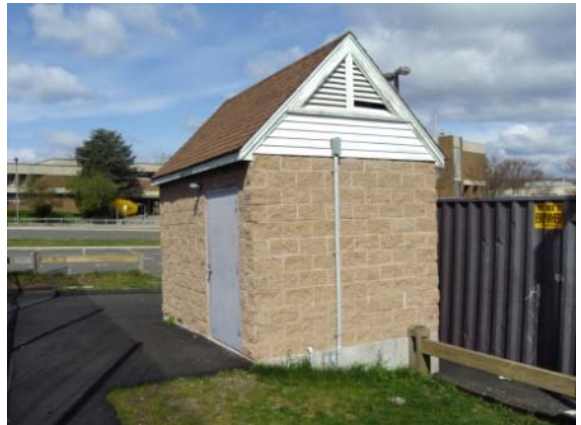
Photo #166: Old pump house building adjacent to new soccer field

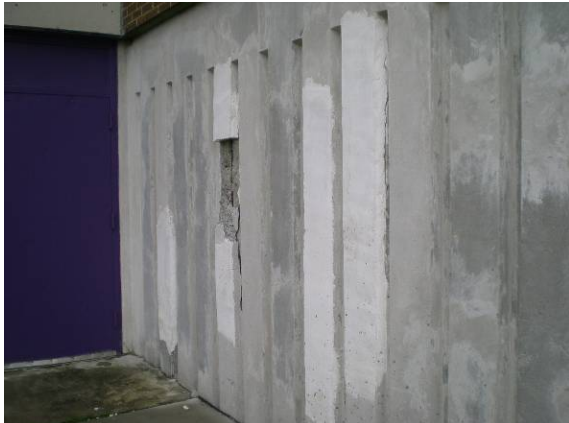
Photo #171: Concrete foundation wall with failing patches, exposed steel rebar and severe spalling

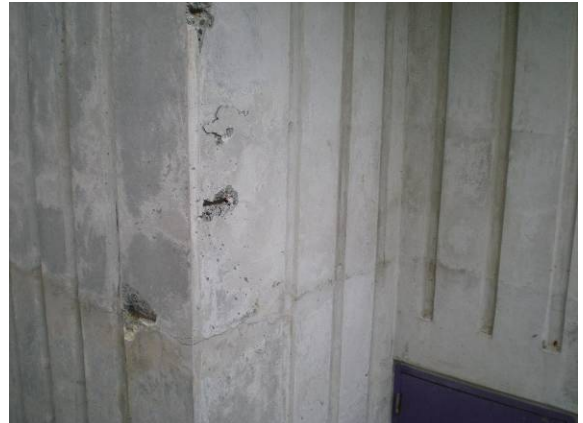
Photo #172: Concrete foundation wall with failing patches, exposed steel rebar and severe spalling

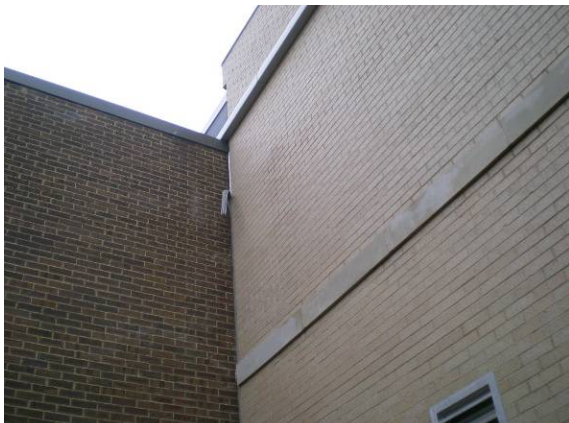
Photo #173: Loose gasket at joint of 9th grade wing and original building

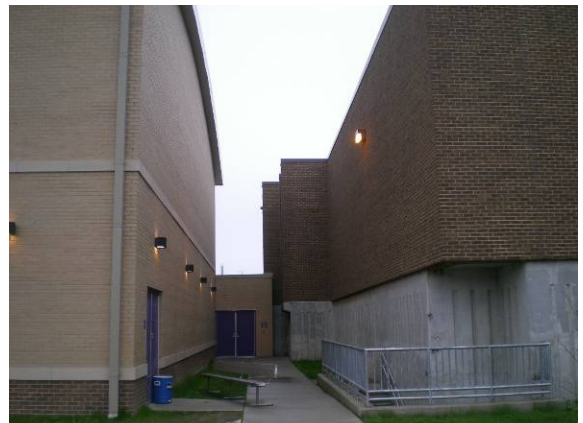
Photo #174: Walkway between old gym and new gym

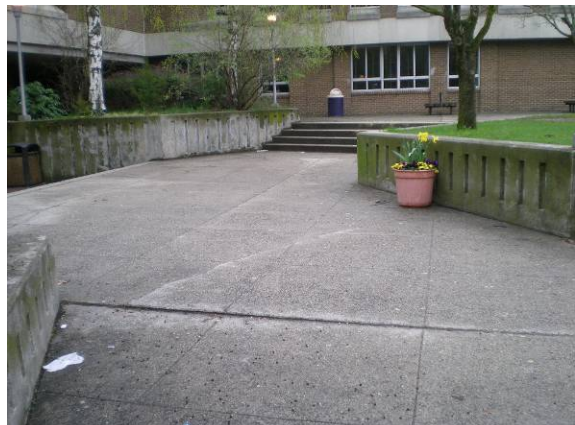
Photo #180: Potential tripping condition in courtyard with vertically displaced concrete

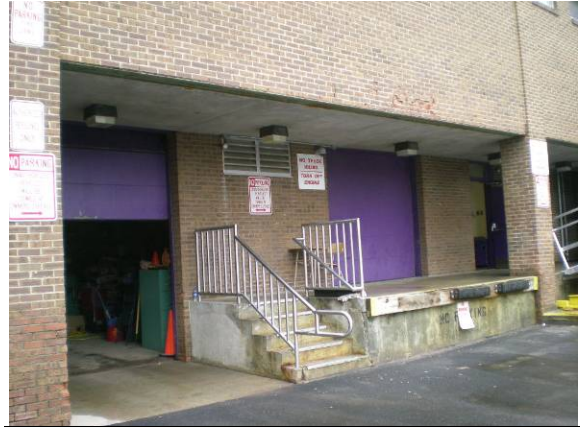
Photo #182: Loading dock damage at brick overhead

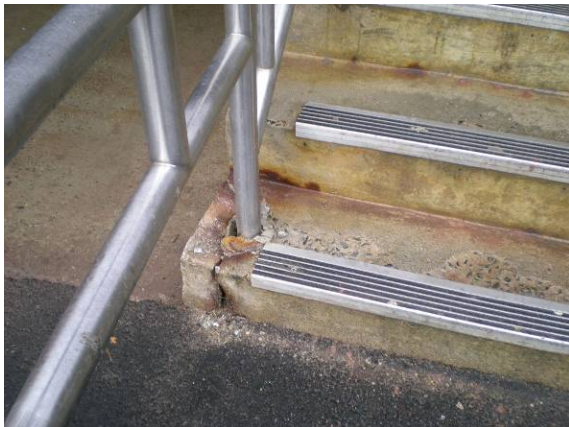
Photo #183: Damaged stairs at loading dock

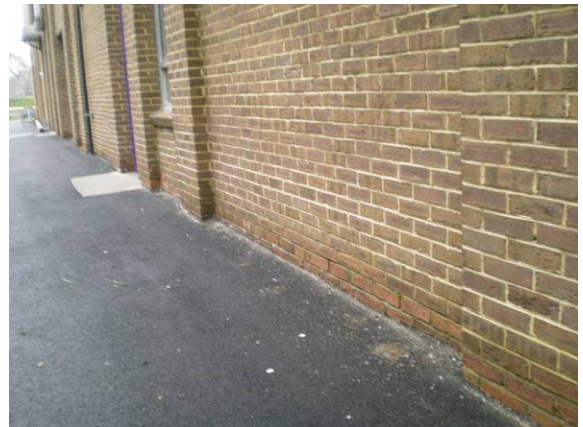
Photo #184: Worn mortar along base of wall perimeter including perimeter of old gym area, loading dock and audit.

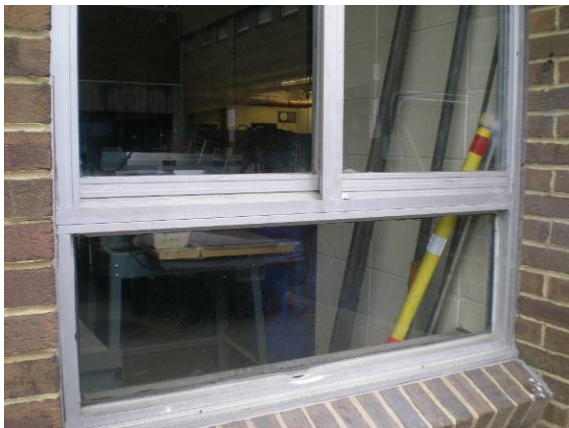
Photo #185: Single paned sliding window with damaged frame

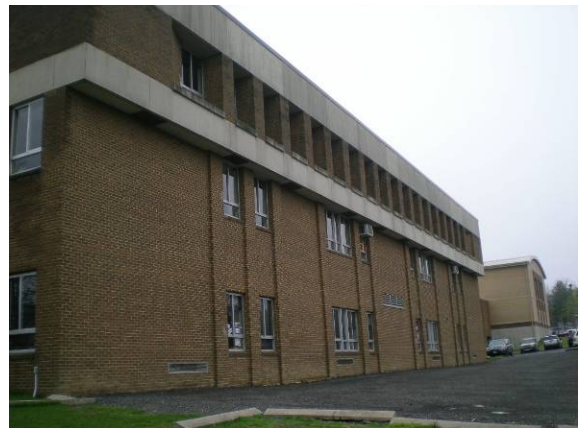
Photo #186: Partial north elevation of Finch (A) Wing

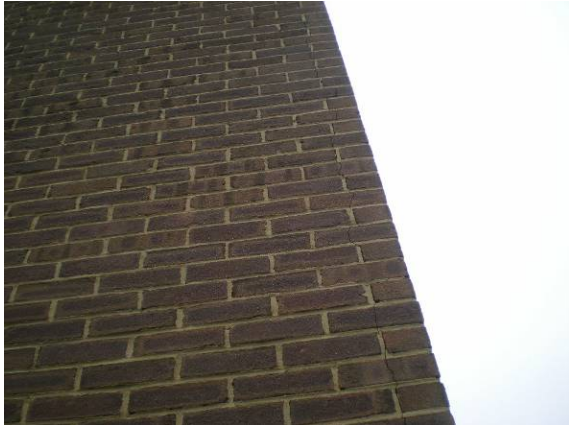
Photo #187: Minor cracking of brick veneer at corner

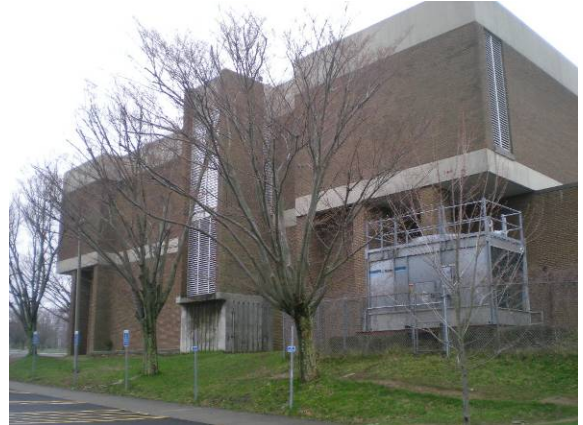
Photo #188: East elevation of auditorium

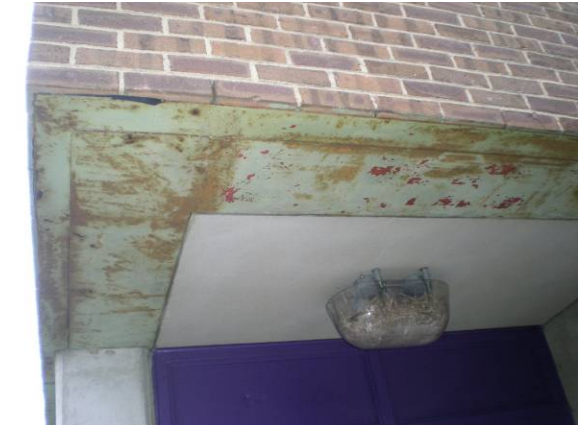
Photo #190: Steel lintel beginning to rust

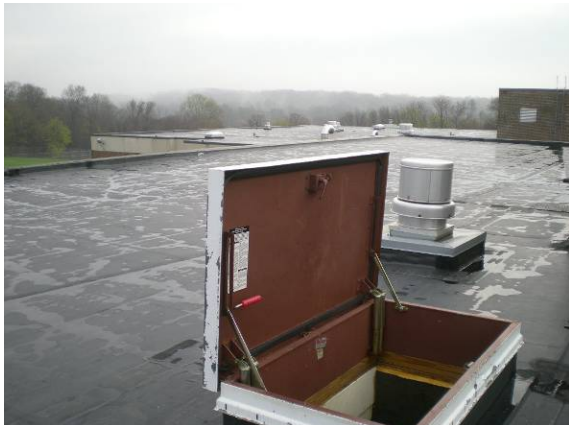
Photo #191: Roof hatch

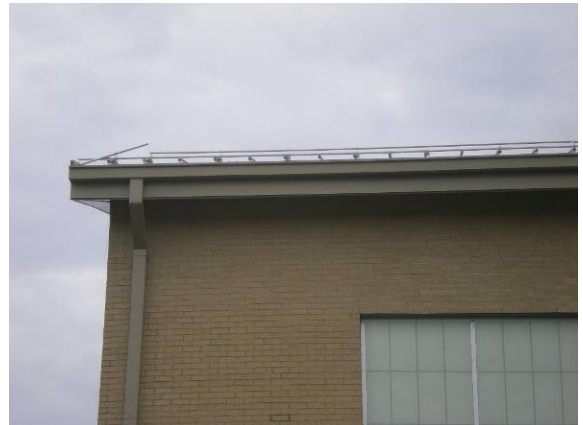
Photo #192: Damaged snow guard over new gym entrance – overall design of snow guard does not work

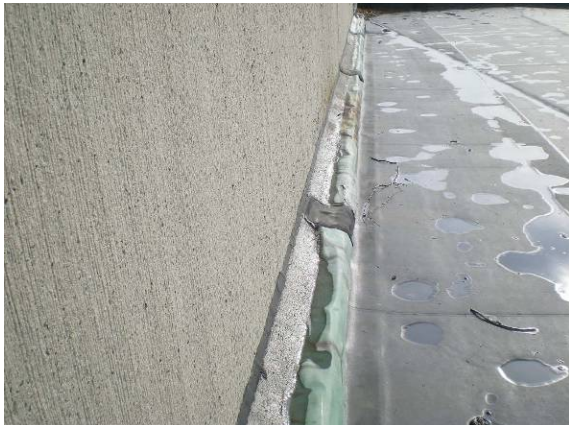
Photo #195: Roof flashing improperly shaped to hold water

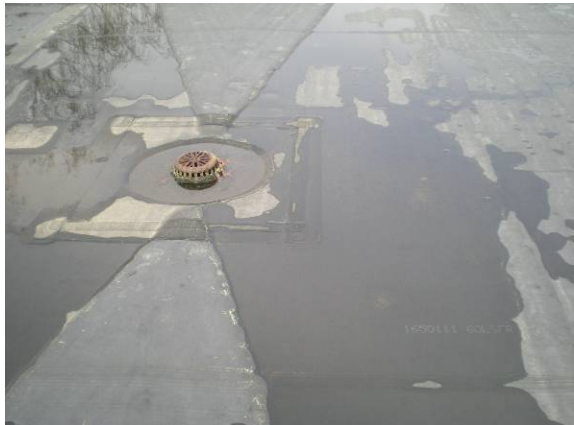
Photo #196: Large area of ponding at clogged roof drain

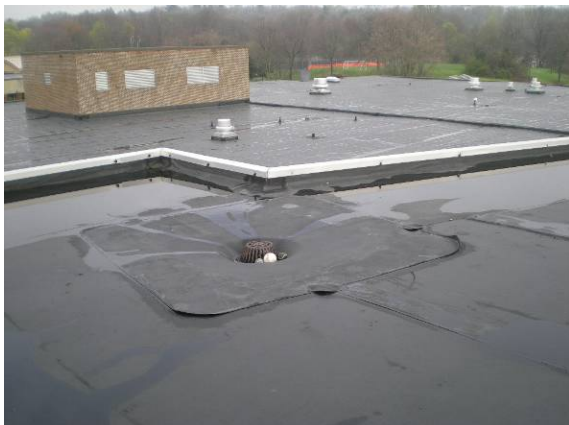
Photo #197: Failing roof patches and ponding areas not sloped to existing drains

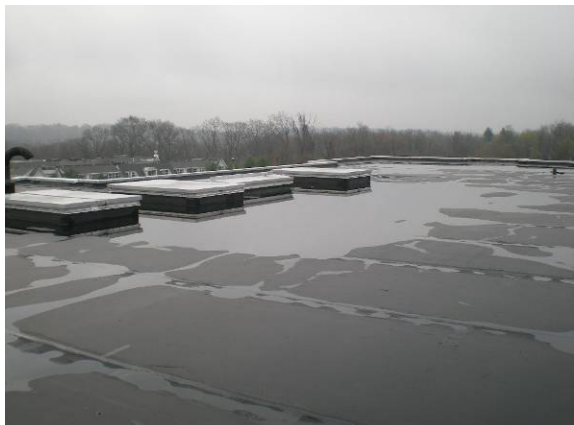
Photo #198: Large area of ponding at auditorium roof smoke evacuation hatches

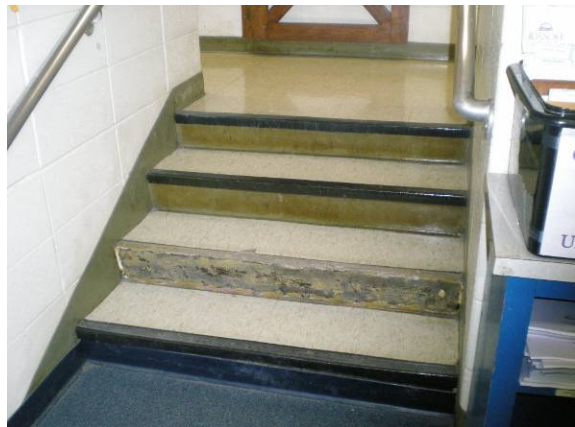
Photo #204: Finishes in guidance center – missing stair riser nosing and vinyl surface

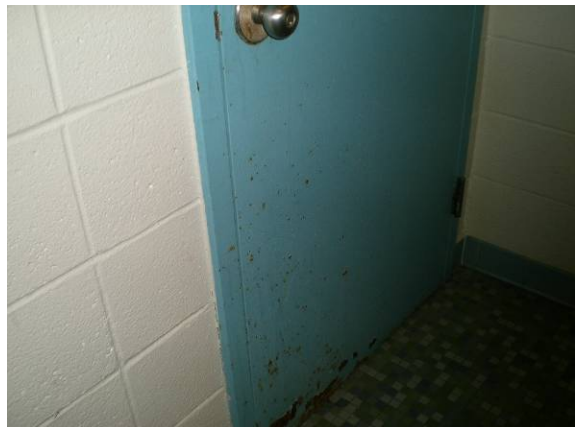
Photo #216: Door conditions in locker room off pool

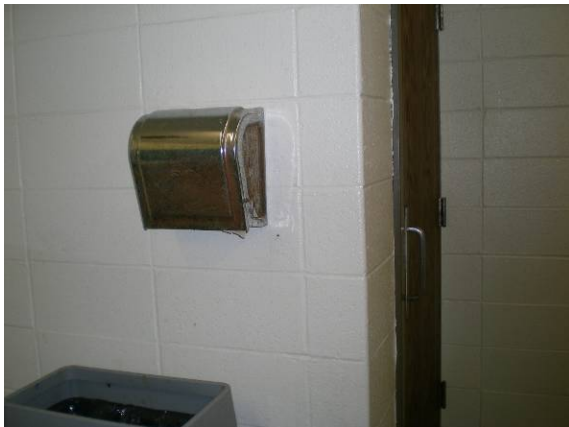
Photo #219: Paper towel dispenser requiring replacement due to twisting mechanism

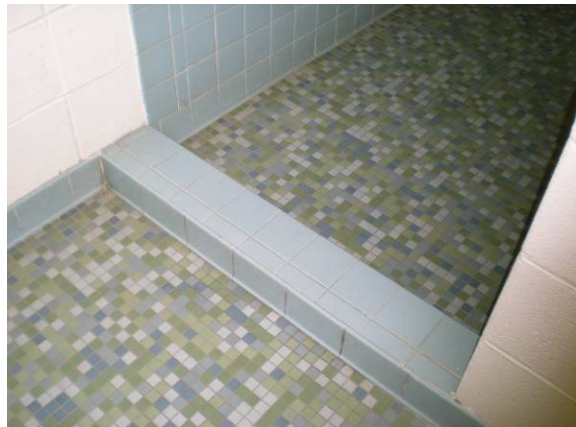
Photo #220: Entrance to Boys' Locker room – non-ADA

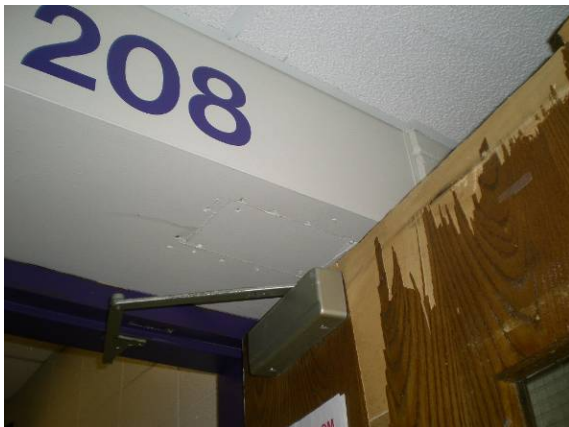
Photo #227: Condition of classroom door

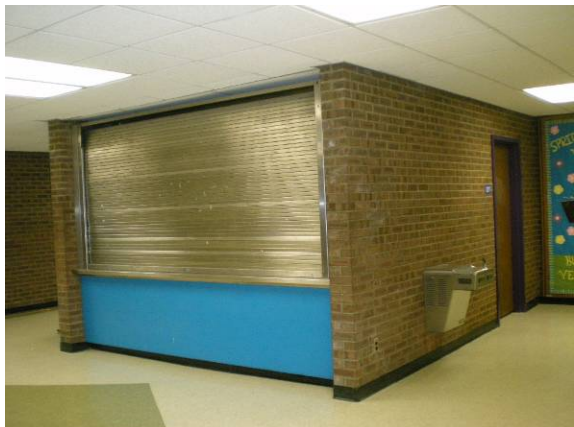
Photo #228: Student store

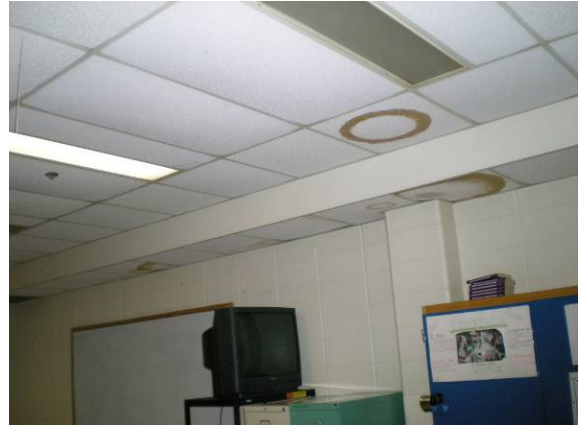
Photo #230: Leaks in classroom 435

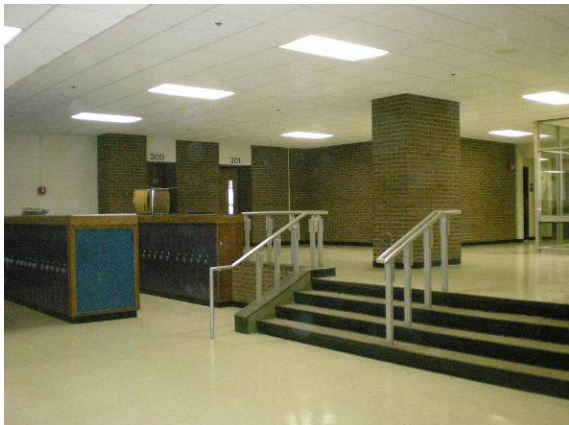
Photo #231: No ADA access to Main Office in Raynor (B) Wing

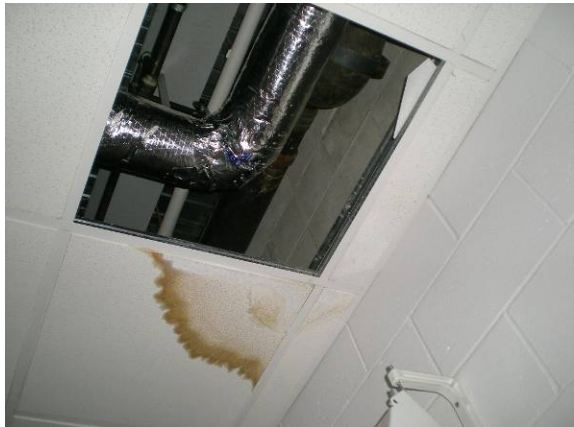
Photo #258: Leak in classroom #12

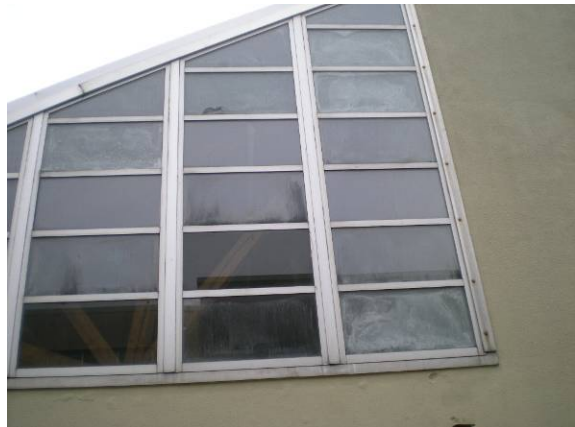
Photo #262: Close up of window damage

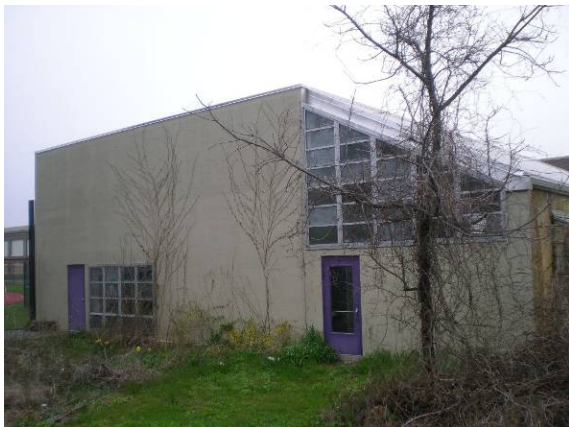
Photo #263: Old AgriScience Building – west elevation

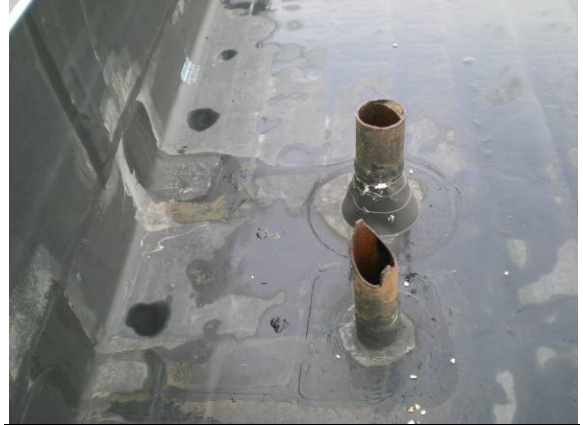
Photo #266: Close up of roof vent damage at old AgriScience Building

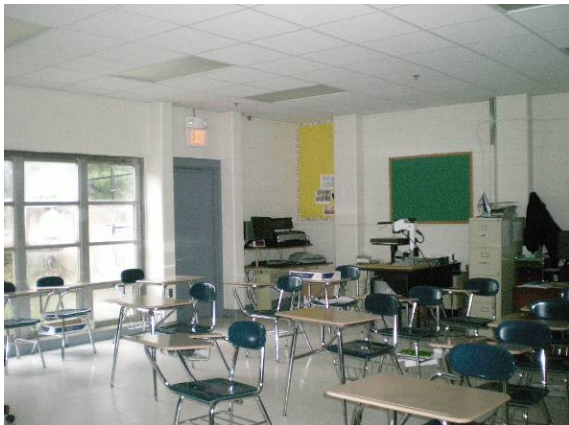
Photo #267: Classroom in old AgriScience Building

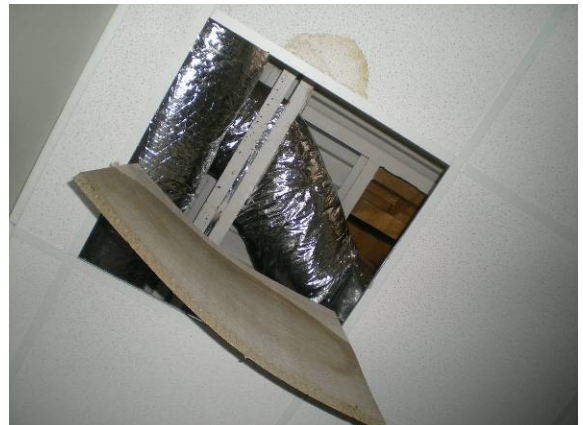
Photo #268: Leak at old skylight locations

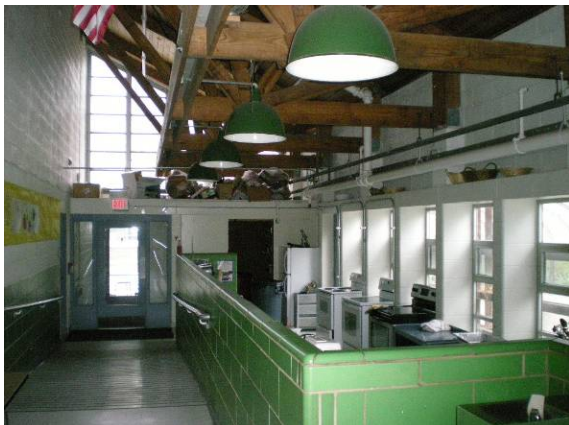
Photo #269: SPED classroom with kitchenette workstations and ADA access

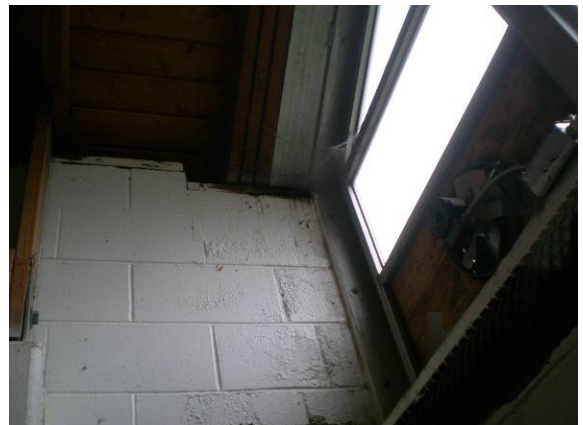
Photo #270: Water leak with rotted wood timber structure

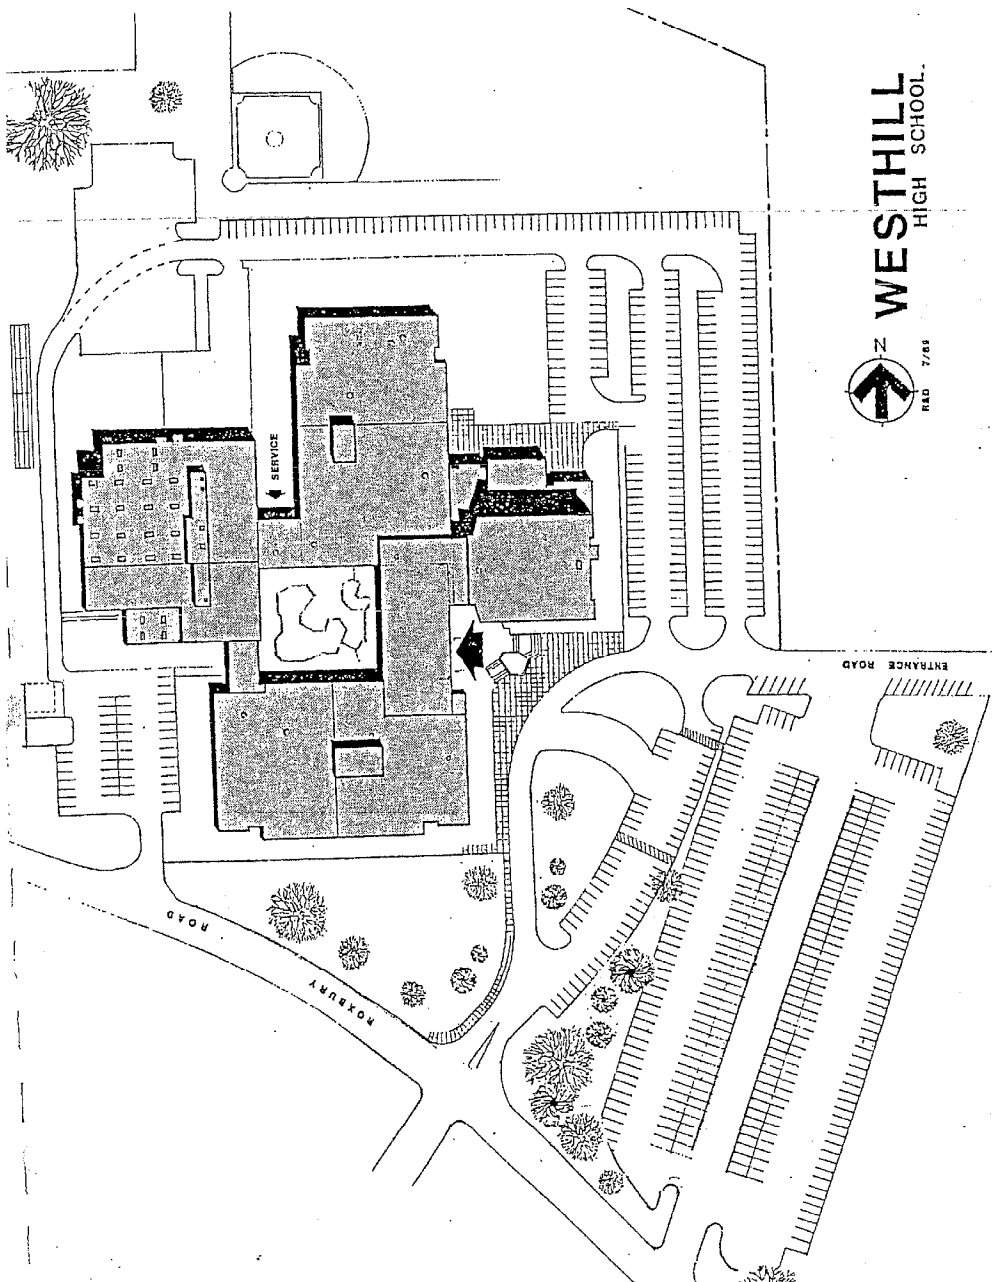
**APPENDIX B:
SITE AND FLOOR PLANS**
